EXHIBIT 2-A

Property Address:
195 Ardsley Ln
Alpharetta GA 30005

Inspector: Tim Skillingstad

Residential Inspector of America, Inc.

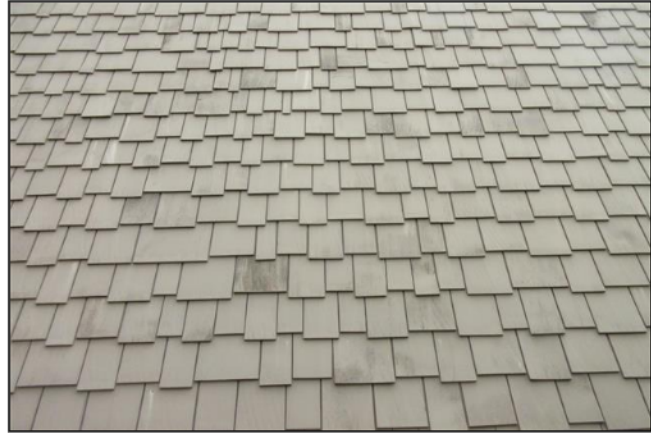
1.1 Item 1(Picture)

🔧 Wood shingle siding is prone to curling, cracking, carpenter bees and woodpeckers. This type of siding will have some boards curl due to seasonal heat or sunlight and this will help pull the nails loose.

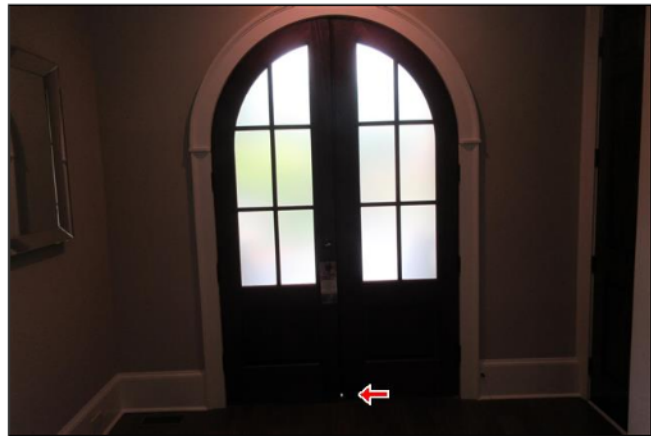
1.2 Item 1(Picture)

🔧 Adjust the weather stripping around the front of home door so that no light can be seen coming through the door while it is in the closed position.

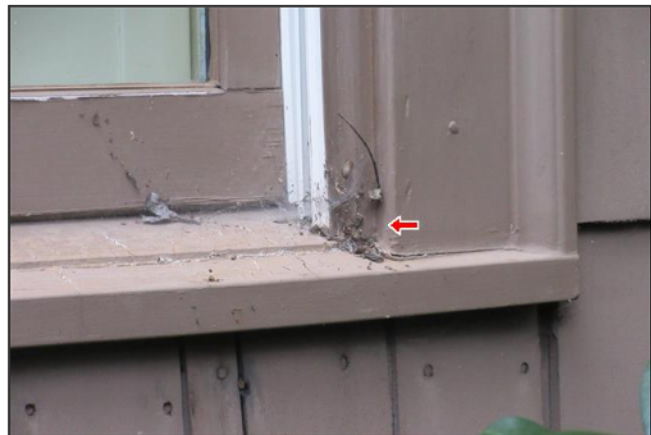
1.3 Item 1(Picture)

🔧 Recommend to repair/replace the water damaged wood trim on the window(s) at the right side of home. See photo(s) for location.

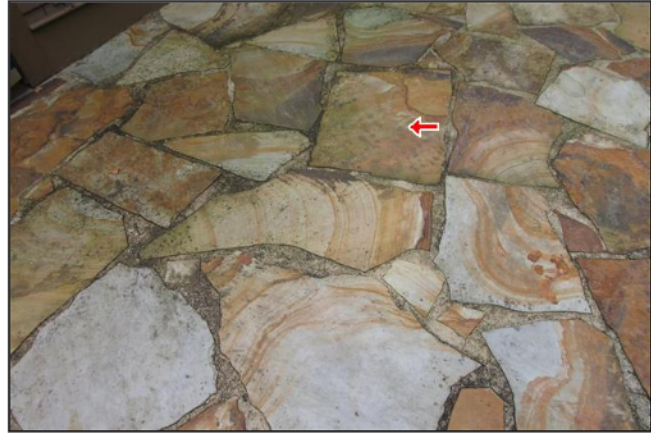
1.4 Item 1(Picture)

Patio has moss growing on stones.
Recommend to power wash to remove any fungus.

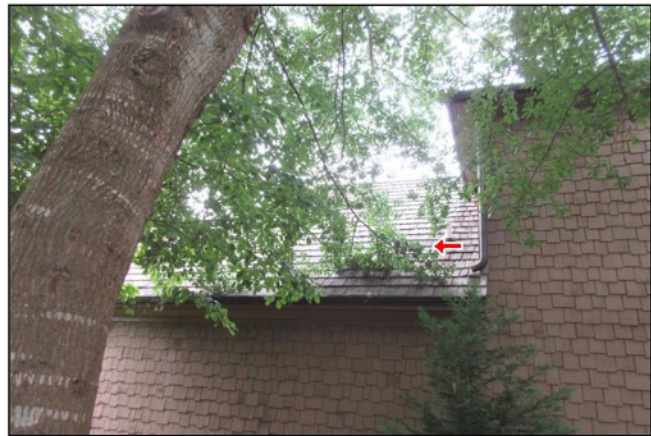
1.5 Item 1(Picture)

👉 (1) The tree limbs that are in contact with roof or hanging near roof at the right side of home and should be trimmed away. This will help prevent against rodent entry into the attic. See elevation photos for location.

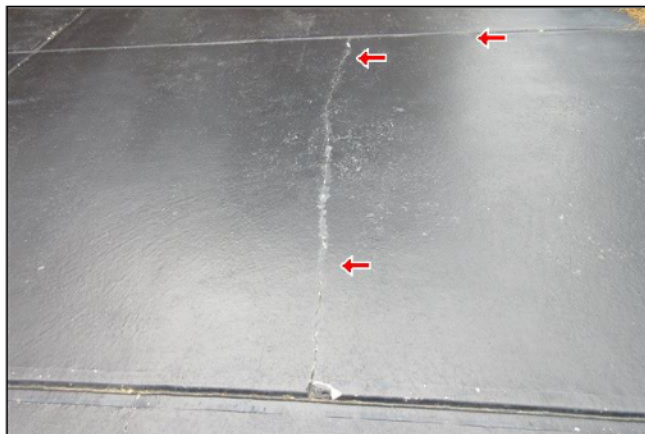
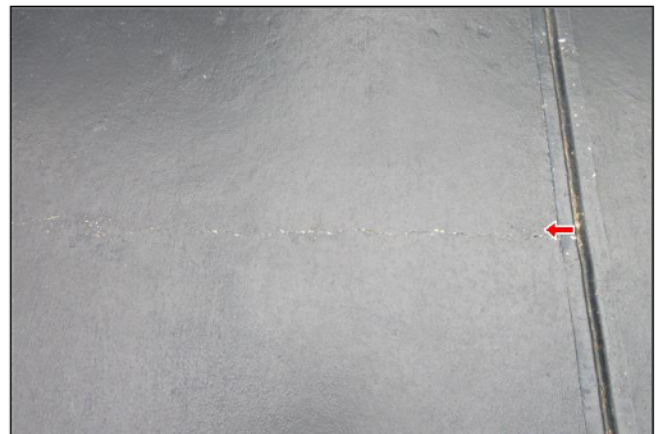
👉 (2) Recommend to repair or replace all cracked and settling portions of the driveway. See photo(s).

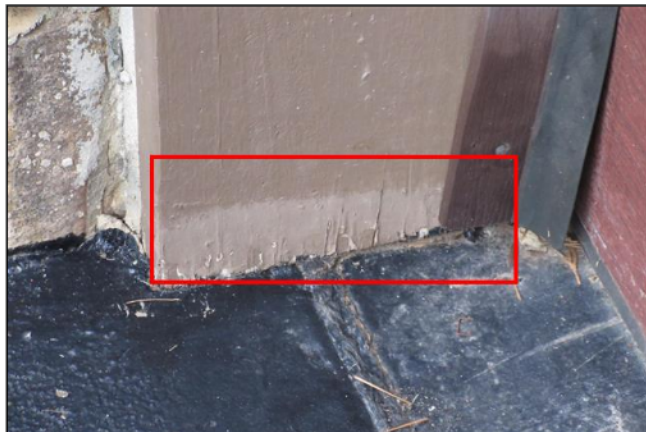
1.7 Item 1(Picture)

Repair the water damaged wood trim at the bottom of the garage door frame. See photo(s) for location.

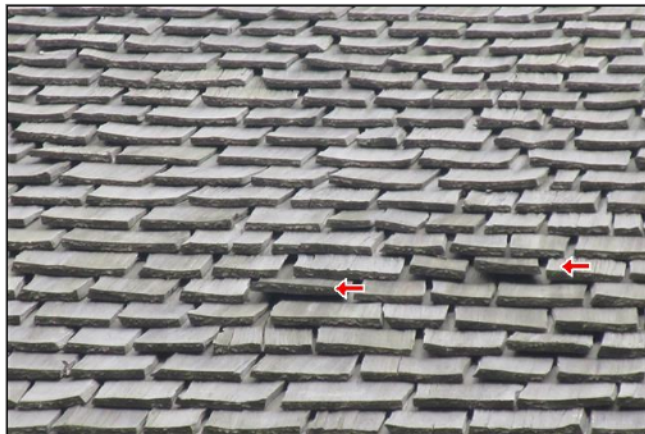
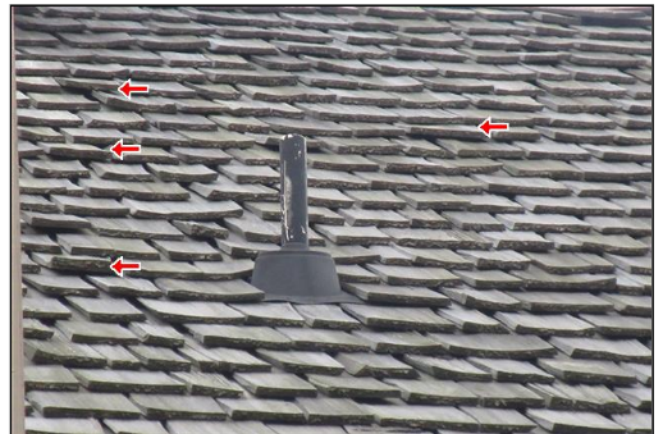
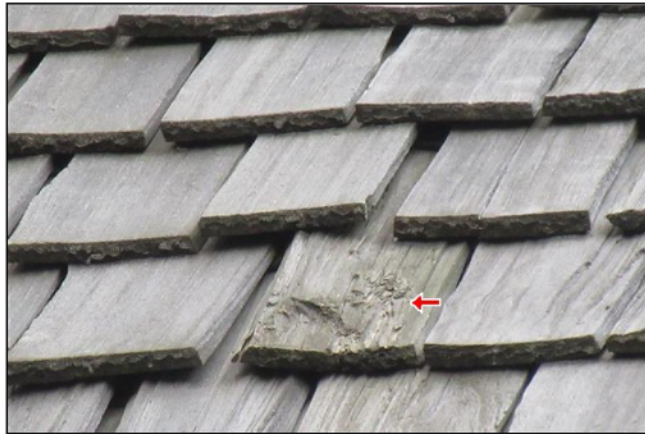
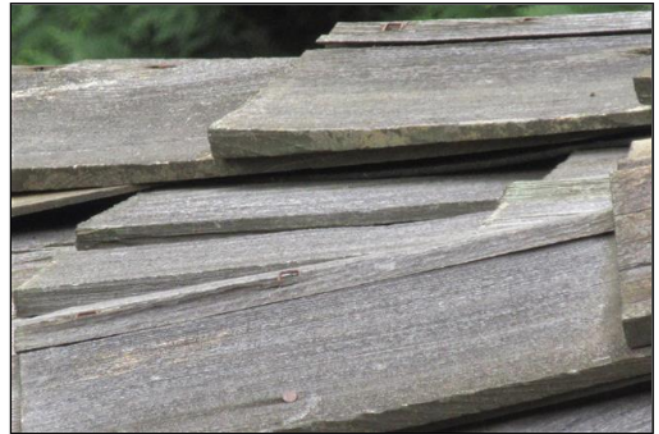
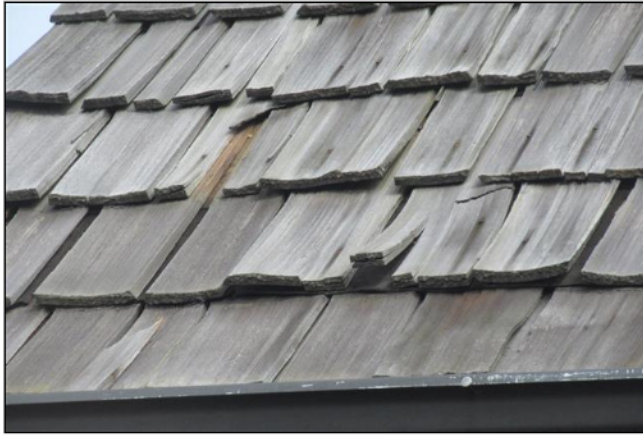
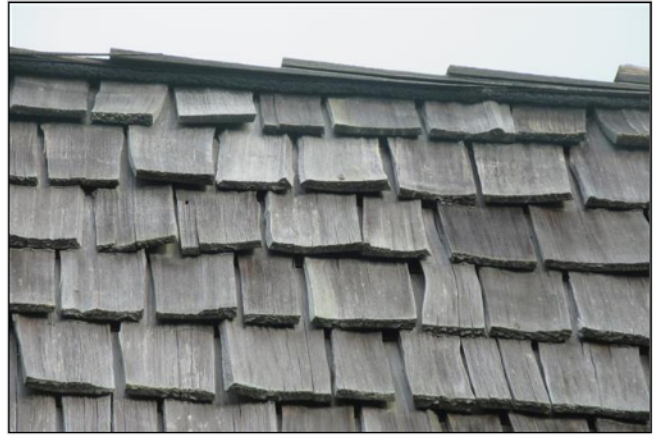
The wood shakes on the roof are showing signs of aging and are nearing the end of their expected life. It is recommended that a roofing contractor further evaluate this situation.

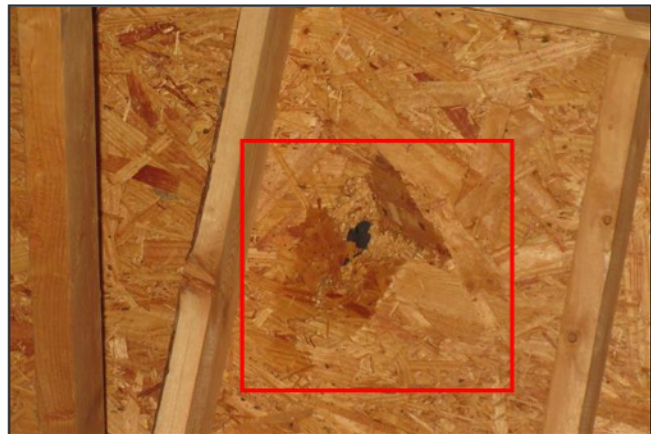
4.4 Item 1(Picture)

Water stains and possible slight damage noted on roof decking left of center (above Garage) in the attic. Roofer will need to evaluate roof and ensure that the roof covering is water tight. Even though these areas may not have been wet during this inspection, it is possible that outdoor and weather conditions could change and cause leaks to become active again. See photo(s) for location(s).

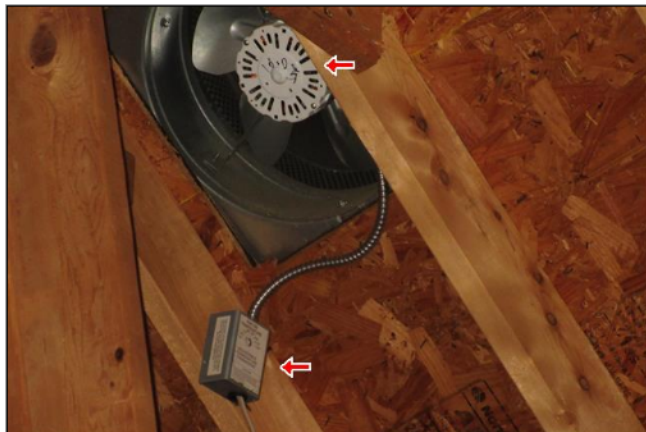
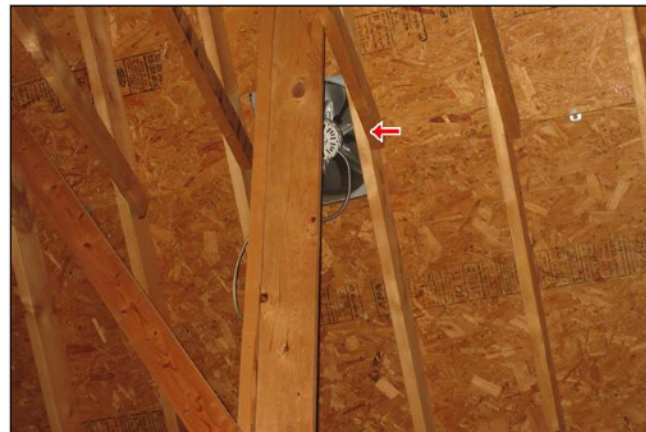
🔧 The power fan would not function at time of inspection. Make fan operational. The power fan is the primary form of ventilation for the attic. It is imperative that this fan operate to maintain circulation for the attic. This will increase the longevity of the roof. If the attic gets too hot then there is a possibility that the shingles could bake from underneath.

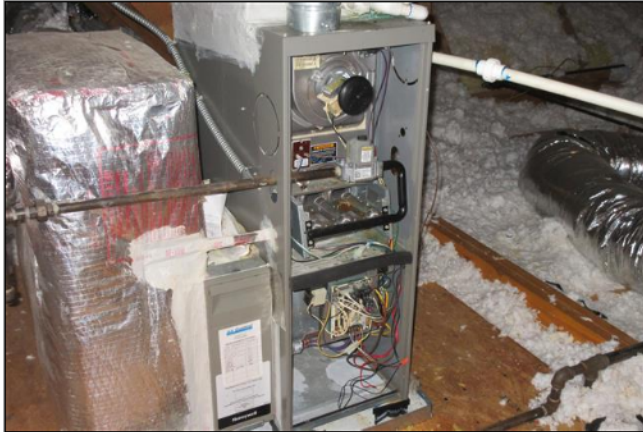
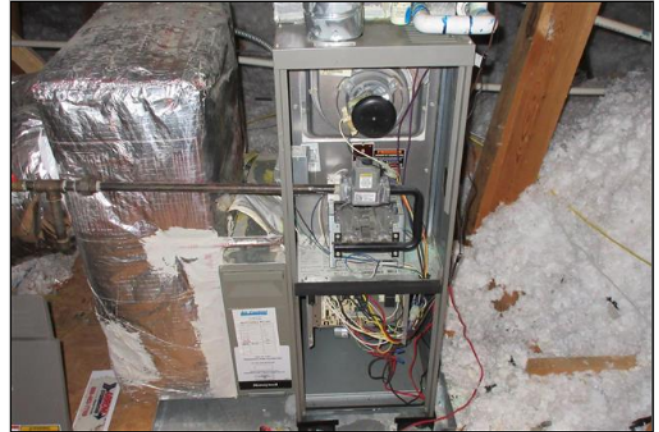
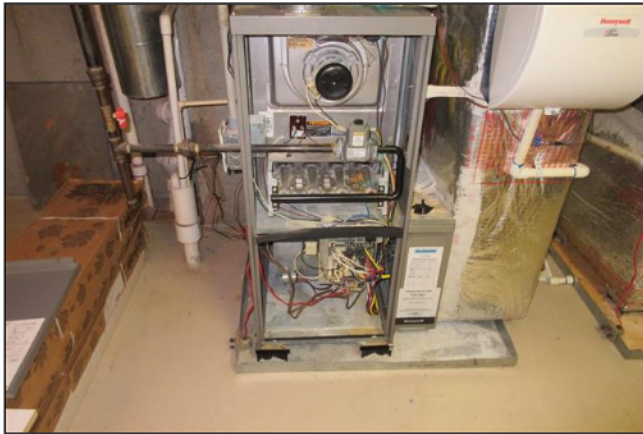
🔧 (1) Have an HVAC tech service the heating and cooling equipment to clean the blower motor, the evaporator coils, the condensing coils, the electrical contacts, check refrigerant levels, check size of units compared to size of home and ascertain that the heat exchangers are not cracked and the equipment is safe to operate and functioning properly. Most of internal parts of the HVAC system are concealed from view, and our inspection is visual and is intended to check the function of the systems. This inspection does not make any assessment of the internal parts of the air duct system, since it is not visible. Therefore, an HVAC tech should evaluate for any concealed defects or hazards in the system. Furthermore, manufacturers recommend annual maintenance and servicing to keep the system working at peak efficiency.

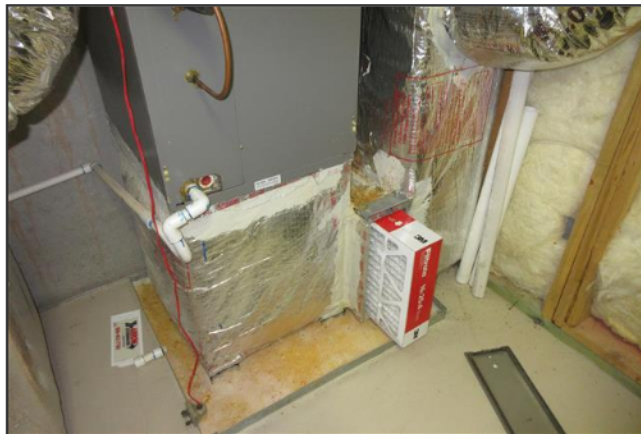
6.0 Item 4(Picture) heat pump

🔧 (2) Have an HVAC tech service the heating and cooling equipment to clean the blower motor, the evaporator coils, the condensing coils, the electrical contacts, check refrigerant levels, check size of units compared to size of home and ascertain that the equipment is operating properly and efficiently. Most of internal parts of the HVAC system are concealed from view, and our inspection is mostly visual and is intended to check the operation of the system(s). Therefore, an HVAC tech should evaluate for any concealed defects or hazards in the system. Furthermore, manufacturers recommend annual maintenance and servicing to keep the system working at peak efficiency.

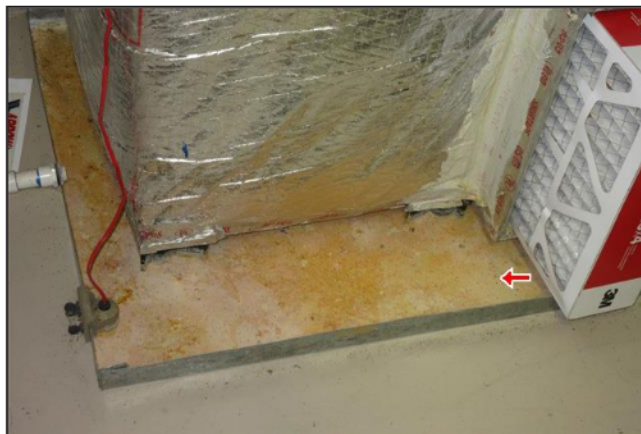
6.0 Item 5(Picture)

🔧 (3) Visible rusting noted on the overflow pan for the air handler in the basement utility room. This may be caused by a clogged condensate drain line or a blockage in the evaporator coil. Recommend to have HVAC contractor inspect for further evaluation and repair as needed. See photo(s).

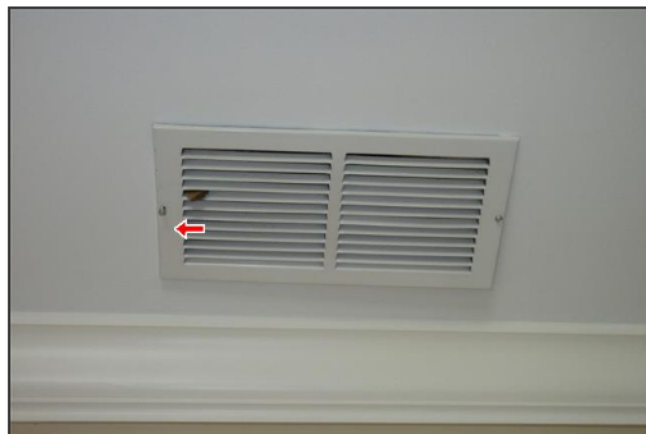
6.2 Item 4(Picture)

🔧 (2) Secure the loose register to the ceiling in the left front bedroom to eliminate the rattling noise. .

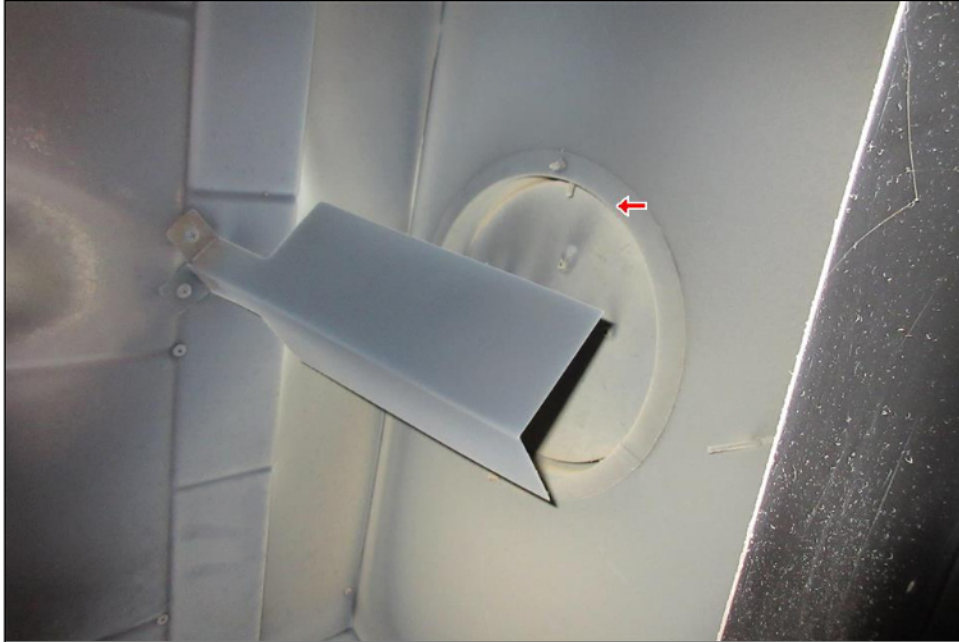
6.6 Item 1(Picture)

🔧 C-clamp needed on the damper in the master bedroom fireplace, because gas logs are in use. C-clamp will prevent the damper from being shut and allowing some carbon monoxide to escape into the living space.

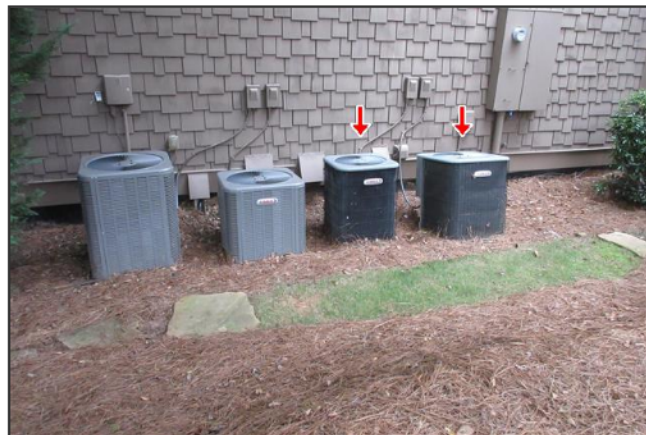
6.7 Item 1(Picture)

🔧 (1) This A/C unit(s) uses the older R-22 type of refrigerant gas (freon) that is being phased out of production and will likely be expensive and difficult to find in the near future. The newer type of refrigerant does not mix with the older type. This is for your information.

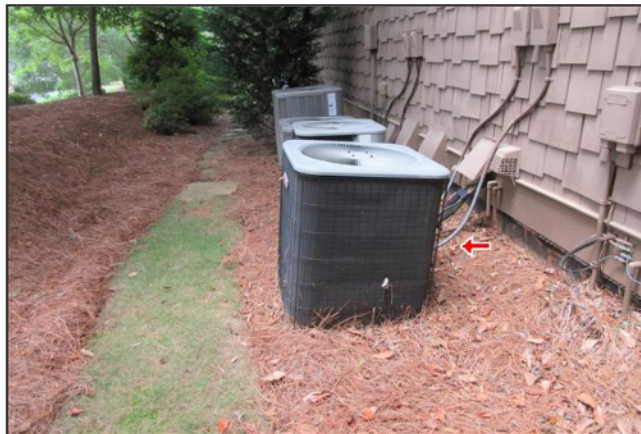
6.7 Item 2(Picture)

👉 (2) Recommend to have the compressor(s) on the side of the home properly leveled. This will help prevent potential damage to the unit(s). See photo(s).

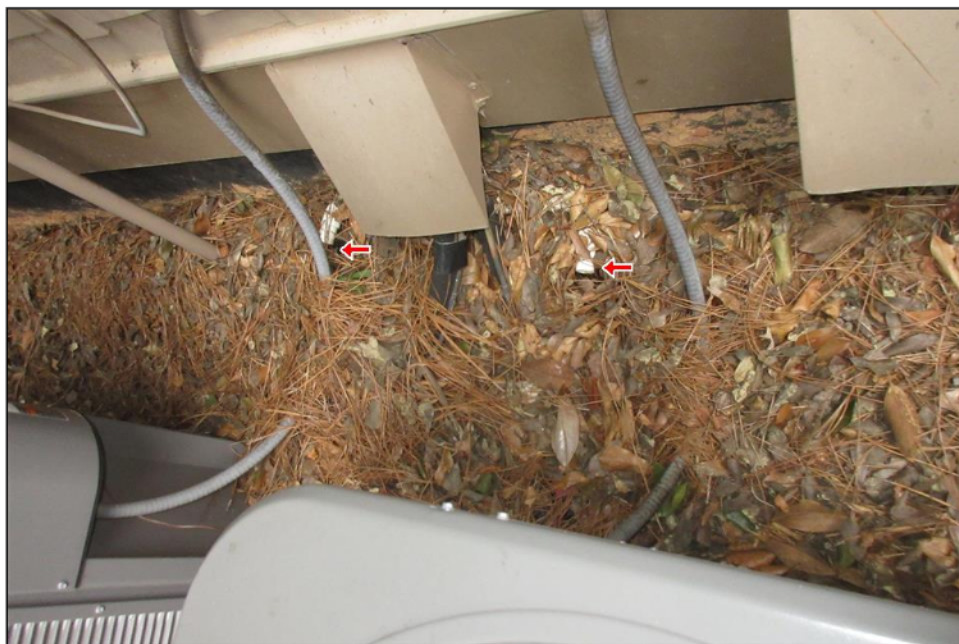
6.7 Item 4(Picture)

👉 (4) The condensate drain lines are buried in the soil at the right side of the home. Recommend to have these lines cleared of debris and free flowing. See photo(s).

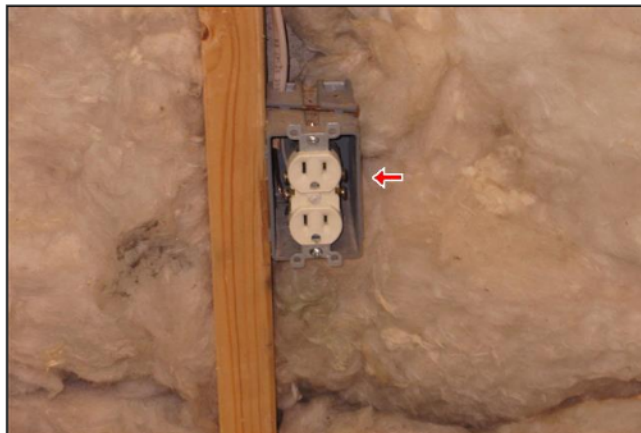
7.5 Item 1(Picture)

🔧 Recommend to place a cover over the exposed outlet in the basement mechanical room. Covers are used to control sparking.

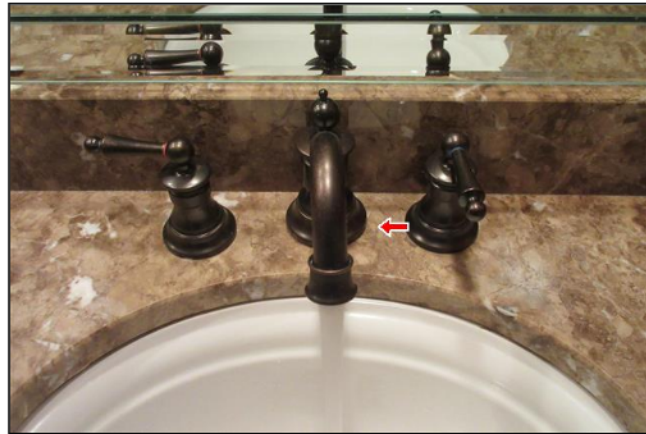
8.2 Item 1(Picture)

🔧 (1) The faucet for the right side master bath sink is loose to the countertop. Recommend to secure faucet and make area water tight.

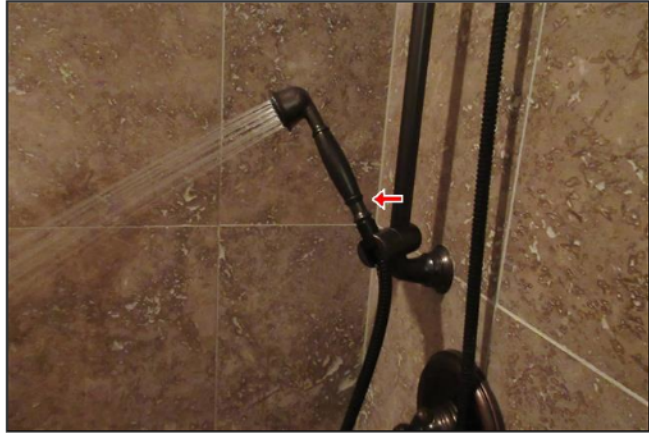
8.2 Item 2(Picture)

🔧 (2) Recommend to repair the leaking shower head in the master bath. Teflon tape may help resolve this issue. Have plumber inspect and make necessary repairs.

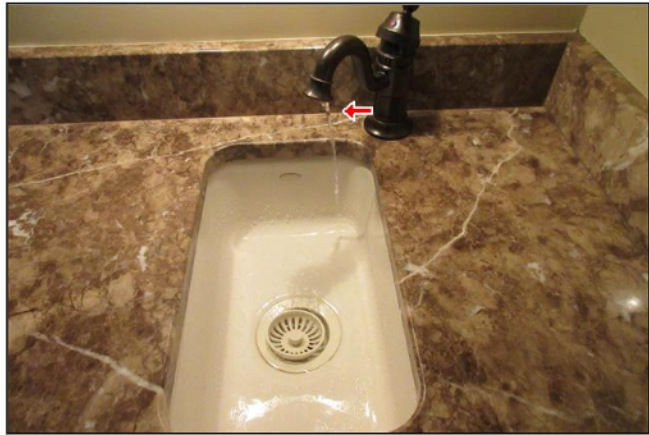
8.2 Item 3(Picture)

🔧 (3) Faucet for the sink in the master bedroom had no pressure and water only trickled out. Recommend to have plumber evaluate to repair or replace.

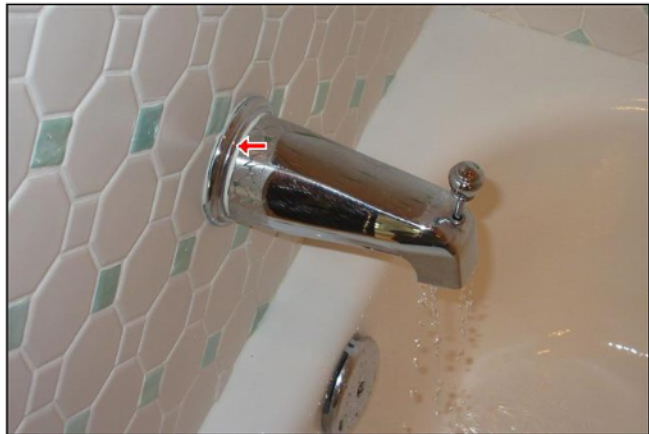
8.2 Item 4(Picture)

🔧 (4) Seal around the faucet where it meets the shower in the upstairs center bath. This will help prevent water from leaking behind the wall cavity.

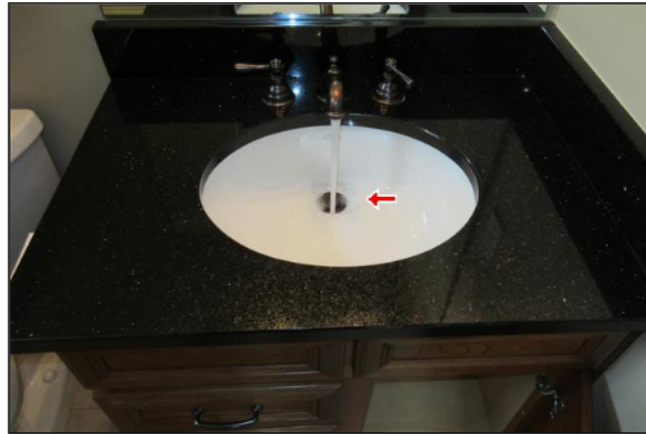
8.2 Item 5(Picture)

🔧 (5) The sink in the upstairs left front bath drained very slowly. Have the drain line checked for a possible clog.

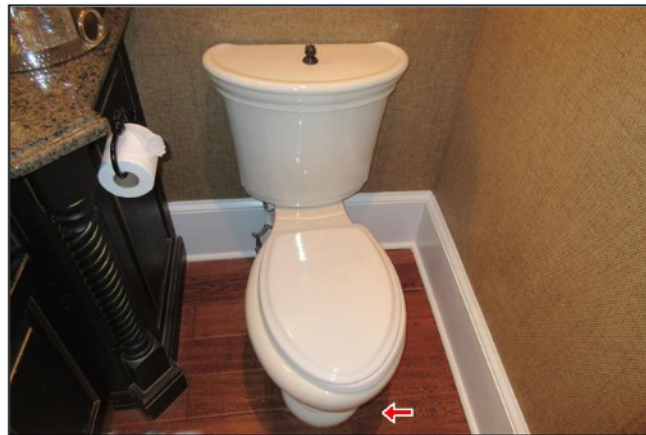
8.2 Item 6(Picture)

🔧 (6) Recommend to secure the loose toilet to the floor in the main hall bath. This will help prevent damage to the wax ring and possible leakage.

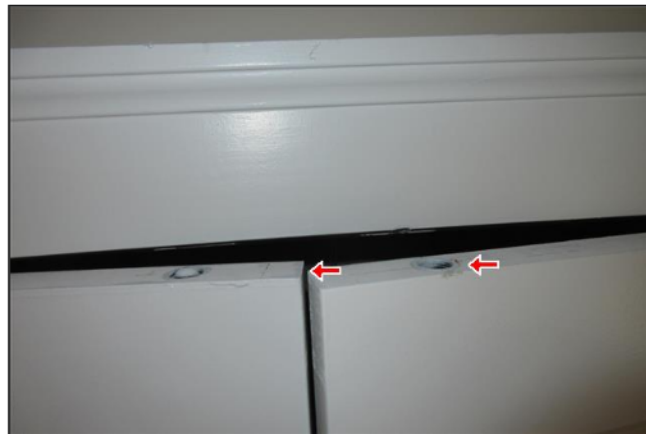
9.5 Item 1(Picture)

🔧 (1) Recommend to adjust the front center bedroom closet door so that it fits in the frame properly.

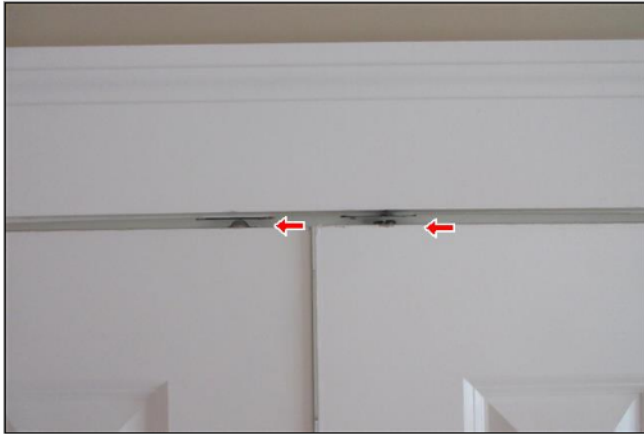
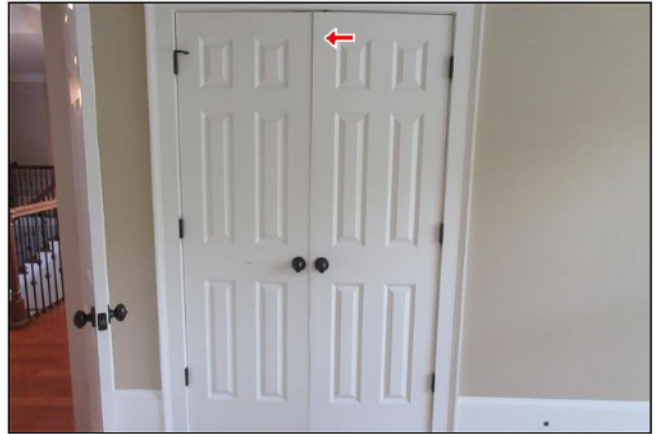
🔧 (2) Recommend to adjust the front left bedroom door so that it latches properly.

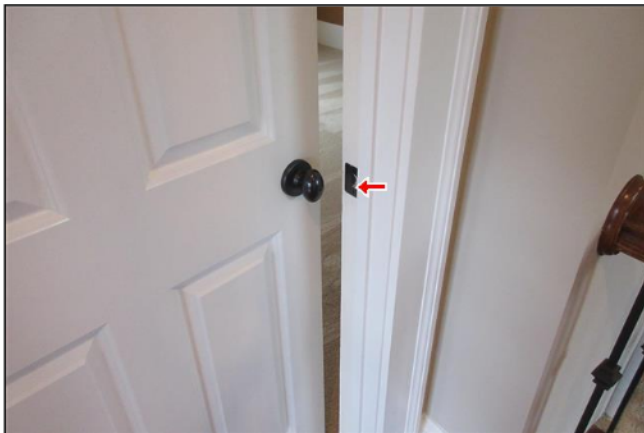
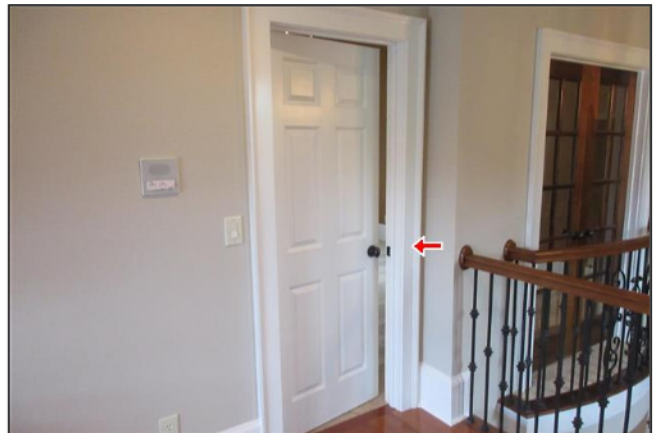
🔧 (3) Recommend to adjust the rear left bedroom door so that it latches properly.

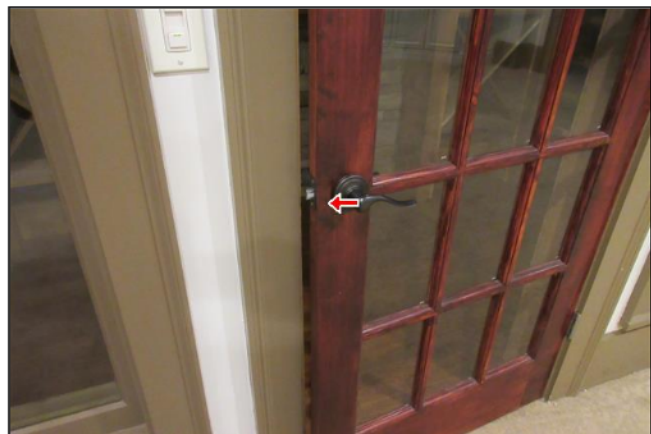
9.5 Item 6(Picture)

🔧 (4) Recommend to adjust the wine cellar door so that it latches properly.

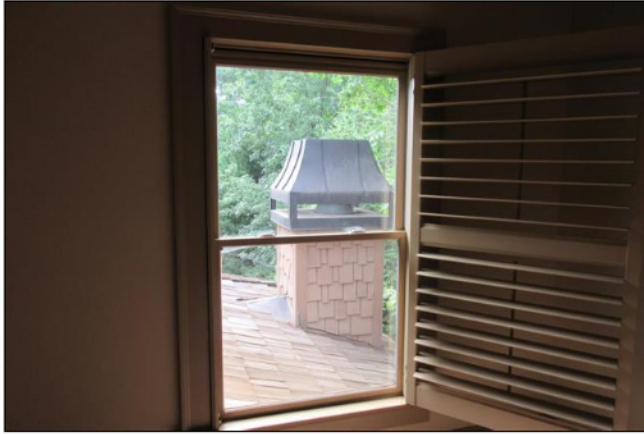
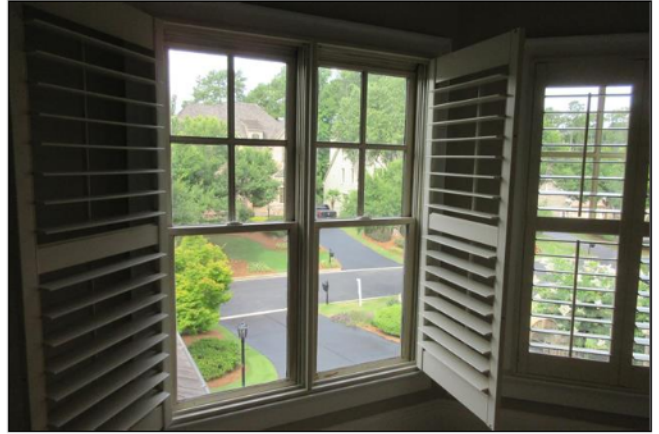
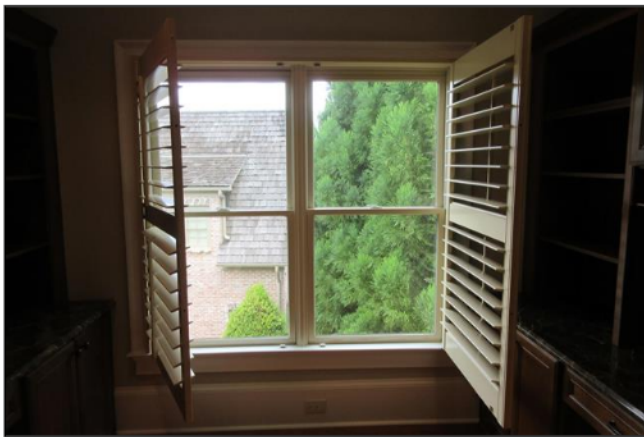
Many of the windows were stuck in place and would not open. Have this condition corrected. There should be at least one operable window in each room for means of egress during an emergency.

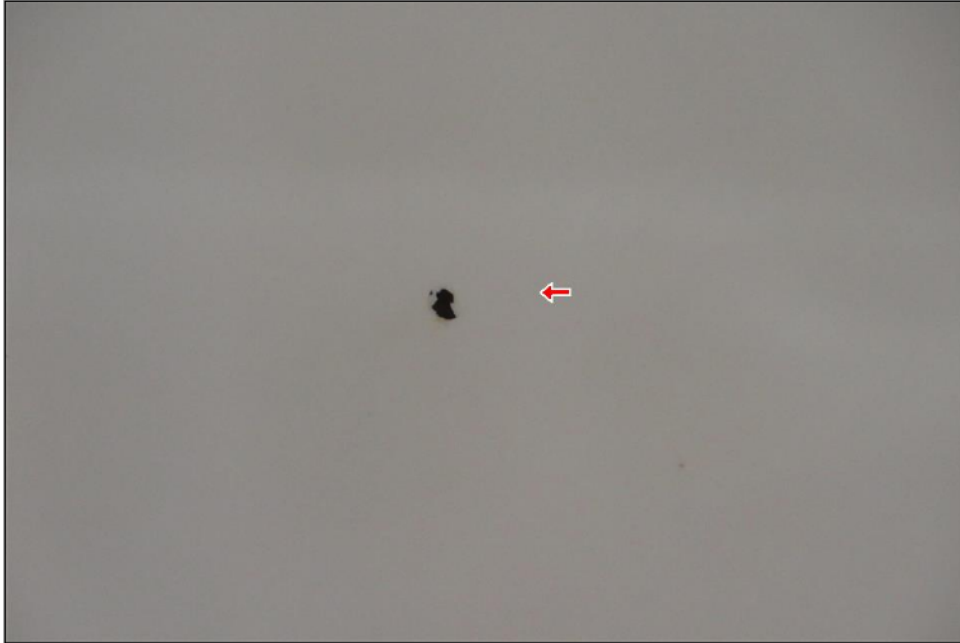
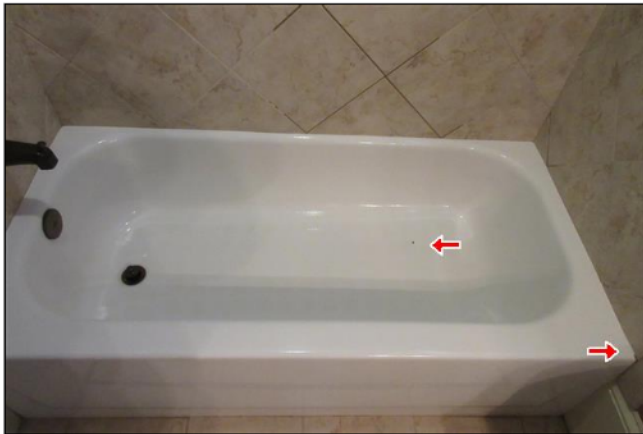
🔧 (2) Repair the chip(s) in the tub for the upstairs rear left bath. Chips in the tub can rust and eventually cause leaks.

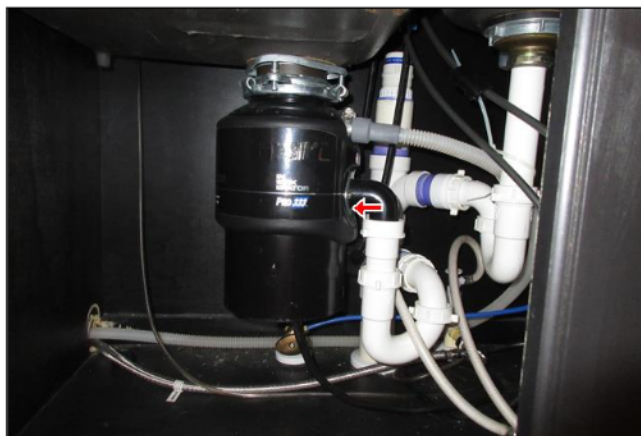
10.3 Item 1(Picture)

🔧 Recommend to make the garbage disposal in the main kitchen operational. It would not test at the time of the inspection.
