## Property Inspection Report

Property address: **1795 Horsham Trail  
Alpharetta GA 30004**

Inspection date: **Wednesday, August 5, 2020**

**Report number:** 080520JM1

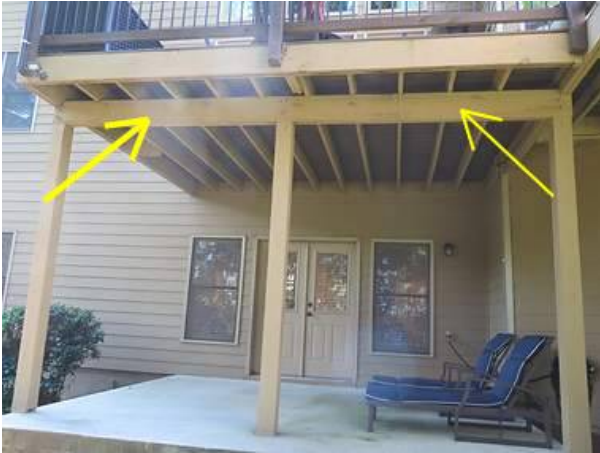
Photo 4-1

4) **+** One or more decks or porches were unstable due to missing or substandard bracing, or lack of attachment to the main structure.

This is a safety hazard since severe movement may cause the decks or porches to collapse. Recommend that a qualified contractor evaluate and provide options and costs to repair per standard building practices prior to the end of the contingency period.

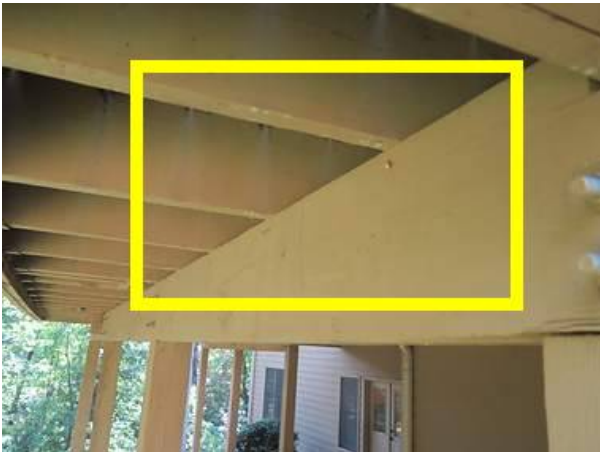
Photo 5-1

The beams appear to be improperly attached to the post. This could result in a structure collapse causing injury. Decks and porches are subject to movement under live loads and require a positive connection between their support posts and beams. Currently accepted standards recommend that beams should be supported by posts and footings that are properly spaced.

Deck or porch beams are commonly connected to support posts by "toenailing," which is inadequate. Recommend that a qualified contractor repair per standard building practices. For example, by installing metal plates, plywood gussets or dimensional lumber to connect posts and beams.

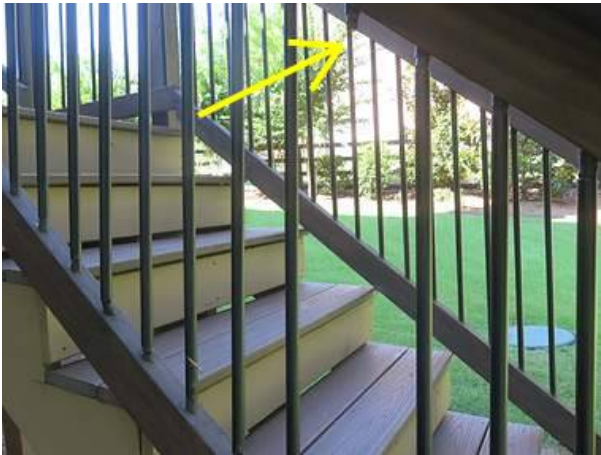
Photo 7-1

Guardrails at one or more locations with drop-offs higher than 30 inches had gaps that were too large. This poses a safety hazard for children (e.g. falling, getting stuck in railing). Guardrails should not have gaps or voids that allow passage of a sphere equal to or greater than 4 inches in diameter, or 6 inches in diameter at triangular spaces between stair edges and guardrails. Stair guards should not have gaps or voids that allow passage of a sphere equal to or greater than 4 3/8 inches in diameter. Recommend that a qualified contractor repair or replace guardrails per standard building practices.

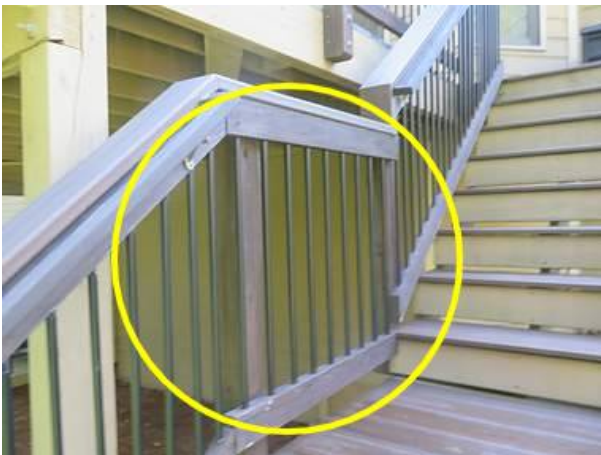
Photo 8-1

Handrails at one or more flights of stairs were loose and/or wobbly. This is a safety hazard. Recommend that a qualified person repair as necessary.

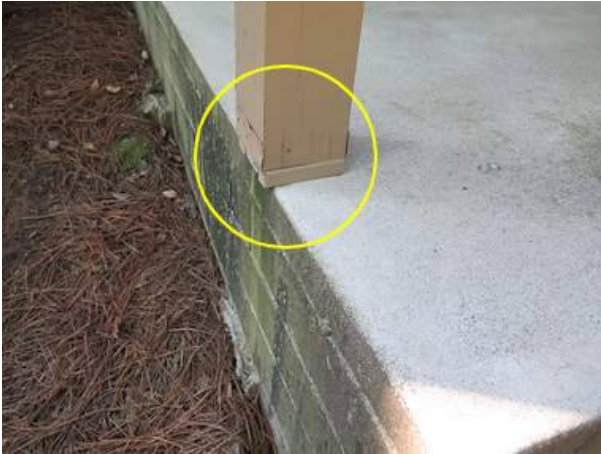
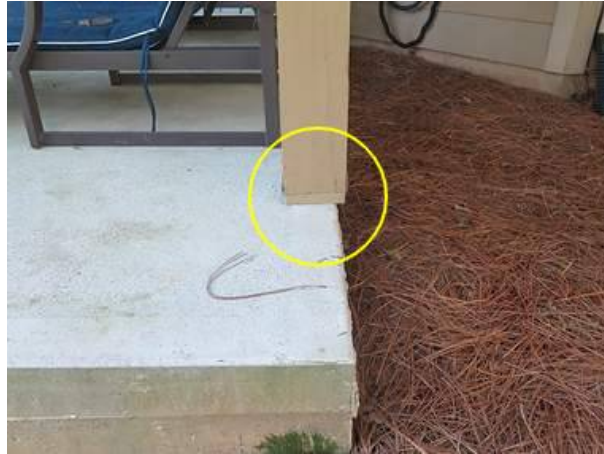
The concrete footings below one or more posts supporting the deck were substandard or missing. (Footings should be a minimum of 12" x 12", 7" thick, and 12" below grade or equivalent). **The posts should be centered on one-third of the footing.** Recommend that a qualified -contractor evaluate

and provide options and costs to repair per standard building practices prior to the end of the contingency period.

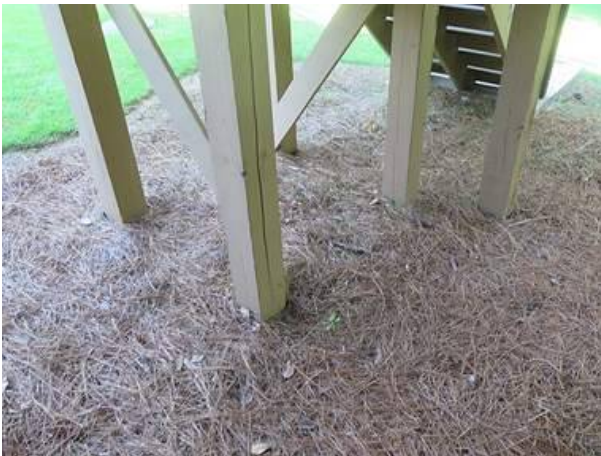
Photo 10-1

The inspector was unable to fully evaluate the deck footings and their attachment to the support posts. They were buried and not visible. The inspector was unable to confirm whether the footings are the proper size and if the deck support posts are properly attached to the footings. The inspector was unable to determine the condition of the support post below ground level. Recommend evaluation by a qualified contractor if you wish additional information about the condition of the support posts and footings.

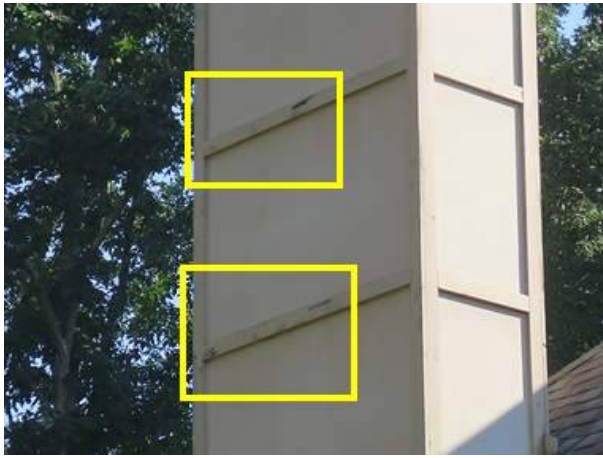
Photo 12-1

Some sections of siding and/or trim were deteriorated and/or damaged. Recommend that a qualified person repair, replace or install siding or trim as necessary.

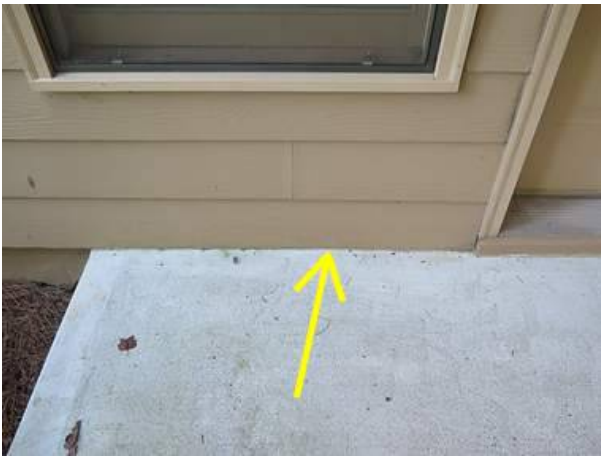
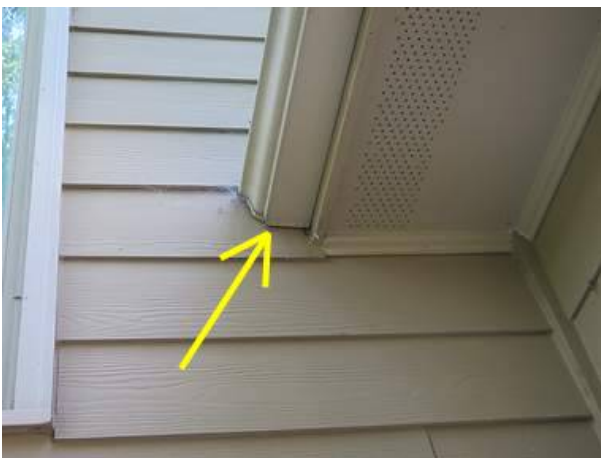
Clearances between the cement-fiber siding and surfaces below and/or gutter end caps were too small. Moisture can penetrate and damage the siding as a result, and the manufacturer's warranty can be voided. Normally, minimum clearances below the bottom of cement-fiber siding and trim include:

Recommend that a qualified contractor repair per the siding/trim manufacturer's specifications.

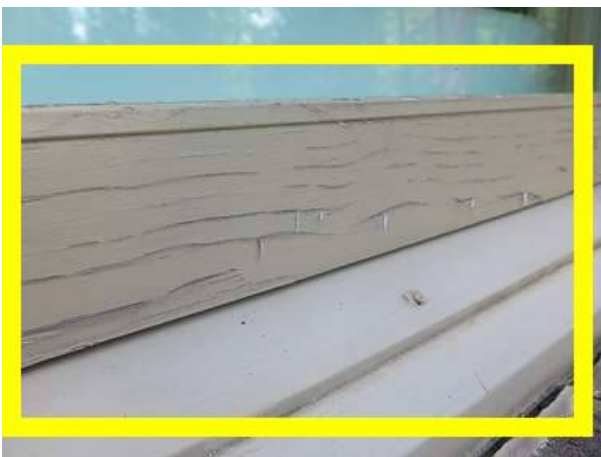
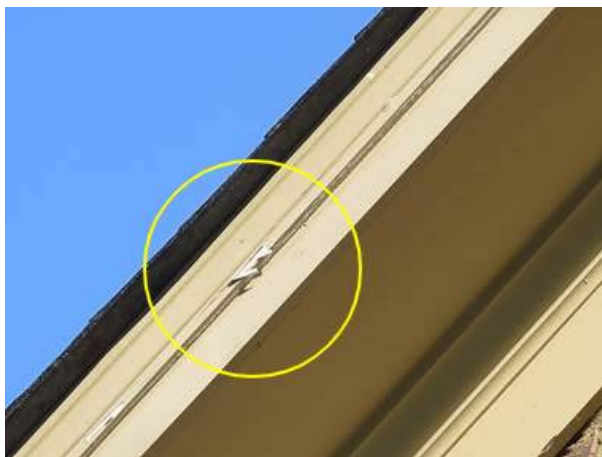
14) 🛠️💧 The paint or stain finish in some areas was failing (e.g. peeling, faded, worn, thinning). Siding and trim with a failing finish can be damaged by moisture. Recommend that a qualified contractor prep (e.g. clean, scrape, sand, prime, caulk) and repaint or restain the building exterior where necessary and per standard building practices. Any repairs needed to the siding or trim should be made prior to this.

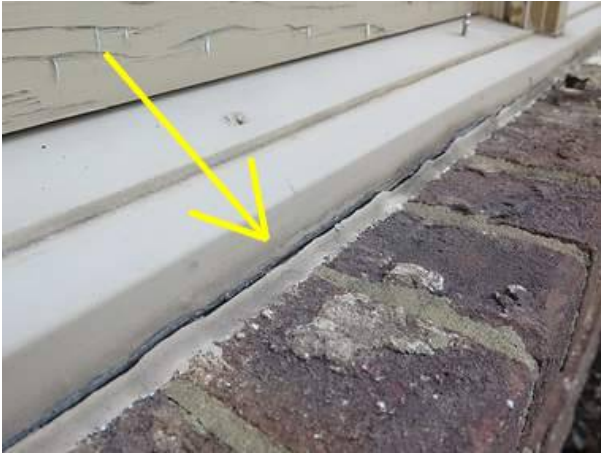
Photo 15-1

15) 🛠️💧 Sealant was deteriorated in some areas. For example, around windows. Recommend that a qualified person renew or install sealant (caulking) as necessary. Where gaps are wider than 1/4 inch, an appropriate material other than sealant should be used. For more information, visit: <https://www.reporthost.com/?CAULK>

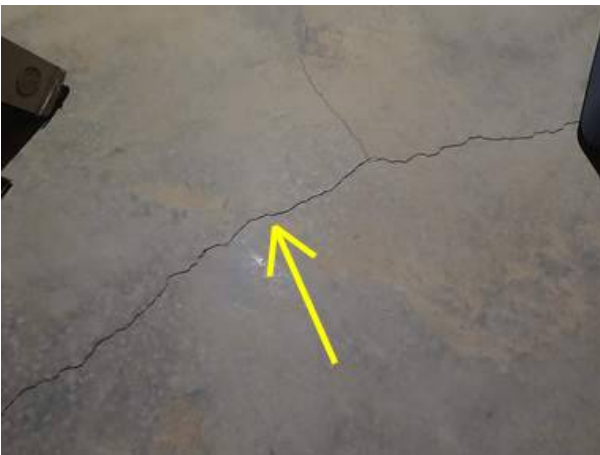
Photo 18-1

Minor cracks were found in the concrete slab floor. These are common and appeared to be only a cosmetic issue.

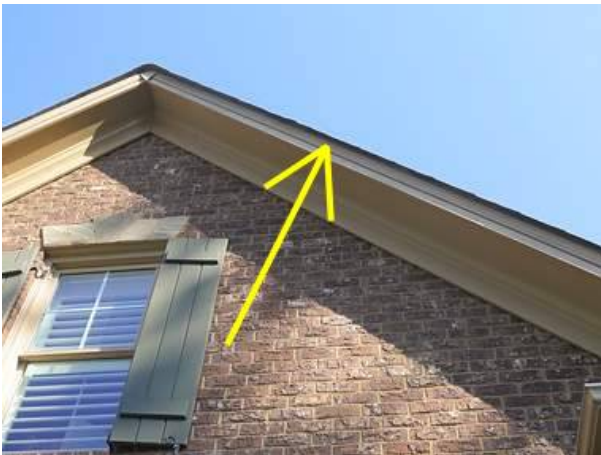
Photo 20-1

No "drip edge" flashing was visible at roof eaves (lower edges) or rakes (gable end edges). Drip edge helps prevent water from soaking into the edges of the roof sheathing material (typically plywood or oriented strand board). This reduces the chance of fungal rot or deterioration from water damage in the roof sheathing. Recommend that a qualified contractor install drip edge flashings where missing and per standard building practices.

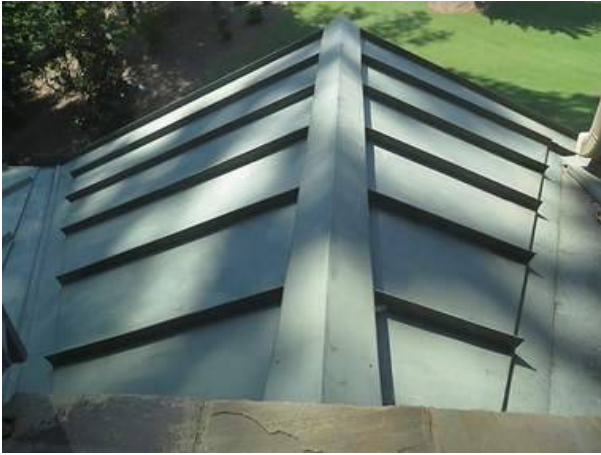
Photo 21-1

One or more sections of metal roofing had a failing paint finish. For example, peeling and/or missing paint. The service life of the metal roofing may be reduced as a result. Recommend having a qualified contractor prep and repaint metal panels where necessary.

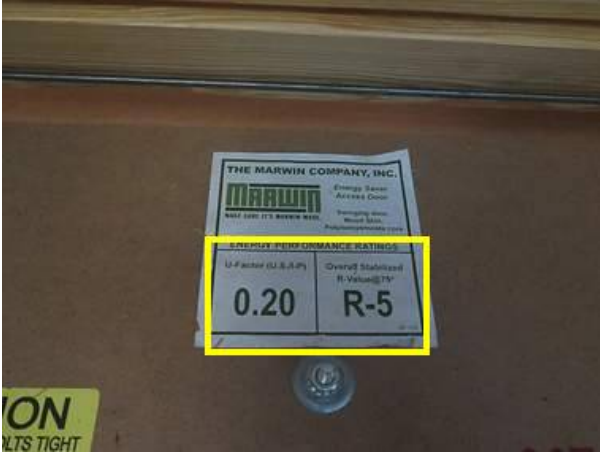
Photo 23-1

The pull-down attic stairs were poorly insulated. Typically, such stairs that are not insulated also do not have any weatherstripping installed. Recommend that a qualified person install insulation and weatherstripping per standard building practices for better energy efficiency. For more information, visit:

\*Note that code requirements for hatches have recently been tightened. According to the 2009 IECC and IRC, "Access doors from conditioned spaces to unconditioned spaces ... shall be weatherstripped and insulated to a level equivalent to ... surrounding surfaces." In this home that would be an R30 or equivalent.

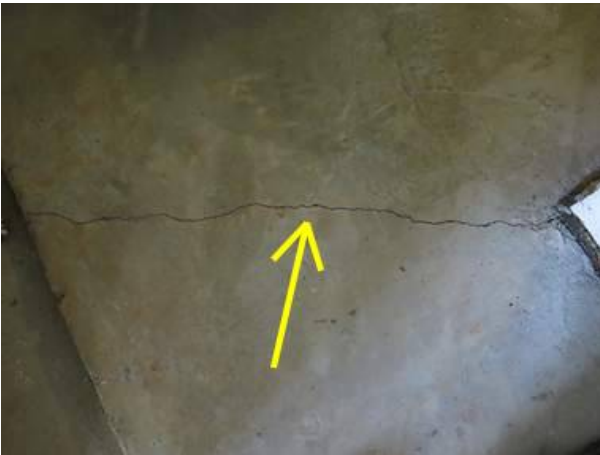
Photo 29-1

29) ⓘ Minor cracks were found in the concrete slab floor. These are common and appeared to be only a cosmetic issue.

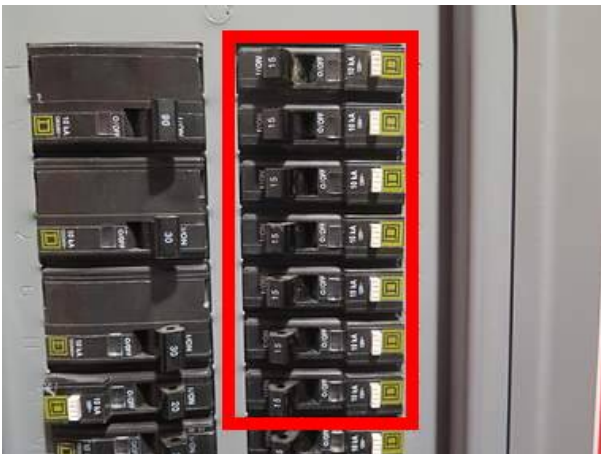
Photo 33-1

Arc fault circuit interrupter breakers were installed in one or more electrical panels. These devices reduce the risk of fire by protecting against overheated or arcing receptacles (outlets) or light fixtures. The inspector did not test or trip these devices during the inspection because doing so would disrupt power to clocks, computers and other devices that might be in use. Recommend that upon taking occupancy, and periodically in the future, the homeowner test AFCI breakers per the manufacturer's guidelines.

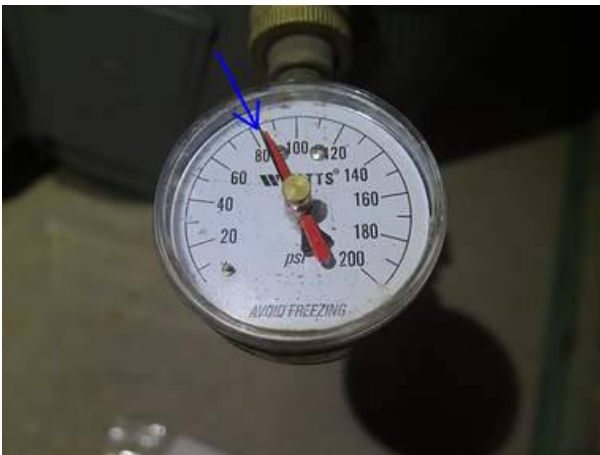
Photo 34-1

The water supply pressure was greater than 80 pounds per square inch (PSI). Pressures above 80 PSI may void warranties for some appliances such as water heaters or washing machines. Flexible supply lines to washing machines are likely to burst with higher pressures. 40-80 PSI is considered the normal range for water pressure in a home, and most plumbers recommend 50-60 PSI. Typically, the pressure cannot be regulated at the water meter. Recommend that a qualified plumber evaluate and make modifications to reduce the pressure to below 80 PSI. Installing a pressure reducing valve on the main service pipe is a common solution to this problem. If one exists, then it should be adjusted, repaired or replaced as necessary to maintain lower pressures. Note that installing a pressure reducing valve creates a "closed system," which may require installing an expansion tank at the water heater if one is not already installed.

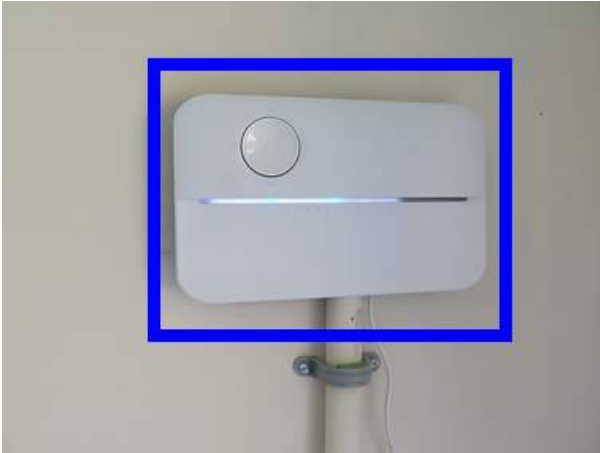
Photo 35-1

Based on visible equipment or information provided to the inspector, this property appeared to have a yard irrigation (sprinkler) system. These are specialty systems and are excluded from this inspection. Comments in this report related to this system are made as a courtesy only and are not meant to be a substitute for a full evaluation by a qualified specialist. When this system is operated, recommend verifying that water is not directed at building exteriors, or directed so water accumulates around building foundations. Sprinkler heads may need to be adjusted, replaced or disabled. Recommend that a qualified plumber verify that a backflow prevention device is installed per standard building practices to prevent cross-contamination of gray water and potable water, and install an expansion tank at the water heater if missing and necessary. Recommend that a qualified specialist evaluate the irrigation system for other defects (e.g. leaks, damaged or malfunctioning sprinkler heads) and repair if necessary.

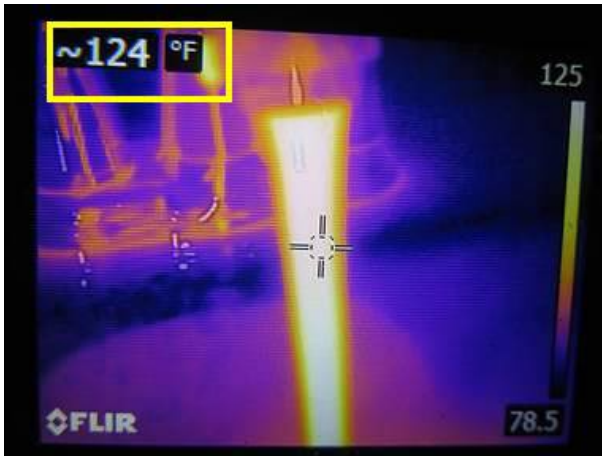
Photo 39-1

The hot water temperature was greater than 120 degrees Fahrenheit. This is a safety hazard due to the risk of scalding. The thermostat should be adjusted so the water temperature doesn't exceed 120 degrees. If the water heater is powered by electricity, a qualified person should perform the adjustment, since covers that expose energized equipment normally need to be removed. For more information on scalding dangers, visit:

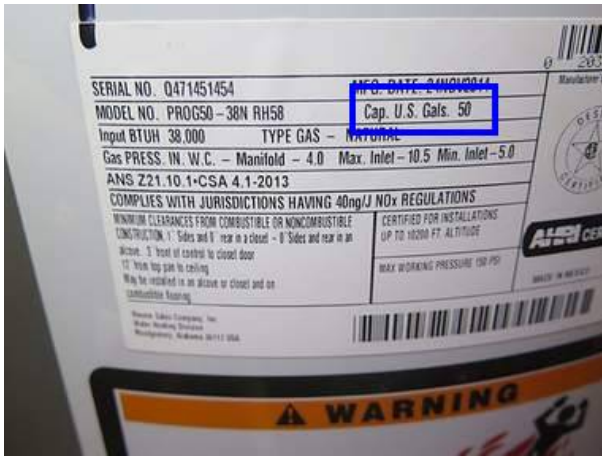
Photo 41-1

41) ⓘ Based on the capacity of the water heater, the number of bedrooms in this structure, and the number of occupants expected to live in this structure, this water heater may be undersized. Consult with a qualified plumber or water heater distributor for more information, and may wish to upgrade the size of the water heater.

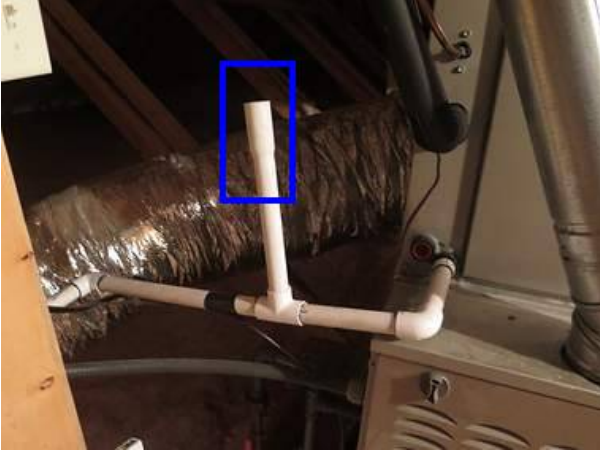
Photo 42-1

Trapping is a major issue on draw-through systems. Untreated air can be drawn into the airstream while the system is running. If the coil is located in an attic or other warm space, there is even greater reason for concern. As on a blow-through system, an untrapped drain on a draw-through system is an efficiency issue. But more importantly, the air being sucked through the drainpipe can prevent the pan from draining, causing it to run over.

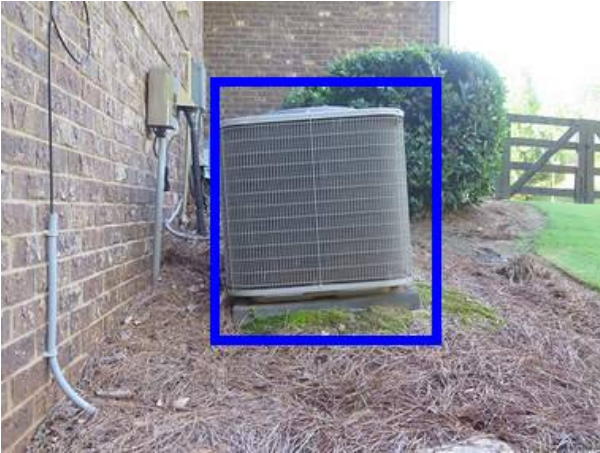
Photo 43-1

The pad for the heat pump or air conditioning condensing unit was not level. This unit requires adequate support. The compressor may be damaged if this unit is tilted 10 degrees or more. Also, the pad should elevate the unit above the soil to prevent corrosion. Recommend that a qualified person repair as necessary.

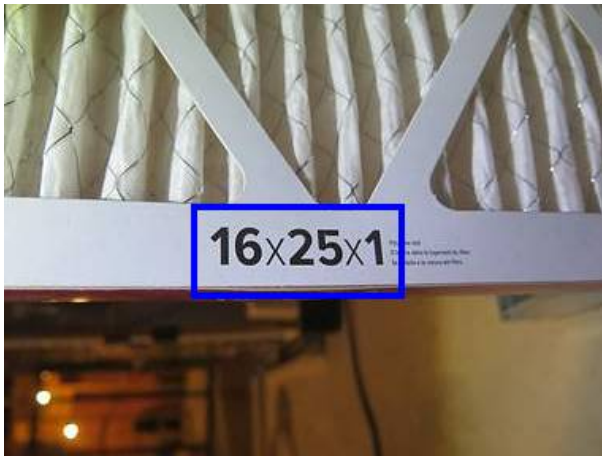
Photo 47-1

Recommend replacing or washing HVAC filters upon taking occupancy depending on the type of filters installed. Regardless of the type, recommend checking filters monthly in the future and replacing or washing them as necessary. How frequently they need replacing or washing depends on the type and quality of the filter, how the system is configured (e.g. always on vs. "Auto"), and on environmental factors (e.g. pets, smoking, the frequency of house cleaning, number of occupants, the season).  
 \*NOTE\* filter size - 16x25x1

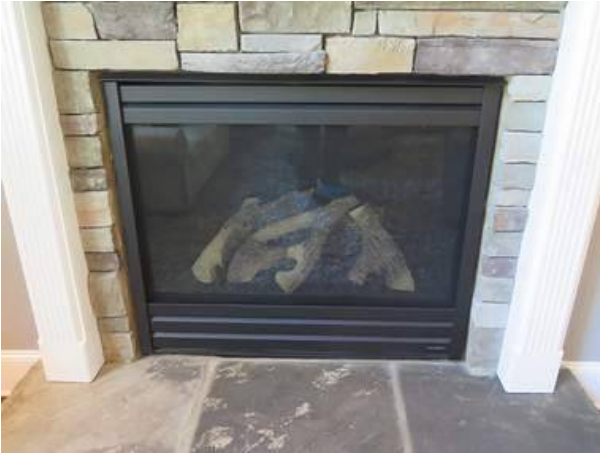
Photo 50-1

Recommend that the client review all available documentation for gas-fired fireplaces and stoves. Depending on how they are operated (for routine heating versus ambiance), such appliances normally need servicing annually or every few years. Consult with the property owner and/or a qualified specialist to determine if service is needed now.

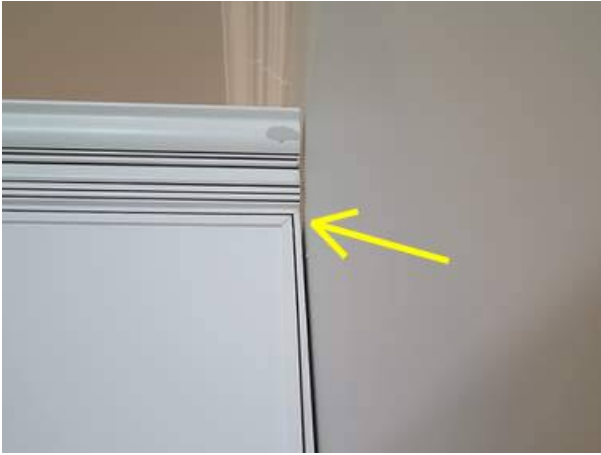
Photo 51-1

One or more cabinets appear to be loose. An adequate number of appropriate fasteners should be used. Recommend that a qualified person repair as necessary.

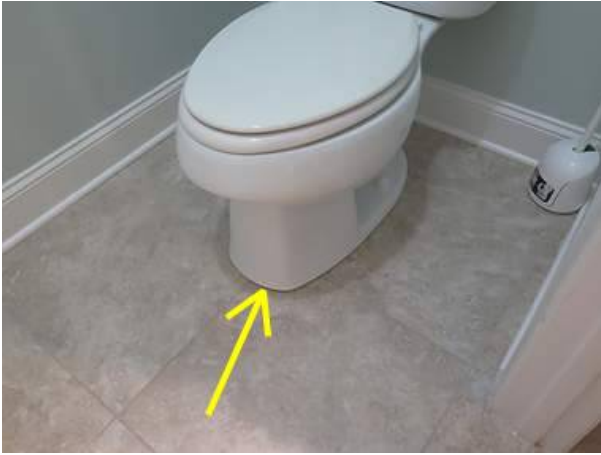
Photo 60-1

Caulk around the base of the toilet at location(s) #E was missing, substandard and/or deteriorated. Modern standards require caulk to be installed around the entire toilet base where it meets the floor for sanitary reasons. Without it, soiled water can soak into flooring and sub-floor materials if the toilet overflows. Condensation from the toilet can also soak into the flooring. Recommend that a qualified person caulk around toilet bases per standard building practices.

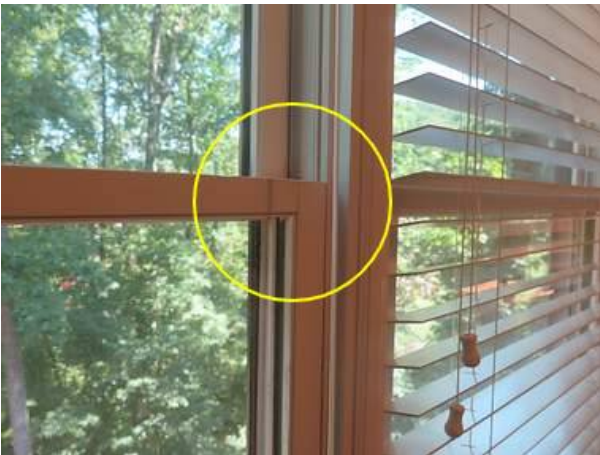
Photo 63-1

One or more windows that were designed to open and close were stuck shut and/or difficult to open and close. Recommend that a qualified person repair windows as necessary so they open and close easily.

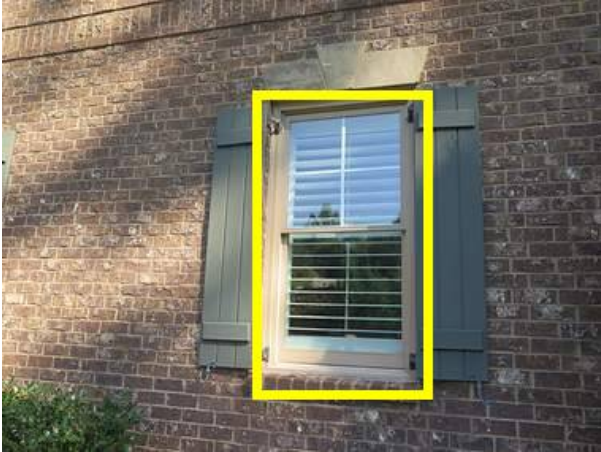
Photo 64-1

64) **i** Screens were missing from many windows. These windows may not provide ventilation during months when insects are active.
