Your Inspection Report

2238 Edison Avenue
Atlanta, GA 30305

INSPECTION DATE:
Wednesday, December 18, 2019

Home-Probe
315 West Ponce de Leon Ave, Suite 559
Decatur, GA 30030

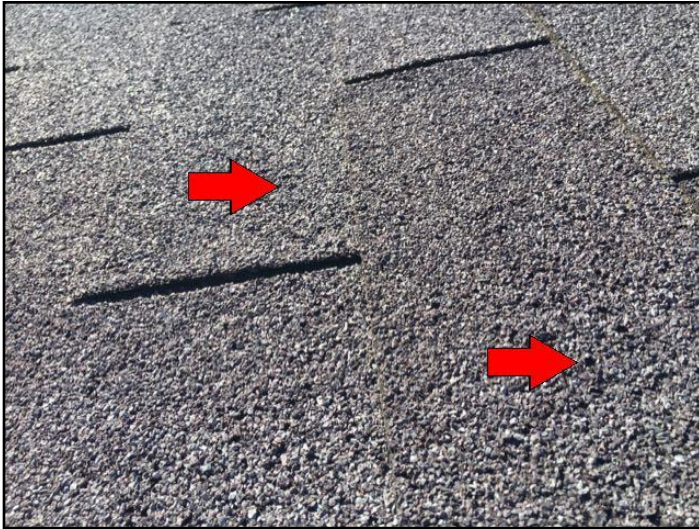
1. Blistering shingles

1. Condition: • Excessive blistering on shingles. Recommend further evaluation by qualified roofing contractor to determine cause and scope of work to repair / replace shingles if necessary.

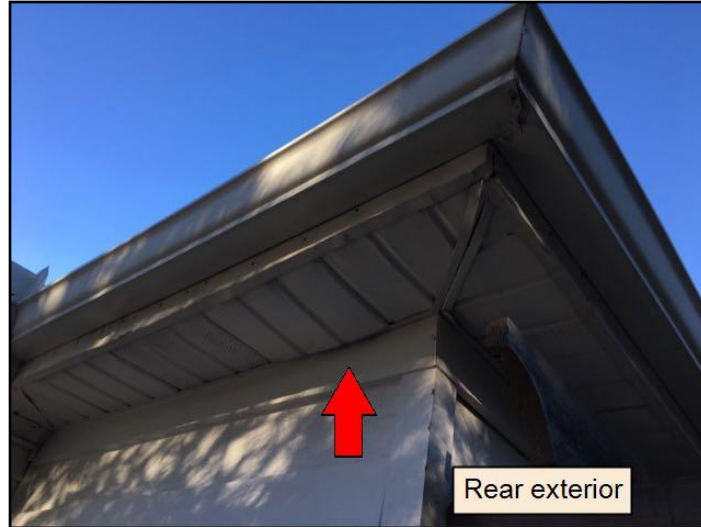
11. Loose/Missing pieces Task: Reinstall piece...

4. Condition: • Loose/Missing pieces

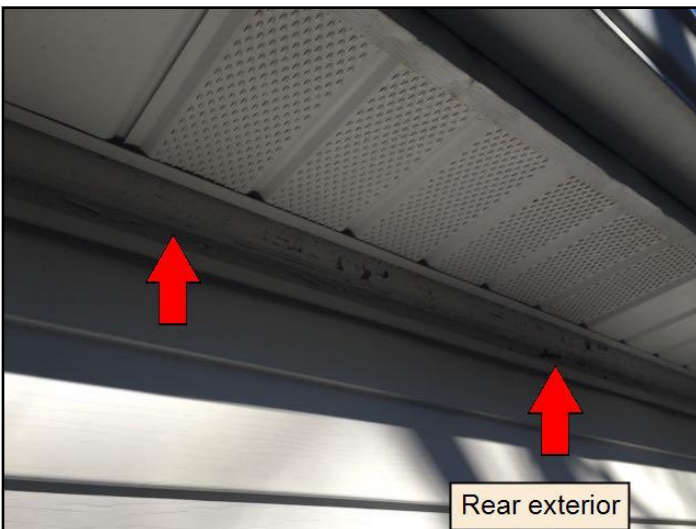
12. Paint or stain needed Task: Provide Time: A...

5. Condition: • Paint or stain needed

Wood trim throughout exterior

Cost: As a general rule, painting is about \$1,000 per side. Spot repairs may be less and it is unlikely the paint will match.

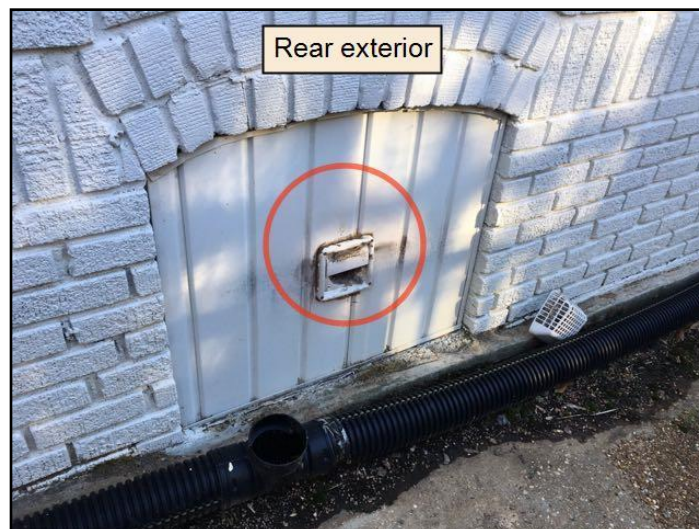
15. Vent cover damaged/missing Location:...

6. Condition: • Vent cover damaged/missing

Task: Repair or replace

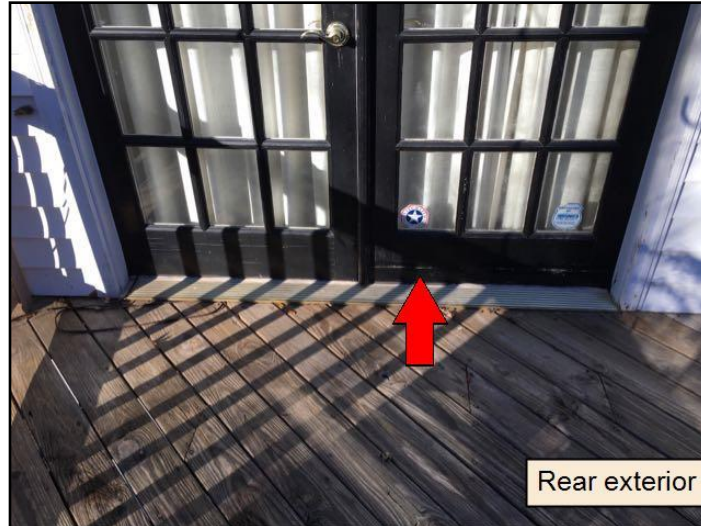
16. Damage Task: Repair or replace Time: As...

7. Condition: • Damage

Task: Repair or replace
Time: As soon as possible

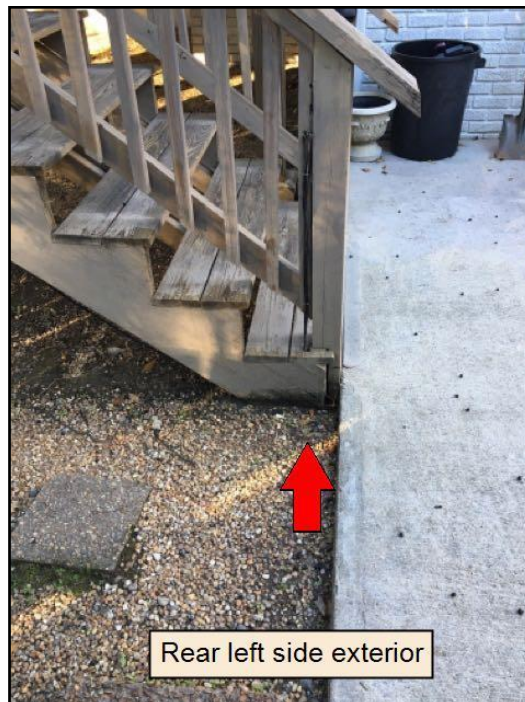
17. Wood/soil contact Task: Correct Time: As...

8. Condition: • Wood/soil contact

Recommend excavating 6 to 8 inches away from the wood and replace with gravel or like material for drainage.

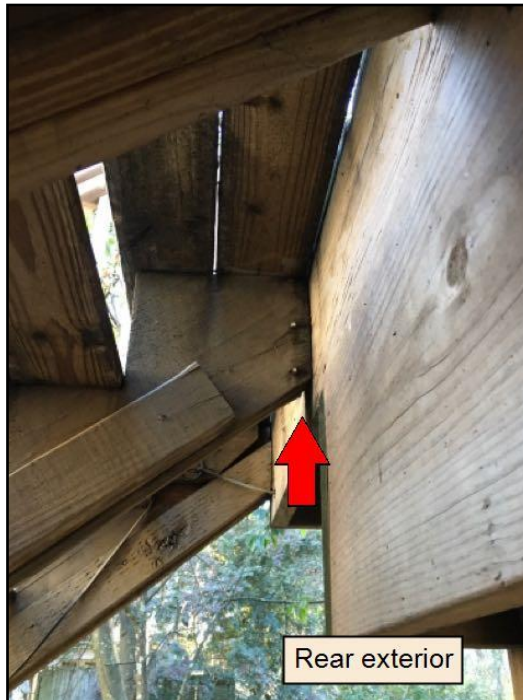
18. Weak/inadequate connections Task:...

9. Condition: • [Weak/inadequate connections](#)

Intersections should be attached with bolts or brackets designed specifically for this application and a qualified contractor familiar with Georgia Prescriptive Deck Details

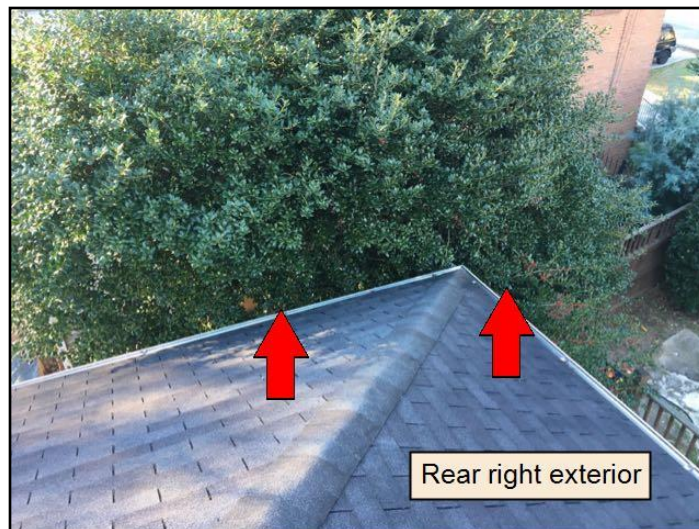
19. Trees or Shrubs too close to building Task...

10. Condition: • Trees or Shrubs too close to building

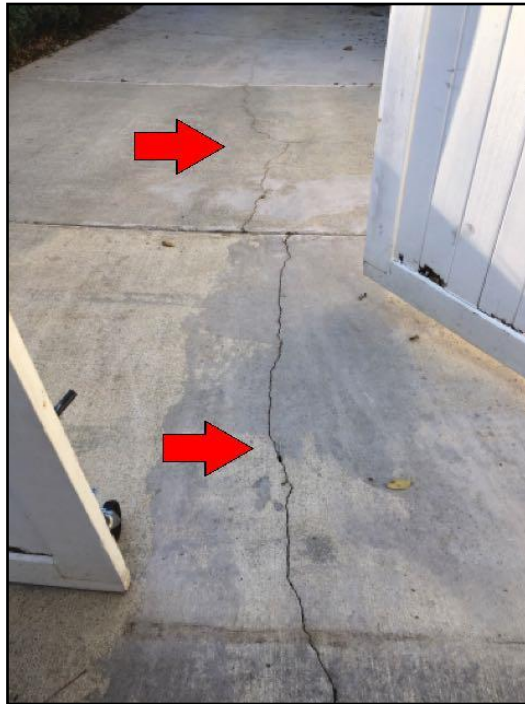
20. Cracked or Damaged Surfaces Task: Repair a...

11. Condition: • Cracked or Damaged Surfaces

Task: Repair as Needed/Be Advised

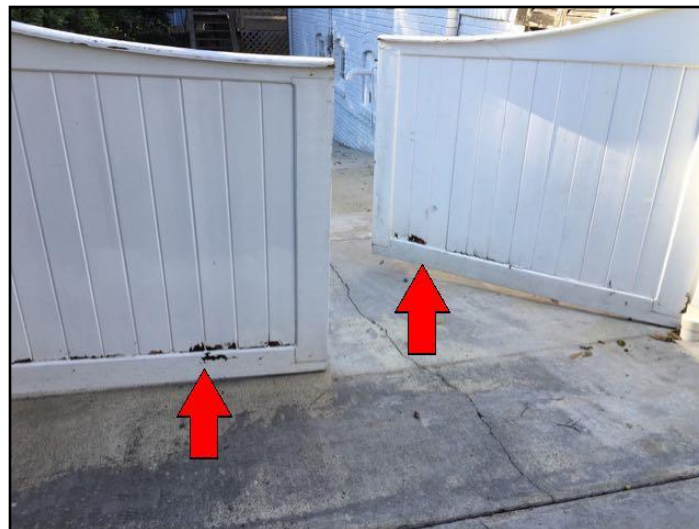
21. Damage

12. Condition: • Damage

Rot at driveway gate

Task: Repair

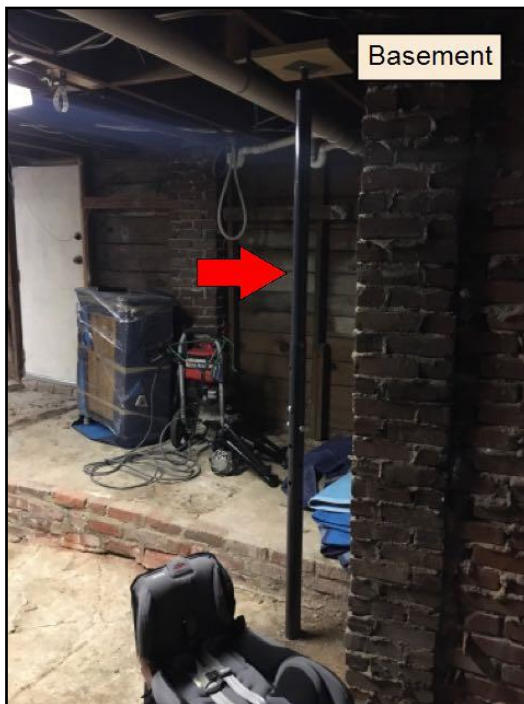
22. Temporary Supports Task: Repair as...

13. Condition: • Temporary Supports

Although there are no issues with the temporary or supplemental supports installed in the crawlspace, this is usually done in response to some type of movement or settling and as a temporary corrective measure. Although there were no issues noted that were a concern at the time of inspection, it is recommended that a qualified contractor install more permanent supports that are properly secured at the top and bottom.

Task: Repair as needed

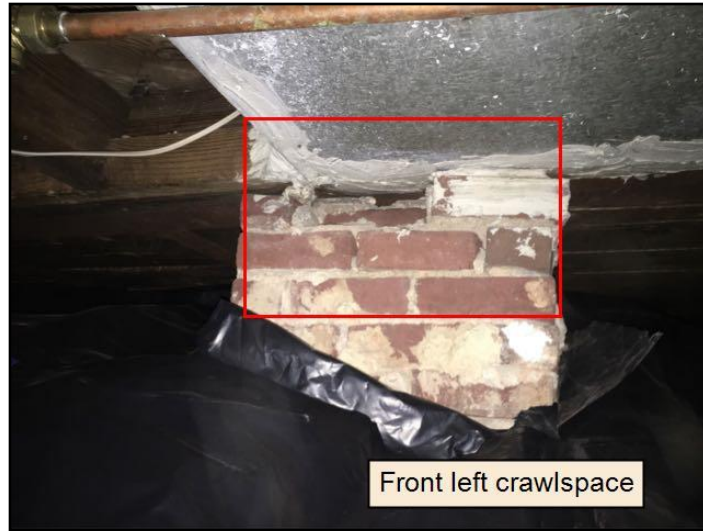
23. Mortar deterioration Task: Repair as...

14. Condition: • Mortar deterioration

Task: Repair as needed

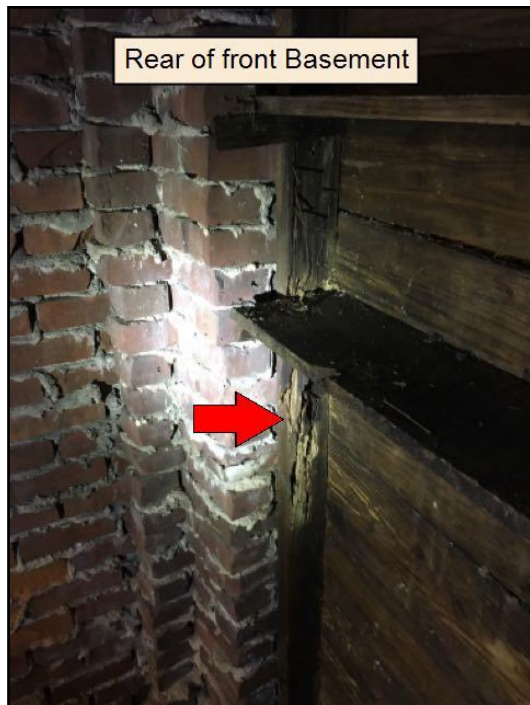
32. Insect damage

17. Condition: • [Insect damage](#)

Task: Repair

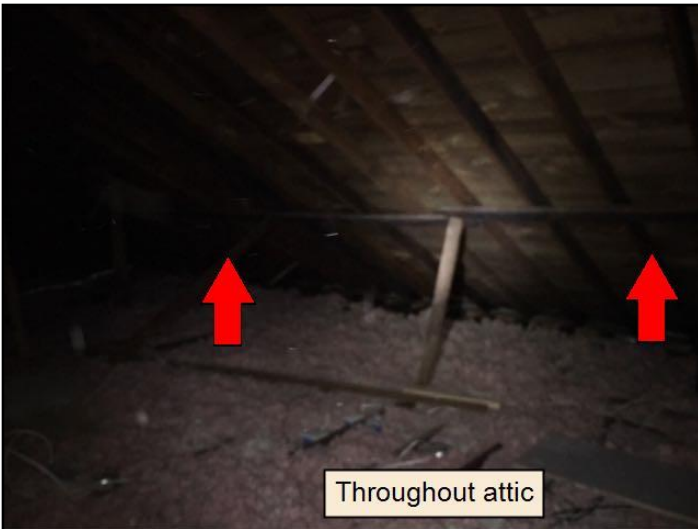
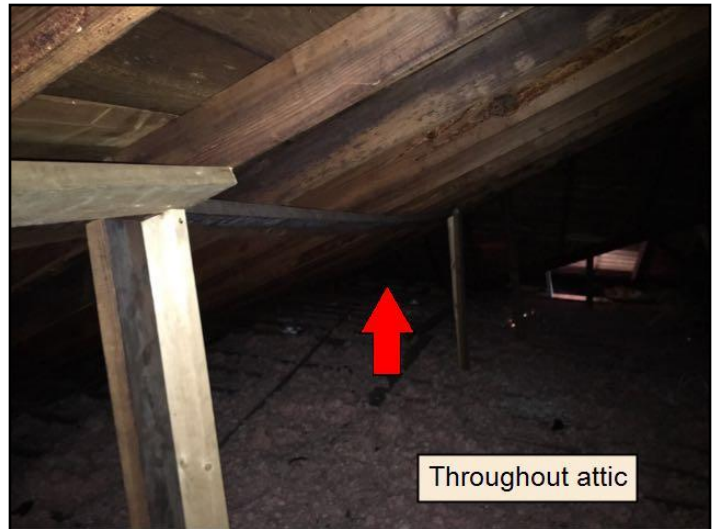
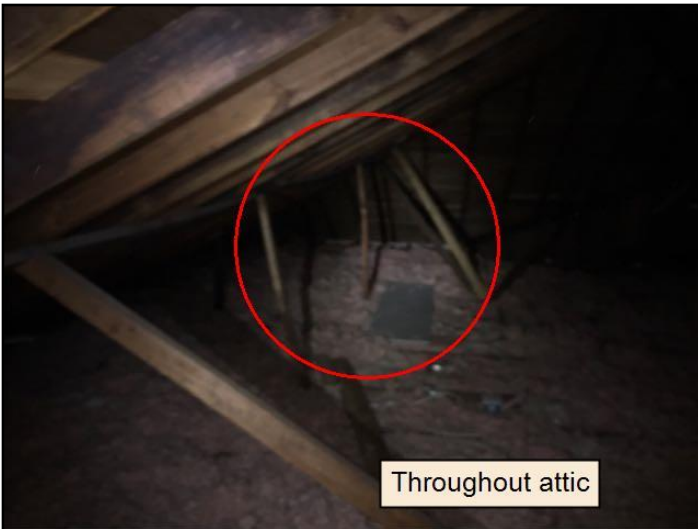
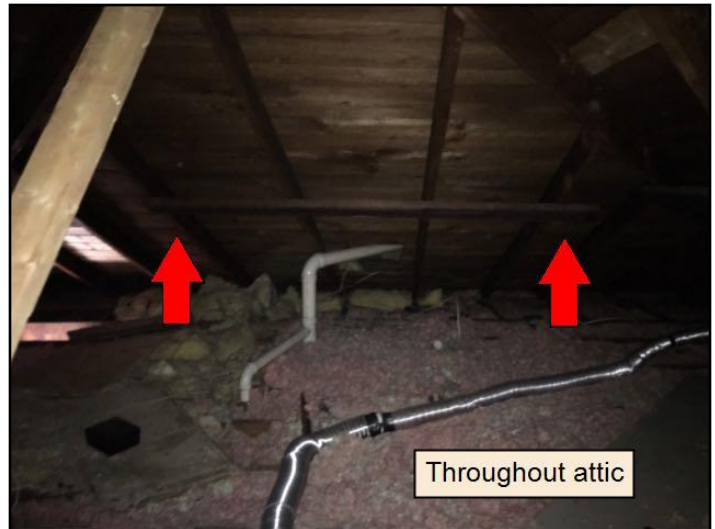
18. Condition: • Purling Bracing Sagging/Damaged

Multiple areas of poor mid-span roof structure support. Sagging or missing supports. A qualified contractor should evaluate to determine scope of work necessary. Notable areas of deflection on exterior roof.

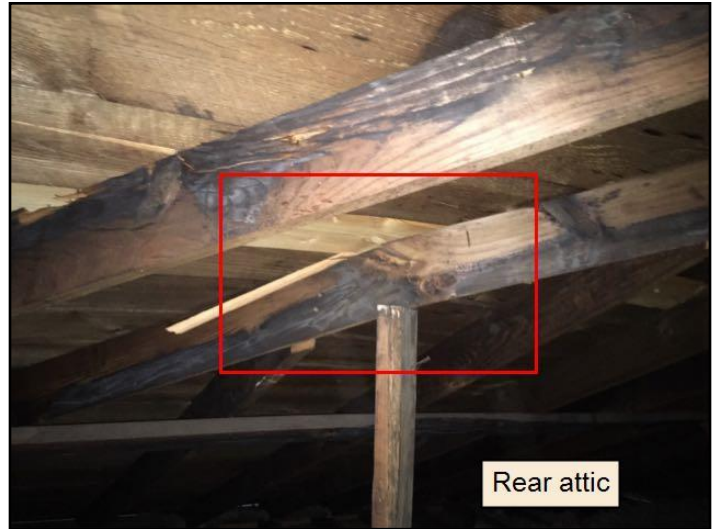
41. Split

20. Condition: • [Split](#)

Task: Repair

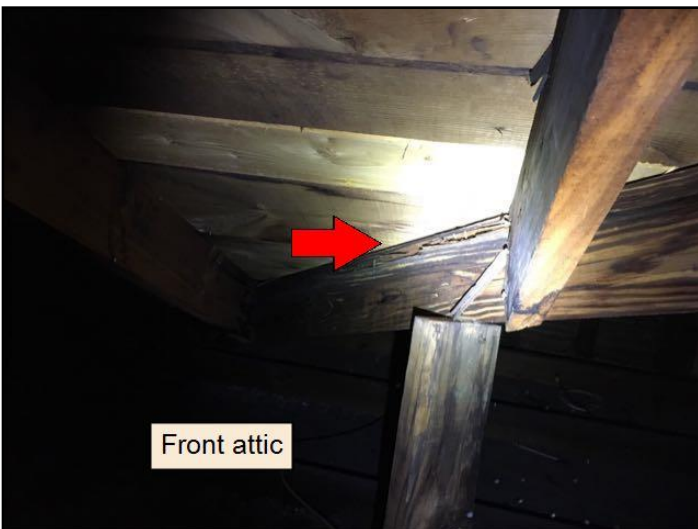
42. Rot

21. Condition: • [Rot](#)

Task: Repair

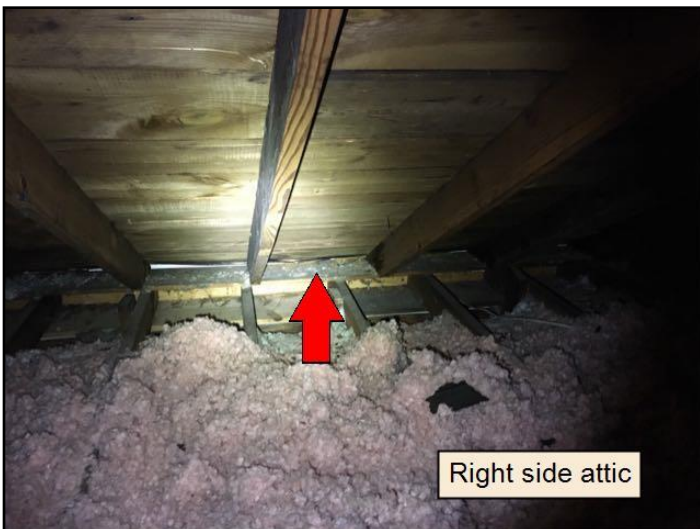
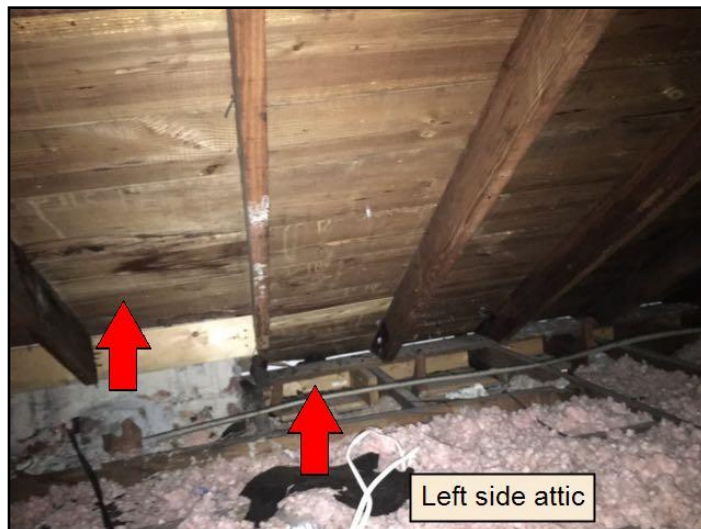
22. Condition: • [Water stains](#)

Water stains on roof sheathing. Dry at inspection. These should be monitored or evaluated by a qualified roofing contractor to ensure that

they are not active.

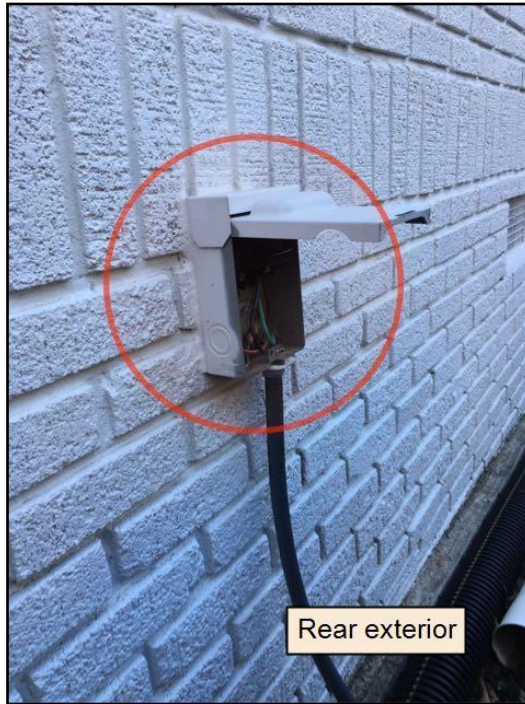
47. Cover loose or missing Task: Correct Time...

25. Condition: • Cover loose or missing

Cooling system condenser unit disconnect missing interior cover panel

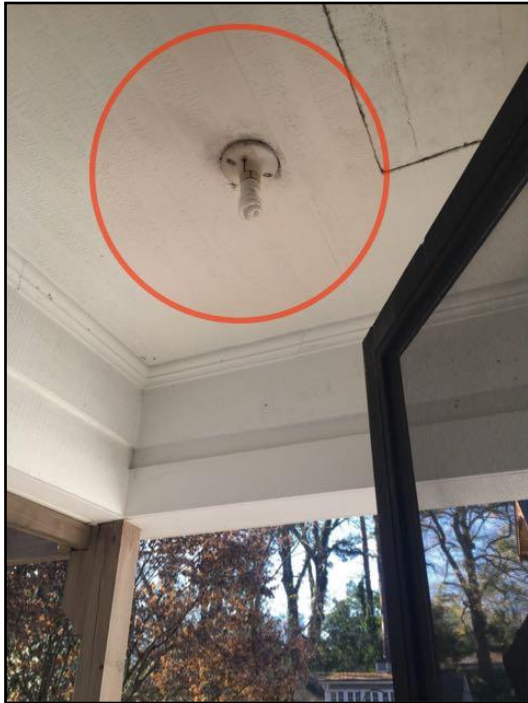
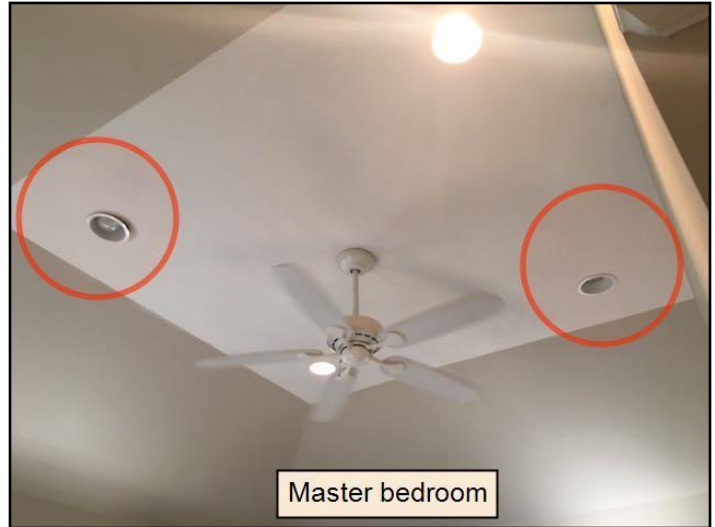
27. Condition: • Inoperative

This is most likely blown bulbs and recommend confirming operation from the seller.

Task: Repair

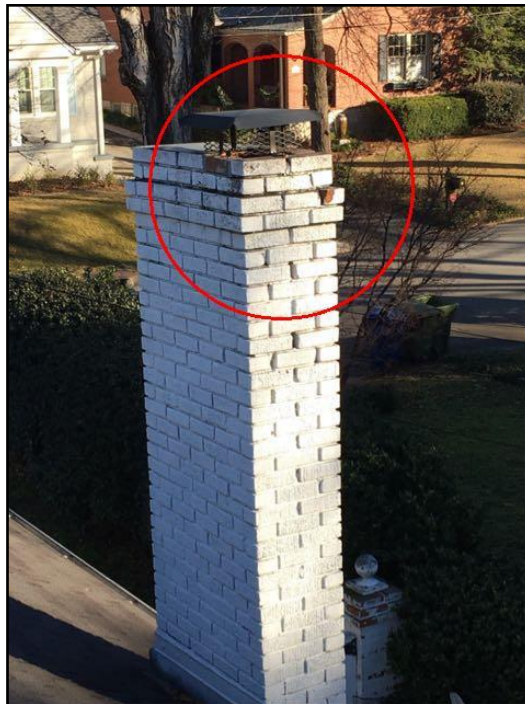
54. Loose, missing or deteriorated masonry

29. Condition: • [Loose, missing or deteriorated masonry](#)

Task: Repair

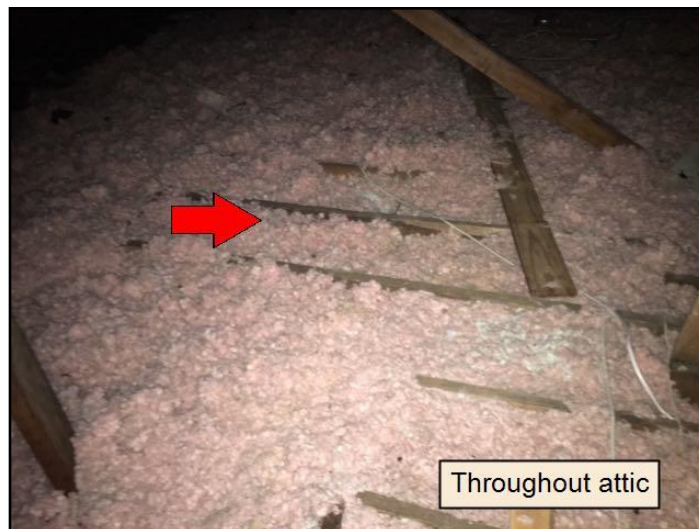
57. Amount inadequate

30. Condition: • Inadequate Ventilation

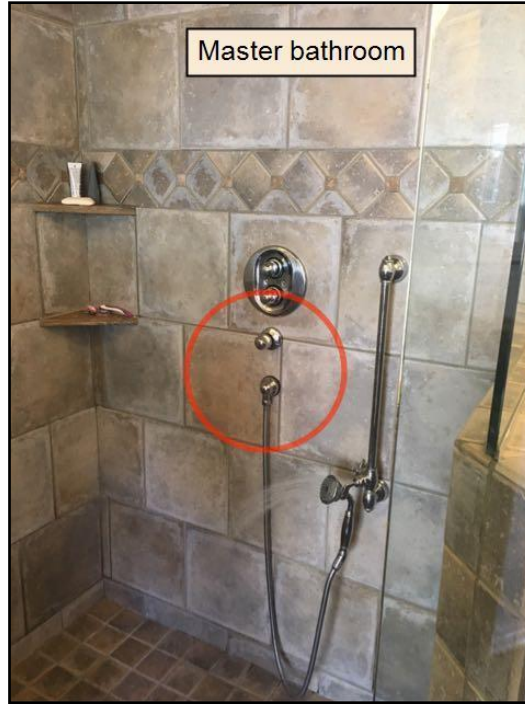
63. Loose Task: Secure Time: Immediate Cost:...

38. Condition: • Loose

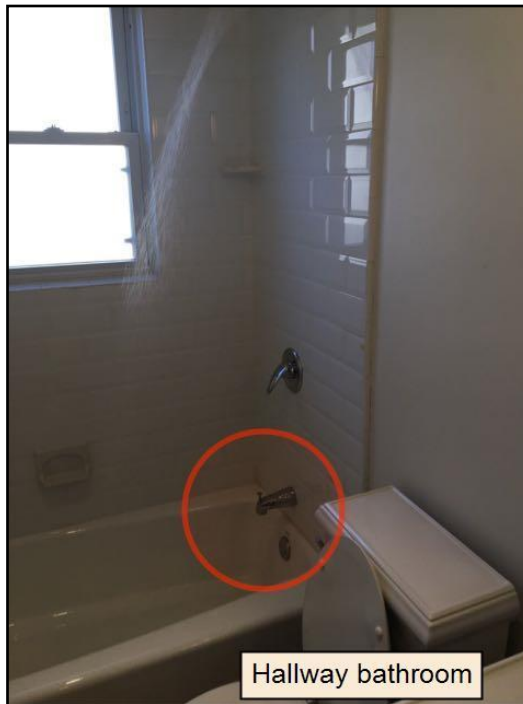
64. Spout Diverter Defective Task:...

39. Condition: • Spout Diverter Defective

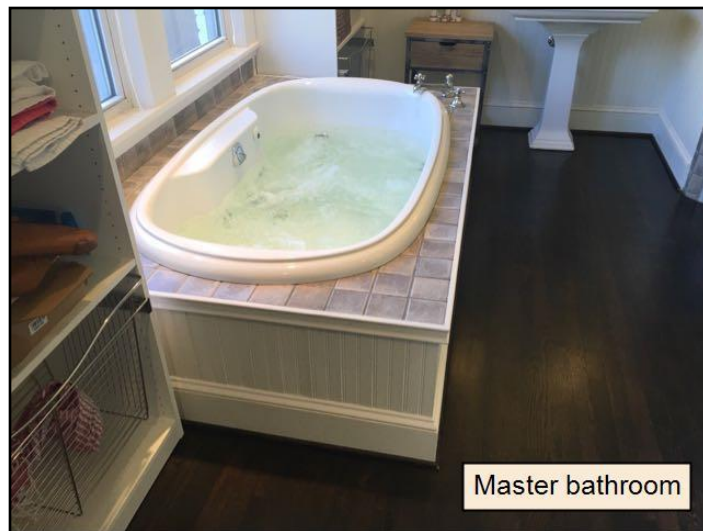
67. No pump access

42. Condition: • [No pump access](#)

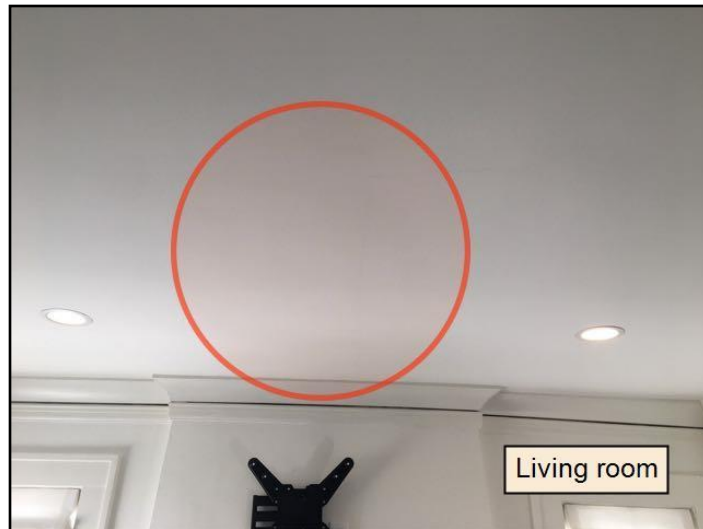
69. Water Stains Task: Request...

Could not recreate leak at the time of inspection and suggest consulting with seller as to what repairs have been done.

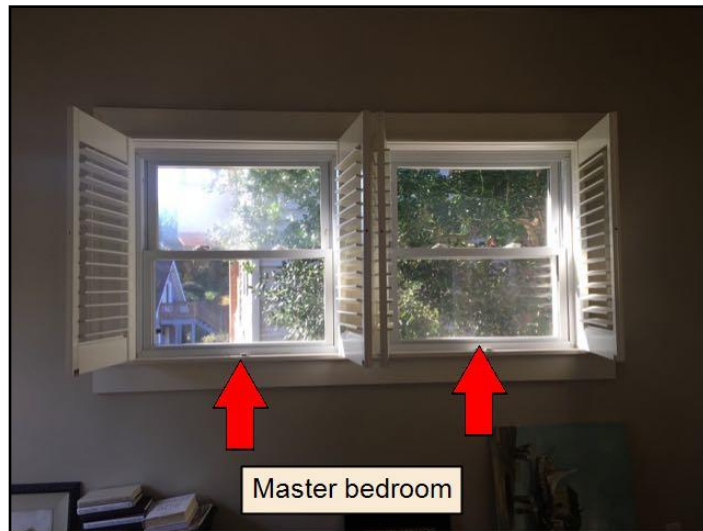
77. Sash Won't Stay Open Task: Repair Time:...

48. Condition: • Sash Won't Stay Open

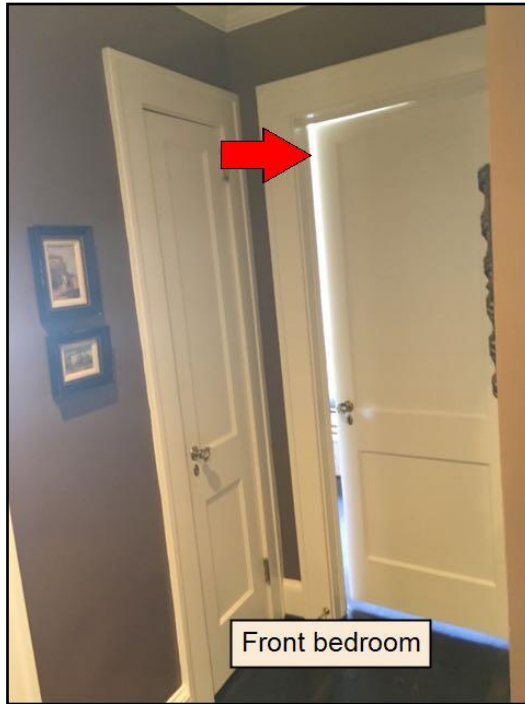
78. Poor Fit Task: Adjust As Needed Time:...

49. Condition: • Poor Fit

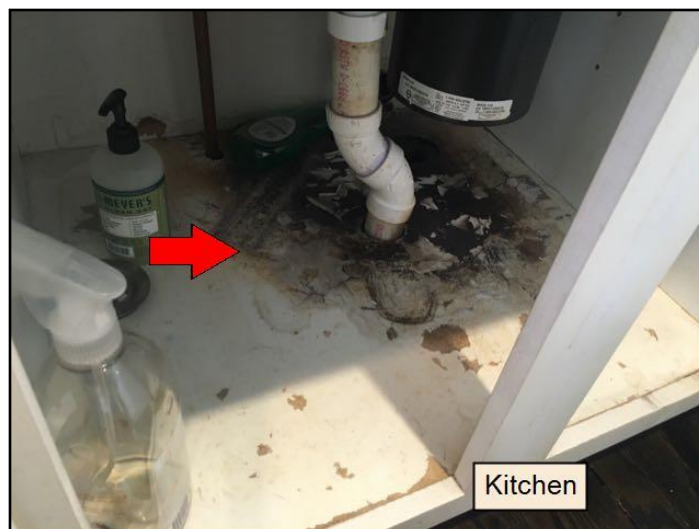
82. Water damage

52. Condition: • [Water damage](#)

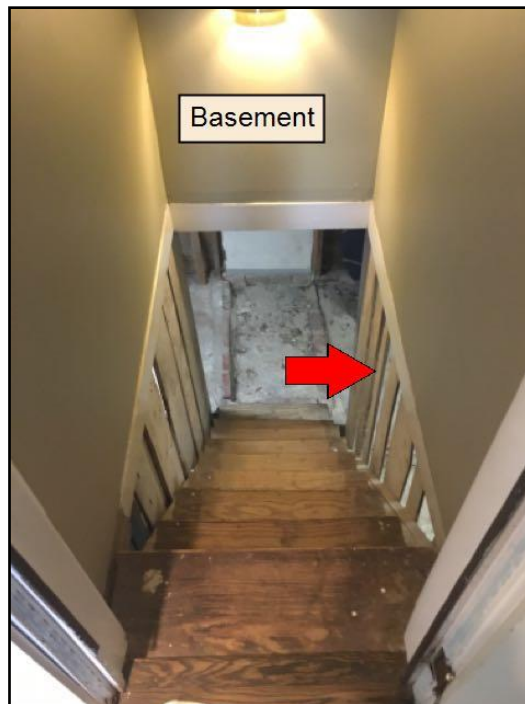
84. Missing Handrail Task: Provide Time:...

55. Condition: • Missing Handrail

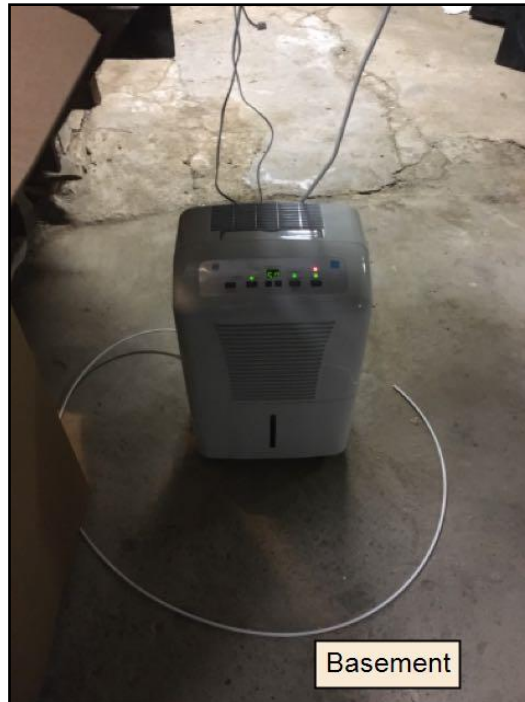
89. Dehumidifier in basement

58. Condition: • [Dehumidifier in basement](#)

Task: Request disclosure
