# AMENDMENT TO ADDRESS CONCERNS WITH PROPERTY AMENDMENT #1

Exhibit 1

Property Address 6007 Casleton Manor

Others Present Buyer Property Occupied Occupied  
Estimated Age 20 Years Entrance Faces North  
Inspection Date 01/11/2020  
Start Time 12:20 PM End Time 3:40 PM  
Electric On  Yes  No  Not Applicable  
Gas/Oil On  Yes  No  Not Applicable  
Water On  Yes  No  Not Applicable  
Temperature 67 Degrees  
Weather Rain Soil Conditions Wet  
Space Below Grade Basement  
Building Type Single family Garage Attached  
Sewage Disposal County How Verified Visual Inspection  
Water Source County How Verified Visual Inspection  
Additions/Modifications None

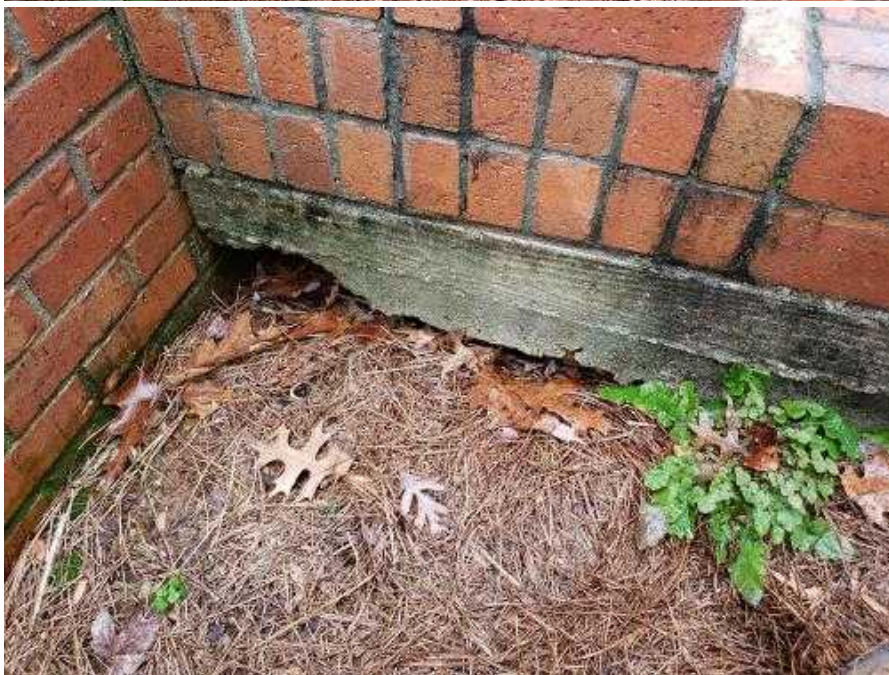
3.     Steps/Stoops: Brick -

Brick steps at front of home were not properly back filled with dirt and there is a void under stairs the needs to be back filled with gravel to ensure proper support.

2. The sellers agree to have all the void under stairs professionally back filled with gravel to ensure  
proper support of the brick steps at front of home.

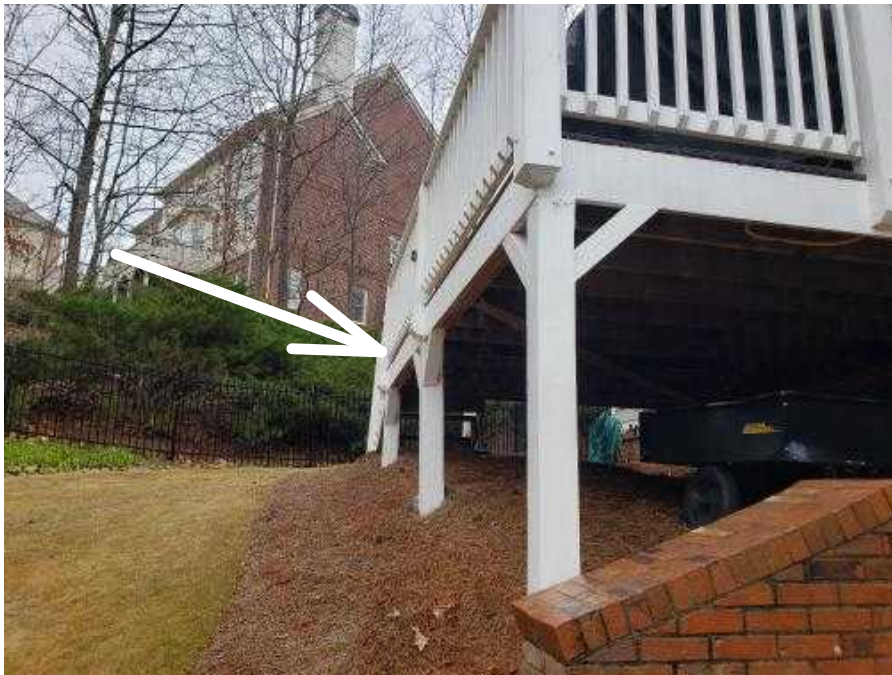
4.      Porch: Concrete  
5.      Deck: Treated wood -

Center post at deck was not properly supported and has shifted forcing the floor joist to separate from outer ban. Many of the floor joist are not in contact with outer ban. Further evaluation by qualified contractor is needed to estimate repairs. A new 6x6 post should be installed with permanent footer installed. Outer ban is heavily warped and many need to be replaced. All floor joist should be brought up to code : Floor joist for deck are not properly supported by joist hangers. Joist hangers need to be installed at outer and inner bands to ensure floor system is properly supported.

1. The sellers agree to have the deck thoroughly and professionally fixed by qualified contractors:  
Center post at deck was not properly supported and has shifted forcing the floor joist to separate from  
outer ban. Many of the floor joist are not in contact with outer ban. A new 6x6 post should be  
installed with permanent footer installed. Outer ban is heavily warped and many need to be replaced.  
All floor joist should be brought up to code: Floor joist for deck are not properly supported by joist  
hangers. Joist hangers need to be installed at outer and inner bands to ensure floor system is  
properly supported. After fixed, the deck underneath needs to be pressure washed and painted.

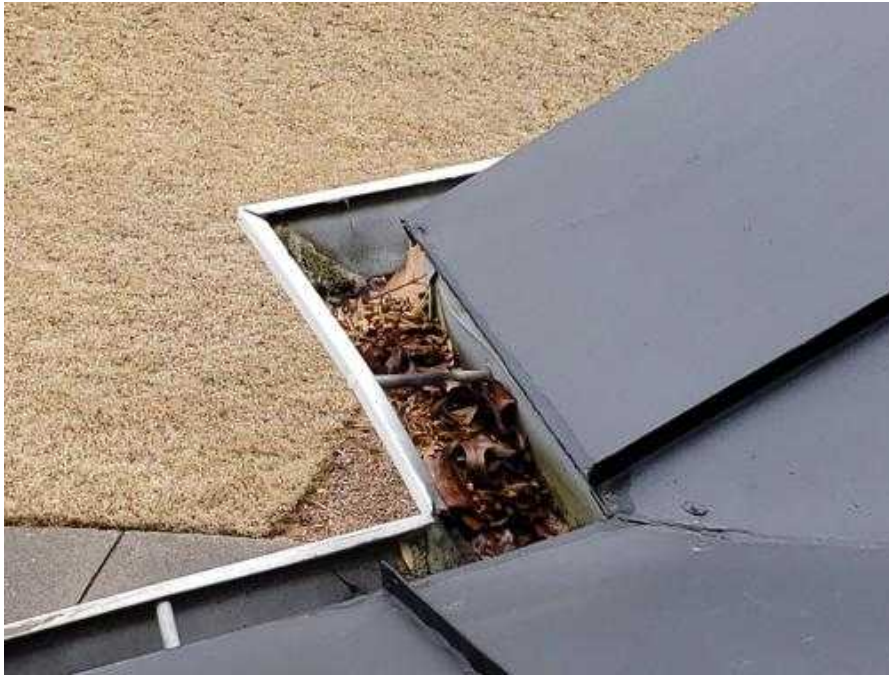
9.      Gutters: Aluminum -

Gutters and roof need to be cleaned out to ensure proper rainwater run off.

Gutter at rear of home is pulling away from home and needs to be repaired.

11. The sellers agree to clean the dirty gutters and roof to ensure proper rainwater run off and repair/replace the gutter at rear of home which is pulling away from home.

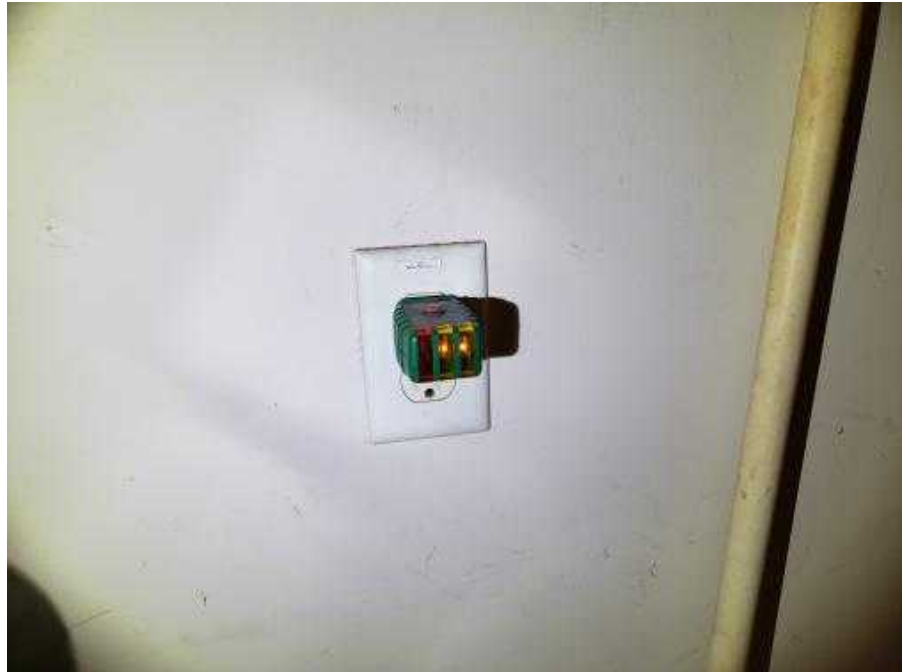
Non-GFCI circuit  
-recommend GFCI circuit  
be installed.

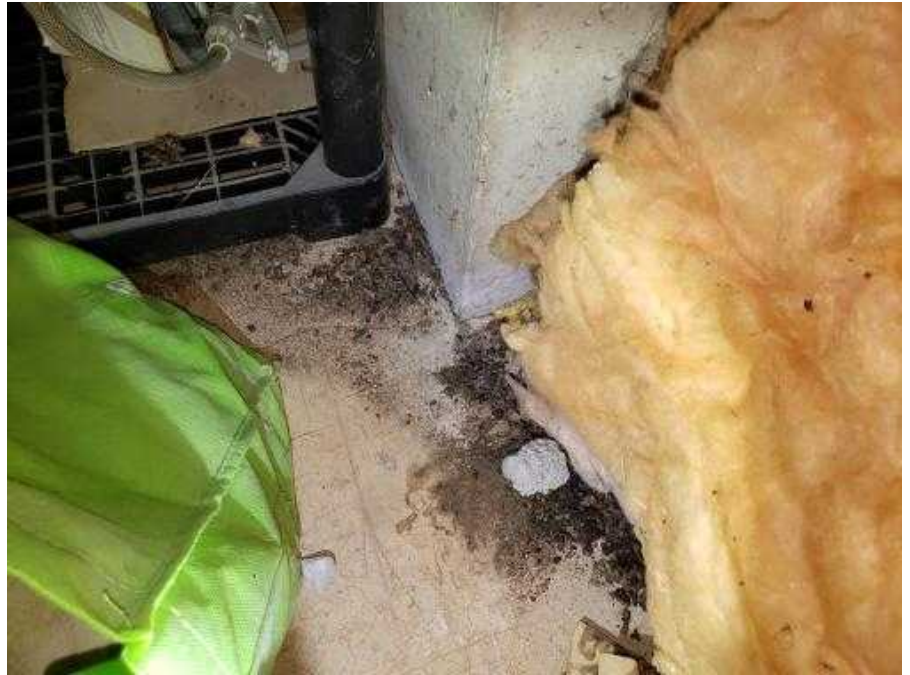
Rodent activity observed at unfinished room in basement. Recommend further evaluation by pest control company.

9. The sellers agree to have a pest control company further evaluate the whole house for rodent activity observed and provide the buyers with a clear of any rodent infestation and damage letter and one year warranty prior to the expiration of due diligence period.

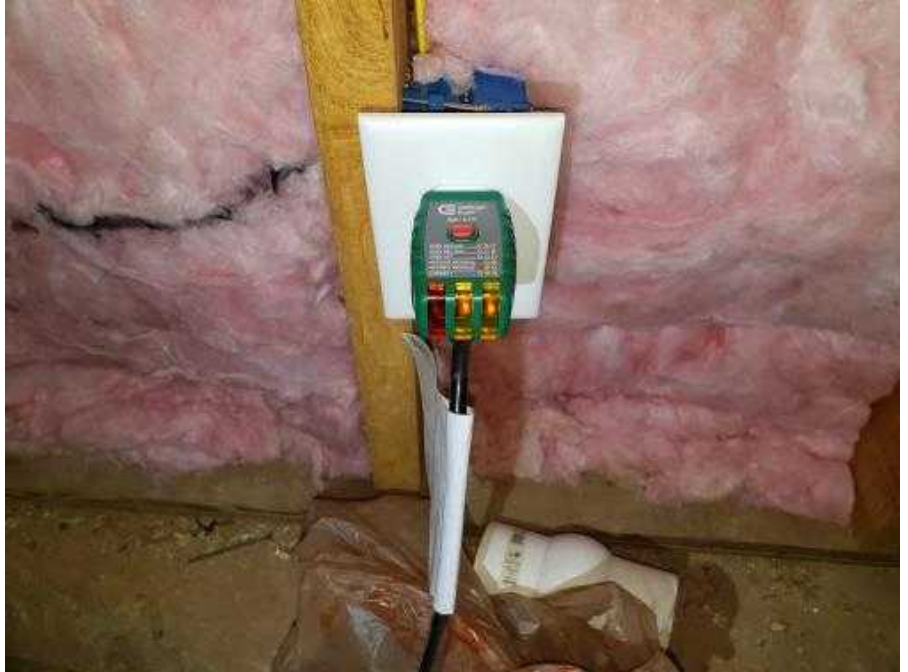
Sump pump not connected to dedicated GFCI circuit. Recommend GFCI outlet be installed.

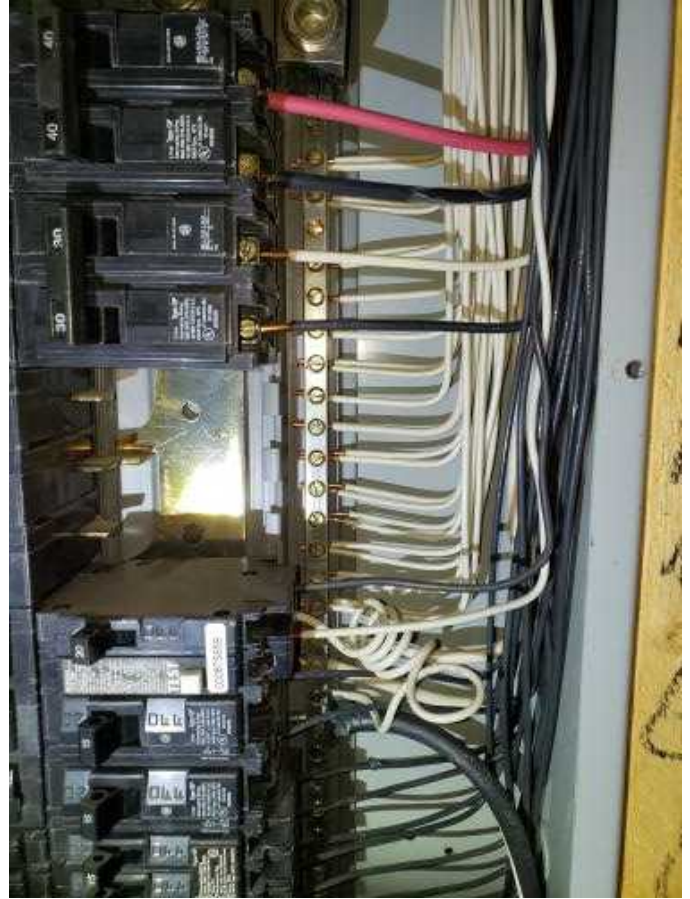
Doubled up neutrals need to be separated out onto individual on locations on the bus bar.

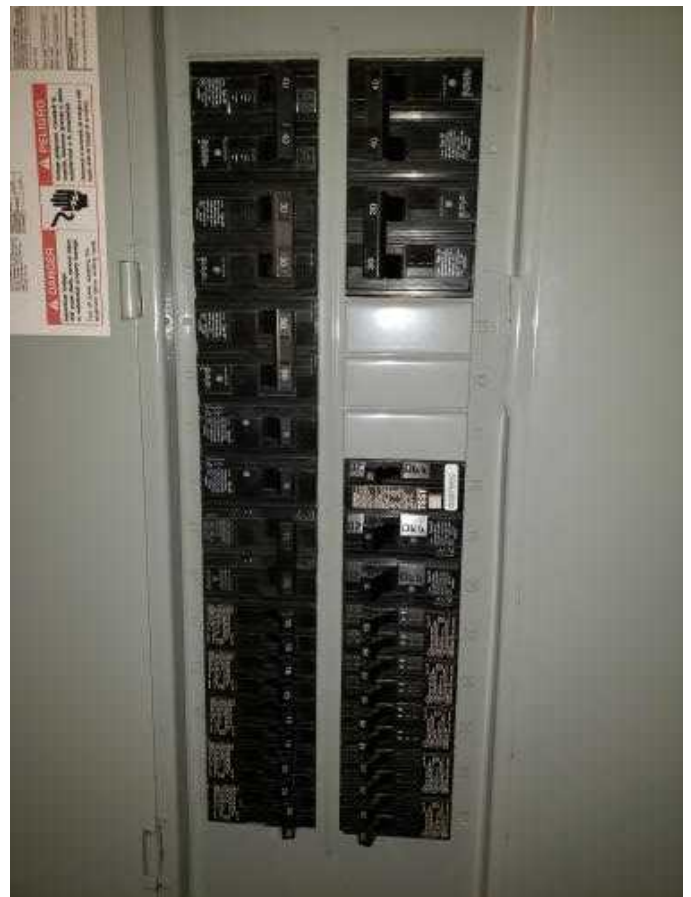
11.      AFCI: 110 volt -

Current code calls for all living spaces to have AFCI breaker and outlet protection installed. Recommend updating homes electrical system to ensure safe and proper operation per code.

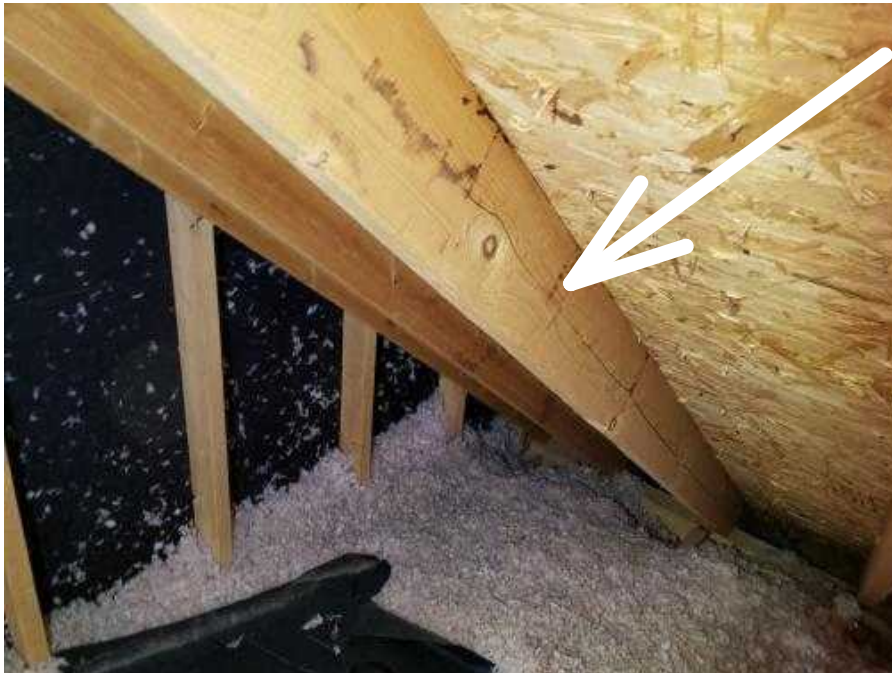
There is a cracked/damaged 2x6 framing member at rear of home the needs an additional 2x6 sistered up to it to ensure integrity.

There a few loose 2x4 framing members that are loose and need additional fasteners added.

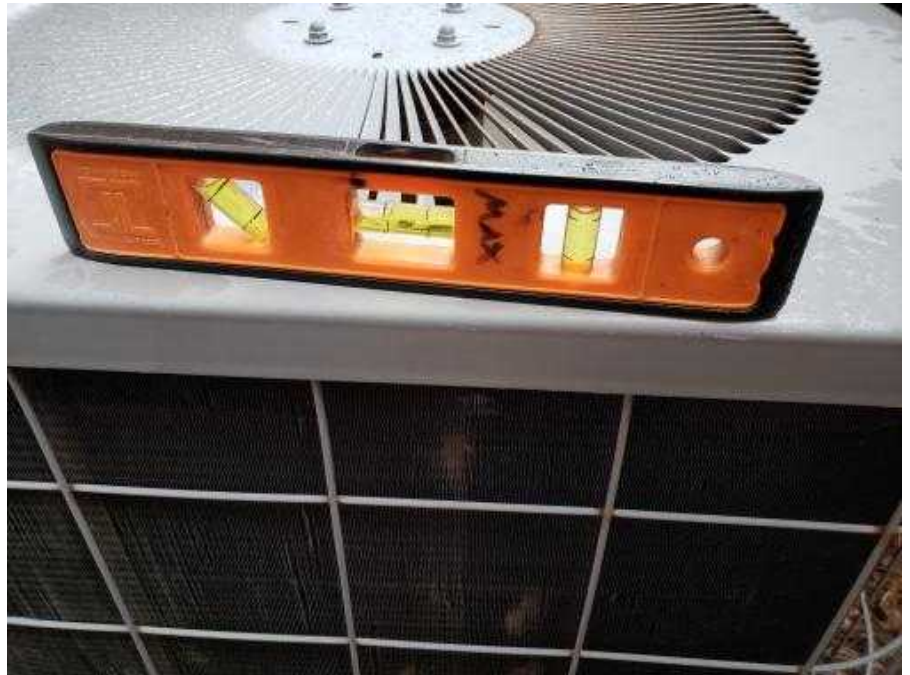
A/C unit is not level.  
Recommend leveling to  
ensure proper operation.

The unit is nearing the end  
of the manufactures stated  
design life.

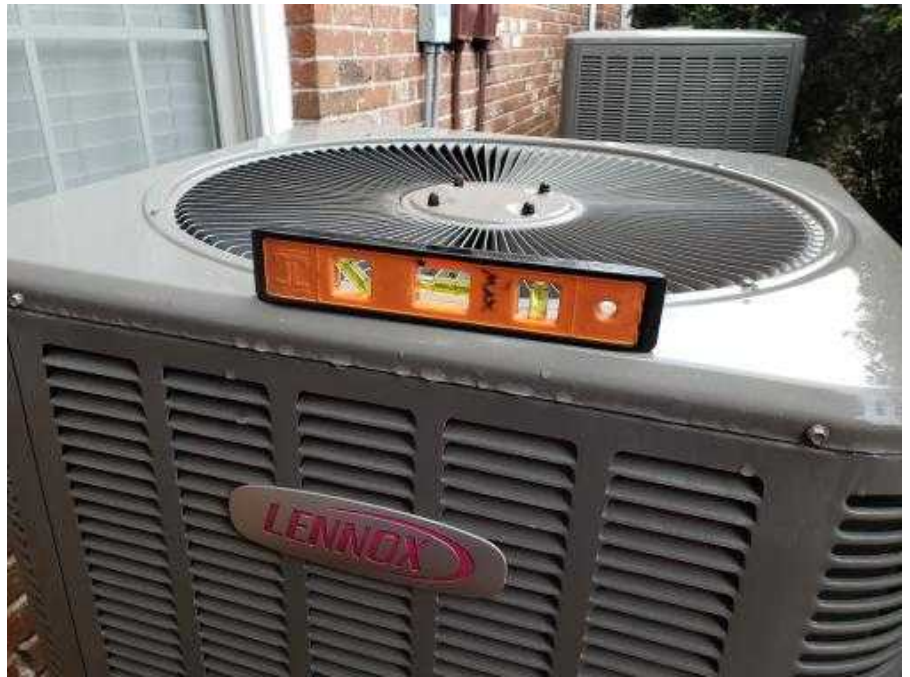
A/C unit is not level.  
Recommend leveling to  
ensure proper operation.

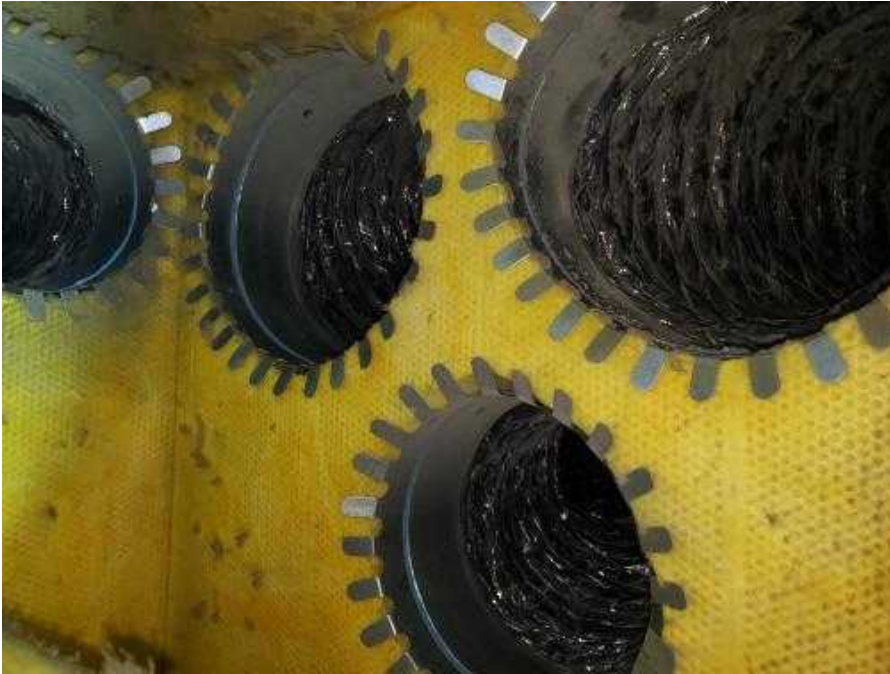
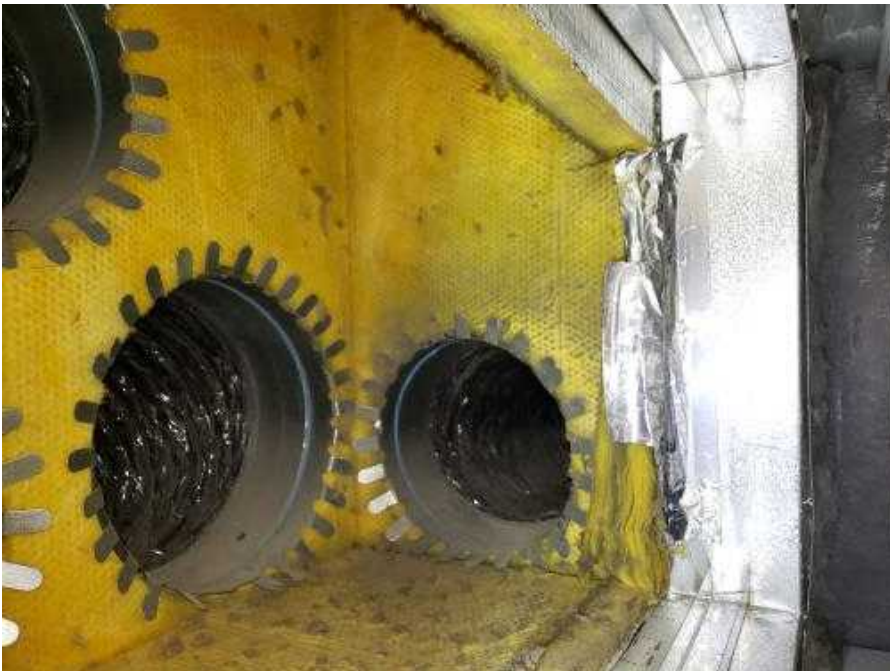
Recommend duct cleaning service for all ductwork.

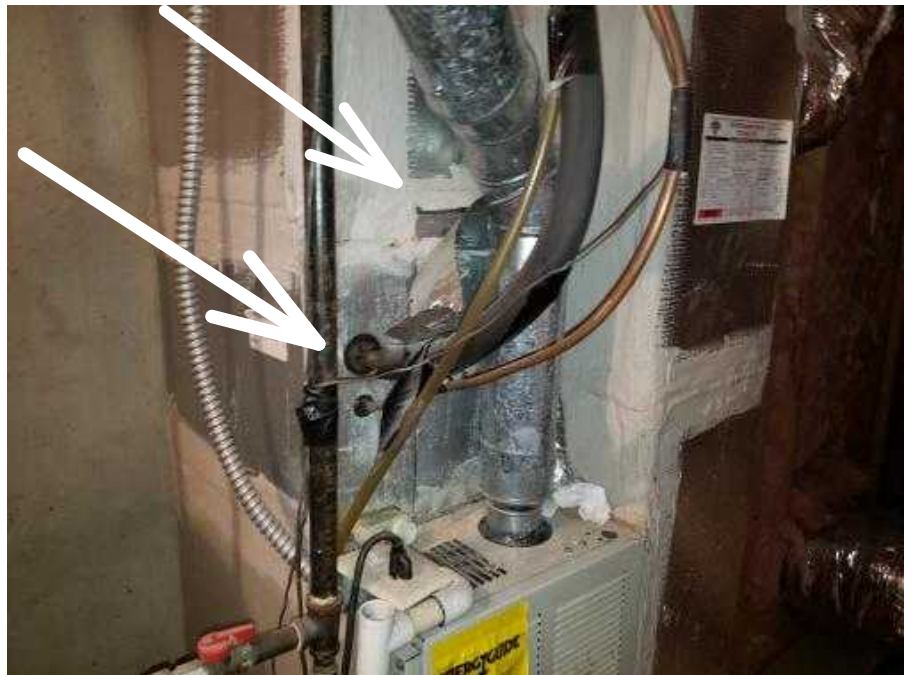
Furnace is not properly sealed and is allowing conditioned air to escape which is effecting overall efficiency. Seal unit to ensure proper efficiency.

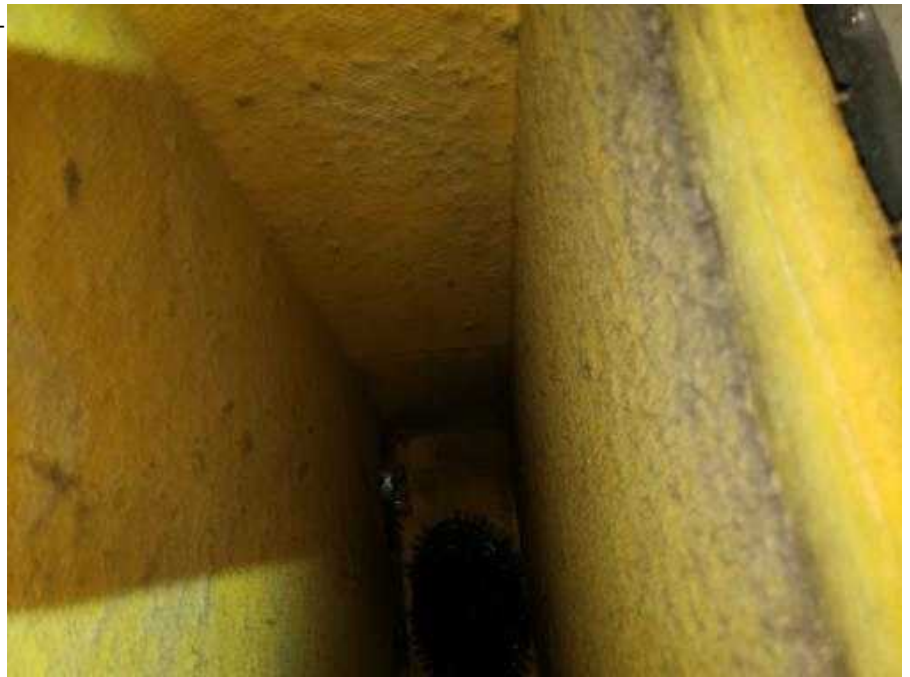
Recommend duct cleaning  
service for all ductwork.

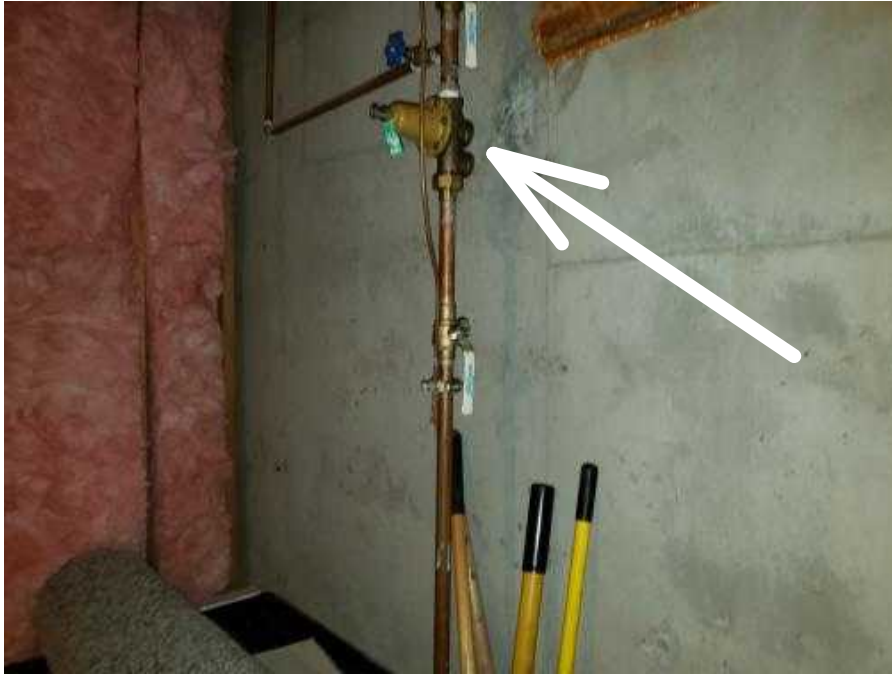
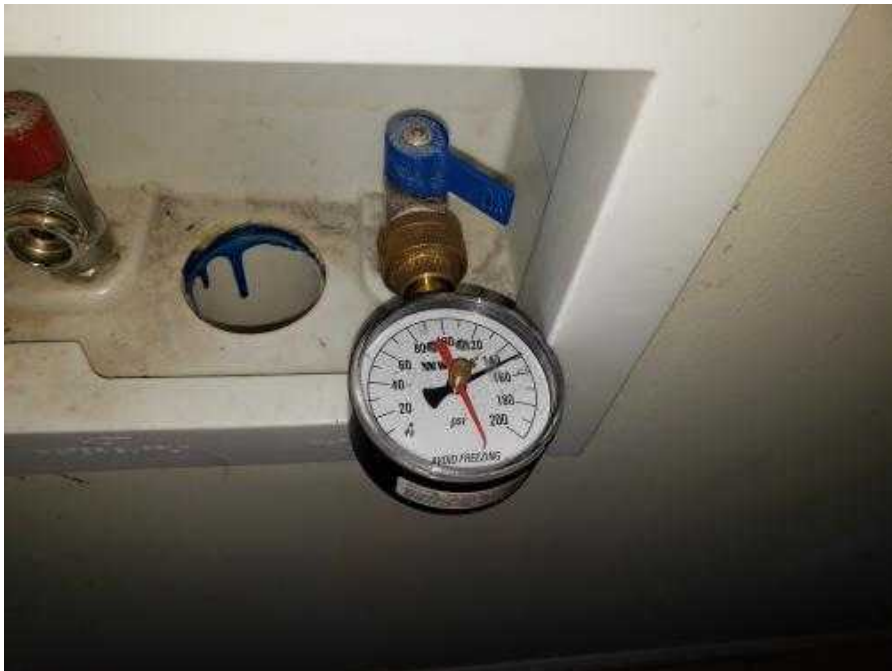
Faulty pressure regulator needs to be replaced.

3. The sellers agree to replace the faulty pressure regulator with a new and well-functioning regulator.
4. The sellers agree to properly install a tankless or bigger (80 Gal.) tank water heater to meet the  
current home needs (over 5,000 sqft with kitchen and full bath added in basement).

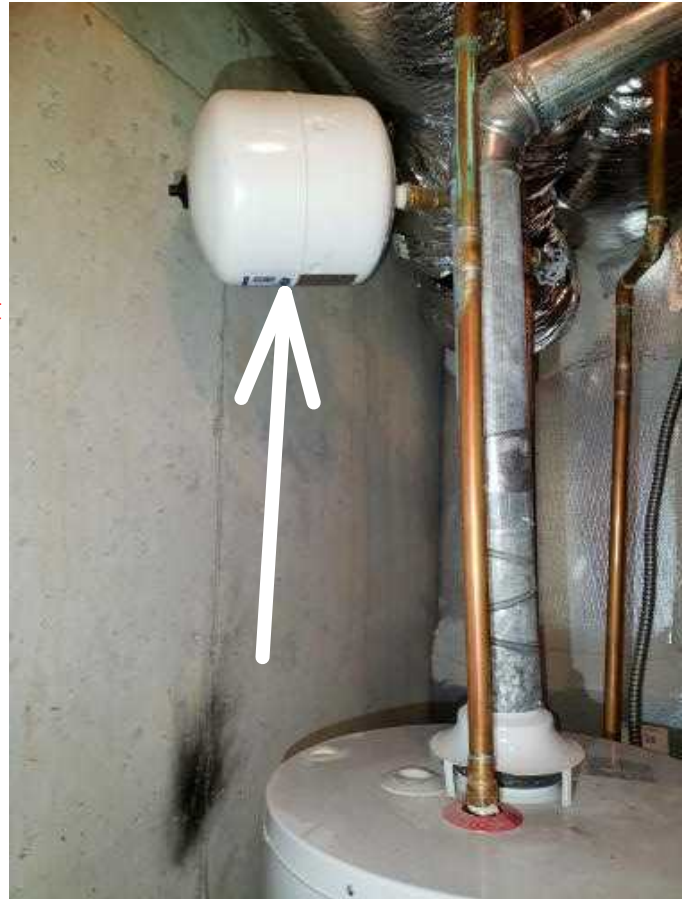
Water heater is undersized/inadequate for homes current needs with the addition of kitchen and full bath in basement. Recommend tank less water heater be installed.

Expansion tank was not installed properly. It is design to be installed vertically to ensure water can not enter the tank and add unwanted pressure to plumbing. Support strap should be added from tank to framing above.

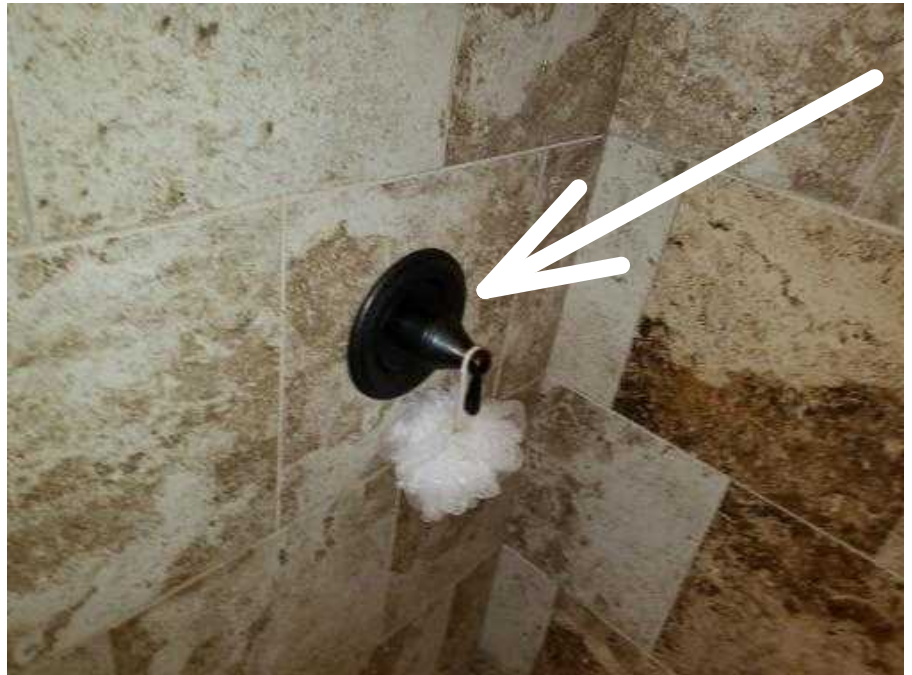
Mixture valve is loose behind wall and should be secured to framing.

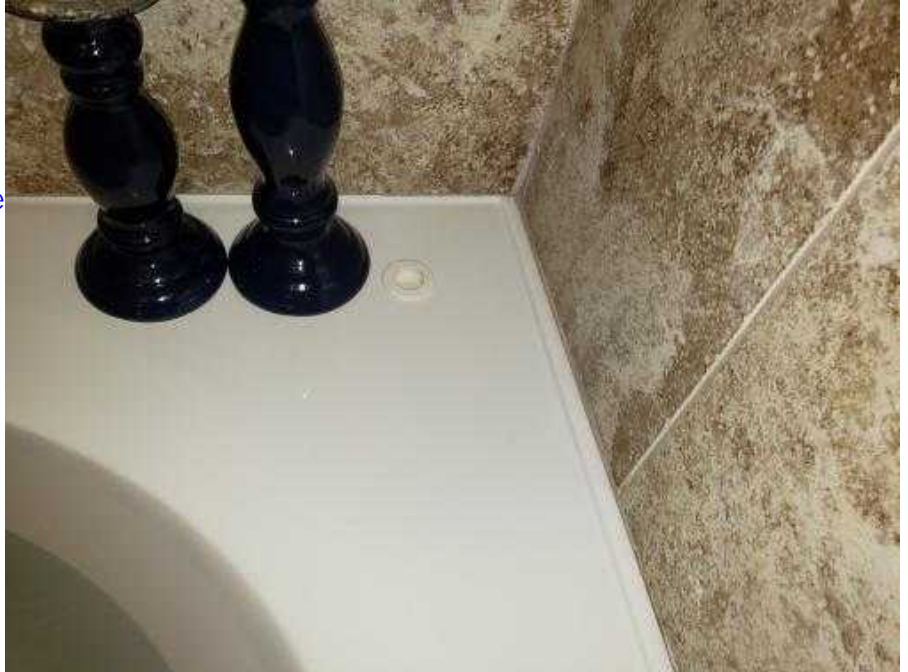
11.  Tub/Surround: Fiberglass tub and ceramic tile surround -

Jacuzzi action button is inoperative and needs to be replaced.

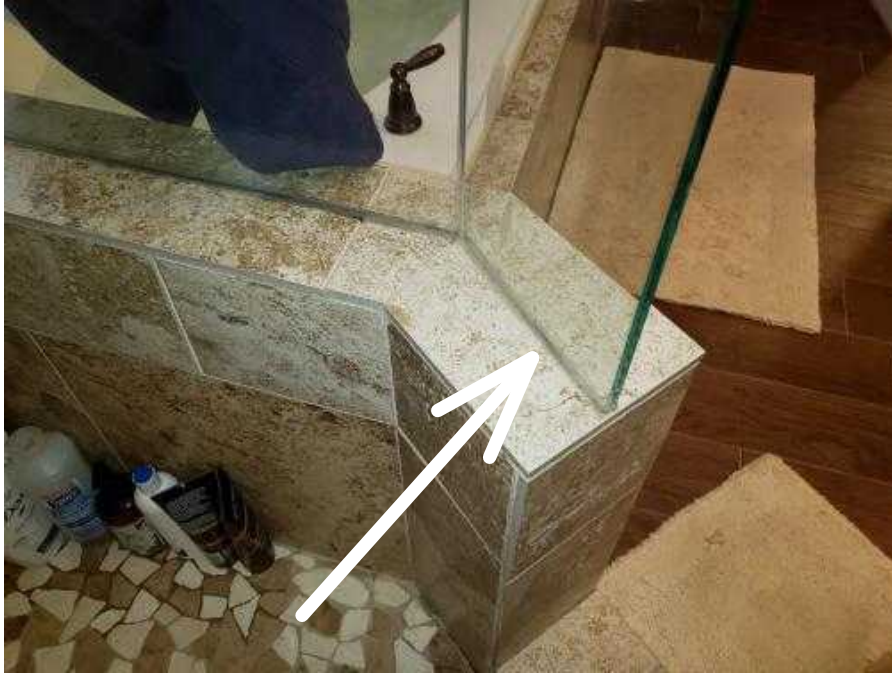
All seams in shower surround need to be sealed.

Glass shower partition is loose and needs additional bracket installed to secured it to surround.

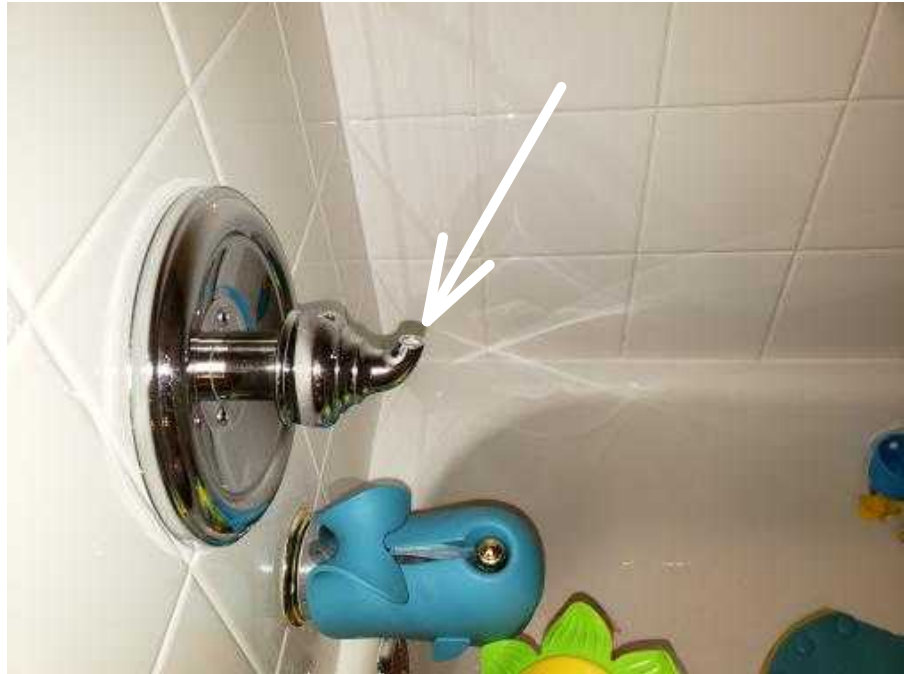
Mixture valve handle is missing parts and needs to be repaired.

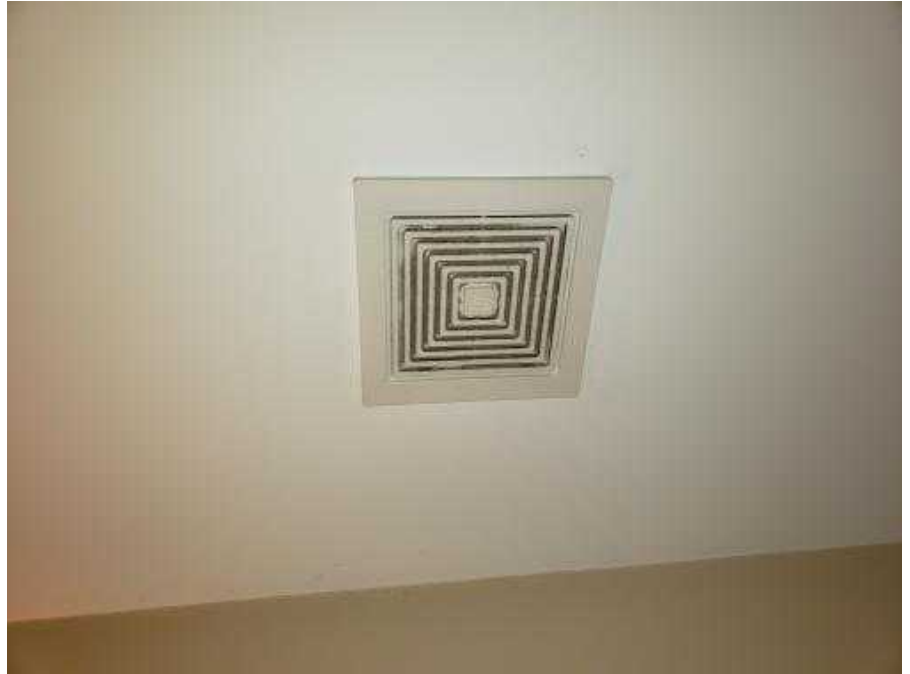
Vent and vent cover need to be cleaned to ensure proper ventilation.

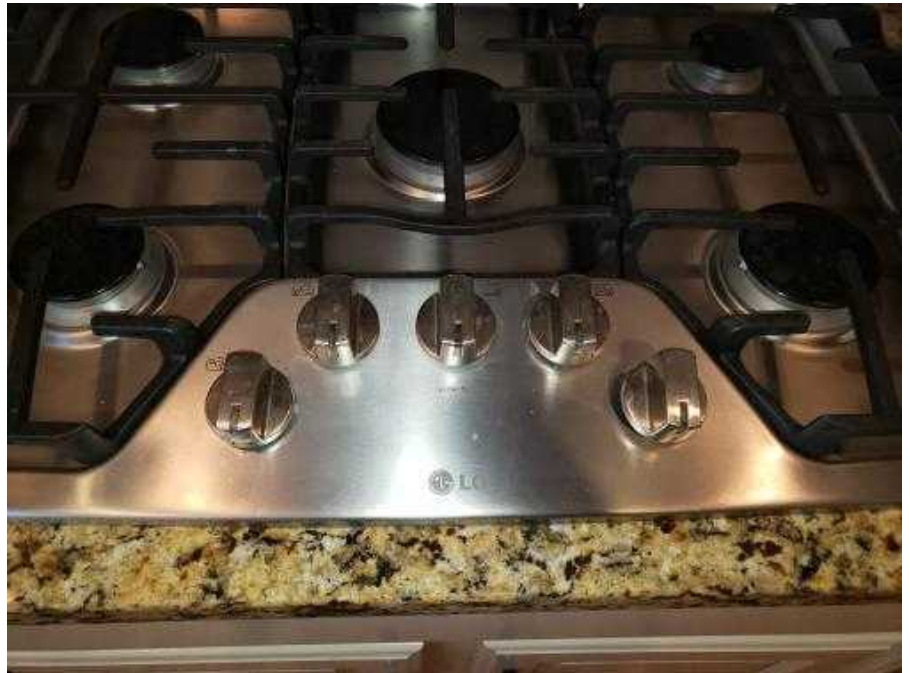
Cook top burner displays are not legible.

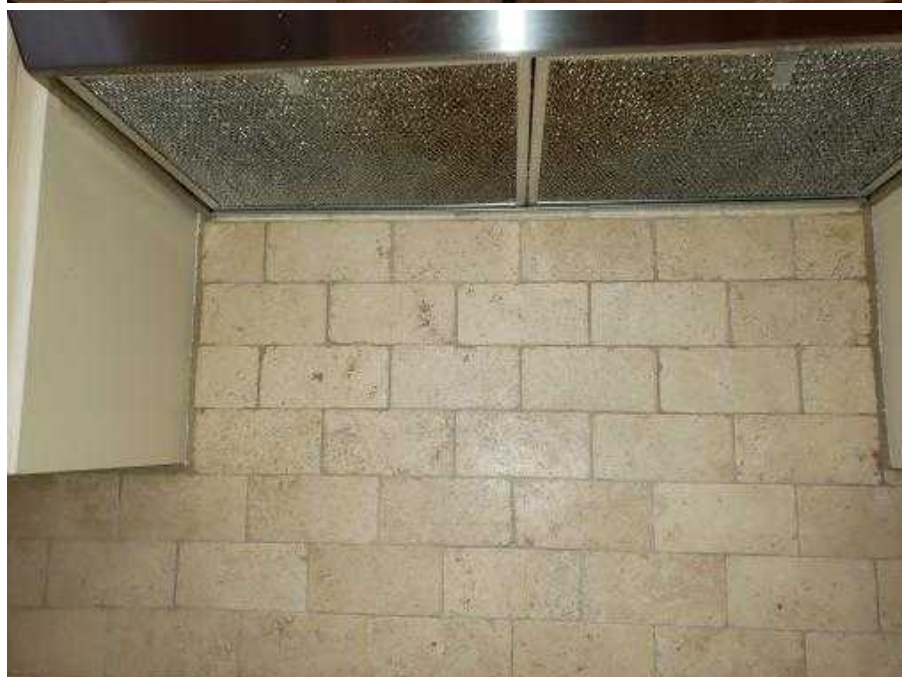
2.  Ventilator: Allure -

Grease filters need to be cleaned.

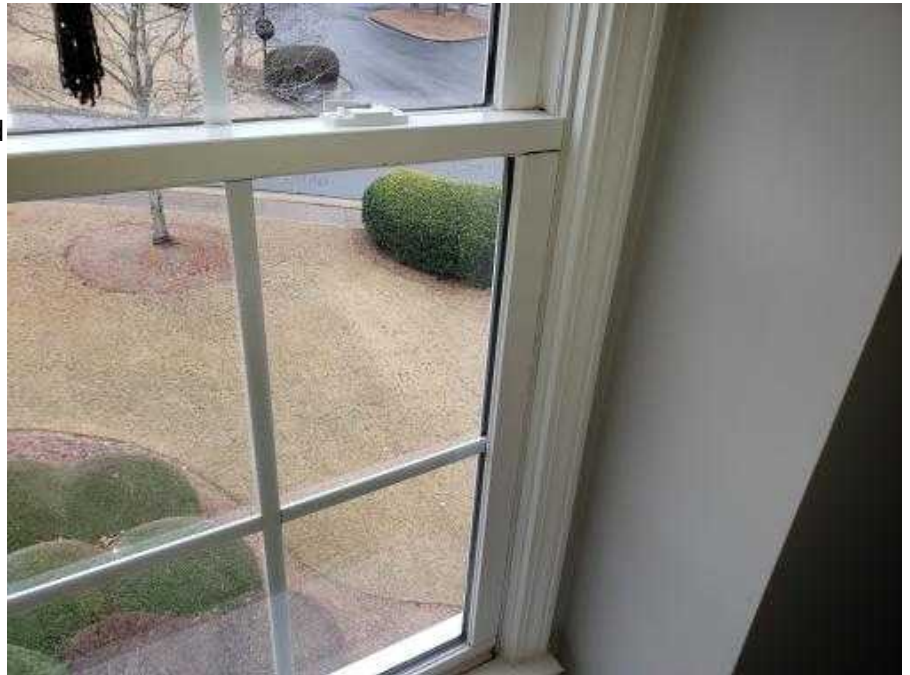
Window is painted shut and needs to be repaired.

8. The sellers agree to repair one front bedroom window which is painted shut.

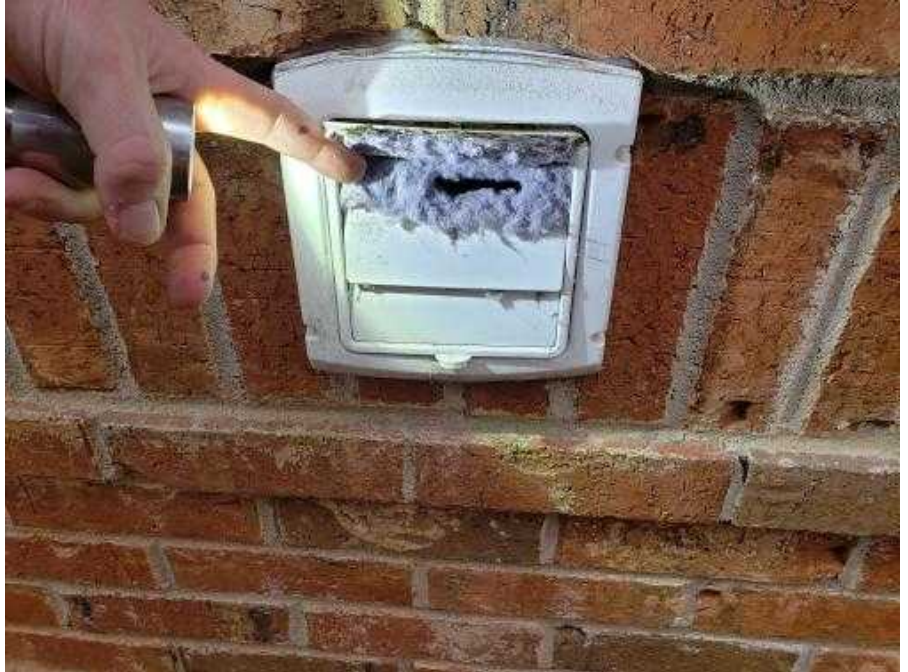
Dryer vent needs to be cleaned to ensure proper operation.
