# Atlanta Property Inspections, Inc.

## HOME INSPECTION REPORT

**3799 Crossvine Bend, Marietta, GA 30066**  
**Inspection prepared for: Kelley Debeb**  
**Date of Inspection: 12/19/2019 Time: 1:30**  
**Age of Home: 5 Years Old (2014) Size: 4134 SF**  
**Weather: Sunny, Dry Soil, 49 Degrees**

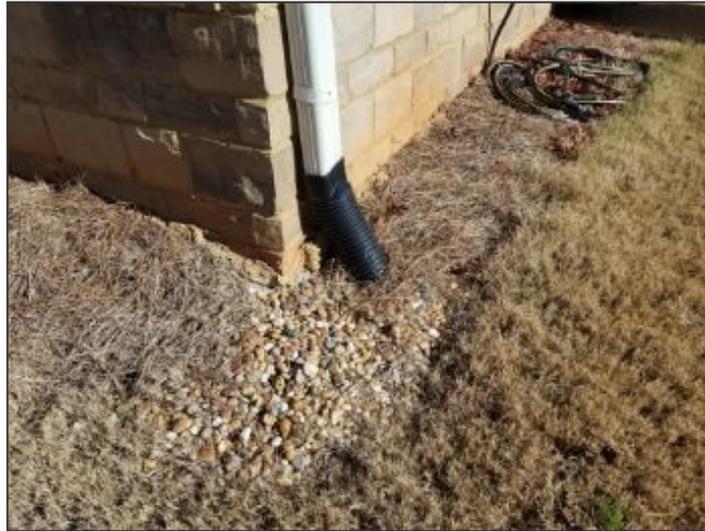
Underground downspouts present for improved drainage

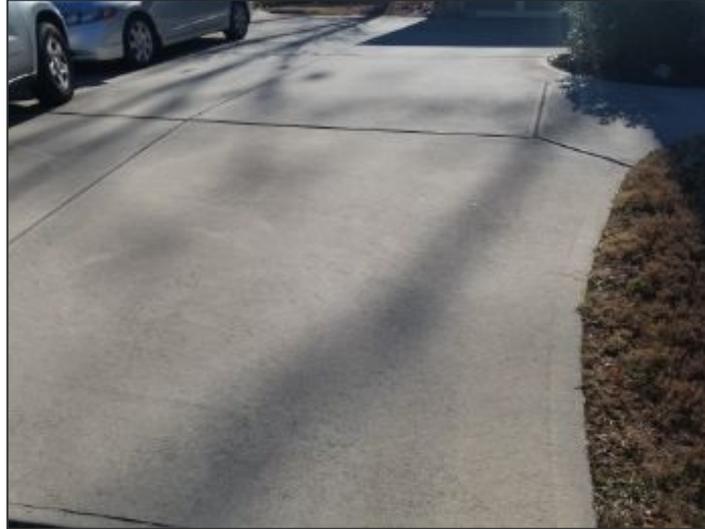
- **A concrete driveway and sidewalk are present.**
- **The overall condition of the driveway and sidewalk is good; the driveway has been finished with several control joints that are designed to help to prevent significant cracking of the concrete in the future (see photo).**

Good control joints at driveway

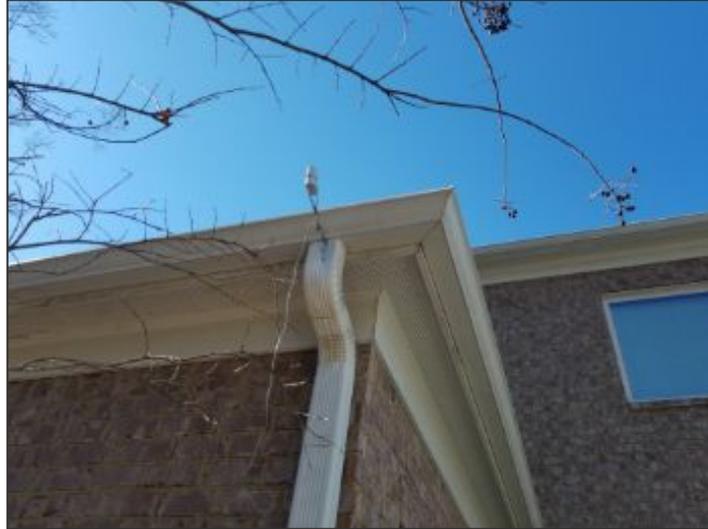
A rain free sensor is present and will help prevent the system from operating during periods of rain when irrigation is not needed.

**Rain sensor for irrigation**

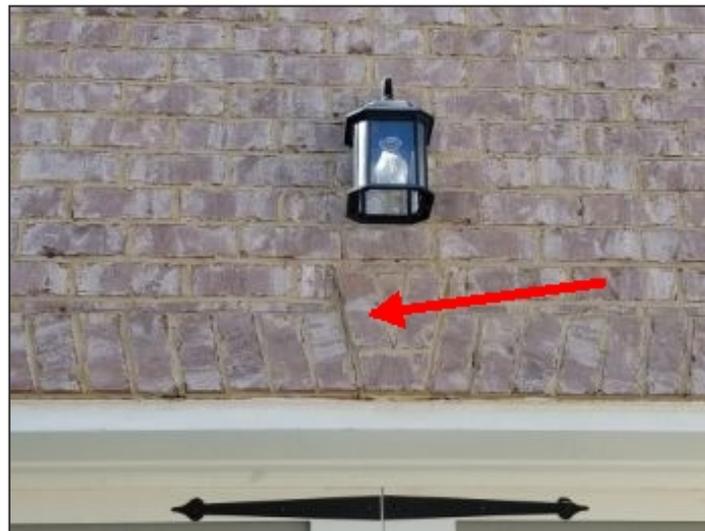
• **A minor crack was observed in the brick veneer at the center portion of the double car garage door opening (see photo). This type of crack is not considered to be structurally significant and is most often a minor concern. Continue to monitor for any changes in crack length and width, future repairs may be needed.**

Minor brick crack at center of overhead garage door

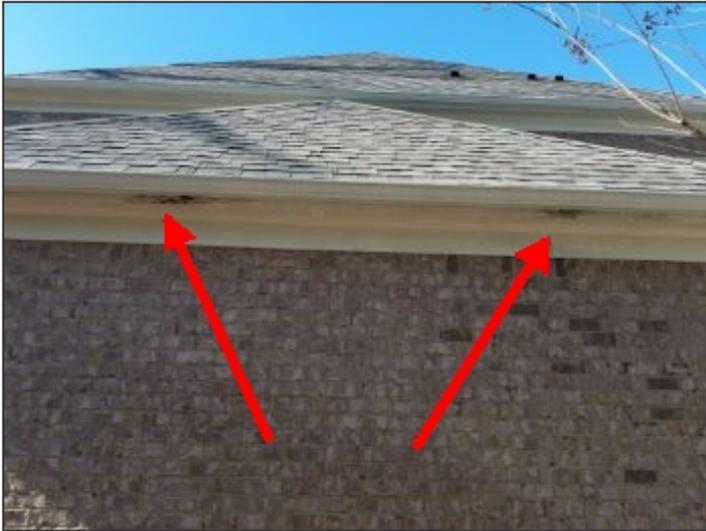
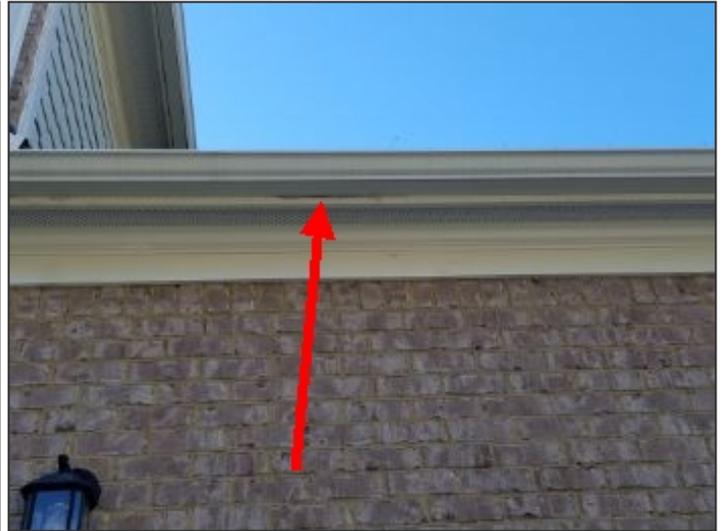
• **Damaged wood was observed at the fascia board located at the center portion of the left single car garage roof, and at the fascia board above the double car garage roof (see photos). Replacement of the damaged wood is recommended; further evaluation is recommended to determine the source of the water damage and to make necessary repairs.**

Damaged fascia at left side single car garage roof

Damaged fascia at left side garage roof

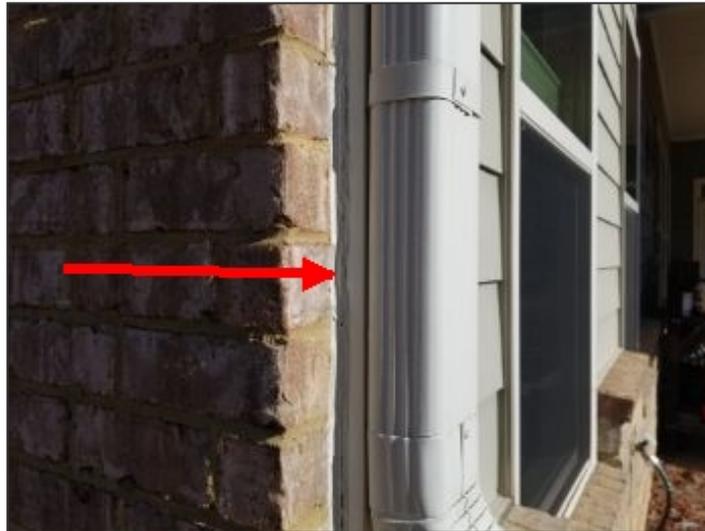
• The exterior painting and caulking is in very good condition and the exterior is well sealed. Continue to maintain as needed.

Exterior walls / trim well sealed with caulking

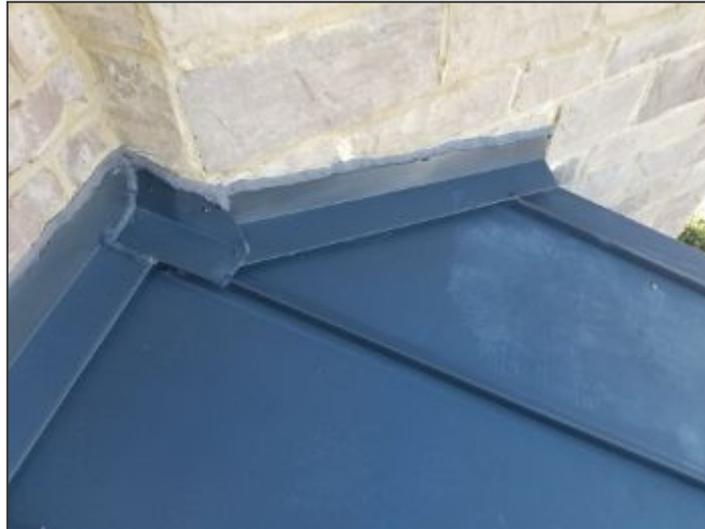
Front porch roof well sealed at wall connection

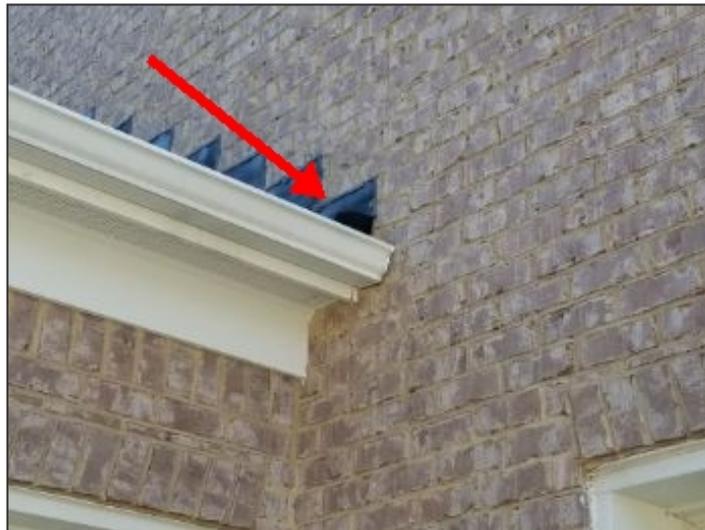
Good kickout flashing at roof intersections

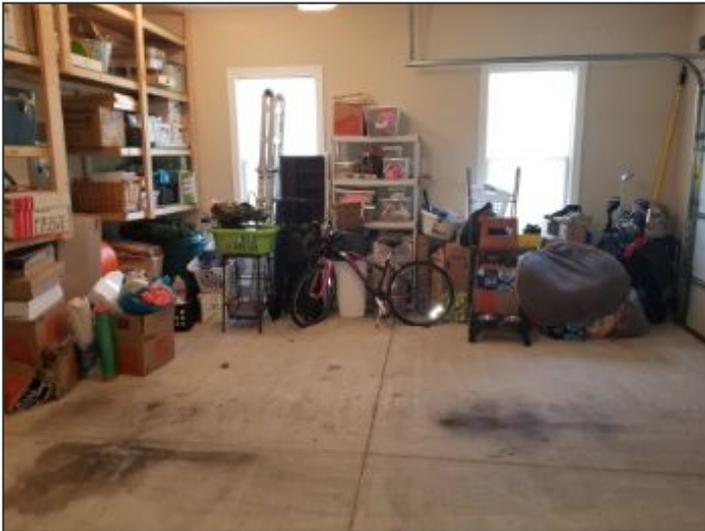
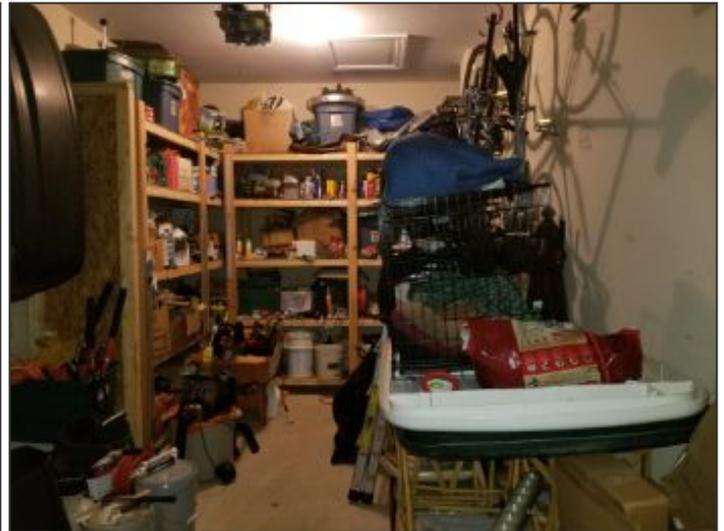
• **Storage obstructions in the garages restricts full visibility of the floor and lower walls, unable to fully inspect (see photo). Further evaluation is recommended after the storage items have been removed.**

Storage obstructions in garage

Storage obstructions in single car garage

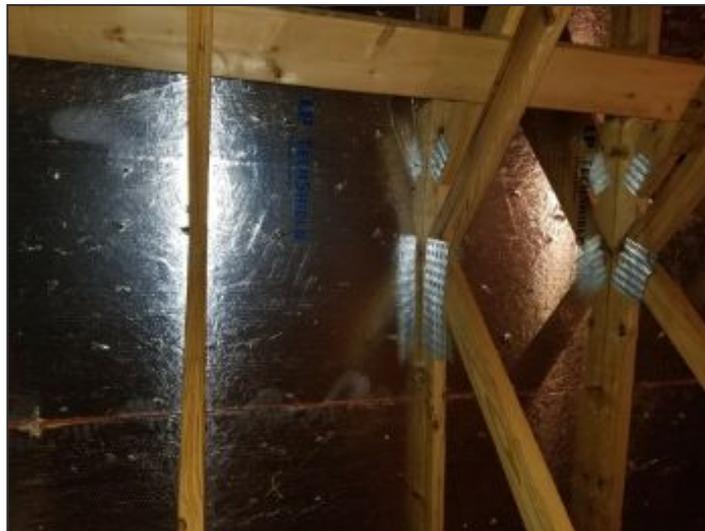
The roof has been framed with TechShield roof decking that contains a foil based coating designed to significantly reduce heat gain into the attic from the hot sun outside. This roof type of roof decking can reduce attic temps by up to 30-40 degrees in the hot summer months which can help to reduce air conditioning loads and energy use in the home.

Tech Shield roof decking present

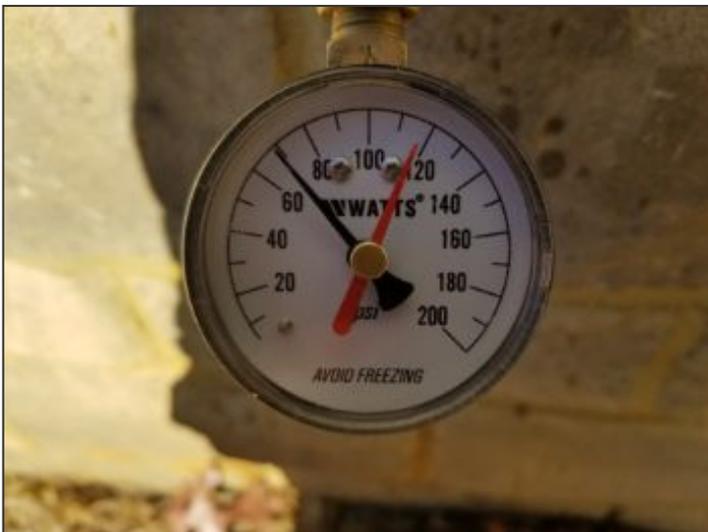
• The supply piping appears to be serviceable, no concerns were noted. A water pressure reading was taken at the rear hose bib and was found to be normal at 69 PSI (see photo).

Water pressure normal at 69 PSI

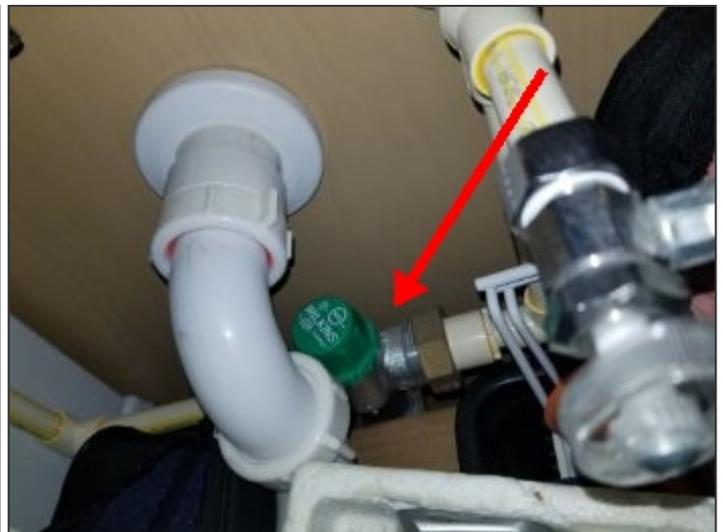
• A tempering valve is present below the master bathroom sink (see photo).  
Tempering valves are required in most newer homes. The tempering valve typically contains an internal temperature sensor that permits the valve to mix cold water into the hot supply to prevent accidental burns or scalding.

Tempering valve below master bathroom sink

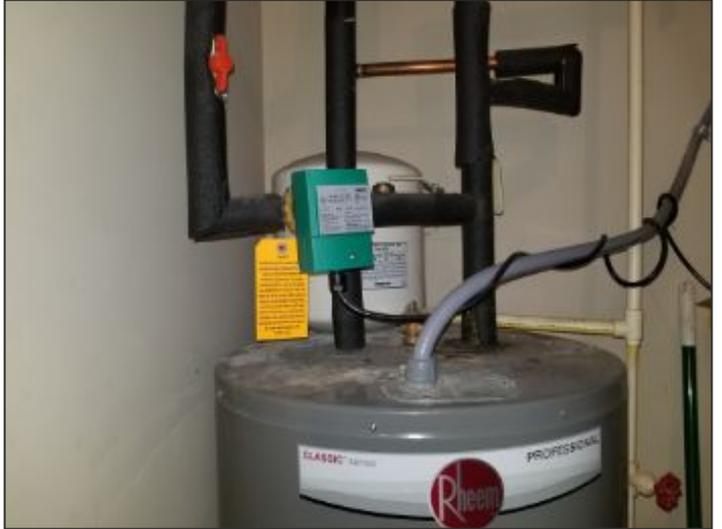
**Recirculating pump present at water heater**

**Because the hot water recirculating pump can become a constant energy user, installation of a timer is recommended to control when the recirculating pump should come on and turn off.**

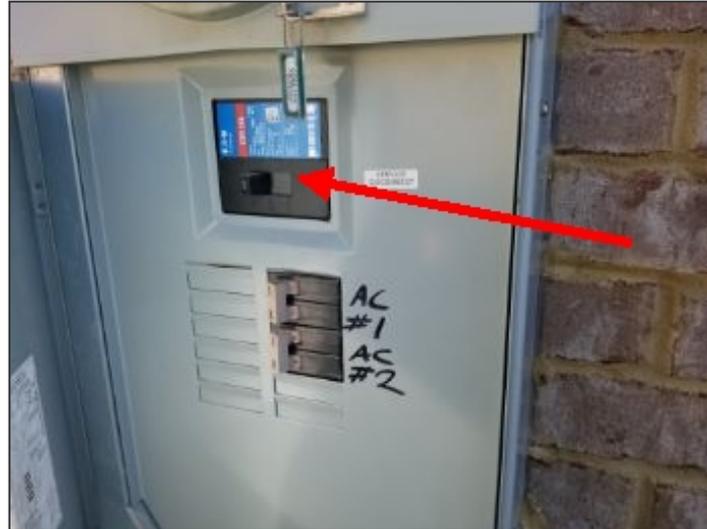
- The electrical service is underground - 110/220 volt;
- A 200 amp main breaker is present at the exterior meter location (see photo); appears serviceable, no concerns were noted.
- The electrical grounding consists of a UFER ground in the single car garage. The electrical service and grounding appears serviceable; no concerns were noted.

Main electrical disconnect at exterior meter

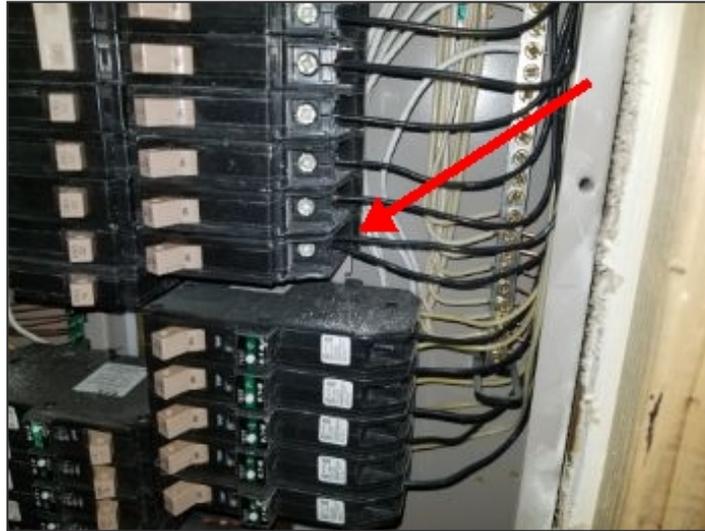
- The main panel is located in the garage. Circuit breakers are present.
- Improper Wiring: A **double tap** wiring connection is present inside the panel box - two wires are connected to one circuit breaker (see photo). This condition is not allowed for this type of circuit breaker and can create loose connections at the breaker or possible overload conditions. Correction is advised by a licensed electrician to meet the safety requirements of the National Electric Code (NEC).

Double tap wiring connection inside main panel box
