Home Inspection Report

547 Gables Run
Alpharetta, GA 30004

Prepared for: Jon Kuck

February 11, 2020

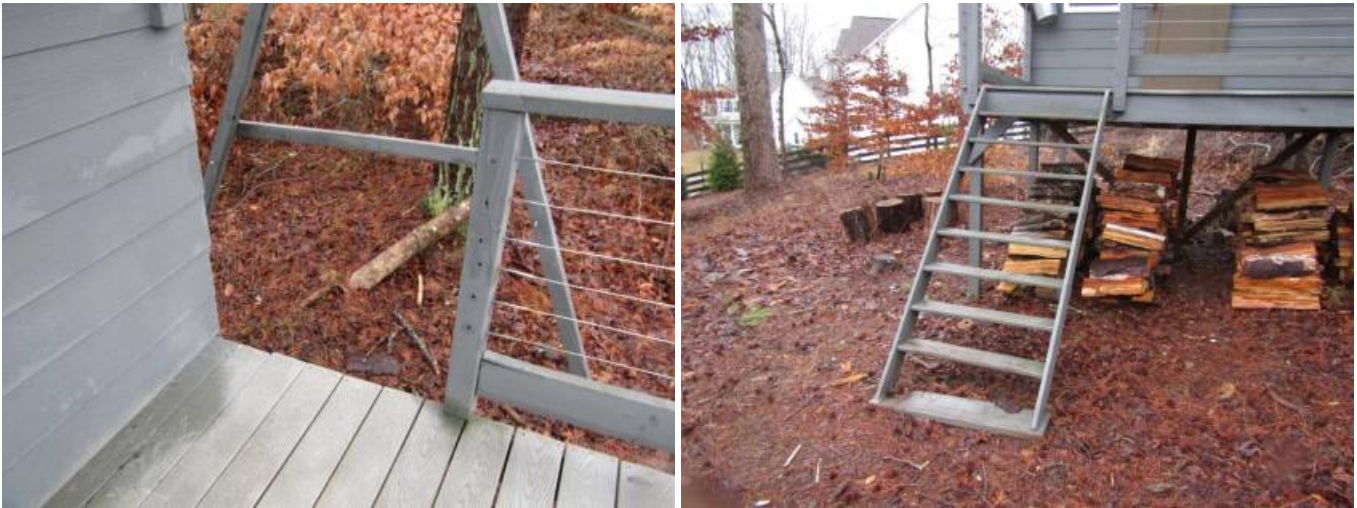
Action - There is an opening in the guard-rail on the play house and there is not a handrail on the stairway. Repair is recommended for safety.

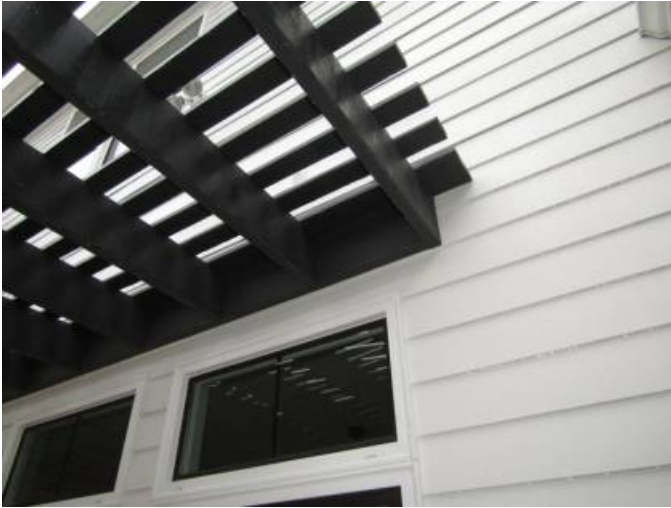
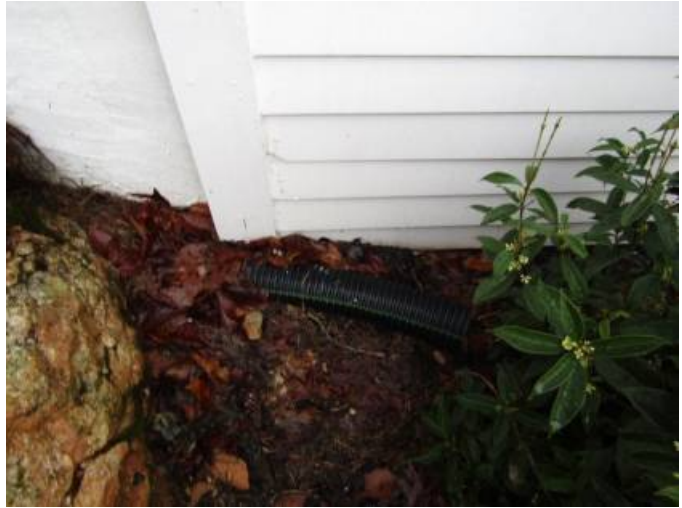
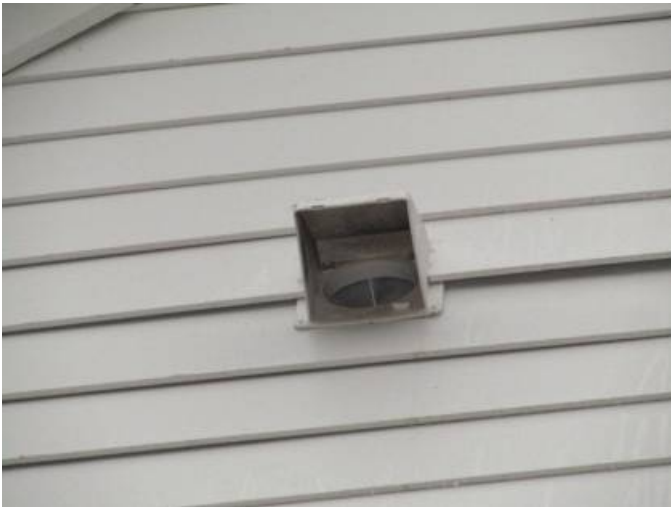
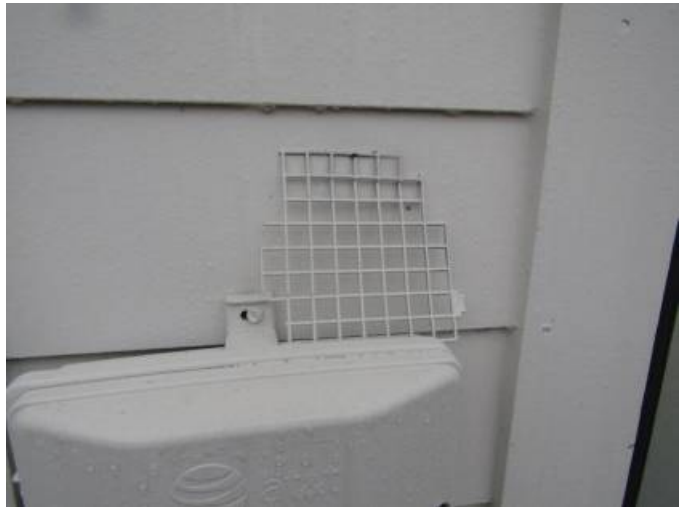
Siding Condition: **Action** - There is not a flashing between the ledger board for the pergola and the siding. This can cause water damage. Recommend installing a flashing.
- The siding on the left side of the home is in contact with the soil. This contact can cause wood rot and give access for insects.

- The screen has fallen out of one of the vent hoods on the left exterior of the home. This is needed to prevent animals from building a nest in the vent and blocking it.

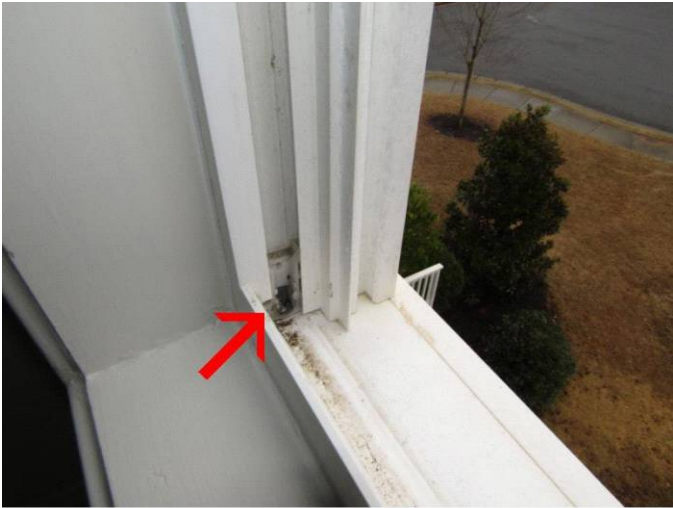
Windows Condition: **Action** - The left window in the left rear bedroom does not stay up when opened. The counterbalance spring on the left side of the window is in need of repair or replacement.
- There is evidence of water entry at the basement window.
Recommend having the windows evaluated and repaired by a qualified contractor.

disconnected ballance spring

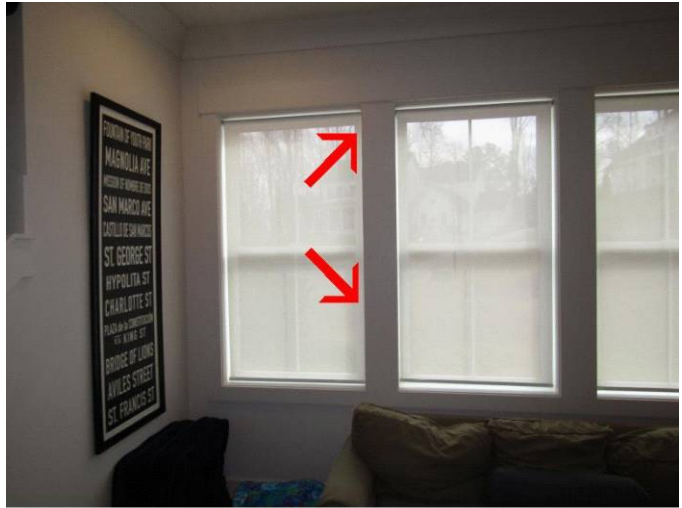
water stains

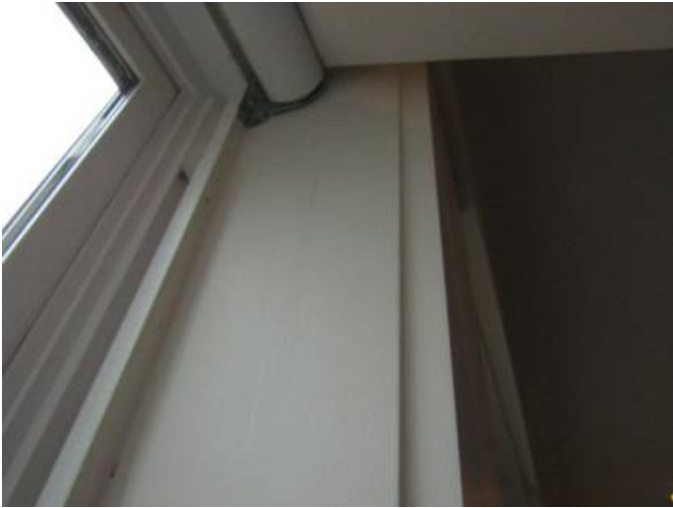
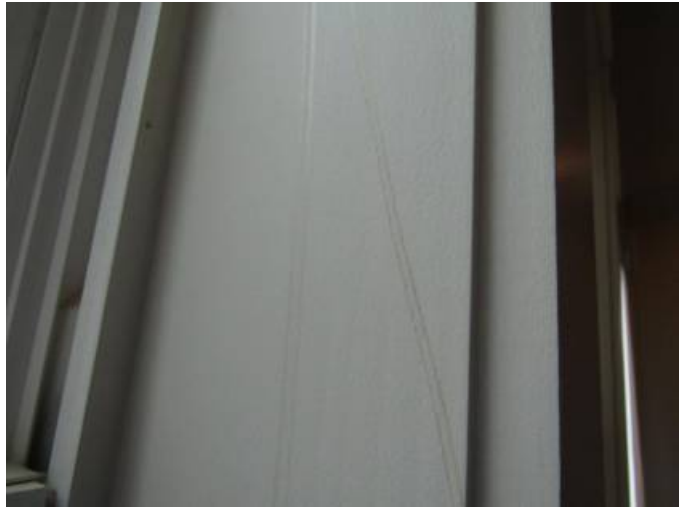
Exterior Doors: **Attention** - There are stains indicating water entry at the door to the store room above the garage. Recommend having a qualified contractor determine the cause of the moisture entry and make repairs to prevent water damage.
- The door from the master bedroom to the patio hits the frame, adjust or plane the door to open and close properly.

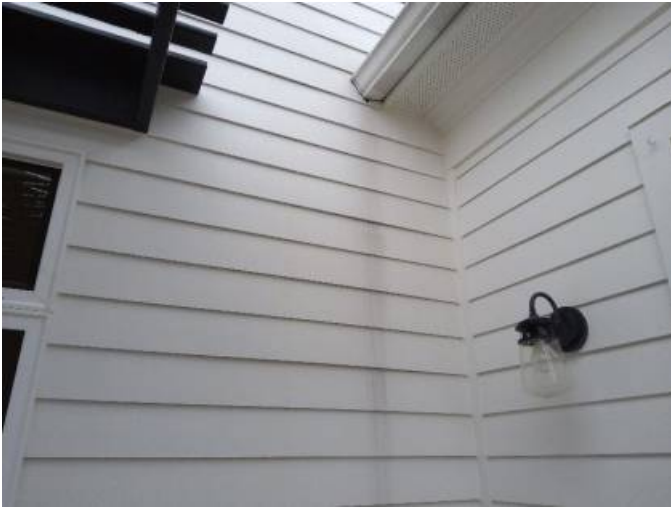
- Description:** Gable style roof.
- Description** **GOOD NEWS:** This roof is metal. This is an upgrade from traditional shingles and will last much longer than shingled roofs.
- Means of Inspection:** The roof inspection was completed from the ground. The surface of the roof was not walked on because it was wet, making it hazardous to walk on.
- Condition of Roof:** The visible shingles are in satisfactory condition.
- Flashing:** **Action** - Water is running down the siding on the rear of the home. Repair is recommended to prevent water damage.

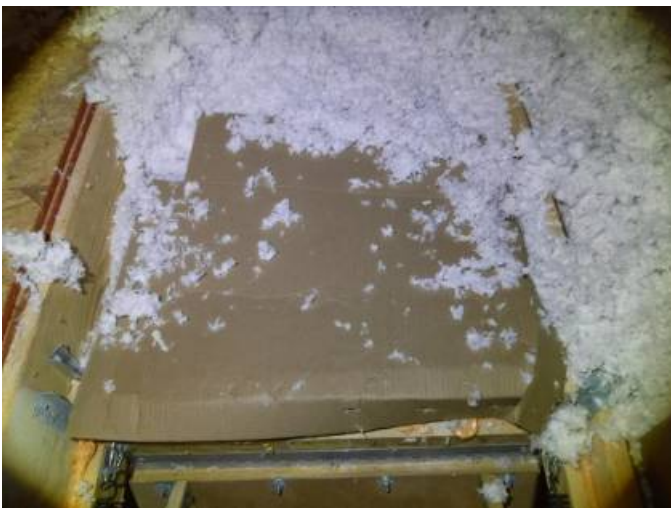
Attic Floor: **Action** - There is not any flooring at the top of the attic stairs, this poses a fall hazard. Recommend installing flooring to prevent someone from falling.

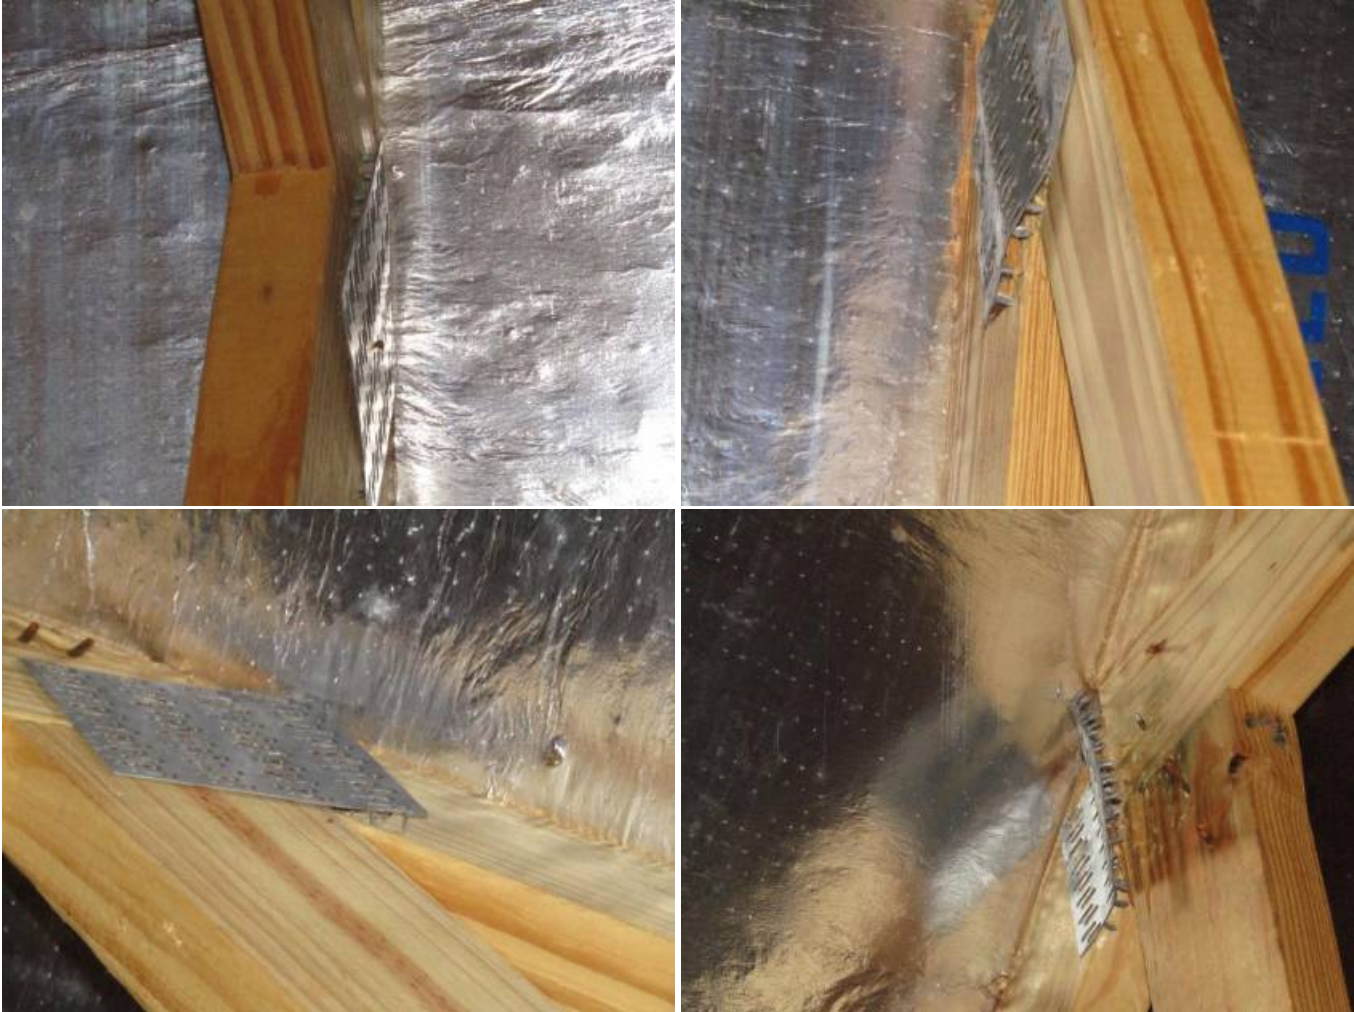
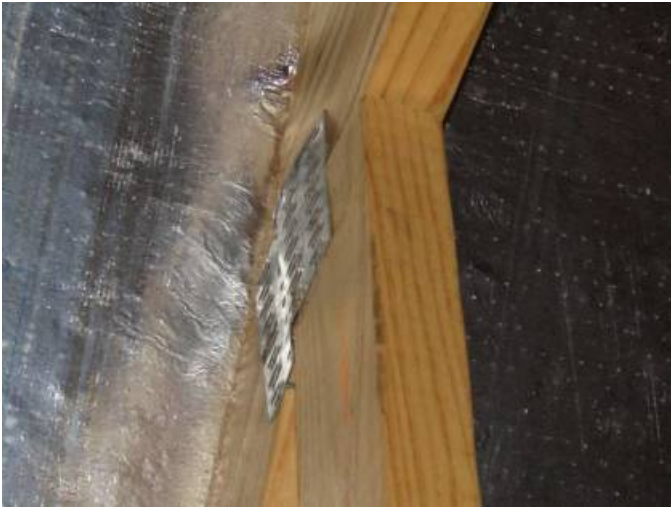
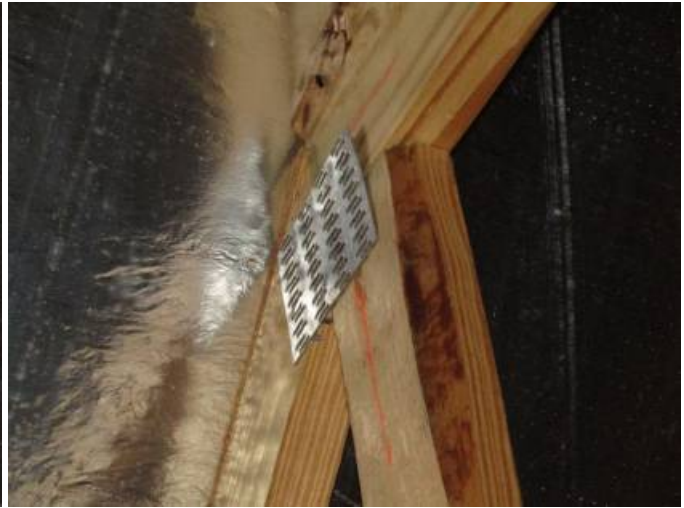
Action - Loose gusset plates were noted on some of the trusses in the attic. Locations noted, but not limited to are the ninth and eleventh trusses from the left end of the home; the fourth, fifth, sixth, seventh, eighth, ninth, and tenth trusses from the right end of the home. Not all locations are listed here or shown below. According to building standards and truss manufacturers, all repairs to damaged trusses are required to be designed by an engineer or the truss manufacturer. Further evaluation of all roof trusses by an engineer or truss manufacturer is recommended. Have a qualified framing contractor repair according to the engineers instructions. Be sure to get a copy of the repair specifications and keep it for your records when selling.

- The typical repair of a damaged or loose gusset plate is to install a 2' x 2' piece of 3/4" plywood on both sides of the truss and nail them to the truss members every 6" in a staggered pattern.

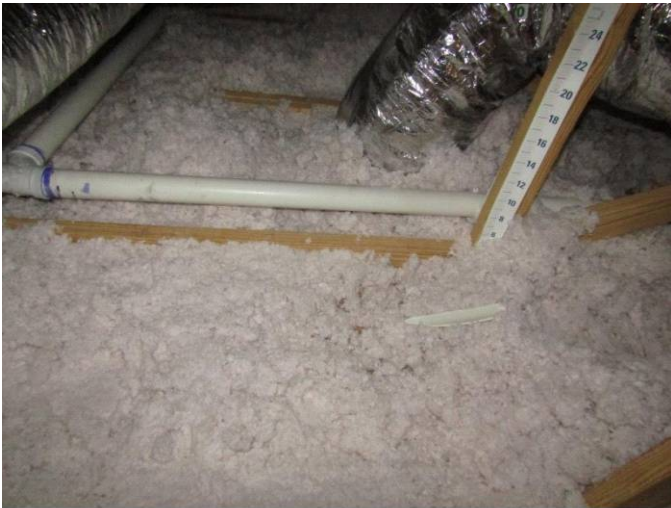
Condition of Insulation: **Attention** - Compacted insulation and missing insulation was noted in several locations of the attic. Not all locations are shown below. Recommend adding insulation for energy efficiency.

compacted insulation in the upper attic

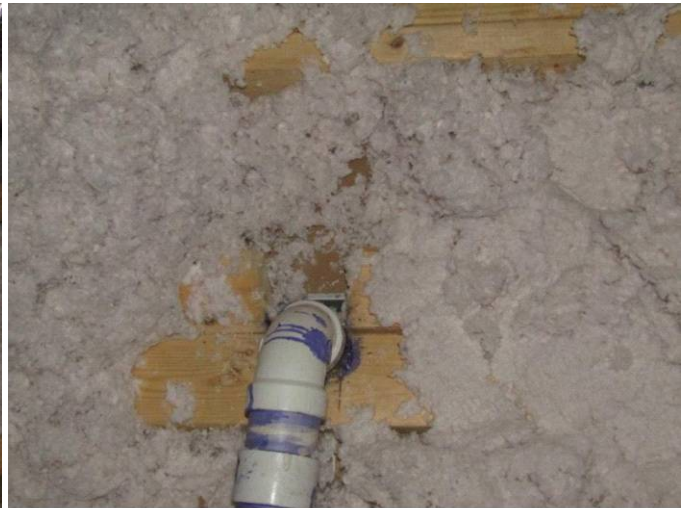
compacted insulation in the upper attic

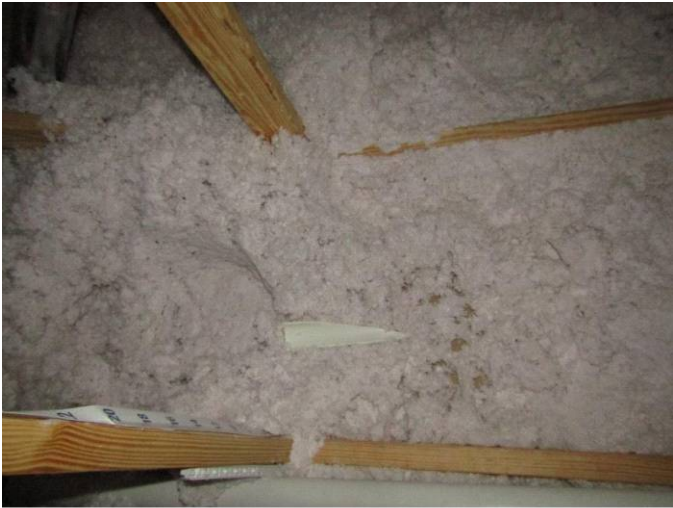
compacted insulation in the upper attic

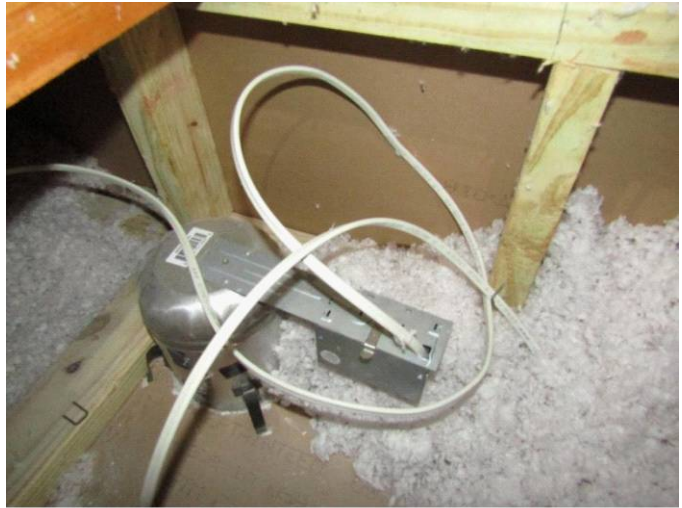
missing insulation above master bedroom

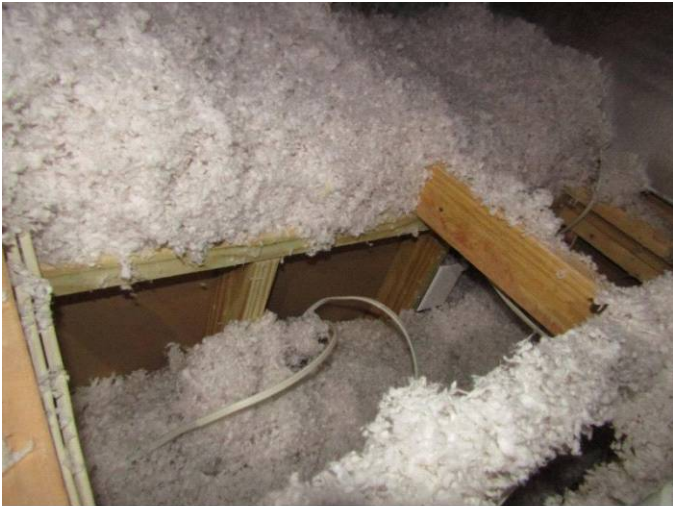
missing insulation above master bedroom

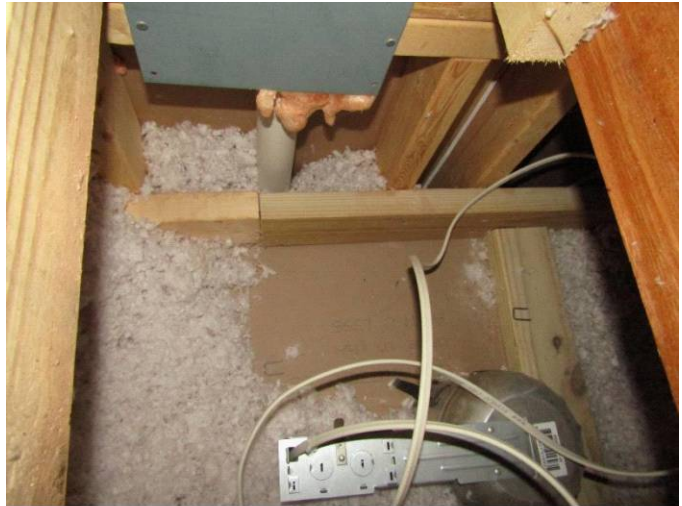
missing insulation above master bedroom

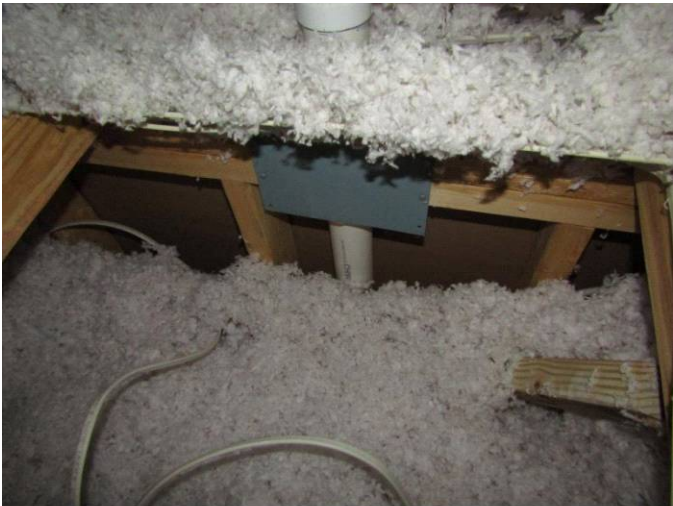
missing insulation above master bedroom

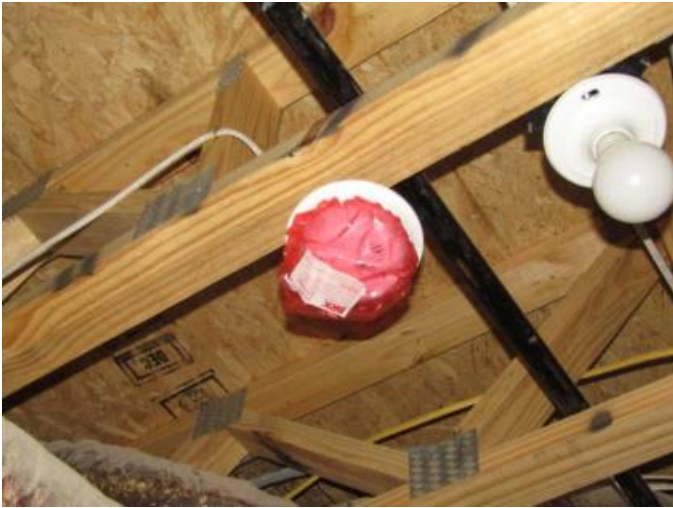
Receptacles:	The receptacles that were tested are in satisfactory condition.
GFCI Protection:	GFCI protection is installed at all locations required. They functioned properly when tested.
Interior Lighting:	A representative number of lights and switches were tested and were functional at the time of inspection.
Exterior Lighting:	The exterior lighting appears functional.
Smoke Detectors:	The smoke detectors functioned when the test button was pushed. They should be tested regularly. Action - The dust cover needs to be removed from the smoke detector in the basement so that it can operate properly.

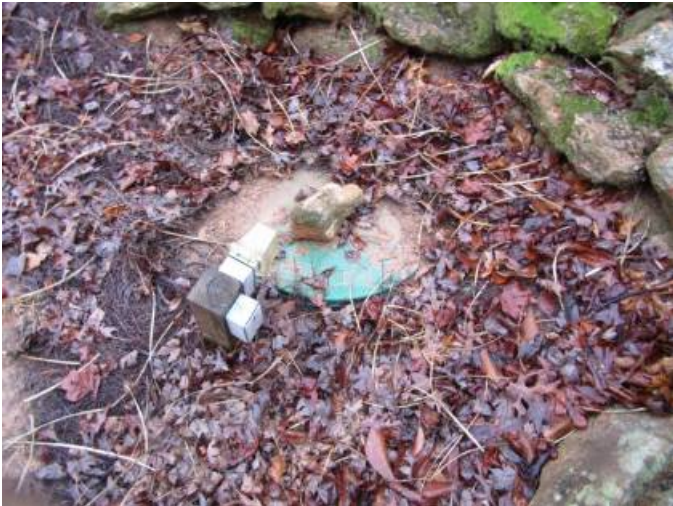
Sewage Disposal: **Attention** - A private septic system is installed. Septic tanks and drainage fields are beyond the scope of this inspection.

- This septic system has a pump. The condition and performance of the pump and related parts cannot be determined in this visual inspection. This inspection merely identifies the type of sewage waste disposal system, it does not determine the adequacy or condition of the system.
- The GFCI receptacle at the sewage pump was tripped when I arrived. There was a sewer odor at the access lid. I reset the GFCI device.
- Recommend having the septic pump, tank and field lines checked. Have the tank pumped if needed.

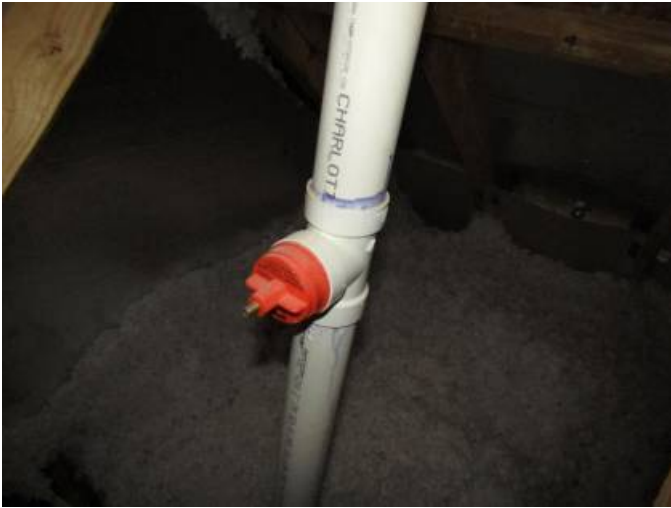
Waste & Vent Pipe Condition: **Action** - There is a test plug in the vent piping in the attic above the hall by the master bedroom. Repair by a plumber is recommended.

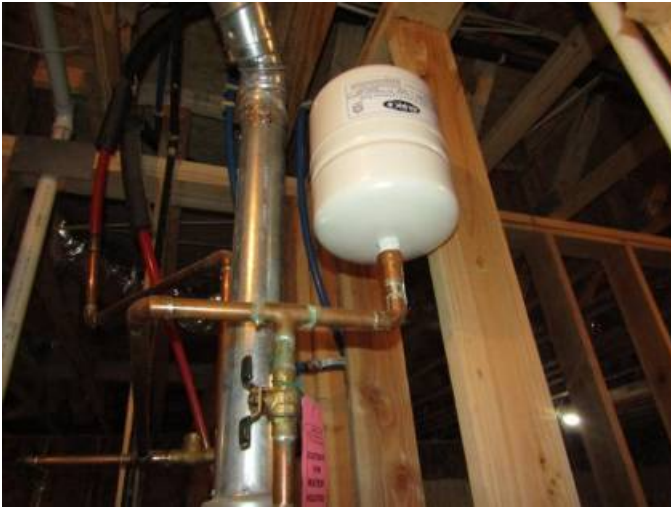
Thermal Expansion: **Action** - The thermal expansion tank is not strapped up or supported. According to the plumbing standards it is not allowed to be supported by the piping but must have a separate strap or support. Repair is recommended to prevent damage to the piping and leaks.

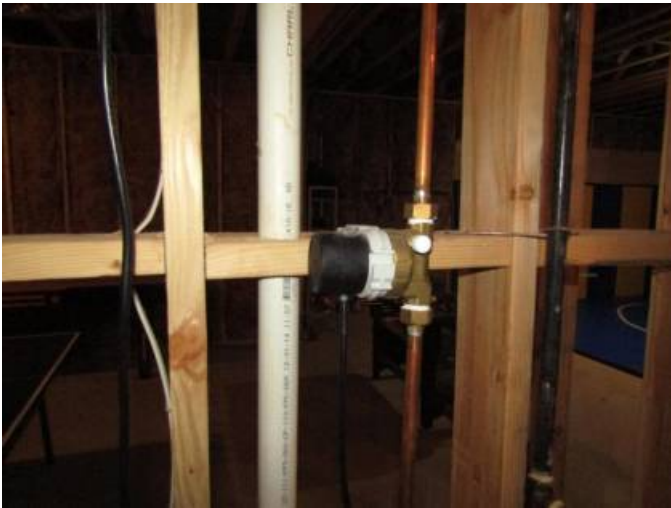
Attention - Recommend installing a plug in type time clock for the hot water circulation pump and setting it to your schedule for optimum performance and energy savings.

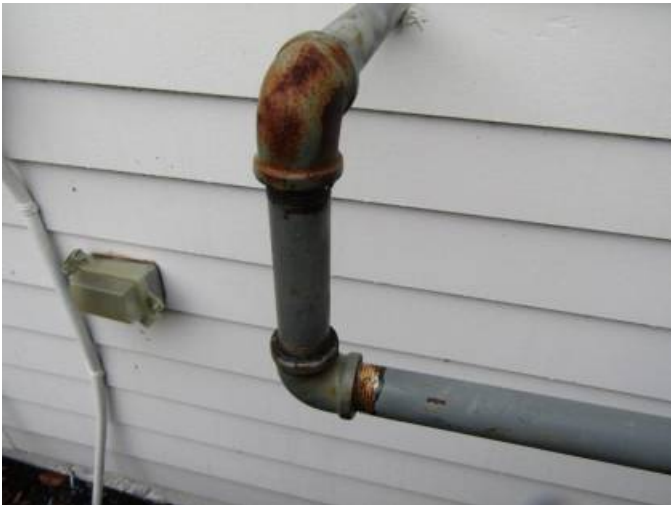
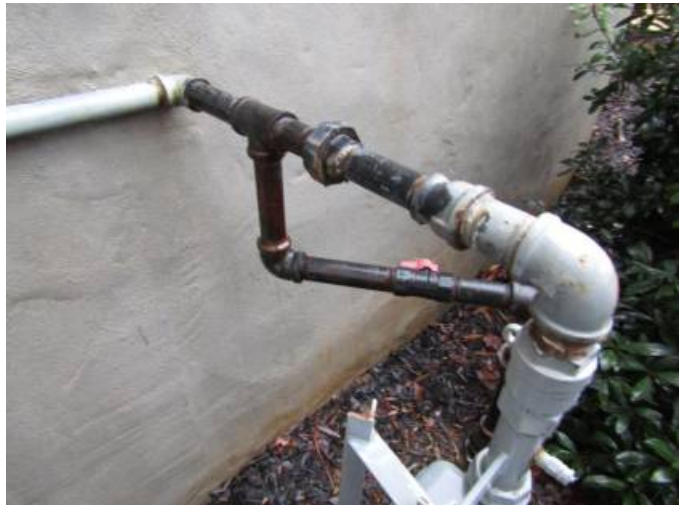
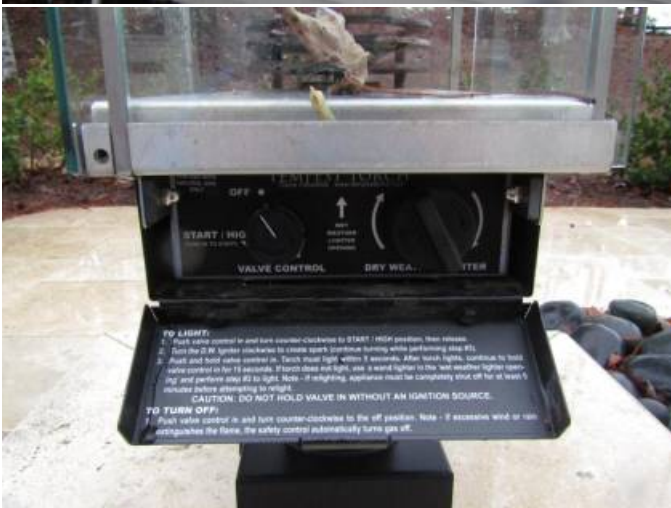
Action - There is a gas leak at the gas meter on the exterior of the home. Contact your local gas supplier or Atlanta Gas Light Co at 770-907-4231.

- The gas piping on the exterior of the home at the gas meter is rusted. Recommend removing the rust and painting with a rust inhibiting primer and paint to prevent damage to the pipes.
- I could not get the gas lamps in the back yard to light. They were wet.

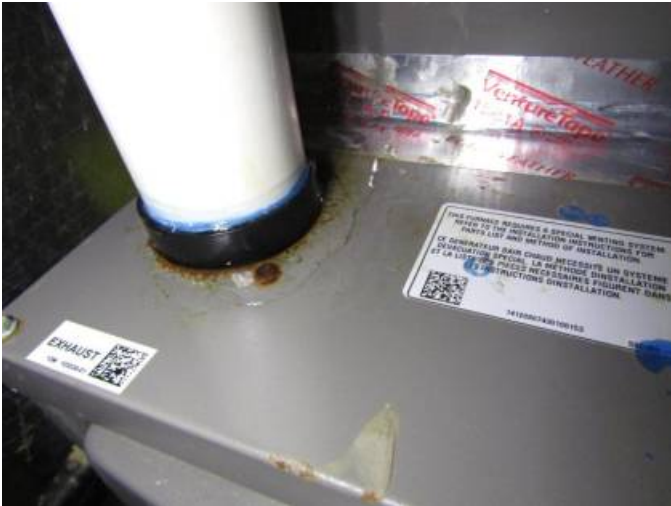
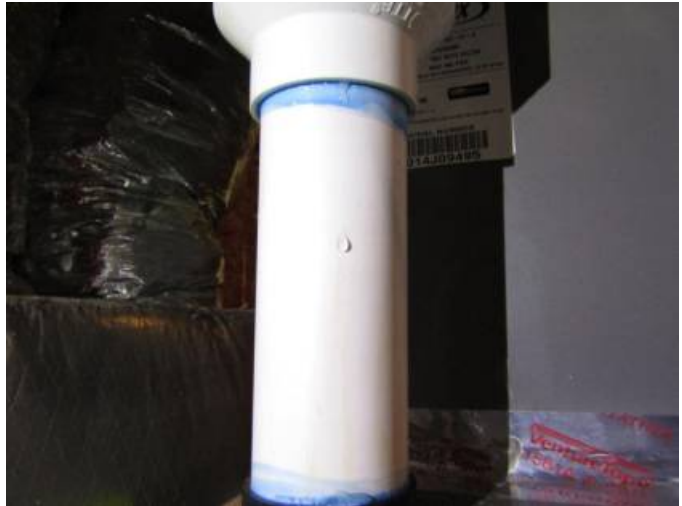
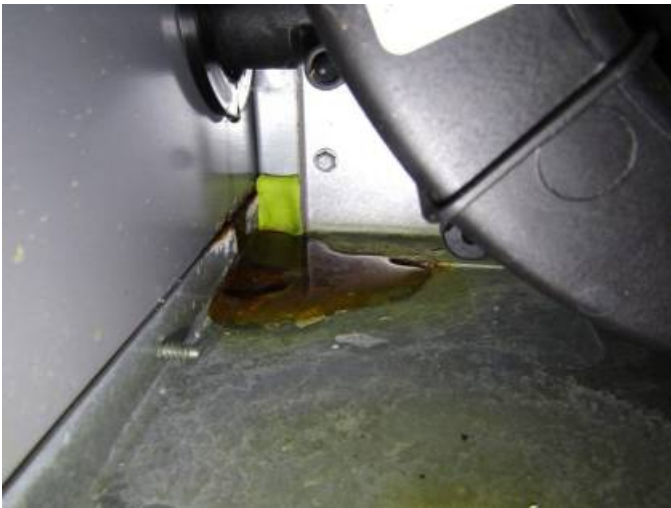
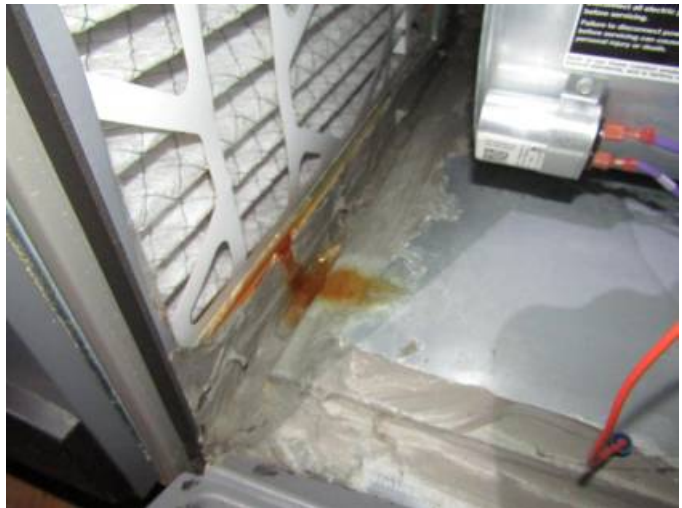
Flue: **Action** - Water is leaking from the flue of the main level furnace in the basement. It is causing rust inside the furnace.
Recommend having a licensed HVAC contractor check the flue and furnace, and make all necessary repairs.

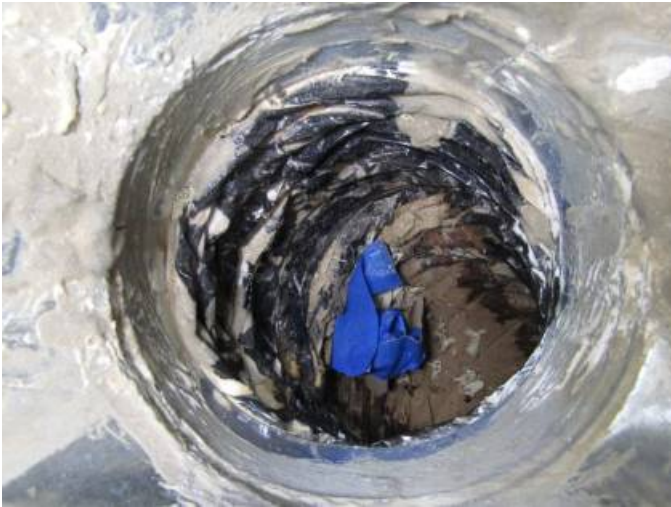
Ducts Condition: **Action** - The ducts are dirty, professional cleaning of the ducts is recommended.
- The duct at the return vent in the family room is pinched.
- There are shutters on the return vents. Return vents are not allowed to be restricted or have shutters.
Repair by a qualified HVAC contractor is recommended.

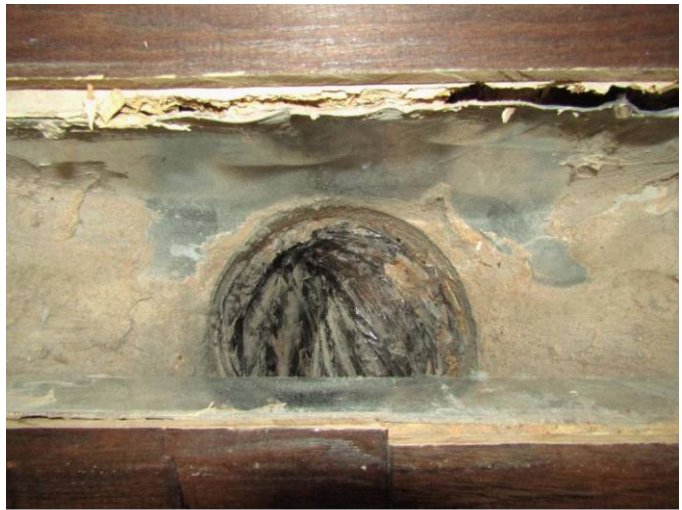
pinched duct

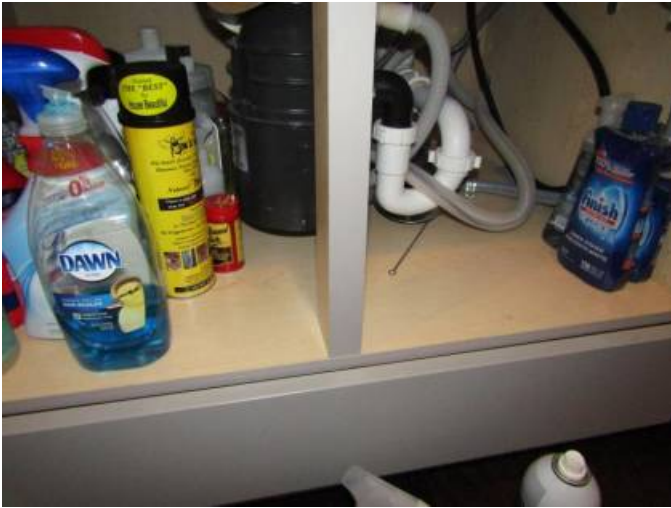
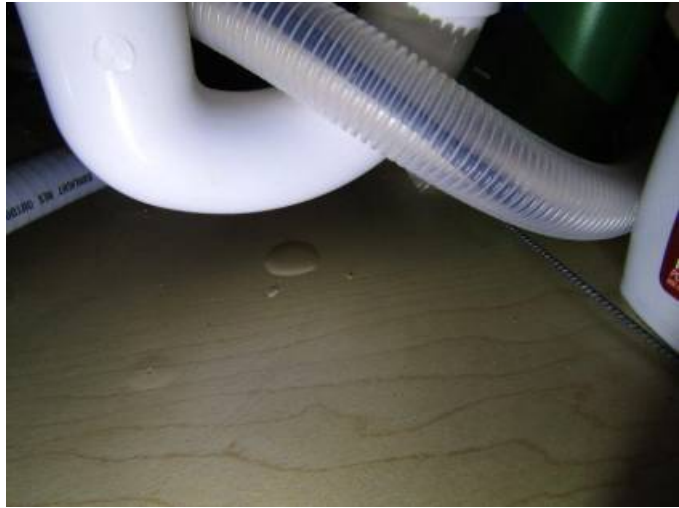
- Countertops:** **GOOD NEWS:** Stone counter tops are installed in the kitchen.
- Cabinets:** **Attention** - The bottom drawers on the left and the right side of the range do not have soft close mechanisms on them, all the others do.
- Sink / Faucet:** **Action** - There is a leak on the drain at the kitchen sink. Repair by a plumber is recommended.

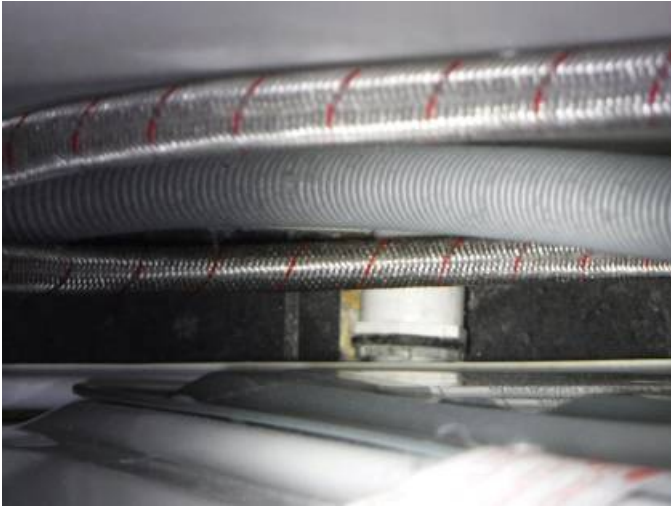
Overflow Pan: **Action** - The overflow pan under the washing machine is damaged, the pipe is not connected to the pan. Recommend replacing the pan and connecting it to the drain pipe to help prevent damage in case of a leak.

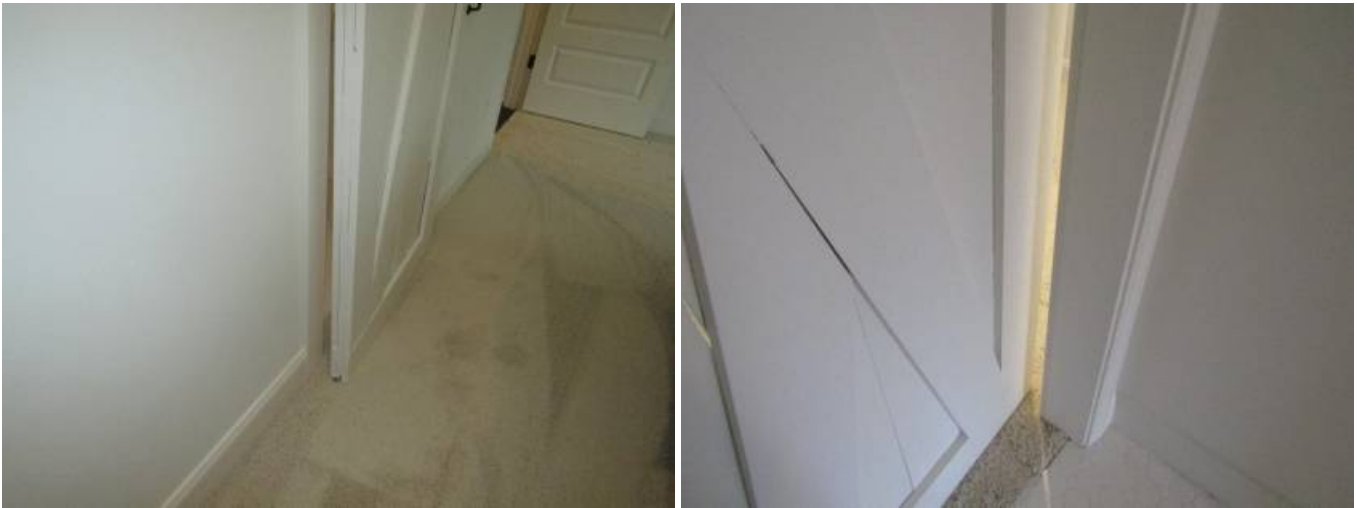
Doors: **Attention** - The door from the left rear bedroom to the bathroom and the door from the right rear bedroom to the Jack and Jill bathroom are warped.
- The stops for the door to the right front bedroom closet and the Jack and Jill bathroom doors need adjustment.

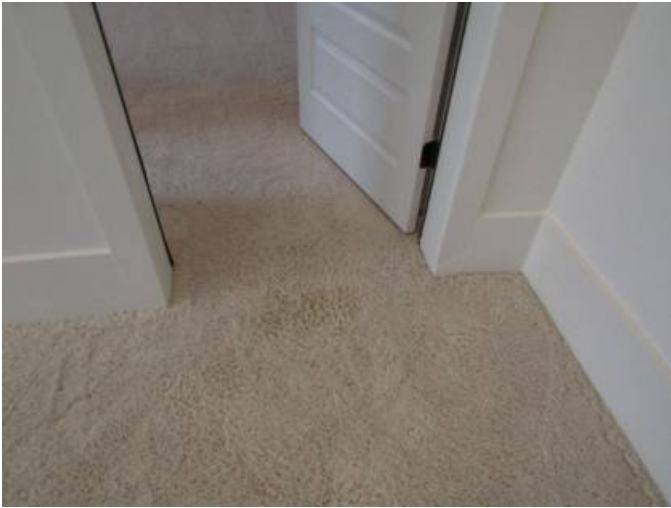
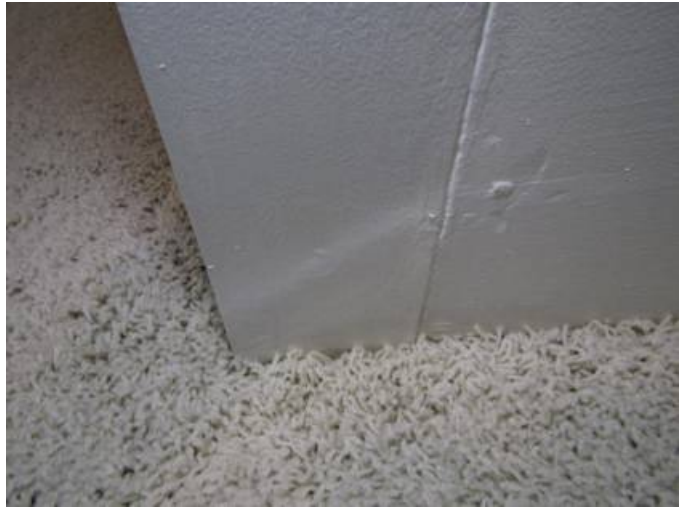
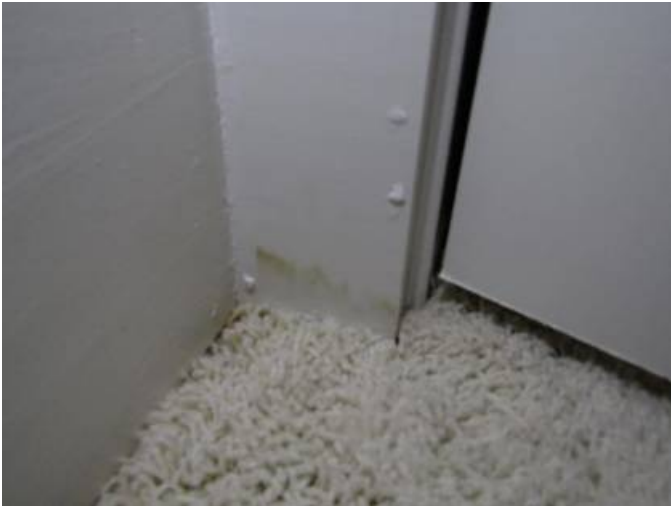
Comments: **Action** - The carpet at the door to the basement bedroom was wet. I could not determine if it was from a plumbing leak below the slab or from ground water coming up through the slab.
- Water stains and swelling was noted on the baseboards inside and outside the room. Further evaluation and repair is recommended.

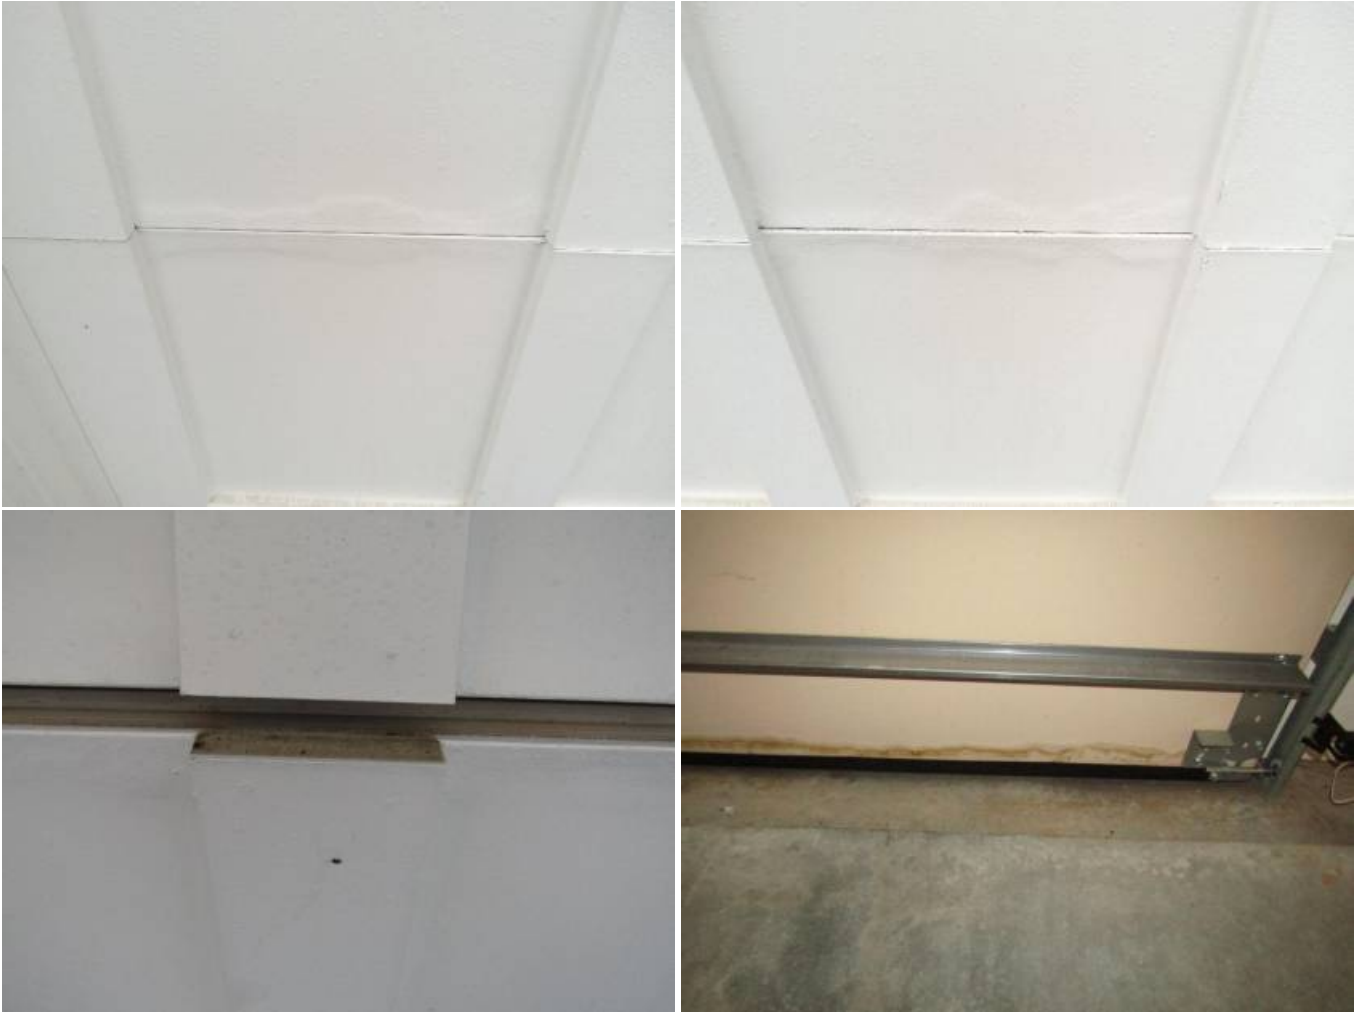
- Type:** Attached three car garage.
- Vehicle Door:** The overhead garage doors are made of wood.
- Vehicle Door Condition:** **Attention** - The garage doors are deteriorating from moisture.
