Atlanta Property Inspections, Inc.

HOME INSPECTION REPORT

5780 Asby Way, Cumming, GA 30040
Inspection prepared for: Sean Malloy
Date of Inspection: 1/18/2020 Time: 9:00 AM
Age of Home: 13 Years (2007) Size: 2200 SF
Weather: Rain, Wet Soil, 40 Degrees

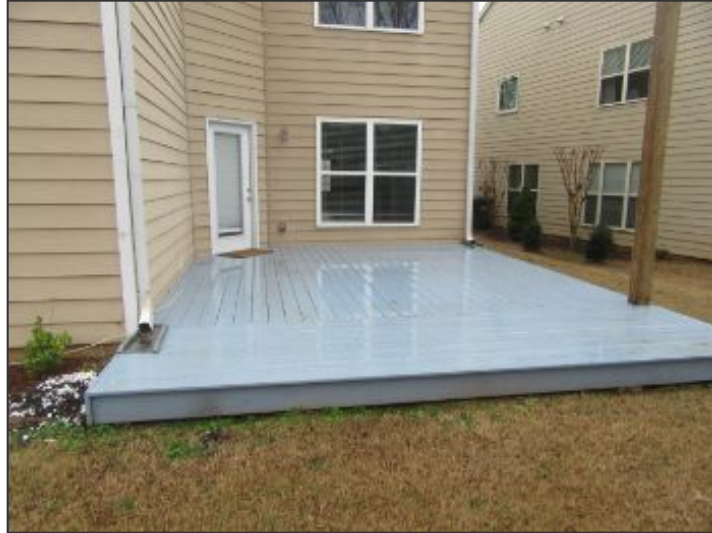
• **LIMITED INSPECTION:** The underside of the rear wooden patio is not fully visible for inspection due to low clearances from the ground. The inspector is unable to inspect the anchorage system, the ledger flashing or the joists.

Rear wooden patio

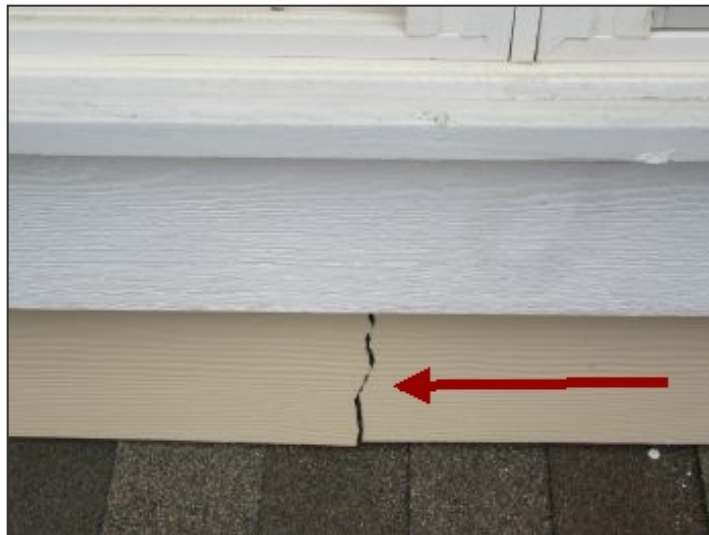
• **Damaged fiber cement siding is visible at the front wall above the front porch roof (see photo). Replacement of the damaged siding is recommended.**

Damaged siding at the front wall above the front porch roof

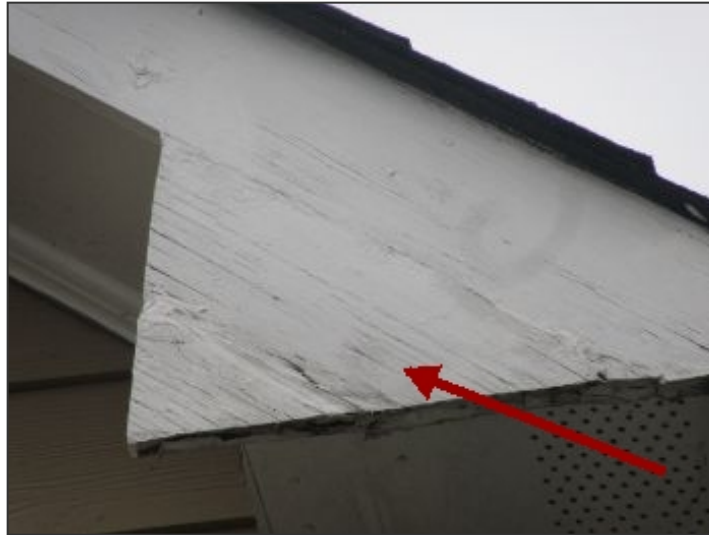
• **Damaged wood was observed at the fascia board located at the rear gable roof (see photo). Replacement of the damaged wood is recommended; further evaluation is recommended to determine the source of the water damage and to make necessary repairs.**

Damaged wooden fascia at the rear gable

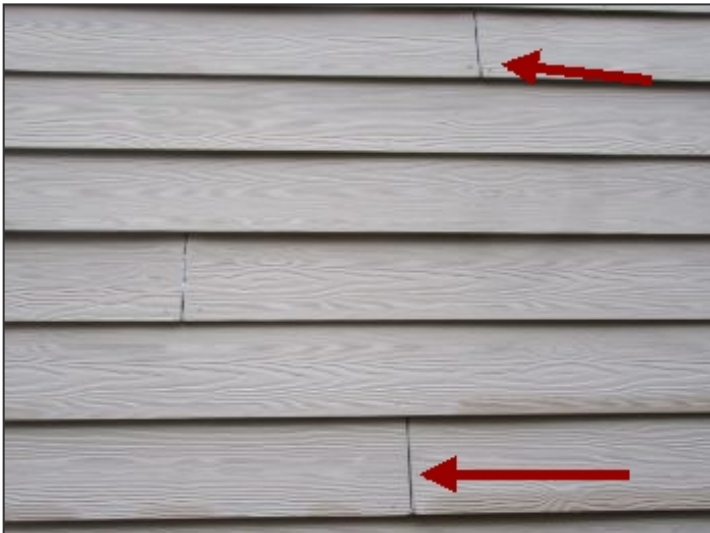
• Open caulk joints were noted at the siding joints throughout all of the walls (see photo). Correction is recommended so that the exterior walls are fully sealed to prevent air infiltration and possible water entry.

Caulking recommended at the siding joints

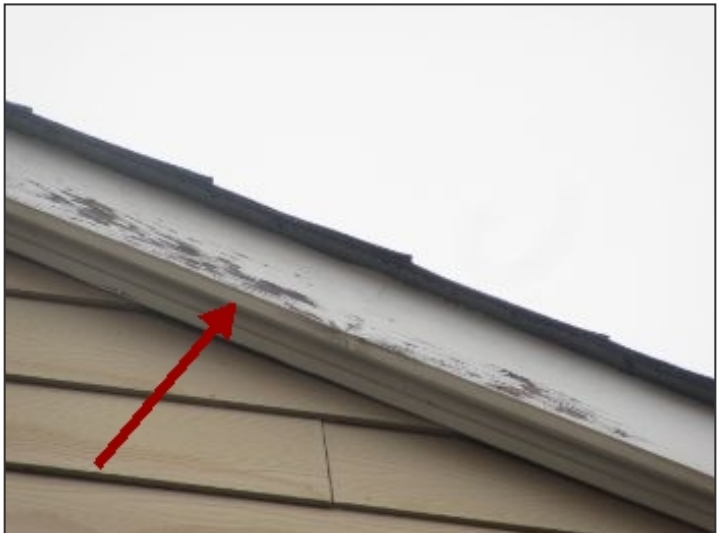
• Peeling paint and bare wood were noted at several wood fascia locations throughout the house (see photo). Scraping off loose paint, recaulking, and repainting is recommended soon to fully seal and protect the wood surfaces.

Peeling paint at the fascia boards

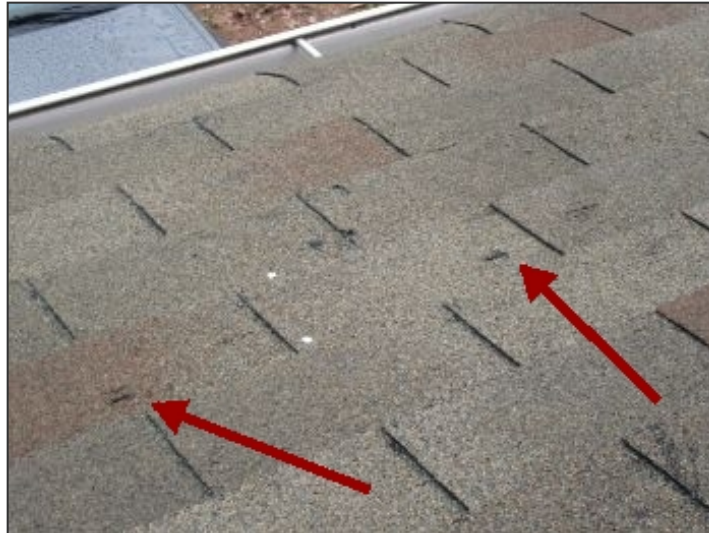
• **Several front porch roof shingles are damaged and have been punctured by ladder activity on the roof (see photo). Replacement of the damaged shingles is recommended.**

Shingle damaged at the front porch roof

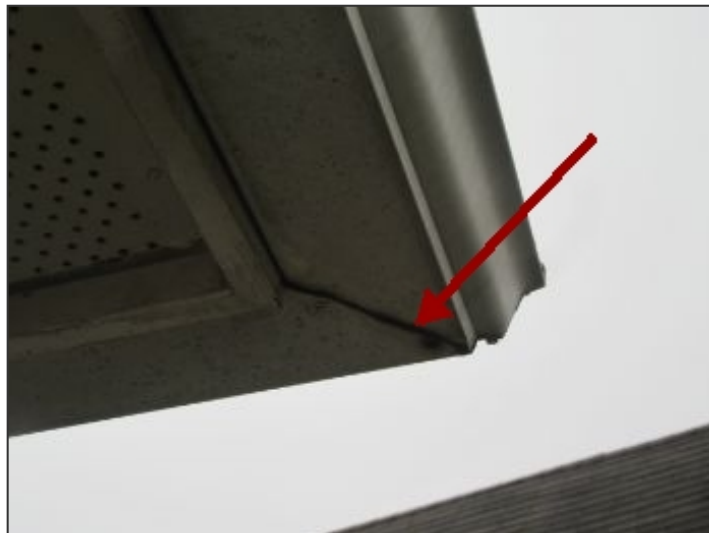
• Multiple gutter seam leaks were observed at the front and rear roof (see photo); this condition can lead to water damage at the roof fascia and soffit. Further evaluation and repair is recommended by a professional gutter contractor, check all gutter seams and seal all that are needed.

Gutter seam leak at the front gutters

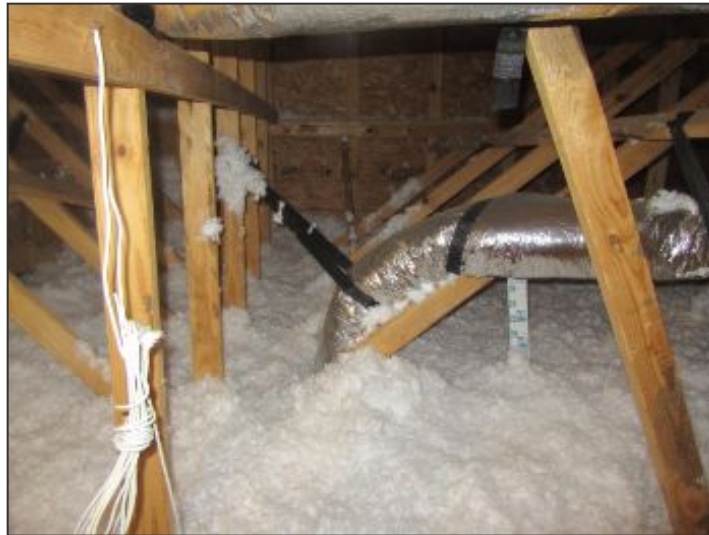
• **The roof is framed with engineered trusses in the attic and includes oriented strand board (OSB) roof decking.**

Attic framing and insulation looks good

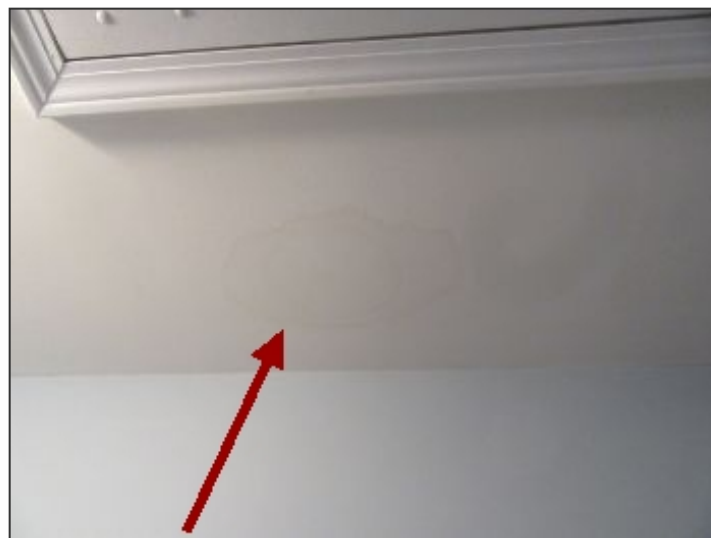
A water stain was observed in the sheetrock at the kitchen above the refrigerator area and at the upstairs hallway near the attic ladder (see photo). This is an indication of an active or previous leak. Because this is a limited visual inspection, we are unable to determine if this is an active leak or not.

Water stain at the hallway near the attic ladder

1. Ask seller for full disclosure information regarding this leak.
2. Further evaluation may be needed to determine repair needs, if any.
3. Continue to monitor, future repairs may be needed.

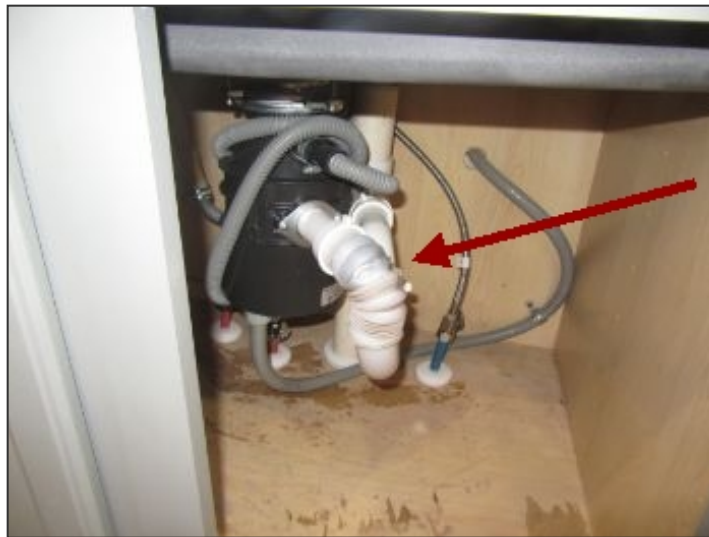
• **The drain below the kitchen sink is incorrectly using a flexible connector which is not approved by local plumbing codes (see photo). This type of drain pipe can allow debris collection, clogged drains and unsanitary waste food buildup. Although the use of this type of drain is common and the drain may be working correctly at this time, replacement of the flexible connector is recommended with an approved rigid, smooth bore drain pipe instead.**

Improper flex drain below kitchen sink

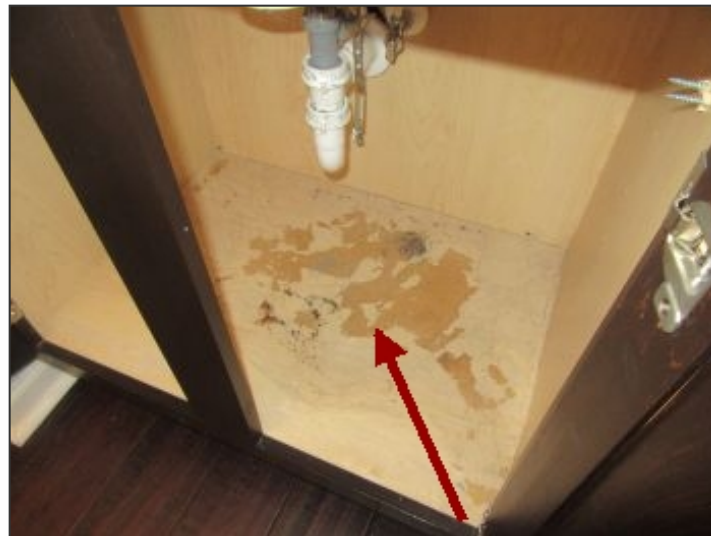
- Damage was observed at the first floor bathroom cabinet floor (see photo). Further evaluation is recommended to determine the full scope of repair or replacement needs and costs.
- A defective sink drain stopper is present at the first floor bathroom sink. Repair or replacement is recommended.
- The left master bathroom faucet is actively leaking at the faucet handle / valve. Further evaluation and repair is recommended by a professional plumber.

Damaged cabinet floor at the first floor bathroom

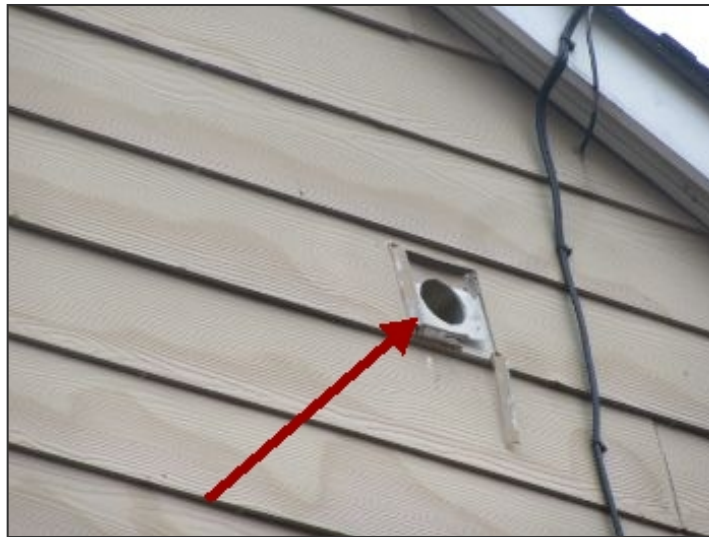
• The bathroom vent fan cover is damaged at the right exterior wall (see photo). Replacement of the cover is recommended to prevent unwanted air infiltration, possible bird nesting, and insect entry.

Damaged vent at the right wall

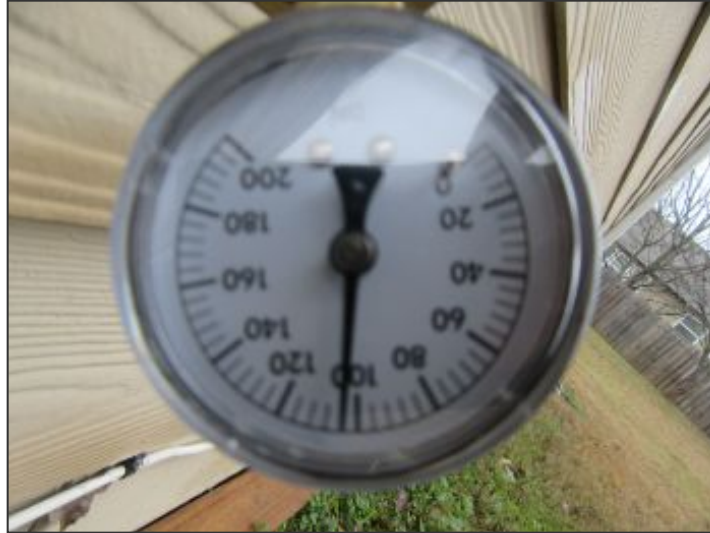
A water pressure reading was taken at the rear hose bib and was found to be too high at (105) PSI. A normal water pressure reading is in the 40 - 80 PSI range. This condition could be an indication that the pressure reducer valve is defective. Further evaluation is advised by a professional plumber to determine repair needs and costs. Excessive water pressure can create potential leaks in the plumbing system such as the water heater tank, the water heater T&P valve and the washing machine supply hoses.

Water pressure is high at 105 psi

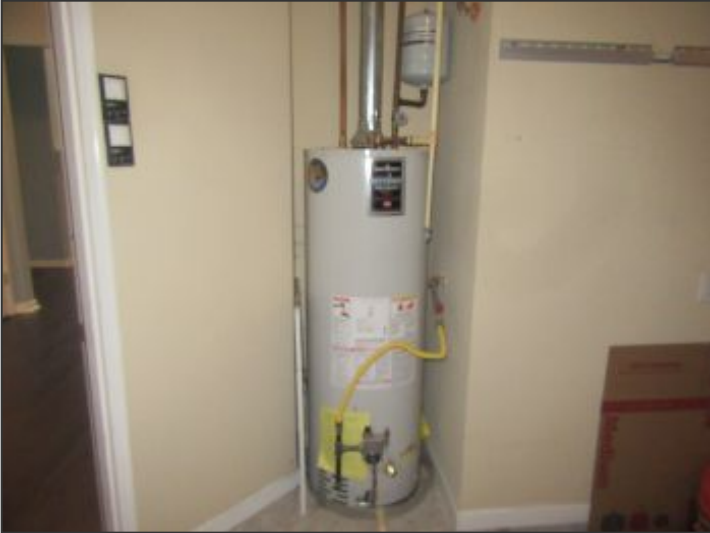
Due to the advanced age of this aging gas water heater, client should budget for replacement of the water heater tank soon. The water heater tank is at, or past, the normal expected lifespan of 10 years.

Water heater in the garage

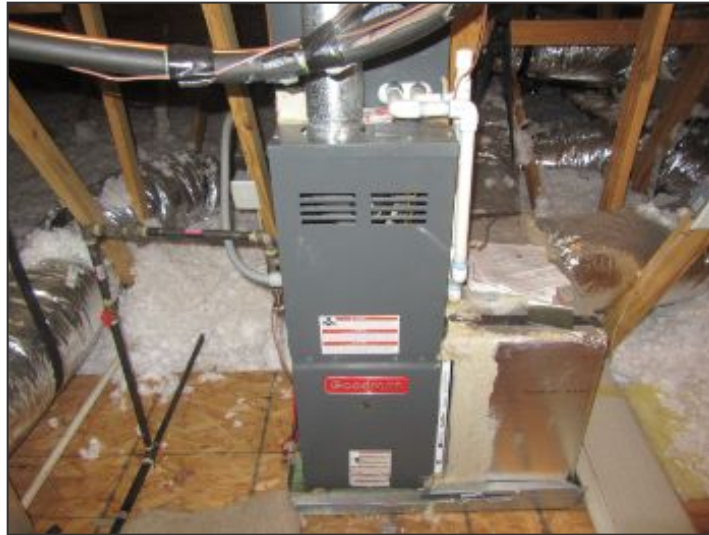
Unable to operate, fully test, and inspect this heating system - the first floor furnace would not come on or respond to normal thermostat controls during the inspection. This inspection is limited to a visual inspection only and is not complete. Further evaluation is advised by a professional HVAC contractor to determine the full scope of repair needs.

First floor furnace in the attic

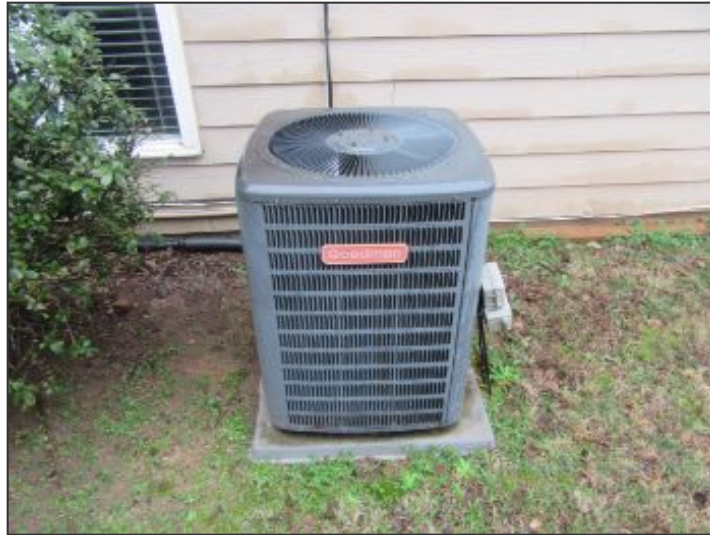
• **AGING EQUIPMENT - BUDGET FOR REPLACEMENT:** Due to the advanced age of this AC unit, client should budget for replacement soon which is expected to be a major expense. Based on the available manufacturing date on the equipment, the AC unit is at or past the normal expected lifespan of 12-15 years.

First floor AC unit

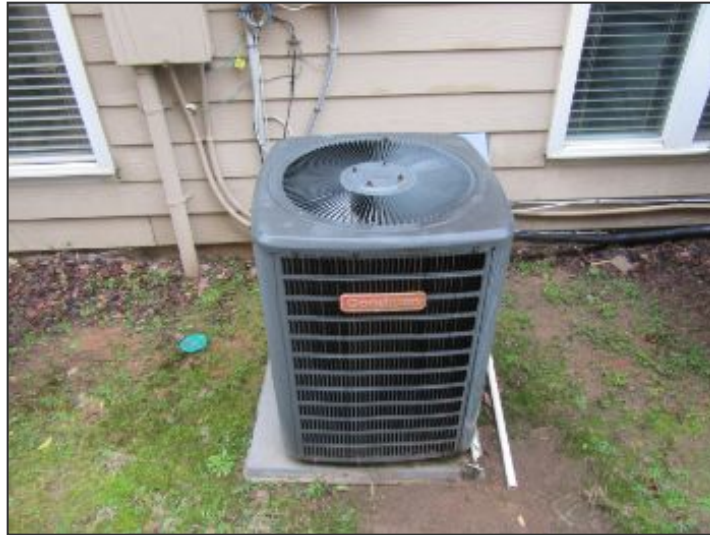
Page 35	AC UNIT 2:	<p>• AGING EQUIPMENT - BUDGET FOR REPLACEMENT: Due to the advanced age of this AC unit, client should budget for replacement soon which is expected to be a major expense. Based on the available manufacturing date on the equipment, the AC unit is at or past the normal expected lifespan of 12-15 years.</p> <p>Consider these cost saving strategies when replacing HVAC equipment:</p> <p>1. MANUFACTURERS REBATES: Check for current rebates from manufacturers on models that may be discontinued or that have higher energy ratings: Carrier Rebates: http://www.carrier.com/homecomfort/en/us/rebates-and-financing/ Lennox Rebates: http://m.lennox.com/promotions/national.asp Trane Rebates: http://www.trane.com/residential/en/buying-a-trane/savings-and-offers.html York Rebates: http://york.com/residential/promotions-savings/default.aspx</p> <p>2. UTILITY COMPANY REBATES: Check for rebates or incentives from your local power company or gas provider - many offer rebates for higher efficiency equipment</p> <p>3. TIME OF INSTALLATION: Wait to have your equipment to be installed in the fall or spring when HVAC contractors are not as busy and ask for an off season discount.</p> <p>4. GET MULTIPLE QUOTES: Always get more than one quote before making your decision - prices can vary widely from one company to another.</p>

Second floor AC unit
