Atlanta Property Inspections, Inc.

HOME INSPECTION REPORT

286 Devonshire Drive, Alpharetta, GA 30022
Inspection prepared for: Lisa Tran
Date of Inspection: 1/27/2020 Time: 1:30 PM
Age of Home: 22 Yearsd Old (1998) Size: 1200 SF
Weather: Overcast, Damp Soil, 40 Degrees

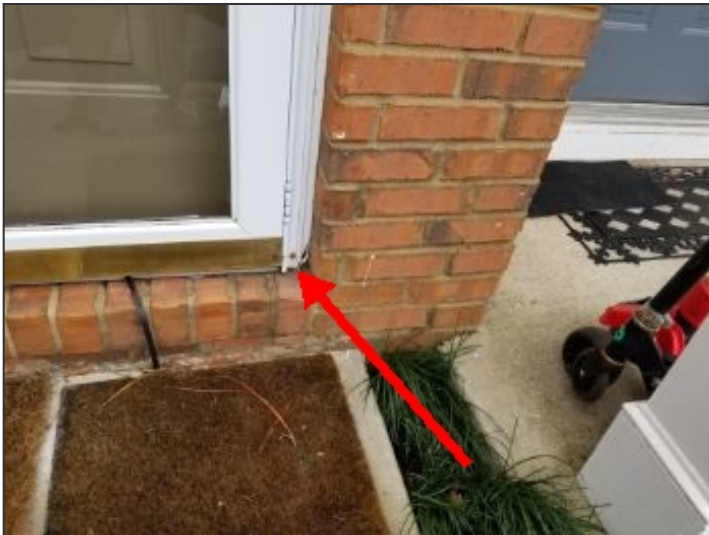
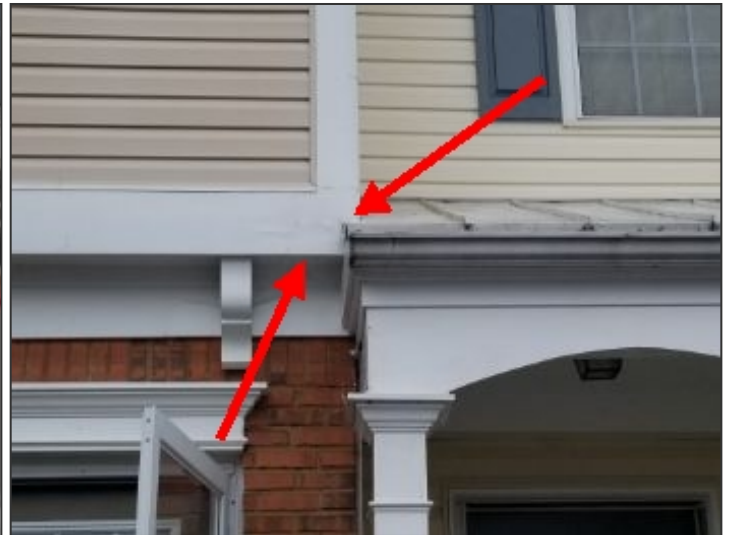
• **Damaged wood trim was noted at the lower right portion of the front entry door, and the vertical trim, on the front wall, where it meets to=he neighboring metal roof (see photos). Replacement of the affected wood trim is recommended.**

Damaged wood trim at front corner roof above adjoining metal roof

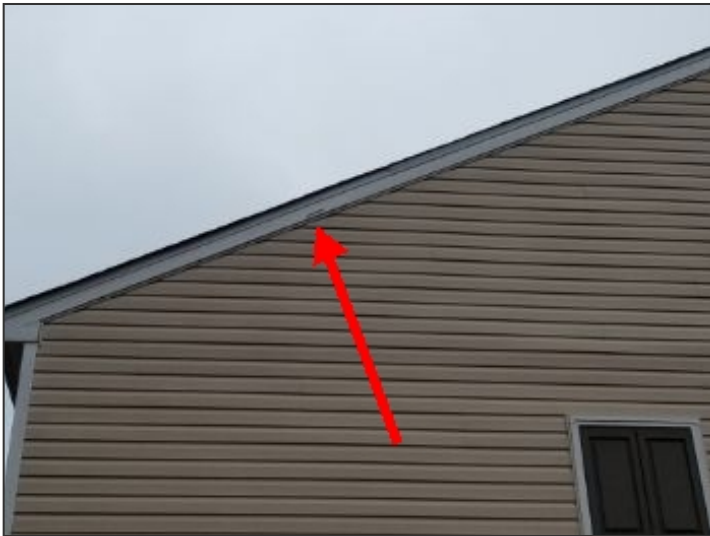
• **Damaged wood was observed at the fascia board located at the following locations (see photos):**

Damaged fascia at left side gabled roof

Replacement of the damaged wood is recommended; further evaluation is recommended to determine the source of the water damage and to make necessary repairs.

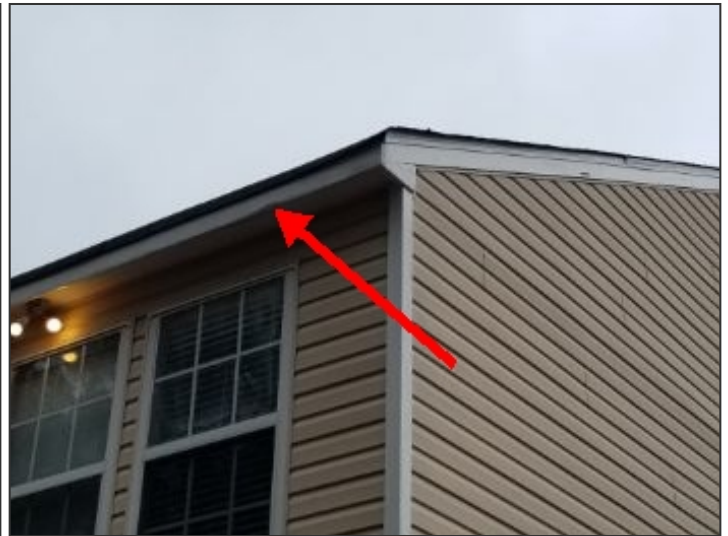
Damaged fascia at rear corner roof

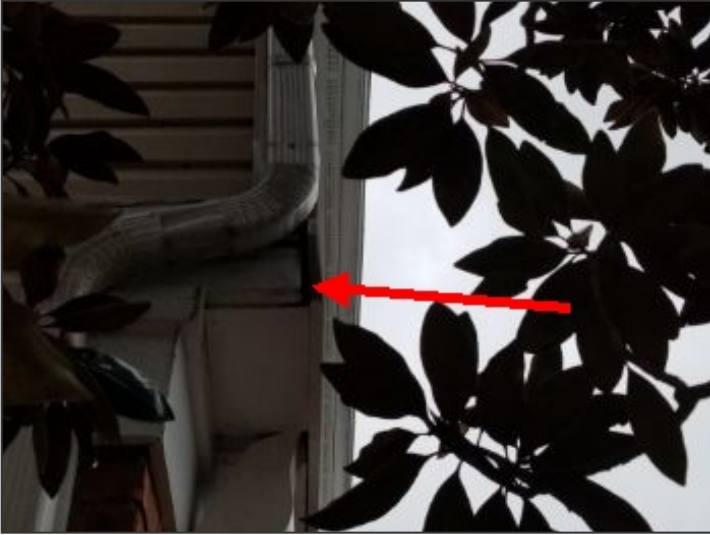
• **Open caulk joints were noted at the left side wall corner trim just above the brick (see photo). Large openings are present which could allow air and water infiltration into the wall or trim. Correction is recommended so that this area is properly sealed.**

Open caulk joints at front left corner trim

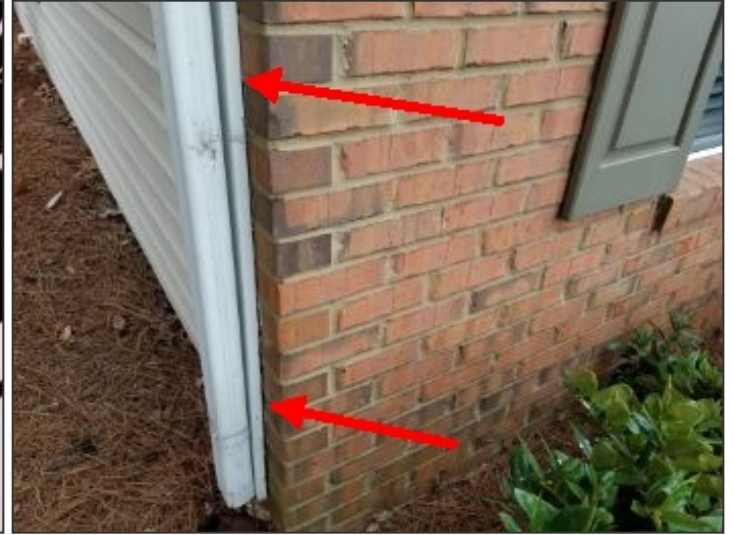
• **Caulk sealant is missing at the vertical wood to brick location at the front left corner (see photo). Gaps are present that could lead to moisture entry and air infiltration into the wall. Caulk sealant is recommended at these locations to fully seal the wall.**

Caulk sealant missing at front left corner wood to brick location

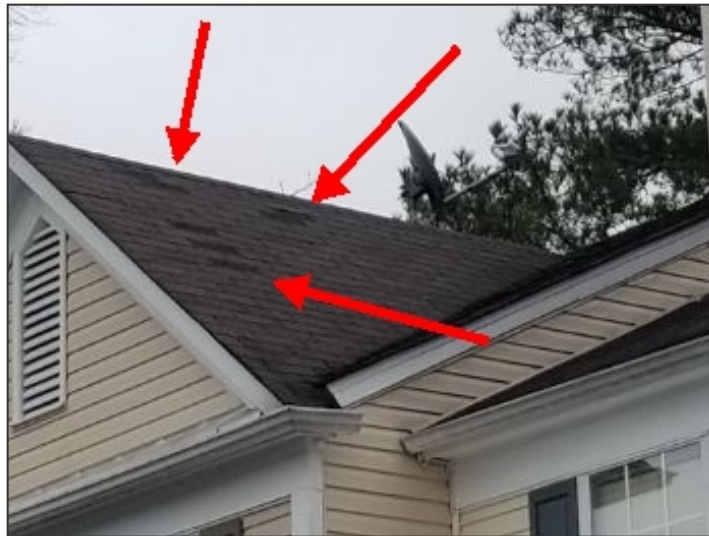
• **Missing roof shingles were noted at the right side of the front gabled roof (see photo). This is a leak concern; replacement of the missing roof shingles is recommended by a professional roofing contractor.**

Missing shingles at front right gabled roof

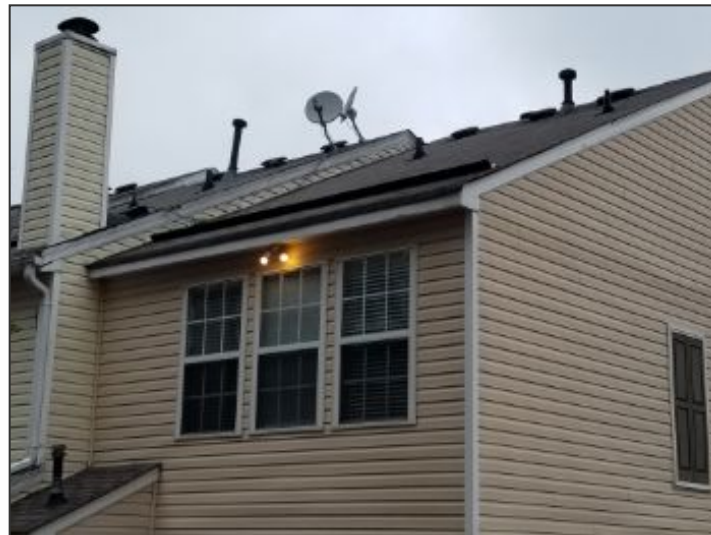
• **CLIENT RECOMMENDATION:**
No gutter system has been installed at the rear roof (see photo). Although gutters are not required, it is suggested that gutters be installed for improved drainage and water management around the perimeter of the home.

Recommend gutter installation at rear roof

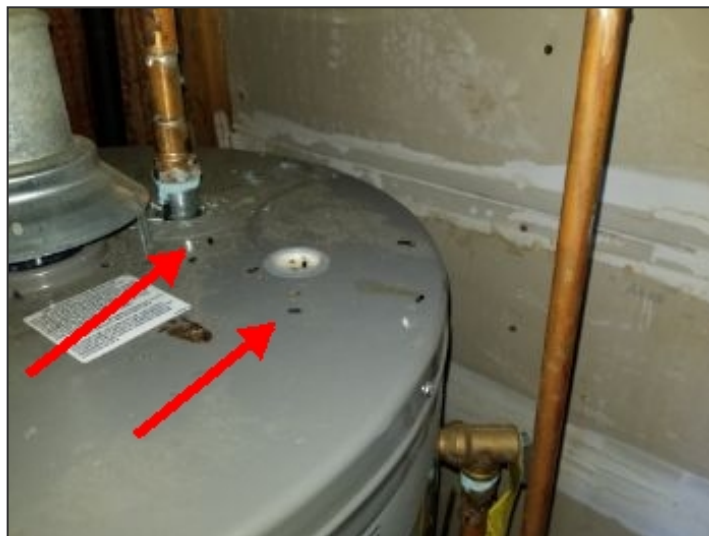
• **Rodent droppings are present in the exterior closet (see photo). This is an unsanitary condition; removal of all rodent droppings is recommended.**

Rodent droppings on top of water heater in exterior closet

• **Due to the evidence of rodent activity noted above, it is recommended that further evaluation be conducted by a professional wildlife control contractor to determine the full extent of rodent exclusion needs and costs. All potential rodent entry access points should be sealed to prevent future rodent entry. In many cases, this type of repair can develop into a major expense.**

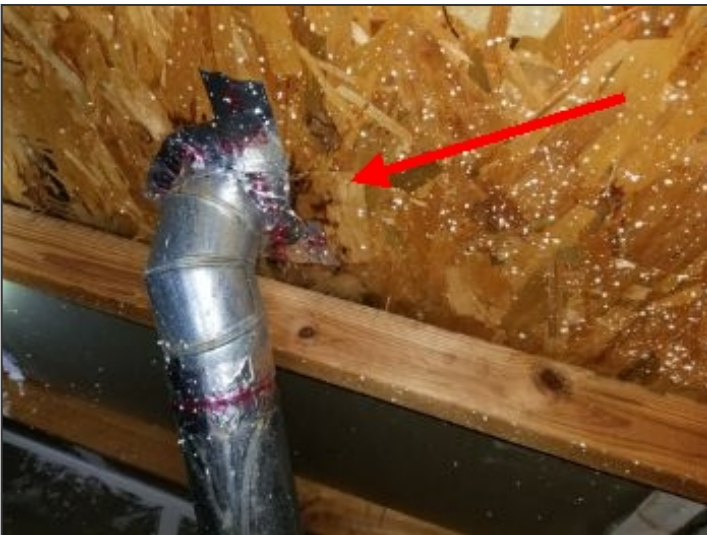
• Evidence of multiple roof leaks were observed in the attic and include at the following (see photos):

Evidence of a leak at laundry room dryer vent penetration

This condition is evidence of possible roof leaks but could not be verified during this limited visual inspection. Further evaluation is recommended by a professional roofer to determine the full scope of repair needs and costs.

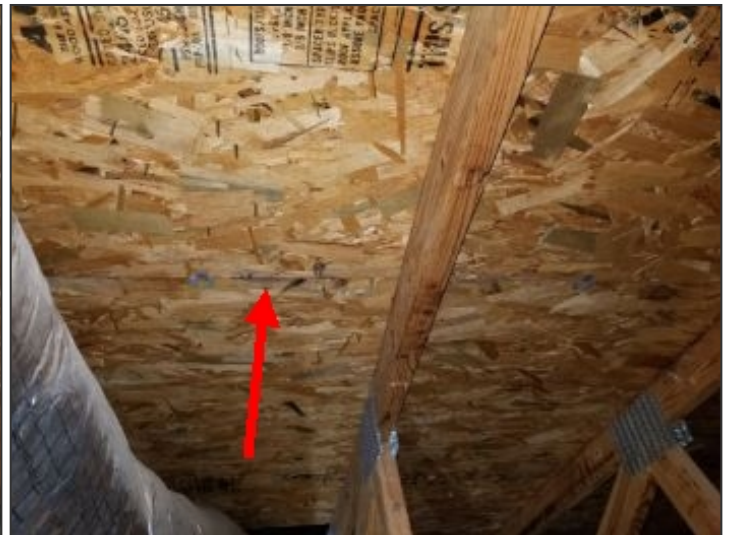
Evidence of a leak at front center roof above guest bedroom

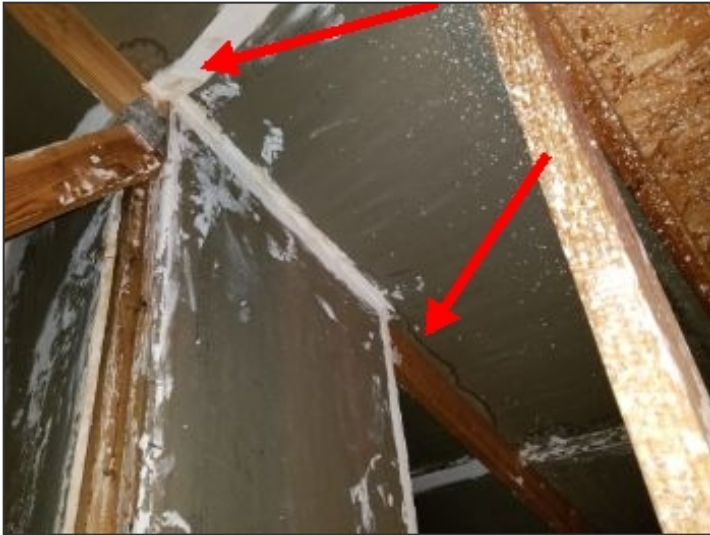
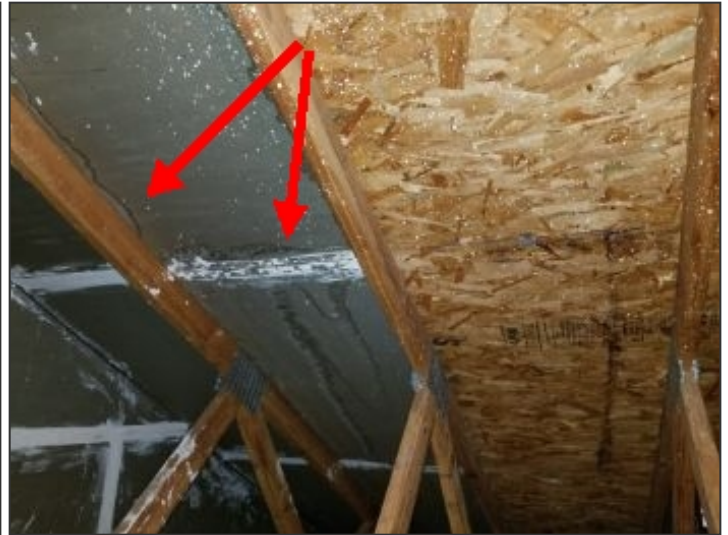
Evidence of a leak at chimney

Evidence of a leak from chimney

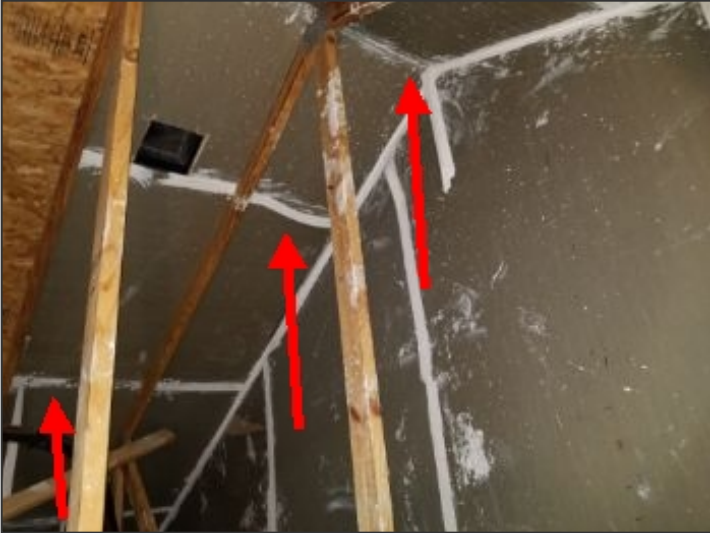
- Loose sheetrock tape was noted at the attic fire wall panel located at the side wall of the attic (see photo); repair or replacement of the affected sheetrock is recommended to maintain the integrity of the fire wall.

Loose sheetrock tape at fire walls

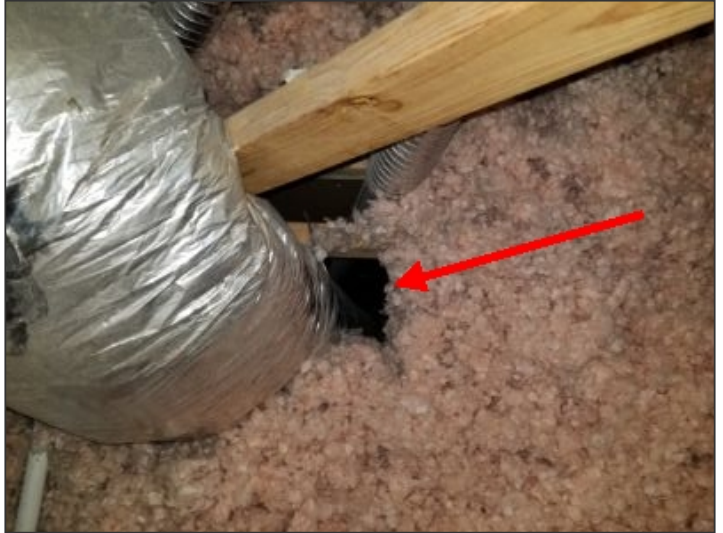
• No fire separation is present at the open chase located to the right of the furnace (see photo). Visibility down to previous floor is present. This condition does not meet current fire safety standards that call for this opening to be sealed or covered. Installation of a fire separation barrier is recommended and could include the use of wood, sheetrock, sheet metal, or in some cases 16" of unfaced insulation batts.

Open chase at attic floor to the right of furnace

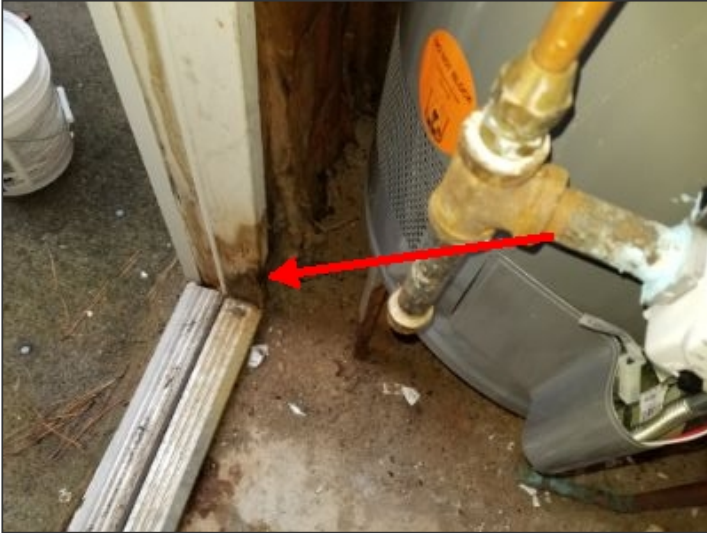
• Evidence of water entry and moisture damaged wood was noted at the rear exterior closet entry door (see photo). Further evaluation is recommended, by a professional contractor, to determine the source of water entry and to make all necessary repairs.

Evidence of water entry and damaged wood at rear exterior patio entry door

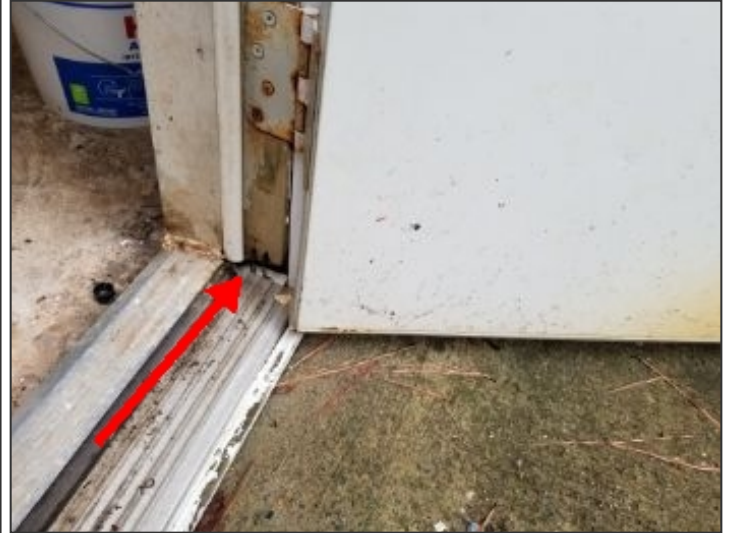
Moisture damaged wood at inside casing of exterior closet door

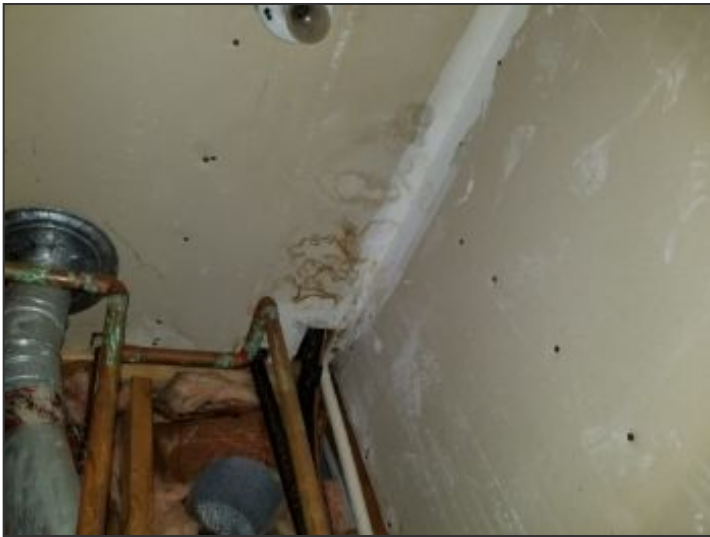
Water stains were observed in the sheetrock ceiling above the water heater (see photo). The staining appears to be from the coolant line which passes through the sheetrock and above this location. The coolant line may need to be re-insulated to prevent more condensate from dripping on to the ceiling below. Further evaluation is recommended to determine the source of the staining and to make all necessary repairs.

Water stains at exterior closet ceiling below coolant line

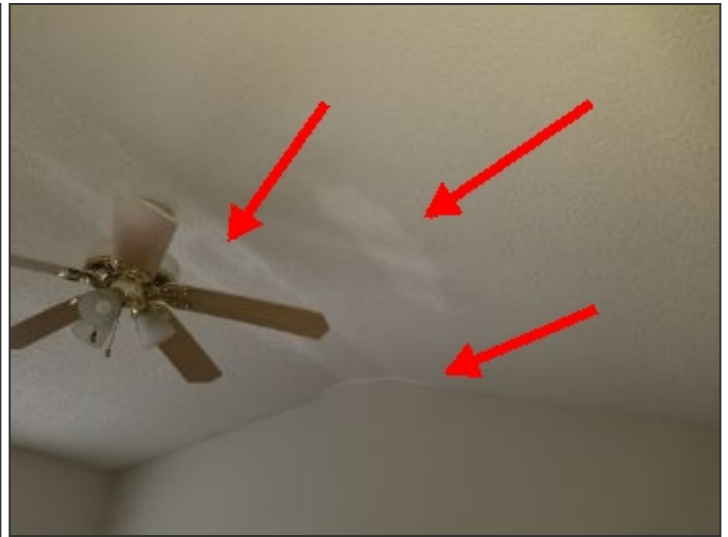
Paint repairs at front guest bedroom ceiling

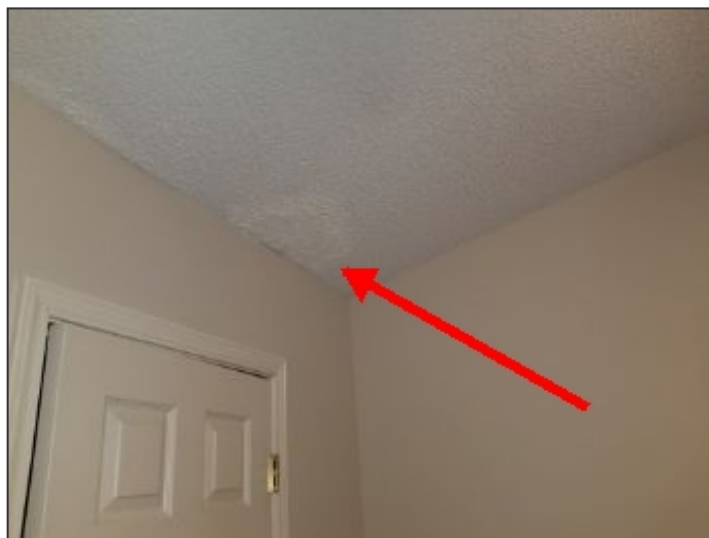
Ceiling / paint repair at master bedroom above bathroom entry

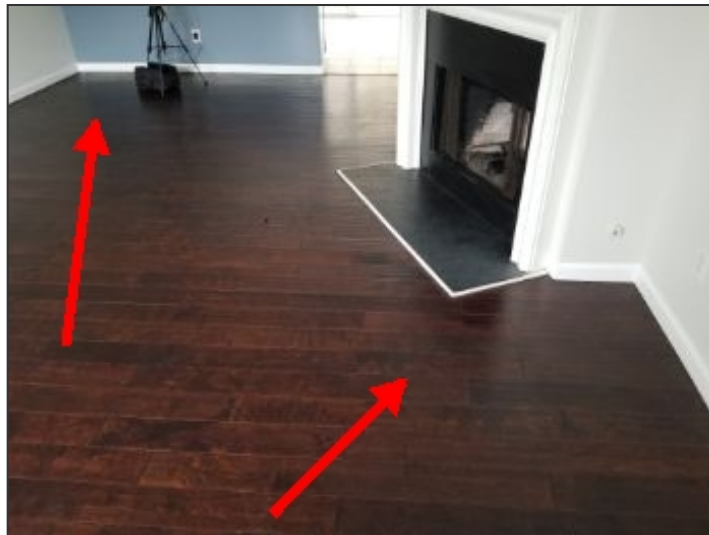
• Excessive floor movement was noted at the family room near the fireplace and in the eat-in kitchen near the bar area (see photo). Due to floor coverings and lack of access / visibility, we are unable to fully evaluate this condition and could be caused by unevenness of the concrete slab.

Vertical movement at flooring

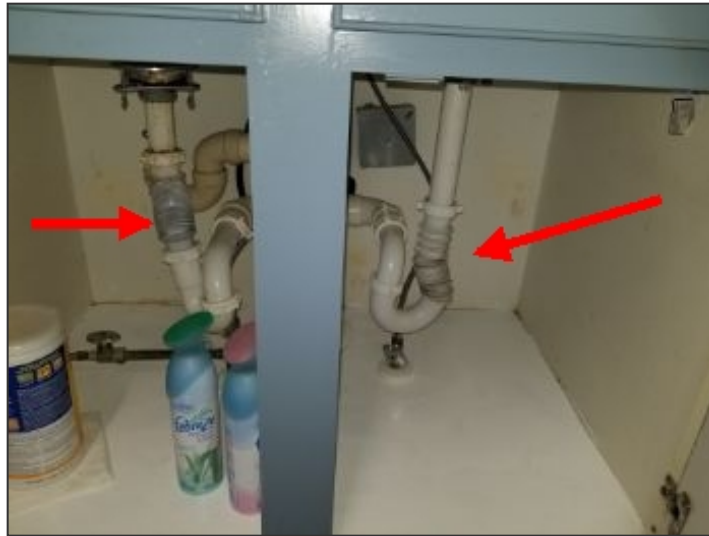
• **The drain below the kitchen sink is incorrectly using a flexible connector which is not approved by local plumbing codes (see photo). This type of drain pipe can allow debris collection, clogged drains and unsanitary waste food buildup. Although the use of this type of drain is common and the drain may be working correctly at this time, replacement of the flexible connector is recommended with an approved rigid, smooth bore drain pipe instead.**

Flex drain lines below kitchen sink

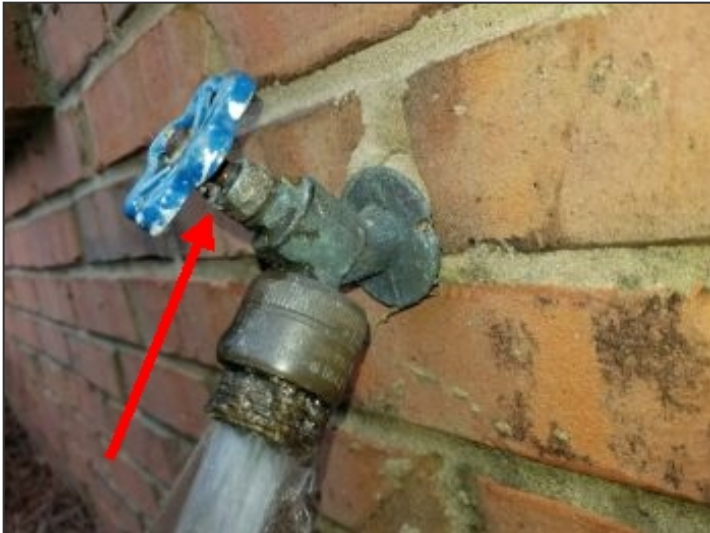
• The front and rear hose bibs are leaking from the turn handle when the water is turned on (see photo of front hose bib). Further evaluation and repair is recommended by a professional plumber.

Active leak at turn handle when water is turned on at exterior hose bibs

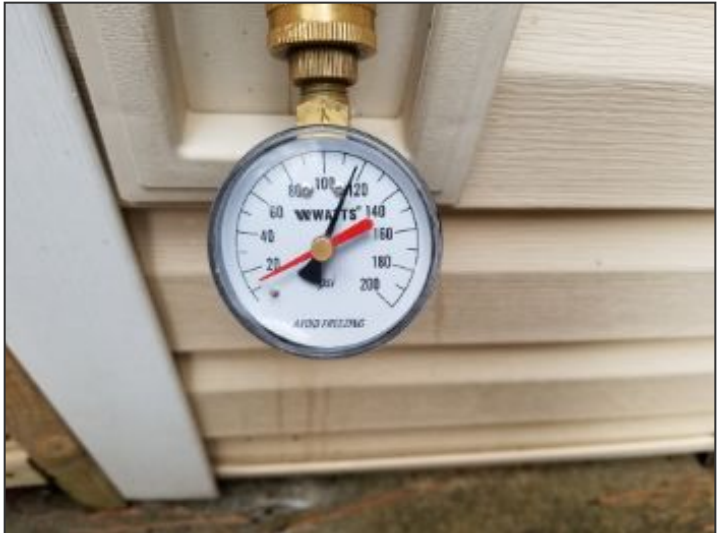
A water pressure reading was taken at the front and rear hose bibs and was found to be too high at 120 PSI at both locations (see photos). A normal water pressure reading is in the 40 - 80 PSI range. This condition could be an indication that the pressure reducer valve is defective. Further evaluation is advised by a professional plumber to determine repair needs and costs. Excessive water pressure can create potential leaks in the plumbing system such as the water heater tank, the water heater T&P valve and the washing machine supply hoses.

Water pressure too high at rear hose bib

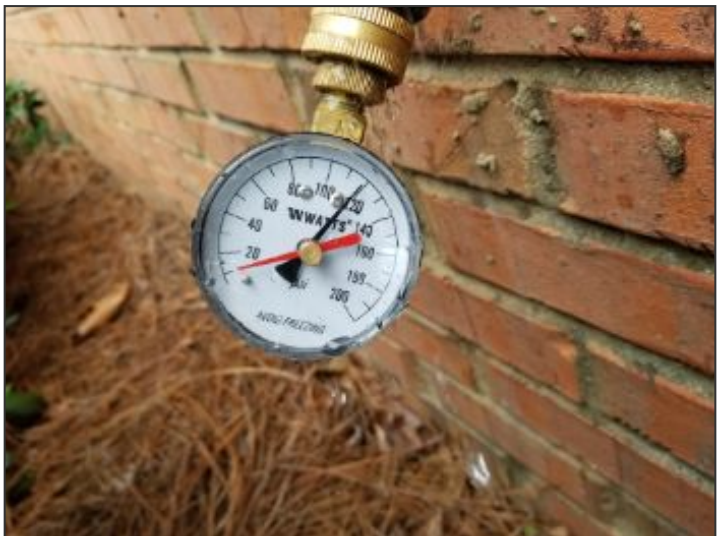
Water pressure too high at front hose bib

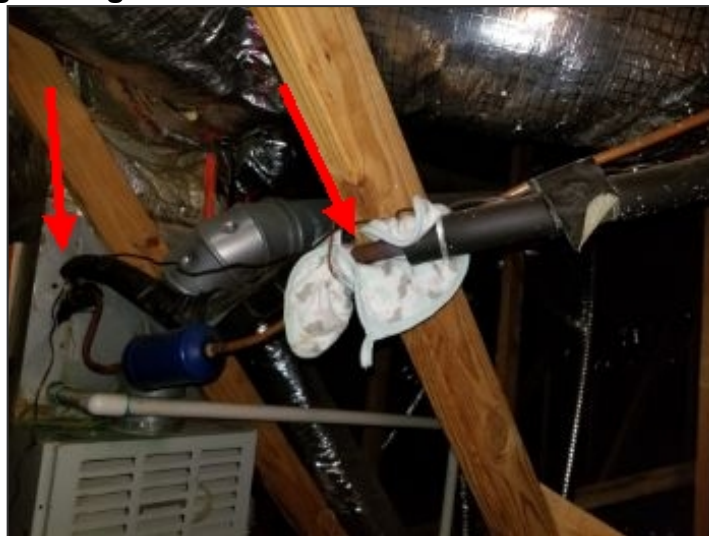
• The coolant line at the attic HVAC system is not fully insulated and has been dripping moisture onto the attic floor and on the furnace (see photo). This condition can lead to water stains and possible ceiling damage if not repaired. Correction is recommended so that the coolant line is fully insulated.

Coolant line not fully insulated in attic and at evaporator

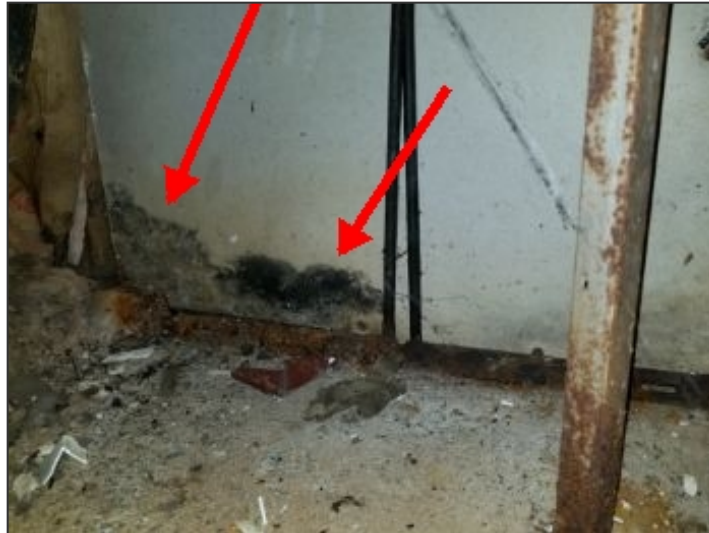
Suspected mold growth at lower sheetrock wall in exterior closet
