# Atlanta Property Inspections, Inc. HOME INSPECTION REPORT

**2560 Highland Pointe Drive, Cumming, GA 30041**

**Date of Inspection: 1/30/2020 Time: 1:00 PM**

**Age of Home: 26 Years old (1994) Size: 3500 SF**

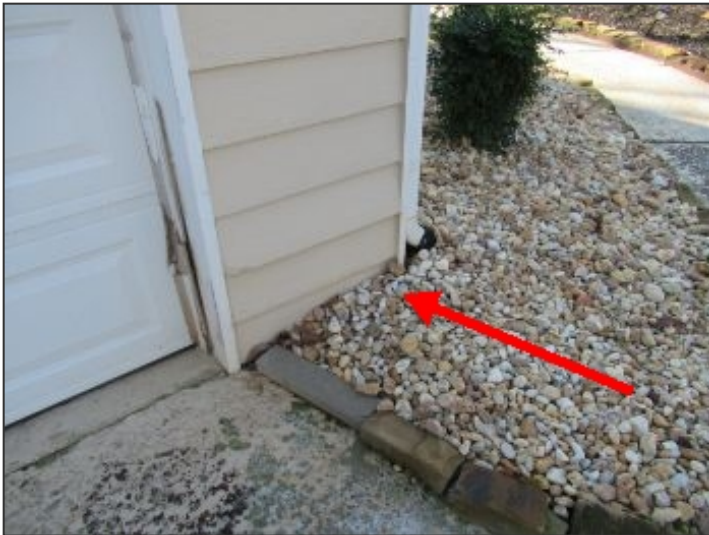
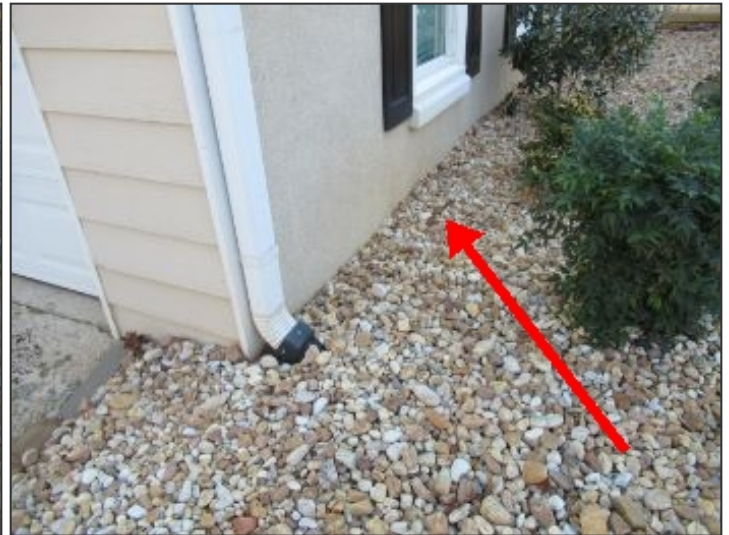
• **Inadequate clearance of wood to soil was observed at the front garage. The grade / soil / stones are too high above the bottom of the stud wall which is not recommended. This condition can lead to water damage issues with the wood and can attract termite activity to this location if not corrected. It was noted thsat water stains are present at the lower wall inside the garage - see Garage section of this report. Generally accepted building practices call for a clearance of 6 inches between wood materials and the soil and 4 inches of clearance to exterior wall cladding. Due to this concern, it is recommended that the soil be regraded and lowered to meet as much of the 6 inch clearance as possible and to provide adequate slope for proper drainage.**

Soil and stones are too high above siding and trim

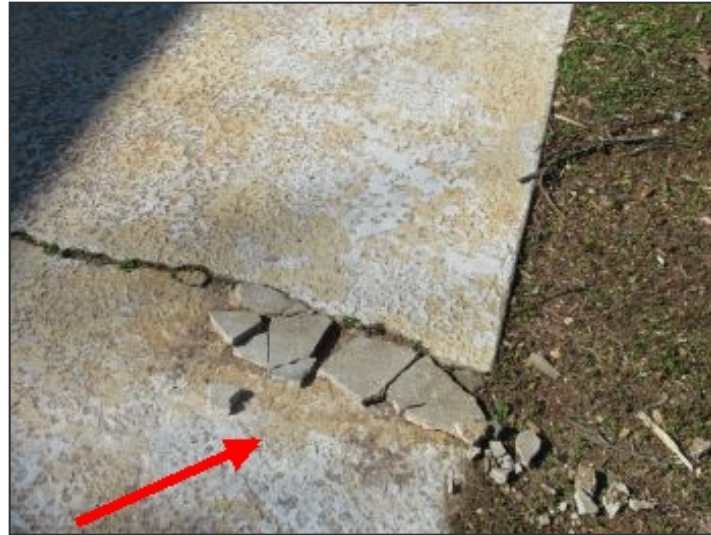
- **1. The driveway and sidewalk both have surface damaged concrete , it appears that the concrete surfaces were covered with a skim coat of additional concrete which has since peeled off (see photo). Although the driveway is functional, future concrete repairs may be needed. Further evaluation is recommended by a concrete contractor to determine the full scope and cost of repair.**
- **2. Cracked and damaged concrete is present at the rear driveway parking pad (see photo). Repair is suggested but is not considered to be a critical repair.**

Damaged concrete at driveway parking pad

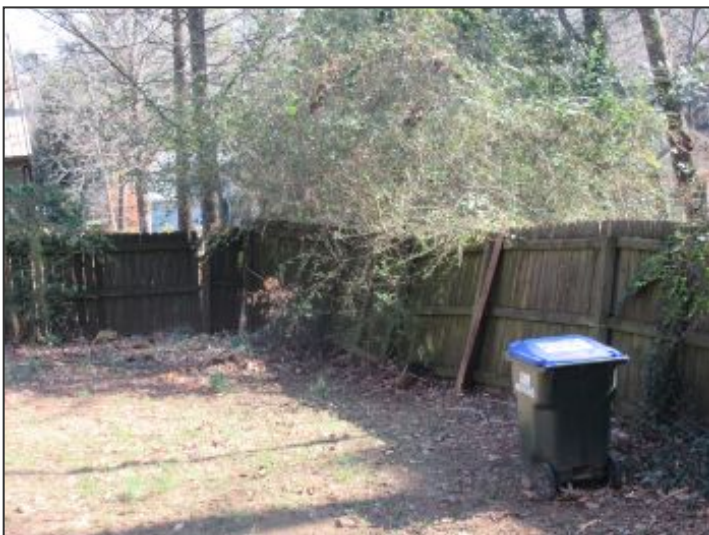
• The rear yard has leaning sections of fencing at the gate area behind the driveway as well as the rear corner of the yard (see photos). The rear corner yard has openings that could let dogs out of the yard if dogs are present. Repair or replacement of the affected fencing is recommended.

Leaning fencing at rear corner yard

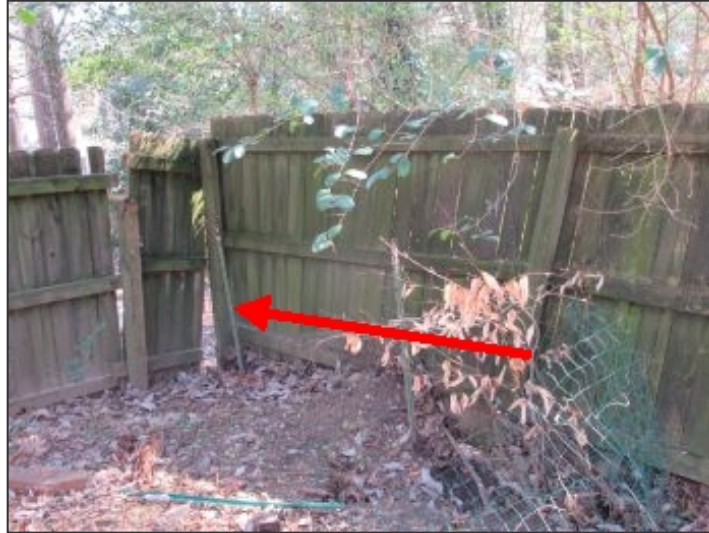
Openings at rear corner fencing

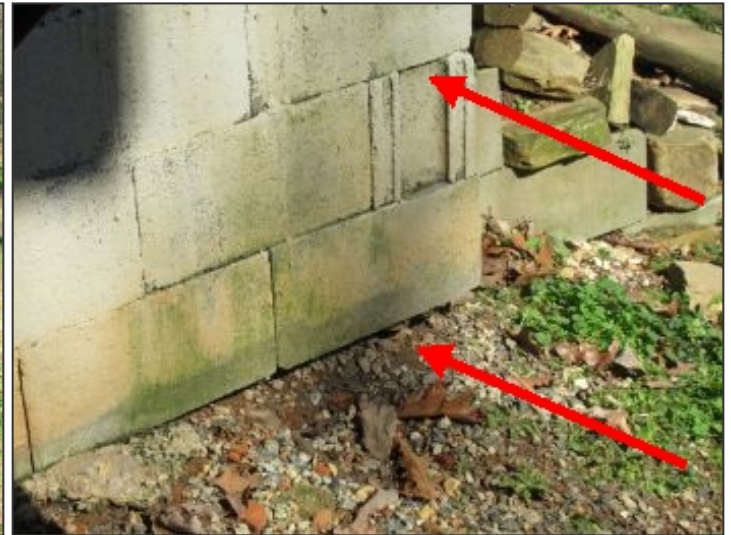
• The concrete block retaining wall is incorrectly built - the wall has no structural footing below the blocks, and the wall was constructed with dry blocks with no mortar between the blocks. In addition, there are voids below the wall confirming the lack of a proper footing (see photos). Due to this concern, further evaluation is recommended by a professional retaining wall contractor to determine the full scope of repair or replacement needs and costs.

Retaining wall has no mortar and no footings

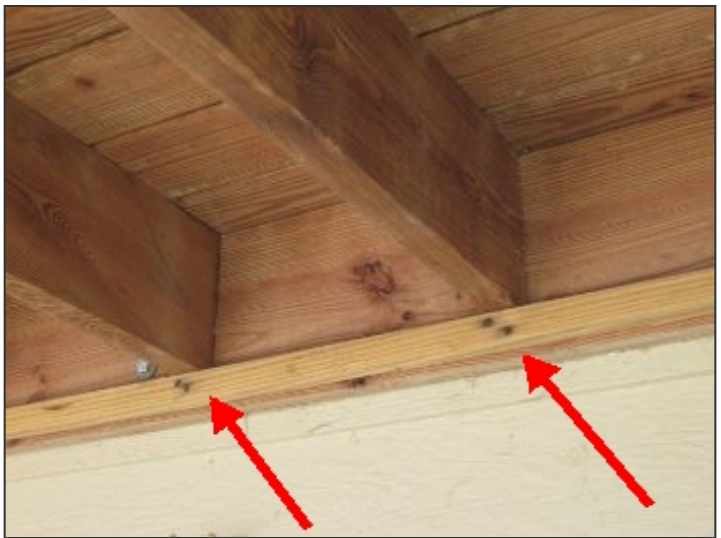
• **The rear screened porch appears serviceable, except as listed below:**  
 1. The porch joists are supported by a small 2x2 ledger strip; the ledger strip is not adequately nailed. Recent nailing standards call for at least 3 nails on the ledger strip below each joist to support the weight at this location. Correction is recommended to fully nail the 2x2 strip below each joist. For even better support, installation of joist hangers is suggested instead of the 2x2 ledger strip.

Joist hangers are recommended at porch

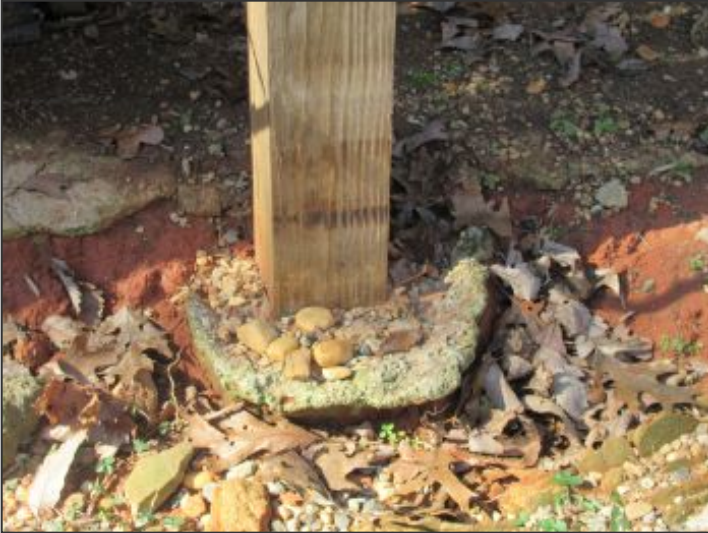
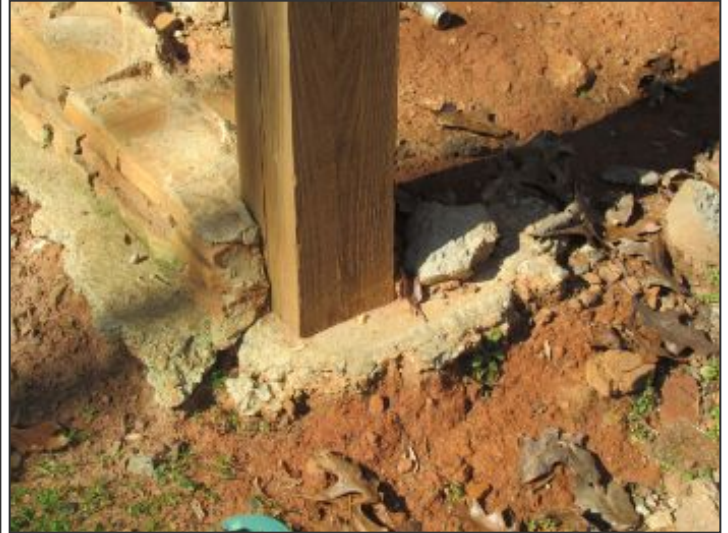
Two of the screened porch support posts have concrete footings that have severe soil erosion at the footings (see photo); this condition can lead to destabilization of the support footings. Repair is advised.

Severe soil erosion at porch support footings    Severe soil erosion at porch support footings

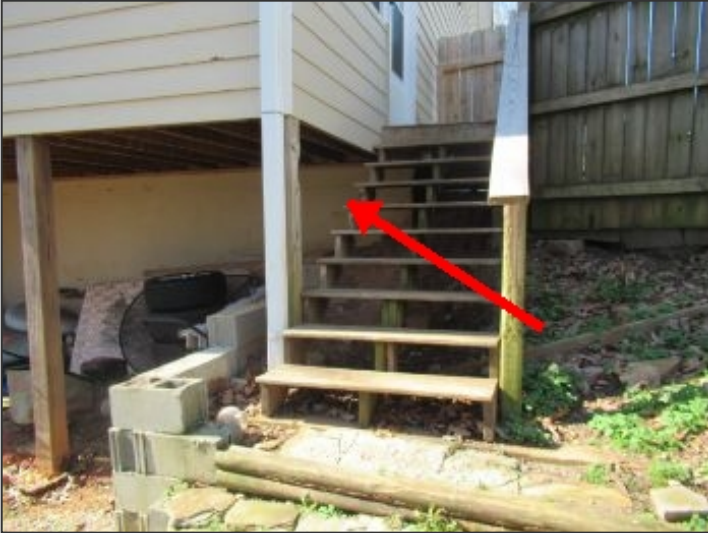
**Unsafe condition at rear stairs - missing railings**

Due to these concerns, further evaluation is recommended by a professional stairway contractor to determine the full scope of repair or replacement needs and costs.

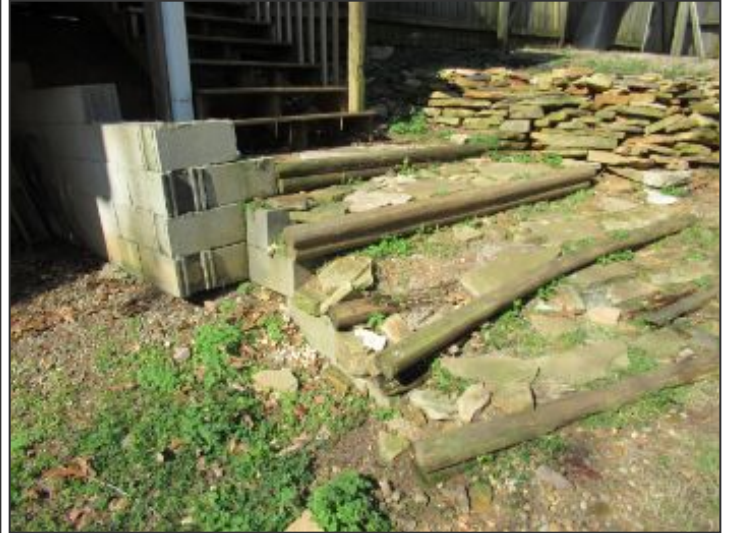
3. The lower portion of the stairway has poorly built small wood timbers holding back soil, stones, and gravel. The bottom area of this stairway has moved and has shifted due to soil erosion (see photo). This condition is a safety concern due to unstable footing. Replacement of this lower stairway is advised.

**Unsafe condition: damaged and loose timbers at bottom of stairs**

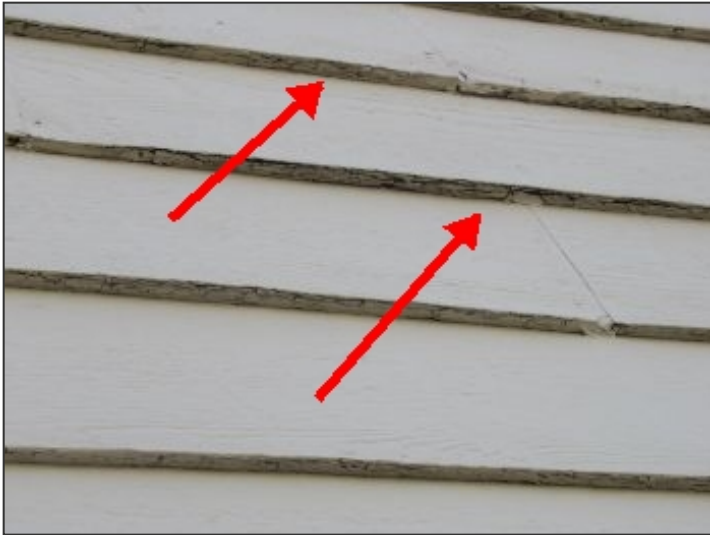
1. **LEFT WALL:** The left side garage wall has moderate levels of moisture damage, moisture swelling and black mildew growth were noted at the siding board drip edges (see photo); many boards should be considered for replacement.
2. **REAR WALL:** The rear screened porch wall has moderate levels of moisture damage, moisture swelling and black mildew growth were noted at the siding board drip edges (see photo); many boards should be considered for replacement.
3. **REAR WALL:** The rear family room wall and bedrooms all have moderate levels of moisture damage, moisture swelling and black mildew growth were noted at the siding board drip edges (see photo); some boards have more severe damage (see photos); many boards should be considered for replacement.
4. **CHIMNEY:** The chimney has moderate levels of moisture damage; many boards should be considered for replacement.

Moisture damaged siding boards above garage doorway

Due to the extent of moisture damage, further evaluation is advised by a professional siding replacement contractor to determine the full scope of repair needs and costs. Budget for a major repair.

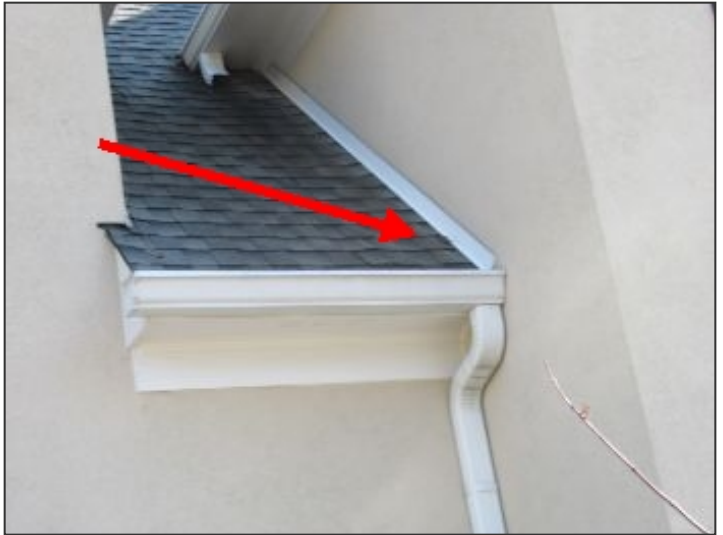
No kickout flashing at stucco wall and roof

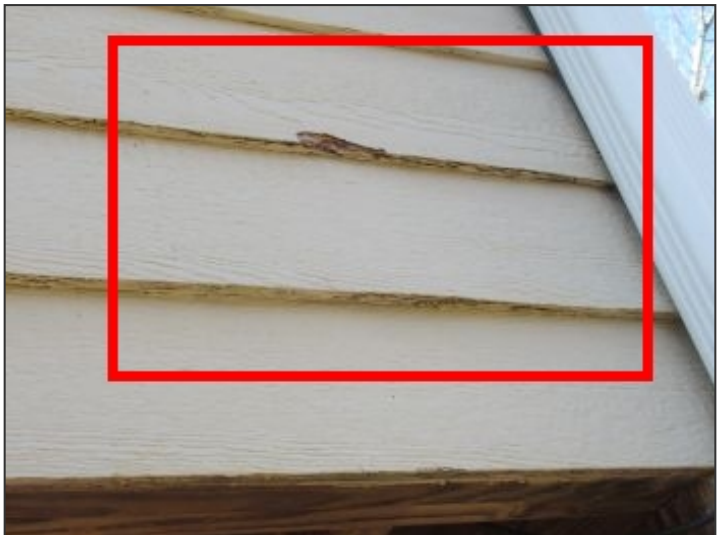
Damaged siding at rear porch wall

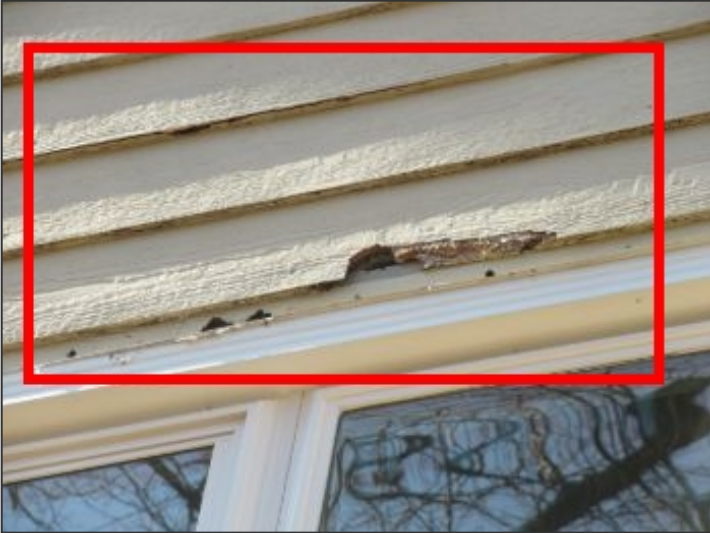
Damaged siding at rear family room

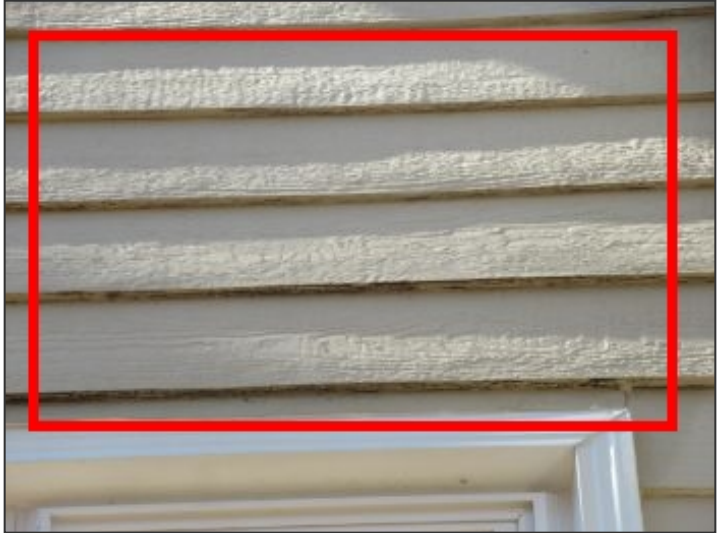
Damaged siding at rear wall

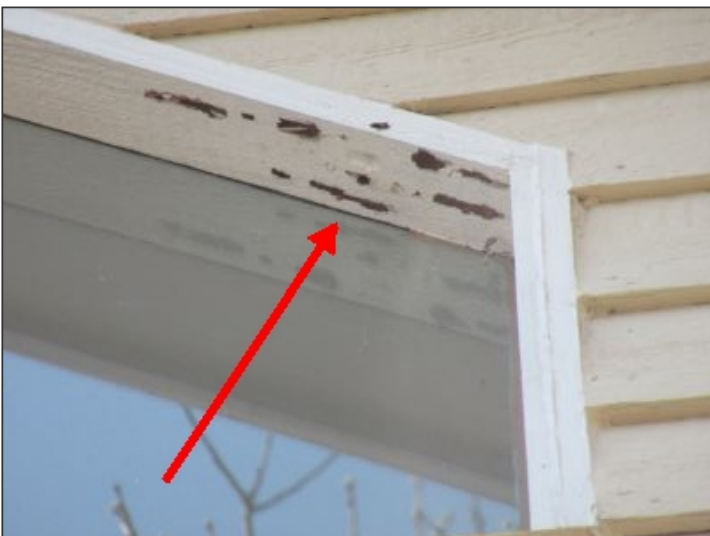
2. **Insect / carpenter bee damage is visible at the rear windows at the upper master bathroom (see photo); replacement of the damaged wood is recommended.**

Insect damage at rear master bath windows

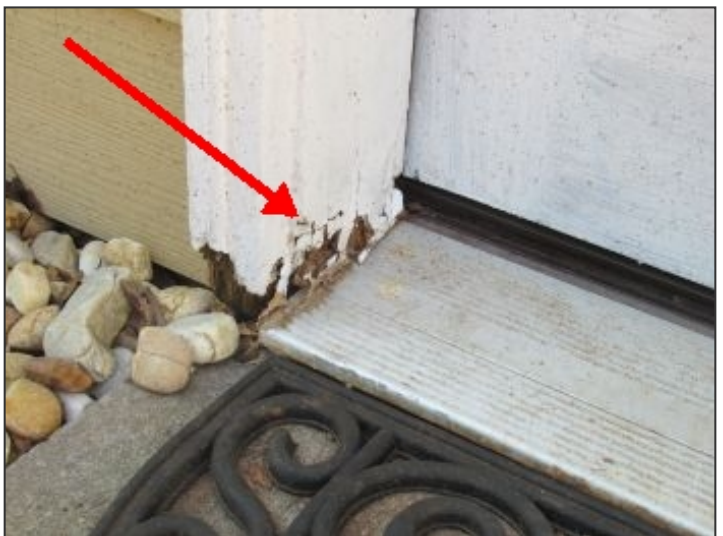
• **Damaged wood trim was noted at the following exterior locations:**  
1. **Damaged wood trim was noted at the exterior door jamb of the rear basement door just above the threshold (see photo). Replacement of the damaged wood is recommended.**

Water damaged trim at basement entry door

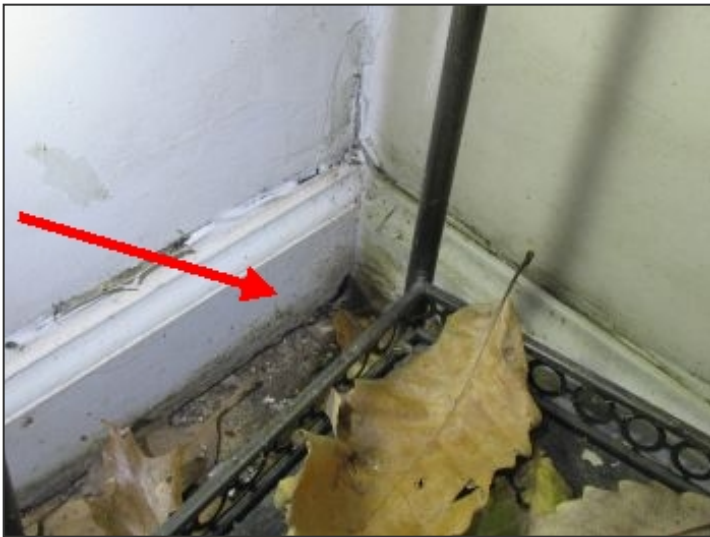
- **An attached two car garage is present.**
- **Storage obstructions in the garage restrict full visibility of the floor and lower walls, unable to fully inspect. Further evaluation is recommended after the storage items have been removed.**
- **There is evidence of moisture entry in the garage at the front garage wall. Further evaluation is recommended to determine the source of this water entry and to make necessary repairs.**

Signs of water entry at front garage wall, damaged baseboard

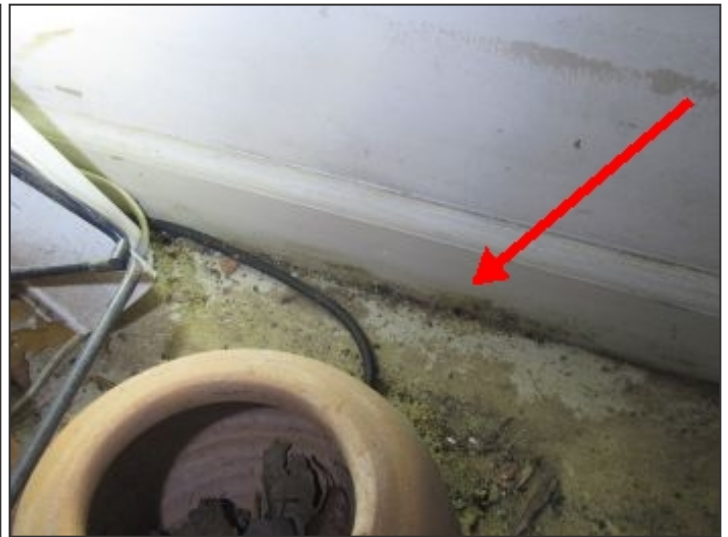
Water staining at front garage wall

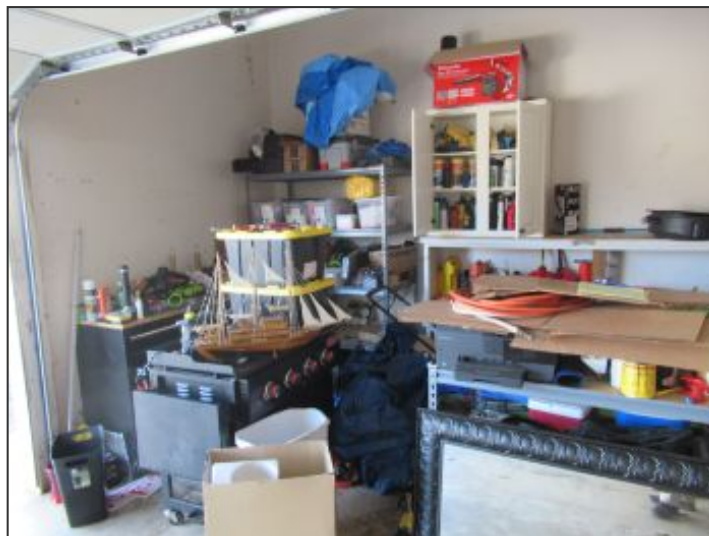
Storage obstructions in garage restrict full access

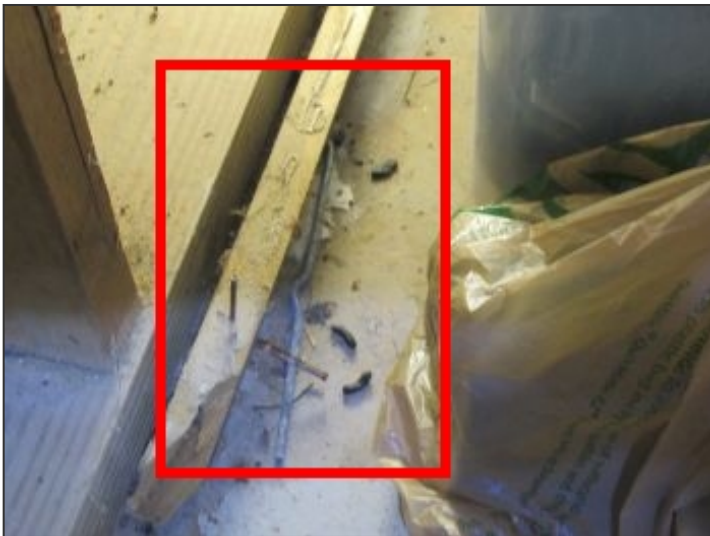
Rodent dropping on floor below stairs

Due to the evidence of rodent activity noted above, it is recommended that further evaluation be conducted by a professional wildlife or pest control contractor, prior to closing, to perform a full rodent infestation inspection, and to determine the full extent of rodent exclusion needs and costs, if needed. It is understood that this type of specialized inspection may identify other infestation issues not identified or mentioned in this inspection report. All potential rodent entry access points should be sealed to prevent future rodent entry. In many cases, this type of service can develop into a major expense depending upon the amount of work needed.

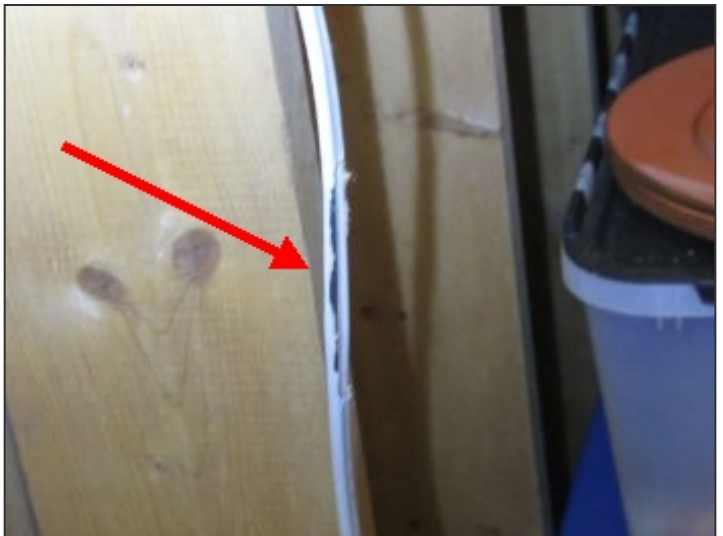
2. Chewed electrical wiring was noted at the romex electrical wire below the stairway (see photo). Damaged electrical wiring is an unsafe condition and is a potential fire hazard. Further evaluation is advised by a licensed electrician; all damaged wiring should be repaired or replaced.

Rodent chewed electrical wiring below basement stairs

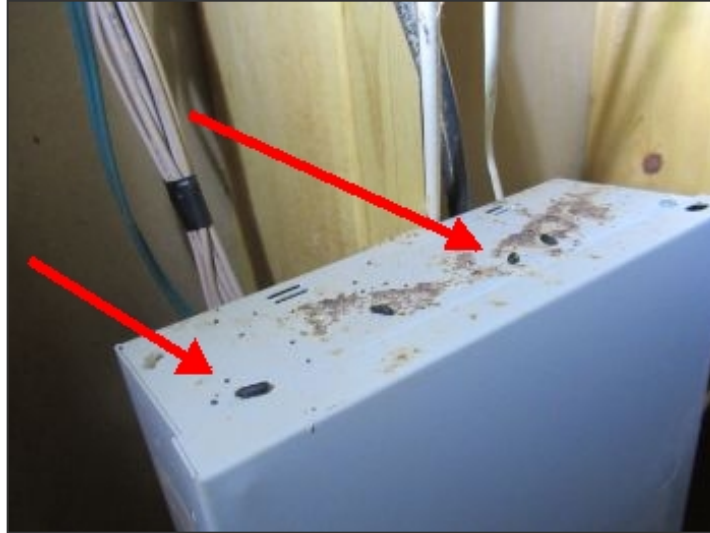
**Rodent droppings on box below stairs**

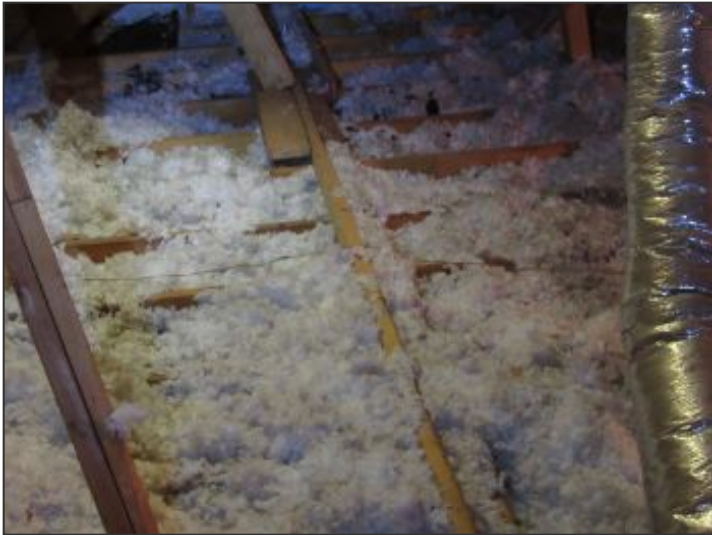
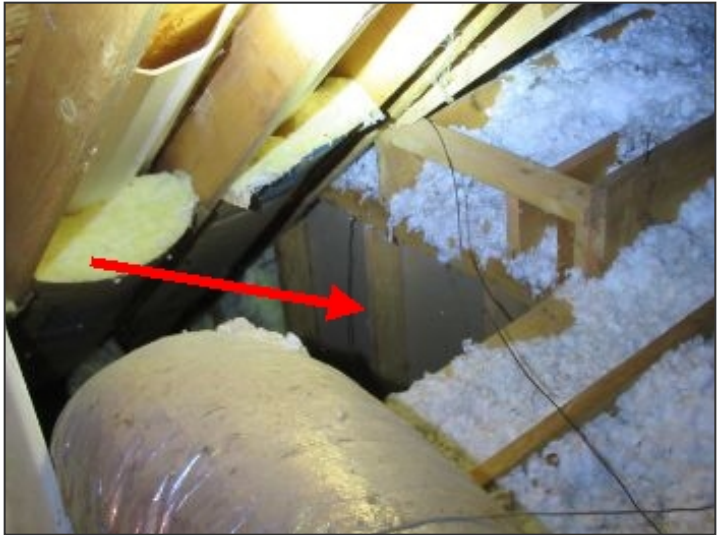
Missing attic insulation on master bedroom wall near thermostat

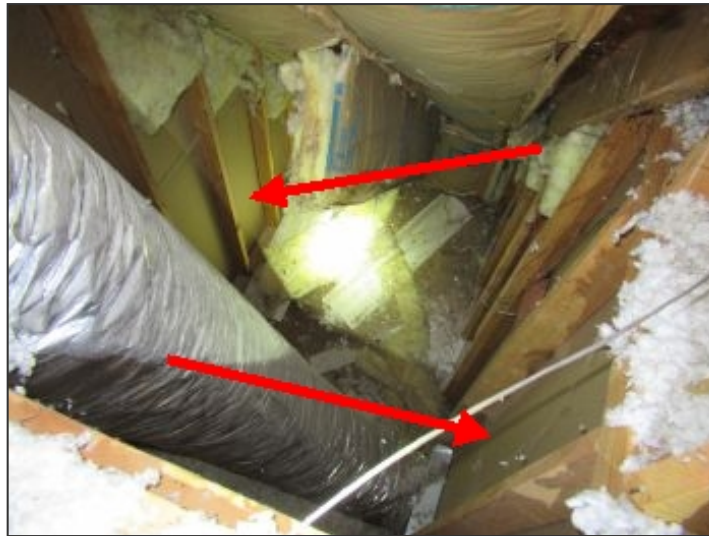
Missing wall insulation at front attic near master

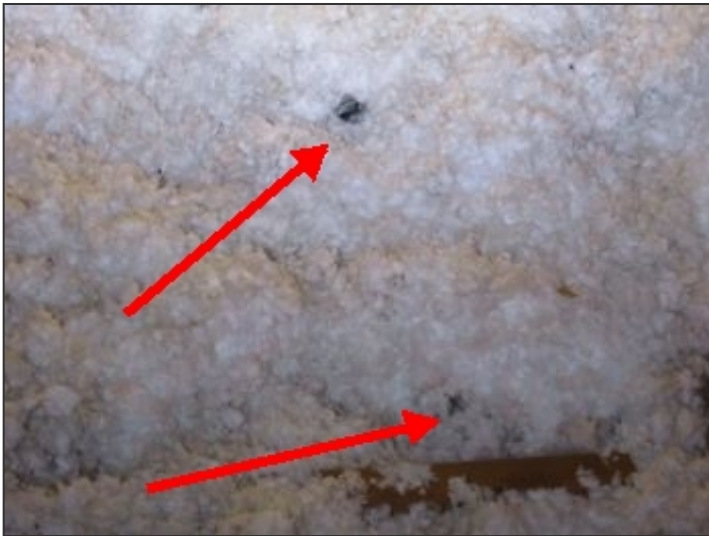
1. Disturbed attic insulation was noted in the attic along with visible rodent trails in the insulation (see photo).
2. **UNSAFE CONDITION:** Chewed electrical wiring was noted in the attic above the front master bedroom (see photo). Damaged electrical wiring is an unsafe condition and could develop into a potential fire hazard. Further evaluation is advised by a licensed electrician to determine the full scope of repair needs and costs; it is our opinion that all damaged wiring should be replaced.

Rodent tunnels in attic insulation

Due to the evidence of rodent activity noted above, it is recommended that further evaluation be conducted by a professional wildlife control contractor to determine the full extent of rodent exclusion needs and costs. All potential rodent entry access points should be sealed to prevent future rodent entry. In many cases, this type of repair can develop into a major expense depending upon the amount of work needed.

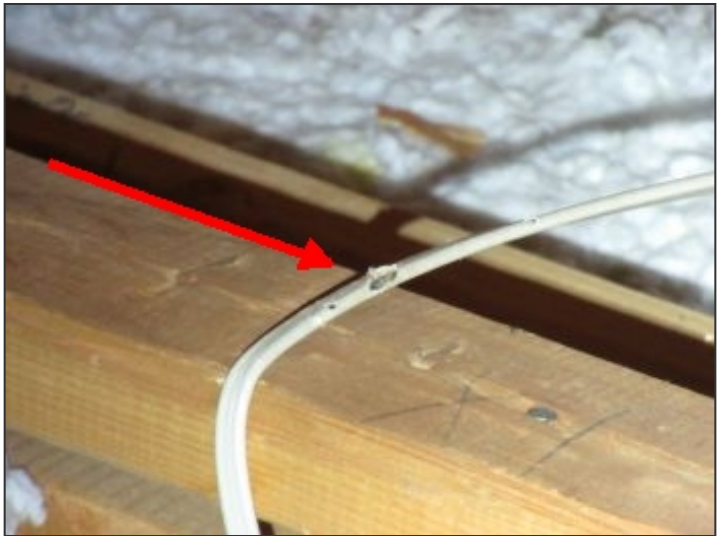
Rodent chewed wiring in attic above master bedroom

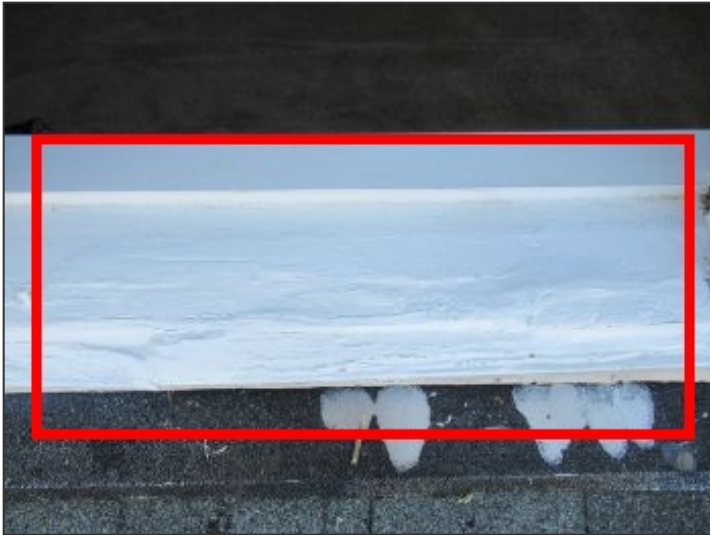
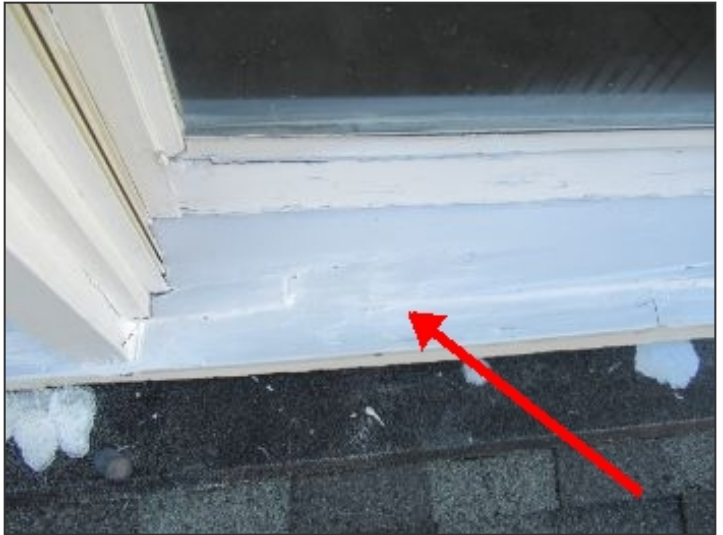
**4. Severe water damage was noted at the window sills of the rear master bedroom windows (see photos). Inadequate caulk patch repairs are present, the repairs are soft and damaged wood is still present. Based on the extent of water damage, it appears that the windows will need full replacement.**

Severe water damage at rot at rear master windows

Severe water damage at rot at rear master windows, inadequate patch repairs

**Due to these concerns, further evaluation is advised by a professional widow repair / replacement contractor to determine the full scope of repair needs and costs. Budget for a major repair.**

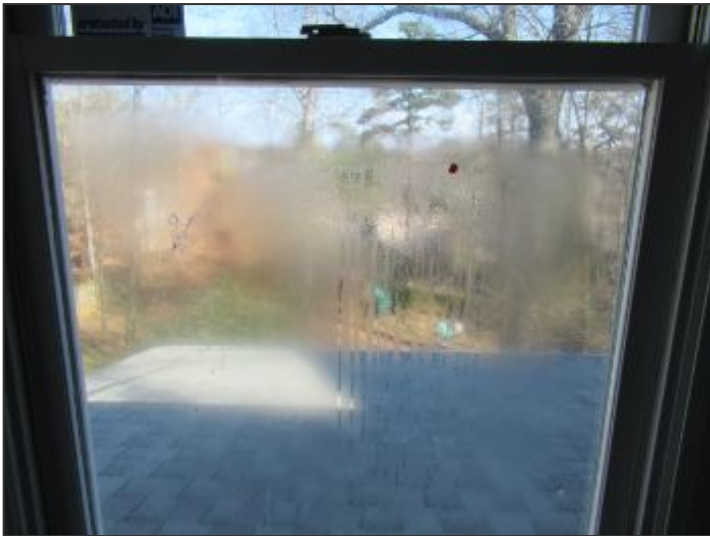
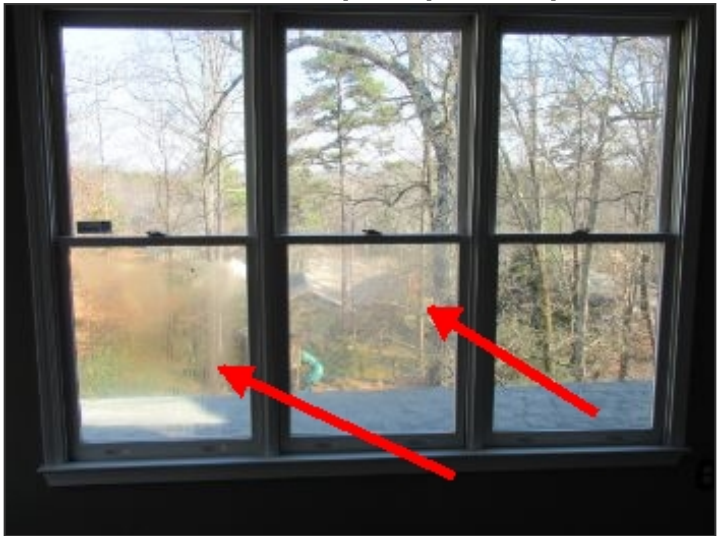
One of several foggy glass windows

Two master bedroom foggy glass windows

This condition indicates a defective thermal seal inside the dual pane glass and is most often corrected by replacement of the glass panel or the full window. This condition can become a major expense when multiple windows are affected or when larger windows are involved. Further evaluation is recommended by a professional window replacement contractor to determine the full extent of repair needs and costs.

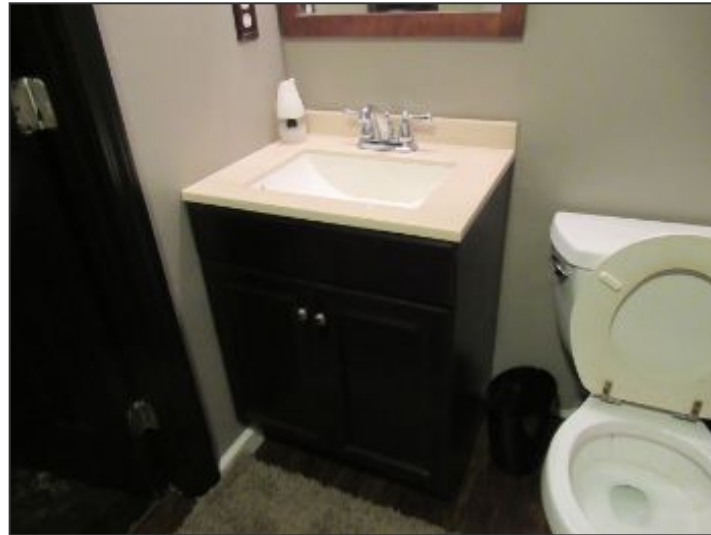
• **The basement bathroom cabinet is loose and is not properly anchored to the floor or wall as needed to reduce stress to the plumbing pipes. Correction is advised to fully secure and anchor the sink cabinet.**

**Basement bath vanity cabinet is loose, unsecured**

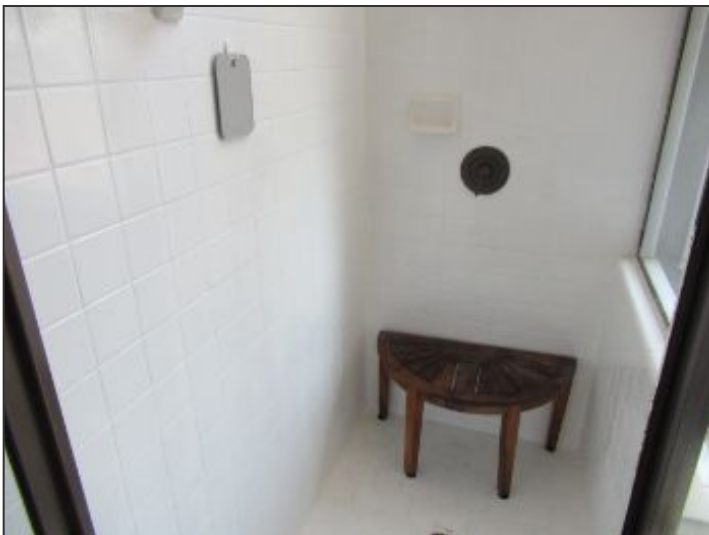
Master bath tiles have been re-coated

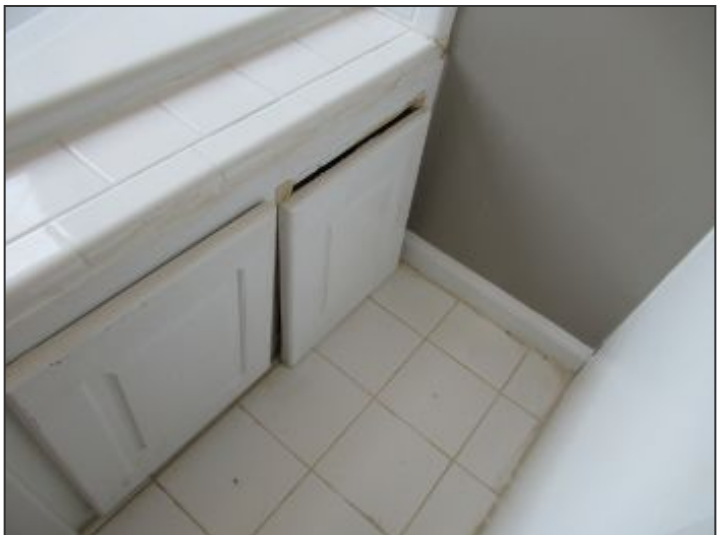
Loose access doors to jetted tub

Due to these concerns, further evaluation is recommended by a professional plumber to determine the full scope of repair costs and needs.

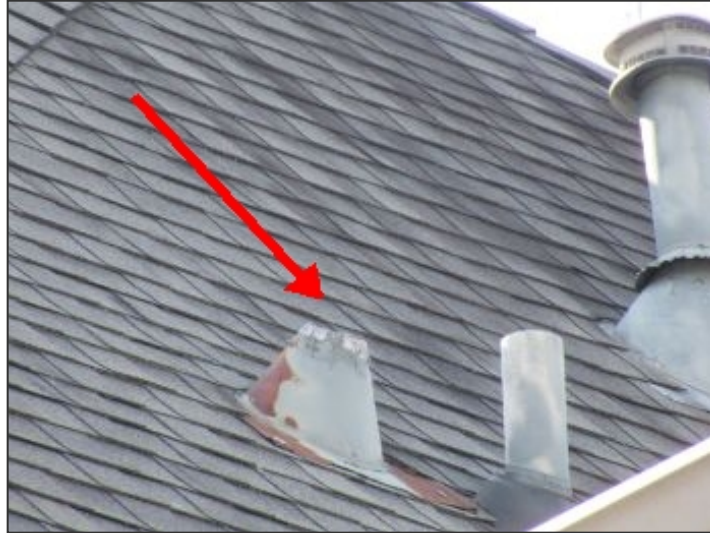
• Improper laundry dryer ducting was noted - the original metal dryer duct above the roof has a missing vent cap and appears to have been taped and sealed above the roof (see photo). A vinyl duct is visible in the attic at this location and may be the newer dryer duct but could not be confirmed. Due to fire safety concerns, the dryer duct is not allowed to be vinyl and is required to be a metal duct at this location. Further evaluation and repair is recommended, so the dryer duct is a rigid metal duct.

Laundry dryer vent is missing vent cap, has been sealed off

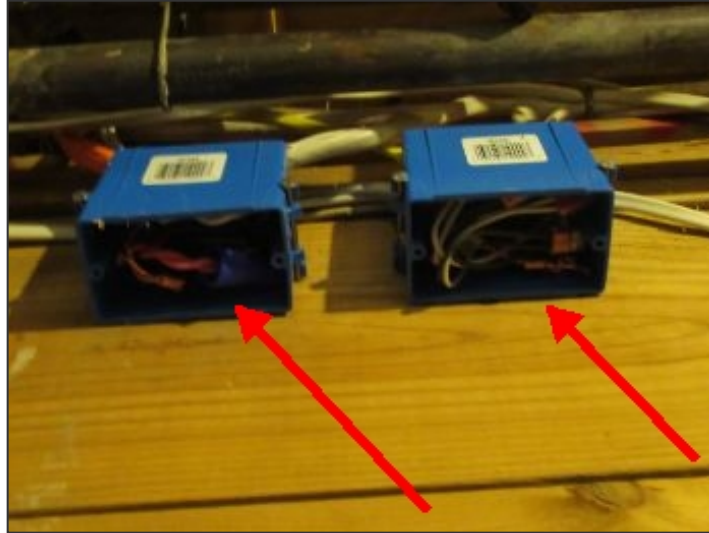
- **The overall condition of the visible wiring appears to be serviceable, except as noted below:**
- **Two open junction boxes were noted at the basement mechanical room (see photo); the wires are exposed. A minor repair is suggested - install an approved junction box cover so that the wiring splices are fully enclosed.**

Two open junction boxes in mechanical room

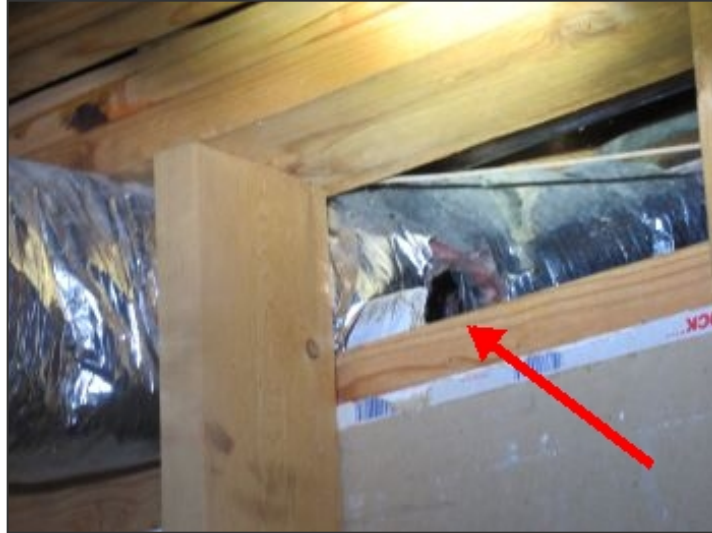
Large hole in HVAC duct in basement mechanical room ceiling

Further evaluation is suggested by a professional HVAC contractor to determine the full scope of repair / adjustment needs.
