Inspection Report

Property Address:
12615 Concord Hall Dr
Alpharetta GA 30005

Date: 1/24/2020	Time: 01:00:00 PM	Report ID: 012420GL572
Property: 12615 Concord Hall Dr Alpharetta GA 30005	Customer: Truin Huntley and Daniel Carroll Huntley	Real Estate Professional: Kristine Hoogacker Independent

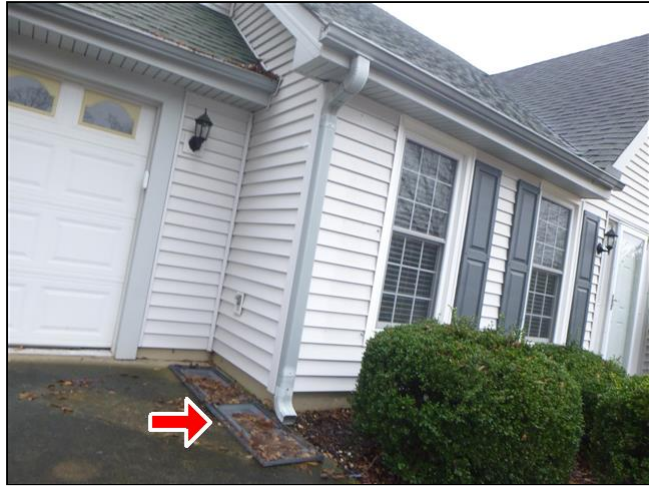
1.1 Item 1(Picture)

🔧 (1) Algae growth noted on the vinyl siding on the wall above the garage. It is recommended to have the siding pressure washed.

🔧 (2) One of the vinyl shutters at the front of the home has fallen off. Repair shutters as needed.

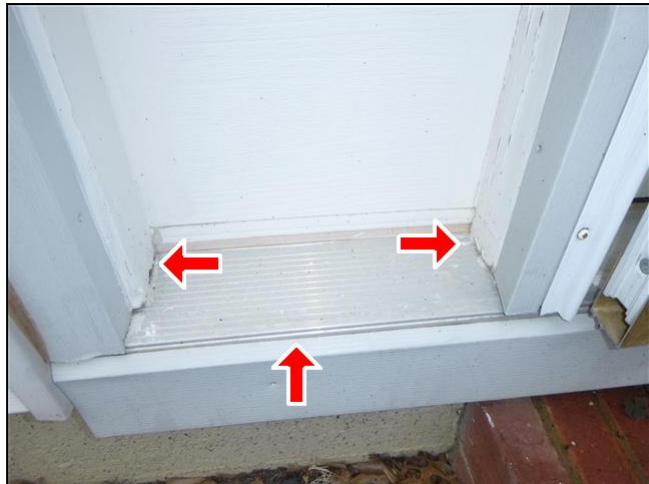
1.2 Item 1(Picture)

🔧 (1) Recommend to seal the gap between the siding and the threshold of the exterior doors. Seal all miters where the brick mold meets the threshold to ensure that the area is water tight.

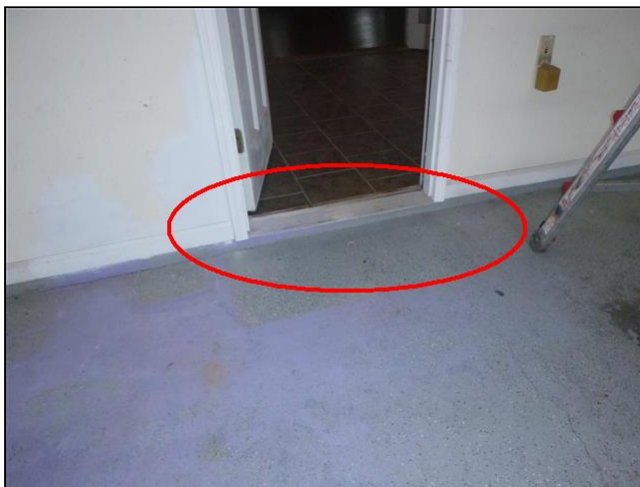
1.2 Item 2(Picture)

🔧 (2) Recommend to install a pressure treated piece of wood under the metal threshold at the bottom of the garage kitchen door. This will strengthen the threshold to keep it from bending or cracking.

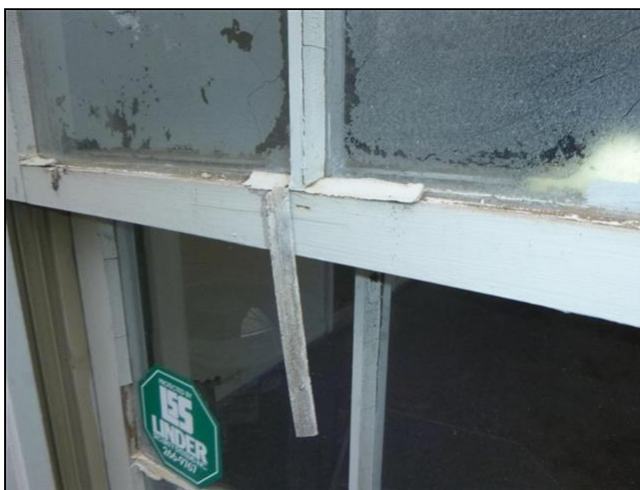
1.3 Item 1(Picture)

🔧 The glazing between glass panes are failing at the garage window due to age. This is common on single pane windows and the glazing compound is ready to be replaced to prevent windows from leaking and becoming drafty.

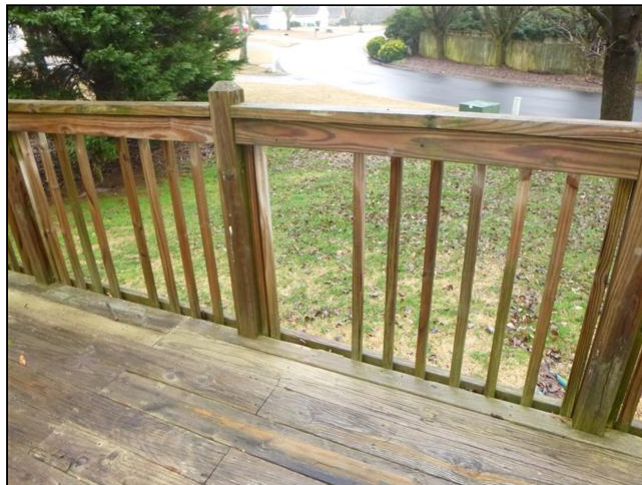
1.4 Item 1(Picture)

🔧 (1) Guardrails are loose and there are missing spindles on the rear deck and need additional bracing and/or fasteners to reduce the amount of movement on the rails. See photo(s) for location. Repair as needed.

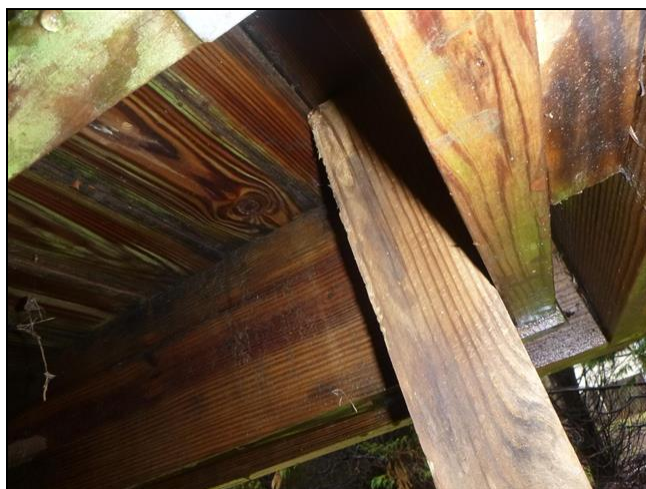
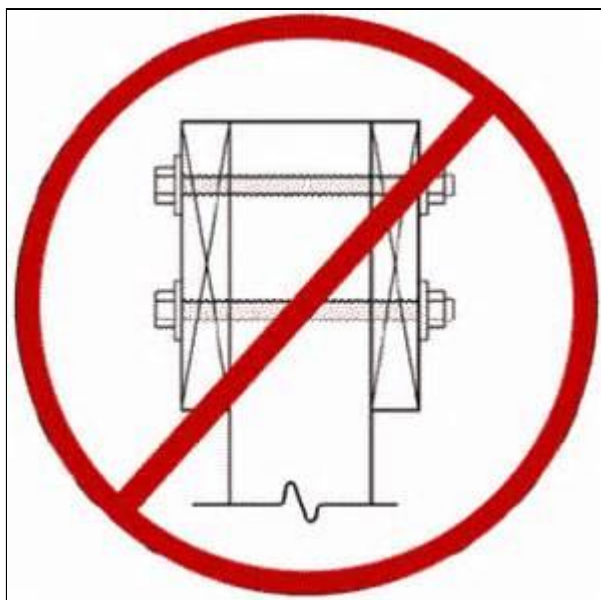
🔧 (3) The deck framing is attached and not resting on its supports. Fasteners failed in shear and withdrawal. Repair is needed by a deck construction professional.

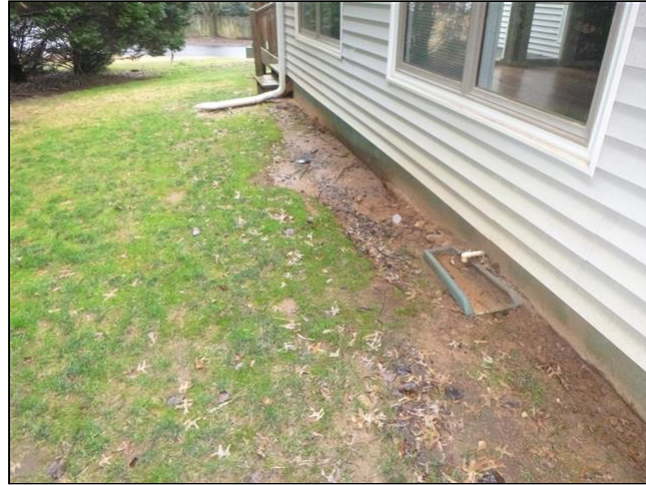
1.5 Item 1(Picture)

🔧 (1) The soil at the rear of home is eroding. Silt travel is occurring and some form of ground cover or landscaping is needed. Recommend a qualified contractor to inspect and perform the necessary repair.

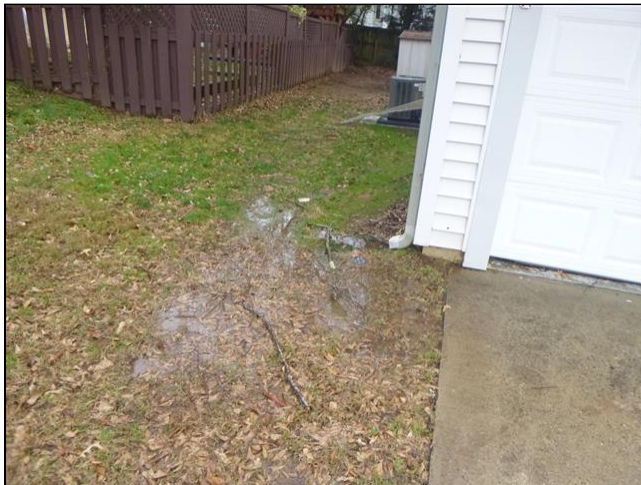
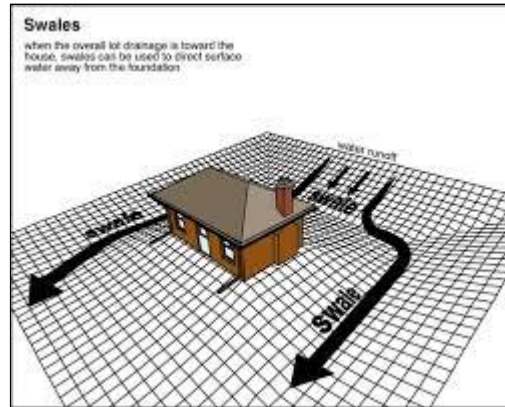
🔧 (2) The landscape at the left side of home may require a trench or drain if water stands or puddles near the home after heavy rain. Areas should be dry 24 to 48 hours after rainfall. Recommend to monitor and repair as needed. All rain water should drain at least 5 feet away from the home.

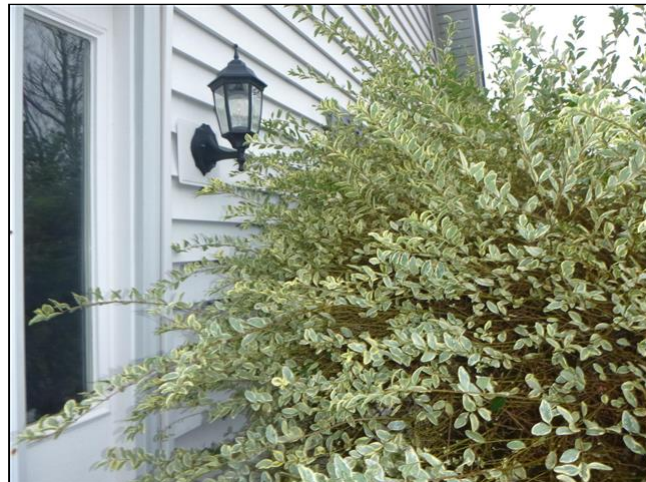
1.5 Item 4(Picture)

🔧 (3) Have all bushes cut away from the home at least 18"-24". This will discourage insects and water from entering the home.

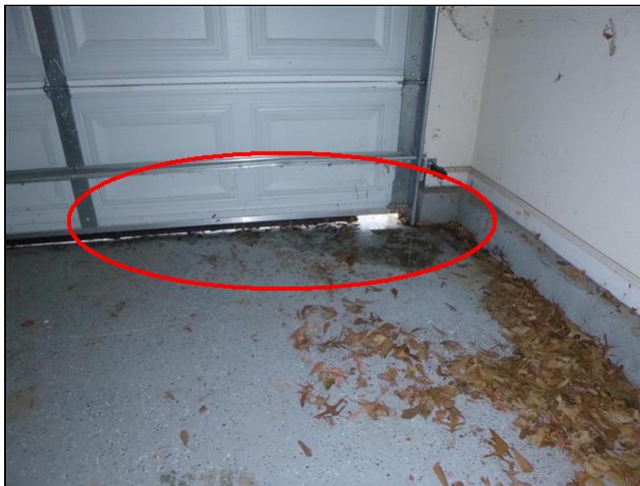
2.3 Item 1(Picture)

🔧 Daylight visible on the bottom of the garage vehicle door. This can be a rodent entry point. Adjust/install the weather stripping in these areas to prevent further entry.

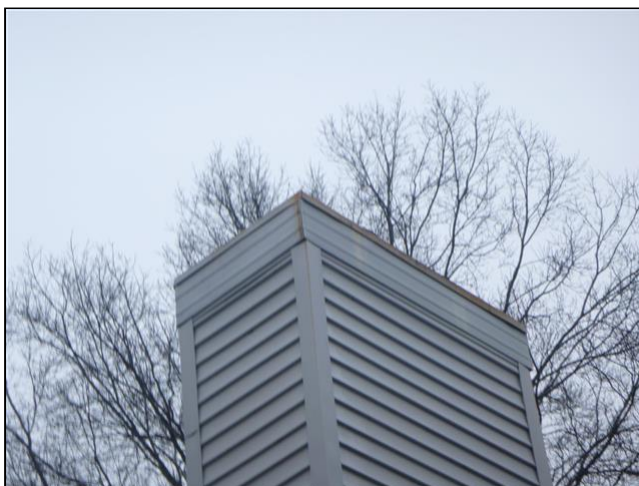
4.2 Item 1(Picture)

🔧 Visible rusting noted on the chimney cap. When rusting is visible on the chimney cap then it is likely that it has become concave and standing water will eventually rust through allowing water to enter into the chase. Have roofing contractor or chimney sweep contractor inspect and make necessary repairs.

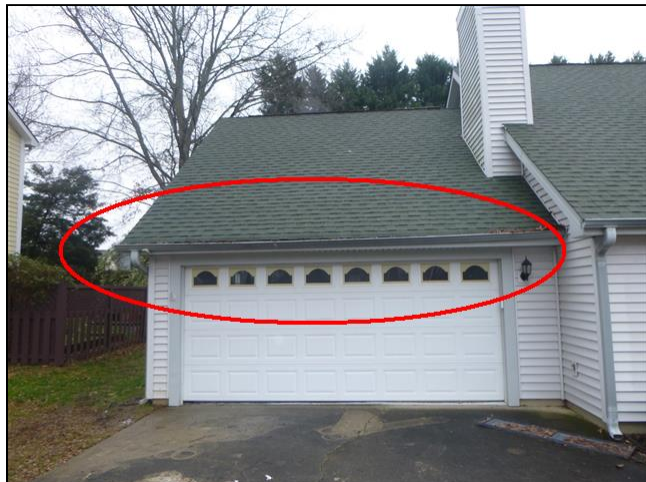
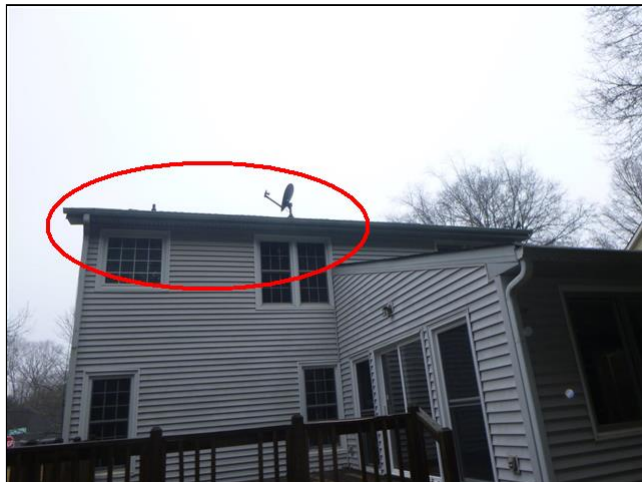
🔧 (1) Recommend to adjust the gutter at the garage and rear of home so that it properly slopes towards the downspout.

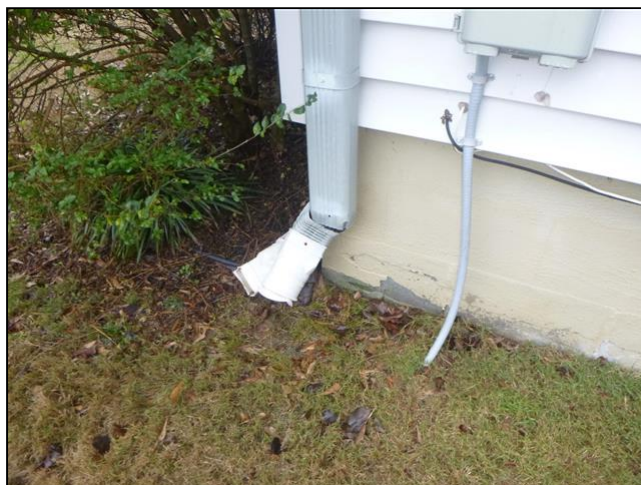
4.3 Item 3(Picture)

🔧 (2) Recommend to install a downspout extension to the downspout at the perimeter of the home. All roof water should drain at least 5 feet away from the home.

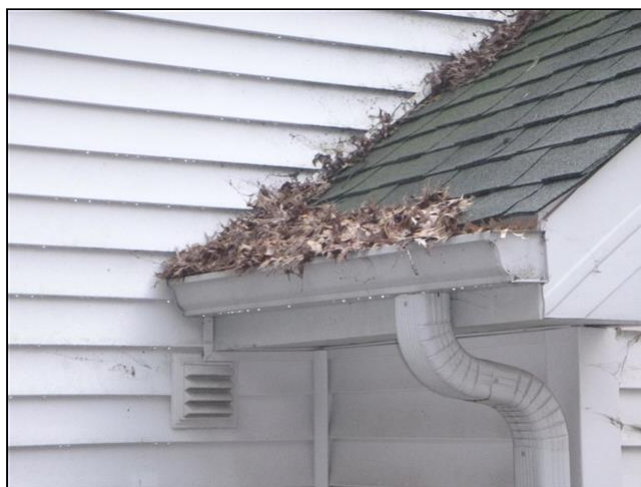
4.3 Item 4(Picture)

🔧 (3) Have all gutters and downspouts cleaned out around the home. Clean gutters are required to maintain water control and drainage.

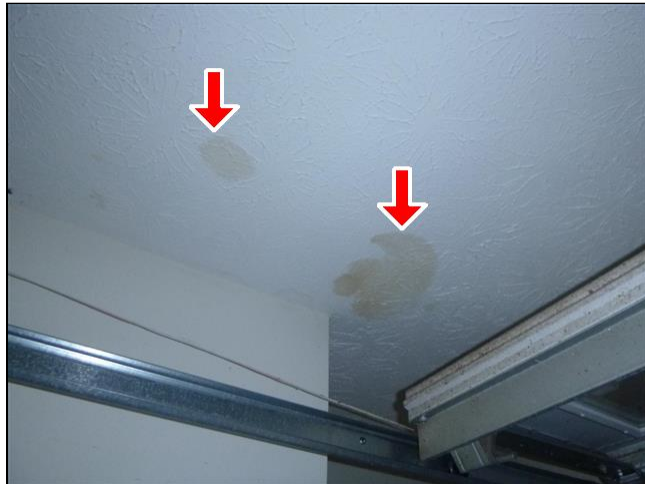
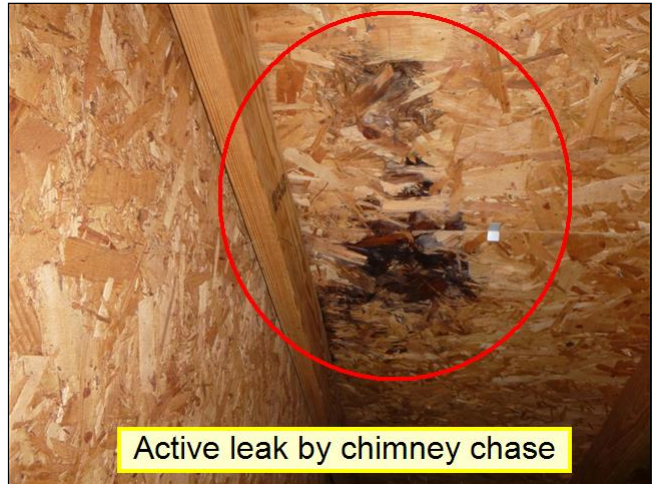
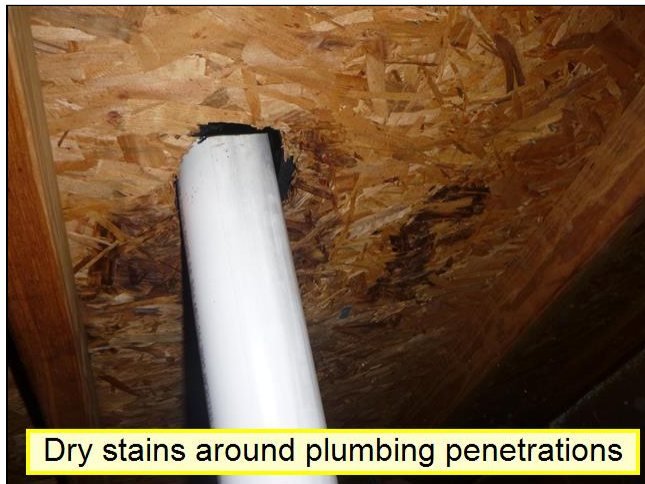
🔧 Active roof leak was observed above the garage by the chimney chase and staining was observed in other areas of the attic. Roofer will need to evaluate roof and ensure that the roof covering is water tight. It is possible that outdoor and weather conditions could change and cause leaks to become active again. See photo(s) for location(s).

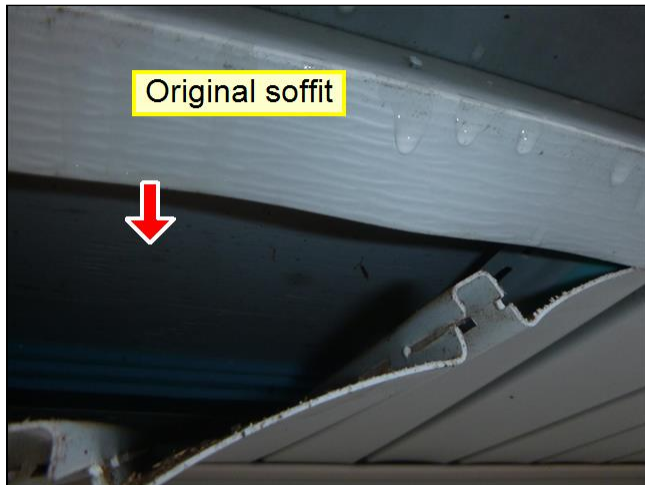
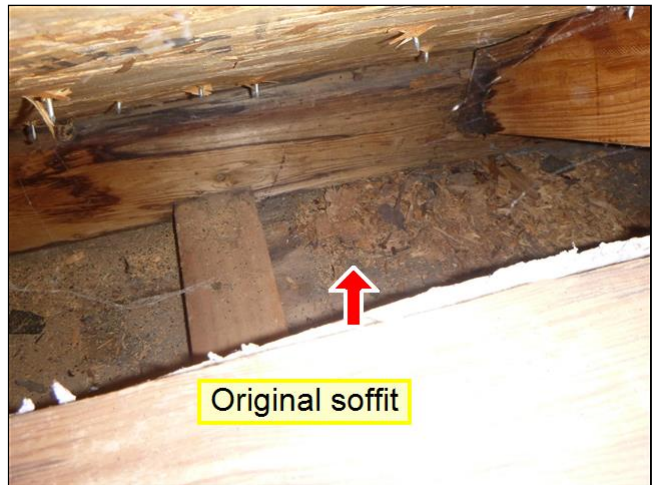
🔧 (1) A vinyl soffit has been installed without first removing the original plywood soffit creating inadequate ventilation for the attic. If the attic becomes too hot then the shingles may overheat prematurely. Increasing the ventilation to promote/maintain the life expectancy of the roof covering will be beneficial. Recommend to have roofing contractor inspect for further evaluation and make necessary repairs. See photo(s).

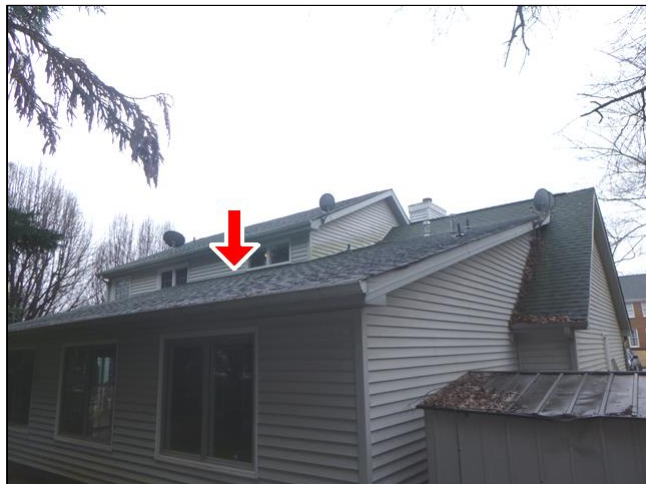
5.1 Item 3(Picture)

🔧 (2) The rear addition is not adequately vented. Recommend installing box vents for this portion of the home. Consult a roofing professional.

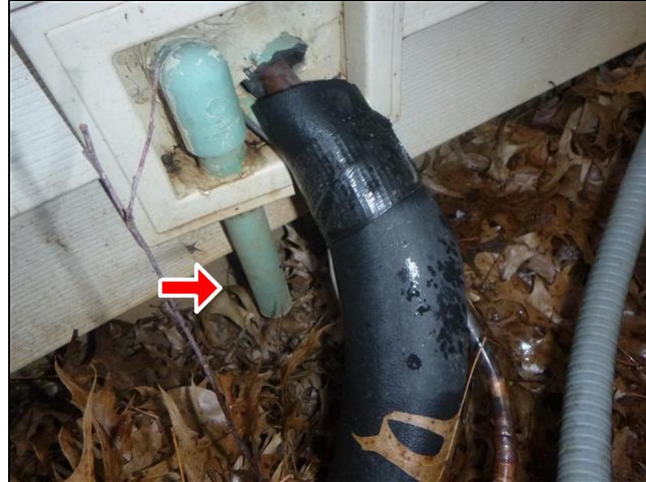
6.6 Item 1(Picture)

👉 (2) Recommend to have the condensate drain lines and/or pump line(s) for the compressors extended out and away from the home. Water should drain at least 5 feet away from the home. This was not required in older homes.

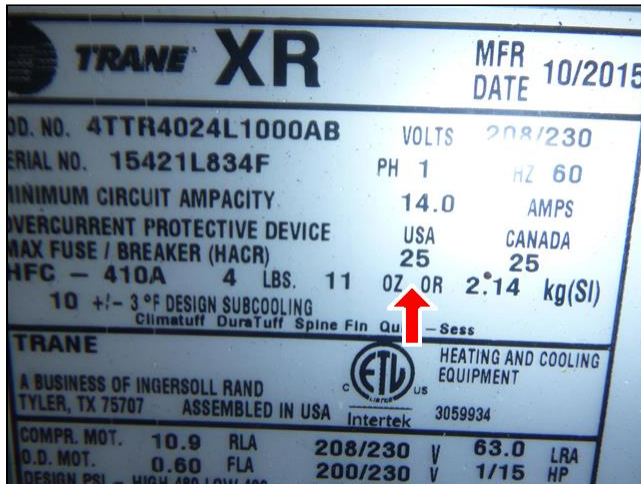
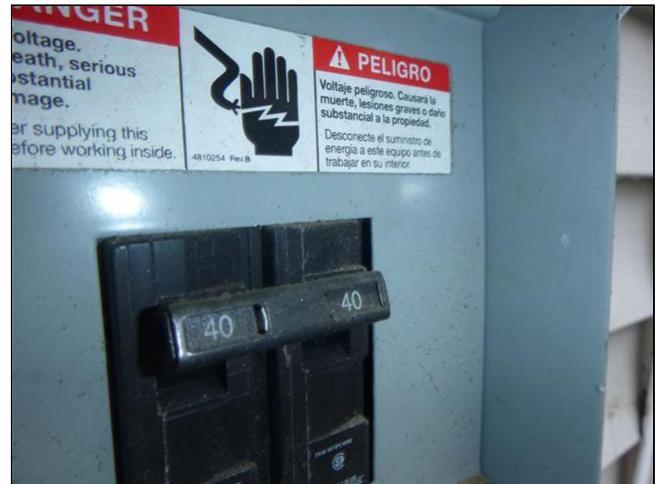
👉 (3) The Trane air conditioner is on a 40 amp breaker, but the data plate on the system states a 25 amp maximum. Properly sized breaker in the disconnect should be installed by licensed electrical professional.

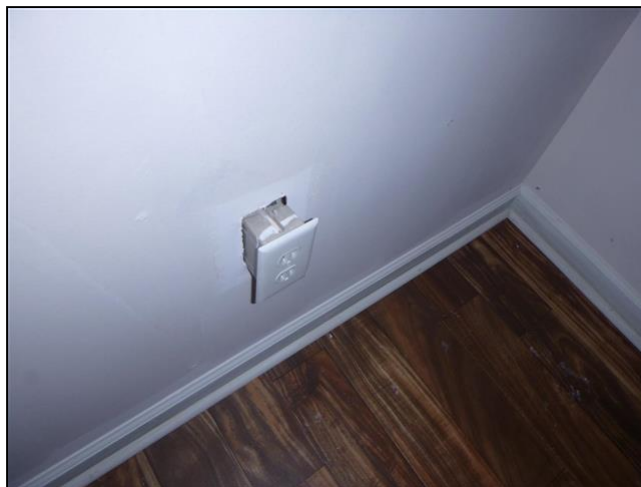
7.5 Item 1(Picture)

🔧 (1) The light fixture in the rear bedroom closet did not function at the time of inspection. Check bulb, repair of needed.

🔧 (2) The receptacle in the rear bedroom closet is loose to the wall. Repair as needed.

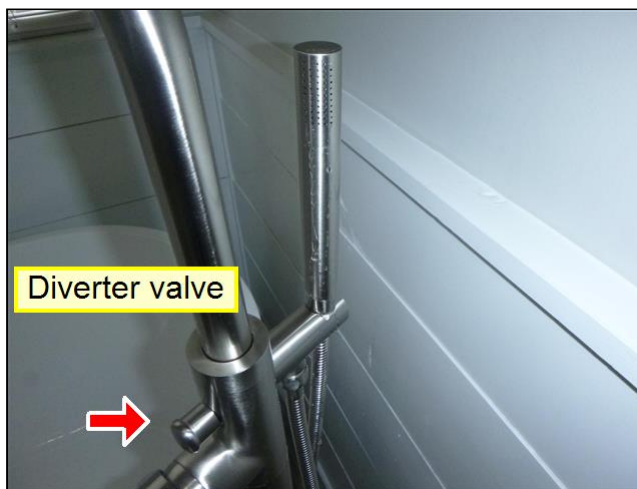
8.2 Item 1(Picture)

🔧 (3) The spray head for the master bathtub was leaking at the time of inspection. Have the diverter valve evaluated by licensed plumbing professional.

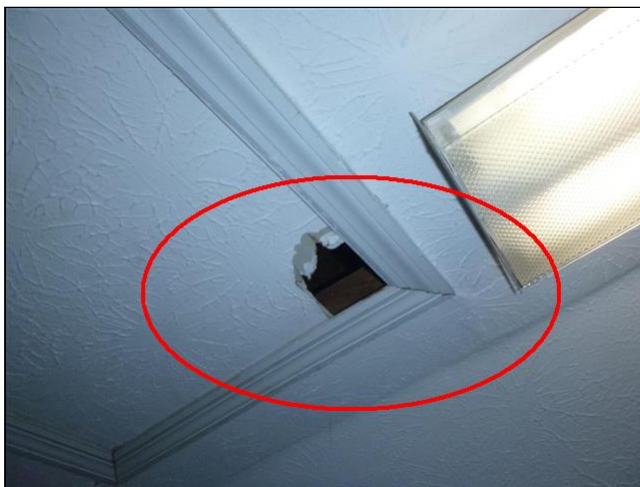
9.0 Item 1(Picture)

🔧 Recommend replacing the attic access panels to improve efficiency.

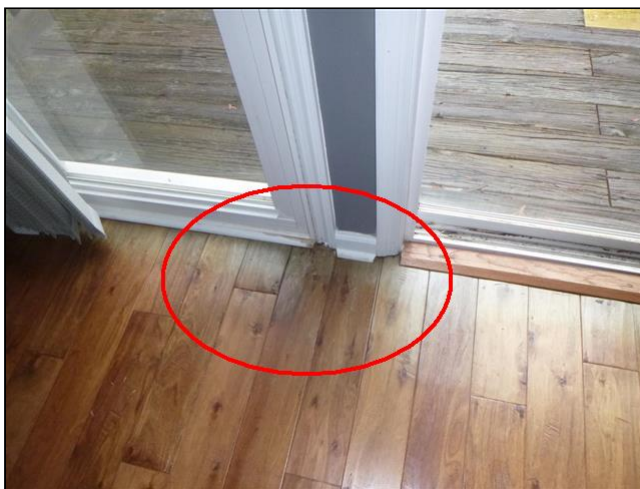
9.2 Item 1(Picture)

🔧 (1) Moisture staining was observed on the floor inside the window at the rear addition. This area should be evaluated by a window and deciding professional and repaired as needed.

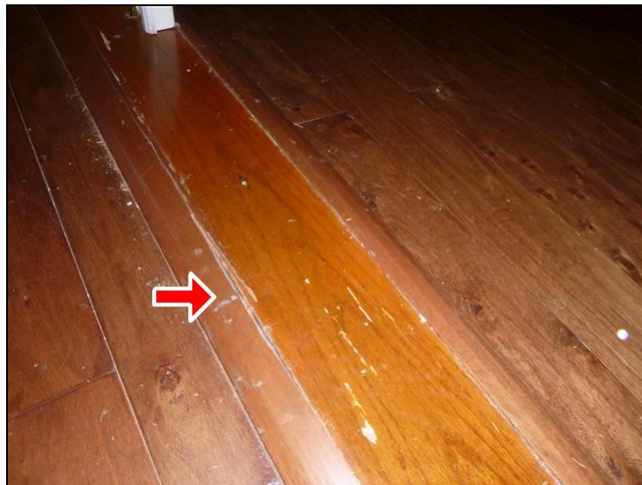
9.2 Item 2(Picture)

🔧 (2) Damage was observed to the threshold between the dining room and rear addition. Have the threshold repaired for safety.

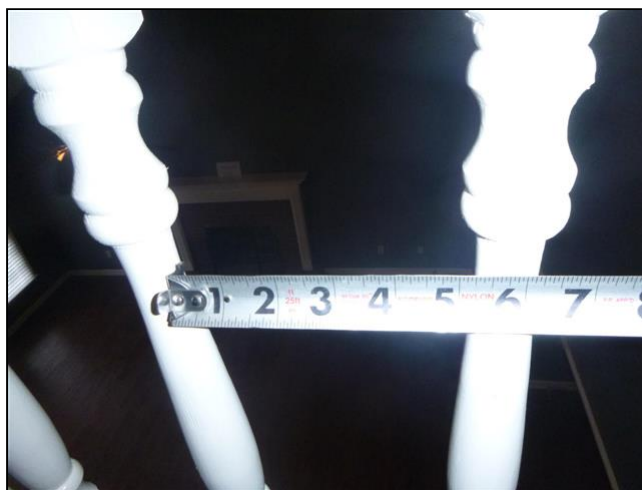
9.3 Item 1(Picture)

🔧 It is recommended that the guard rails on the interior of the home be updated to today's building requirements with spindles with a 4" separation.

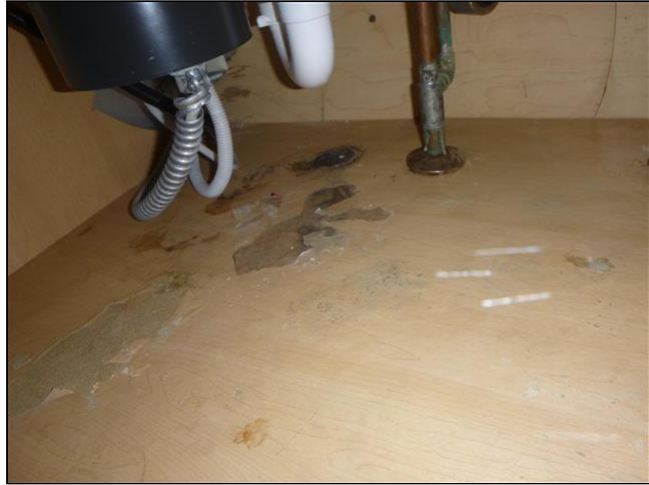
9.4 Item 1(Picture)

Damage was observed in the cabinet under the kitchen sink. Repair damage as needed.
