# *Trademark Home Inspection*

## Property Inspection Report

1769 Drew Dr, Atlanta, GA 30318  
Inspection prepared for: Paul Giobetti and Caitlin Dunn  
Real Estate Agent: Tara Locke - KW Atlanta Partners - South Forsyth

Date of Inspection: 2/3/2020 Time: 9:00 AM  
Age of Home: 2006 Size: 3626  
Order ID: 11644

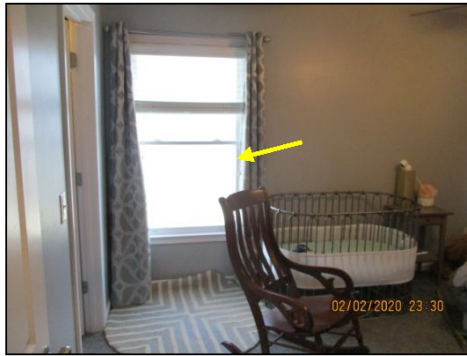
Fog/condensation observed in upstairs thermopane windows. This is an indication of a failed seal. Recommend review for repair or replacement as necessary.

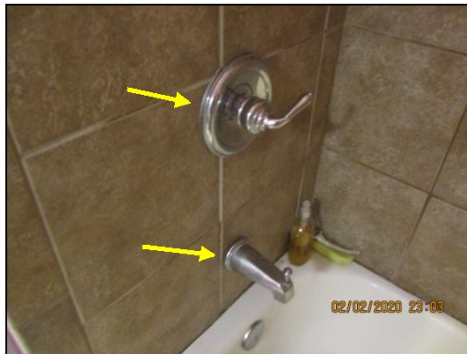
Recommend securing loose plumbing valve and faucet in basement shower to prevent leaks.

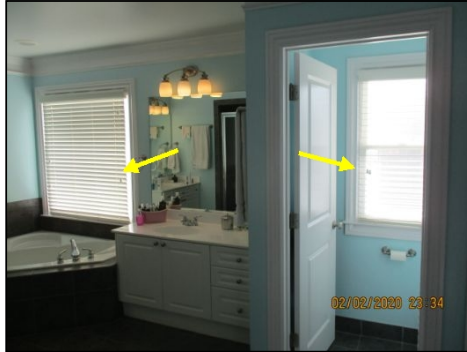
Fog/condensation observed in master thermopane windows. This is an indication of a failed seal. Recommend review for repair or replacement as necessary.

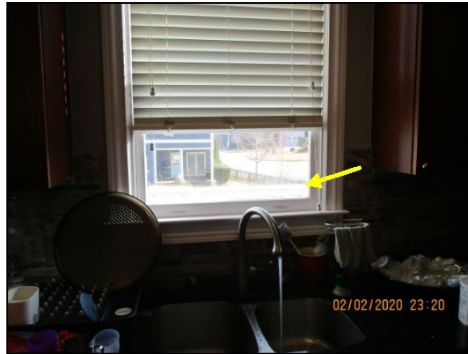
Fog/condensation observed in kitchen thermopane windows. This is an indication of a failed seal. Recommend review for repair or replacement as necessary.

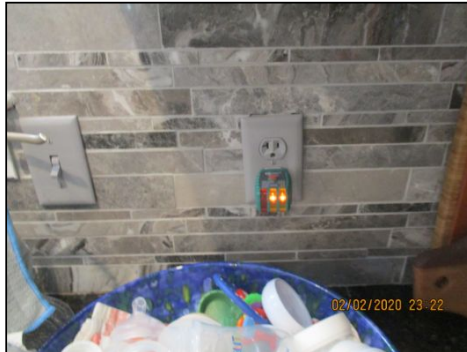
GFCI outlets did not trip in kitchen. Recommend licensed electrician to evaluate kitchen GFCI and repair as necessary.

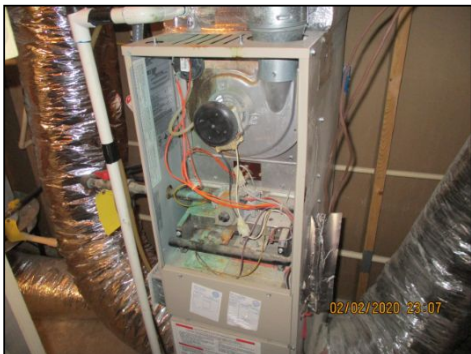
Ducane 2006 gas furnace noted in basement. Unit is nearing the end of its useful life. Recommend licensed HVAC contractor to service unit. Be prepared to replace unit in next few years.

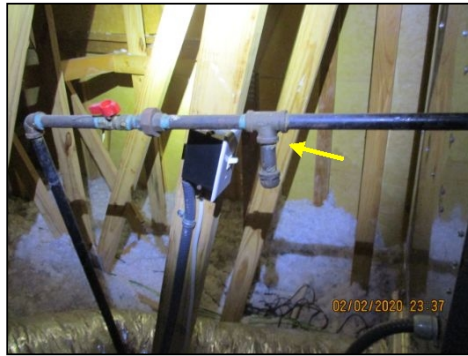
Improper gas line and drip leg noted on attic furnace. Trash and sediment in gas line is bypassing drip leg and routing into unit. Recommend licensed contractor to evaluate and properly route gas line and drip leg.

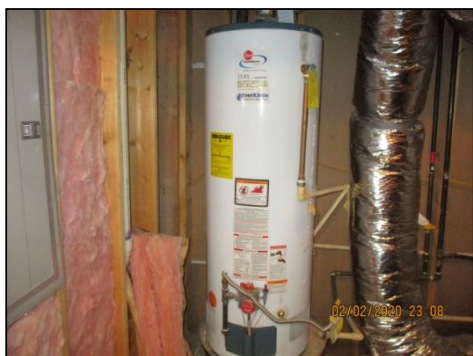
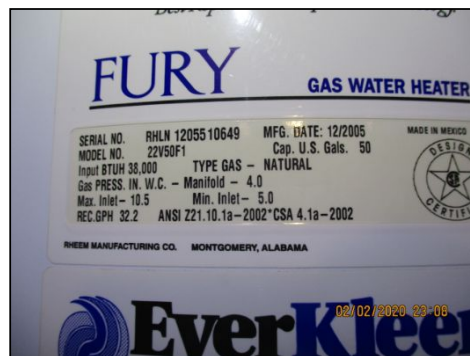
Rheem 2005 gas water heater noted. Unit is nearing the end of its useful life. Recommend licensed contractor to service unit. Be prepared to replace unit in next few years.

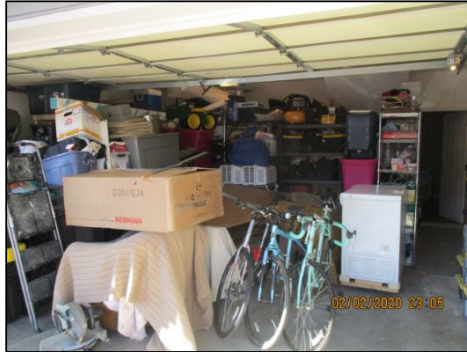
Many areas of garage walls could not be seen or inspected.

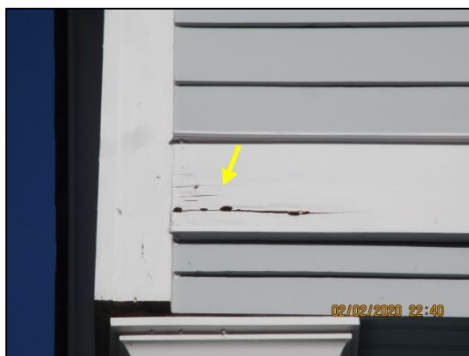
Minor water damage noted on wood rim band on right side of front porch. Recommend licensed contractor to evaluate wood band and seal or replace wood as necessary.

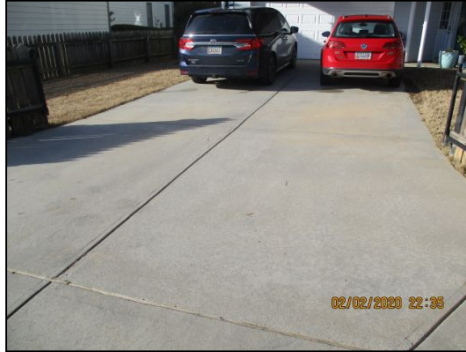
Driveway in good shape for age and wear. Small settlement cracks noted.

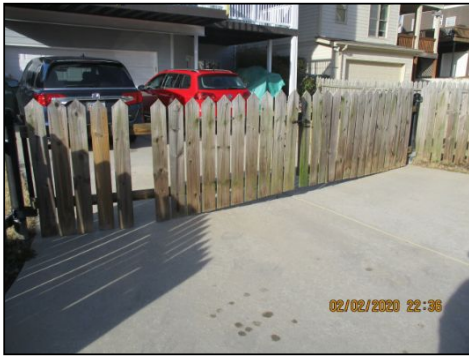
Driveway gate is in good condition with missing slats noted.

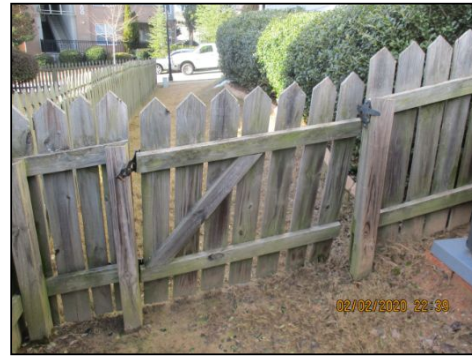
Broken gate noted on right side of house. Recommend licensed contractor to evaluate and repair gate as necessary.

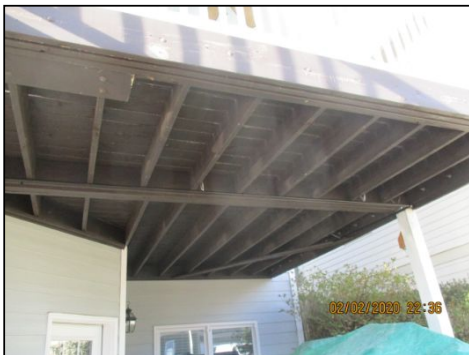
When deck was built code did not permit for joist hangers to be used as supports. Recommend decking company to install joist hangers instead of 1x2 rail that is supporting deck joists.

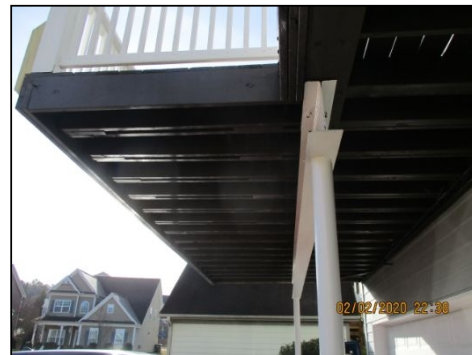
Settlement noted on outer rim band of deck because steel I-Beam is not located in middle to outer section.
