Inspection Report

**Property Address:
5452 Chanel Ct
Dunwoody Ga 30338**

Inspector: Brandon Williams

**Residential Inspector of America
3276 Buford Drive, Ste. 104-306
Buford, GA 30519
770.476.4963**

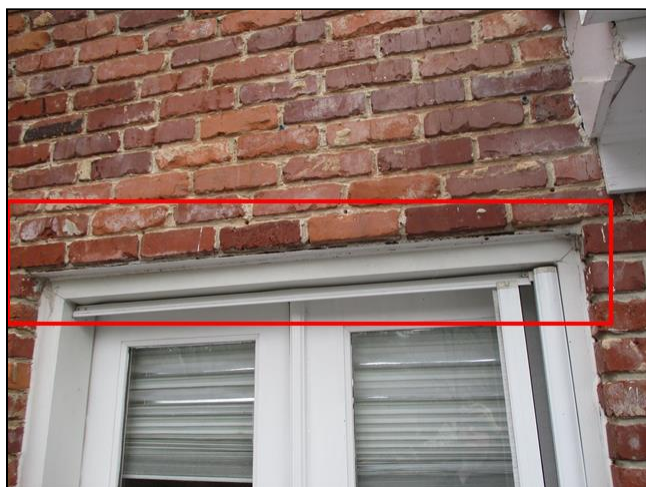
1.1 Item 8(Picture)

(2) Recommend painting rusting metal lintels over the doors and windows around the home with a metal protective paint

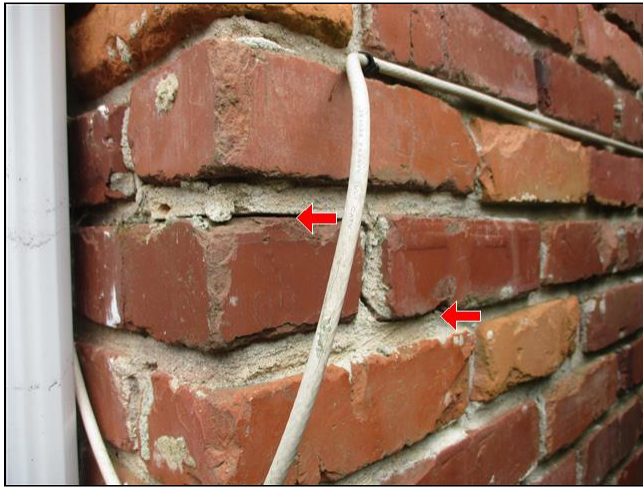
1.1 Item 10(Picture)

(3) Small step cracks found in the brick veneer in a few areas. Cracks are not wide enough to be considered a structural concern and are due to settlement. It cannot be determined if crack will continue to progress, but due to the age of the house, it is likely movement is complete. Have patched as needed.

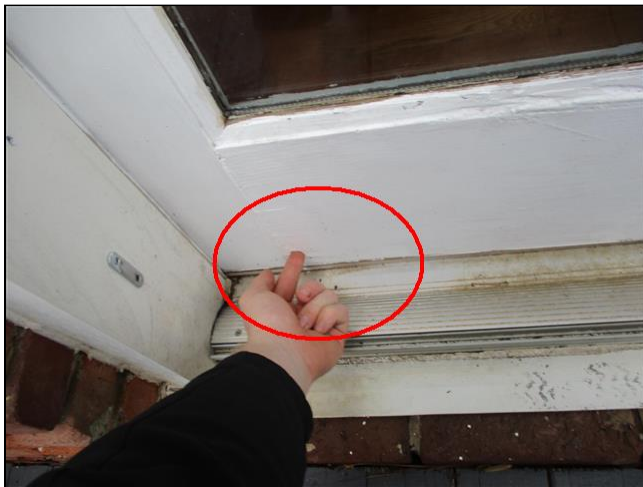
1.2 Item 4(Picture)

(2) Minor rot damage on the lower part(s) of the front and rear deck door. Repair or replace damaged wood. See photo(s). This is a common area for damage and will need to be maintained. Fill repairs will not be long lasting.

🔧 (2) Minor rot damage on the lower part(s) of the front and rear deck door. Repair or replace damaged wood. See photo(s). This is a common area for damage and will need to be maintained. Fill repairs will not be long lasting.

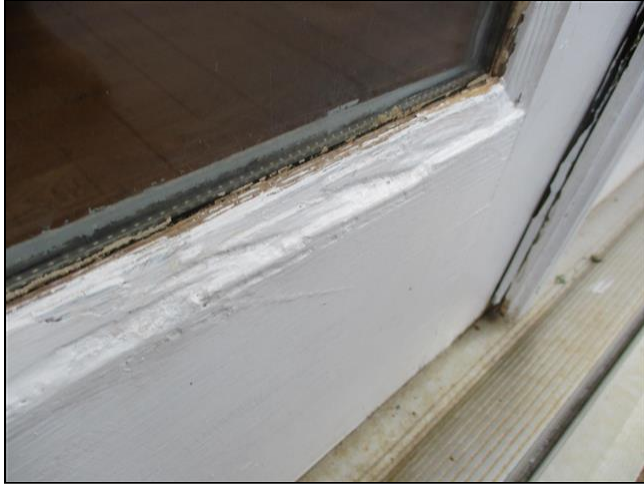
1.2 Item 7(Picture)

(3) Minor animal damage found at the trim on the rear double deck door. Have repaired.

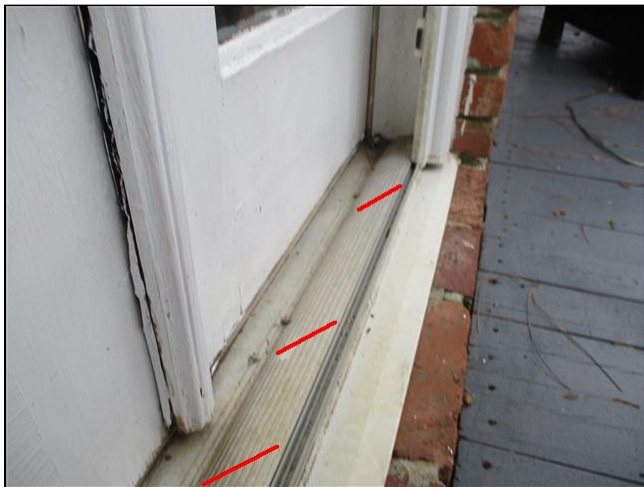
1.2 Item 8(Picture)

(4) Rear double door threshold and the sliding screen threshold create a valley that will hold water and can encourage water entry and damage

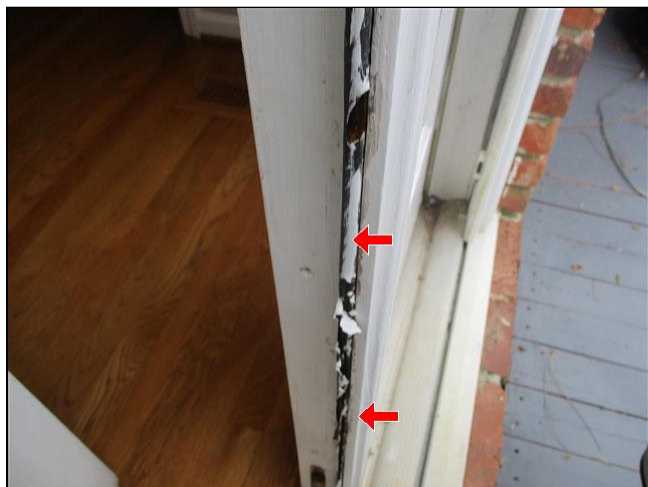
1.2 Item 9(Picture)

(5) Replace damaged weather stripping at rear deck door

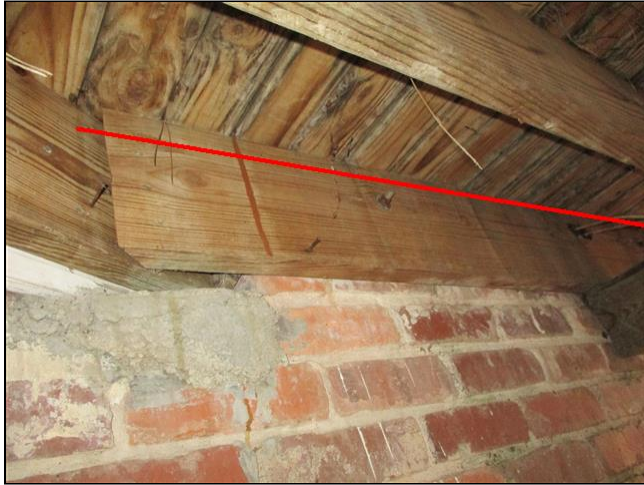
1.4 Item 1(Picture)

(1) No metal flashing could be seen between the rear deck and the rear wall. This was not often enforced or required in older homes, but flashing makes a better seal between the deck and house. Condition of framing between deck and house is not known.

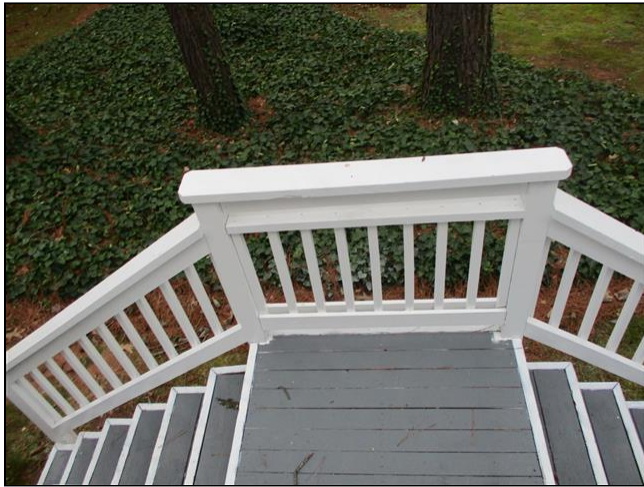
1.4 Item 2(Picture)

(2) Guard rails on rear deck are loose and need additional bracing and/or fasteners to reduce the amount of movement on the rails. See photo for location.

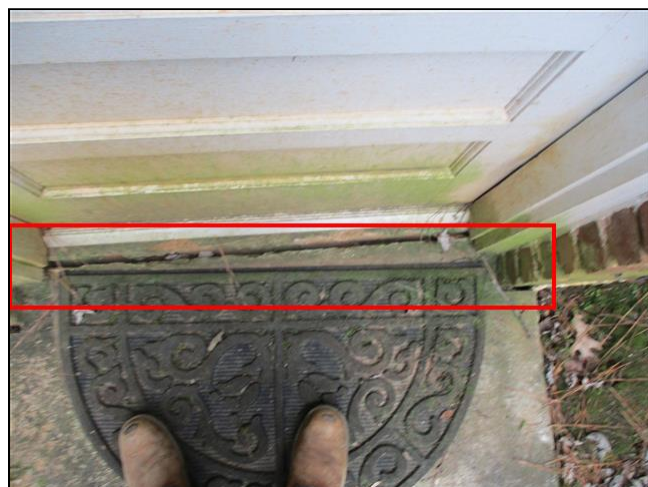
1.5 Item 5(Picture)

(2) Recommend corrective landscaping around the rear basement door pad to help prevent further settlement of the slab

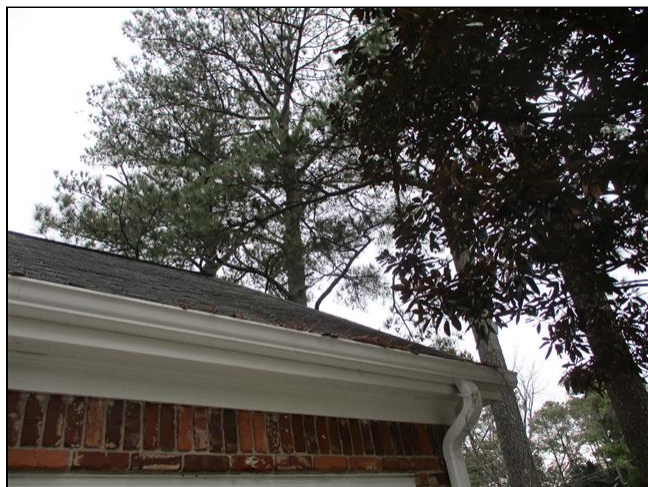
1.5 Item 7(Picture)

The tree limbs that are in contact with roof or hanging near roof should be trimmed.

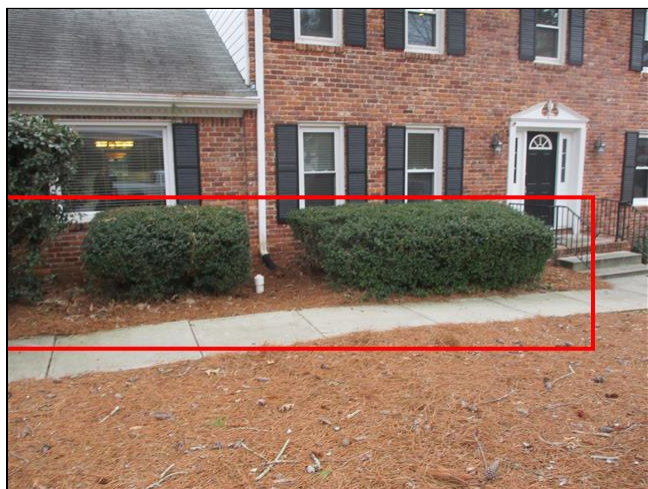
1.5 Item 8(Picture)

(4) The garden area formed by the front wall of the house, and the side walk from the driveway to the front landing, may prohibit quick drainage of run off water. These garden areas often are slow to drain and can cause water entry in the basement.

👉 (4) The garden area formed by the front wall of the house, and the side walk from the driveway to the front landing, may prohibit quick drainage of run off water. These garden areas often are slow to drain and can cause water entry in the basement.

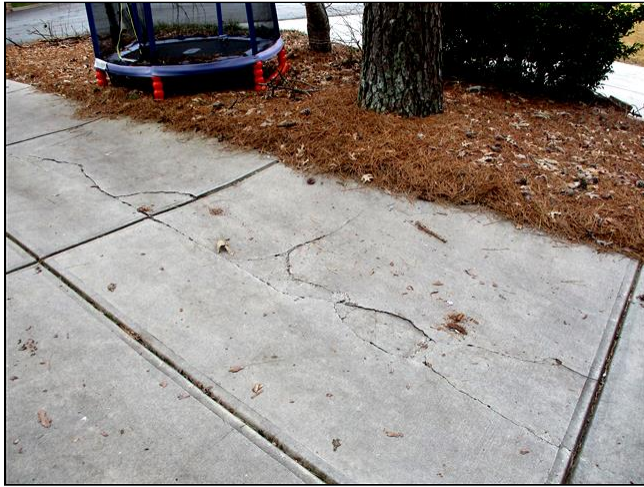
1.5 Item 9(Picture)

(5) Tree roots have likely caused upheaval of driveway panels. These have created trip hazards.

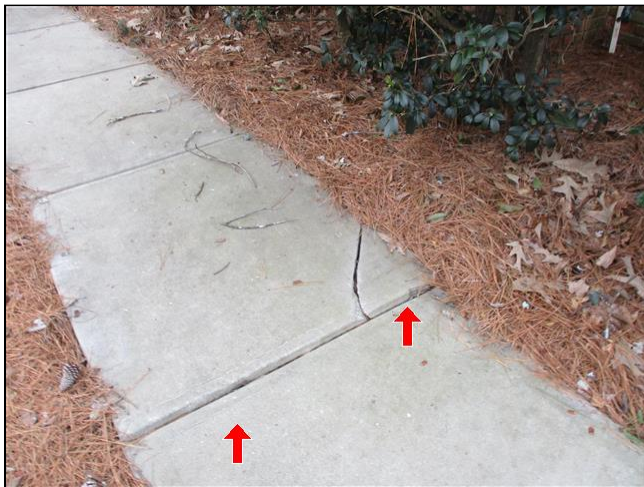
1.5 Item 10(Picture)

(6) Minor settlement of fill dirt under side walk from driveway to front porch has created some minor trip hazards in the concrete. See photo

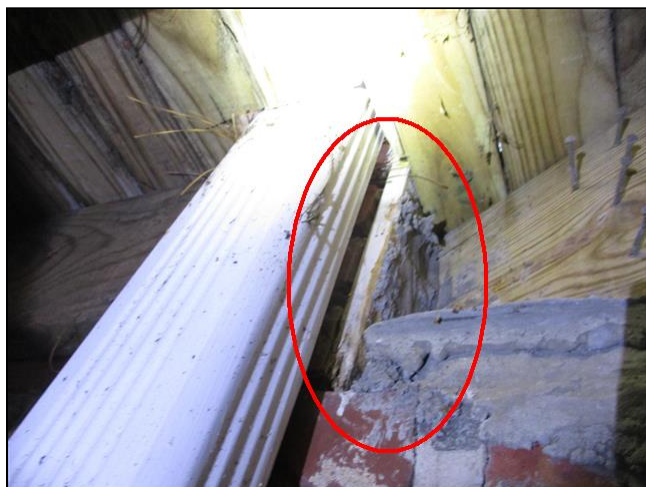
1.7 Item 1(Picture)

Rot damage found on exterior wood trim in a few areas around the home. See photos below for examples of these locations. It should be understood that more minor water damage may be present on other trim around the house.

This is very common and more should be expected in the future. If water damage occurred in the past, it will occur again in the future. Have contractor evaluate all trim and have all water damaged trim replaced or repaired.

🔦 Rot damage found on exterior wood trim in a few areas around the home. See photos below for examples of these locations. It should be understood that more minor water damage may be present on other trim around the house. This is very common and more should be expected in the future. If water damage occurred in the past, it will occur again in the future. Have contractor evaluate all trim and have all water damaged trim replaced or repaired.

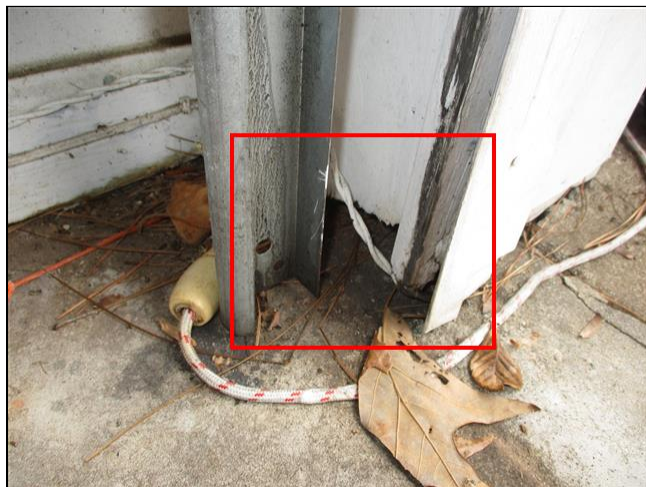
2.1 Item 2(Picture)

- 🔧 (2) Minor water damage on lower parts of wall between the garage door openings. Have damaged wood replaced. This was likely caused by rain water entry.

🔧 (2) Minor water damage on lower parts of wall between the garage door openings. Have damaged wood replaced. This was likely caused by rain water entry.

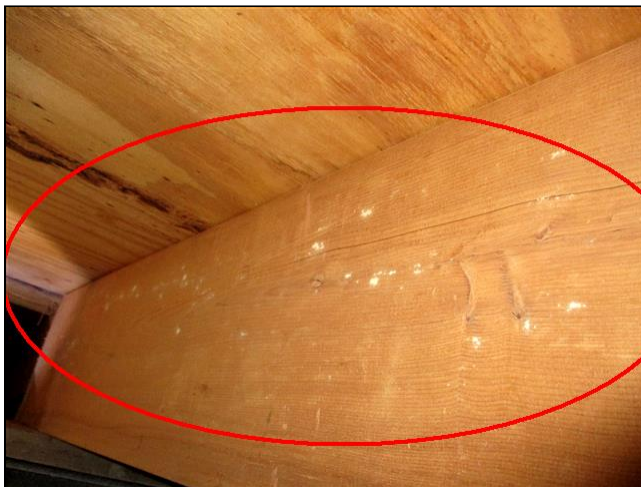
3.0 Item 6(Picture)

- 🔧 (2) Signs of minor mold or suspected mold growth is present on the floor system overhead in basement and crawlspace in several areas. The underlying cause of mold problems is normally moisture or high humidity. A visual inspection cannot determine the extent of the mold problem or if any health hazards exist. Mold testing can be completed if desired. Resolve all mold concerns prior to closing. Please click [HERE](#) for more information on mold testing.

🔍 (2) Signs of minor mold or suspected mold growth is present on the floor system overhead in basement and crawlspace in several areas. The underlying cause of mold problems is normally moisture or high humidity. A visual inspection cannot determine the extent of the mold problem or if any health hazards exist. Mold testing can be completed if desired. Resolve all mold concerns prior to closing. Please click [HERE](#) for more information on mold testing.

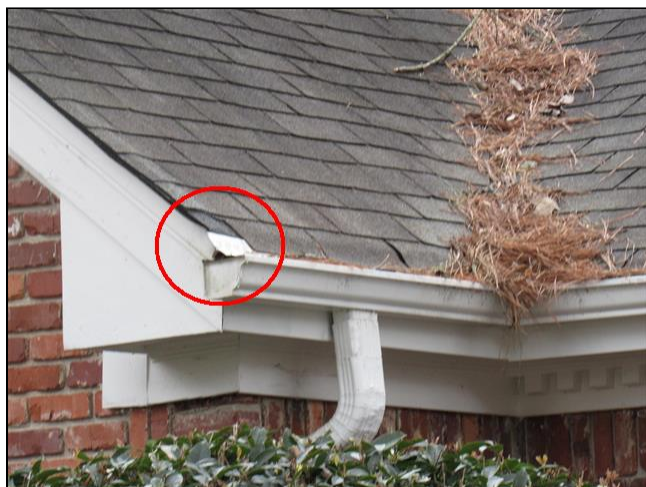
Missing shingle found on the front of the garage level roof near the gutter line, and there were some damaged shingles and hole found in the rear garage roof over the rear gable vent. See photos. Have roofer evaluate all of roof and repair/replace as needed

4.0 Item 7(Picture) missing shingle

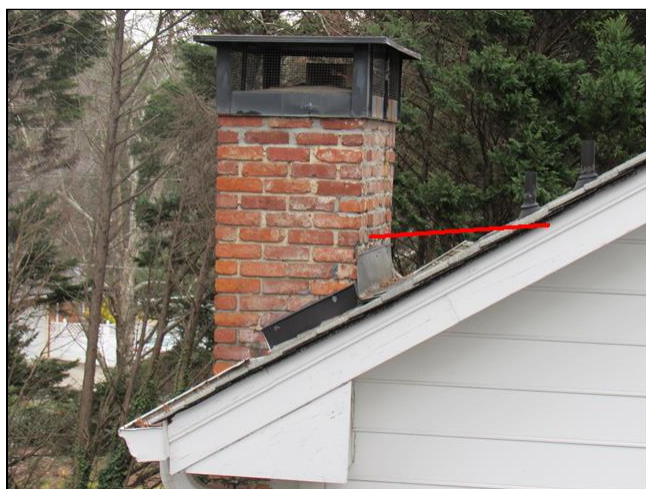
4.0 Item 8(Picture)

- 🔧 (2) Cricket recommended on the roof, on the high side of the chimney. A cricket is a roof shaped diverter that will direct the flow of roof run off away from the chimney. They were not required on older homes, but can be retro-fitted. See photos.

🦋 (2) Cricket recommended on the roof, on the high side of the chimney. A cricket is a roof shaped diverter that will direct the flow of roof run off away from the chimney. They were not required on older homes, but can be retro-fitted. See photos.

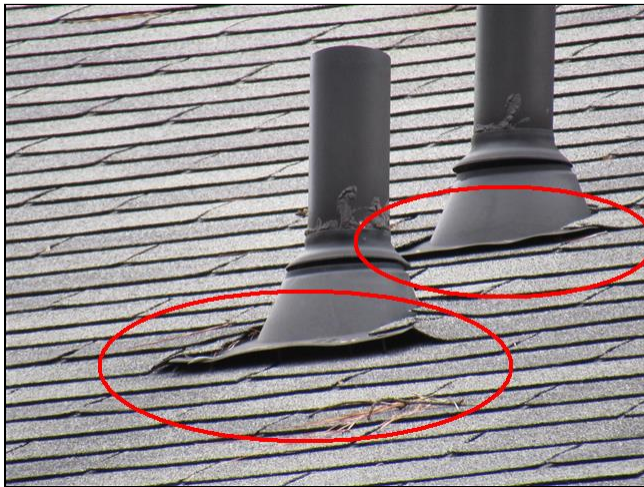
4.2 Item 4(Picture)

🔧 (2) Secure lifted boot flashing on roof surface. Have nails driven down and seal over nail heads.

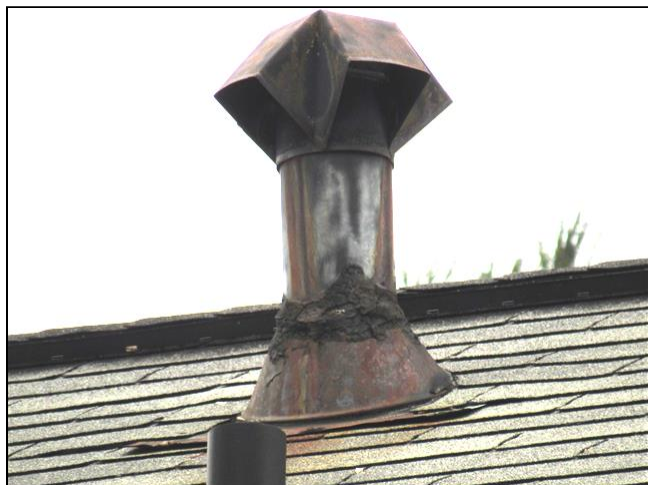
4.2 Item 12(Picture)

🔧 (5) Replace the rusted out caps on the roof for the furnaces. Condition of pipe in the concealed parts of the interior is not known. See photos.

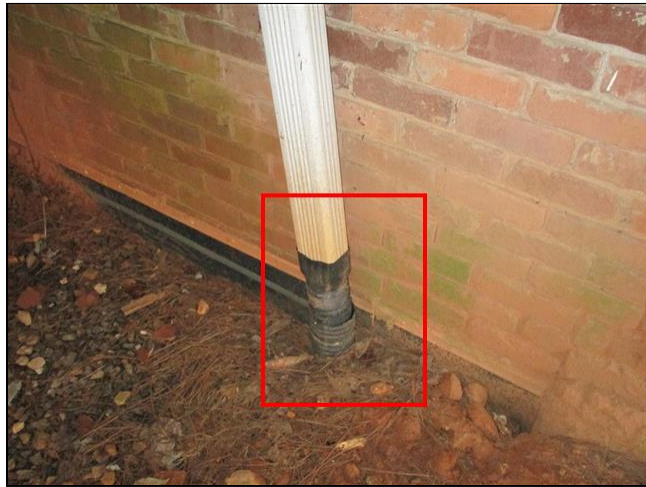
4.3 Item 1(Picture)

👉 (1) Have owner point out location of the outlets of the buried down spout extensions and yard drains. They should come to daylight and the ends were not found.

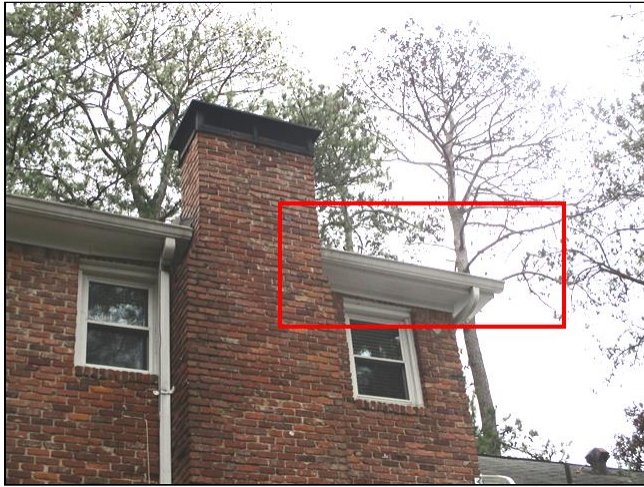
4.3 Item 4(Picture)

🔧 (2) Gutter shown in photo needs more slope towards the down spout to ensure adequate roof drainage.

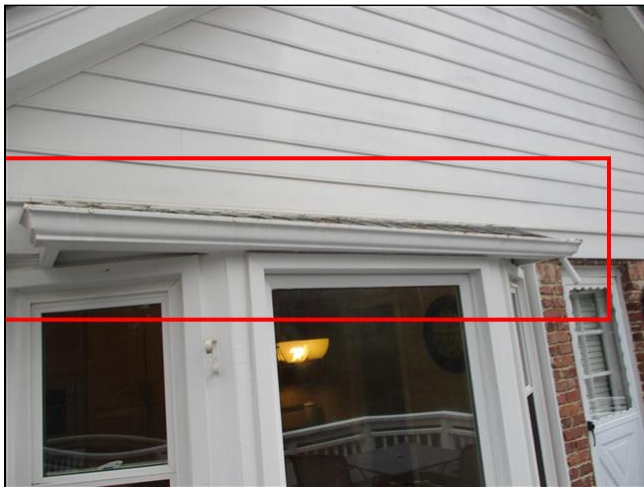
4.3 Item 5(Picture)

(3) Rear bay window gutter rusting out and need to be replaced in the near future. Gutters usually last about as long as a roof if they are kept clean.
-

🔧 (3) Rear bay window gutter rusting out and need to be replaced in the near future. Gutters usually last about as long as a roof if they are kept clean.

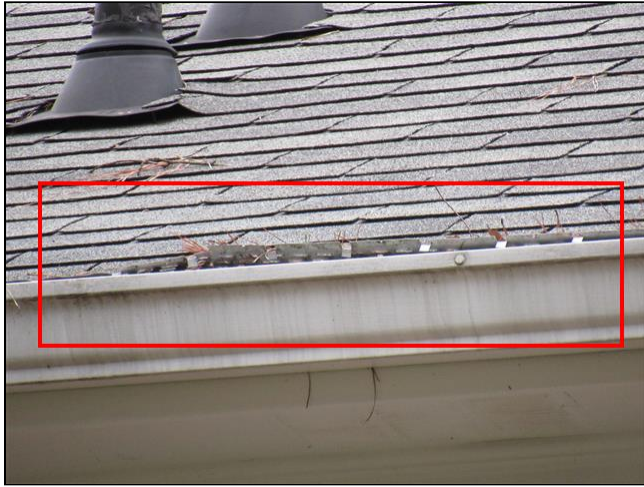
4.3 Item 14(Picture)

(5) Secure all loose/lifted gutter guards around the home. See photos for examples

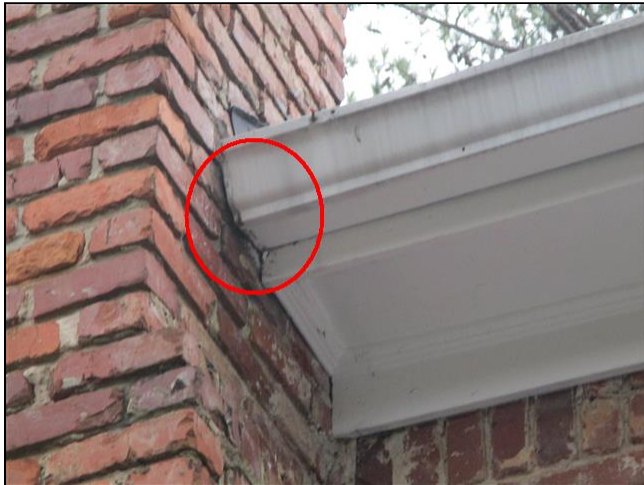
4.3 Item 15(Picture)

(6) Several leaks found in gutters at the seams. Seams need to be sealed to prevent further leaks. See photos for examples.
-

🔧 (6) Several leaks found in gutters at the seams. Seams need to be sealed to prevent further leaks. See photos for examples.

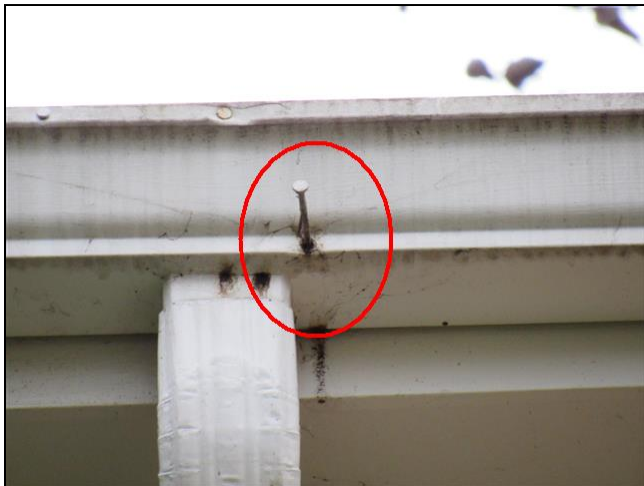
4.3 Item 18(Picture)

(8) Gutter spike has been installed through the bottom of the gutter at the rear right corner of the home. See photo. This can allow gutters to leak in this area. Have gutter contractor evaluate and repair/replace

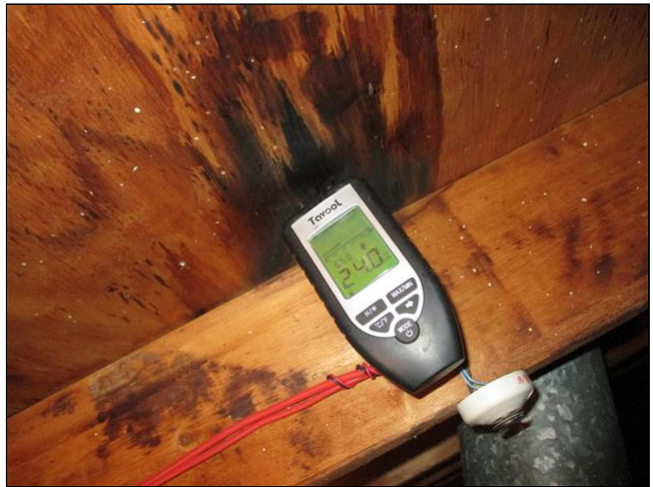
4.4 Item 8(Picture) high levels of moisture near the gas exhaust vent

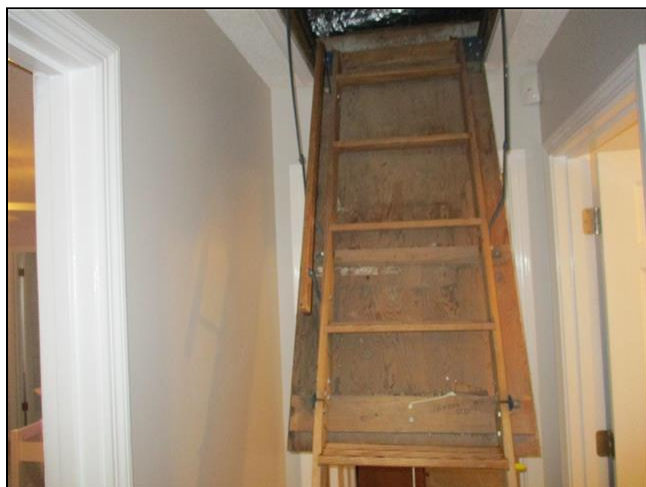
5.0 Item 1(Picture)

(1) Weather strip and insulation of some type (recommend foam board insulation) needed over the attic pull down steps.

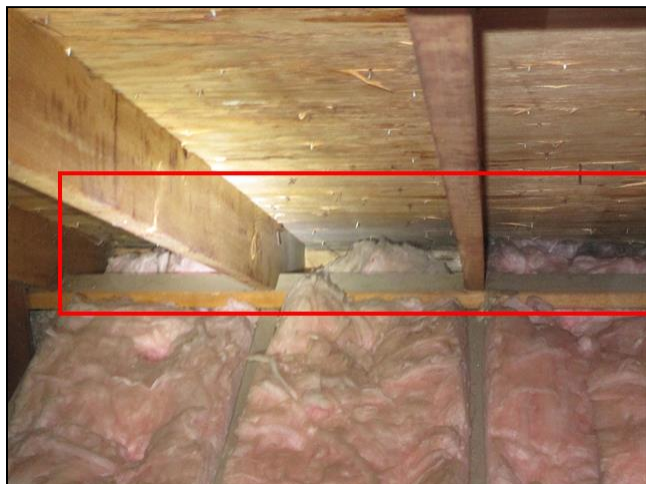
5.0 Item 2(Picture)

(2) Install missing baffles at all soffit vents in the attic to prevent insulation from covering the vents in the eaves.
-

🔧 (2) Install missing baffles at all soffit vents in the attic to prevent insulation from covering the vents in the eaves.

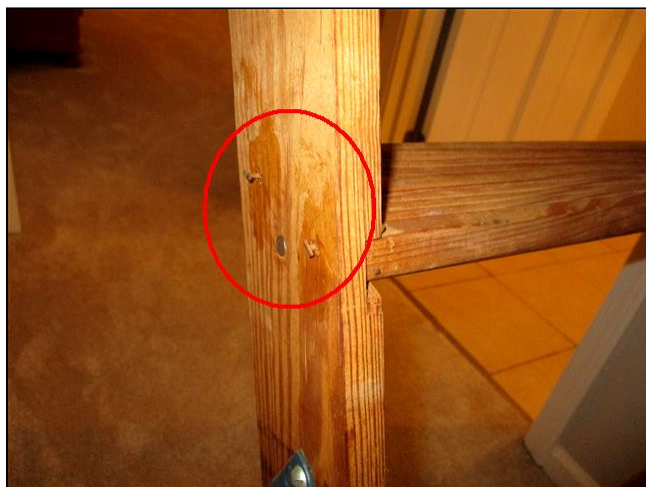
5.0 Item 4(Picture)

(3) Attic steps have had screws and nails come loose over time and poor repairs have been made in response. It is recommended to have a qualified contractor evaluate and make all repairs as needed to put attic steps in a safe condition
-

🔧 (3) Attic steps have had screws and nails come loose over time and poor repairs have been made in response. It is recommended to have a qualified contractor evaluate and make all repairs as needed to put attic steps in a safe condition

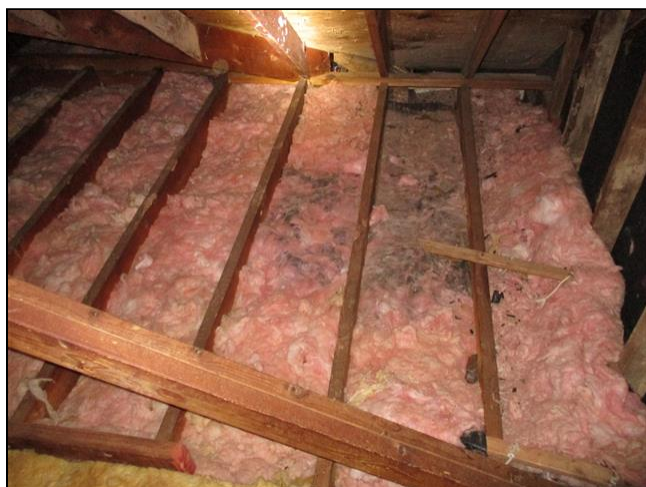
5.0 Item 8(Picture)

(4) Some areas of insulation in lower level attic has been soiled by rodents. It is recommended that it be removed and replaced with an amount equal to R-30 after the rodent entry issue has been resolved

🐭 (4) Some areas of insulation in lower level attic has been soiled by rodents. It is recommended that it be removed and replaced with an amount equal to R-30 after the rodent entry issue has been resolved

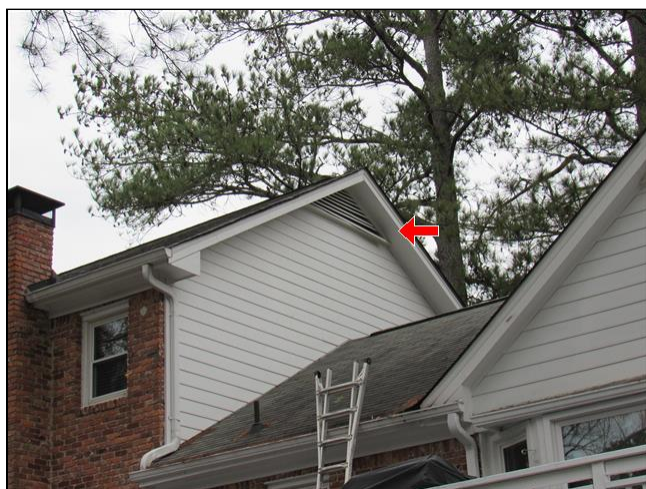
5.3 Item 1(Picture)

Secure loose gable vent slats at the left side upper level gable vent seen in photo

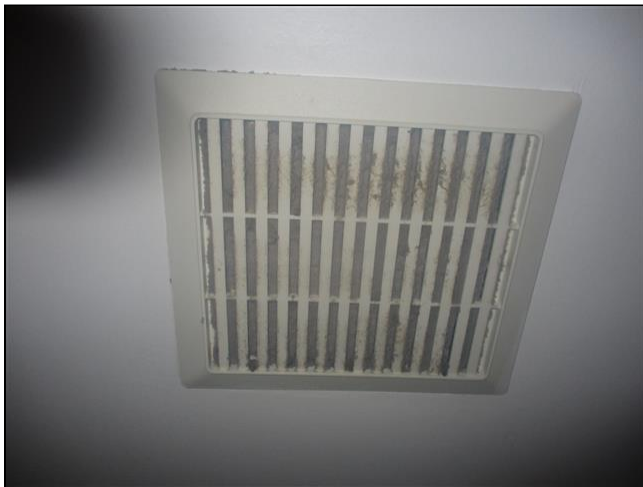
5.4 Item 2(Picture)

(2) Clear all debris out of the bath exhaust vents so they will operate properly

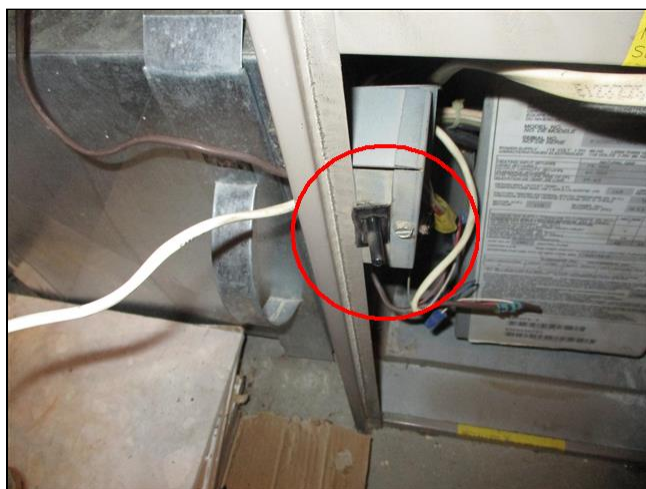
🔧 (3) The basement level furnace was running when first turned onto heat mode. But after removing cabinet doors to inspect interior of furnace unit, the blower door switch was found to be defective and would not shut off the unit. Upon reaching desired heat temp in home the unit turned off, but would not fire again when temperature on thermostat was increased to try and test temperatures. Have hvac tech evaluate and make any repairs as needed

6.0 Item 4(Picture) blower door switch

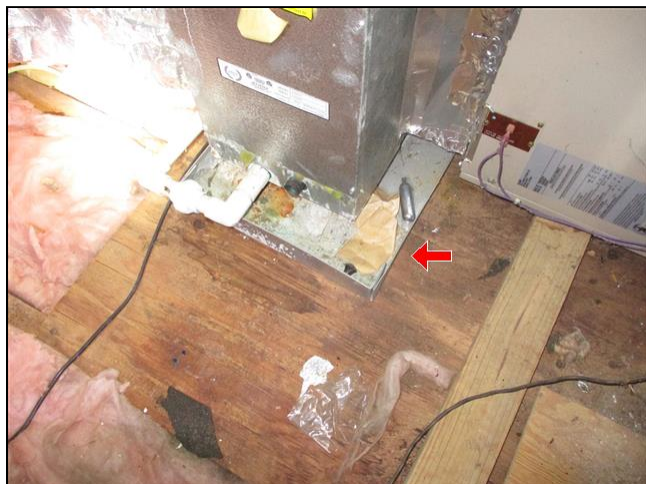
6.0 Item 5(Picture)

(4) Strongly recommended to have a float switch installed in the attic furnace drain pan to act as an emergency shut off in case of moisture/water collecting in the pan.

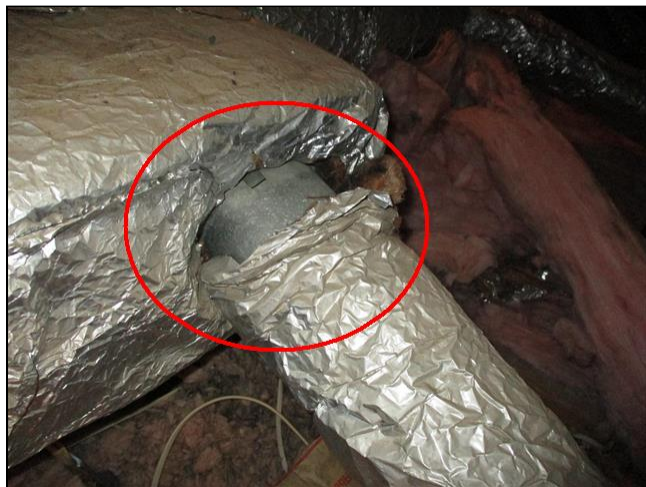
6.2 Item 2(Picture)

- 🔧 (2) One of the ducts in the rear of the attic is disconnected from its supply vent, and is venting conditioned air into the attic space. Have hvac tech evaluate and repair.

There are also gaps felt in the plenum allowing conditioned air to escape into the attic space as well. HAVe hvac tech evaluate and repairs

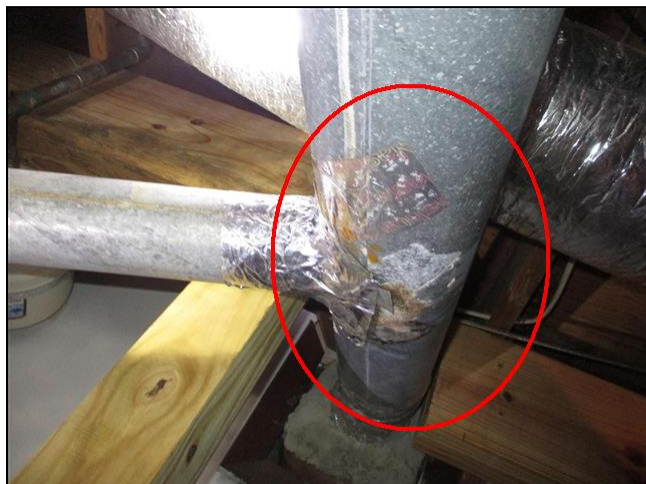
6.4 Item 1(Picture)

- 🔧 Rust and corrosion noted on the gas exhaust vent pipe in the basement. Have an hvac tech evaluate and repair/replace as needed

🔧 Rust and corrosion noted on the gas exhaust vent pipe in the basement. Have an hvac tech evaluate and repair/replace as needed

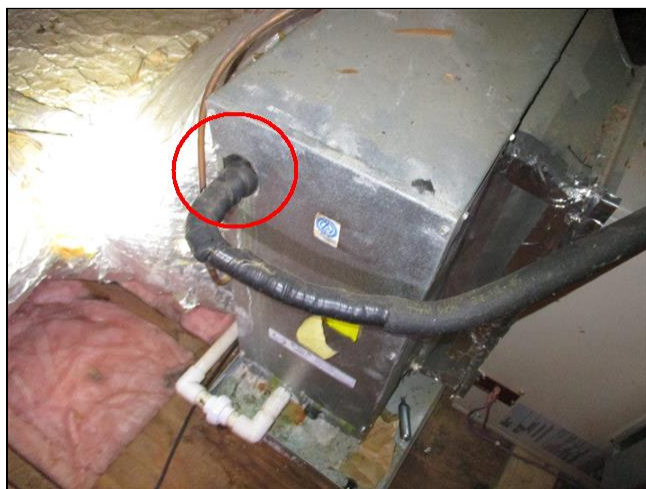
6.7 Item 1(Picture)

🔧 (1) Seal the holes in the evaporator coils where the A/C lines enter the unit in the attic.

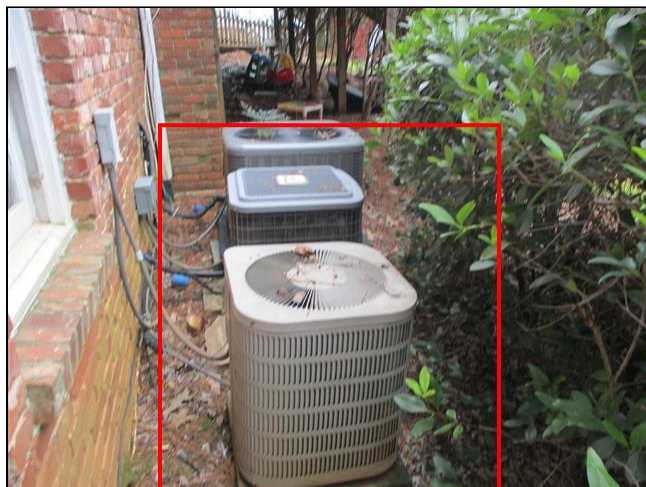
6.7 Item 2(Picture)

These two older A/c units use the older R-22 type of refrigerant gas (freon) that is being phased out of production and will likely be expensive and difficult to find in the near future. The newer type of freon does not mix with the older type.

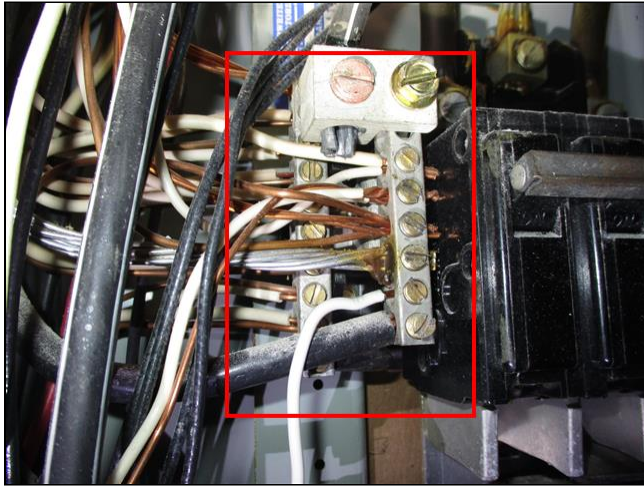
7.2 Item 4(Picture)

🔧 (4) There are multiple wires per hole in the terminal bars in the main panel. It is recommended that the wires be spread out so that one wire is utilized per hole. Have electrician evaluate and correct as needed.

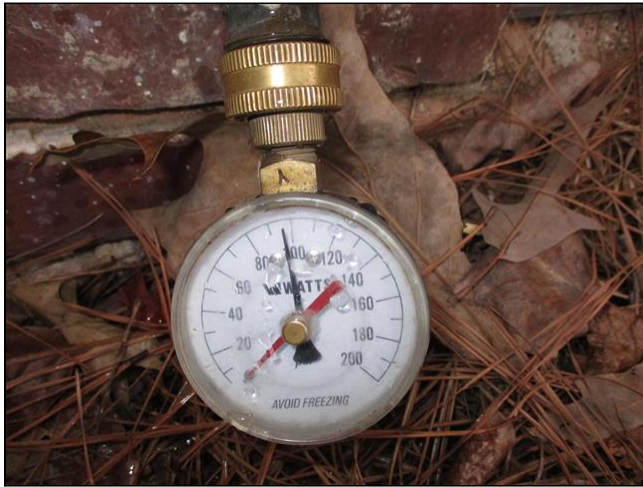
8.1 Item 1(Picture)

🔧 Have plumber check pressure reducing valve and adjust/replace as needed. Pressure was over 95-100 psi when tested at the rear and left side hose bibbs. High water pressure can have an adverse affect on plumbing fixtures, dishwashers, water heaters, washing machines, ect... Maximum pressure is typically 80 psi.

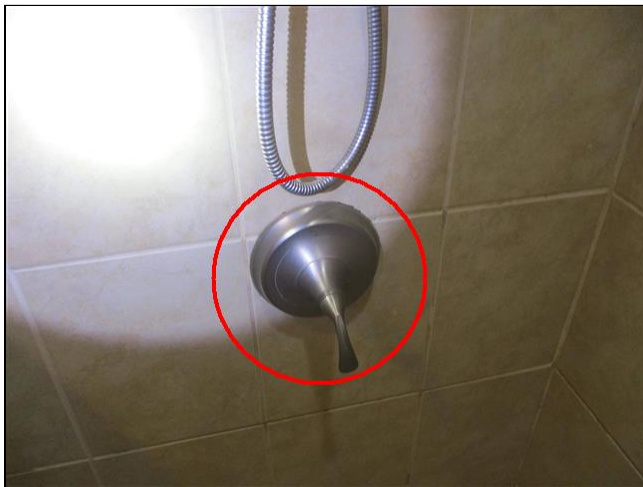
8.2 Item 1(Picture)

(1) Seal gaps around plumbing fixtures in shower stalls to help prevent water entry into the wall cavity behind.

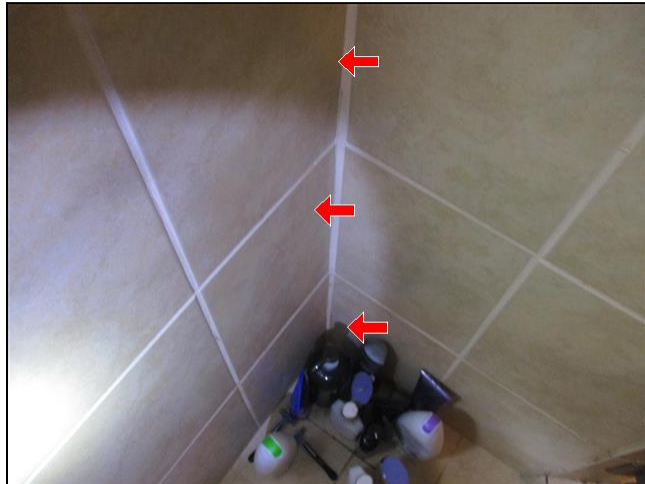
8.2 Item 2(Picture)

(2) Touch up grouting needed between tiles in bathroom shower stalls. Water can enter into the tile and get into wall. Condition of framing behind tiles in baths is unknown.

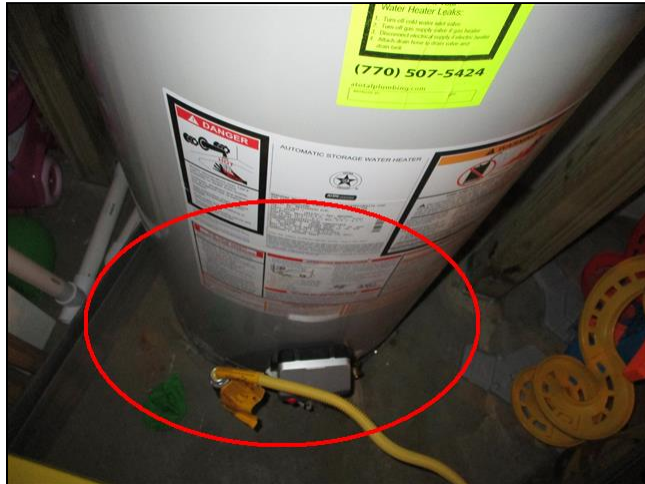
8.3 Item 2(Picture)

(2) It is recommended to install a drain pan underneath the water heater in the basement, as it is located in an area where any future leaks can cause damage to the finished areas nearby.

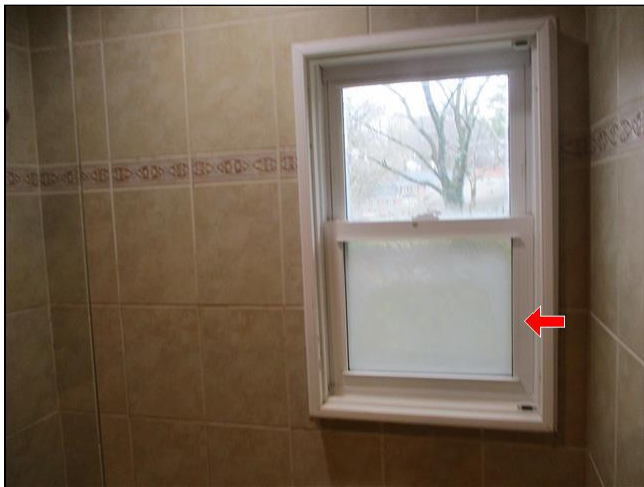
9.5 Item 4(Picture)

🔧 (2) Replace all fogged glass in house that are pictured in photos. The seal between the panes of glass has failed allowing moisture to enter between the panes. It is possible that more may fog in the future. Have window contractor evaluate all windows.

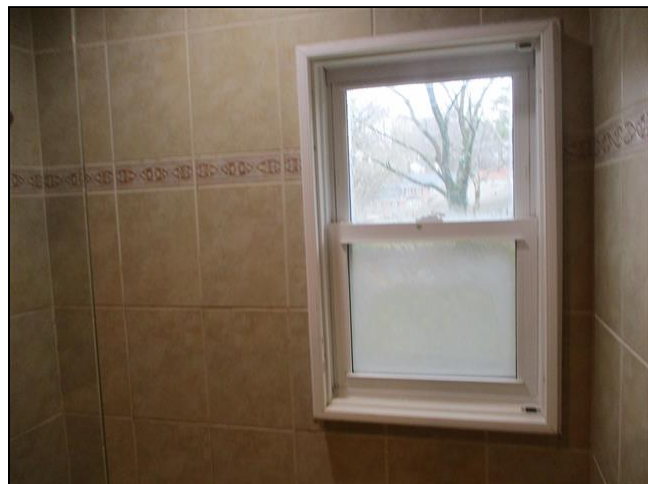
9.6 Item 1(Picture)

Windows are present in the walls of the showers. The seal and paint around the windows needs to be maintained to prevent water damage. This is part of general maintenance.
