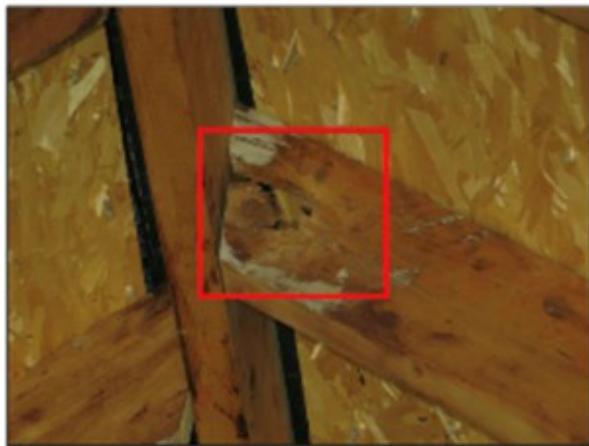
5.0(1) ROOF FRAMING (Picture
1) Hole in frame member

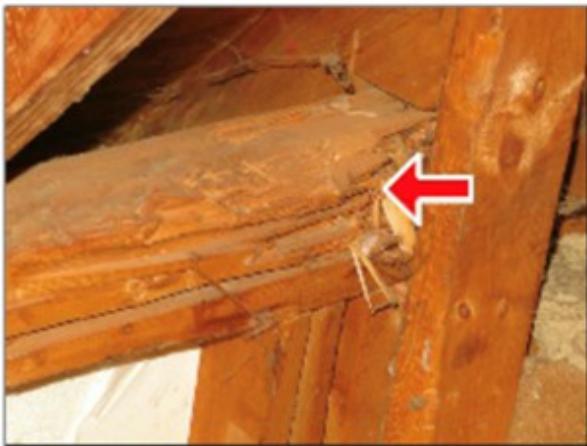
5.0(2) ROOF FRAMING (Picture
1) Damaged framing
