Atlanta Property Inspections, Inc.

HOME INSPECTION REPORT

2150 Weldonberry Drive, Brookhaven, GA 30319
Inspection prepared for: Salena Barnes
Date of Inspection: 12/21/2019 Time: 9:30
Age of Home: 12 Years Old (2007) Size: 1845 SF
Weather: Rainy, Wet Soil, 45 Degrees

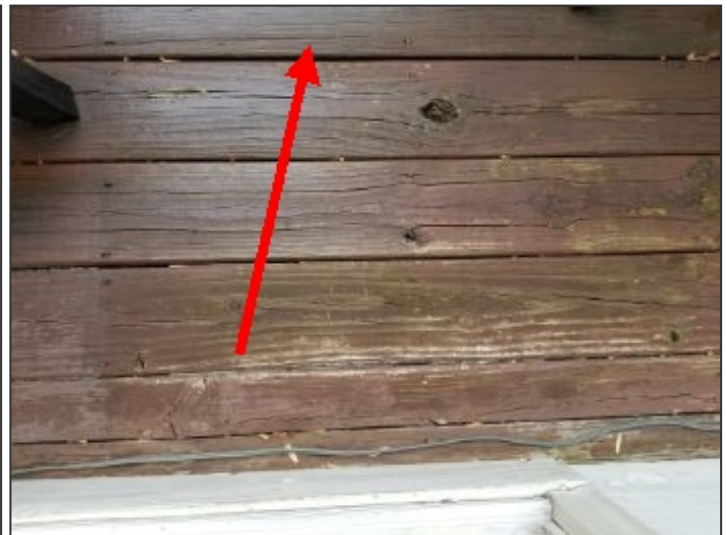
- A wood deck is present at the rear.
- Wood guard railings are present.
- The rear deck appears to be serviceable overall, no concerns were noted except as listed below:
- A deck surface board is damaged near the entry door (see photo). Replacement of the damaged deck board is suggested.

Damaged deck surface board

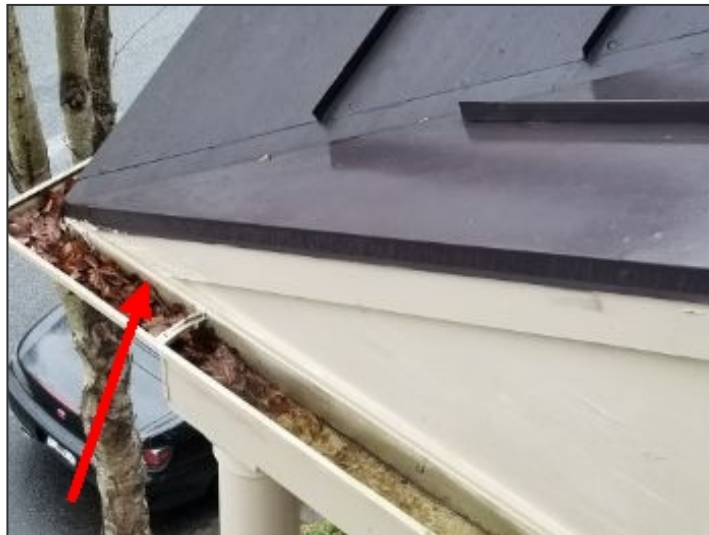
- **Damaged wood trim was noted at the right corner of the porch roof just above the gutter (see photo). Replacement of the affected wood trim is recommended.**

Damaged wood trim at right corner of porch roof

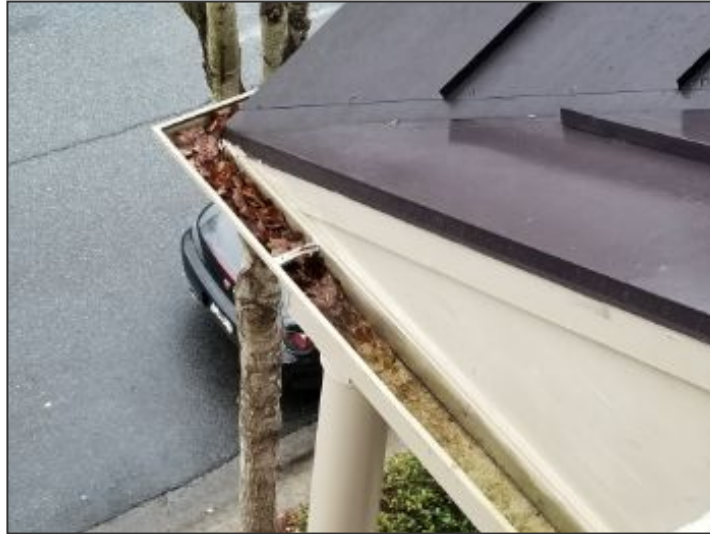
• **The gutters are full of debris at the front porch roof (see photo). Gutter cleaning is recommended so that the gutters can drain correctly.**

Gutter debris at front porch roof

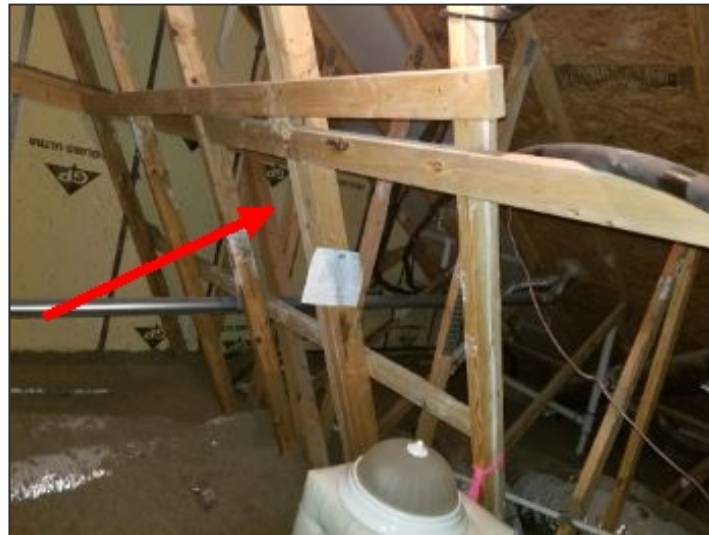
• **An engineered roof truss has been cracked, broken or damaged next to the attic pull down ladder (see photo). The truss has been partially braced but the repair does not appear to be adequate. This type of repair is most often completed by installing full size bracing on both sides of the damaged truss member for the full length of the truss. Further evaluation is advised by an engineer or a truss design professional to determine the full extent of repair needs and to prescribe the repair specifications to meet all structural loads. It is suggested that a copy of the repair design and certification be posted in the attic, in a plastic bag, and stapled to the repaired truss member. In addition, client may want to keep a copy of the original for disclosure when selling the home in the future and pass it on to the home buyers.**

Damaged roof truss in attic partially braced

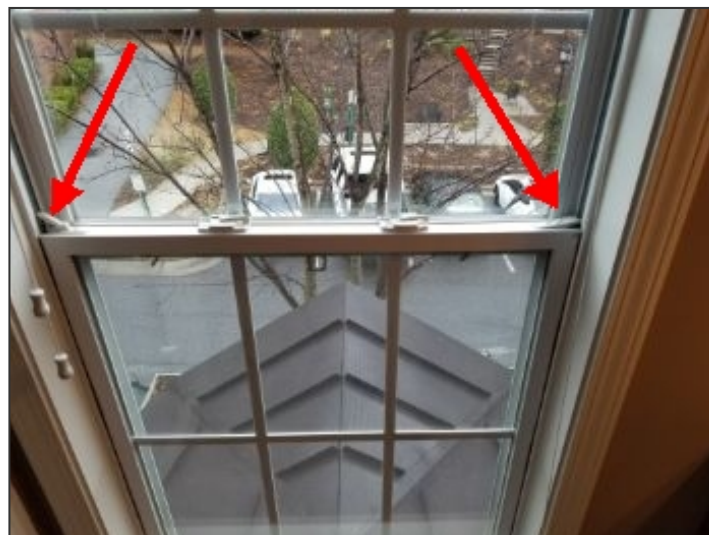
- Vinyl clad frames with double pane glass.
- **The overall condition of the windows is OK except as noted below:**
 - **The exterior coating of the left master bedroom window appears to be defective - the surface of the glass has a splotchy / streaky appearance that is not considered normal and can not be removed with cleaning. Although the window appears to be operating normally, this is a noticeable cosmetic defect. Further evaluation is recommended by a professional window replacement contractor to determine the full extent of repair needs and costs.**
 - **The tilt-out locks are damaged at the front bathroom window, and the left side of the kitchen window (see photo). Replacement of the tilt-out locks is recommended.**

Damaged tilt-out lock at front upstairs bathroom window

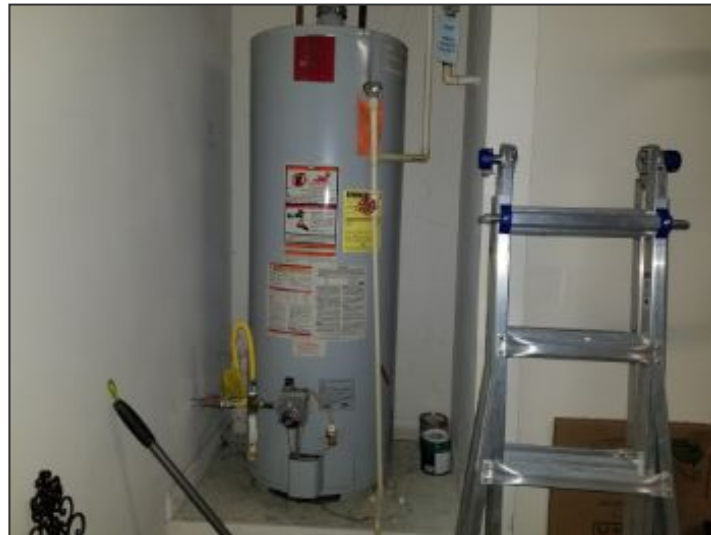
• No thermal **expansion tank** or valve is present. The expansion tank or valve may not have been required at the time of this installation but is required now by local plumbing codes. Client should budget for an additional \$100 - \$200 for an expansion tank or valve when the water heater is replaced.

Water heater located in garage

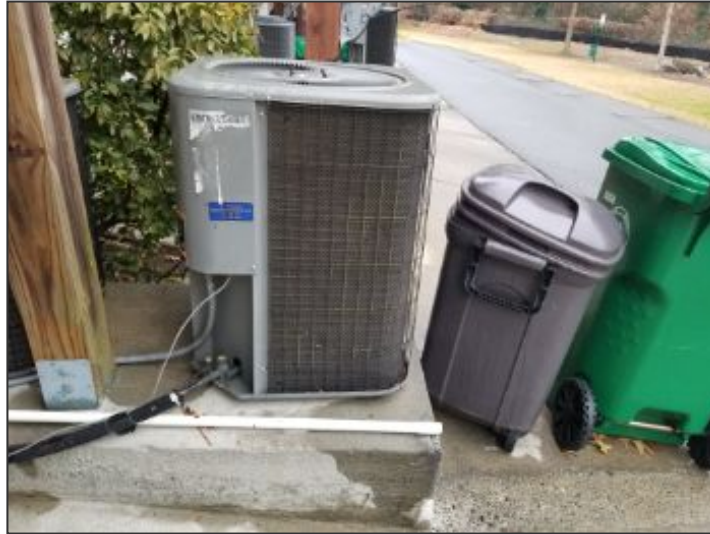
• **AGING EQUIPMENT - BUDGET FOR REPLACEMENT:**

Main floor and lower level AC unit

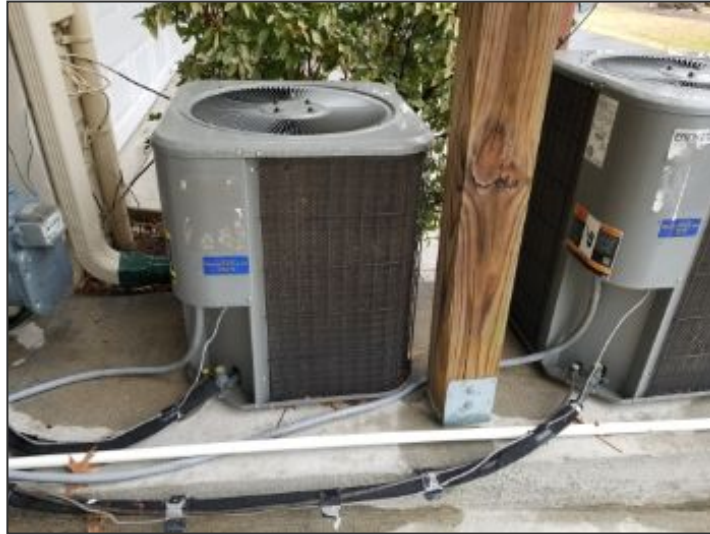
Second floor AC unit
