Inspection Report

**Property Address:
1145 Haven Brooks Ln NE
Atlanta Ga 30319**

Inspector: Brandon Williams

Date: 2/26/2020	Time:	Report ID: 80220
Property: 1145 Haven Brooks Ln NE Atlanta Ga 30319	Customer: Emily Mason	Real Estate Professional: Michael Hermance Keller Williams

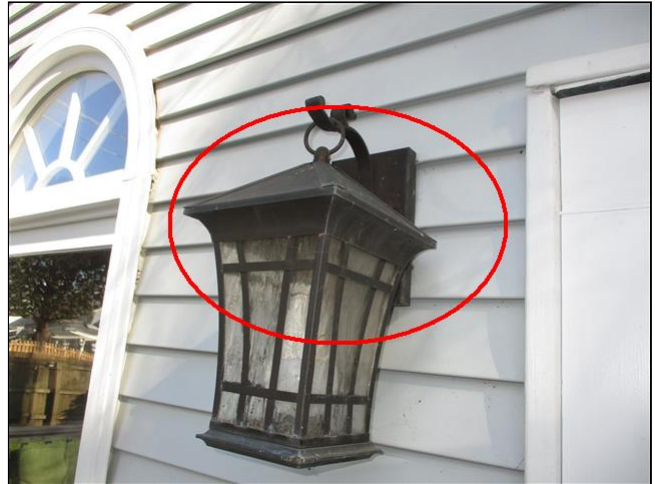
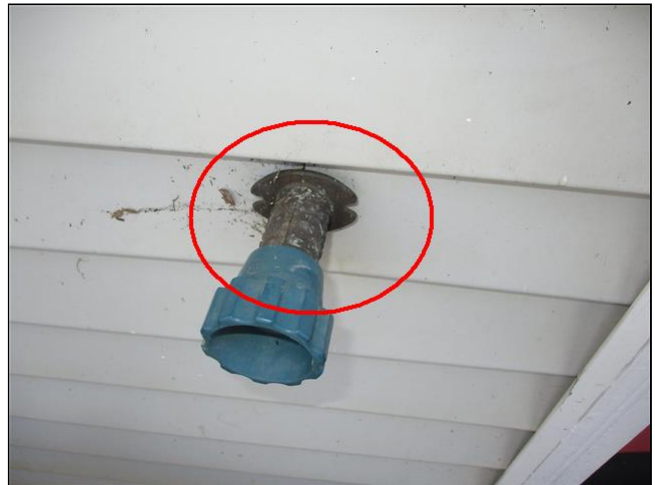
Seal all vent caps to exterior siding to prevent leaks into wall cavities. See photo (s).

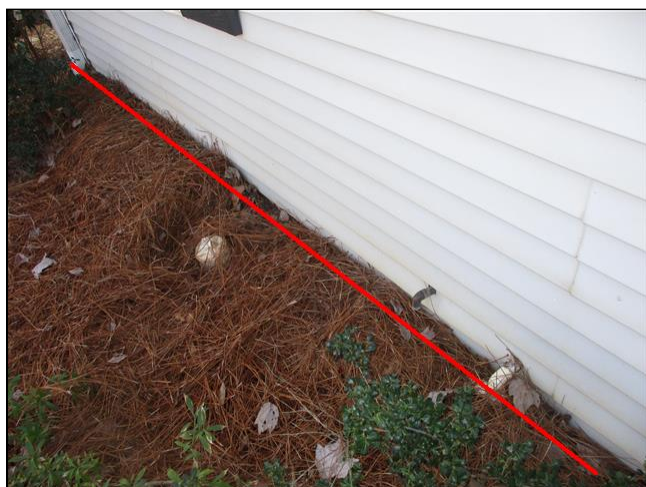
1.1 Item 7(Picture)

🔧 (2) The soil is too close to the last pieces of lap siding front and right side of the home. This could be an avenue for possible termite infestation. Have all soil pulled away from the last pieces of lap siding at least 4-6 inches.

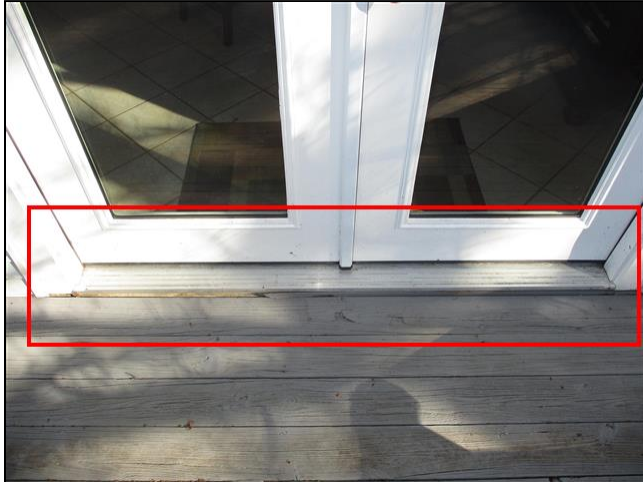
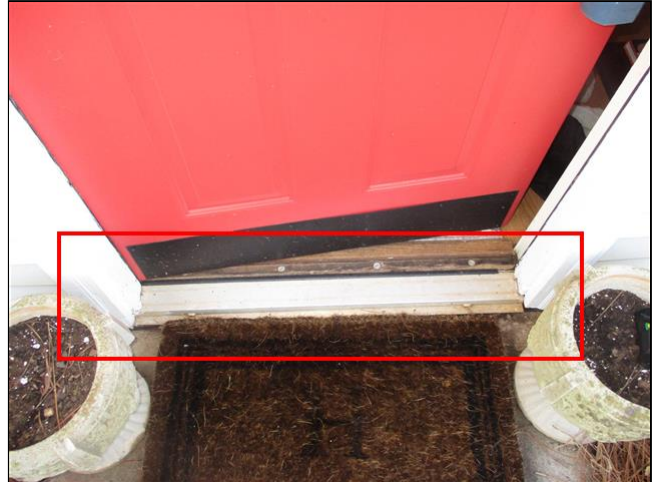
(1) Seal the gaps between the metal threshold, lower parts of side jams, and the lap siding at the bottom of the exterior doors. This is part of general maintenance and should be performed every few years as needed.

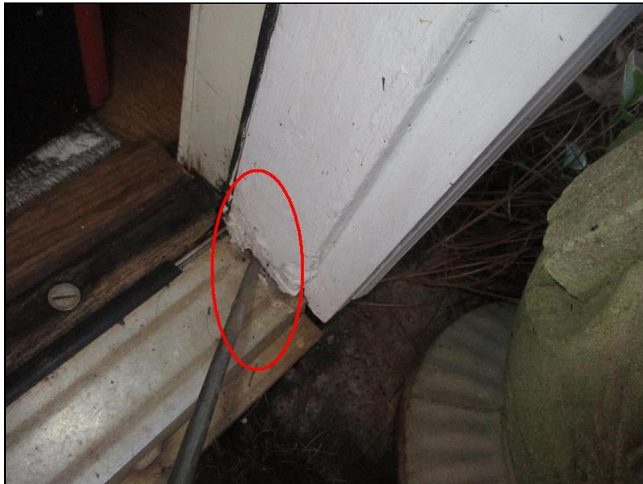
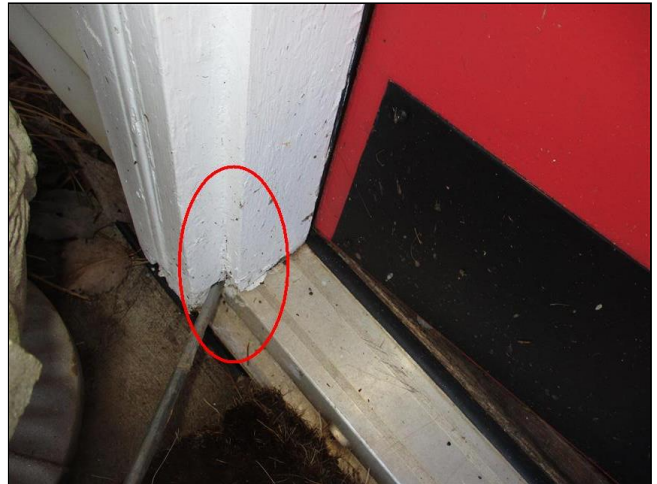
(2) Minor rot damage on the lower part(s) of the front door. Repair or replace damaged wood. See photo(s). There have been past repairs made here and it should be expected that more damage will occur in the future.

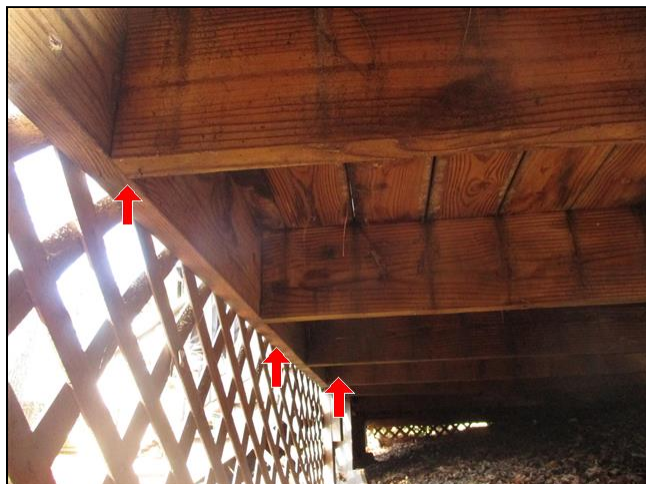
1.4 Item 1(Picture)

(1) Hanger brackets needed on the ends of the deck joist noted in the photos. Hanger brackets make a stronger connection and are required for better support.
-

🔧 (1) Hanger brackets needed on the ends of the deck joist noted in the photos. Hanger brackets make a stronger connection and are required for better support.

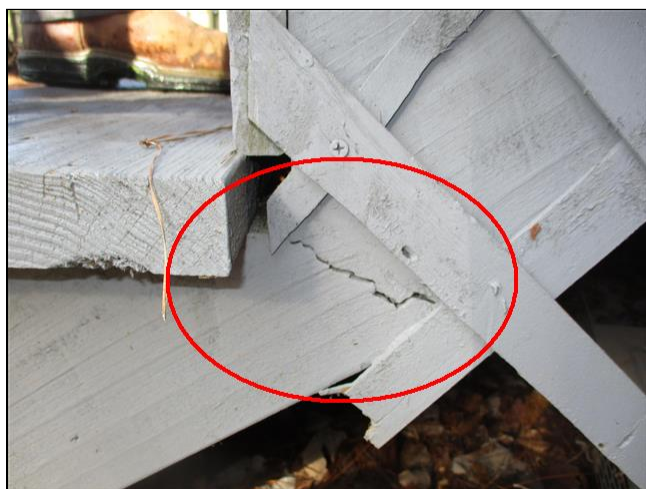
1.4 Item 2(Picture)

(2) Guard rails on rear deck are loose and need additional bracing and/or fasteners to reduce the amount of movement on the rails. See photo for location.
-

(3) Crack noted on stair stringer to rear of deck. No movement noted when stepped on, but it is recommended to have repairs made to prevent future issues with the stair stringer
-

🔧 (2) Guard rails on rear deck are loose and need additional bracing and/or fasteners to reduce the amount of movement on the rails. See photo for location.

🔧 (3) Crack noted on stair stringer to rear of deck. No movement noted when stepped on, but it is recommended to have repairs made to prevent future issues with the stair stringer

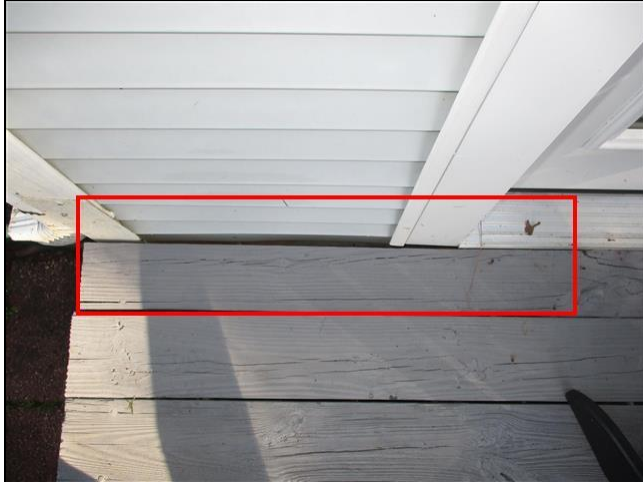
1.4 Item 3(Picture)

(5) No metal flashing could be seen between the rear deck and the rear wall. This was not often enforced or required in older homes, but flashing makes a better seal between the deck and house. Condition of framing between deck and house is not known.

🔧 (5) No metal flashing could be seen between the rear deck and the rear wall. This was not often enforced or required in older homes, but flashing makes a better seal between the deck and house. Condition of framing between deck and house is not known.

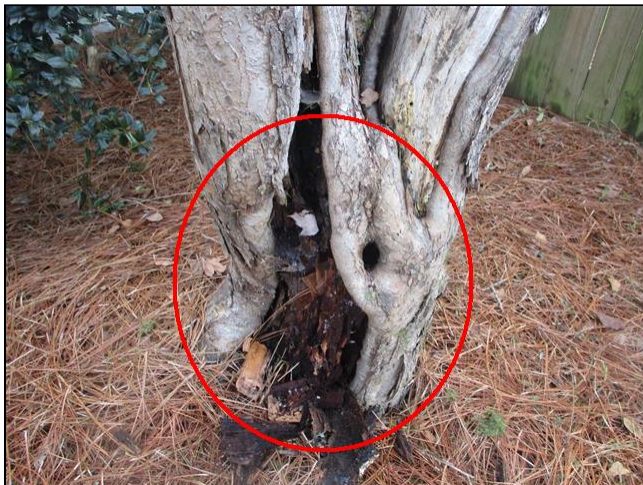
1.5 Item 5(Picture)

(3) Tree at right side of home is decaying and rotting. Recommend having this removed. See photo.

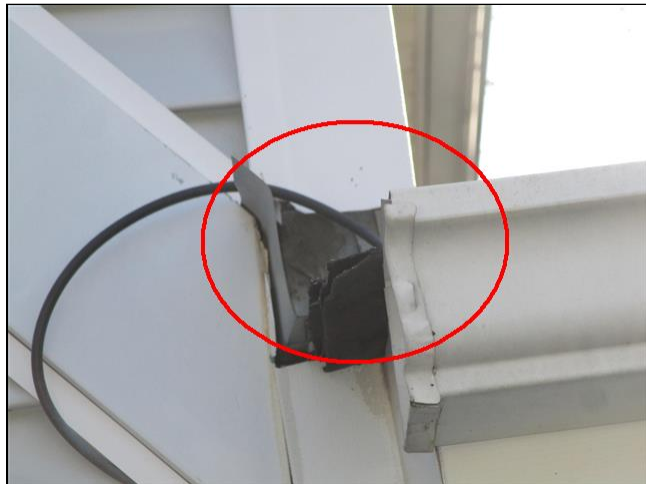
1.7 Item 1(Picture)

Trim at right rear of home, above the lower level roof, is missing at the bottom. The area is flashed, but it is recommended to have a qualified contractor evaluate and make all repairs as needed

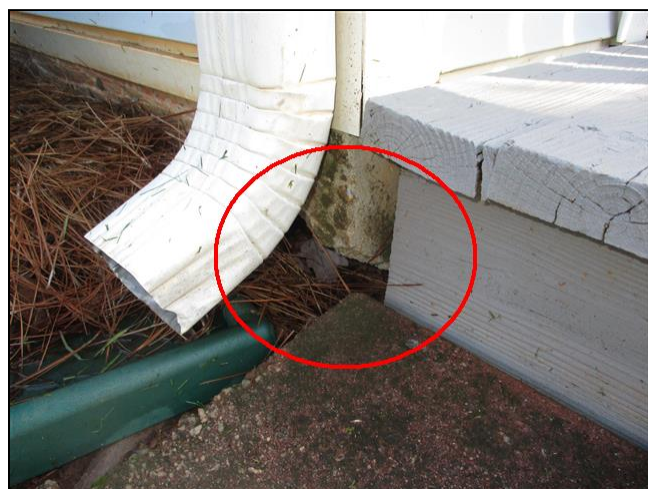
3.0 Item 1(Picture)

- 🔧 Minor erosion noted under the foundation/slab at the rear right corner of the home, no settlement was noted in the slab or home at time of inspection. Recommend backfilling and compacting. Gutter extensions should be install to prevent this.
-

🔧 Minor erosion noted under the foundation/slab at the rear right corner of the home, no settlement was noted in the slab or home at time of inspection. Recommend backfilling and compacting. Gutter extensions should be install to prevent this.

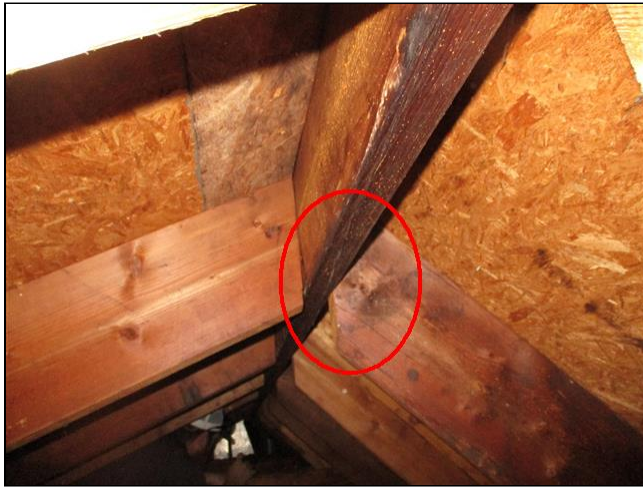
3.5 Item 1(Picture)

(1) Several rafters do not have full bearing on the ridge beam at the peak of the roof. Wood to wood contact between the rafters and ridge will make a stronger frame. Blocking or brackets can be installed to bridge gap. See photo(s).

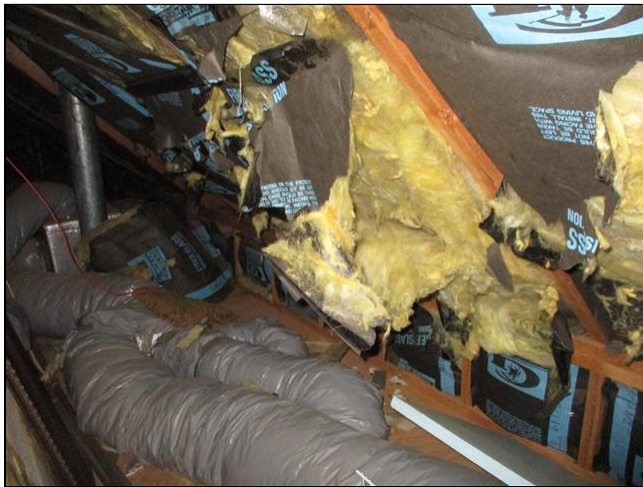
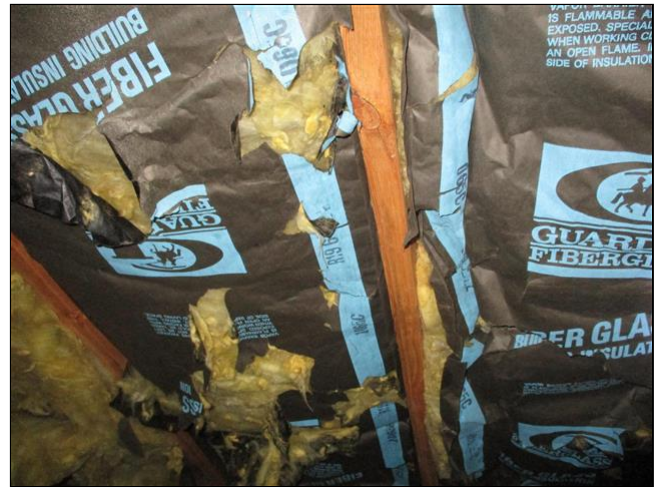
(2) Insulation between roof rafters in the front crawl in attic limited view of roof framing and roof decking. It was not all removed for inspection and this prevented a visual of the entire roof framing system in the front attic. It is possible that some defects are hidden or not in view during this inspection.

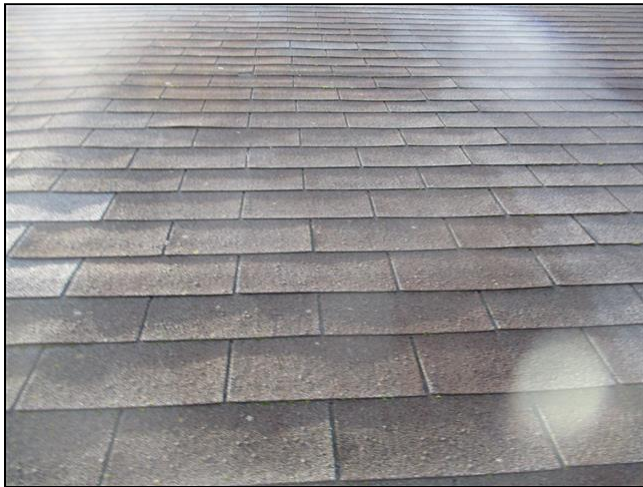
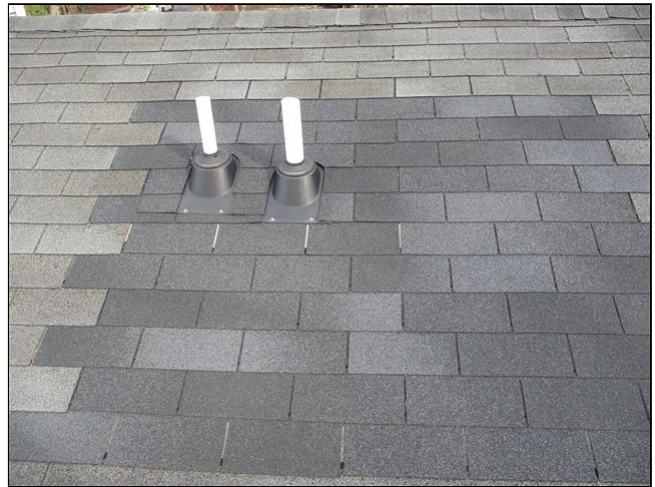
(1) Shingles on the roof are the 3 tab type with a life expectancy of about 15-20 years (depending on conditions) and the shingles are showing signs of age and wear. Some shingles have lost granules and some shingle mats are getting brittle. As the roof continues to age, it may begin to leak.

Past repairs made in areas, repairs are adequate

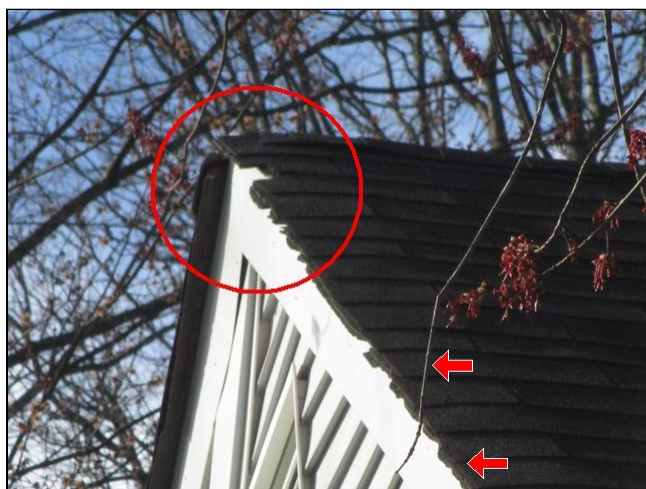
4.0 Item 4(Picture)

(2) Have roofer replaced the damaged shingles at the left side roof at the ridge line.

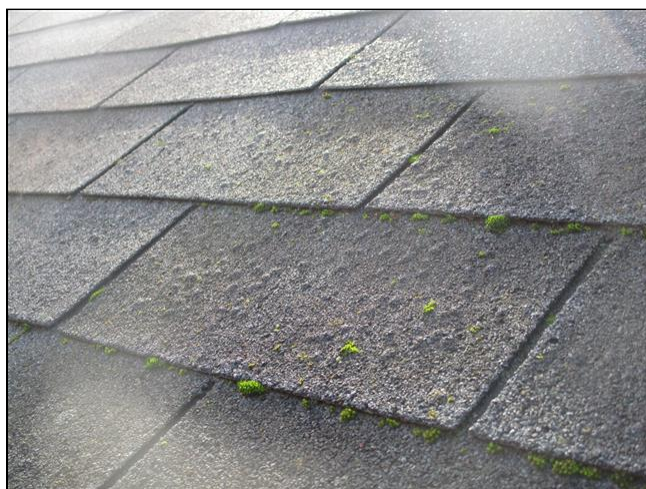
4.0 Item 6(Picture)

- 🔧 (2) Have roofer replaced the damaged shingles at the left side roof at the ridge line.
- 🔧 (3) The lower part of the roof on the front of the home is blistering. Likely due to lack of ventilation in lower attic. Have roofer evaluate and make any repairs/replace as needed.

(3) The lower part of the roof on the front of the home is blistering. Likely due to lack of ventilation in lower attic. Have roofer evaluate and make any repairs/replace as needed.

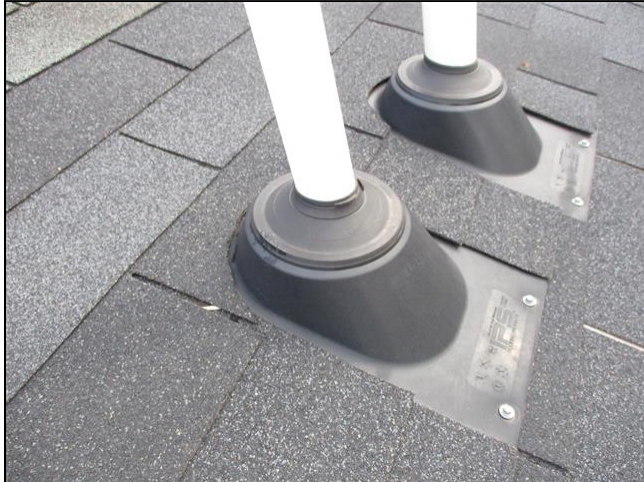
4.2 Item 1(Picture)

(1) Boot flashing around plumbing vents on the roof are ok now, but these last about 5-7 years before needing replacement. They crack and split and allow rain water to leak into attic.

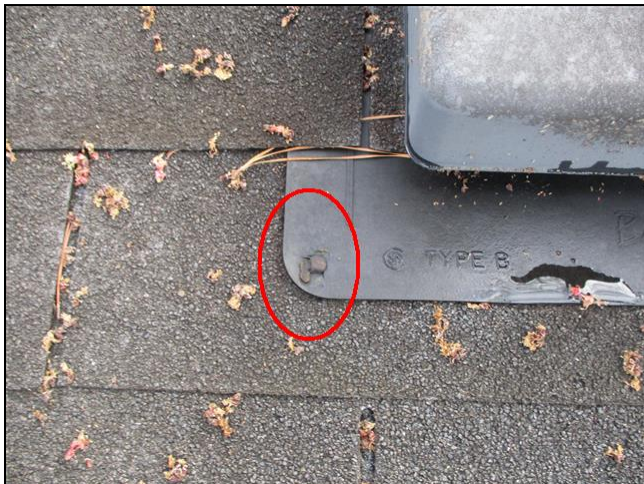
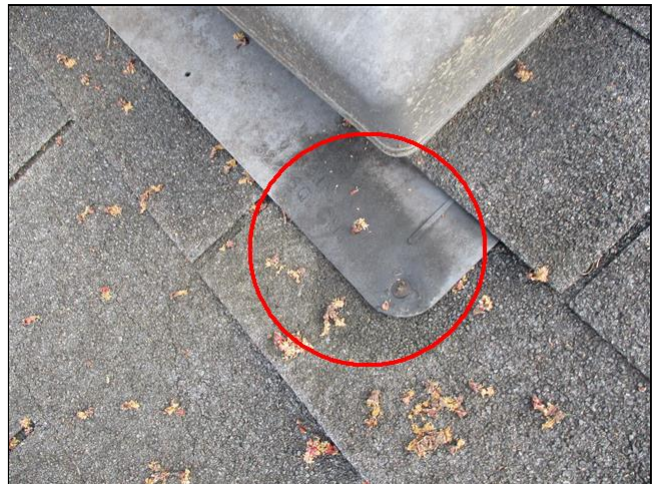
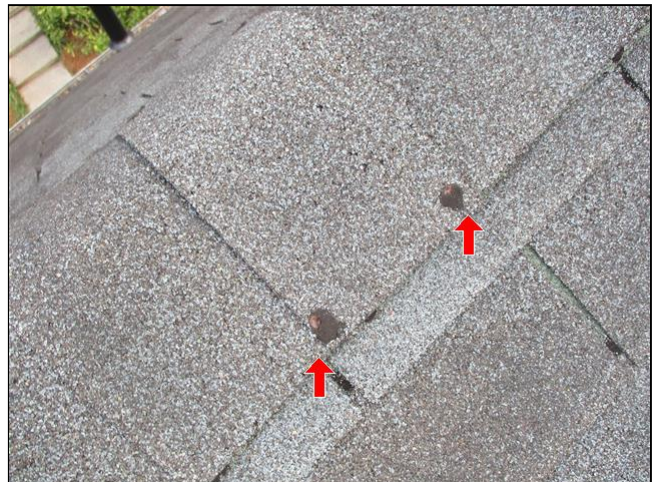
- 🔧 (2) Seal all exposed nail heads with tar or other type of sealant on the roof vents and exposed nail heads on the boot flashing. This will help prevent leaks.
- 🔧 (3) Chimney chase caps are metal and are somewhat dome shaped when new so they can shed water. Cap is now bowl shaped and is rusting. See photo. These last about 20-25 years. Have roofer/chimney sweep evaluate and make repairs as needed

(2) Seal all exposed nail heads with tar or other type of sealant on the roof vents and exposed nail heads on the boot flashing. This will help prevent leaks.

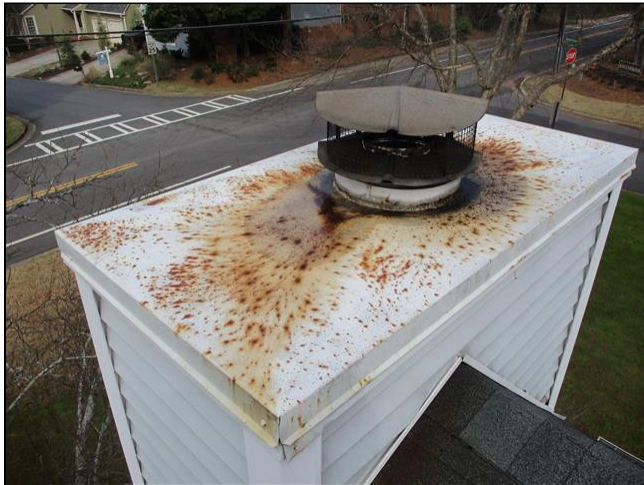
4.2 Item 6(Picture)

🔧 (3) Chimney chase caps are metal and are somewhat dome shaped when new so they can shed water. Cap is now bowl shaped and is rusting. See photo. These last about 20-25 years. Have roofer/chimney sweep evaluate and make repairs as needed

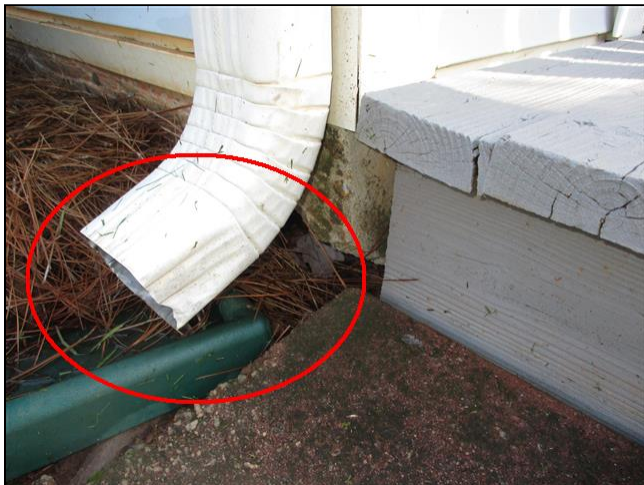
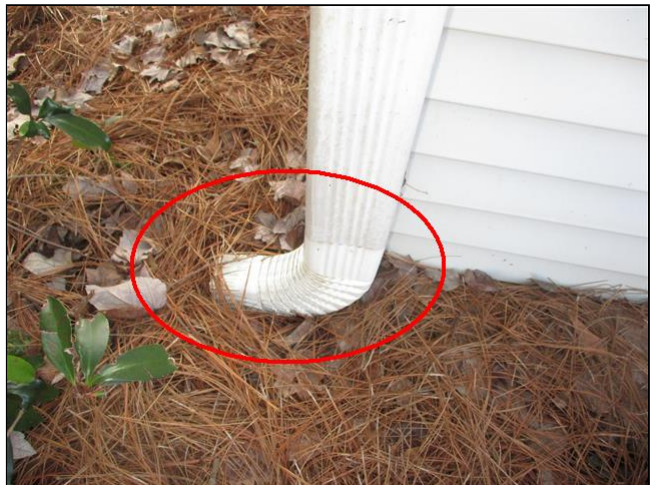
- 🔧 (1) Install all missing downspout extensions at the ends of the downspouts. All roof water should drain at least 5 feet away from the home.
- 🔧 (2) The gutters are full of debris in areas and needs to be cleaned. The debris in gutters can also conceal rust, deterioration or leaks that are not visible until cleaned, and I am unable to determine if such conditions exist.
- 🔧 (3) Gutter guards are recommended over the gutters to prevent leaves from clogging gutters. Over flowing gutters often cause water damage on siding and trim, and cause water entry into walls and basements.

🔧 (1) Install all missing downspout extensions at the ends of the downspouts. All roof water should drain at least 5 feet away from the home.

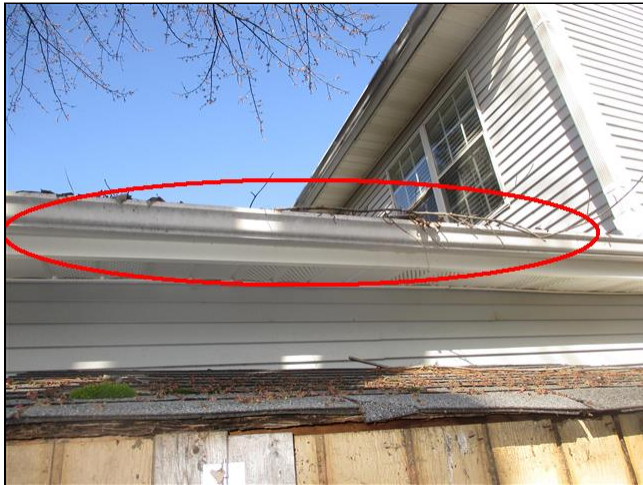
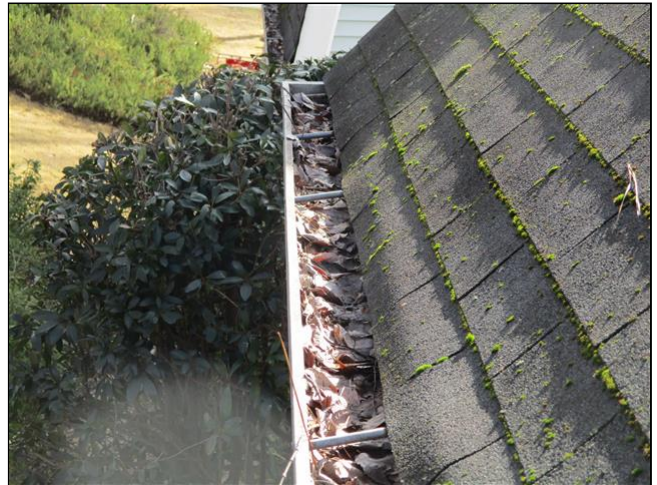
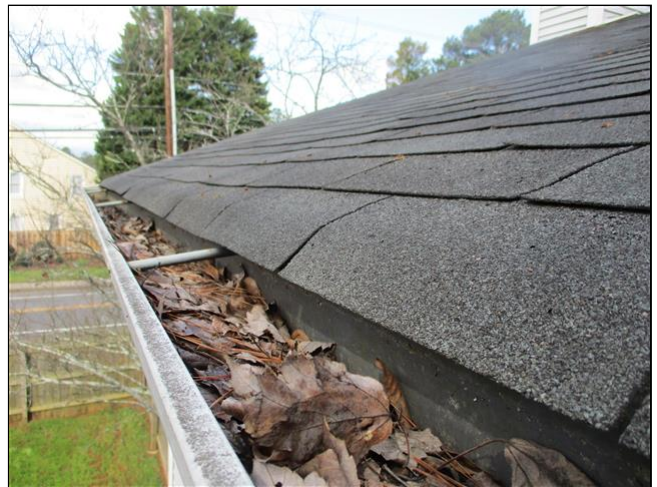
🔧 (2) The gutters are full of debris in areas and needs to be cleaned. The debris in gutters can also conceal rust, deterioration or leaks that are not visible until cleaned, and I am unable to determine if such conditions exist.

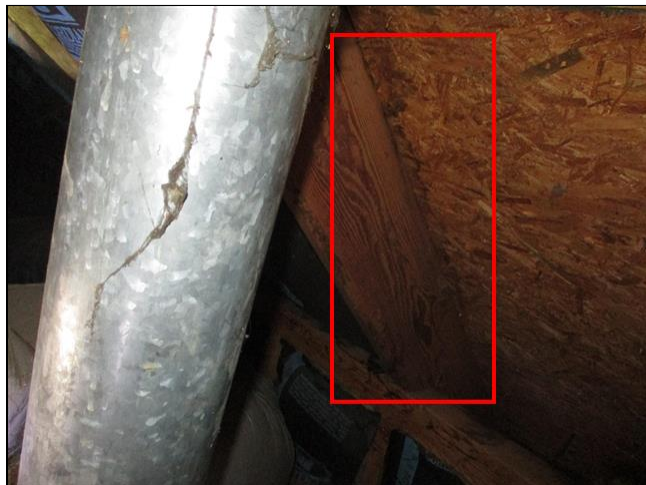
- 🔧 Water stains and possible slight damage noted in the roof decking in the attics in a couple areas. Roofer will need to evaluate roof and ensure that it is water tight. Even though these areas were not wet during the inspection, it is possible that outdoor and weather conditions could cause leaks to become active again. See photo(s) for examples of location(s).
-

Water stains and possible slight damage noted in the roof decking in the attics in a couple areas. Roofer will need to evaluate roof and ensure that it is water tight. Even though these areas were not wet during the inspection, it is possible that outdoor and weather conditions could cause leaks to become active again. See photo(s) for examples of location(s).

4.4 Item 1(Picture) lower attic

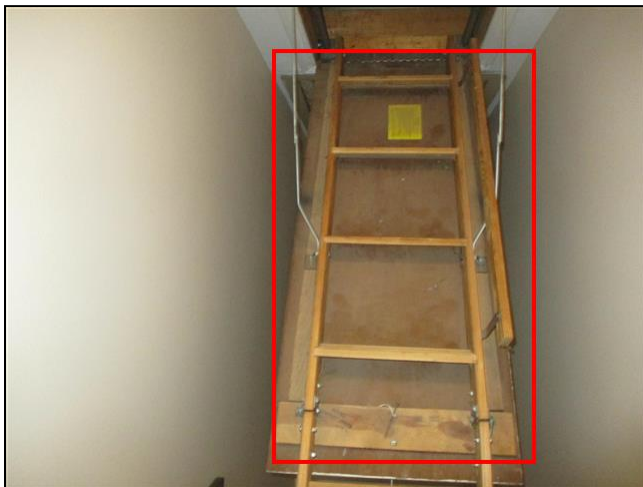
5.0 Item 1(Picture)

(1) Weather strip and insulation of some type (recommend foam board insulation) needed over the attic pull down steps.

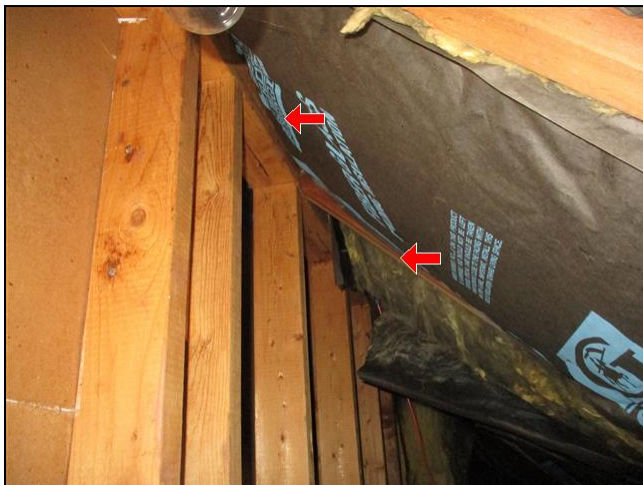
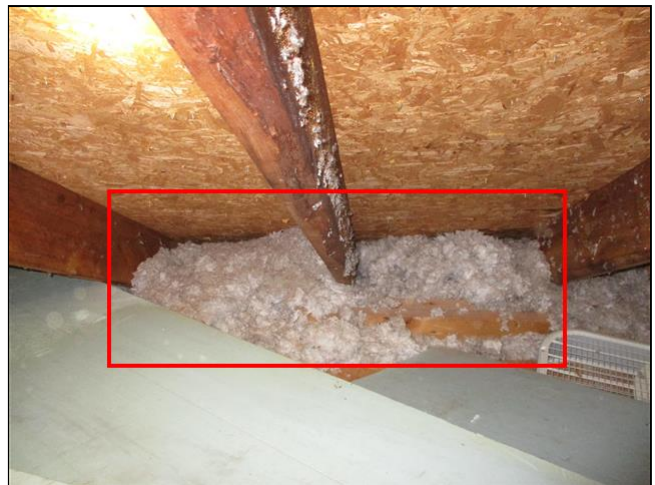
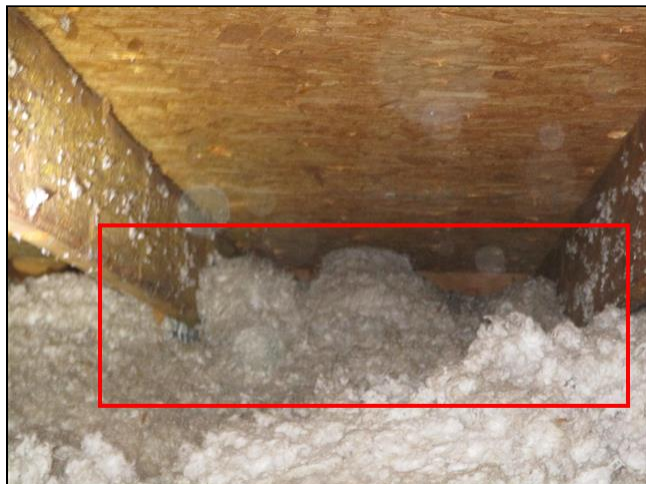
- 🔧 (2) Install missing baffles at all soffit vents in the attic to prevent insulation from covering the vents in the eaves. Majority of the roof eaves were blocked and restricting air circulation in the attic

(2) Install missing baffles at all soffit vents in the attic to prevent insulation from covering the vents in the eaves. Majority of the roof eaves were blocked and restricting air circulation in the attic

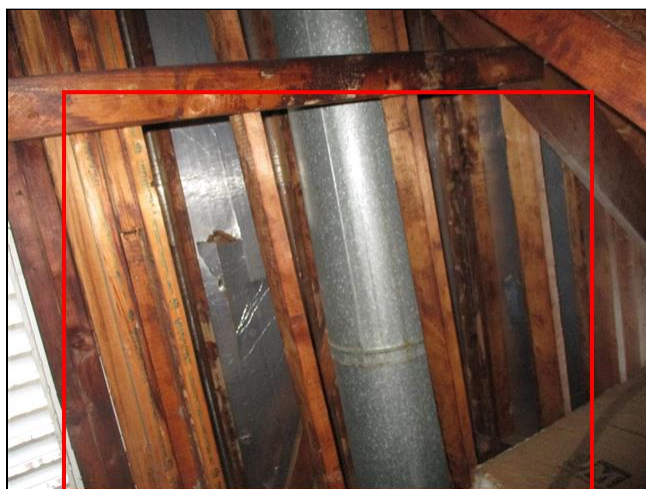
5.0 Item 5(Picture)

(3) Recommend having the open chimney chase in attic be properly closed. This is a potential fire safety hazard that could funnel fire up fro the main level through the house up to the roof. Recommend a qualified contractor repair as needed

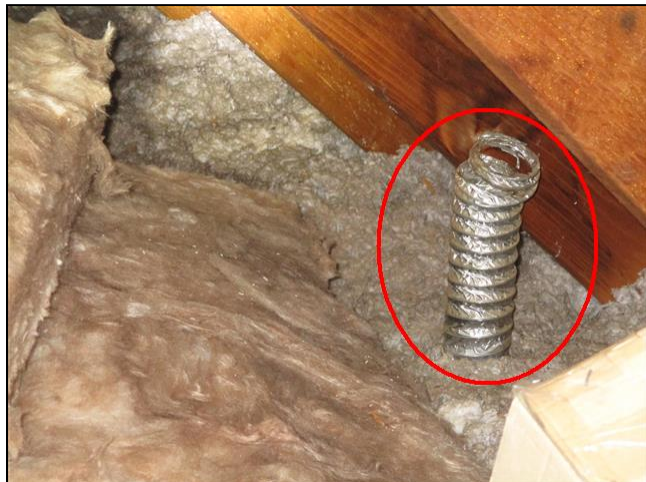
5.4 Item 1(Picture)

Bath exhausts are venting into the attic. This was accepted and common at the time the house was built, but it is strongly recommended that flex duct be attached and run to the exterior of the home

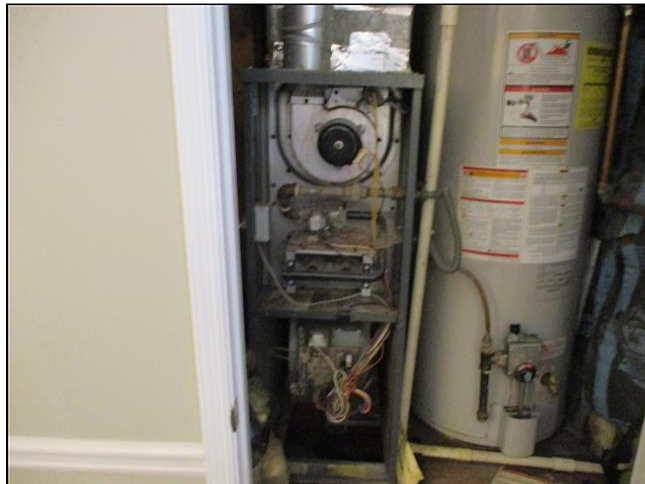
6.0 Item 1(Picture)

🔧 (1) Have an hvac tech service the heating and cooling equipment to clean the blower motor, the evaporator coils, the condensing coils, the electrical contacts, check refrigerant levels, check size of units compared to size of home and ascertain that the heat exchangers are not cracked and the equipment is safe to operate and functioning properly. Much of internal parts of the hvac system is concealed from view, and our inspection is visual and is intended to check the function of the systems. The inspection does not make any assessment of the internal parts of the duct system, since it is not visible. Therefore, an hvac tech should evaluate for any concealed defects or hazards in the system. Furthermore, manufacturers recommend annual maintenance and servicing to keep the system working at peak efficiency.

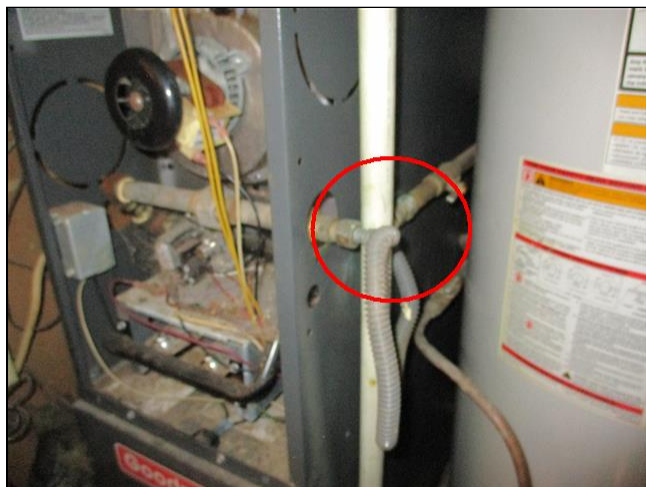
6.0 Item 2(Picture)

🔧 (2) Install missing sediment trap on gas pipe by furnace. See photo

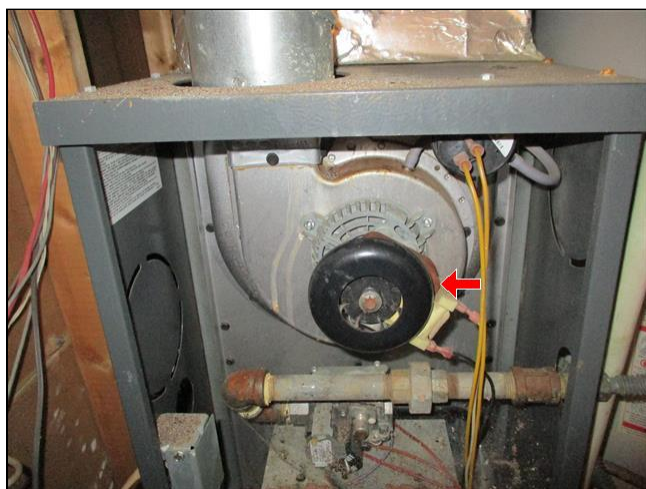
6.0 Item 3(Picture)

🔧 (3) Buzzing/whirring sound coming from the furnace unit when running. Have an HVAC tech evaluate and make any repairs as needed.

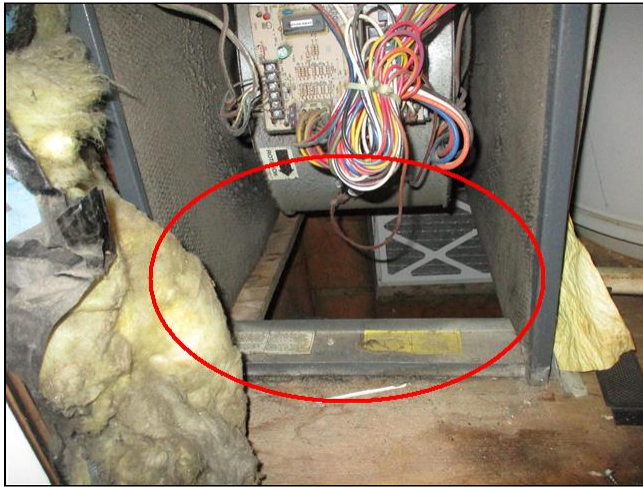
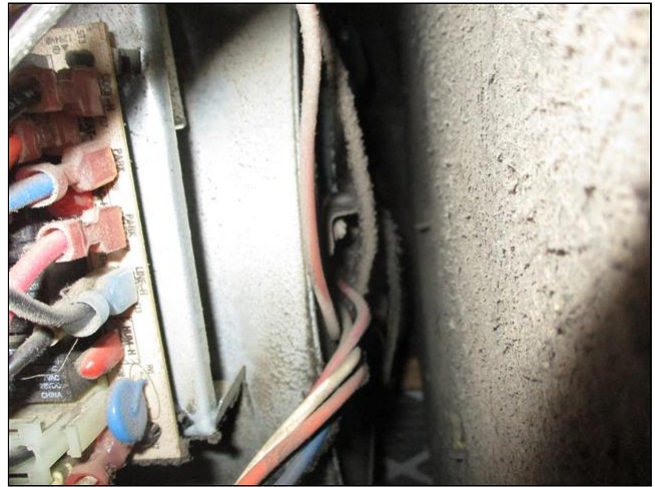
- (1) Strongly recommend installing filter at bottom of unit, unit is currently pulling unfiltered air through the louvered door and the interior of the unit is very dirty. Have HVAC system cleaned and serviced prior to closing.

(1) Strongly recommend installing filter at bottom of unit, unit is currently pulling unfiltered air through the louvered door and the interior of the unit is very dirty. Have HVAC system cleaned and serviced prior to closing.

6.2 Item 2(Picture) Interior of unit is dirty

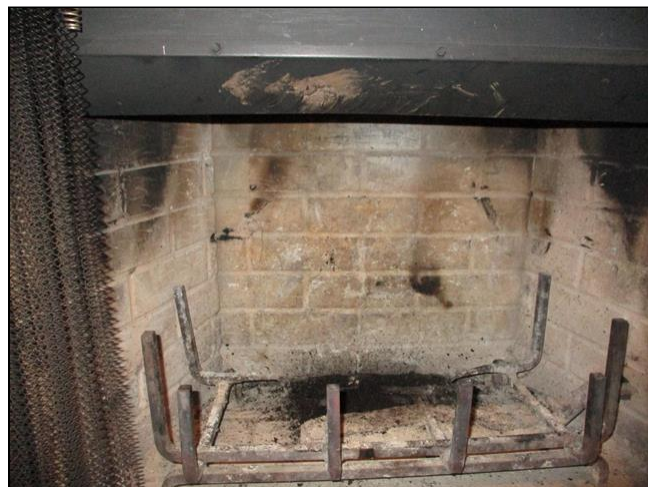
6.6 Item 1(Picture)

- (1) Replace the cracked concrete panel in the fire place. These are usually held in place by clips or screws and are subject to wear.

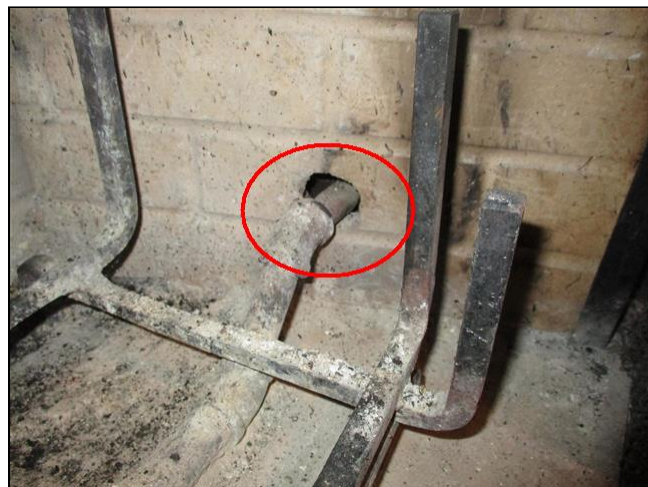
6.6 Item 2(Picture)

- (2) Have heat resistant caulk applied around the gas pipe where it enters the fire box in the fireplace. This is needed to prevent any hot embers from entering framing behind fireplace.

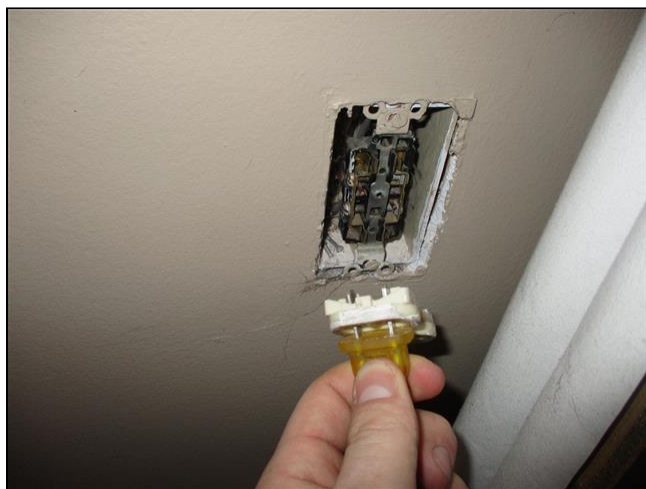
7.4 Item 1(Picture)

- Replace broken outlet to right of front door in the living room. See photo.

🔧 Replace broken outlet to right of front door in the living room. See photo.

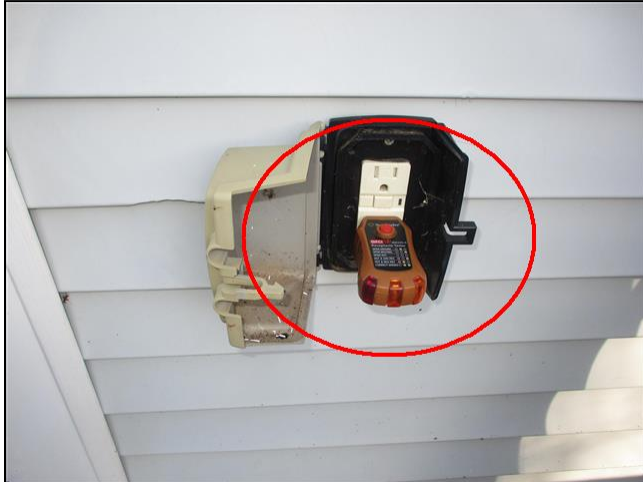
7.6 Item 1(Picture)

Gfci outlet by the rear exterior door did not have power and would not reset. Have electrician evaluate and make all repairs/replacements as needed

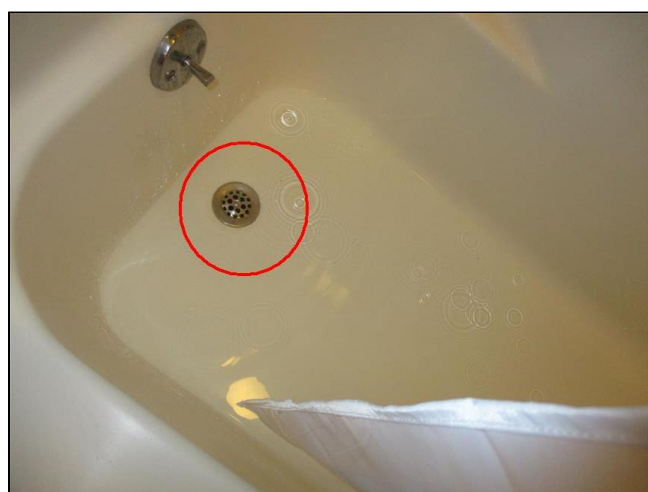
8.0 Item 1(Picture)

(1) Slow drain in the front right bedroom bath tub(s). Have plumber check for a clog and repair. See photo(s) for location(s).

🔧 (1) Slow drain in the front right bedroom bath tub(s). Have plumber check for a clog and repair. See photo(s) for location(s).

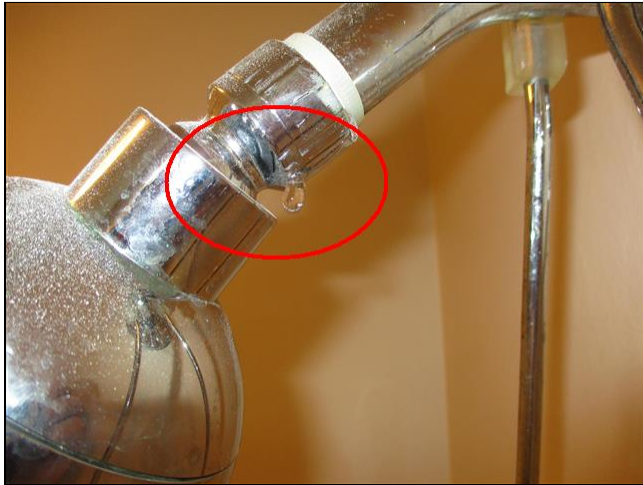
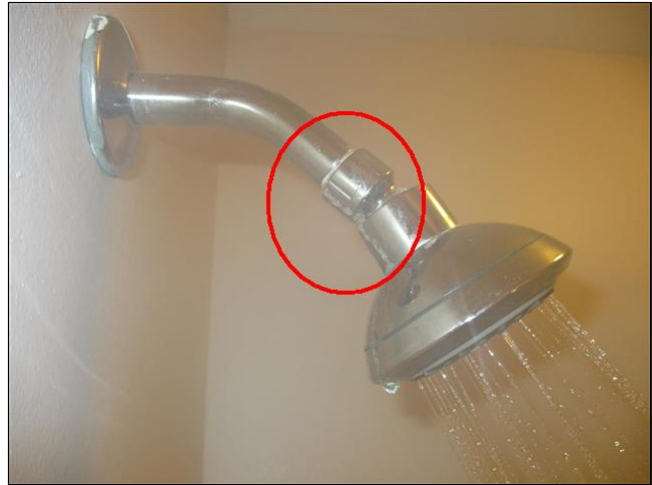
(2) Leaks at all bathtub fixtures in both bathrooms at the shower heads, faucets, and shower diverter. Have plumber evaluate and make all repairs/replacements as needed

⤴ (2) Leaks at all bathtub fixtures in both bathrooms at the shower heads, faucets, and shower diverter. Have plumber evaluate and make all repairs/replacements as needed

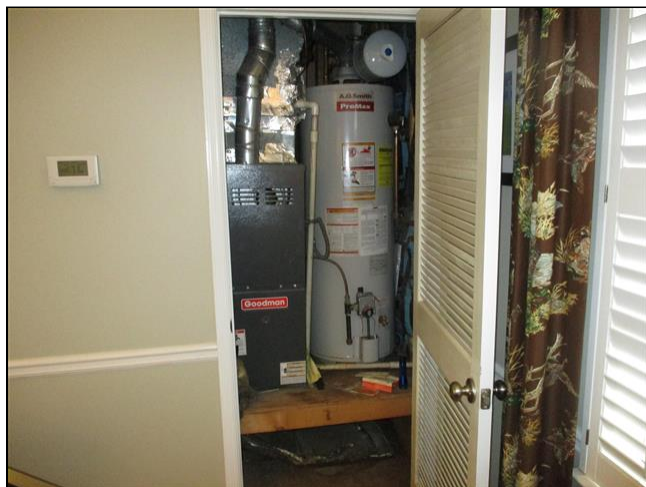
8.3 Item 1(Picture)

(1) Water heaters generally last about 10-12 years before needing replacement. Current water heater works and makes hot water but will likely need replacement in the near future due to its age. Unit is a 2005 model

🔧 (1) Water heaters generally last about 10-12 years before needing replacement. Current water heater works and makes hot water but will likely need replacement in the near future due to its age. Unit is a 2005 model

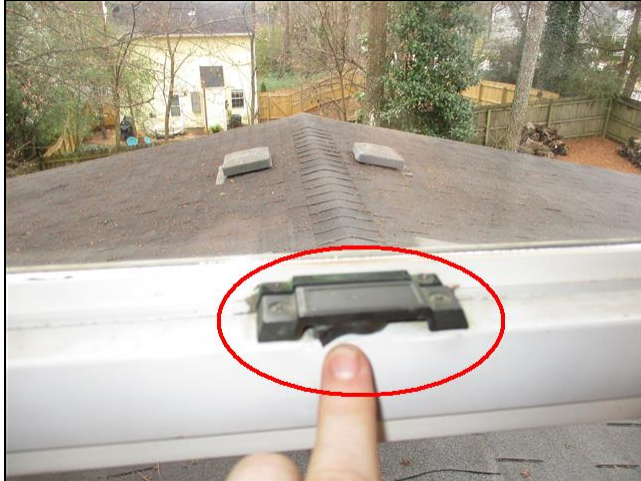
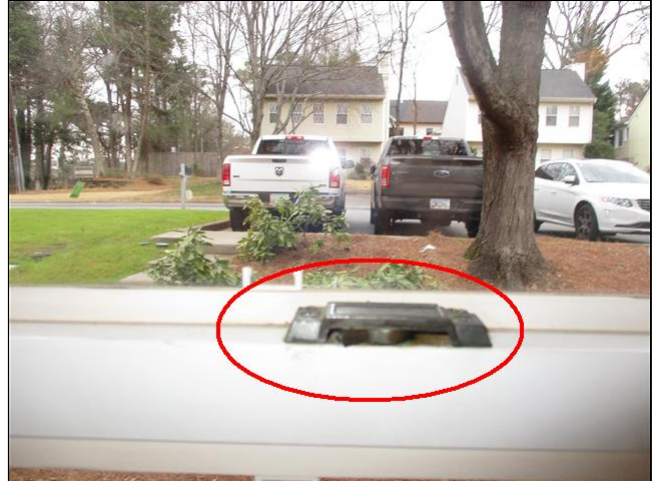
Window lock at top of stairs and both front main level were broken, unable to open. Replace broken window locks

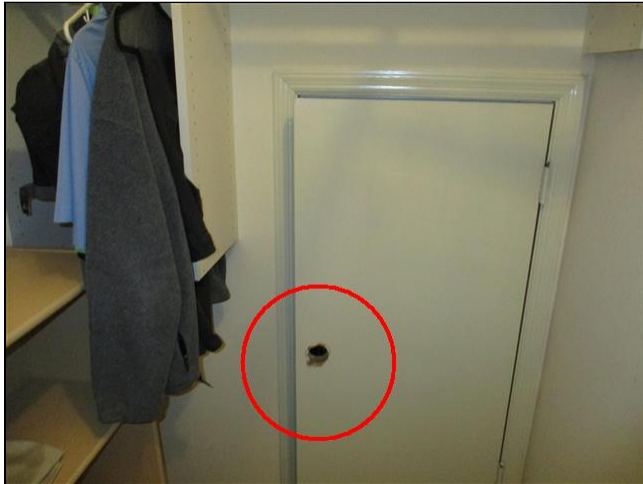
9.7 Item 1(Picture)

Missing door knob on knee wall attic door so door will close and latch.

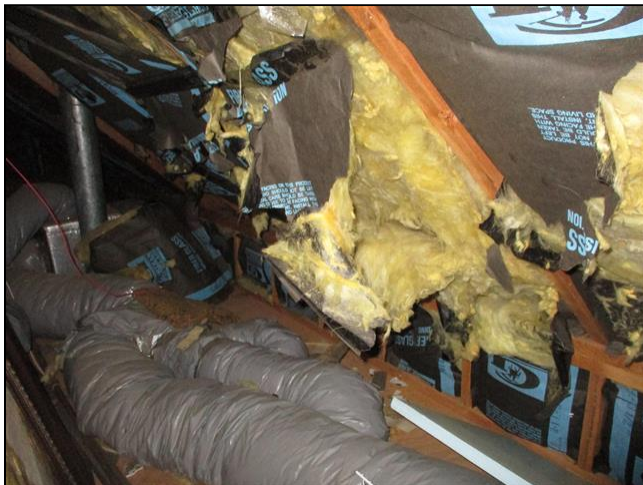
There is evidence of rodent activity in the attic spaces as noted by tunnels/trails in attic insulation and some chewed batts insulation in the front attic space. No evidence of droppings or nesting were seen at the time of the inspection. A wildlife company should be consulted to determine if the activity is past or present and to repair all possible entry points to the attic and the entire home

🐭 There is evidence of rodent activity in the attic spaces as noted by tunnels/trails in attic insulation and some chewed batts insulation in the front attic space. No evidence of droppings or nesting were seen at the time of the inspection. A wildlife company should be consulted to determine if the activity is past or present and to repair all possible entry points to the attic and the entire home

9.8 Item 1(Picture) chewed batts insulation

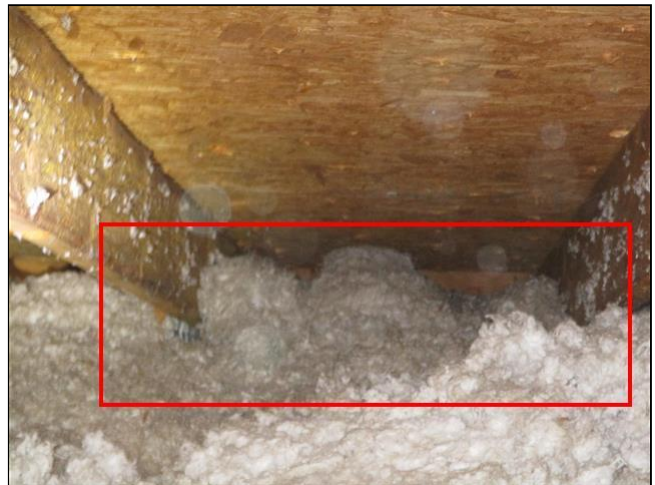
9.8 Item 2(Picture) rodent trails in attic insulation

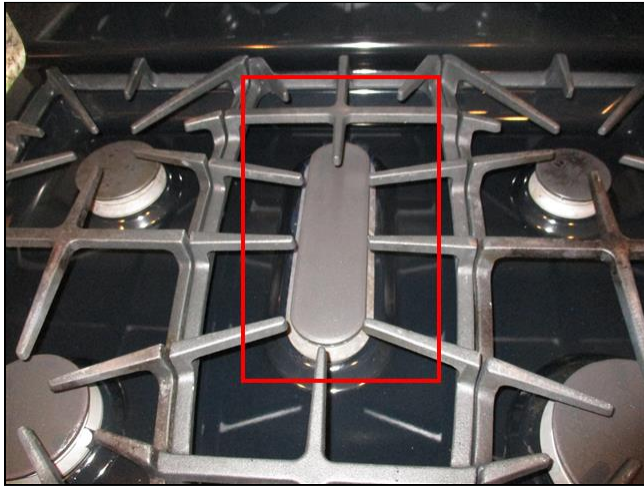
10.1 Item 1(Picture)

The center burner on the stovetop did not light the full perimeter of burner, Have corrected.

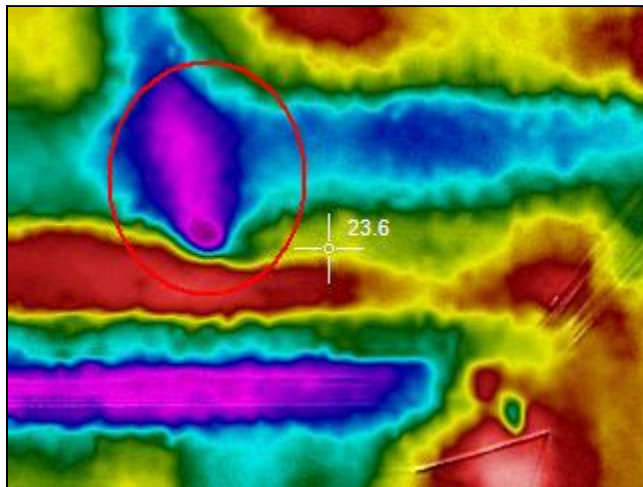
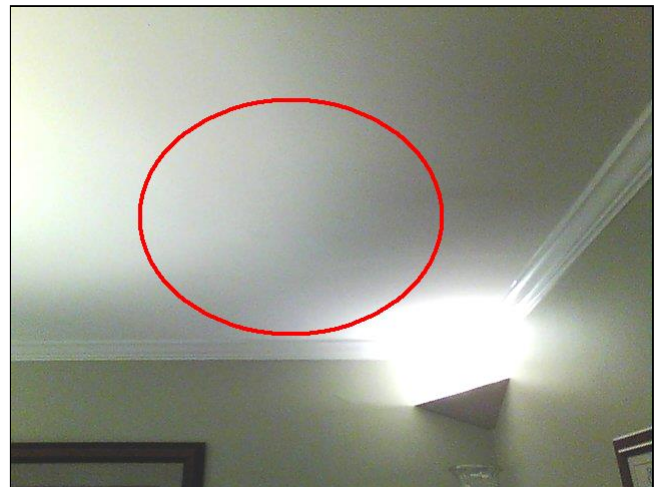
Small cold spot found on the main level front left office room at a past repair. No moisture was detect, likely low insulation. See photo for location. Have any concerns resolved prior to closing

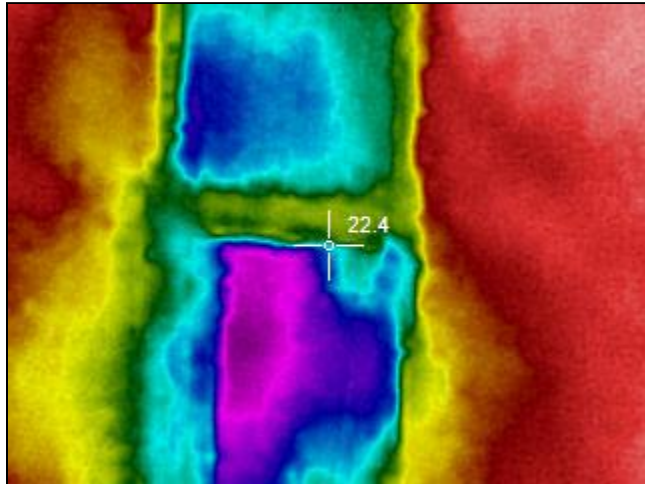
There were a couple areas of low insulation in the attic, and insulation was missing around the attic pull down stairs and the whole house fan. See photos. Have missing insulation installed

11.3 Item 1(Picture) pull down attic stairs and whole house fan
