Inspection Report

**Property Address:
1145 Haven Brooks Ln NE
Atlanta Ga 30319**

Inspector: Brandon Williams

Date: 2/26/2020	Time:	Report ID: 80220
Property: 1145 Haven Brooks Ln NE Atlanta Ga 30319	Customer: Emily Mason	Real Estate Professional: Michael Hermance Keller Williams

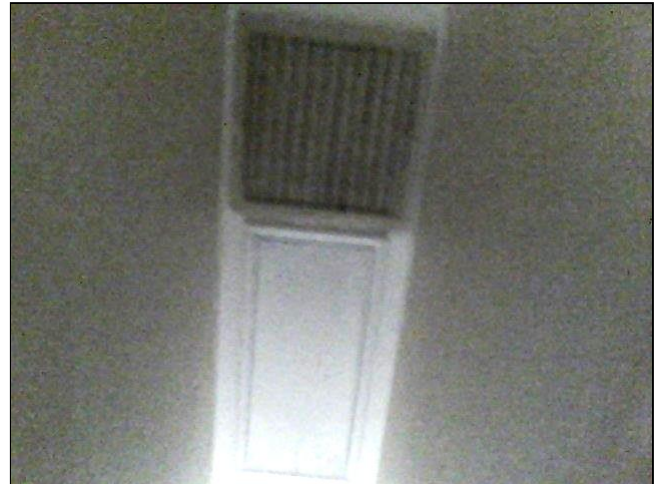
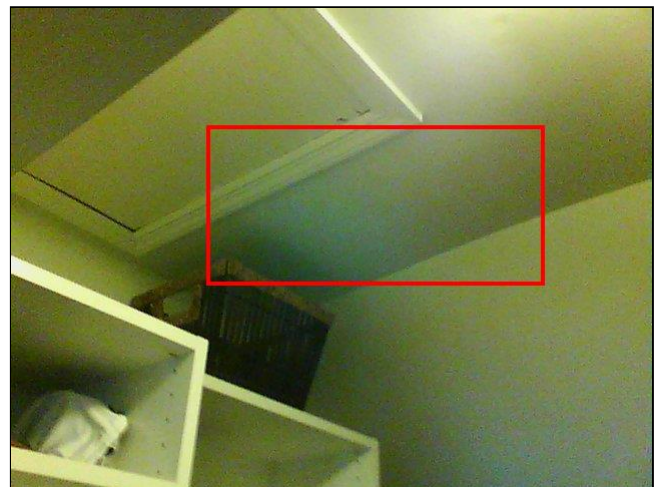
There were a couple areas of low insulation in the attic, and insulation was missing around the attic pull down stairs and the whole house fan. See photos. Have missing insulation installed

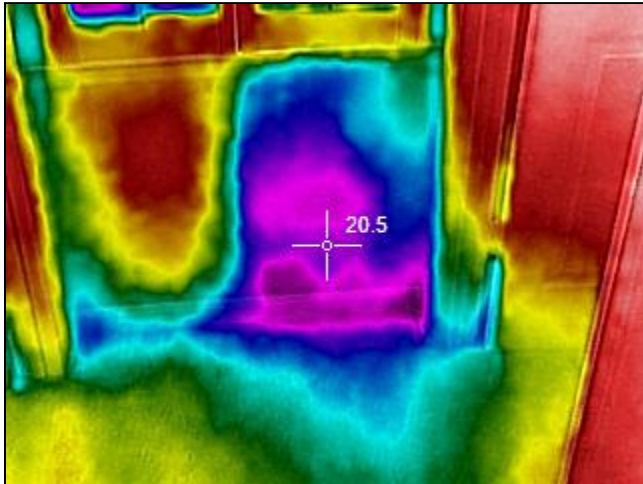
Wall insulation was seen to be missing in two spots on the second floor. See photos for location. have missing insulation installed as needed

11.4 Item 1(Picture) under window at top of stairs
