Inspection Report

715 Doe Ct

Alpharetta, GA 30005

Thursday, March 12, 2020

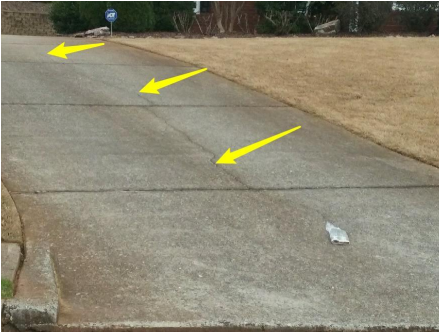
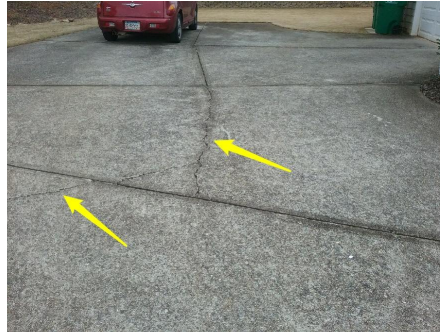
14: Cracking observed and appears normal for a driveway of this age and size. No repairs needed, but take pictures to compare in future years. Avoid heavy moving trucks with a full load.

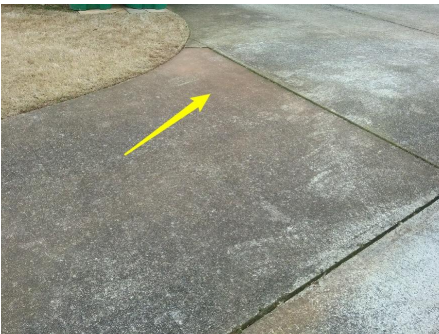
15: Uneven settlement typically caused from varying soil compaction or surface water flow was noted, we recommend further evaluation and repairs by a licensed contractor.

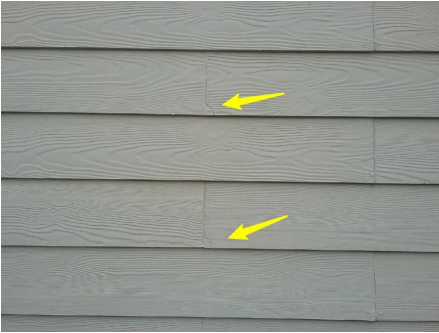
26: Minor damage was observed at the exterior hardi type siding located at various places of the home. Recommend repair by a licensed general contractor.

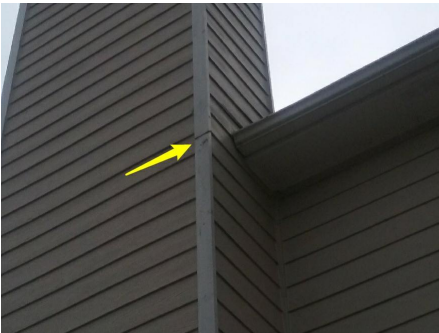
29: Unsealed caulking gaps were noted at the exterior wood trim boards located at various places of the chimney chase. Recommend caulking by a licensed general contractor.

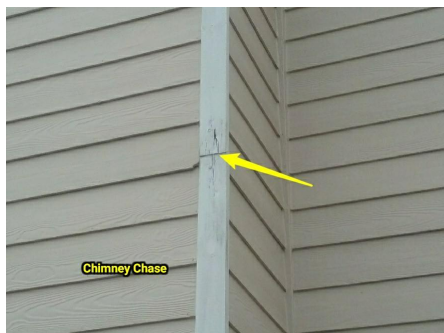
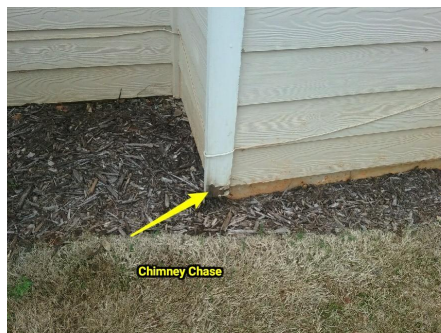
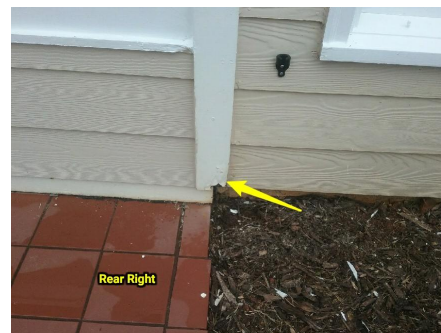
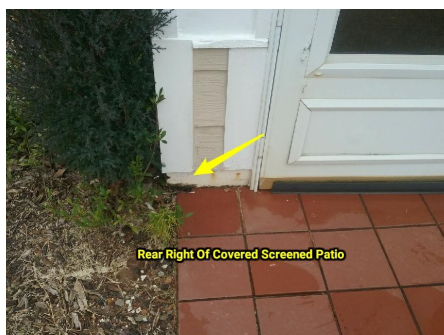
30: Moisture damage and peeling paint was observed at the exterior wood trim boards located at the chimney chase and rear right portions of the home. Recommend repair by a licensed general contractor.

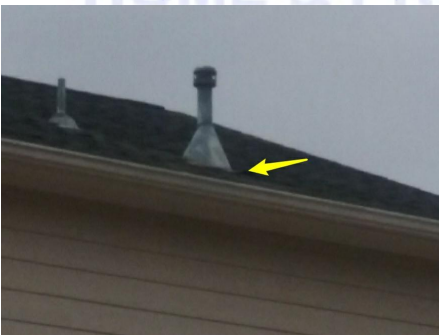
44: Lifted metal flashing was observed at the rear left metal exhaust vent. Recommend repair by a licensed general or roofing contractor.

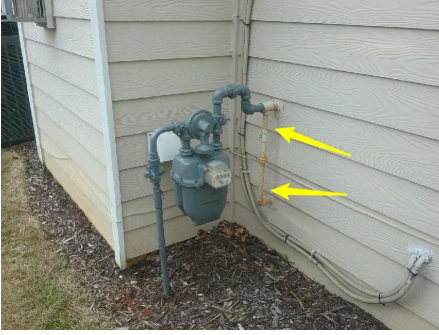
65: Rusting and corrosion on meter/ pipes, recommend painting.

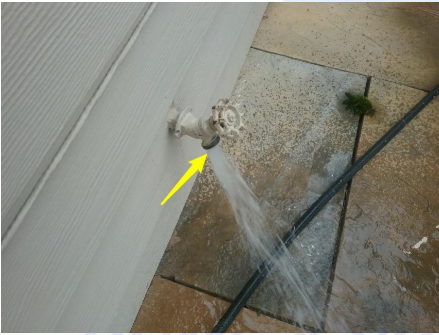
66: Anti siphon valves were not visible on the exterior hose faucets at the time of the inspection. We recommend installing anti siphon device to prevent possible backflow water contamination.

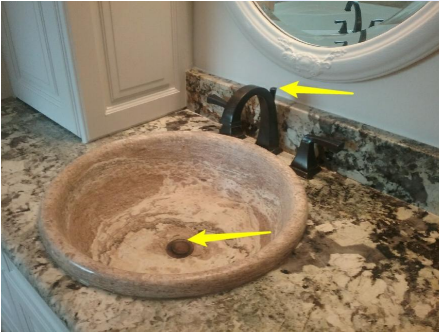
70: A disconnected sink pull was observed at the front master bathrooms sink. Recommend repair by a licensed general or plumbing contractor.

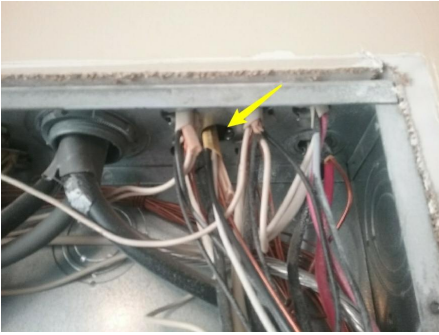
94: A missing circuit wire bushing(s) was observed inside the electrical sub panel located in the garage. Recommend installation by a licensed electrical contractor.

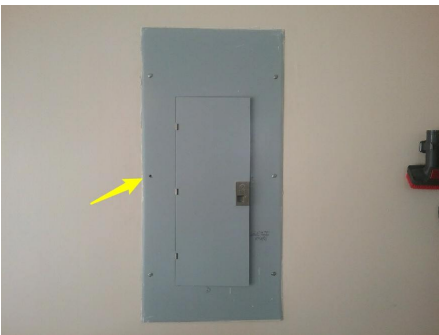
95: Missing dead front panel screws were noted at the electrical sub panel.

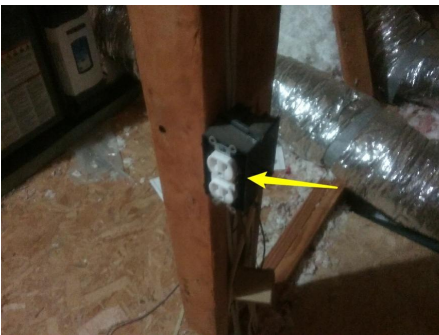
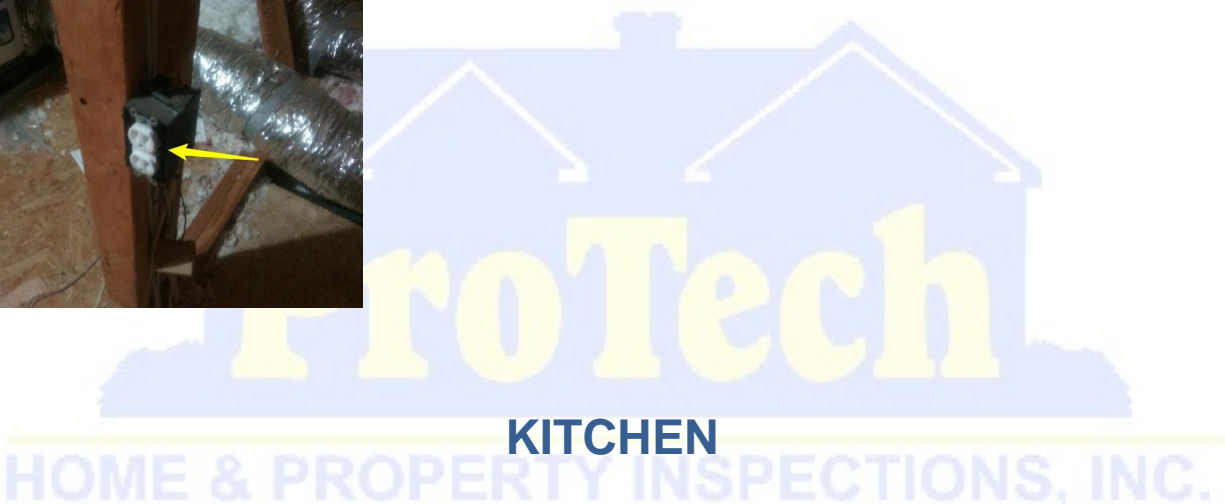
100: Missing outlet cover plate observed in the attic, recommend adding cover plates for safety.

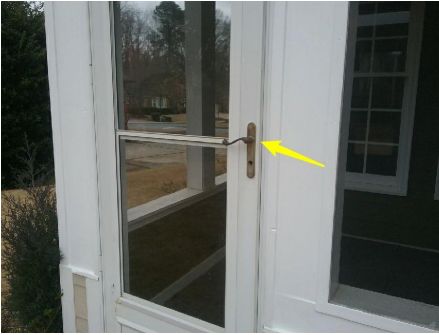
113: Doors don't latch. Located at the rear right exterior storm door and at the master bathrooms entrance door. Minor adjustment is recommended for proper operation by a licensed general contractor.

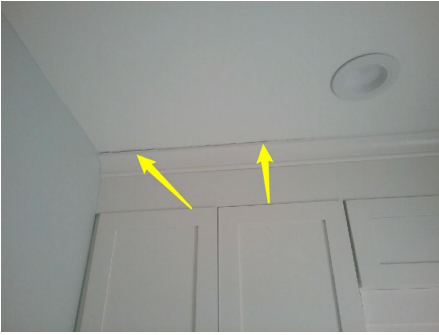
122: Unsealed gaps were noted at the laundry room cabinet. Recommend repair by a licensed general contractor.

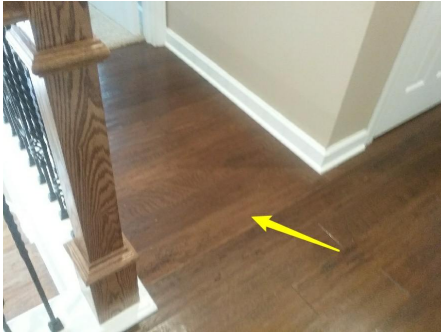
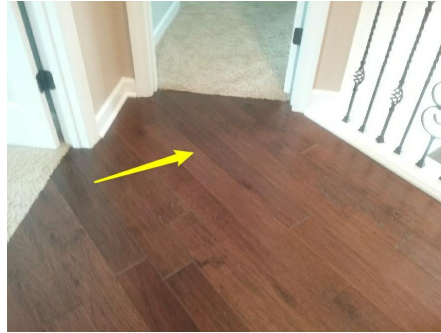
130: Uneven flooring noted in the upper hallway. Recommend further evaluation by a licensed flooring contractor.

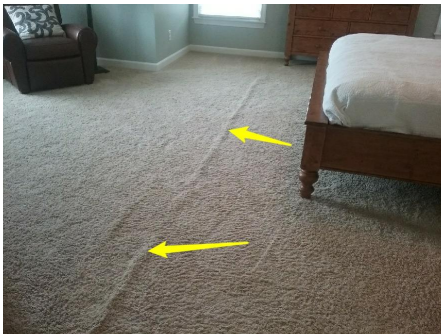
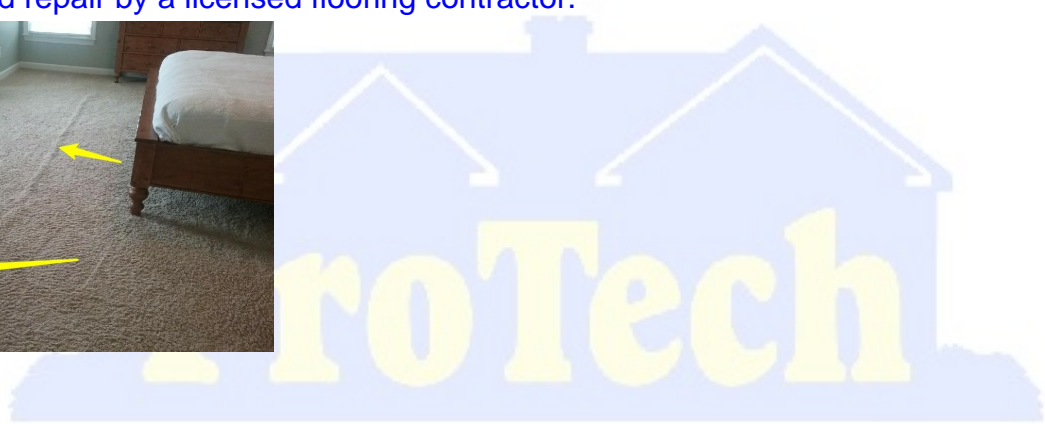
131: The carpet needs stretching for proper fit. Located in the master and rear right bedrooms. Recommend repair by a licensed flooring contractor.

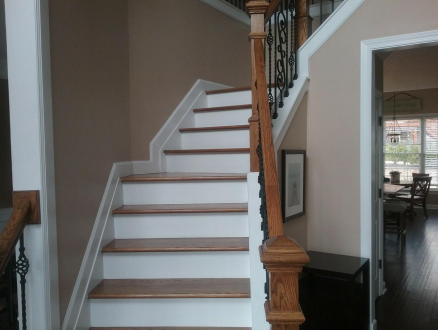
134: Squeaking noted. Typical for the age of the building.

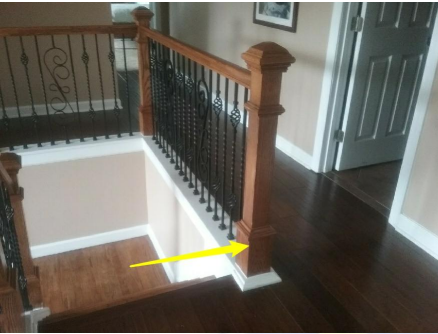
135: Loose hand railing was observed at the top of the staircase. Recommend repair by a licensed general contractor.
