BPG Inspection Services

**1229 McLendon Avenue Northeast
Atlanta GA 30307**

Client(s): English
Inspection Date: 3/9/2020
Inspector: Chuck Turner ,

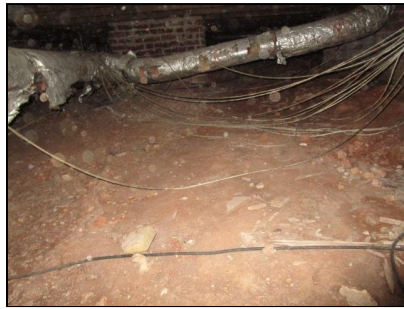
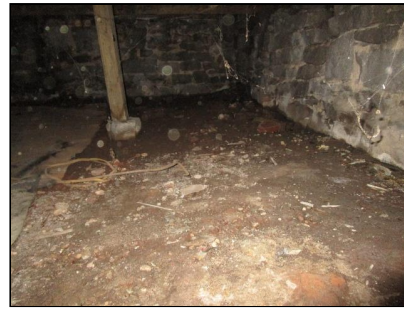
- ❌ 3. **SERVICE / REPAIR:** An inadequate vapor barrier is present in the crawlspace. The installation of a complete vapor barrier is advised to prevent moisture rising from the crawlspace area into the home. Not installing a vapor barrier can lead to high humidity problems in the home and may result in mold growth. A vapor barrier should be placed on the crawl space dirt floor to stop moisture penetration of the floor and sub-floor under any habitable space. The barrier must be taped and sealed at all barrier joints and be extended one foot up the exterior walls and around support columns leaving 3-6 inches minimum at the top for observation of termite tracks. Seal the top to the columns and walls. This approach is approved by the US Department of Energy and building envelope specialists. At a minimum, use 6 mil. polyethylene plastic material. Have a contractor evaluate and add barrier.

Inadequate vapor barrier missing. Add complete vapor barrier to the crawlspace.

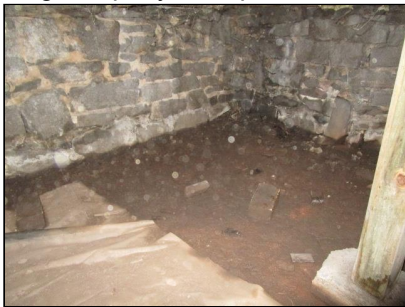
- ❌ 4. **MAJOR DEFECT:** There is active water penetration of the crawl space area. Water in the crawl space area promotes mold growth, decay of wood structures and attracts termites and pests. The cause of water penetration must be found and eliminated. Recommend further investigation and correction by a qualified contractor or water infiltration specialist. Sloping the ground or trenching may be needed to direct water. Consult professional moisture proofing company for repairs

Active moisture intrusion around the perimeter of the crawlspace.

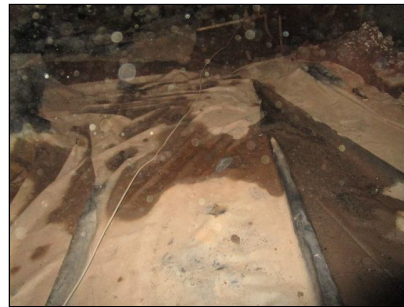
Standing water in places in the crawlspace.

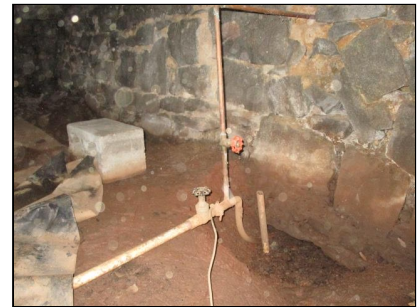
Heavy moisture intrusion in the crawlspace.

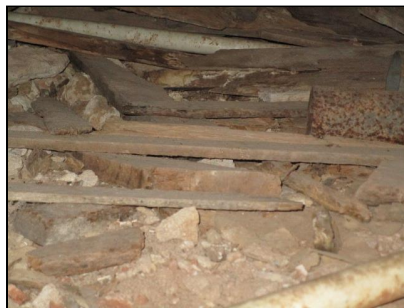
- ❌ 5. **SERVICE / REPAIR:** Wood and other cellulose debris found in crawlspace. Required by most termite companies to eliminate conducive conditions for termites. Have all removed for best protection of property.

Remove all debris from the crawlspace.

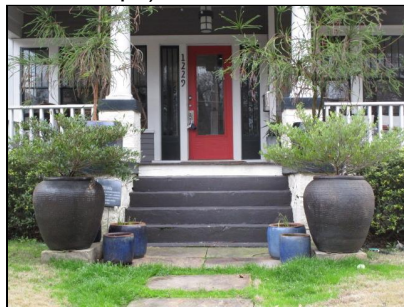
- 7. **SERVICE / REPAIR:** Missing hand railing on at least one side of stair. Required for any stairway of 30 inches or more in height (more than 4 steps). Recommend install for safety.

Add handrail to the front porch steps.

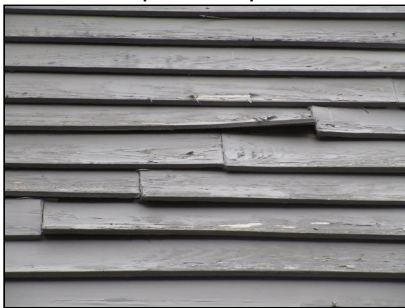
- 8. **MAJOR DEFECT:** Extensive deterioration of the siding/trim materials observed. Have a professional contractor evaluate and repair or replace as needed.

Replace all warped and damaged siding

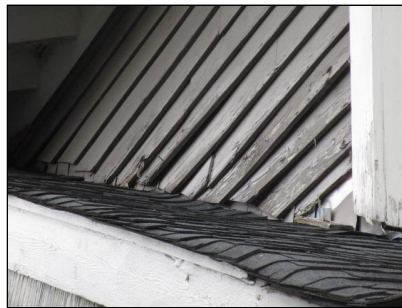
Replace all damaged siding.

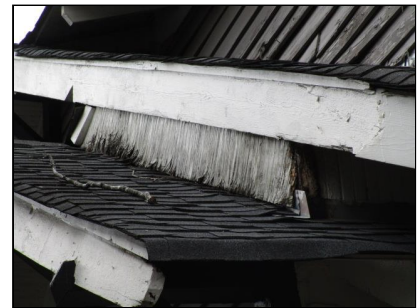
Replace all damaged siding

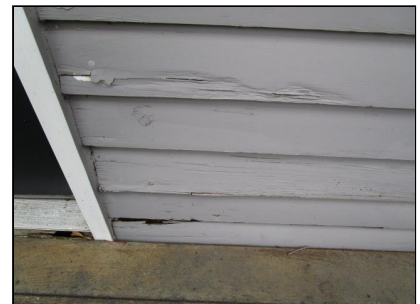
Replace damaged siding

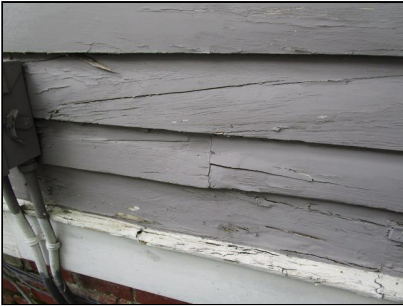
Replace damaged siding

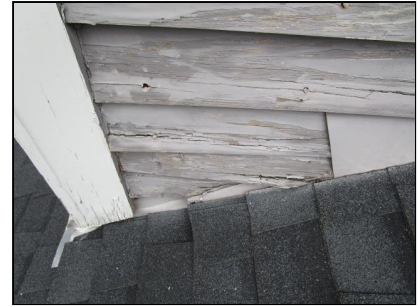
Replace damaged siding

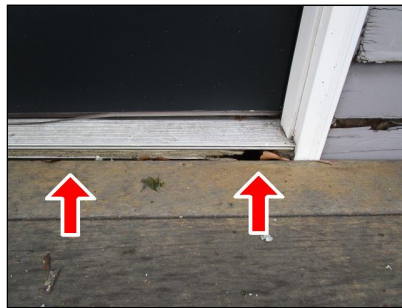
- ☒ 9. **SERVICE / REPAIR:** Deterioration of the door sill observed. Repair or replace the door sill to prevent moisture entry to the building and damage to the subfloor or flooring materials. All damaged wood should be repaired / replaced to the extent found.

Deterioration of the rear door sill.

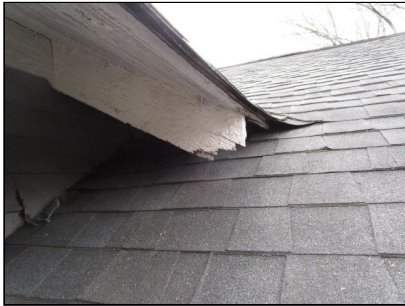
❌ 11. **MAJOR DEFECT:** Wood rot and deterioration are present. Evaluate all areas and replace/repair all wood rot to the extent found to prevent further damage to any area. All replacement wood should be primed on all sides, caulked and painted as required. Any damage on the exterior wall or trim that allows openings into the wall cavity or interior can cause significant water damage over time if not repaired.

Repair all damaged trim

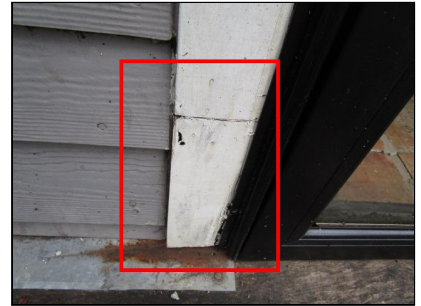
Repair all damaged trim

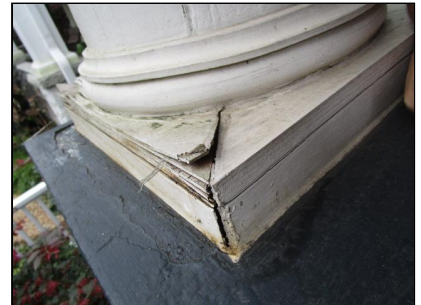
Repair all damaged trim

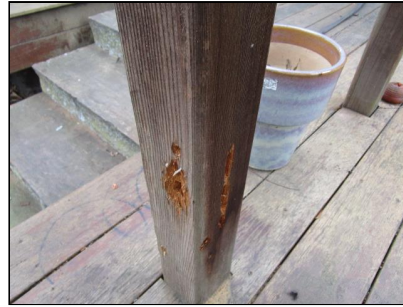
- ❌ 13. **SERVICE / REPAIR:** There is noticeable carpenter bee damage to the rear deck roof support posts with residue splattered on surfaces below entry hole. Damage is generally not significant but should consider having repaired by sealing holes to avoid further damage to the wood.

Repair carpenter bee damage to the posts.

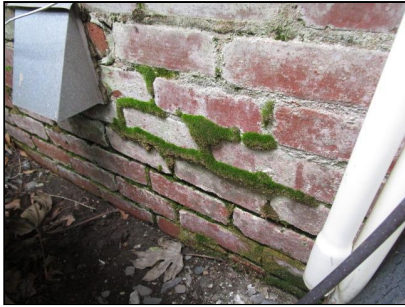
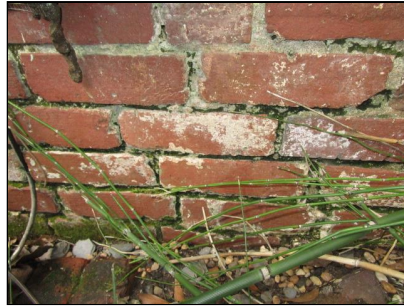
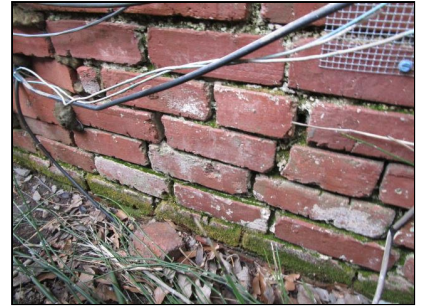
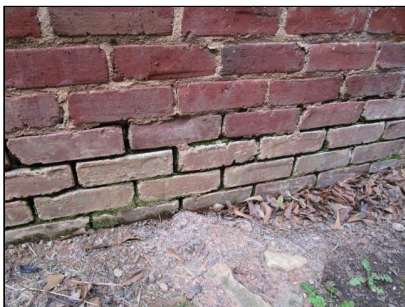
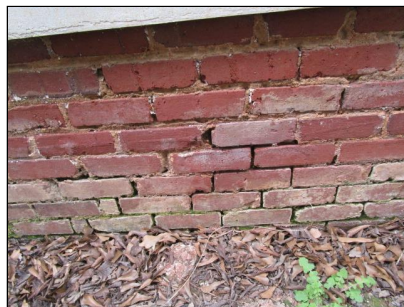
- ✘ 14. **MAJOR DEFECT:** Mortar joints found brittle and missing grout. This condition will continue unless corrected leading to significant problems. Recommend professional mason to evaluate all areas and areas repaired as needed.

Scrape loose mortar on the exterior and repoint between bricks.

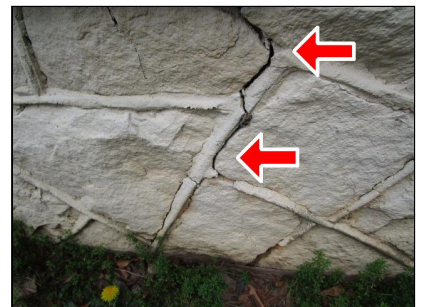
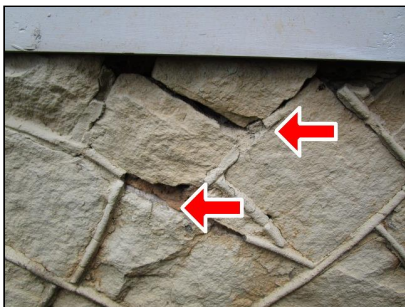
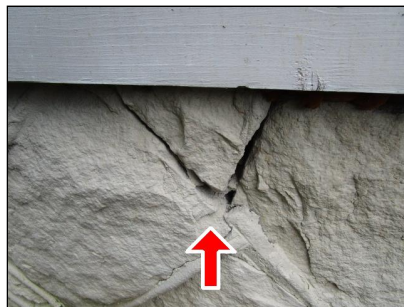
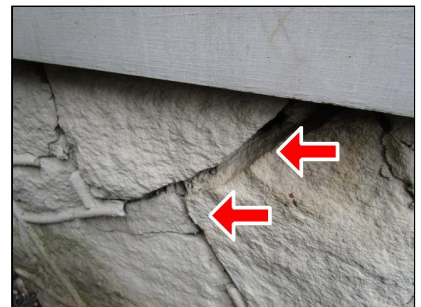
Repoint between stones where missing

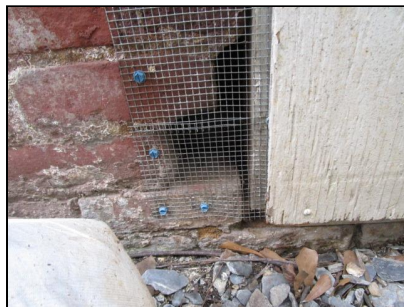
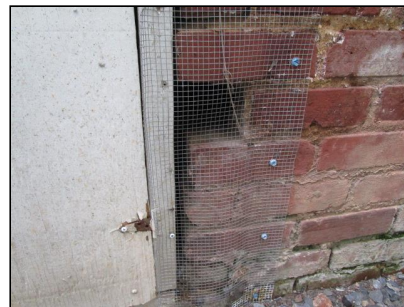
- 15. **SERVICE / REPAIR:** Loose / missing brick veneer found. Recommend qualified mason to repair /replace to the extent found.

Replace the missing bricks at the crawlspace entry door.

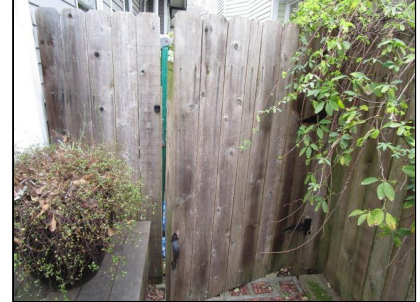
- ❌ 16. **SERVICE / REPAIR:** Damaged sections of fencing observed. Have the fence repaired or modified in a manner to contain children or pets as needed.

Repair or replace all gates to open and close properly

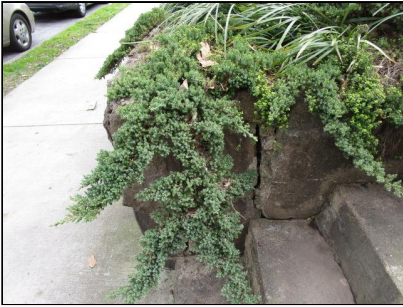
- ❌ 17. **MAJOR DEFECT:** Deterioration of the retaining wall observed. Have a professional contractor evaluate the wall and repair as necessary.

Cracks and settlement in the retaining wall.

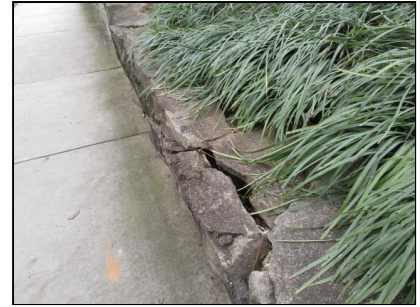
Extensive deterioration of the front retaining wall.

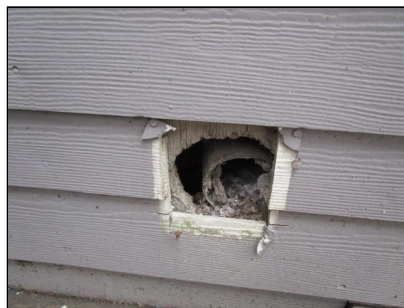
- ❌ 21. **SERVICE / REPAIR:** Missing/ damaged vent cover noted. Replacement is necessary to prevent pest and water entry.

Secure dryer vent to new hood.

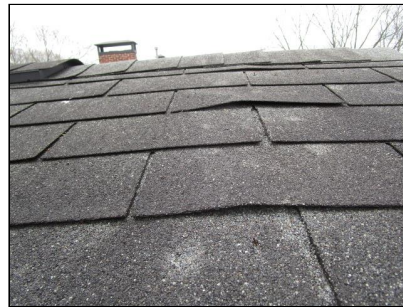
- ❌ 22. **SERVICE / REPAIR:** Nail pops lifting / penetrating shingles in several locations. Have loose shingles secured to prevent wind or moisture damage. Nails popping through roof surface can allow moisture intrusion. Entire roof should be evaluated and all exposed nails should be removed and the holes sealed to protect from moisture.

Nail pops lifting shingles in several places.

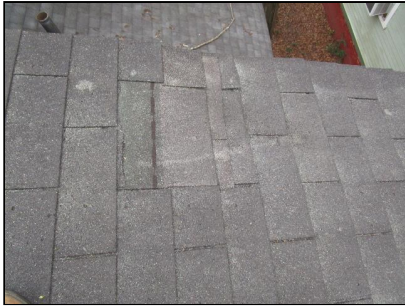
- ❌ 23. **MAJOR DEFECT:** There are soft spots and damage to the roof decking around the perimeter of the house. There appear to be active leaks. Have the roof evaluated by a professional roofer and repaired as needed. Have all damaged decking and decking underlayment repaired / replaced.

Soft area indicates leak at the upper right rear of the roof.

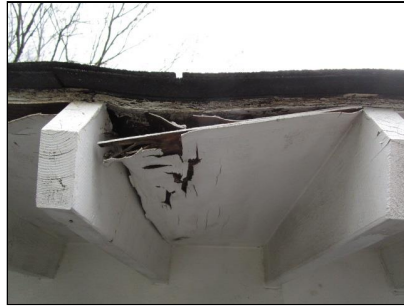
Damaged decking, leaking in the roof.

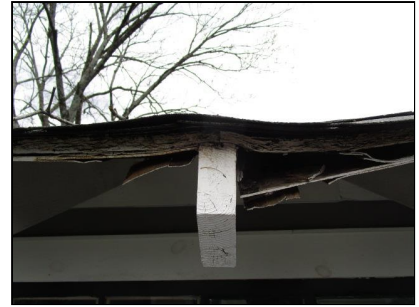
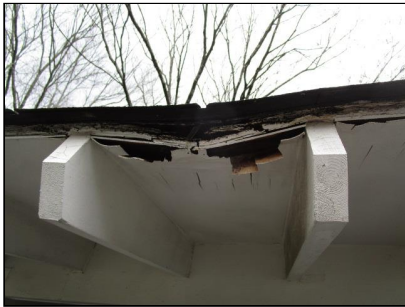
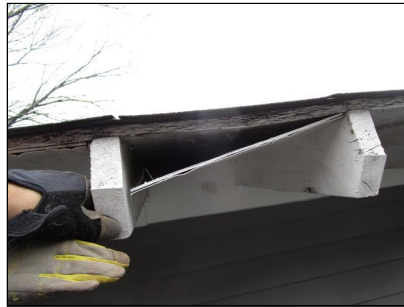
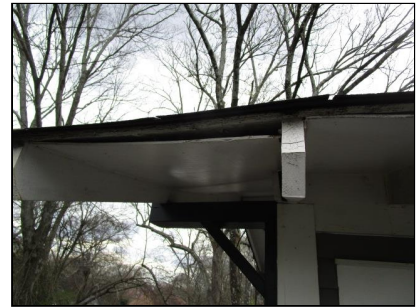
Damaged decking around perimeter of the roof.

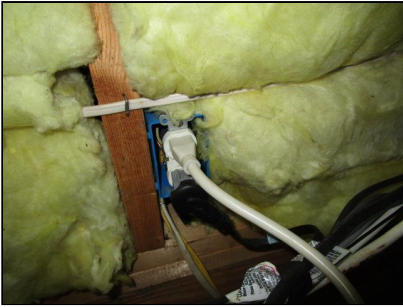
- ❌ 34. **SERVICE / REPAIR:** Missing receptacle/switch plates noted. Replacement is advised to prevent an electrical hazard. One switch in the attic is improperly wired and there is a missing junction box at the connection for the condensate pump in the attic. **LOCATION: Attic area, main level**

Add missing cover in the attic.

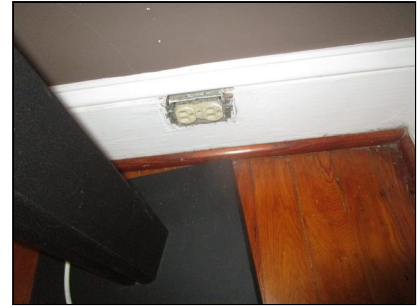
Replace missing cover.

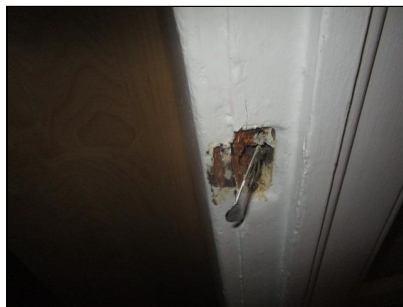
Add cover plate where wiring coming out of the wall on the main level

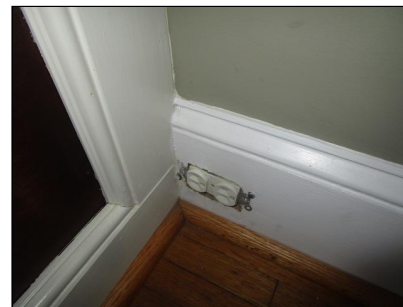
Add missing cover plates on the main level

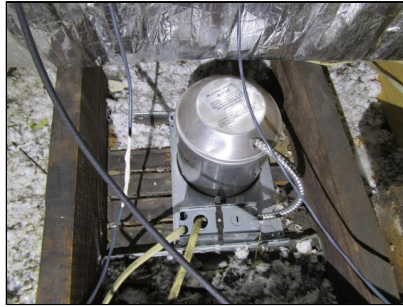
- ❌ 36. **SERVICE / REPAIR:** Recessed lighting found in attic required to have a minimum of 3 inches of clearance from insulation due to fire hazard. Correct as required for safety where found in attic area.

Add baffles around all recessed fixtures.

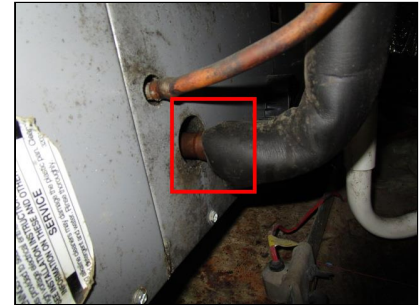
Add insulation and seal to the coil housing.

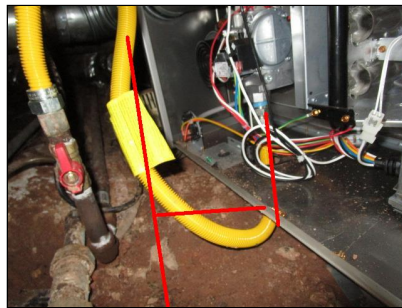
- ❌ 44. **SAFETY / HEALTH:** The flexible gas connector passes through the cabinet of the heating appliance. This is a safety hazard due to the possibility to damage to the line from the furnace wall. Replace the flex gas connector with solid piping or install a rubber grommet to prevent rubbing on furnace wall. ALSO No sediment trap (also referred to as drip leg) is present before the gas line enters heating appliance. A tee fitting should be provided before the gas line enters the heating appliance to allow for dirt, debris, or moisture to accumulate rather than enter the appliance. Install for proper operation.

Flex line not permitted through furnace wall, sediment trap missing.

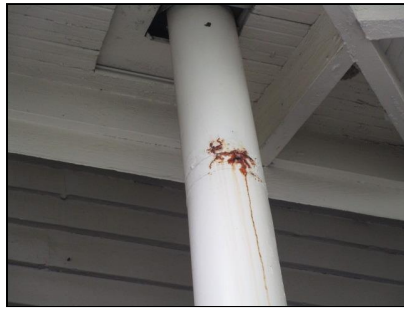
- ❌ 46. **MAJOR DEFECT:** Rust present on the vent for the main level furnace on the exterior and in the crawlspace. Have the vent evaluated and repaired or replaced by a licensed HVAC professional.

Flue rusting through on the exterior of the house.

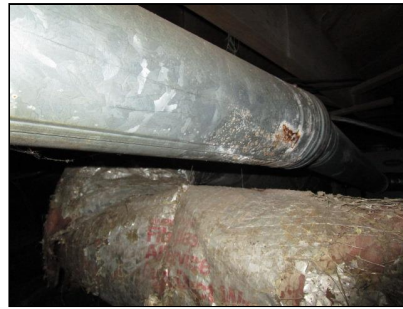
Flue rusting through in the crawlspace.

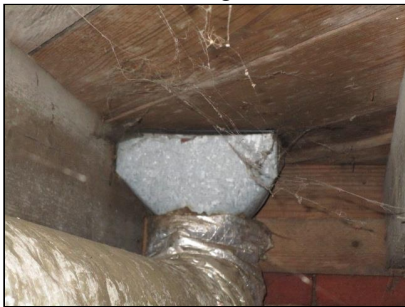
- ✘ 47. **SERVICE / REPAIR:** Areas of ductwork found without insulation. All supply and return air ductwork installed in uninsulated spaces are required to be insulated to prevent energy loss and prevent condensation in and on system. There are ducts on the ground in several places and one damaged return duct. Have all ducts repaired and removed from ground contact. Have damaged and missing insulation replaced. Recommend insulation be installed where missing.

Add insulation to all register boots.

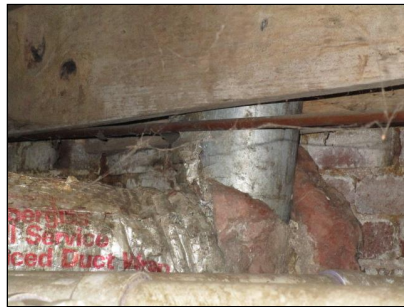
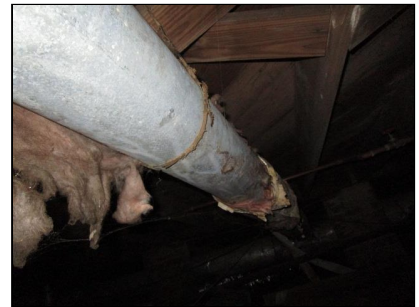
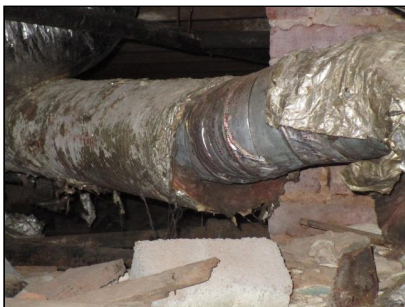
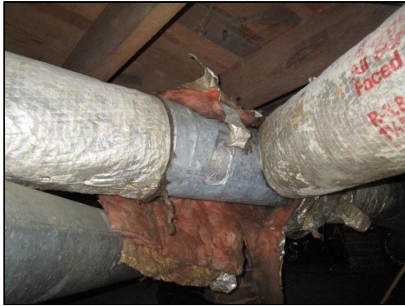
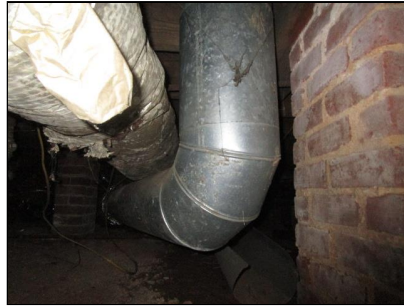
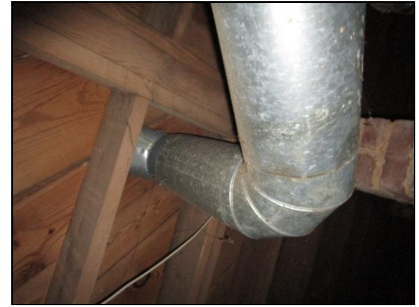
Add insulation to all ducts where damaged or missing

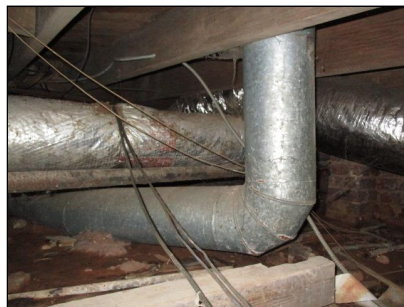
Add insulation where missing

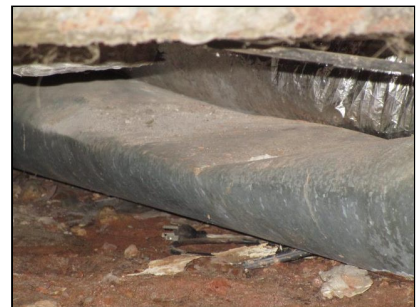
Repair damaged return duct, add insulation

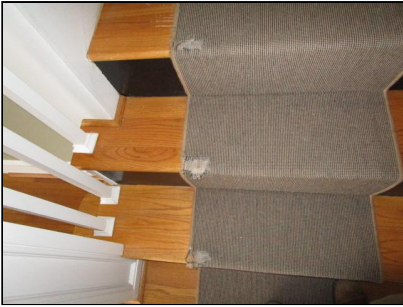
- 49. **MAJOR DEFECT:** Damaged areas of flooring observed. Have a professional flooring contractor evaluate and repair or replace the flooring as needed.

Carpet damaged, replace runner up the stairs.

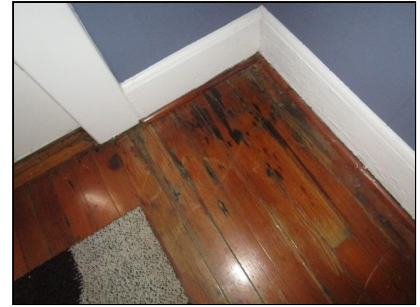
Stained / damaged flooring noted in several places.

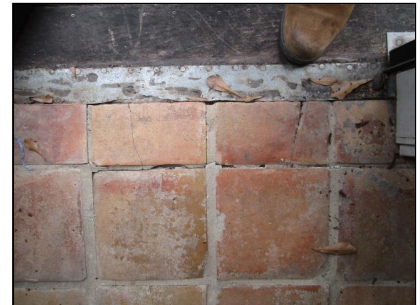
Tiles at the laundry entry door are cracked and loose.

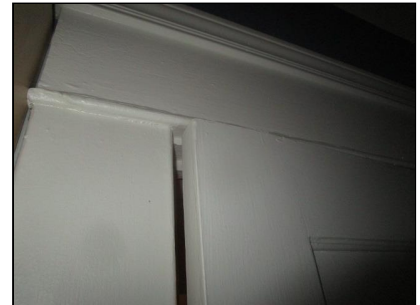
- ☒ 50. **SERVICE / REPAIR:** The doors stick when tested. Evaluate and correct all doors for proper operation. Verify latching when after corrected. Possibly a result in improper installation, settling or misaligned hardware.

Doors stick in the frame, do not close and latch properly

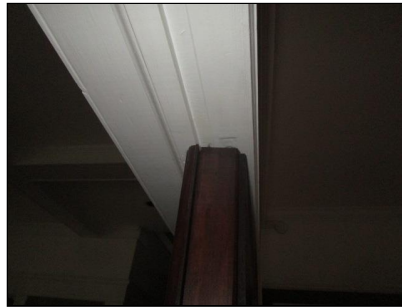
- ☒ 51. **SERVICE / REPAIR:** Modify or adjust door to latch when closed. Recommend correcting to latch as intended.
LOCATION: Office door doesn't latch, main room closet doors

Add missing latching hardware so office doors can be secured.

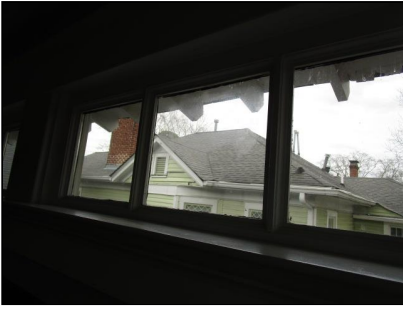
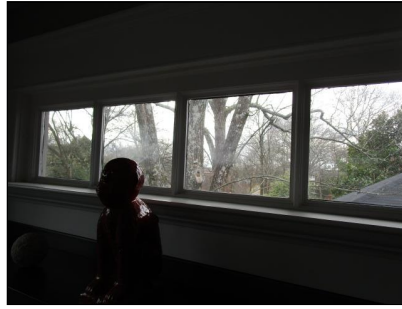
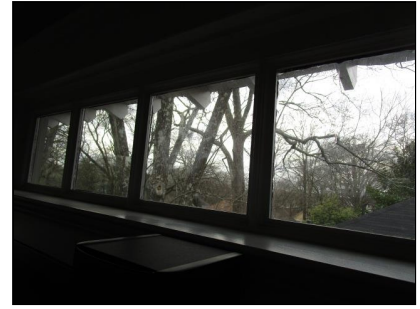
- ❌ 52. **SERVICE / REPAIR:** Condensation and / or hazing was noted between insulated window panes. - Location: upper level small windows - The thermopane insulated glass has lost its vacuum seal and may eventually completely cloud over. Broken seals also reduce the original insulation value of the window. (Dirty windows should be cleaned to assure that conditions do not exist in other units and were not obvious at time of inspection.) Recommend replacement of all damaged windows listed plus any others throughout house that may be identified by glass service.

Failed windows in the upper master sitting area.

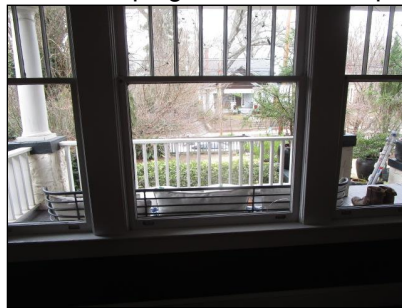
- ❌ 53. **SERVICE / REPAIR:** Paint causes many windows to stick and they should be modified to open normally for the average person. At least one window in each sleeping room must be operable as a means of emergency egress.

Many windows painted shut.

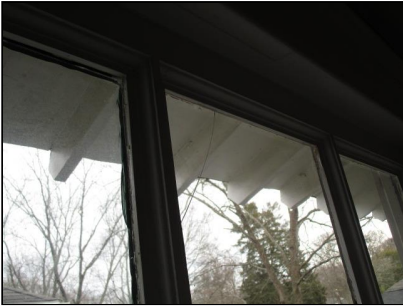
- ❌ 54. **SERVICE / REPAIR:** Cracked window observed. Inspect all windows and replace the affected glass as needed.
LOCATION: Several window panes throughout the house.

Replace cracked upper level window

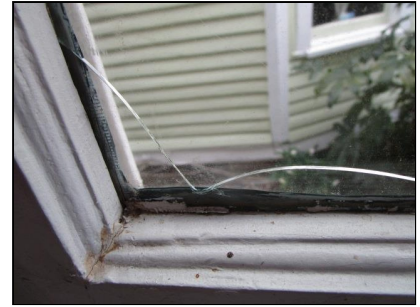
Replace all cracked window panes.

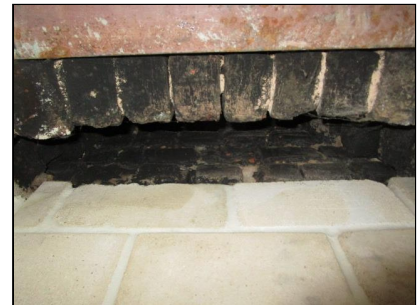
57. **MAJOR DEFECT:** The NFPA (National Fire Protection Association) recommends a Level II examination of a chimney flue whenever a real estate property changes ownership. This examination includes a complete review of all accessible portions of the fireplace and chimney from the top to the bottom, including both the interior and exterior portions. Video scanning equipment or other means shall be used as necessary to observe these areas. There are no dampers on the fireplaces. Have dampers installed. Some fireplaces are currently only decorative and may need extensive repairs to make functional. Some fireplaces will probably only be able to have gas logs installed.

Add dampers where missing
