Atlanta Property Inspections, Inc.

HOME INSPECTION REPORT

5892 Gresham Place, Mableton, GA 30126
Inspection prepared for: Ashley Zomalt
Date of Inspection: 3/14/2020 Time: 9:30 AM
Age of Home: 63 Years Old (1957) Size: 1918 SF
Weather: Overcast, Damp Soil, 58 Degrees

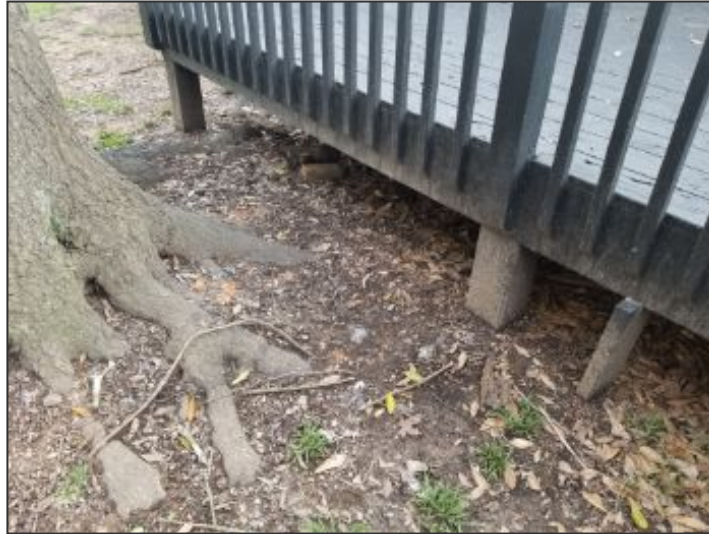
- Wood support posts are present - 4x4 and 6x6.
- Inadequate vertical support was noted at the front porch 4x4 posts. The posts are attached to the sides of the deck framing instead of supporting the framing underneath as needed. This condition allows the weight of the deck to rely on these lateral connections (screws). Further evaluation by a professional deck contractor is recommended to determine repair needs and costs.
- The wood support posts are installed below grade which is no longer allowed; this condition can lead to water damage at the lower post areas. Correction is recommended, eliminate all wood to soil contact.

Wood posts below grade at rear deck

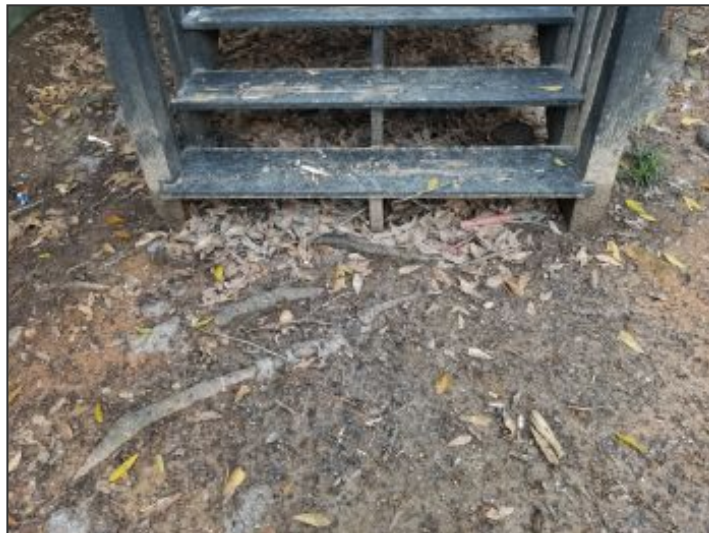
• No stairway landing is present at the bottom of the rear deck stairs as required (see photo); correction is recommended so that a minimum 3 foot landing is present on the ground.

• The wood steps at the rear deck are incorrectly installed in the soil which is not advised. This condition can lead to water damaged wood at the base of the stairway and possible movement / settlement if not corrected. Further evaluation is recommended by a professional deck / stair contractor to determine repair or replacement needs and costs.

No landing and improper support of deck stairs

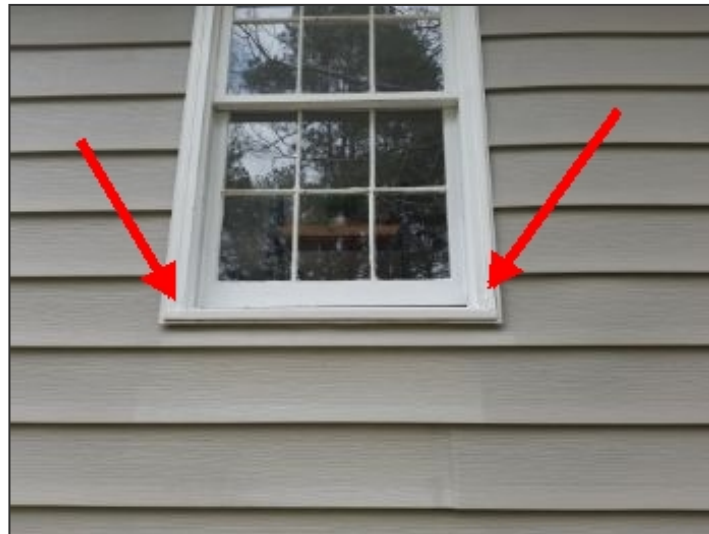
• **Damaged wood trim was noted at the lower corners of the rear master bedroom window (see photo). Replacement of the affected wood trim is recommended.**

Damaged wood trim at rear master bedroom window

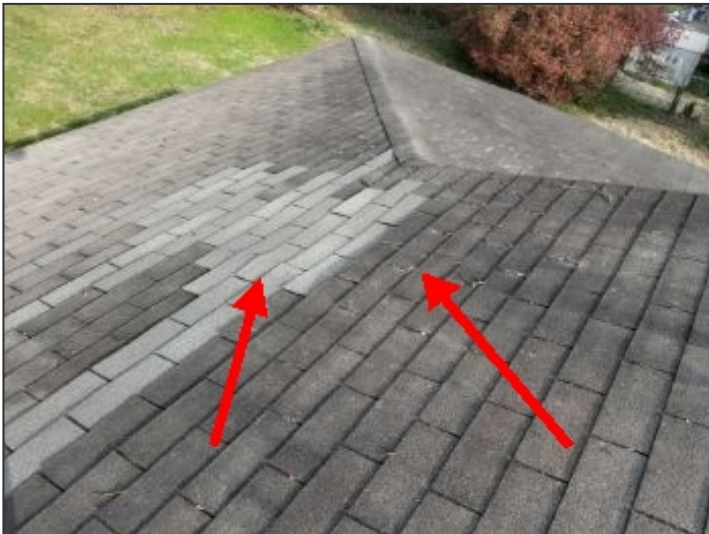
• Shingle replacement was observed on the roof at the rear right roof ridge location (see photo). The repairs appear to be adequate, continue to monitor. Additionally, unprofessional caulking repairs were found near this area which may suggest previous leaks. It is suggested that client ask seller for any available disclosure information regarding this repair.

Shingle replacement at rear right roof and caulking repairs noted above

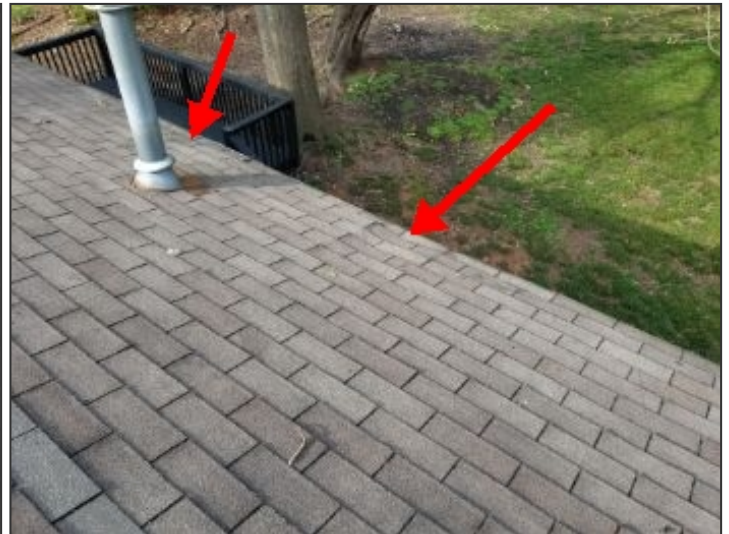
• The roof surface is indented and sagging at the rear roof near the abandoned metal exhaust vent (see photo). This condition appears to be from an active or previous leak. Water stains were found at these areas in the attic. Further evaluation by a professional roofing contractor is recommended to determine repair needs and costs.

Sagging roof surface at rear

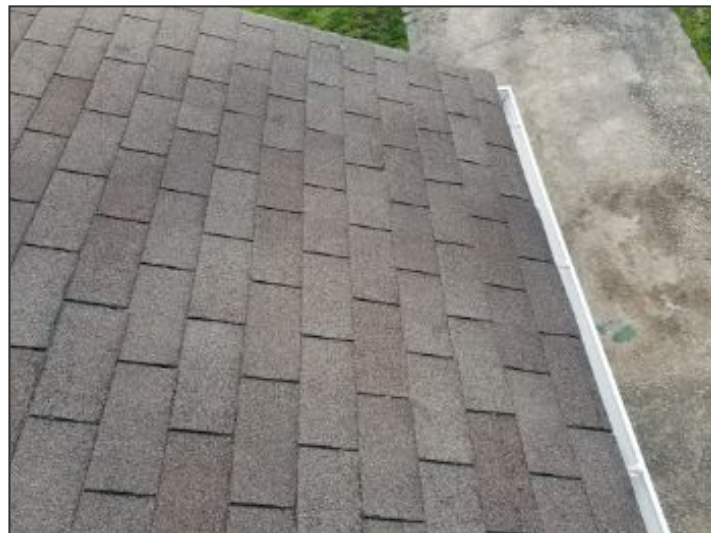
• The roof shingles have normal wear and tear for a roof in this age range, the roof is still adequate at the time of this inspection. Annual inspections are recommended, budget for future replacement in the next few years.

Normal wear and tear at shingle surfaces

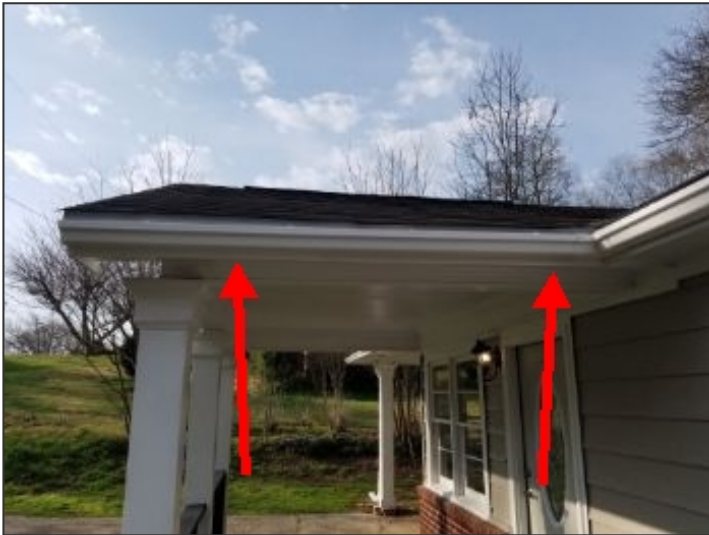
• A gutter is improperly sloped at the rear left corner and the right side porch roof; these gutters are holding water (see photos). Repair / adjustment is recommended so that the gutter is properly sloped and water flows to the downspout.

Improper gutter slope at right side porch roof

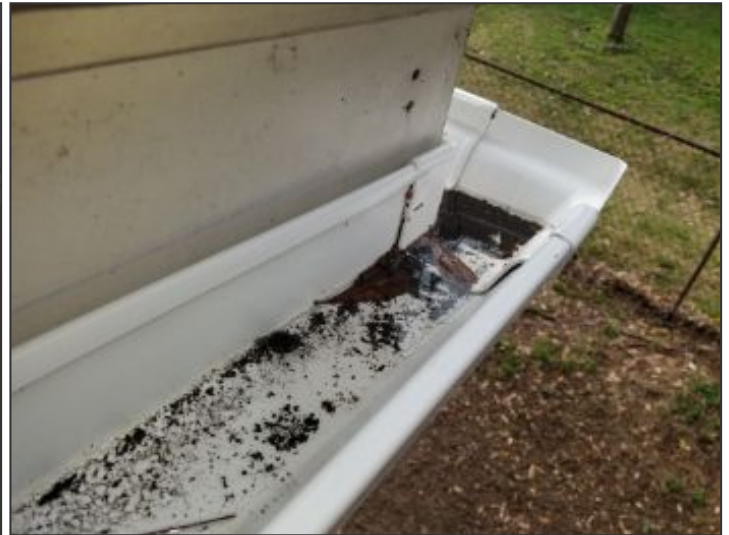
Rear corner gutter holding water

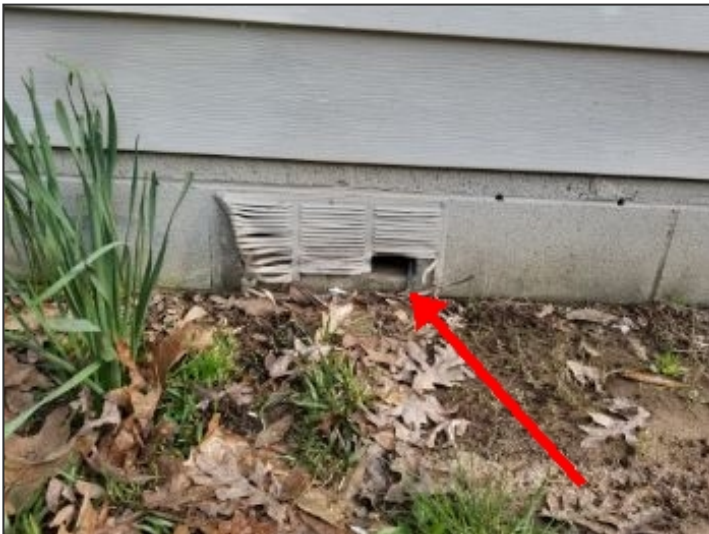
3. The left side foundation vent is damaged and has openings (see photo). Replacement of the affected foundation vent is recommended to prevent possible rodent and or other wildlife from entering the crawl space.

Damaged foundation vent at left side wall

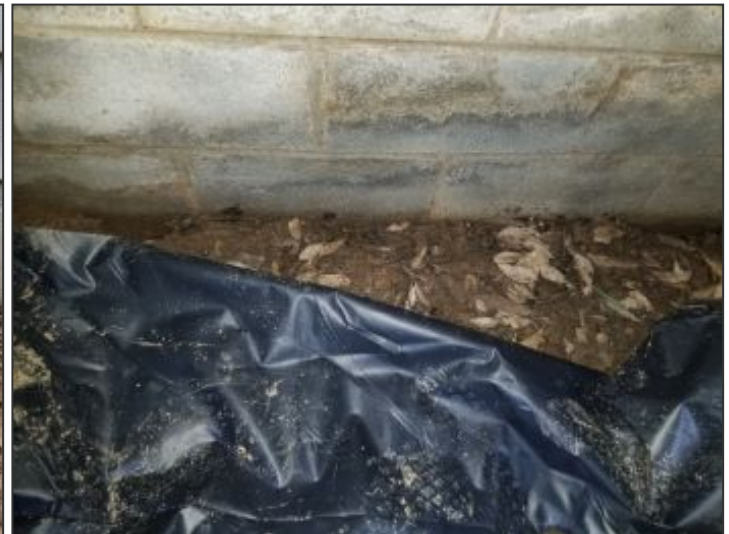
1. There is evidence of water entry in the crawl spaces at the left side foundation walls, including the front and rear corners, and at the rear foundation wall and right corner (see photos). Water stains and wet conditions were noted on the concrete blocks and on the soil in the crawl spaces. Further evaluation is recommended by a professional water proofing contractor to determine the source of the moisture and to make necessary repairs.

Wet conditions at rear foundation wall in rear crawl space

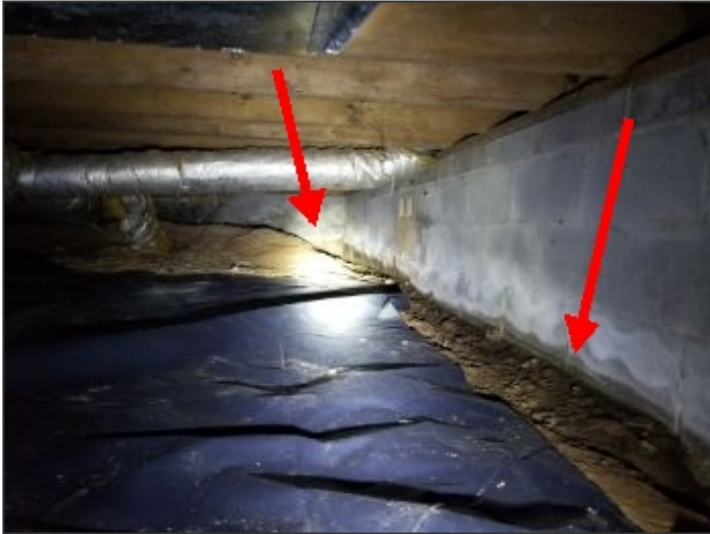
Evidence of water entry at rear and left corner foundation wall

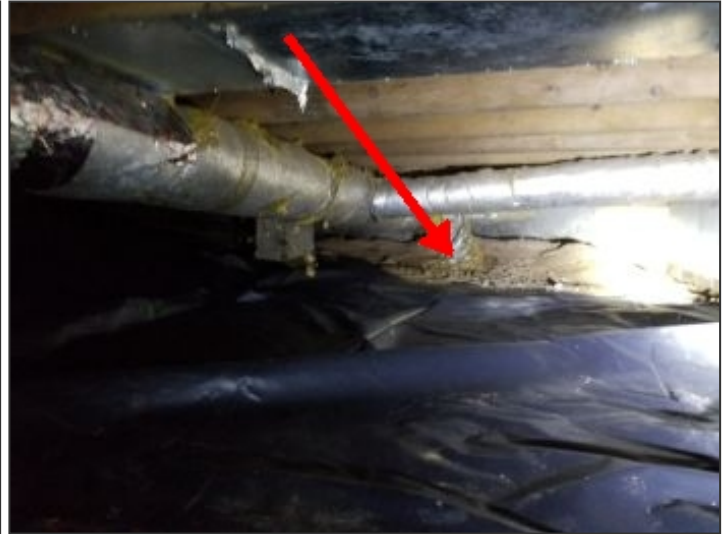
2. No vapor barrier is present on the exposed soil in the crawl space below a small section of the rear family room. A full soil vapor barrier is recommended to control moisture and humidity.

Missing vapor barrier below rear family room

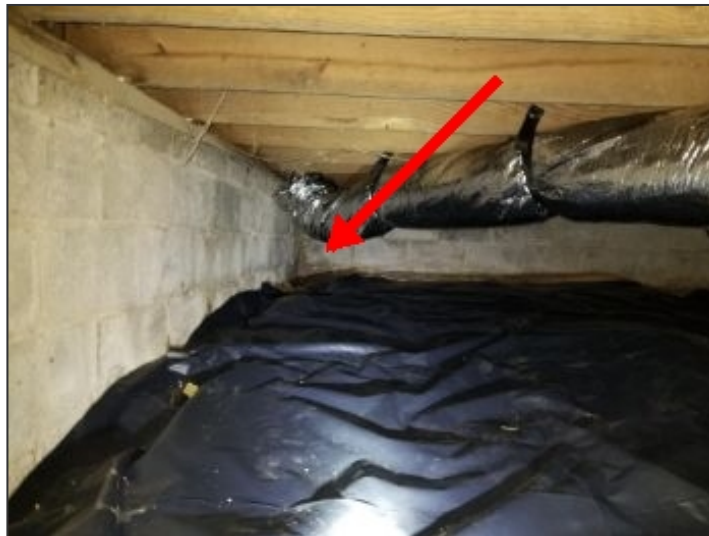
Evidence of previous water entry at front left foundation corner

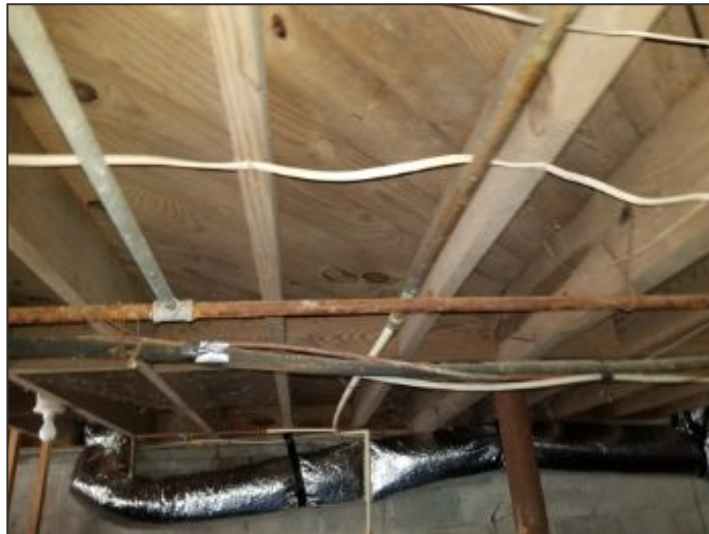
No underfloor insulation is present in the crawl space floor joists as needed to provide a full thermal barrier between the unconditioned crawl space and the heated living space above. As an upgrade, it is suggested that the floor system be fully insulated.

Recommend floor insulation in crawl space

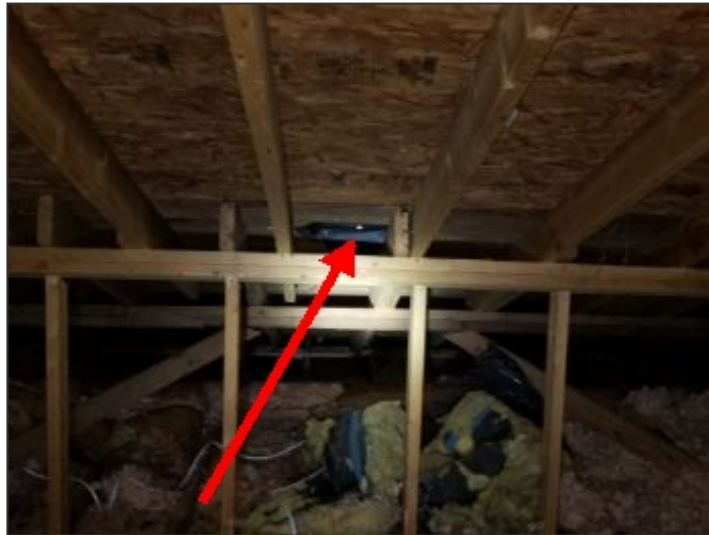
• Damaged / missing roof decking was noted at the front roof above the living room area (see photo). Daylight is present at the underside of the visible shingles. This is a leak concern; repair is recommended by a professional contractor.

Missing roof decking with daylight through shingles at front roof

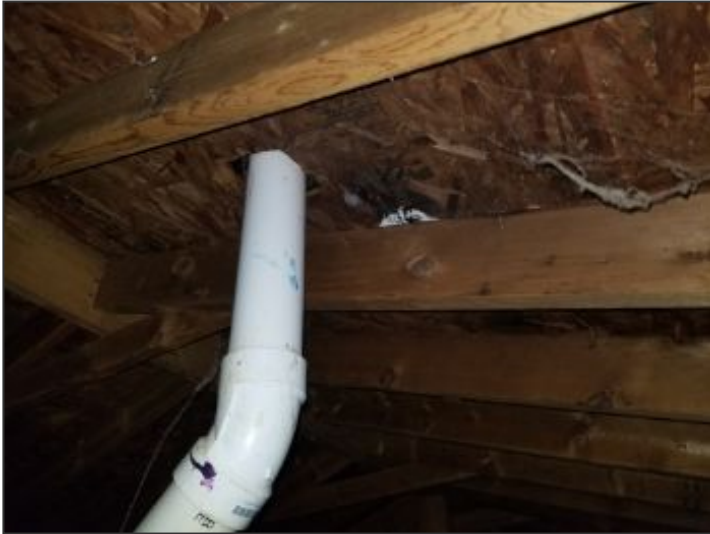
• Evidence of multiple roof leaks were observed in the attic at multiple locations including:

1. The rear center plumbing vent,
2. The rear lower roof near the abandoned metal exhaust vent,
3. The rear right side roof ridge above the master bedroom (see photos).

Evidence of a leak at center roof plumbing vent

Further evaluation is recommended by a professional roofing contractor to determine repair needs and costs.

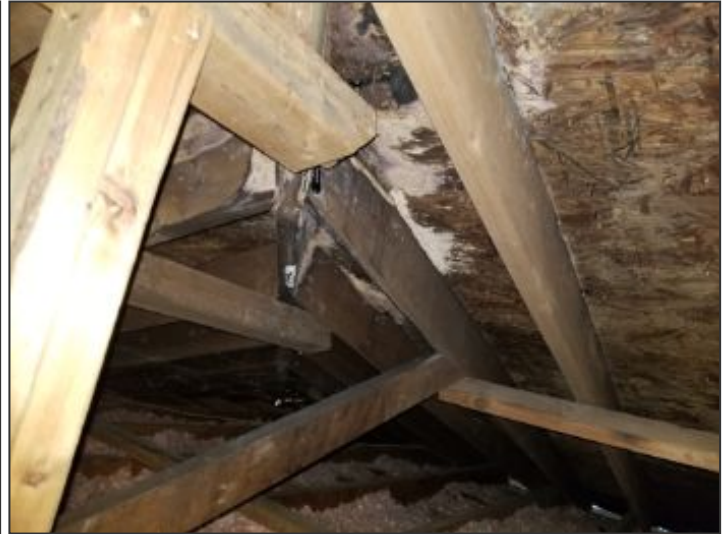
Evidence of a previous leak at right right roof ridge above master

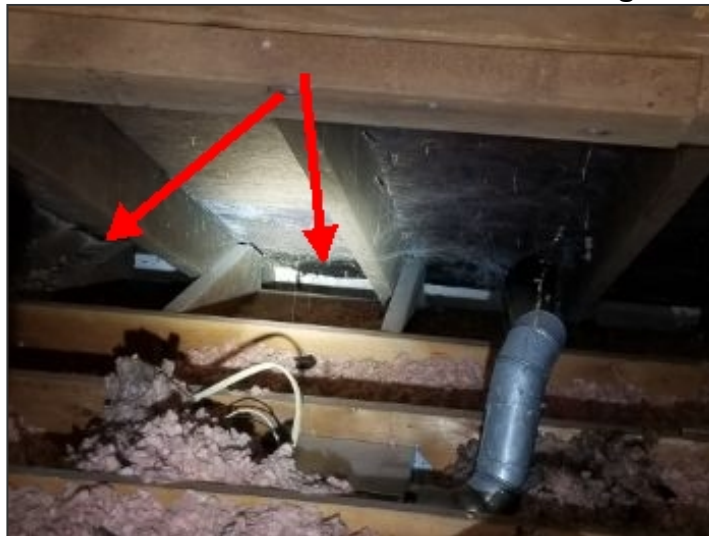
Evidence of roof leaks at rear roof

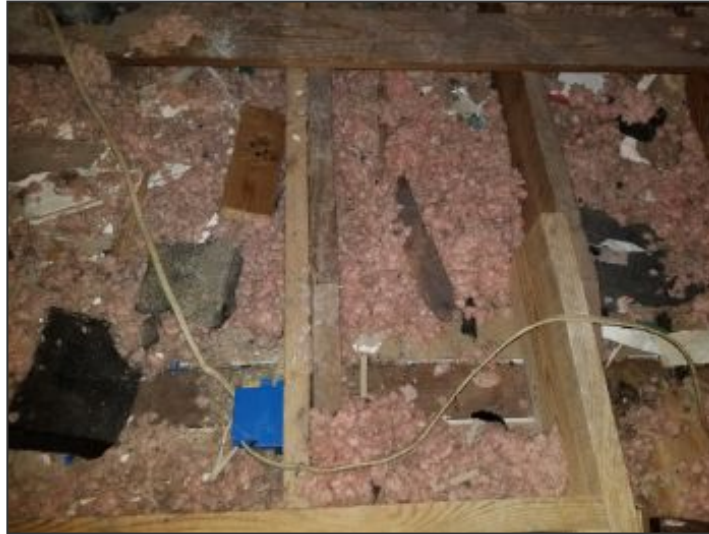
• Inadequate insulation was noted in the attic, the insulation depth is less than 12 inches. This condition does not meet current insulation and energy efficiency standards that call for a rating of R-30. Correction is recommended to meet this minimum standard.

Poor insulation depth in attic

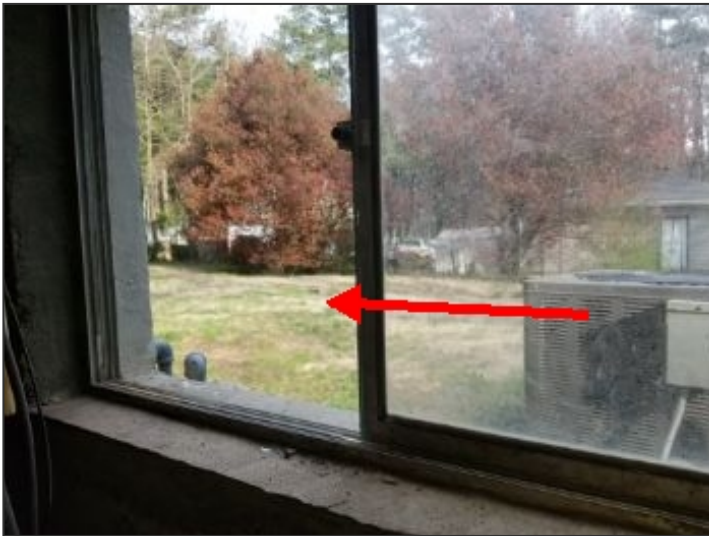
- A previous broken window was noted at the side wall of the front crawl space. The window glass has not been professionally repaired. A new piece of glass has been caulked to the framed opening, but other openings are present in the window. Further evaluation and repair is recommended by a professional window contractor.

Unprofessionally repaired window in crawl space

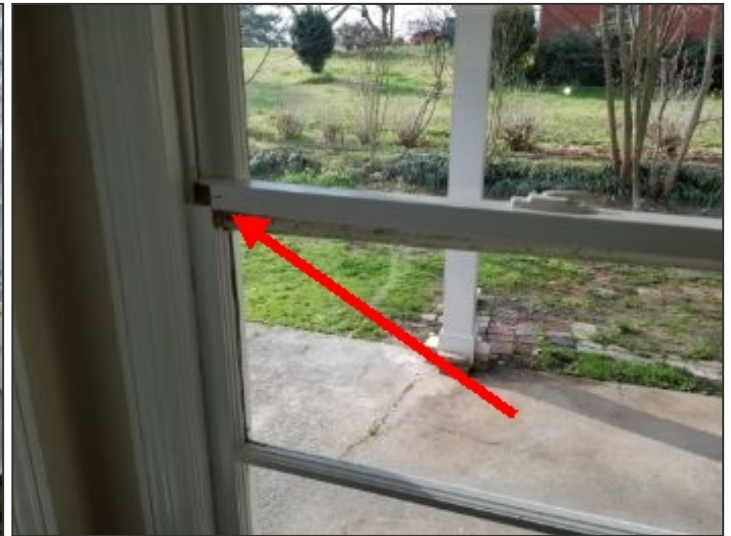
- A loose window frame was found at the corner window of the left living room wall (see photo). Further evaluation is recommended by a professional window contractor.

Damaged / loose window frame in front living room

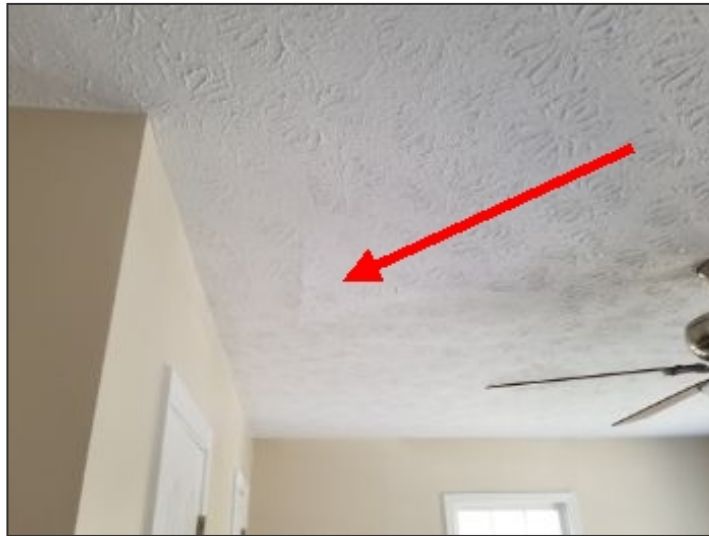
Water stain at master bedroom ceiling

1. Ask seller for full disclosure information regarding this leak.
2. Further evaluation may be needed to determine repair needs, if any.
3. Continue to monitor, future repairs may be needed.

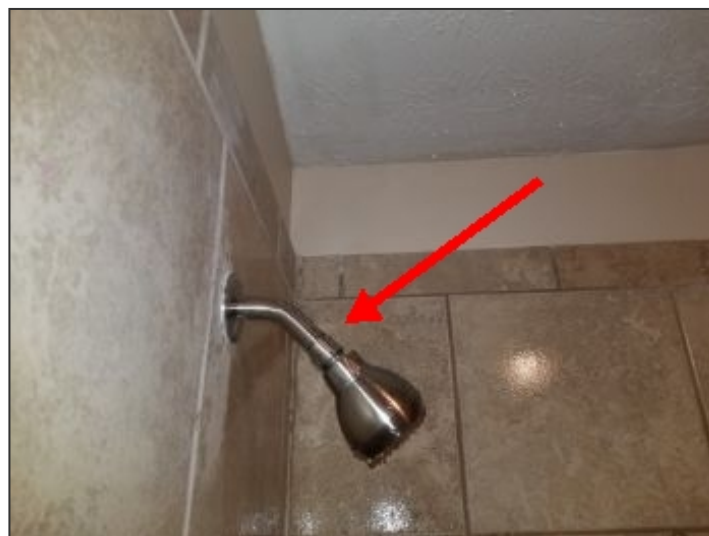
• **The shower heads at both bathrooms are actively leaking at the shower head connections. Repair or replacement is recommended.**

Active leak at master shower head connection

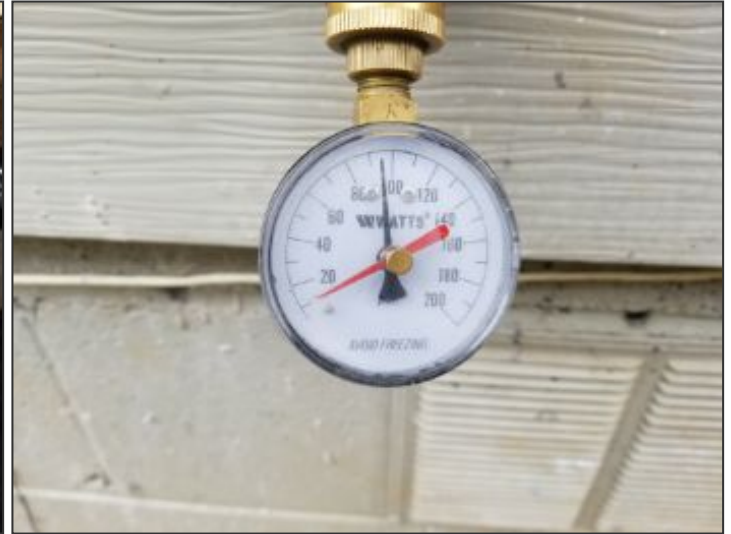
A water pressure reading was taken at the rear hose bib and was found to be too high at 95 PSI (see photo). A normal water pressure reading is in the 40 - 80 PSI range. This condition could be an indication that the pressure reducer valve is defective. Further evaluation is advised by a professional plumber to determine repair needs and costs. Excessive water pressure can create potential leaks in the plumbing system such as the water heater tank, the water heater T&P valve and the washing machine supply hoses.

Water pressure too high at 95 PSI

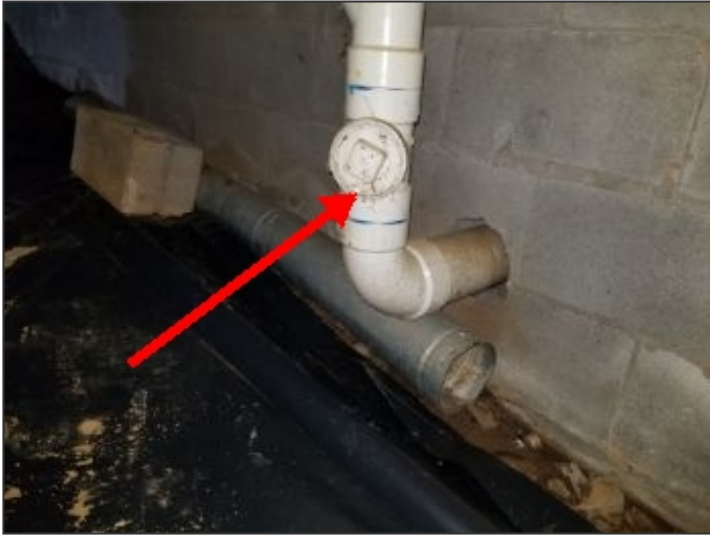
• During testing of this home's plumbing system, the inspector noticed that the exposed PVC drain pipe was leaking / spraying water at the elbow connection and the interior toilets were bubbling (see videos). This condition appears to be from a clog or other issue with the piping or septic system and could not be confirmed during this limited visual inspection. Further evaluation by a professional plumber and or septic contractor is advised to determine repair needs and costs.

Active leak at plumbing drain clean out cap

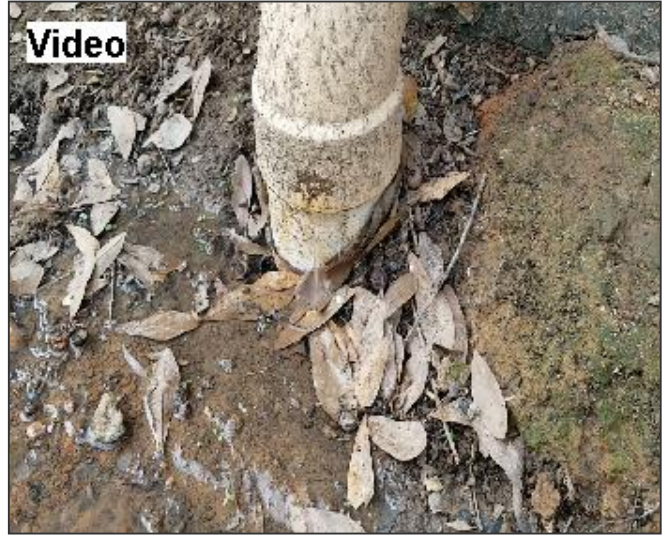
• An exposed drain pipe was noted at the rear foundation wall / yard (see photo). The plumbing drains are not allowed to be exposed to the exterior elements. Further evaluation and correction by a professional contractor is recommended.

Active leak at rear exterior plumbing drain

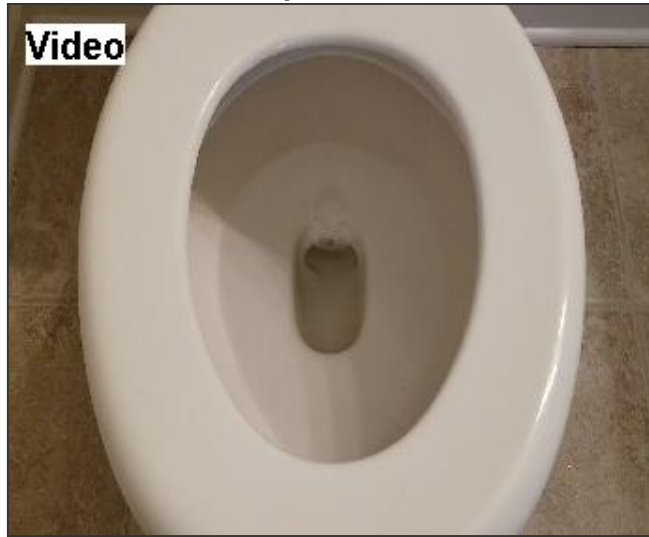
Toilets bubbling during testing of fixtures

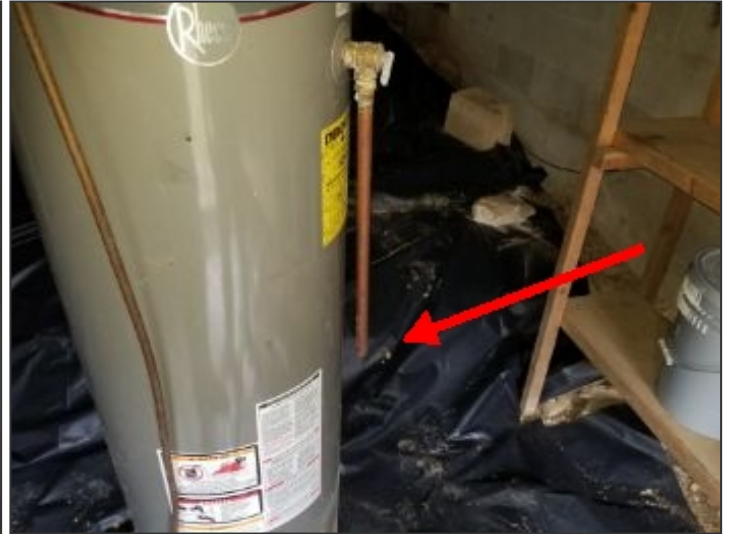
- **The temperature and pressure (T&P) relief drain pipe incorrectly drains onto the crawl space floor which is not advised. Correction is recommended by a qualified plumbing contractor so that the drain terminates outside or into an approved drain.**

Temperature and pressure relief drain terminating into crawl space

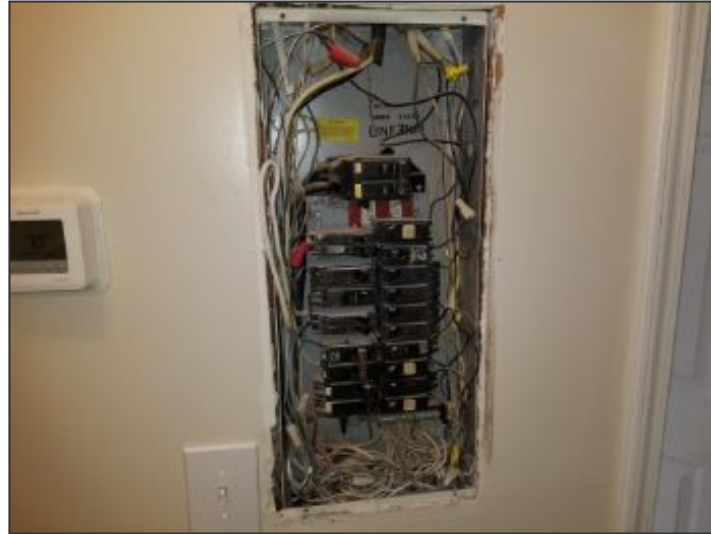
• **The circuit breakers in the main panel are not fully identified as required. Correction is suggested.**

• **Several incoming circuits into the panel box are not clamped and secured at the panel entry as required by the National Electric Code (NEC). Correction is recommended by a licensed electrician.**
