National Property Inspections

Dianna Newton, 1685 Stanwyck Terrace, Tucker, GA, 30084

Inspection Date:
02/18/2020

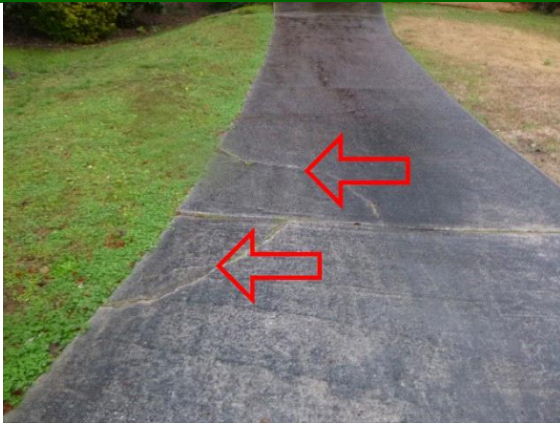
The left side concrete driveway is cracked and in general deteriorating due to age. Recommend repair of all cracked locations by a qualified contractor to avoid tripping hazards.

Driveway: Repair cracking

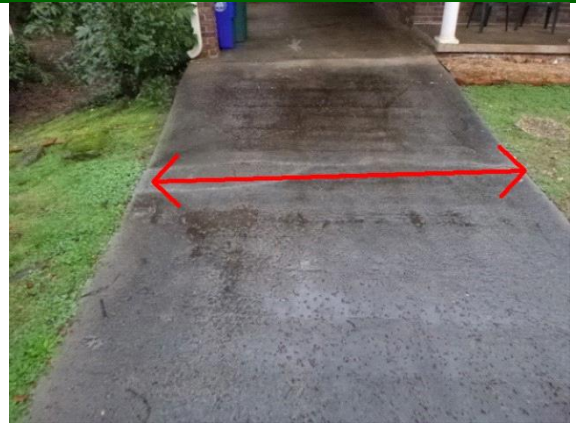
Driveway: Repair cracking

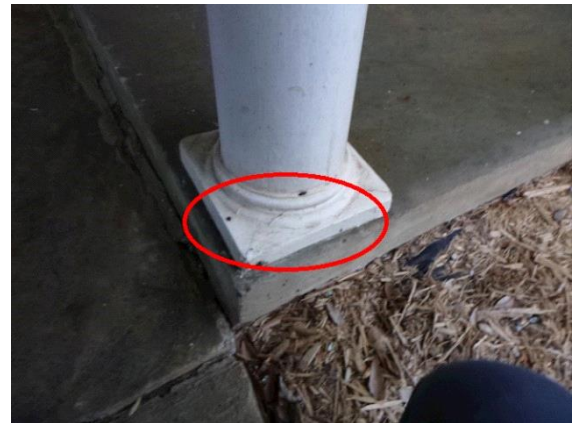
Wood rot observed on the bottom of the porch post trim on 2 of the posts. Recommend repair by a qualified contractor.

Porches / Stoops: wood rot

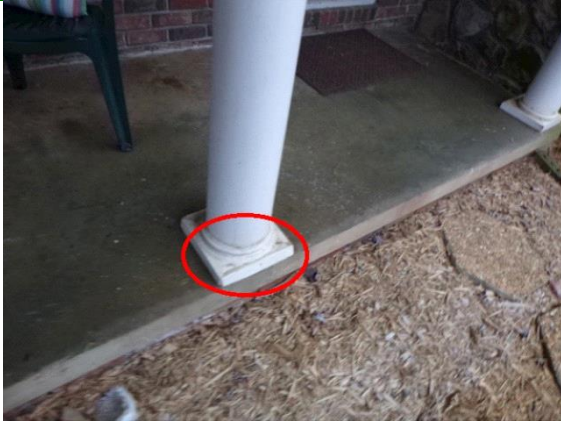
Porches / Stoops: wood rot

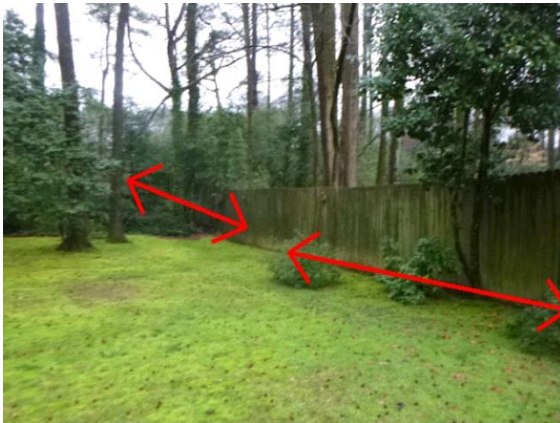
Fence posts and slats are in contact with the ground. Direct contact of the wood to the earth creates a condition conducive to wood deterioration and wood destroying insect activity. Recommend separation of wood from earth contact to reduce potential for deterioration.

The fence along the right side of the property is leaning cracked in a few locations and deteriorating due to age. Recommend repair by a qualified contractor.

Fences / Gates: leaning, rotting

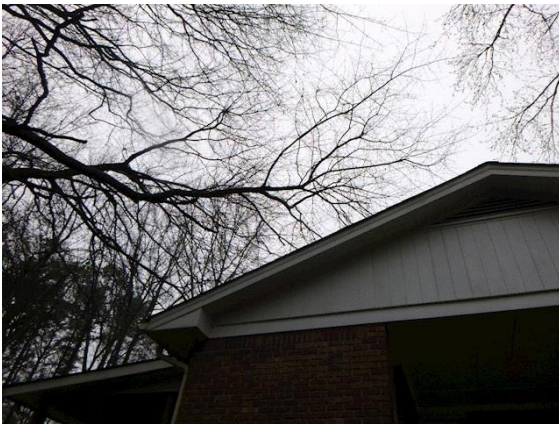
Keep trees and branches trimmed to prevent damage to roof covering.

Roofing: Trim trees

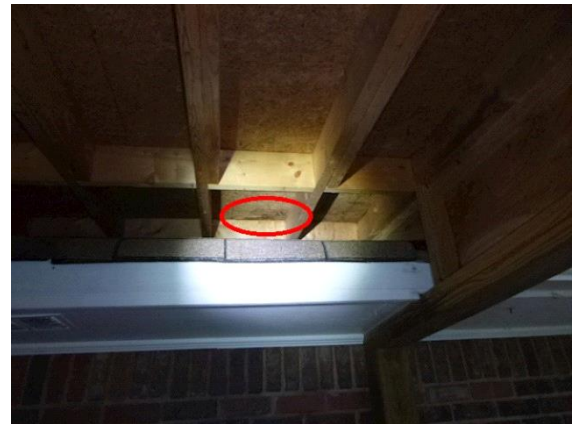
The roof above the deck is leaking in 2 locations where it connects to the main roof. This roof is sloped 1.5/12 and has standard 3-tab shingles. Roofs with a slope less than 3/12 should not use standard shingles according to the shingle manufacturers due to potential for leaks. Recommend a qualified roofing contractor evaluate and repair/replace the roof above the deck to prevent leaks.

Roofing: leaking above deck

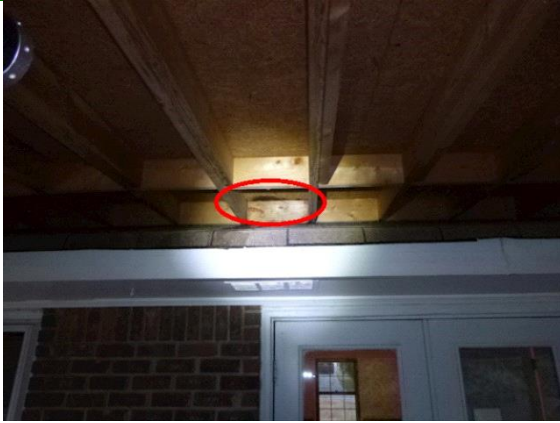
Roofing: leaking above deck

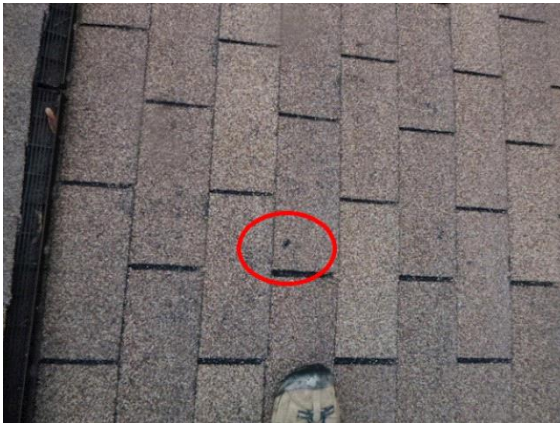
Damaged shingle noted at the front right portion of the roof is actively leaking. There is also 1 other suspected leak at the front middle of the roof above the bathroom. Sealant on nails has deteriorated on most of the roof flashings which can lead to leaks. Recommend further evaluation and repair by a qualified roofing contractor.

Roofing: damaged shingle, active leak

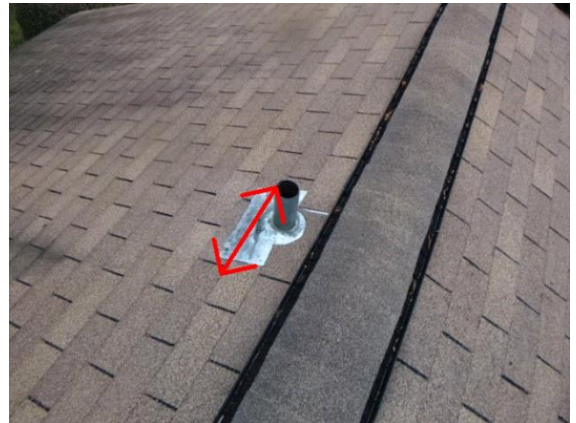
Roofing: sealant on nails is deteriorated/missing

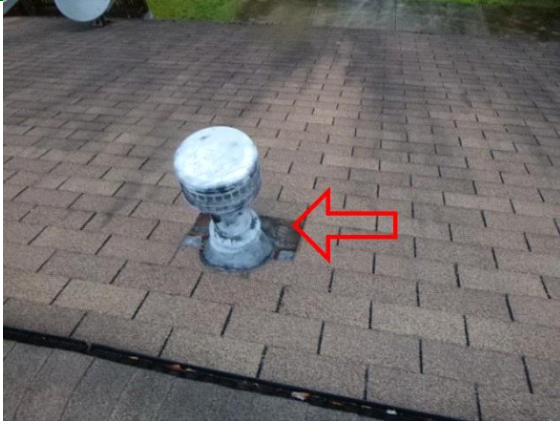
Roofing: sealant on nails is deteriorated/missing

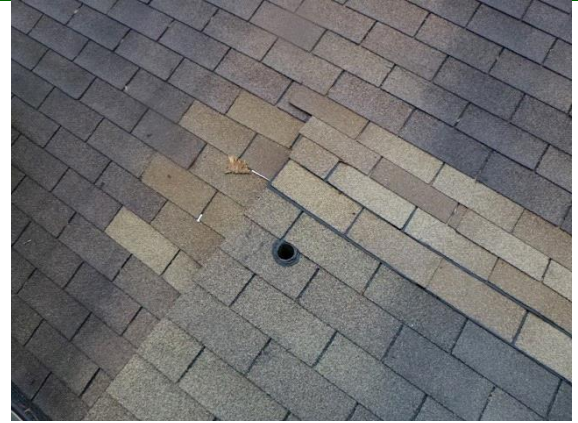
There is a plumbing vent that does not extend 6" above the roof as required. The vent is flush with the roof above the deck and will allow water to enter the system. Recommend a qualified roofing contractor extend the vent and seal the roof properly to prevent leaks.

Roofing: vent flush with roof

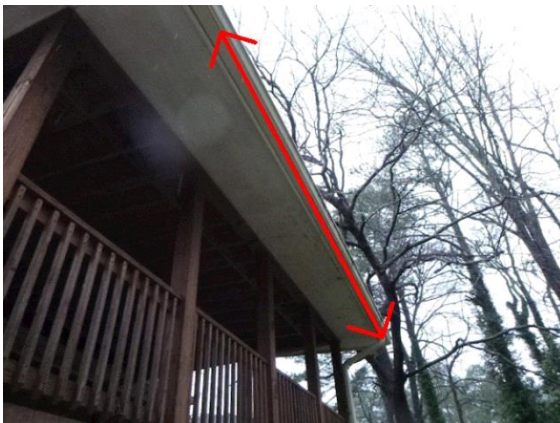
Gutters have signs of overflowing during heavy rainfall, however they are in good condition and are lean. This is likely due to excessive rainfall. Unable to determine a solution. You may want to consult with a gutter contractor for further evaluation and recommendations.

Gutters/Down Spouts: signs of overflowing

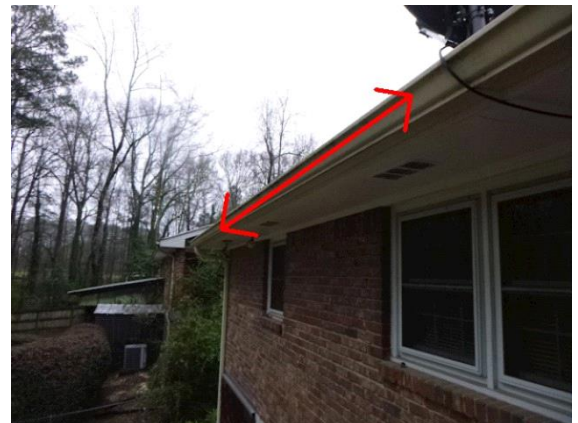
Gutters/Down Spouts: signs of overflowing

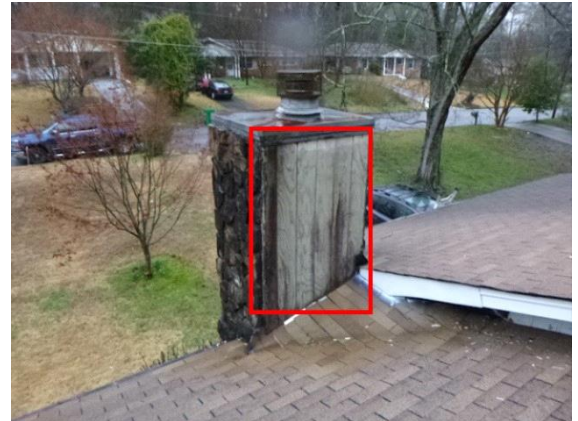
The back of the chimney is composed of wood siding. The siding is rotting. Recommend repair by a qualified contractor,

Chimney: wood rot

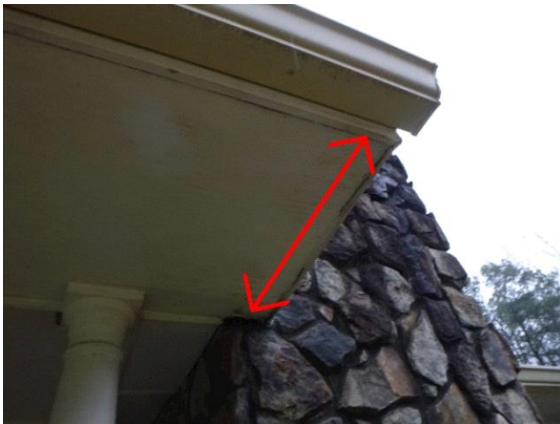
Wood rot observed on fascia at the front left corner of the home and on the soffit at the right end of the porch. Recommend repairs by a qualified contractor.

Exterior Surface: wood rot

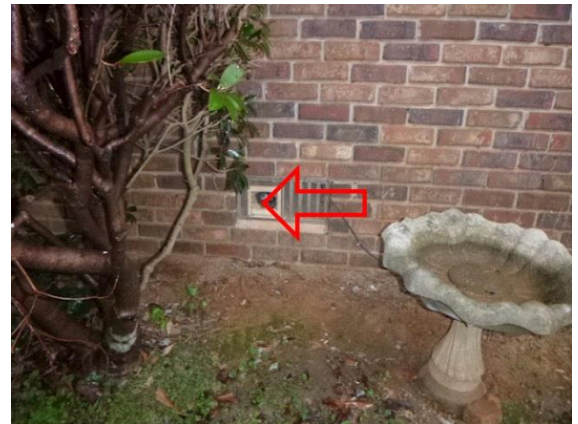
Laundry vent cover is missing/damaged at the front of the home. Recommend repair by a qualified contractor.

Exterior Surface: damaged vent

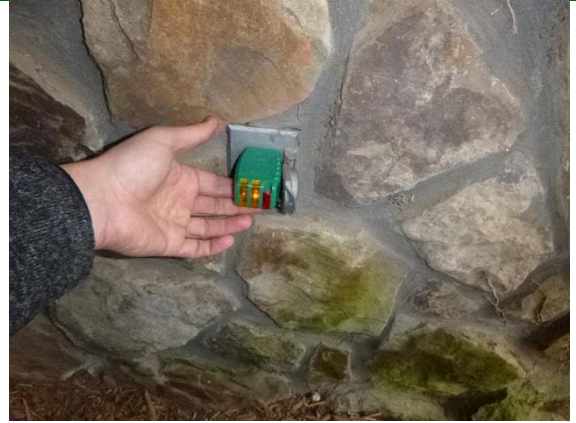
Exterior outlets operate properly. Outlets are not grounded or GFCI protected as required. Recommend installation of grounded GFCI outlets by a qualified electrician.

Exterior Surface: Outlet not GFCI protected or grounded

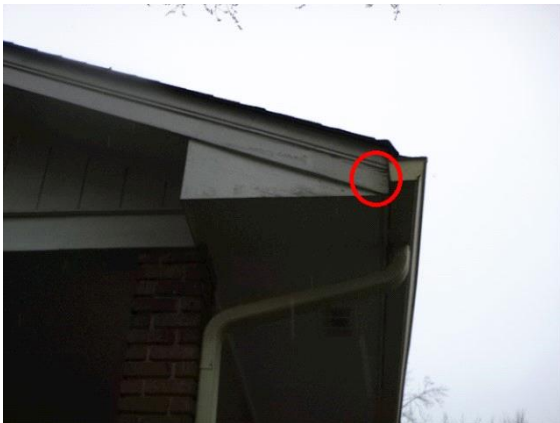
Exterior Surface: Wood rot

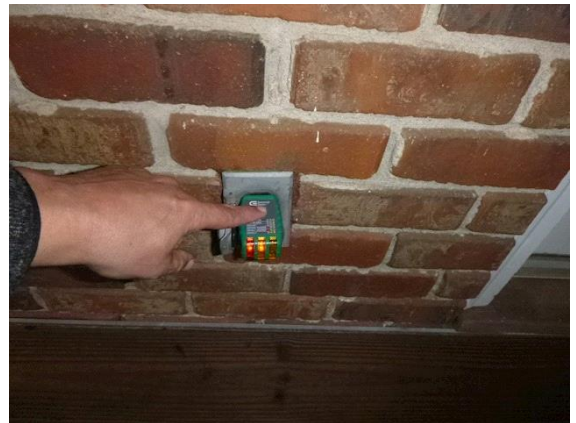
Exterior Surface: Outlet not GFCI protected or grounded

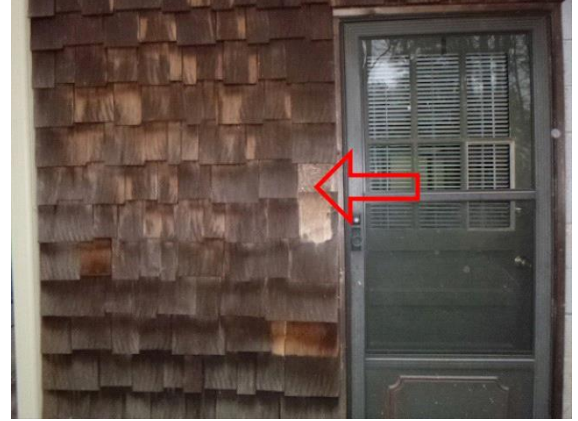
Missing 1 piece of cedar siding at the rear right corner of the home. Recommend repair.

Exterior Surface: missing siding

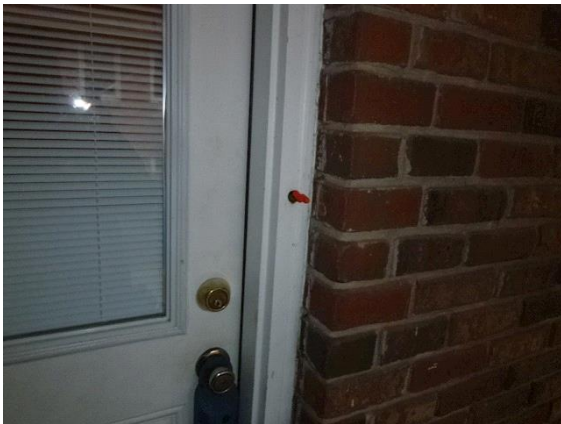
The doorbell dings but doesn't dong. The left side doorbell is missing. Recommend repairs by a qualified contractor.

Exterior Doors: missing doorbell

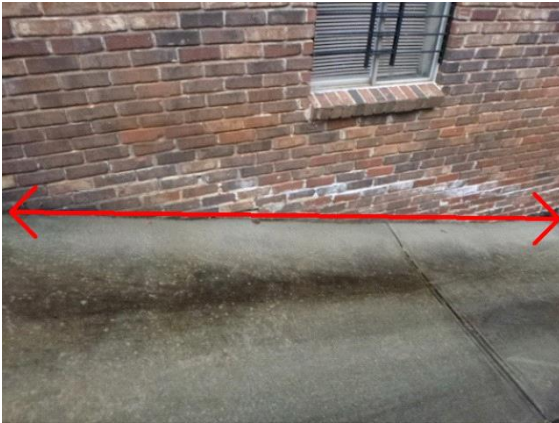
There are signs of previous water intrusion in the basement along the right side foundation wall. This is adjacent to the newer driveway. Recommend sealing the gap between the driveway and foundation to prevent water intrusion.

Foundation: seal gaps

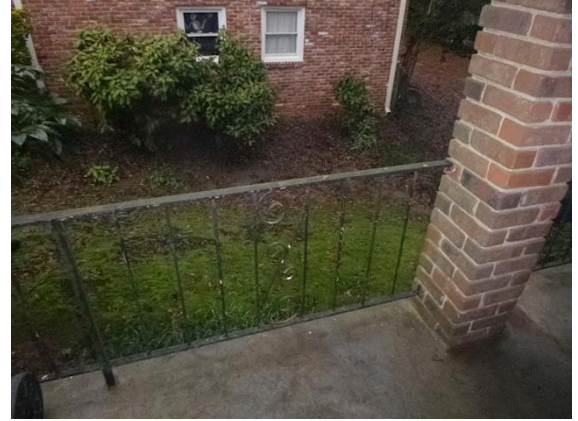
The railings at the left side of the carport are loose from the walls and the openings in the balusters are 6" wide as opposed to 4" wide for safety. Recommend replacing railings by a qualified contractor.

Garage/Carport: loose railing, balusters spaced at 6"

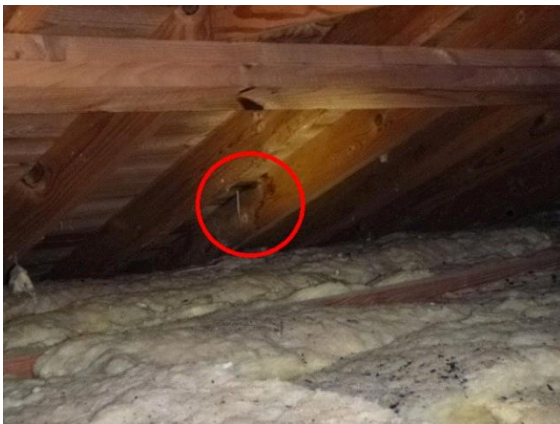
Roof leak and water stains on sheathing noted at the front right portion of the attic, water stains and suspected leak also noted above the hall bathroom. Recommend a qualified roofing contractor evaluate and repair to prevent leaks.

Attic Framing/Sheathing: Water stains

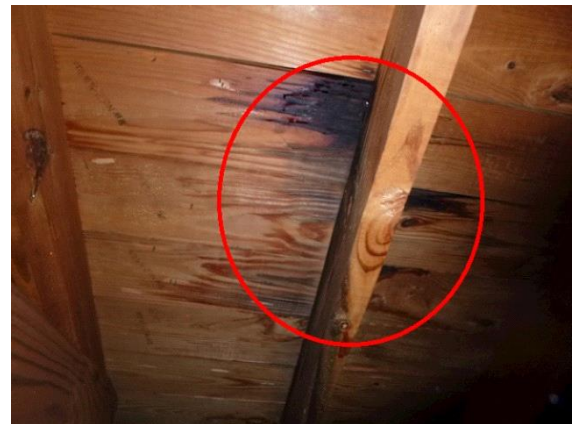
Attic Framing/Sheathing: Water staining, active leak

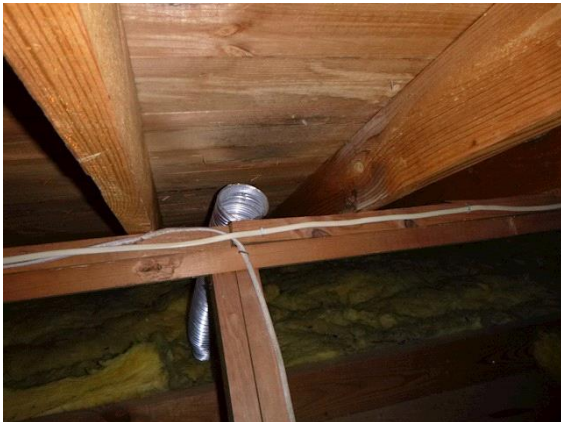
Bathroom exhaust fans are exhausting in the attic causing an increase of moisture in the home. Recommend connection of exhaust tubing to exterior vents by a qualified contractor.

Attic Ventilation: Bathroom venting into attic

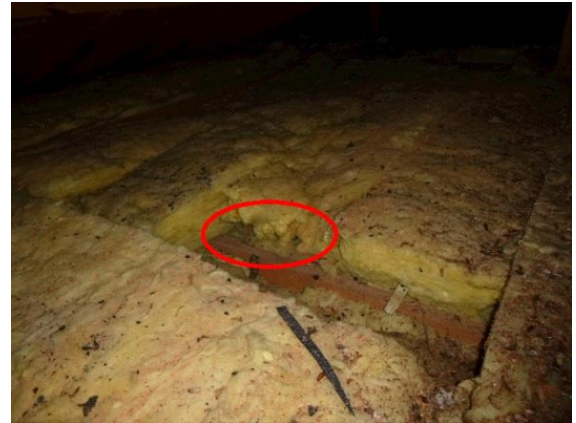
Suspected nuisance pest activity is evident in the attic with tunnels in the insulation and droppings on top of the insulation. Unable to determine if activity is current or not. Recommend wildlife pest control inspection by a qualified contractor. Follow pest control contractor recommendations for repair/exclusion.

Attic Insulation: tunnels

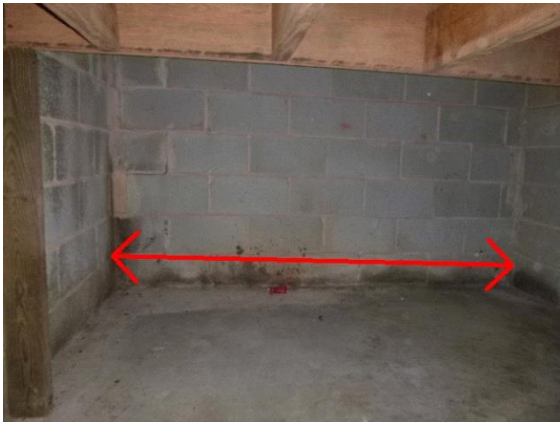
There is efflorescence on the foundation walls at the left, front and right side. Areas were dry at time of inspection. Recommend ensuring the driveway is sealed along the foundation, gutters drain properly and good grading is maintained around the property to prevent further water intrusion. If further water intrusion is noted consult with qualified contractor for repair.

Interior Foundation: efflorescence

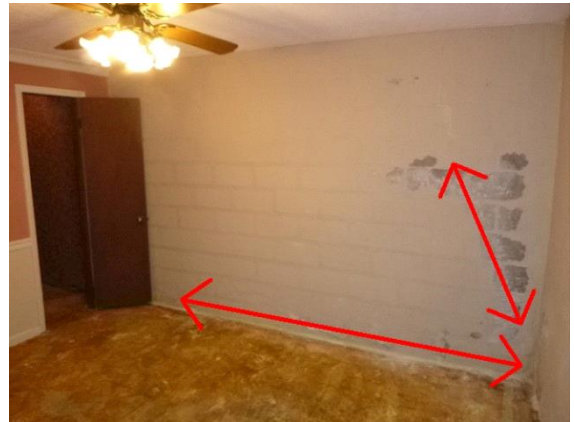
Interior Foundation: efflorescence

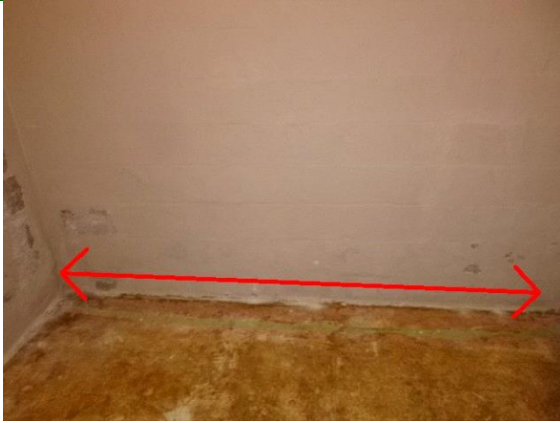
Interior Foundation: efflorescence

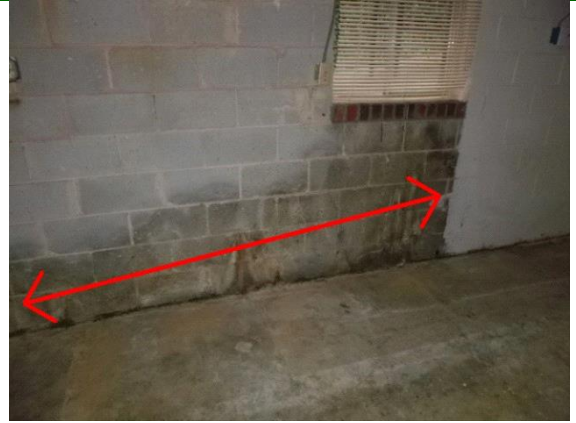
Interior Foundation: Signs of water intrusion

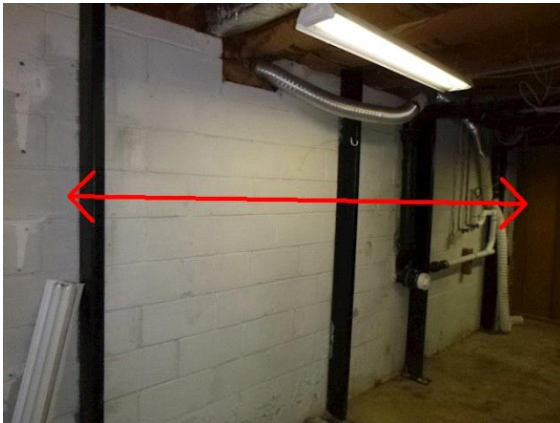
The front foundation wall in the basement has a series of steel supports bolted to the slab and floor joists. The wall appears to have bowed/moved over time likely due to an old grading defect. Recommend consulting with seller to determine if there is any documentation or warranty associated with the repairs. If no documentation is provided you may want to consult with a foundation repair contractor for further evaluation.

Interior Foundation: steel supports added

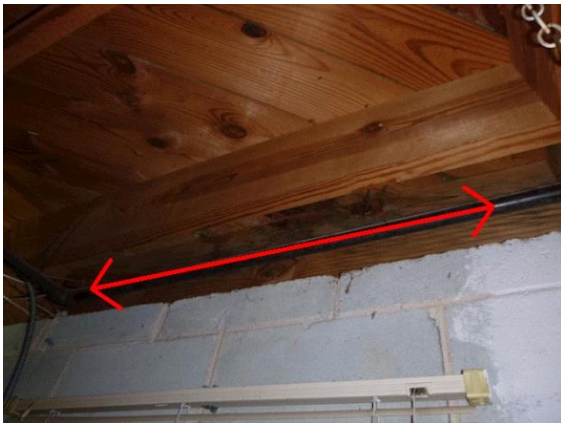
Suspected fungal growth observed on air supply vent in basement front room and on floor joists and subfloor in the basement in numerous locations (see photos). Recommend a qualified mold remediation contractor perform testing and evaluate to determine if mold remediation is needed.

Under Floor Framing & Support: Suspected fungal growth

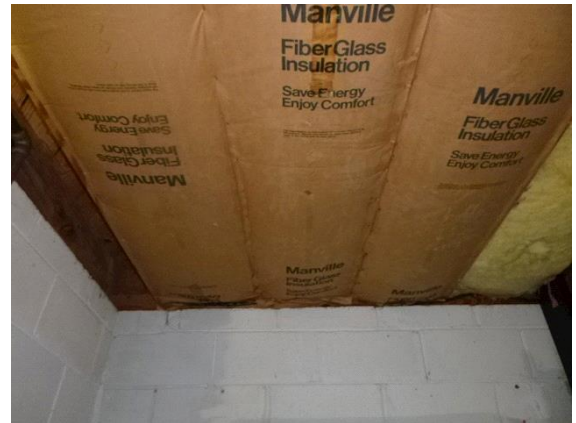
Faced insulation has been installed in the unfinished basement and the facing has been left exposed. This is a fire hazard according to the labeling on the insulation. This type of insulation is designed to have drywall installed over it. Recommend replacing with different insulation or installing drywall to prevent fire hazard.

Under Floor Framing & Support: insulation facing exposed

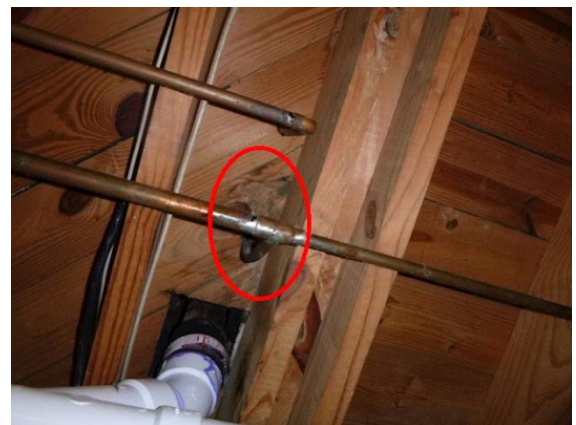
Under Floor Framing & Support: Suspected fungal growth

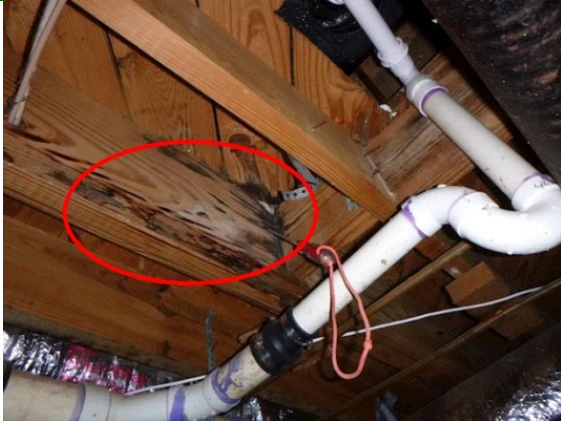
There is a rotted floor joist due to previous leaks below the hall bathroom. Recommend repair by a qualified contractor.

Under Floor Framing & Support: wood rot, Suspected fungal growth

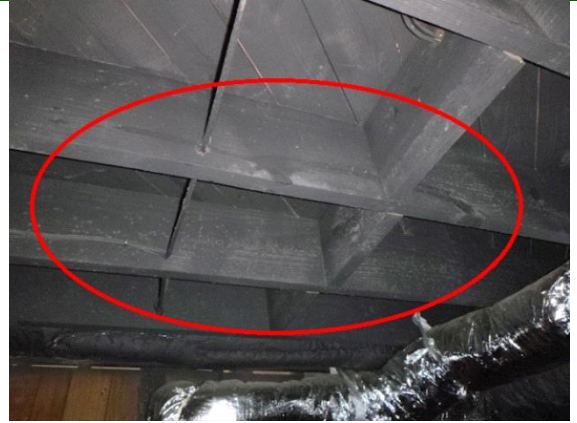
Under Floor Framing & Support: Suspected fungal growth

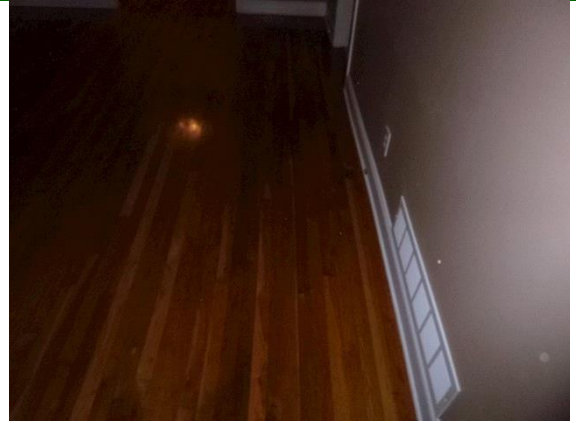
Creaky flooring noted in numerous areas throughout the home. This is typical for an older home. Recommend a qualified flooring contractor repair to prevent creaky floors.

Floor/Slab: creaking flooring

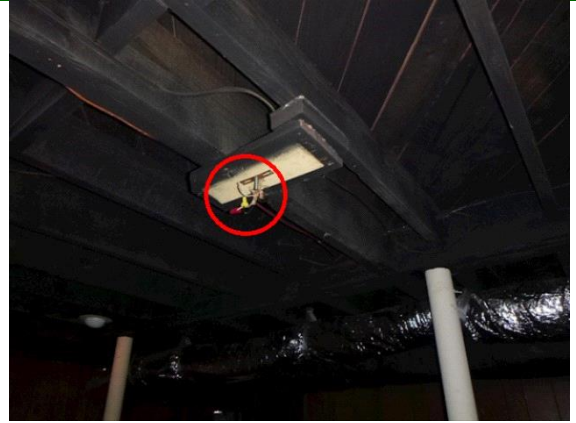
Observed exposed wiring and splices not contained in junction boxes in the basement in 3 locations. These are potential shock hazards. Recommend repair by a qualified electrician.

Electrical: exposed wiring

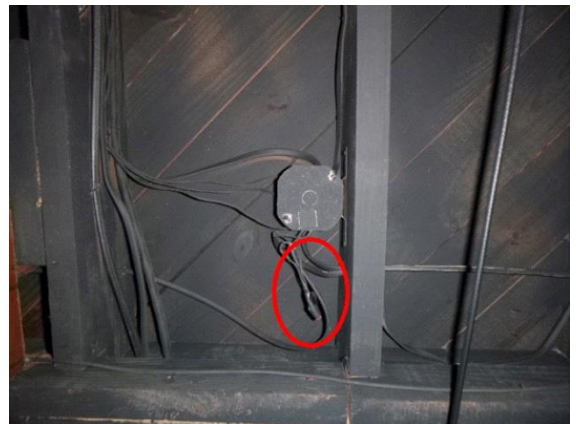
Electrical: exposed splice

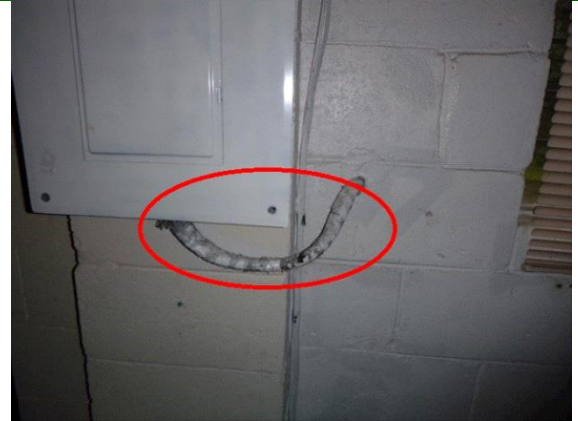
The service entrance cable sheathing is deteriorated and missing on the entrance cable above the meter and inside the home below the panel. This has exposed the internal wiring and is a safety hazard. Recommend further evaluation and repair by a qualified electrician.

Electrical: deteriorated sheathing

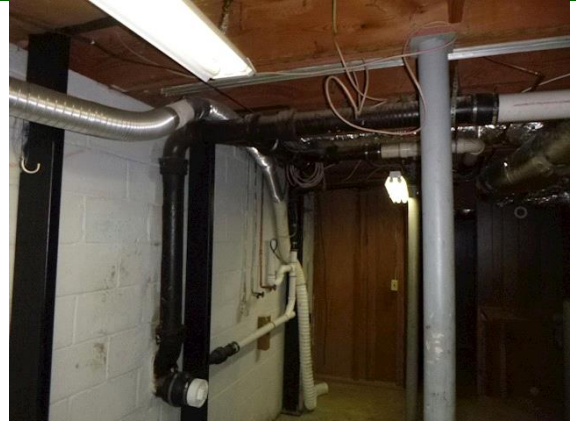
Many of the drain pipes are the original cast iron pipe. These pipes will deteriorate over time and leak. Recommend monitor the drain pipes annually to be aware of the development of any leaks. Consider having the drain line scoped by a licensed plumber to determine the integrity of the drain lines.

Plumbing: Cast Iron Drains

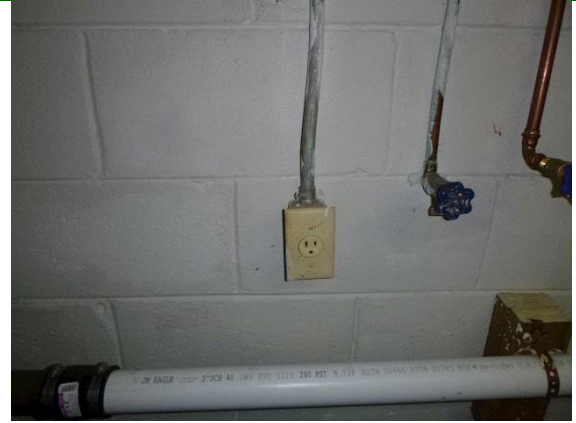
Comments:
 GFCI outlets not present, recommend installing GFCI outlet(s) by a licensed electrician for safety and compliance with current electrical standards.

Laundry Facilities: outlet not GFCI

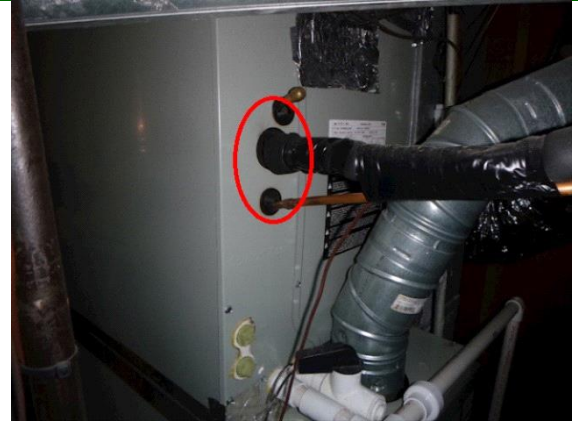
The furnace cabinet is not properly sealed at the condenser line set entering the unit. This is allowing air to escape diminishing the effectiveness of the HVAC system. Recommend seal the opening with a proper boot or HVAC tape.

Heating #1: seal cabinet

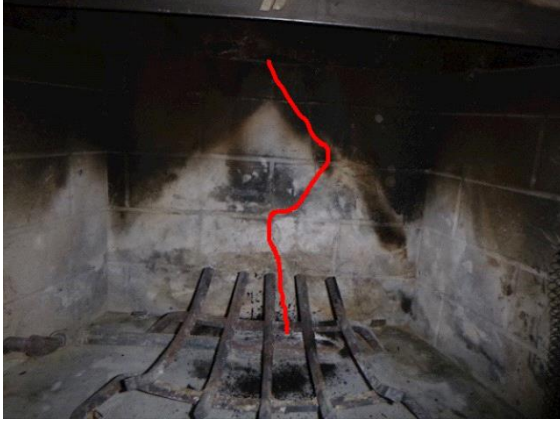
Several cracks/damage to firebox. Use of a damaged firebox may present a risk of fire. Recommend further evaluation and repair by a qualified fireplace contractor.

Fireplace/Stove: Damaged firebox

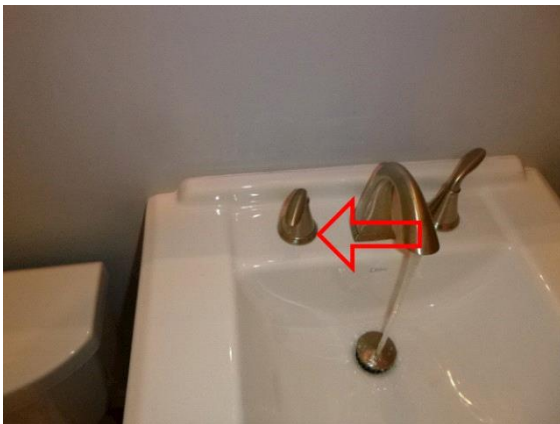
The hot water handle on the sink is loose from the counter. Recommend repair by a qualified plumber.

Hall Bathroom : loose handle

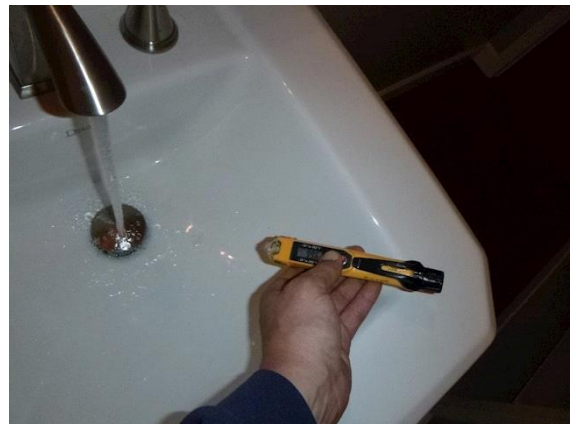
Hot water at shower does not get as hot as other fixtures in the home indicating a problem with the installation or mixing valve. The max temp at the shower was 93F, other fixtures on the home were 99F and above. Recommend repair by a qualified plumber.

Hall Bathroom : water temp at 99F

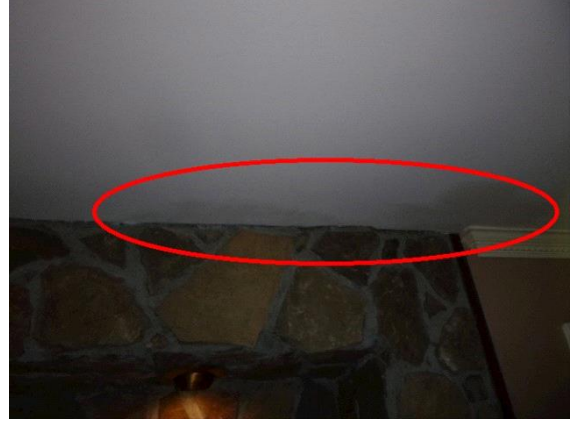
Water stains noted on ceiling around fireplace. Areas were dry at time of inspection. Monitor for leaks and repair as needed.

Family Room: water stains

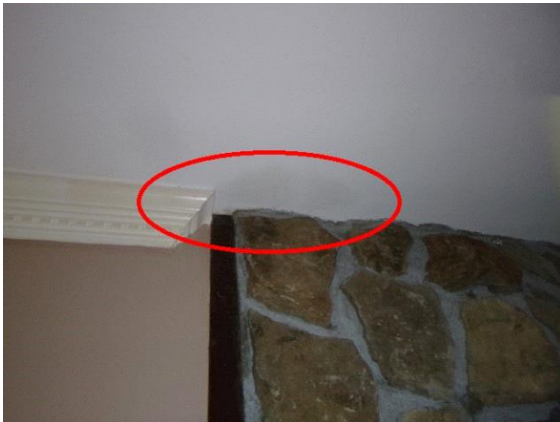
Family Room: water stains

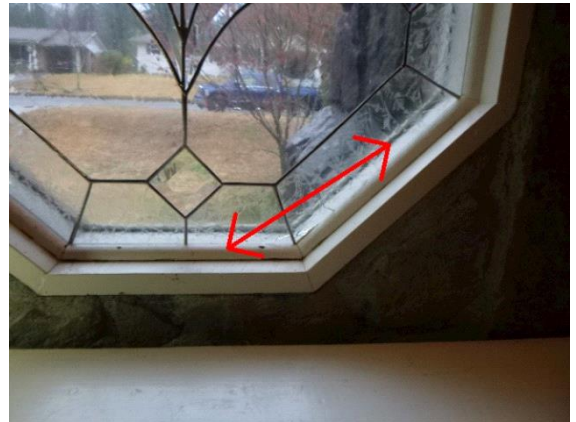
The glass in the front door and the octagonal window are cracked. Recommend repair by a qualified contractor.

Family Room: cracked glass

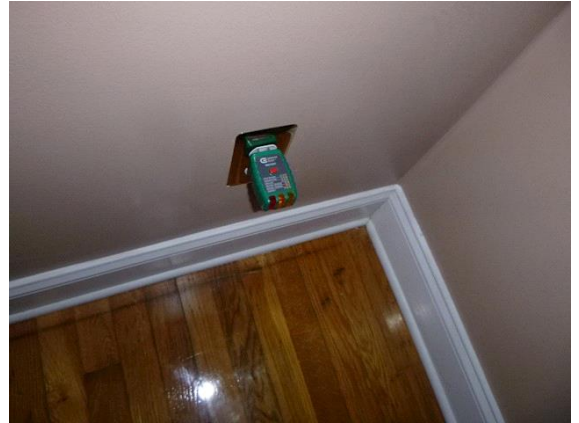
2

outlet not grounded - example

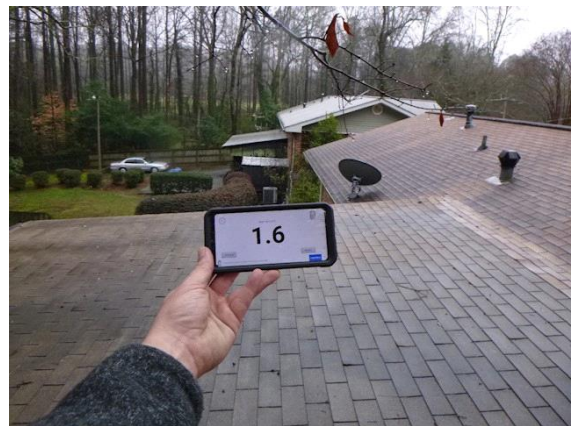
4

roof slope 1.5/12

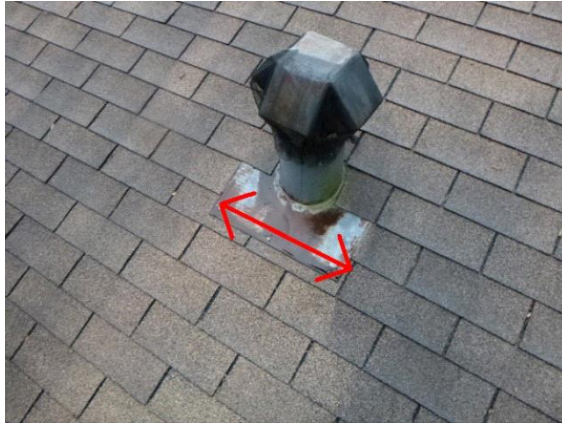
5

sealant on nails is deteriorated/missing
