## HOME INSPECTION

03/17/20

4925 Wimborne Ct  
Suwanee, GA 30024

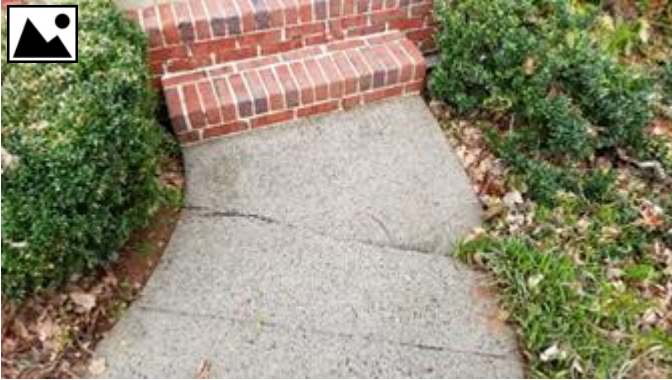
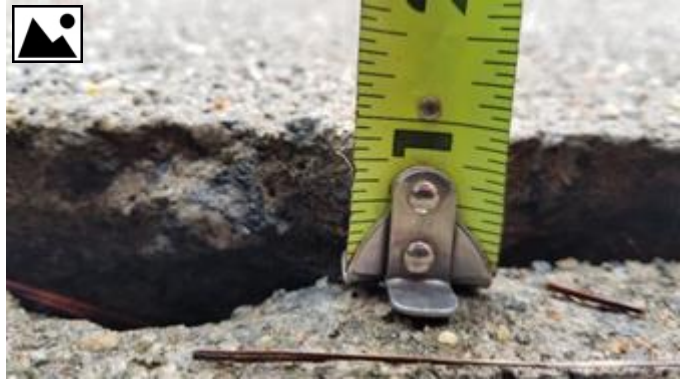
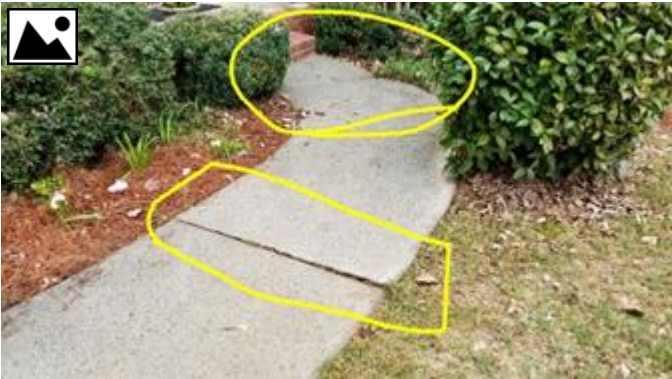
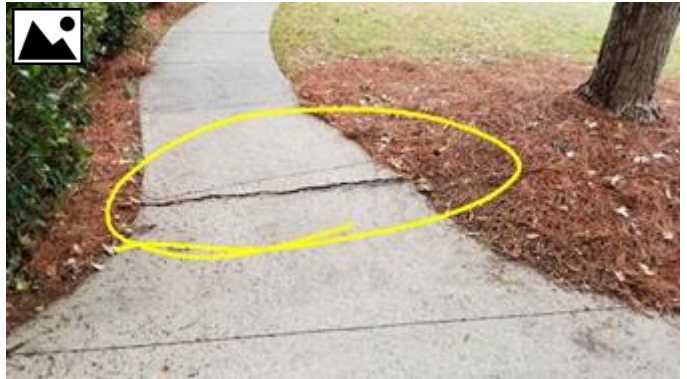
Issue The walk is settled or heaved. Uneven walking surfaces may cause someone to trip and fall. This is a safety concern.
- Location Front
- Action *Repair the walk.*

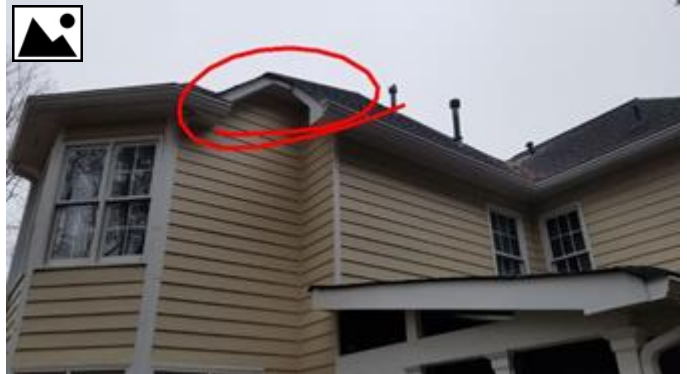
Exterior - Trim

Issue There is evidence of insect damage to the trim. There may be hidden damage behind the trim.
- Location Left rear corner
- Action *Replace the trim and repair any damage which may be revealed.*

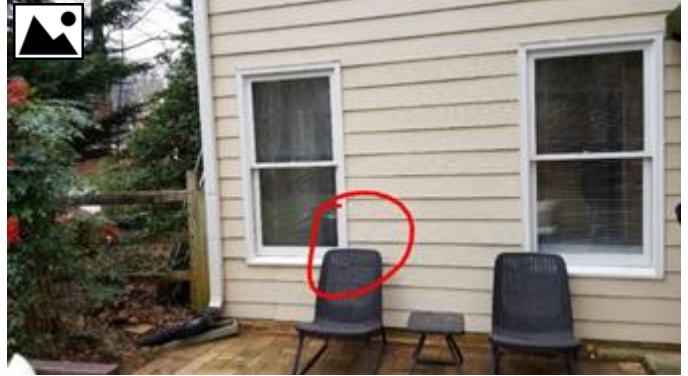
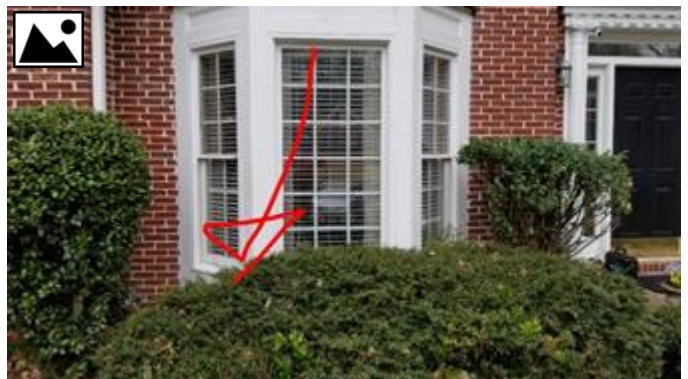
- Issue** The trim is deteriorated. This permits moisture to enter and may cause further deterioration. There may be hidden damage behind the trim.
- Location** Rear windowsills & door, bay window
- Action** *Replace the trim and repair any damage which may be revealed. Caulk, one-part putty fillers, and paint are not acceptable substitutes for solid material.*

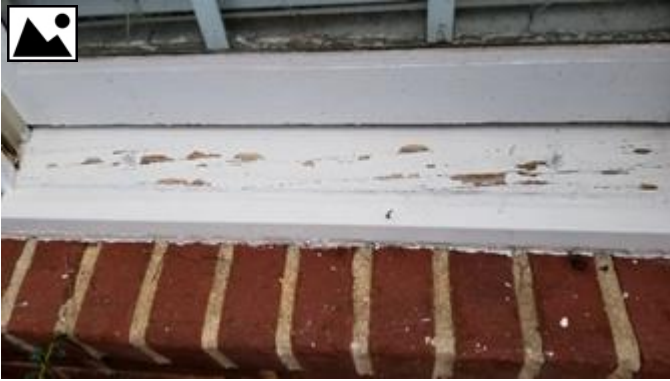
- X** Issue The paint on the trim is peeling or blistering. This implies that moisture has penetrated behind the finishes.
- Location Garage window
- Action *Repair or replace the trim and repair any damage which may be revealed.*

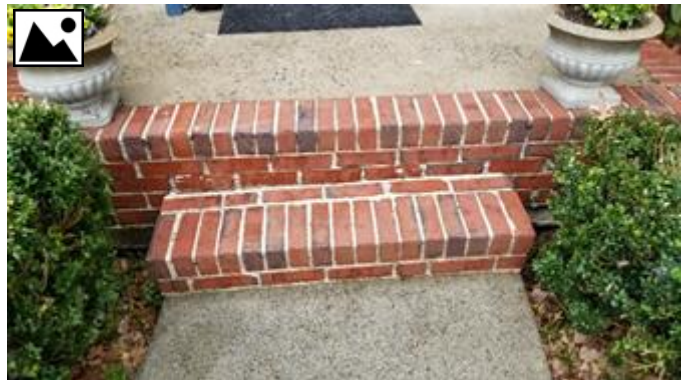
**Exterior - Stairs/Steps**

- X** Issue There is excessive settlement at the steps. This may cause someone to trip and fall, and is a water penetration concern.
- Location Front
- Action *Repair and stabilize the steps to prevent further settlement. Repair and seal any gaps to prevent moisture intrusion.*

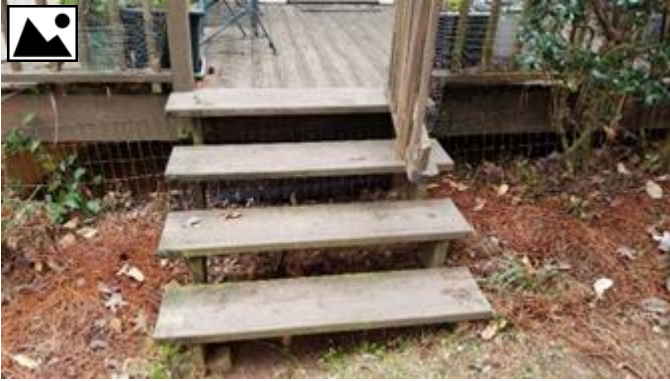
- Issue** The handrail is missing. This is a safety concern. Stairs with 4 more risers or more than 32" in height gain require a hand rail along one side.
- Location** Rear deck
- Action** *Install a handrail.*

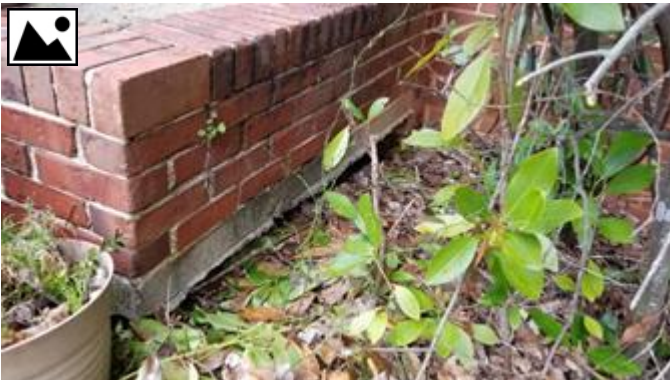
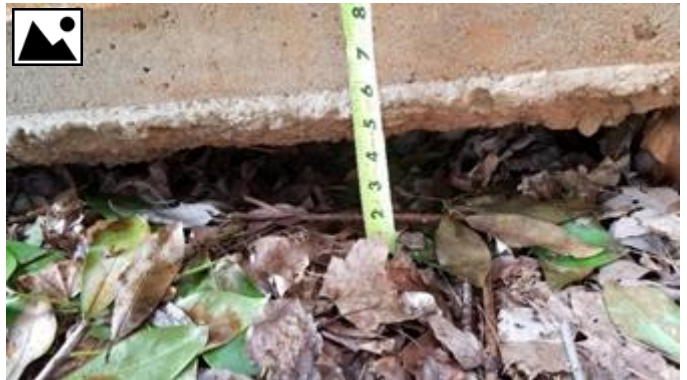
**Exterior - Porch**

- Issue** Portions of the porch are undermined. This may lead to further erosion of the soil, and may cause settlement or failure of the porch.
- Location** Front
- Action** *Repair and stabilize the porch to prevent further settlement.*

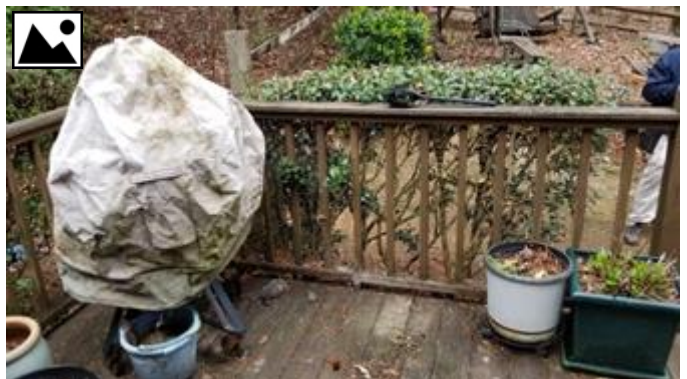
**Exterior - Deck/Balcony**

- Issue** The balusters are improperly spaced at the guardrail. The opening between balusters should not exceed 4". This is a safety concern.
- Location** Rear
- Action** *Repair or replace the balusters.*

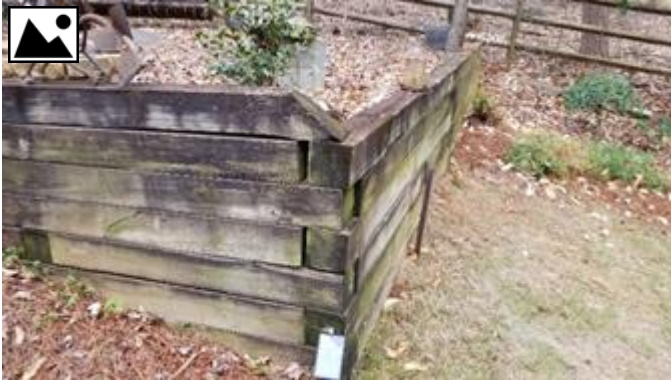
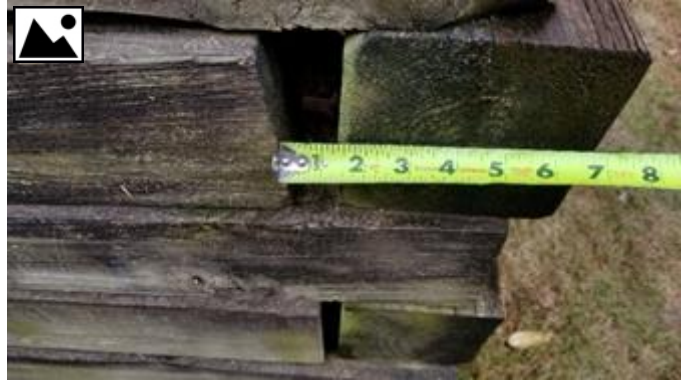
**Exterior - Retaining Wall**

- X** Issue The retaining wall is leaning.
- Location Rear
- Action Hire a contractor to evaluate the movement and provide repairs as needed.

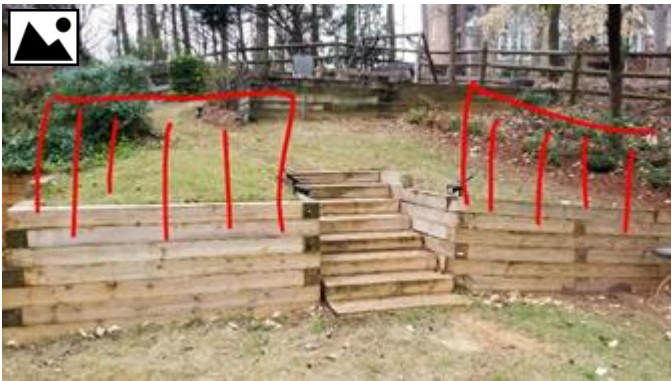
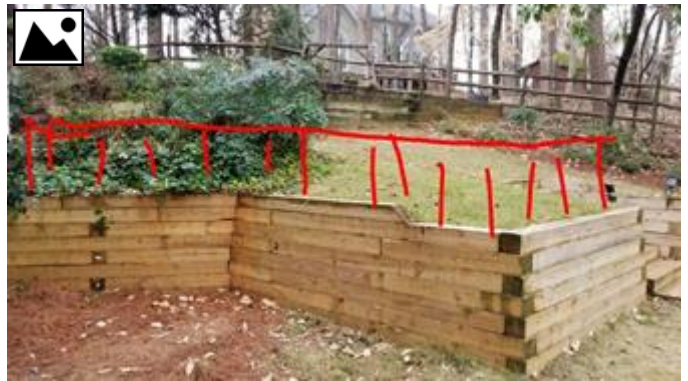
- !** Issue The retaining wall guardrail is missing. This is a safety concern.
- Location Rear
- Action Install a guardrail.

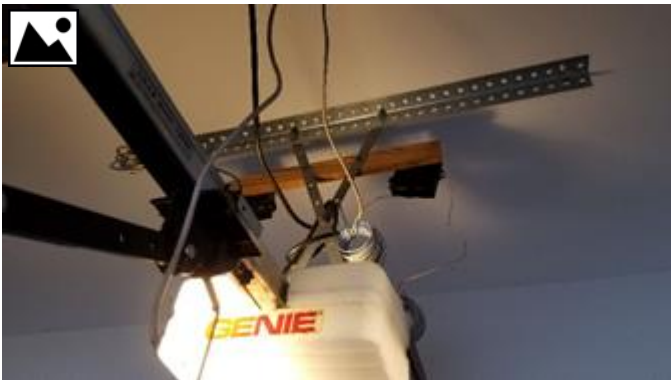
**Exterior - Garage Vehicle Door Opener**

- !** Issue The optical sensors are improperly installed at the garage vehicle door's automatic opener. The recommended height for safe operation is 4" - 6" from the floor. This is a safety hazard.
- Location Attached Garage
- Action Reinstall optical sensors.

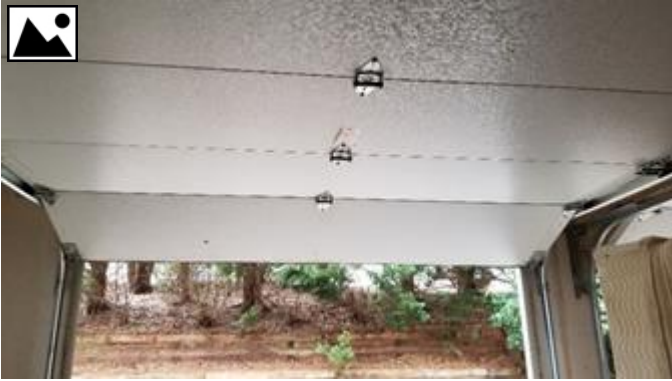
- 🔧 Issue The automatic opener does not reverse properly at the garage vehicle door. It should reverse within 2 seconds of closing on a 1 - 1.5" object placed on the floor. This is a safety hazard.  
Location Attached Garage  
Action *Repair or replace the garage door opener.*

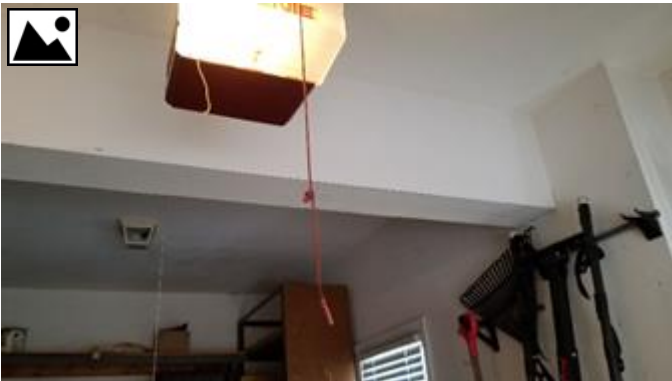
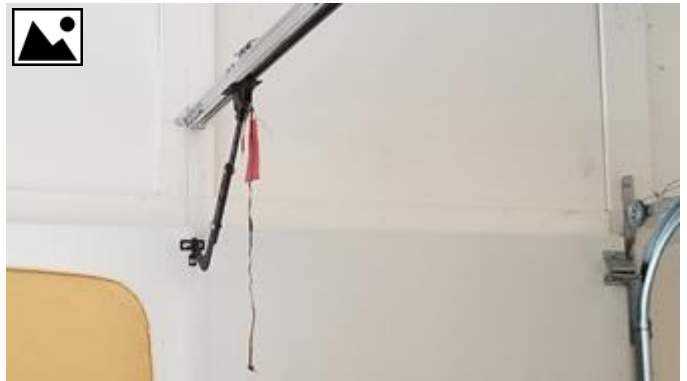
- 🔧 Issue The garage vehicle door opener's emergency disconnect rope is missing or too high. This is a safety hazard.  
Location Attached Garage  
Action *Install or lower a disconnect rope.*

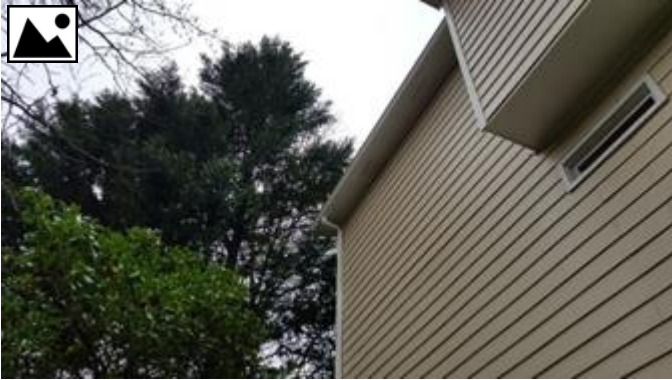
Issue There are tree limbs touching or near the roof. This may damage the roofing and permit water penetration.
- Location Right Side
- Action *Remove the tree limbs.*

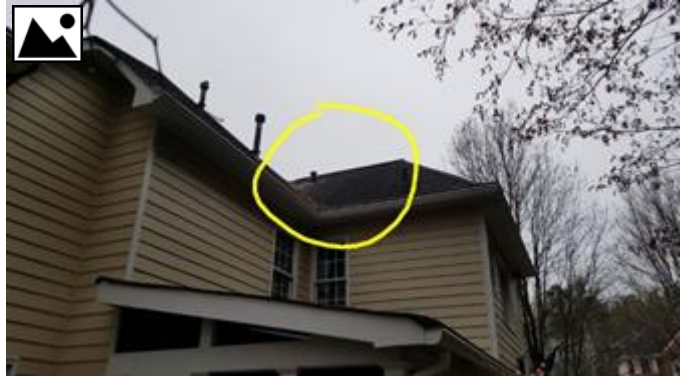
Issue There is a light colored stringy substance on the roof surface around a vent. Unable to determine what the material is or why it's there.
- Location Left Side
- Action *Recommend further evaluation and repair as needed.*

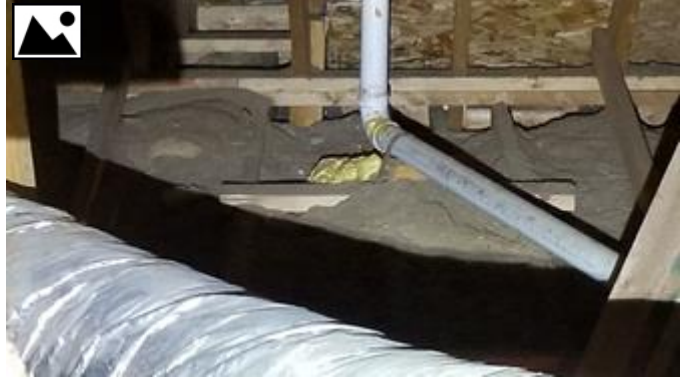
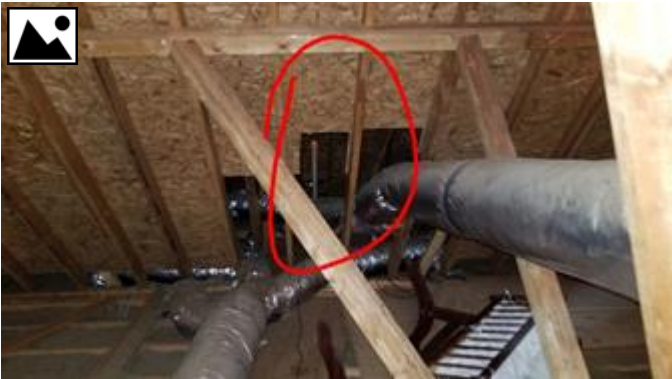
Issue There is expandable foam around a waste vent pipe at the roof sheathing. This is commonly done to prevent leaks.
- Location Right side
- Action *Recommend further evaluation and repair as needed.*

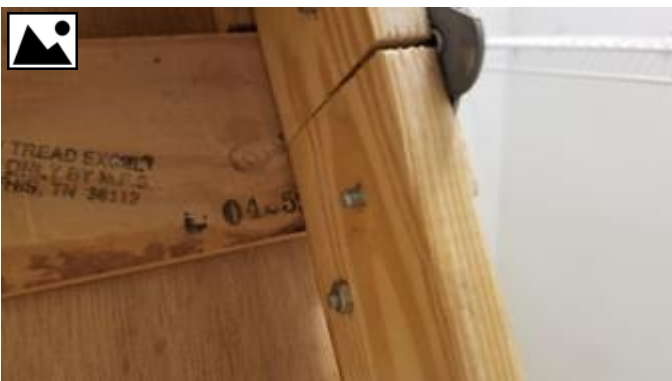
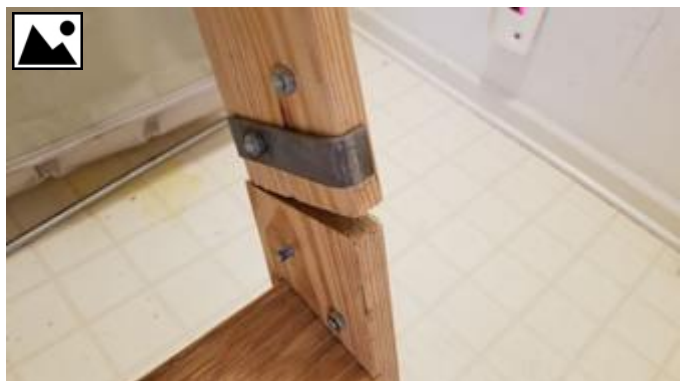
Issue The pull-down stairs have loose hardware. This is a safety concern.
- Location Laundry
- Action *Repair or replace the hardware.*

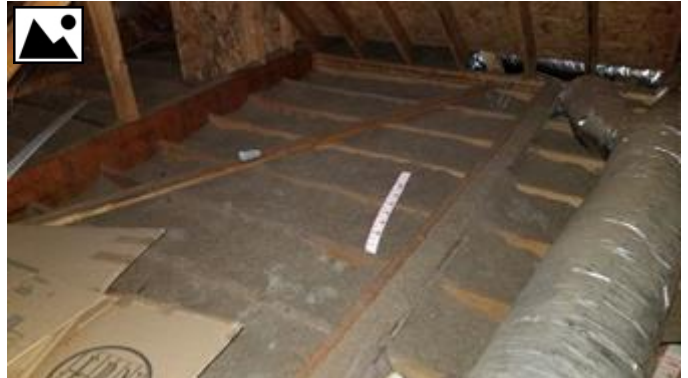
**Issue** The level of insulation is considered inadequate by today's standards. Current standards require R-30 or approximately 8" of cellulose.
- Location** Multiple Locations
- Action** *Install additional insulation in accordance with local guidelines.*

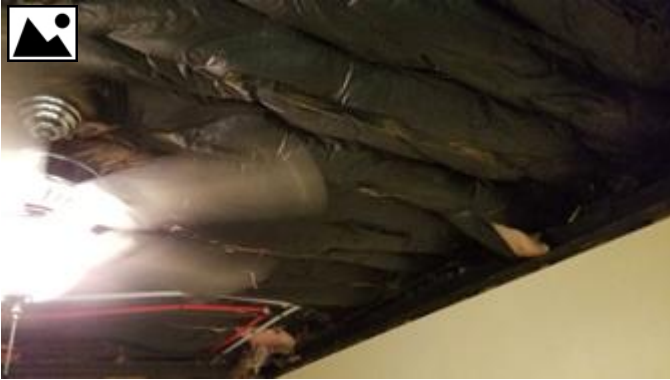
- Issue There is exposed flammable insulation or insulation backing present; it should be protected using fire-rated materials. This is a safety concern.
- Location Basement music room
- Action *Hire a contractor for repairs or replacement as needed.*

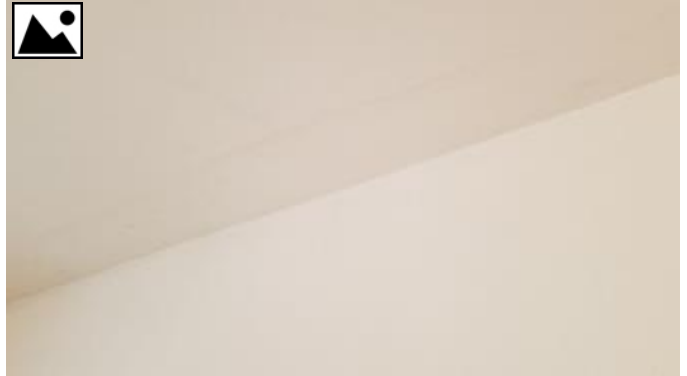
Issue The ceiling is water damaged. Testing with a moisture meter indicates low moisture content (dry).
- Location Bedroom closet, garage ceiling
- Action *Hire a contractor for an evaluation and to make repairs as needed.*

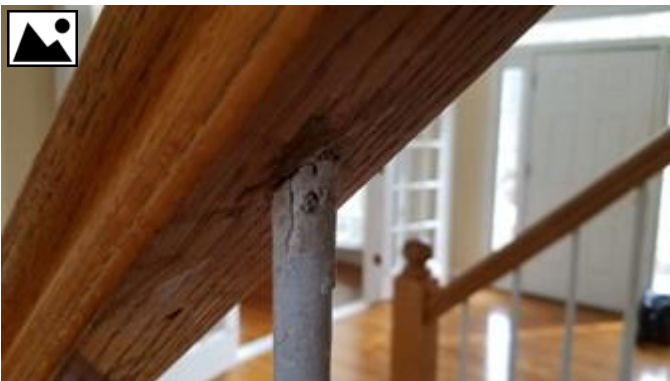
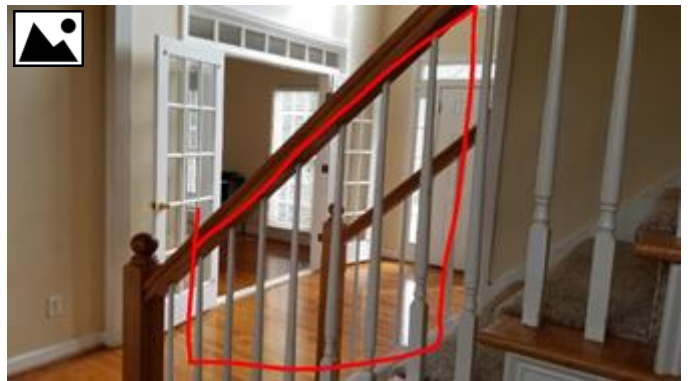
Issue The balusters are damaged or deteriorated at the handrail. This is a safety concern.  
Location Central  
Action *Repair or replace the balusters.*

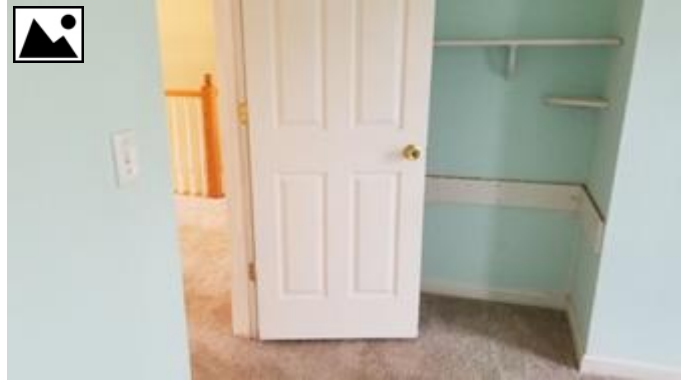
- Ⓜ Issue The door does not latch properly. This affects proper function.
- Location Bedroom, office
- Action *Adjust the door, the latch mechanism, or the striker plate as needed.*

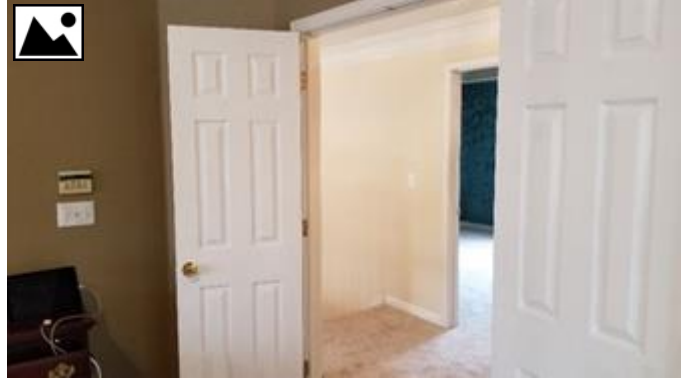
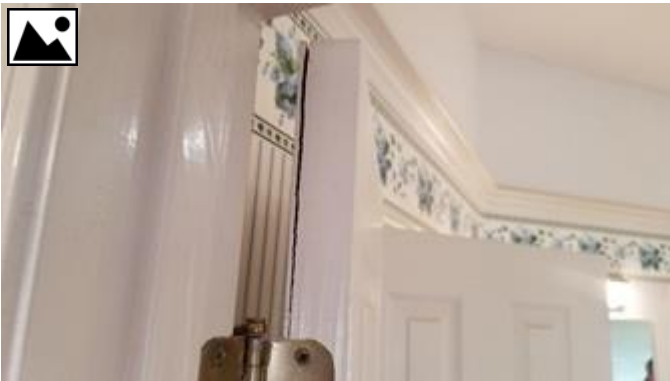
- X** Issue The door is damaged. This affects proper function.  
Location Master bedroom, bathroom  
Action *Repair or replace the door.*

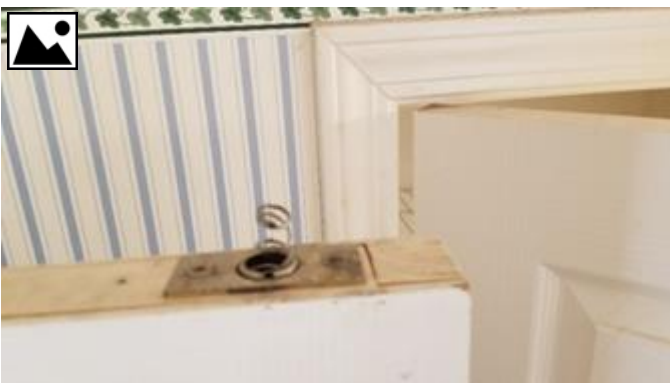
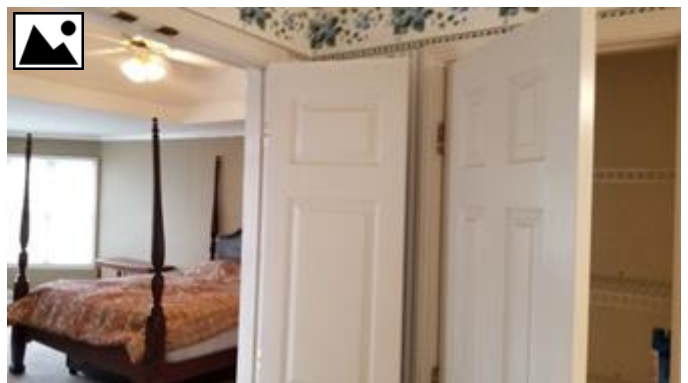
- X** Issue The door hardware is missing. This affects proper operation. The upper door latch is missing.  
Location Master Bathroom  
Action *Install hardware as needed.*

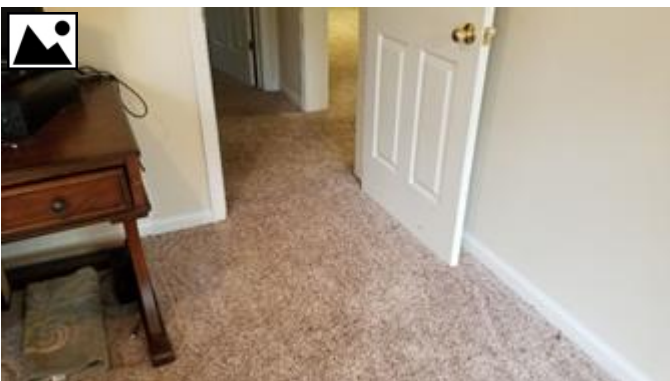
- X** Issue The door rubs on the carpet or floor. This may cause damage.  
Location Basement office  
Action *Adjust or replace the door.*

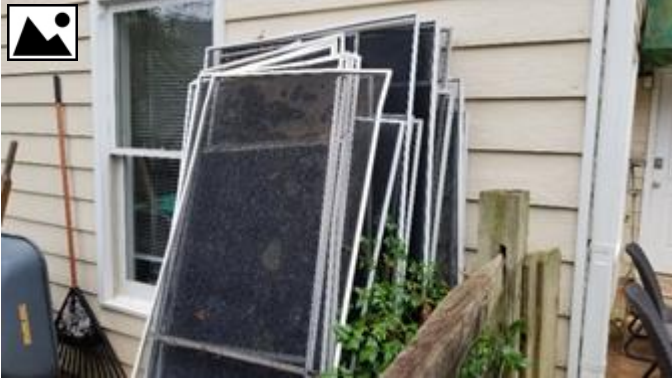
- X** Issue The window screens have been removed and stored on the exterior.  
Location Right rear  
Action *Replace the screens.*

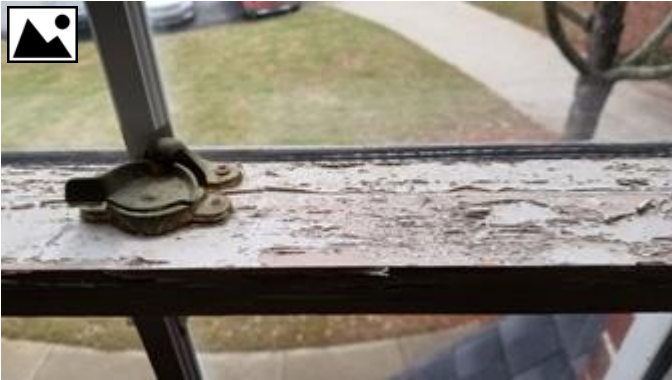
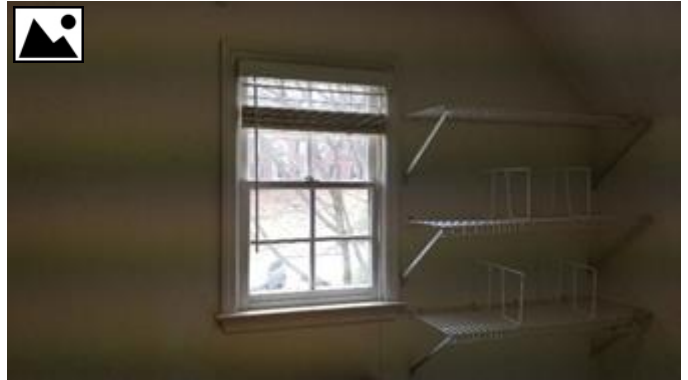
- X** Issue The paint is peeling or failed on the interior window.  
Location Master closet  
Action *Prepare by a painter.*

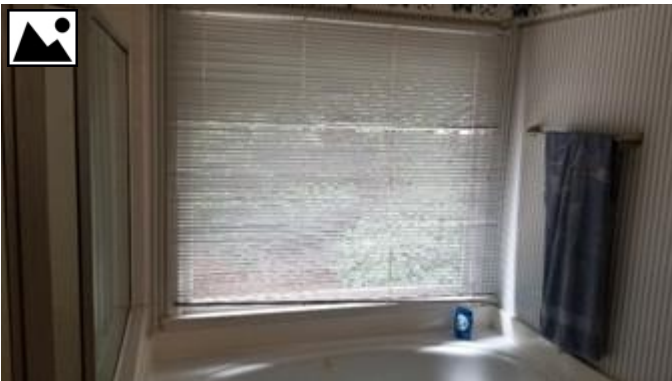
- !** Issue The window is missing safety glass. No manufacturer's mark is visible. While it may not have been required at the time of installation, this is a safety concern.  
Location Master Bathroom  
Action *Replace the glass with safety-rated glass.*

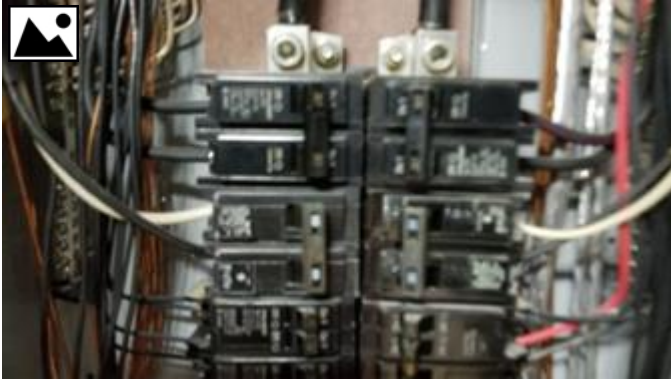
**Issue** There are unmarked neutral wires connected to double-pole breakers or fuses. Neutral wires must be marked to indicate that they are current-carrying conductors. This is a safety concern.
- Location** Utility Room
- Action** Hire an electrician to make the required repairs.

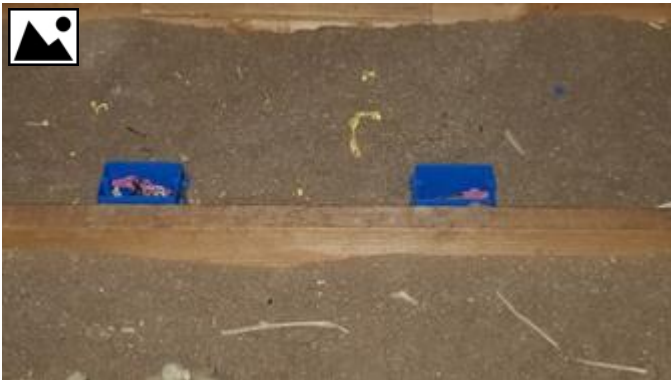
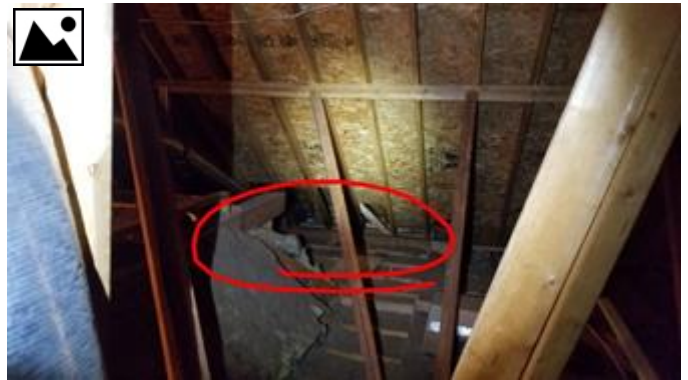
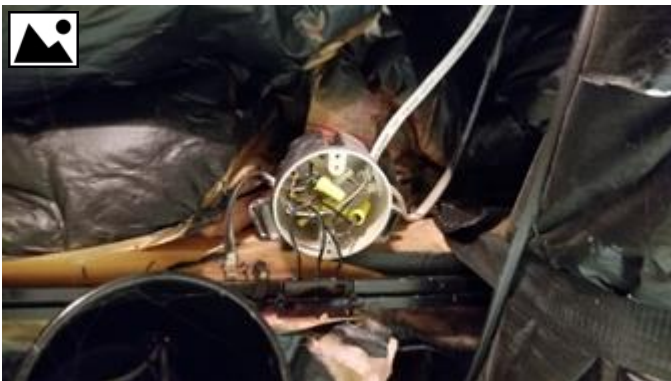
**Issue** There are missing cover plates, which defeats the enclosure's fire rating and permits contact with energized components. This is a safety concern.
- Location** Attic, music room
- Action** Secure or replace the cover plates.

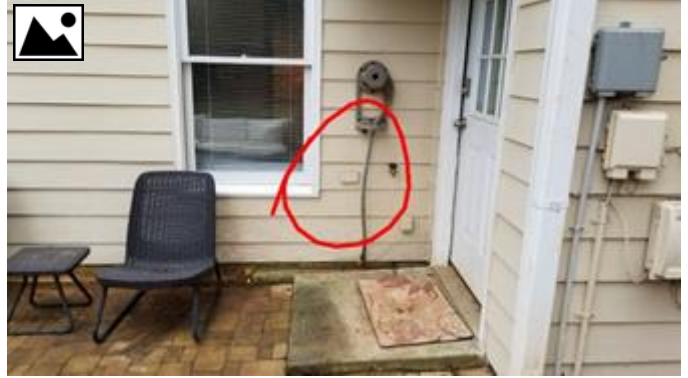
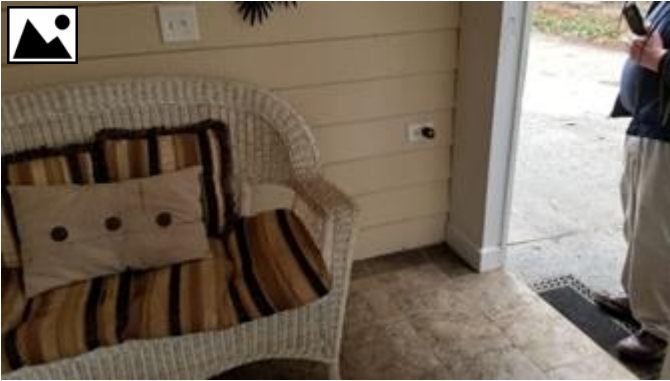
- Issue The GFCI receptacle has power, but it doesn't trip when the test button is pushed. This is a safety hazard.
- Location Over patio, screen porch
- Action Hire an electrician to replace the receptacle.

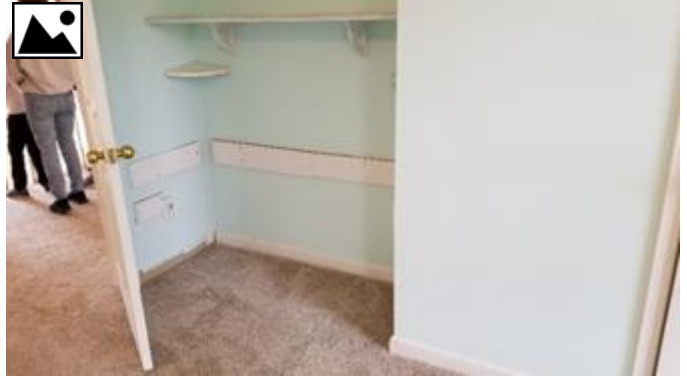
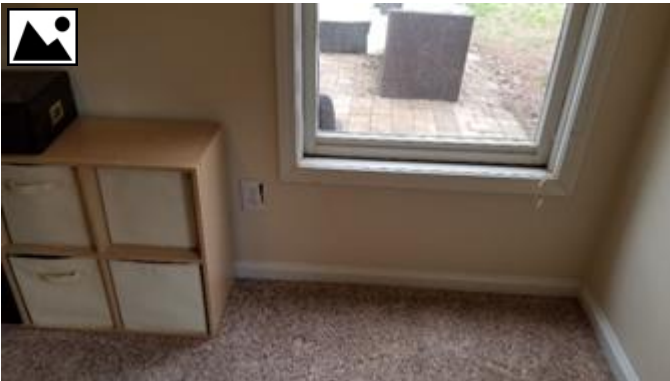
- 🔧 Issue The receptacle's cover plate is damaged. This is a shock and safety concern.
- Location Rear bedroom, basement office
- Action *Replace the cover plate.*

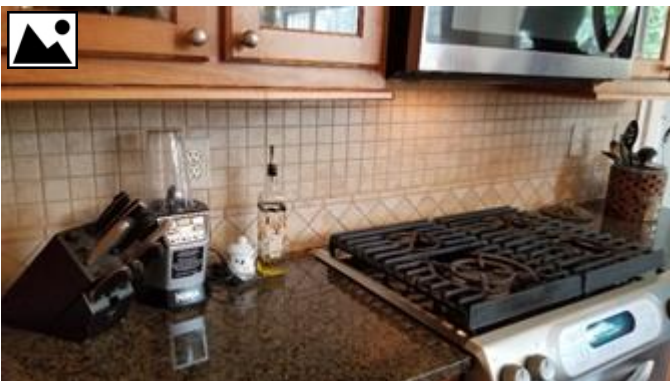
- 🔧 Issue There is a standard receptacle installed in a location that currently mandates a GFCI device. While this may not have been required at installation, it is a safety concern.
- Location Kitchen
- Action *Hire an electrician to replace the receptacle.*

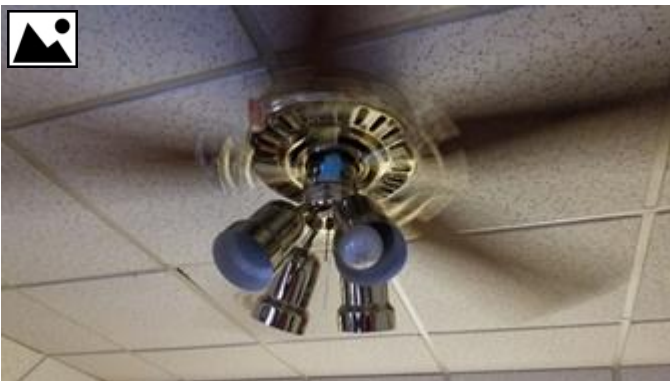
- 🔧 Issue The light fixture is inoperative. This affects proper function. Sparks shot out from the ceiling fan light combo when the pull chain was operated. The circuit breaker tripped.
- Location Theater
- Action *Further evaluate and repair as needed by an electrician.*

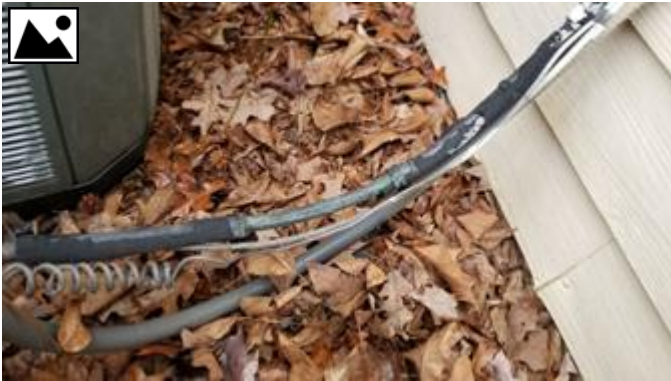
- X** Issue The insulation is damaged or missing at the AC system's suction line. This affects the system's efficiency.
- Location Right Side Exterior
- Action *Install an exterior-grade pipe insulation on the suction line.*

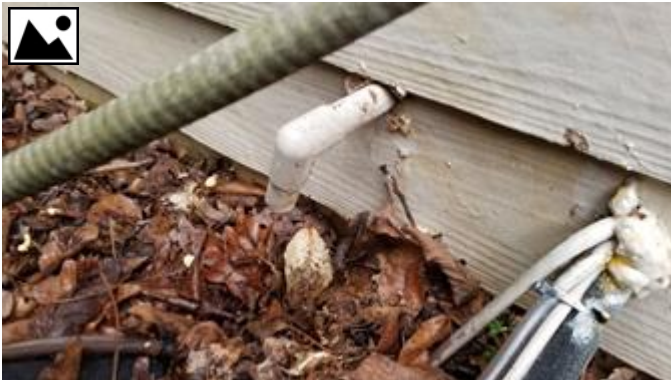
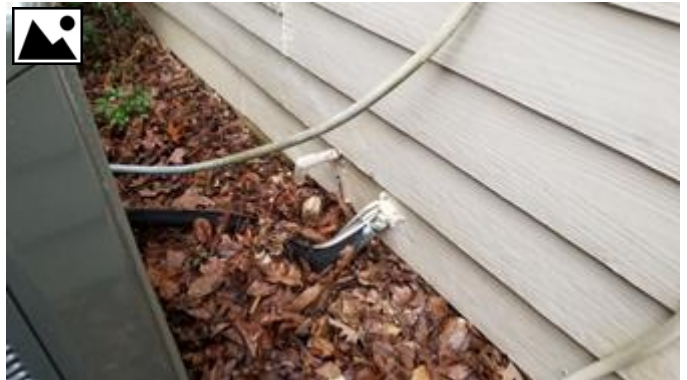
- X** Issue The condensate system's discharge point is improperly located. The condensate must be carried to the exterior and away from the building to prevent water damage and mold or mildew problems.
- Location Right Side Exterior
- Action *Redirect the discharge away from the structure.*

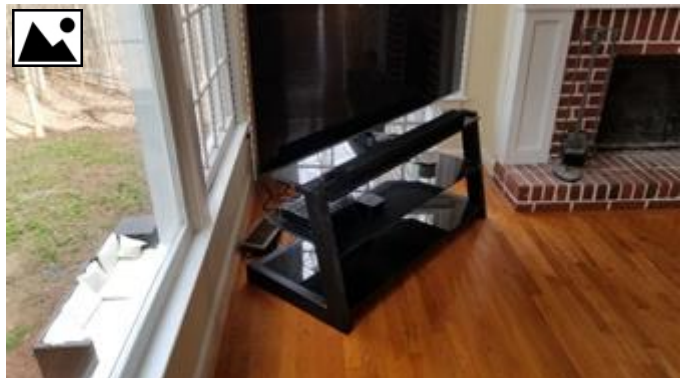
- X** Issue There are damaged or missing supply registers. The airflow cannot be properly controlled.
- Location Family room
- Action *Replace or install registers as needed.*

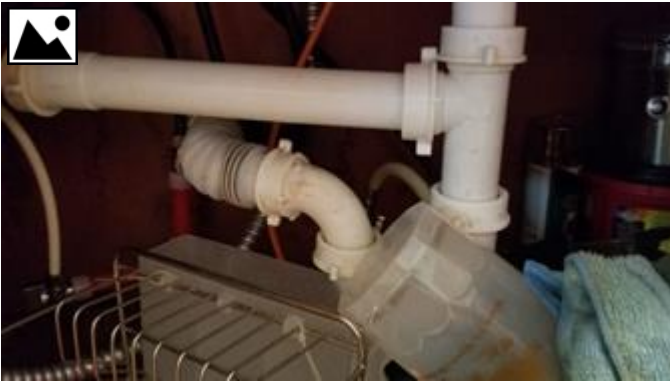
Issue The drain pipe is a corrugated or accordion style. The folds may capture debris and clog.
- Location Kitchen
- Action *Hire a plumber to replace the pipe.*

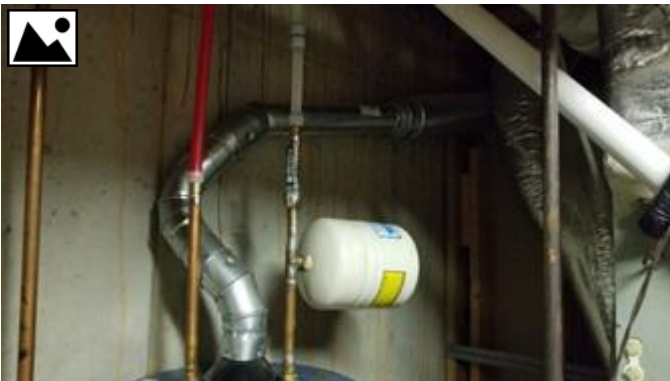
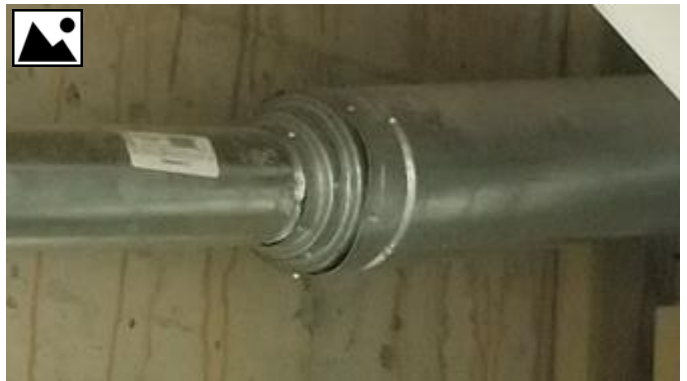
- i** Issue The water heater 4" exhaust flue joins a 6" exhaust flue. The larger exhaust flue is likely oversized for a single device. This can lead to cooling of the gasses and carbon monoxide poisoning or back drafting.
- Location Utility Room
- Action *Recommend further evaluation and repair as needed by a HVAC contractor.*

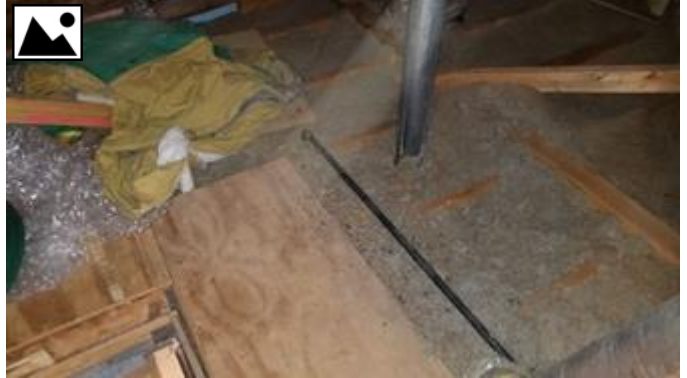
Environmental - Rodents

- Issue There is evidence of rodent activity within the home. This is a health and safety concern.
- Location Attic
- Action *Hire a specialist for an evaluation and to make required repairs.*
