Property Inspection Services, Inc.

171 Red Buckeye Avenue, Marietta, GA 30060

Inspection Date: 03/25/2020

Report Number: 32520PESJPM

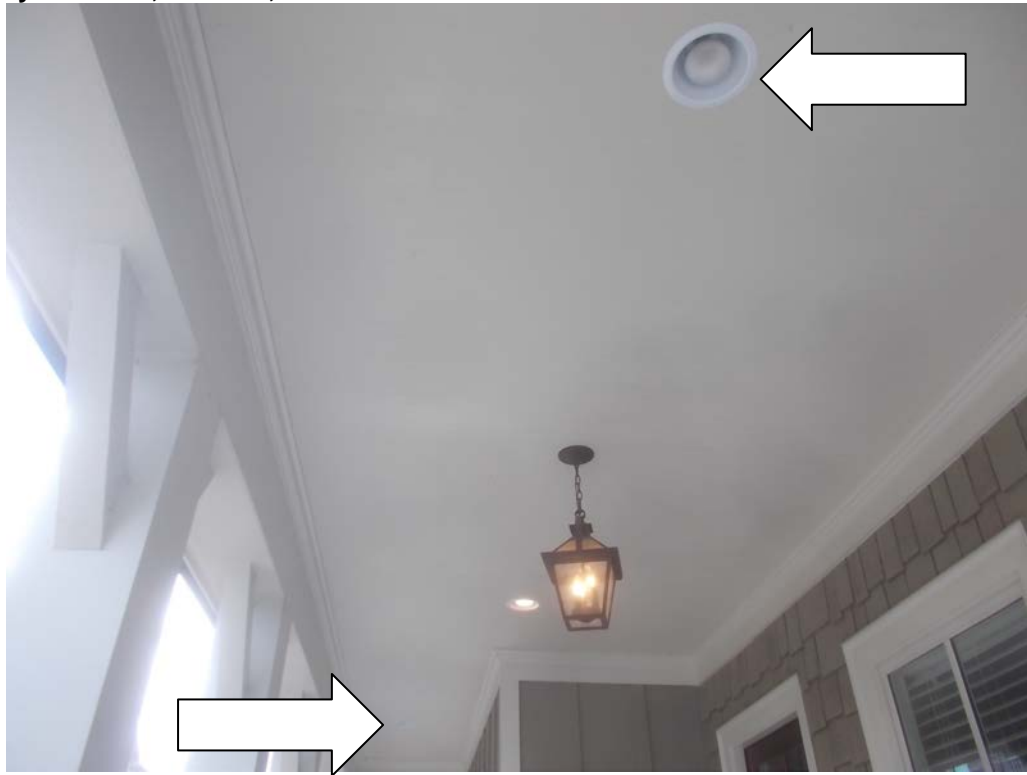
- 1) Three of the exterior can lights on the front and back porches, the floodlights above the garage door and the can light at the top of the stairs to the 2nd floor bedrooms did not operate when tested and probably need new bulbs. See photo
- 2) The fan motor for the convection oven did not operate when tested and needs to be repaired.
- 3) The lights inside the ovens did not operate and may need new bulbs.
- 4) The irrigation system was shut off and appeared to be winterized and was not tested.

Can lights on the front porch are not working

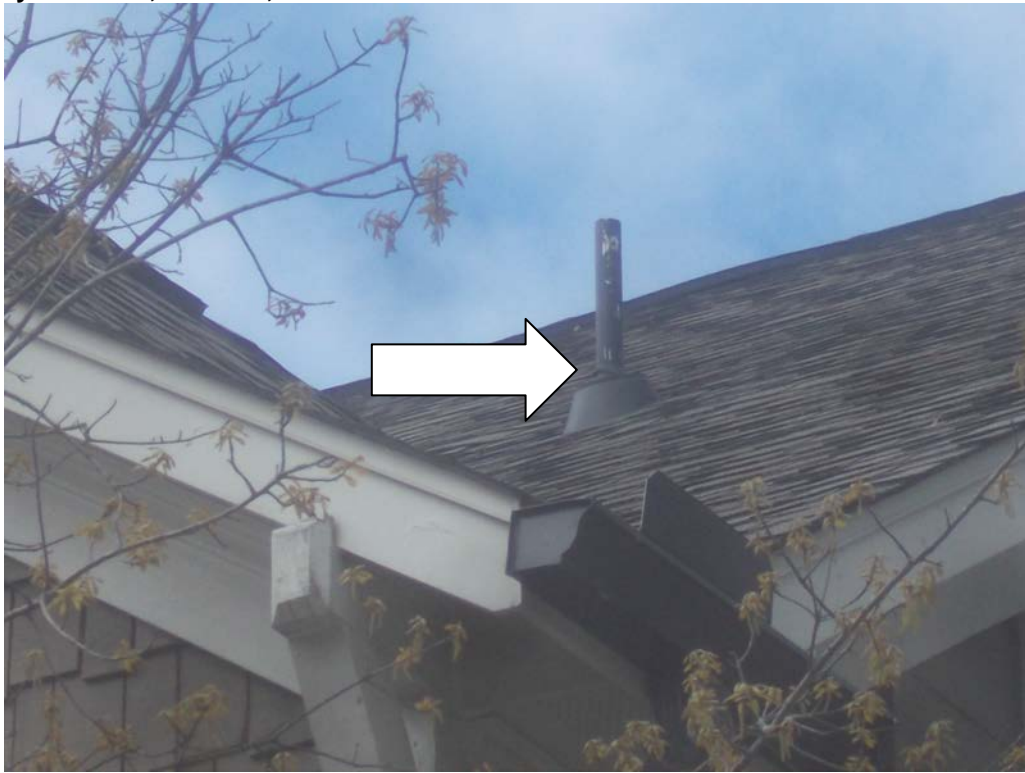
- 11) The boot around the plumbing vent stack at the right front portion of the roof appears to be cracked and needs to be replaced by a qualified roofer to prevent a roof leak.

Boot on the front of the roof is torn

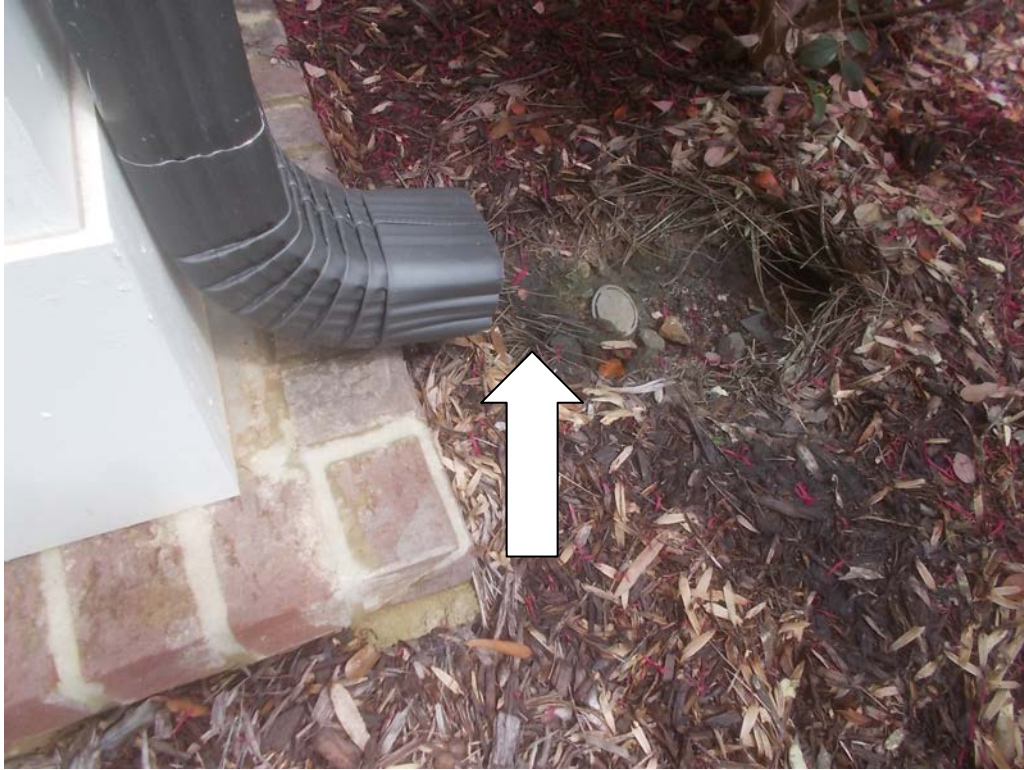
- 10) The downspout at the left front corner of the home needs to be extended away from the concrete slab to prevent further erosion and possible settlement. See photo

Downspout at the left front corner of the home needs to be extended away from the porch slab

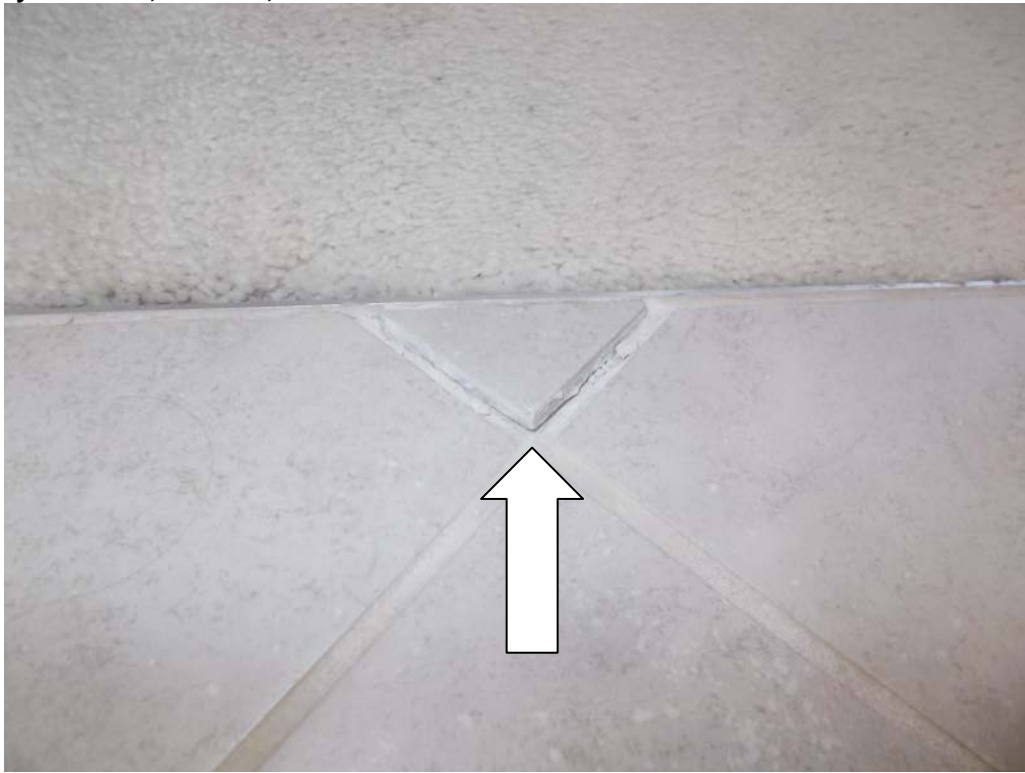
Small loose tile in front of the master bathroom door

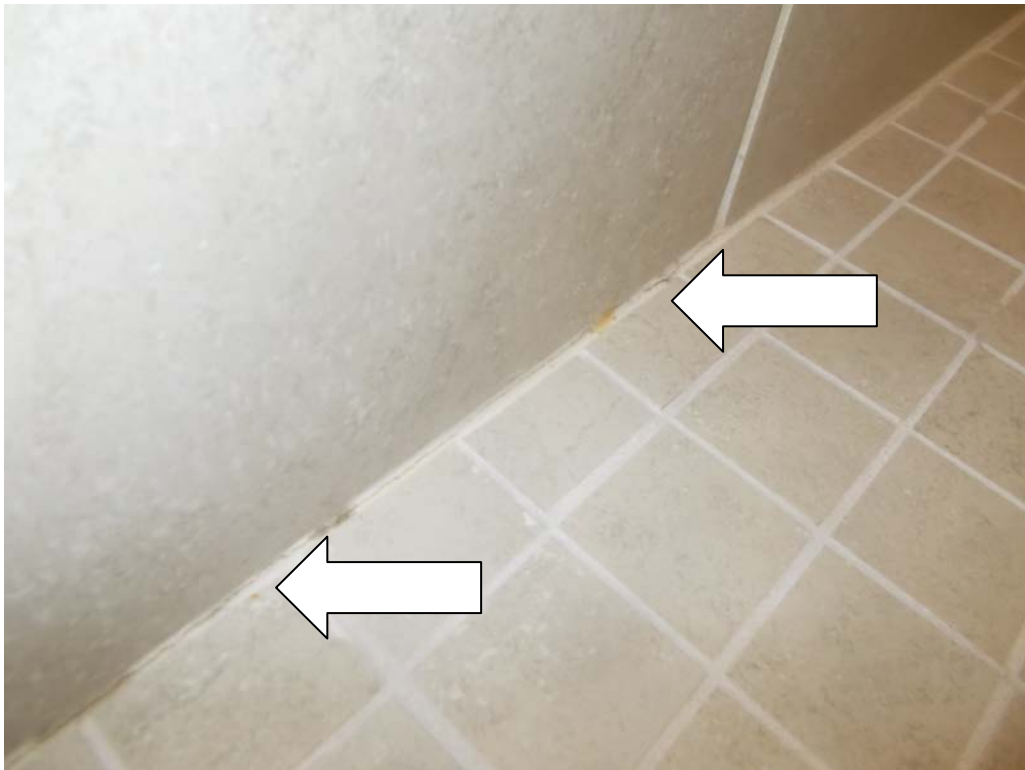
Caulking needed in the master bathroom shower

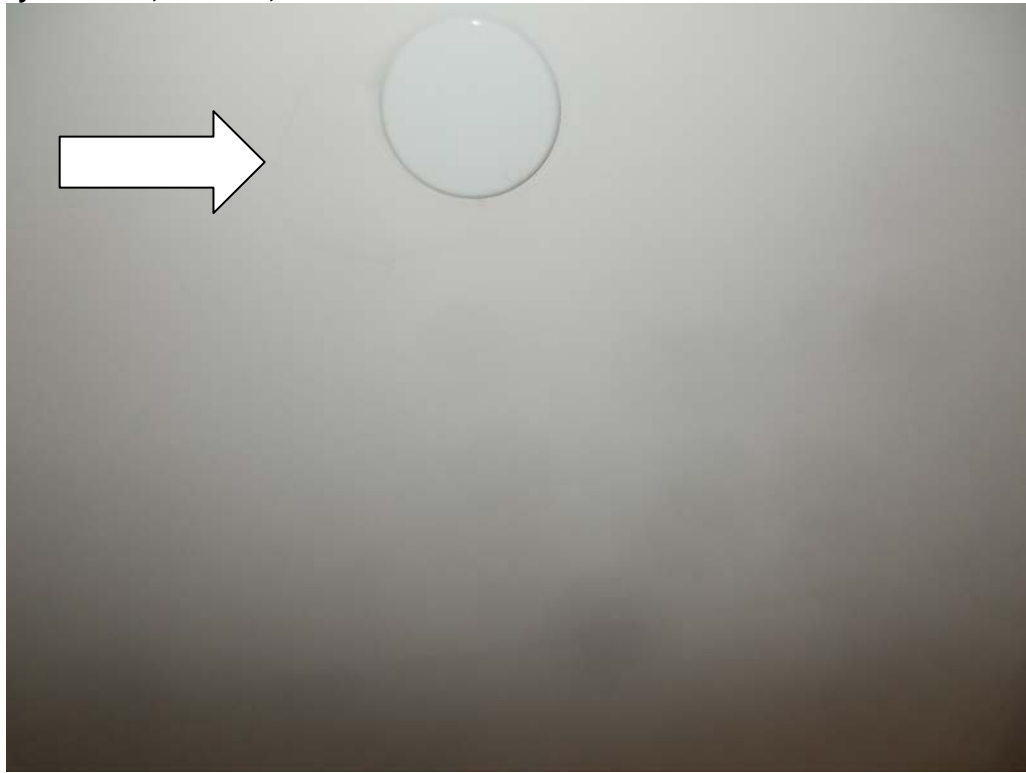
- 15) There are moisture stains on the ceiling in the Jack & Jill bathroom and on the floor in the attic above around the HVAC system. There did not appear to be any active condensation leaks but I would ask the seller to verify. See photos

Moisture stains on the ceiling in the Jack & Jill bathroom above the sink

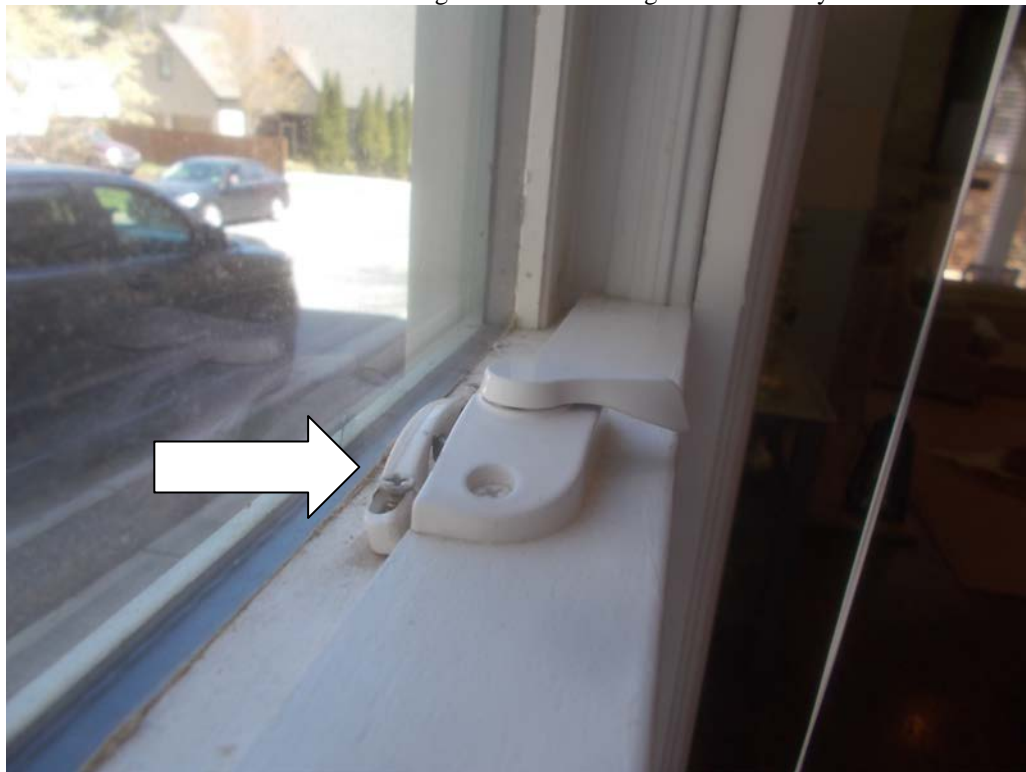
- 8) All 3 of the windows in the hallway between the back door and family room are not locking properly and the locks are coming loose from the windows and need to be repaired.

Window locks are coming loose in the rear hallway

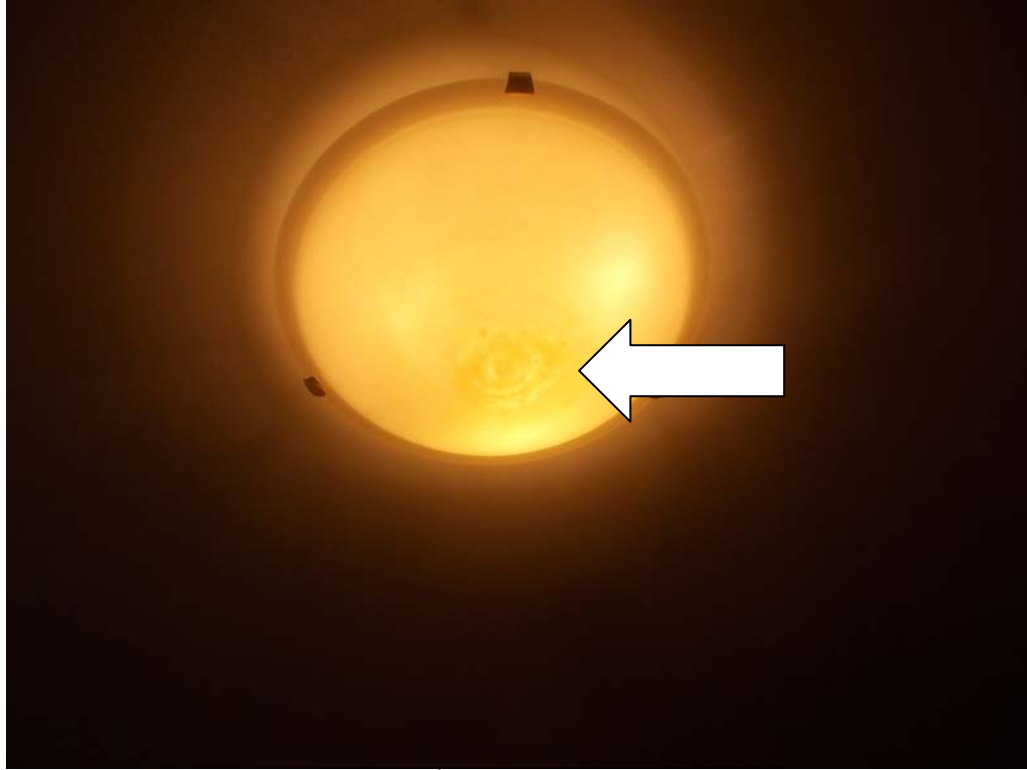
- 14) It appears that the light fixture in the back left 2nd floor bedroom had water in it at some time. There were no signs of any active leaks in the attic above. See photo

Light fixture in the back left 2nd floor bedroom appears to have had water in it

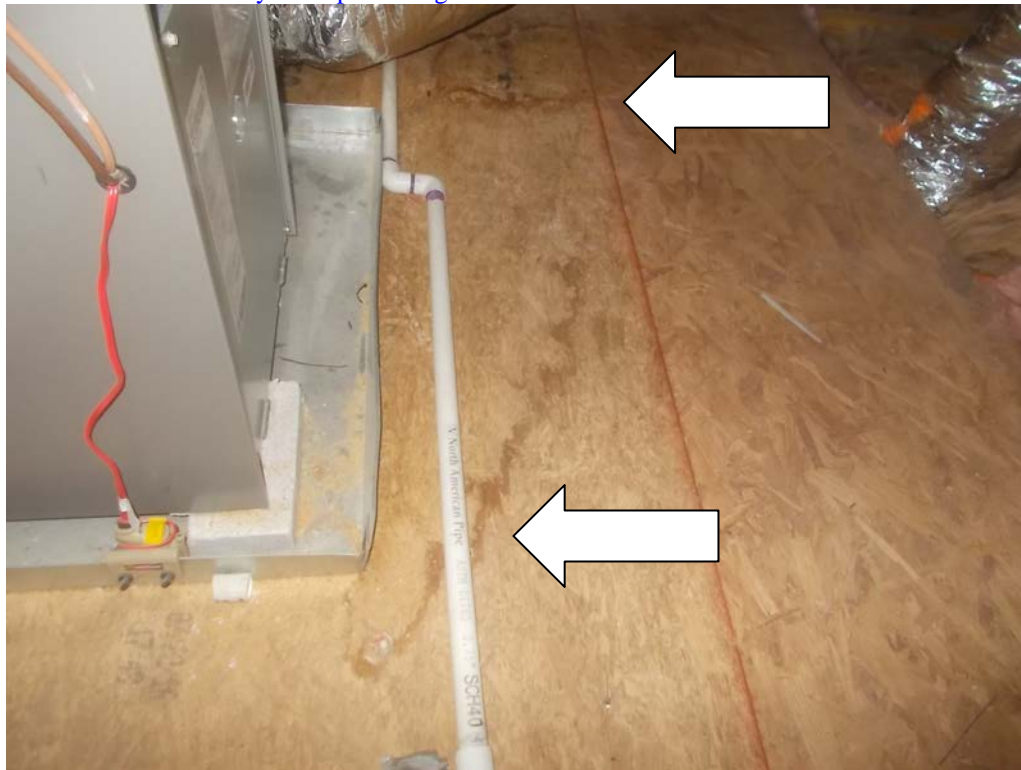
Moisture stains on the floor in the attic around the main floor HVAC system which is also above the Jack & Jill bathroom

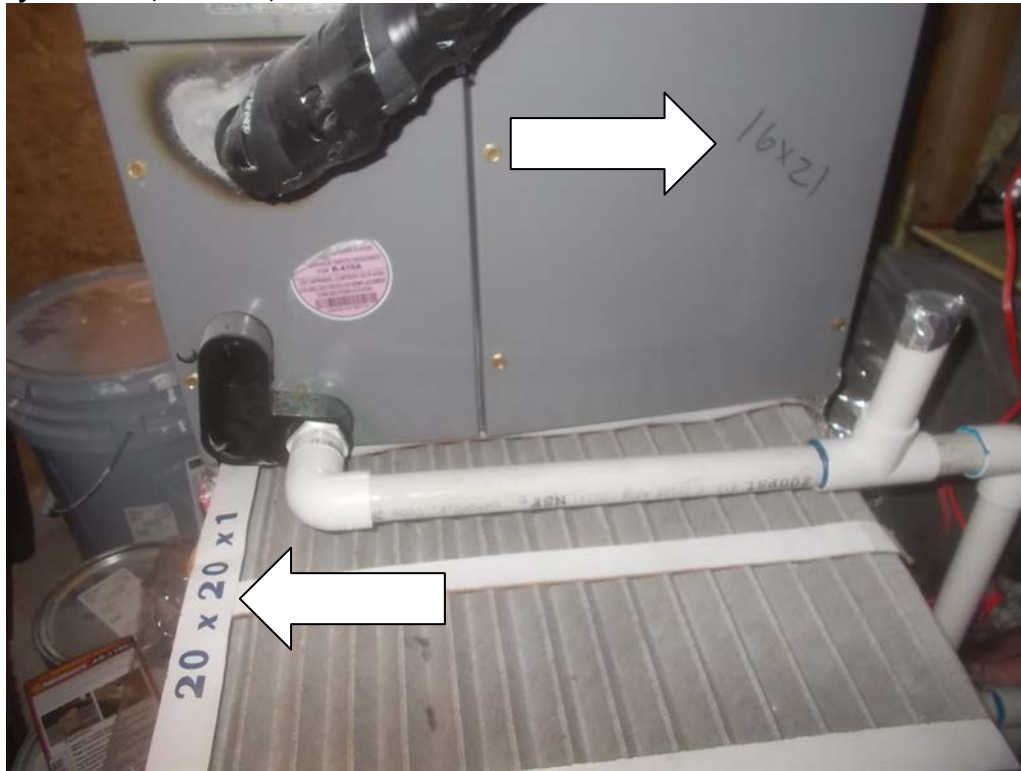
The heat pump filter is dirty and the wrong size

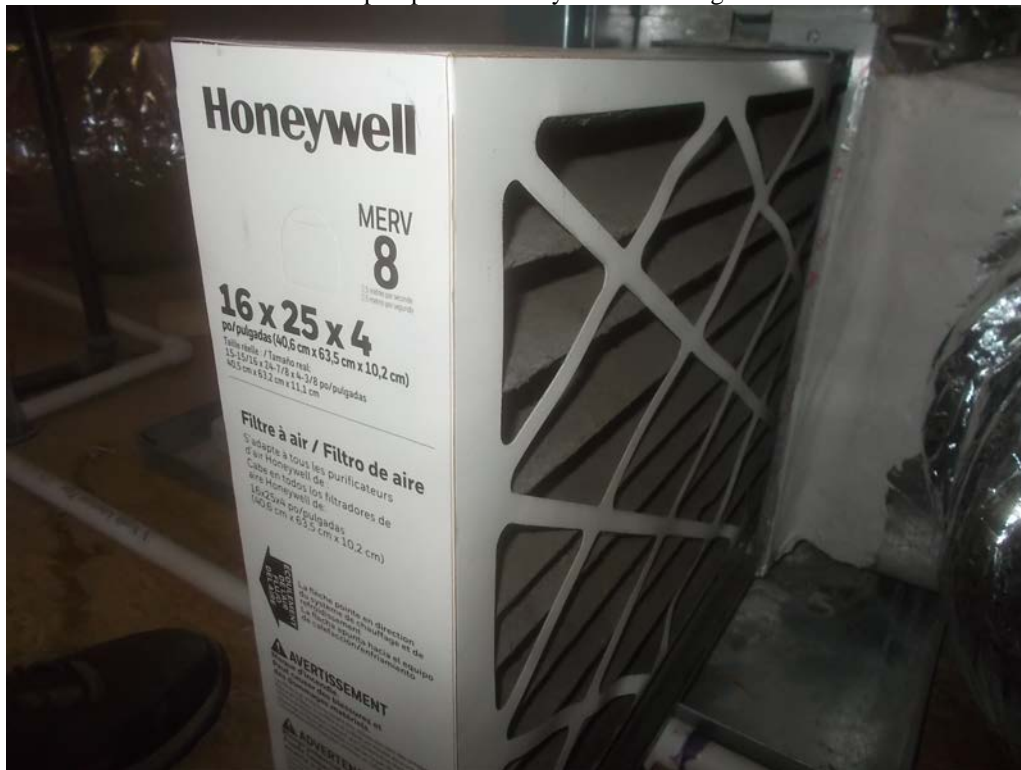
- 9) The 16x25x4 air filter for the furnace is dirty and needs to be replaced and the filter for the heat pump is the wrong size and dirty and needs to be replaced with the correct size. See photos

The furnace air filter is dirty and needs to be replaced

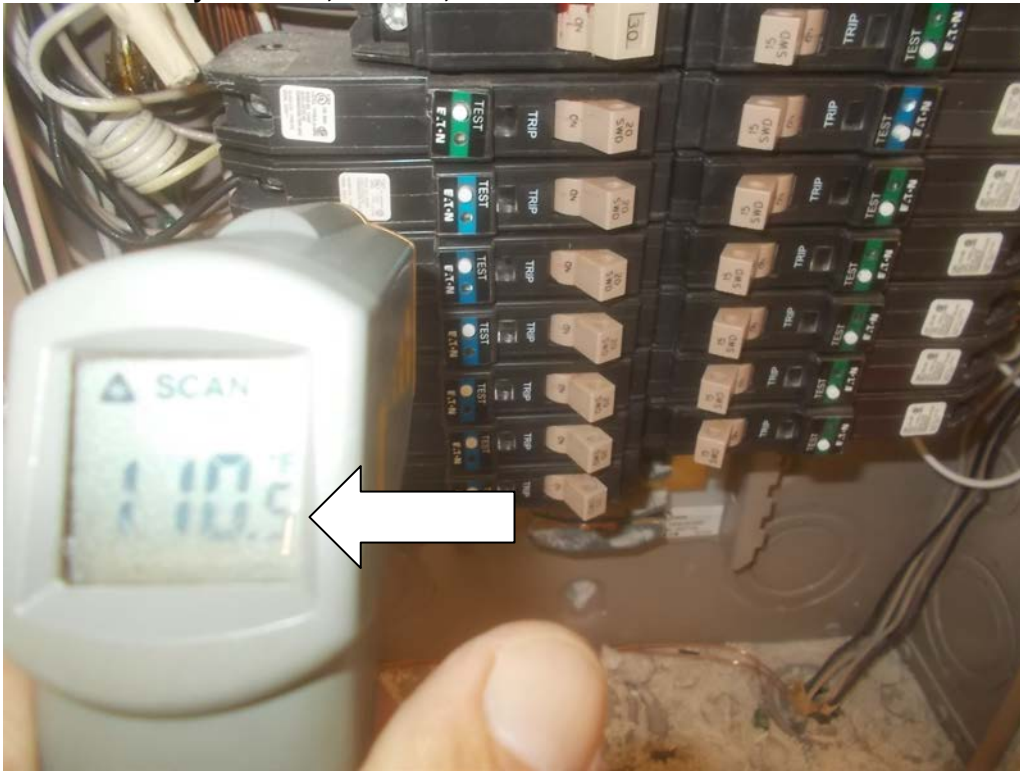
- 7) The ARC fault circuit breakers inside the electrical panel are hot and measured 110 degrees and should be evaluated by a licensed electrician to make sure there are no problems with the breakers. See photo

ARC fault breakers are 110 degrees

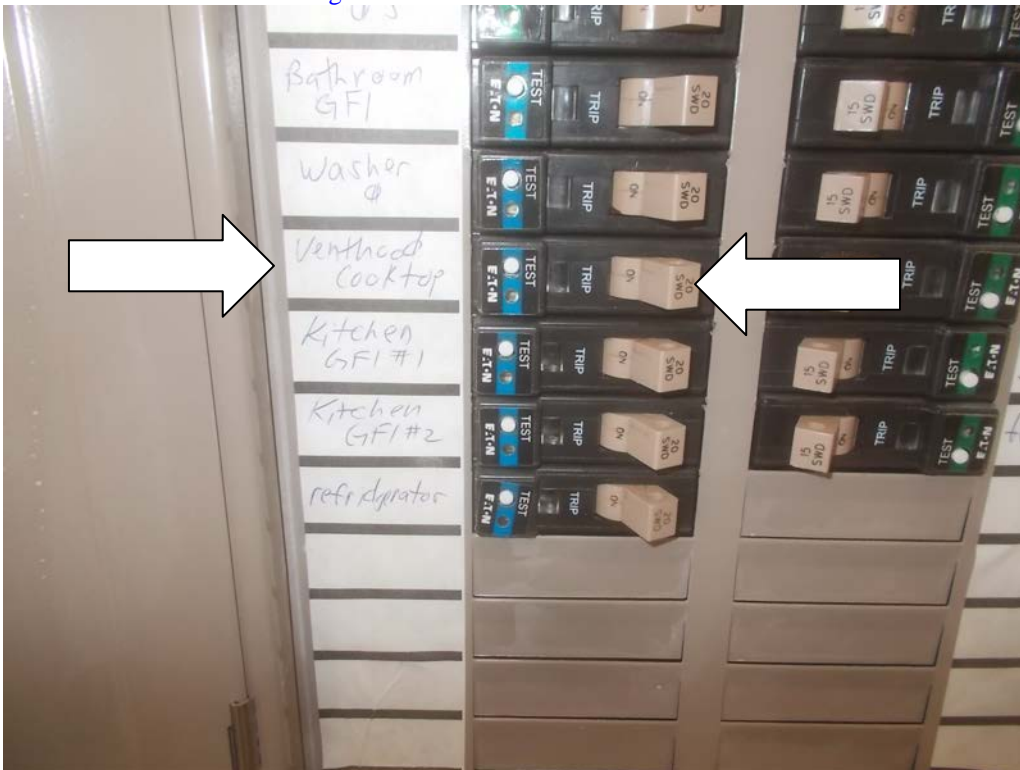
- 6) The ARC fault circuit breaker in the electrical panel labeled cooktop vent hood does not trip when you press the test button and needs to be replaced by a licensed electrician.

ARC fault breaker for the vent hood cooktop does not trip when tested
