## Repairing and rebuilding the Smiths Heater System in a 1973 Land Rover Series III

This short article details a repair and rebuild of the heater system in a Series III. The most important information here relates to the replacement parts for the heater fan motor and squirrel cage that are the correct size and are readily available for purchase at a reasonable price. The interested builder can scroll toward the end of the article for pricing and part numbers.

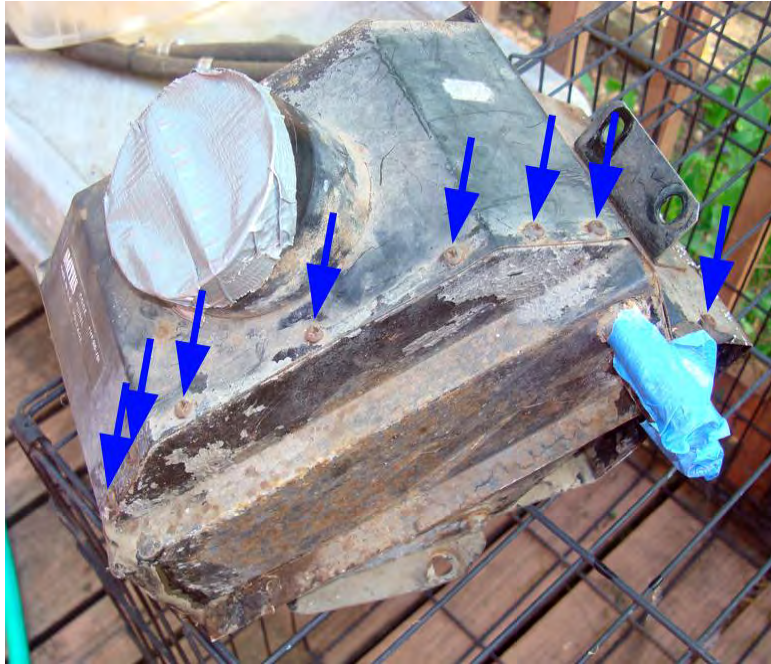
The heater core box was dirty and rusted (Figure 1) but the core was sound and did not leak. I took the box apart by removing all of the small screws (see Figure 1), cleaned and sanded the individual components, primed and then painted with RustOleum black (Figure 2). I taped over the Smiths label so it was not damaged during painting.

Figure 1. Condition of the heater box, with the blower hose inlet covered with duct tape, and the inlet/outlet of the heater core covered over with masking tape. Blue arrows show some of the Phillips screws that must be removed to open the box.

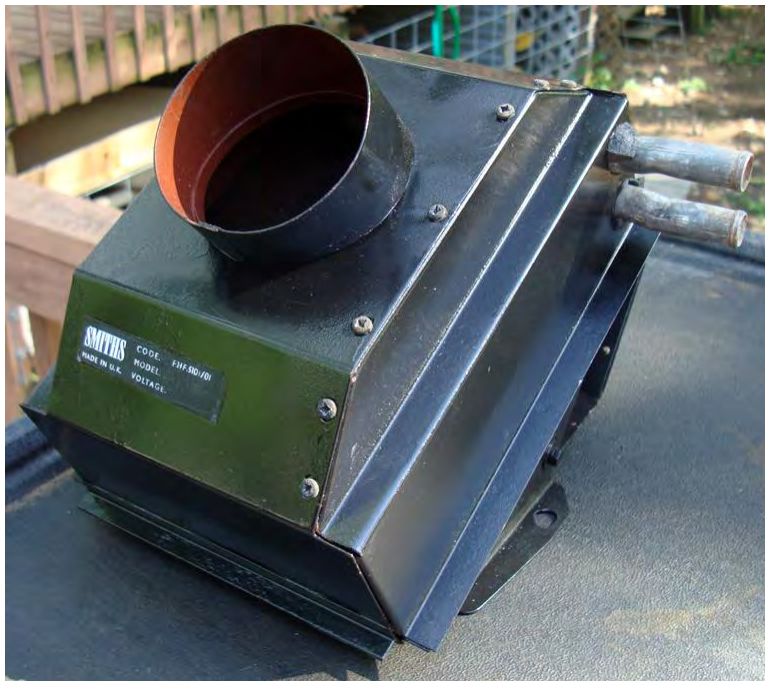
Figure 2. Painted heater core box with core reinserted.

Be sure to add foam insulation at the holes where the core pipes exit the box.

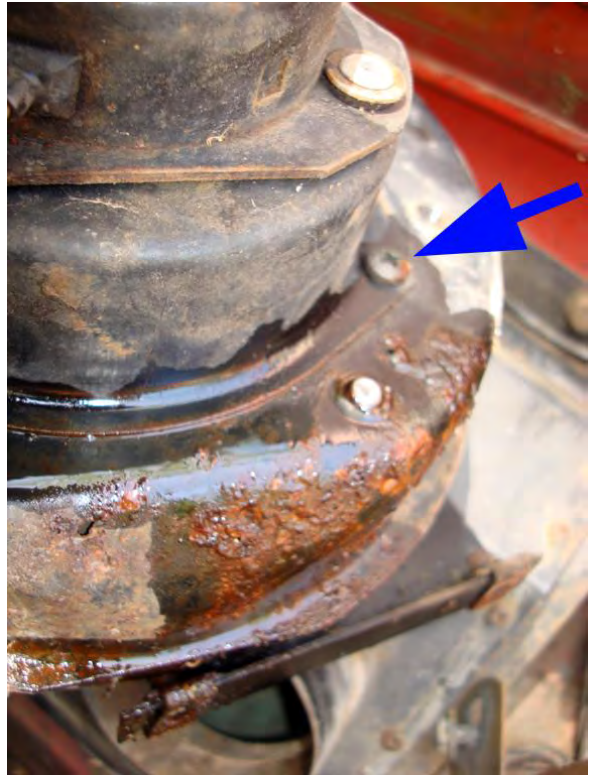
The base of the snail box was badly rusted (Figure 3) because moisture accumulates at its rounded bottom and in some places it was rusted through. I removed the stepped cowling that holds the fan motor and squirrel cage assembly by removing the 3 Phillips screws that attach the cowling to the snail box (blue arrow in Figure 3 shows one of the 3 screws that must be removed).

Figure 3. Base of snail box shows the extensive rust at the bottom of the box due to moisture accumulation. Three Phillips screws (one shown at blue arrow) must be removed in order to remove the cowling that the heater fan motor and squirrel cage assembly are attached to in order to replace the fan and squirrel cage and gain full access to the interior of the snail box.

I sanded the snail box inside and out and used J-B Weld to fill in the holes and build up the rusted and thinned walls. I then sanded down the J-B Weld (Figure 5) and primed and painted the snail box. I drilled a small hole in the base of the snail box to serve as a drain hole for the moisture that accumulates here. Time will tell if this drain hole will prevent future rust.

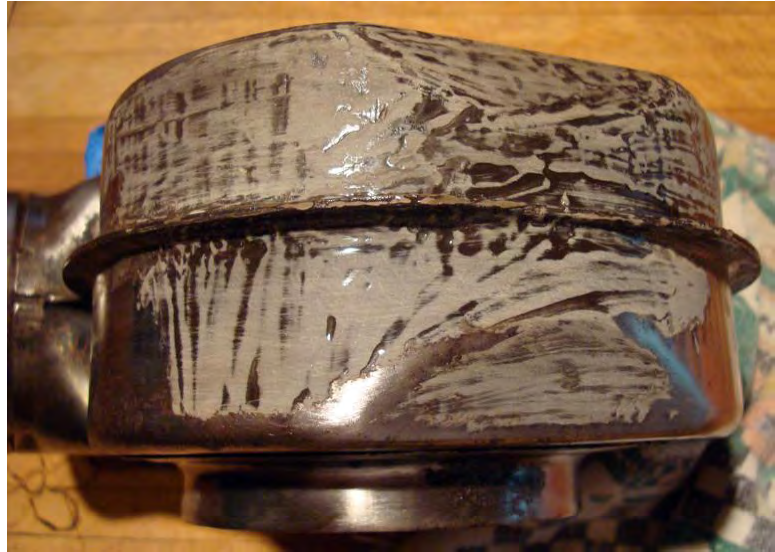
Figure 5. Photo showing base of the snail box with the sanded J-B Weld fill before priming and painting.

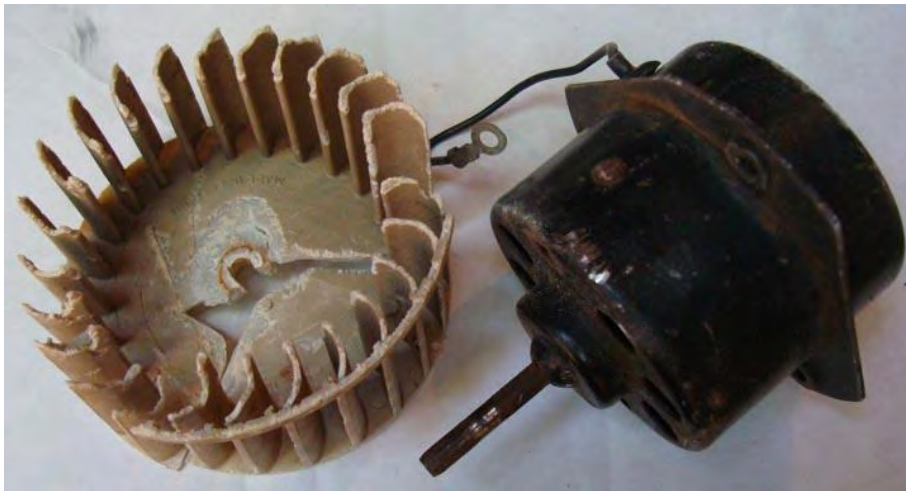
It is possible to sometimes find a new replacement heater fan motor and even a fan motor with attached squirrel cage but the cost of these together can approach \$200. The squirrel cage in my assembly was made of plastic and had largely disintegrated (Figure 6). The rust seen in the snail box was also found in the fan motor and was so extensive that large flakes of rust had broken loose and become so securely attached to the magnets of the fan motor that the entire assembly was frozen (Figure 6).

Figure 6. Photo showing the disintegrated plastic fan squirrel cage and rusty original motor.

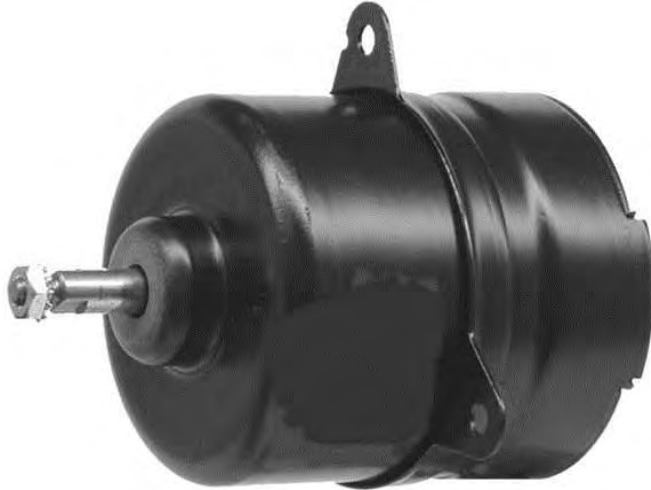
I searched far and wide for a replacement 12V fan motor of the correct dimensions so that it would: (1) fit the cowling, and (2) provide the correct shaft length and diameter so that the attached squirrel cage did not protrude beyond the fender-facing opening of the snail box. I won't bother to tell you how long this search took, but the bottom line is that NAPA Auto had one on the shelf (Figure 7). (I have no financial relationship with NAPA except that it seems that my paycheck should be on direct deposit to them, ha ha!) This fan motor protrudes inward toward the engine a bit more than the original fan motor but there is still plenty of room between it and the heater core box.

Figure 7. NAPA Part No. BK 6552123, radiator fan motor from Balkamp. Price: \$45.49 on 13 June 2010.

The mounting flanges did not match the holes for the original fan motor flanges in the cowling (rivet positions in Figure 4) and so I filled in the old holes with J-B Weld, sanded and primed

and painted the cowling, then drilled new holes that match the flanges for the new fan motor. I mounted the fan motor to the cowling with a stainless steel bolt assembly.

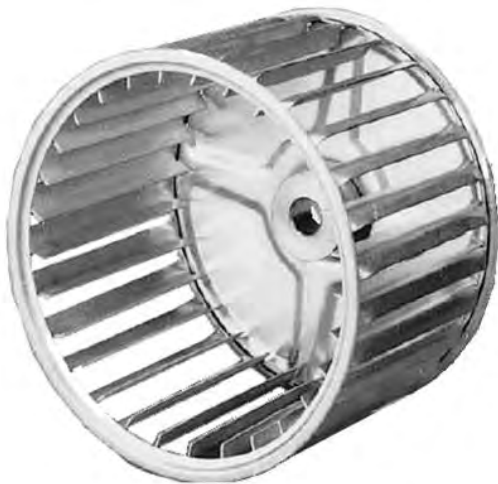
Finding the correct replacement for the broken squirrel cage also took some time. It had to have a CCW rotation. I wanted to go with steel instead of plastic and found one at Indiana Fan (Figure 8) (Again, I have no financial relationship with this company.).

Figure 8. Indiana Fan and Fabrication replacement squirrel cage Part No. 02895776: 4.25" diameter, 2" height, 0.25" bore, and CCW rotation. Price: \$16.87 on 13 June 2010.

The spindle bore of the squirrel cage was slightly smaller than shaft diameter of the fan motor and so I drilled out

the bore of the cage to match the fan motor spindle. I attached the squirrel cage to the fan motor, attached this assembly to the cowling, and then used stainless steel screws to attach the cowling and fan motor assembly to the snail box.

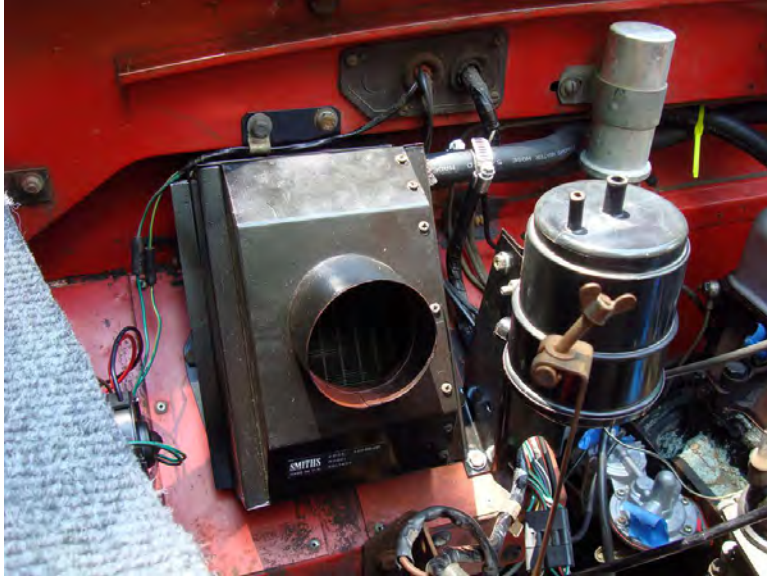
I placed strips of adhesive foam insulation around the opening in the firewall, reinstalled the heater core box, and then reattached the heater hoses (Figure 9).

Figure 9. Photo showing heater core box reinstalled and heater hoses attached.

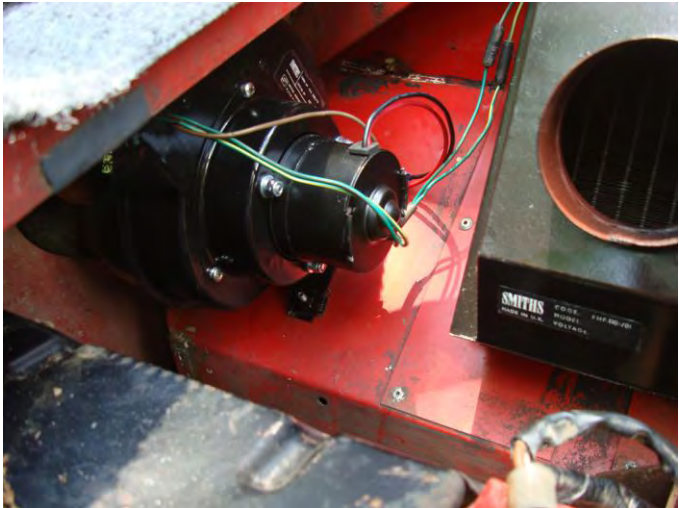
I next installed the snail box and fan motor and squirrel cage assembly (Figure 9). The foam insulation seal at the intake on the front wing can be re-installed by folding it and inserting it into the exterior opening. I used aluminum screws to attach the exterior intake grill to the front wing.

Figure 10. Snail box and fan motor and squirrel cage assembly reinstalled.
