## Replacing the handbrake drum/rear output shaft oil seal. Series models.

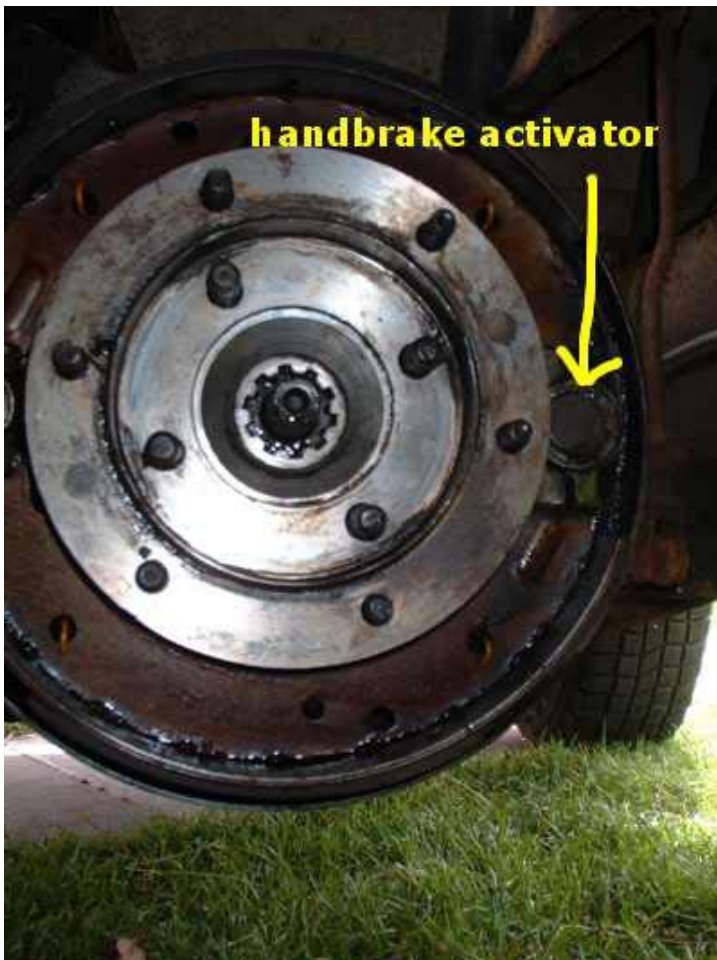
The above photo shows the result. There's a lot of oil in there, as the drain was blocked. That photo is of a late Series III's output shaft and brake setup.

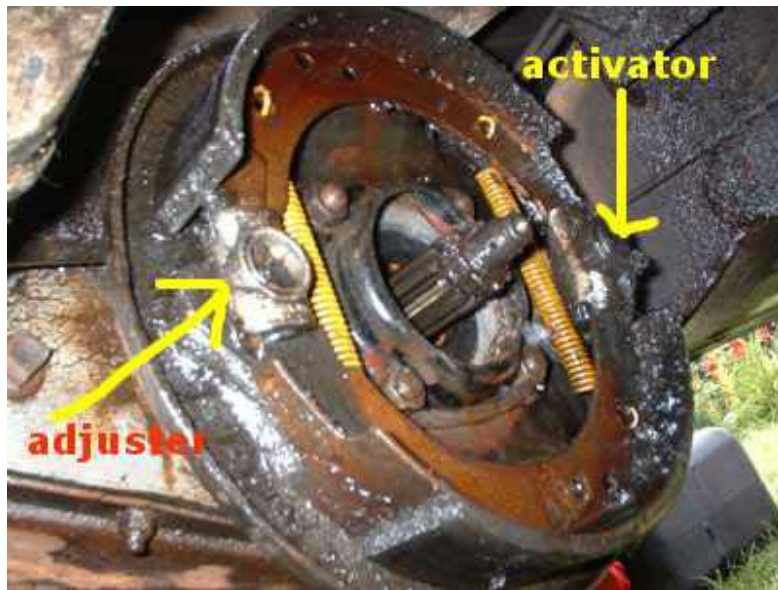
This next photo shows the mess the oil leak can make, especially if you haven't cleaned the drain hole out!

Stuff a lint free rag into the output shaft hole now, and spray the backplate with brake cleaner or degreaser to remove all the oil. You should clean out the drain hole for the oil catcher too at this point, and then dry everything off.

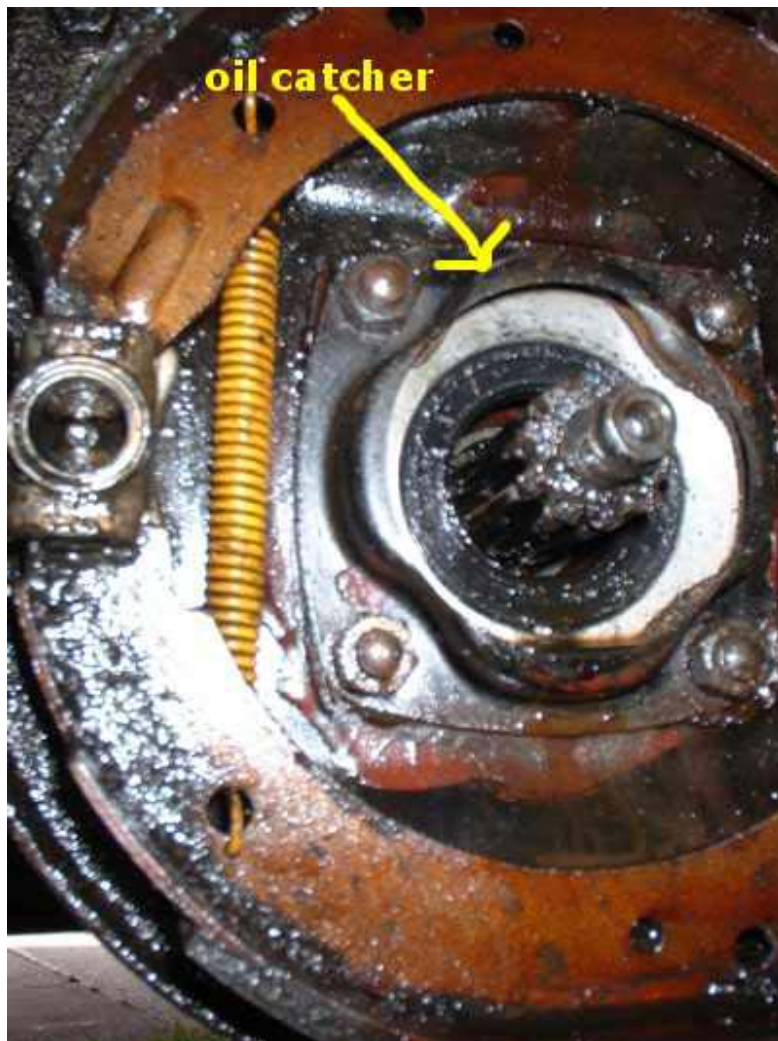
And a quick look to see where the oil catcher is...

You can see the difference quite easily.

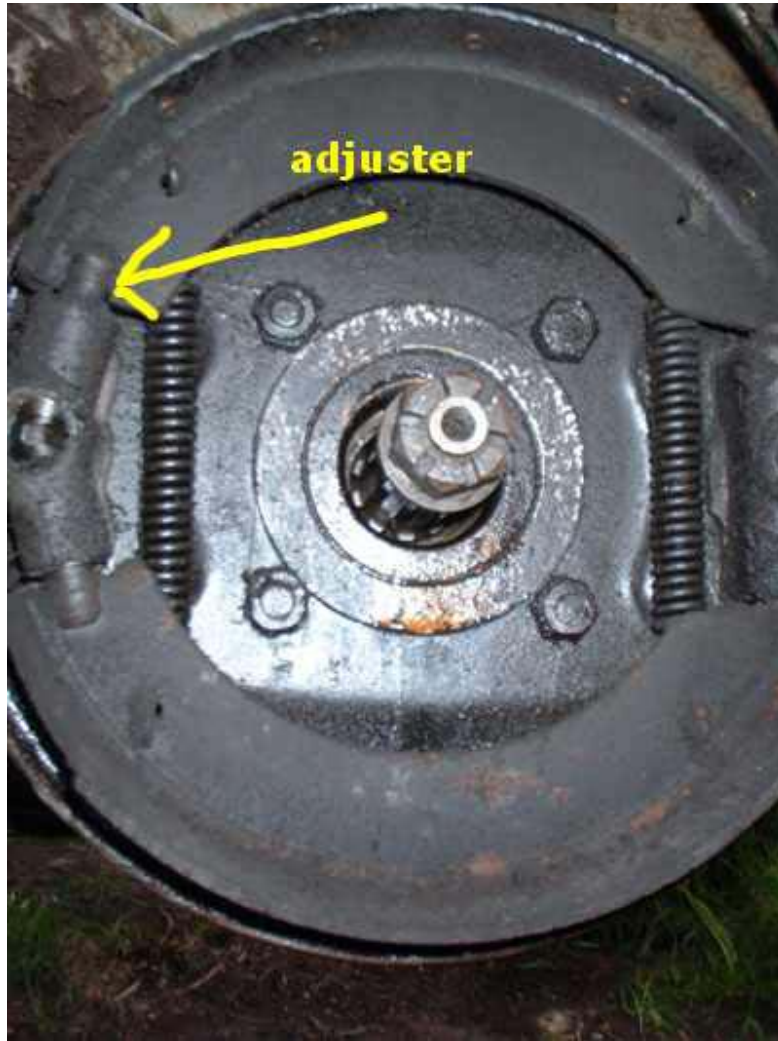
And now a look at the earlier type without the oil catcher...

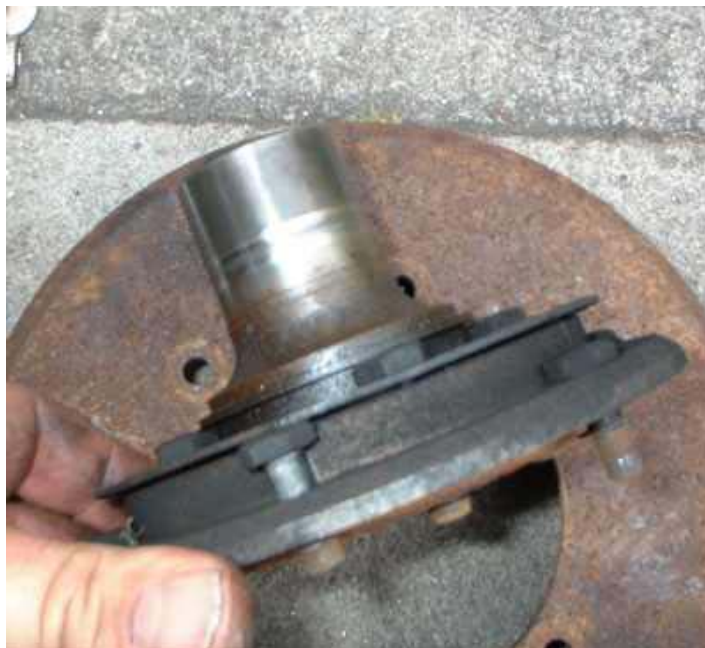
Examine the output flange closely...if it is excessively scored you may need to replace it, as the lips of the seal run on it. If it's badly scored no amount of new seals will stop it leaking! Light wear is acceptable, but it's your decision!

The above is an early output flange. The flanges are the same throughout the series range (236630) from SI to SIII. The V8 box is different though, part number 576627. Later models have an oil catcher, which you can just see on the next photo. It's still the same flange though, the oil catcher is a press fit.
