Property Inspection Report

4510 Ivanhoe Walk, Cumming, GA 30040

Inspection Date:

07/11/2020

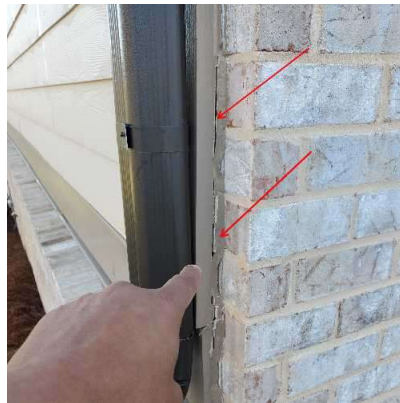
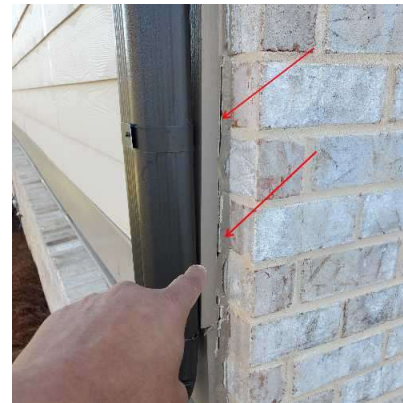
Exterior Walls

- **Repair:** Exterior - On the front-left side, there is a need for re-sealing the siding joint going all the way up. Picture included.

- **Repair:** Exterior - On the front-left side, there is a need for re-sealing the siding joint going all the way up. Picture included.
- **Repair:** External - In the front porch and steps, at multiple locations, cement sealing cracks noticed. Cement re-sealing at cracks recommended. Sample pictures included.

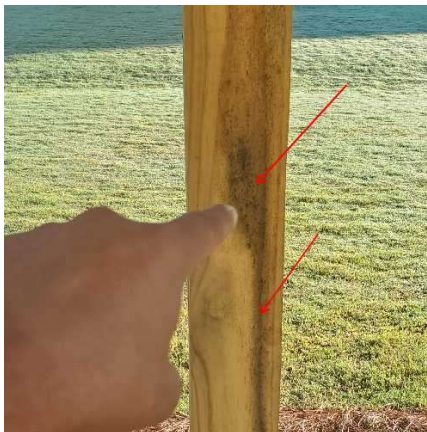
Deck

- **Improve:** Exterior - The deck wood has mold like substance seen. There are multiple spots underneath of the

deck. The deck needs a stain / paint to protect the wood. That will also make deck more durable. Sample pictures attached.

- **Improve:** Exterior - The deck wood has mold like substance seen. There are multiple spots underneath of the deck. The deck needs a stain / paint to protect the wood. That will also make deck more durable. Sample pictures attached.
- **Improve:** Electrical - A couple of bulbs of the main living room's ceiling fan seem to be not working.
- **Improve:** Heating - Both the the filters from attic furnaces, need to be changed. The filters be changed every 3-4 months.

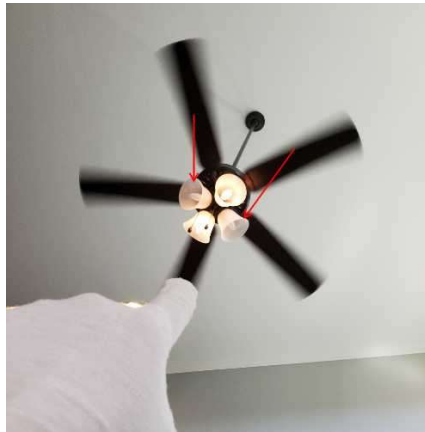
Lights/Ceiling Fans

- **Improve:** Electrical - A couple of bulbs of the main living room's ceiling fan seem to be not working.

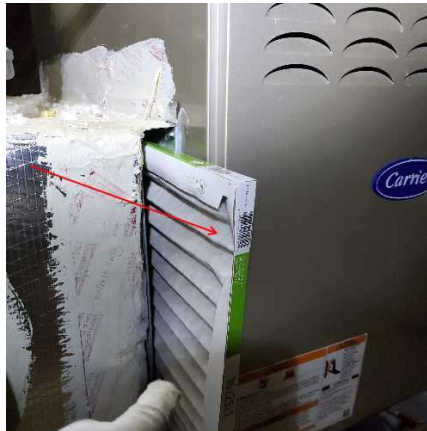
Furnace

- **Improve:** Heating - Both the the filters from attic furnaces, need to be changed. The filters be changed every 3-4 months.

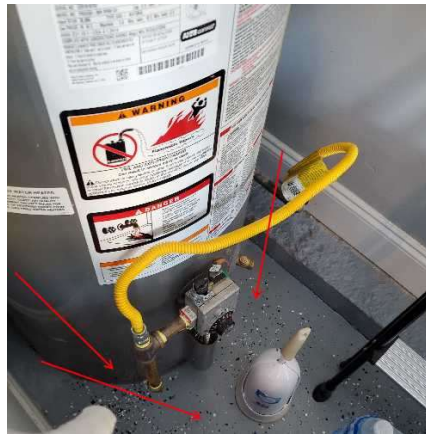
Water Heater

- **Concern:** Plumbing - The gas water heaters are installed on an elevated platform and inside a plan. That seems missing.

- **Concern:** Plumbing - The gas water heaters are installed on an elevated platform and inside a plan. That seems missing.
