# Inspection Report

**Property Address:**  
6851 Roswell Rd Unit I 4  
Sandy Springs Ga 30328

**Scott Mitchell**  
2133 Lawrenceville Suwanee Rd.  
Suite 12-336  
Suwanee Ga. 30024

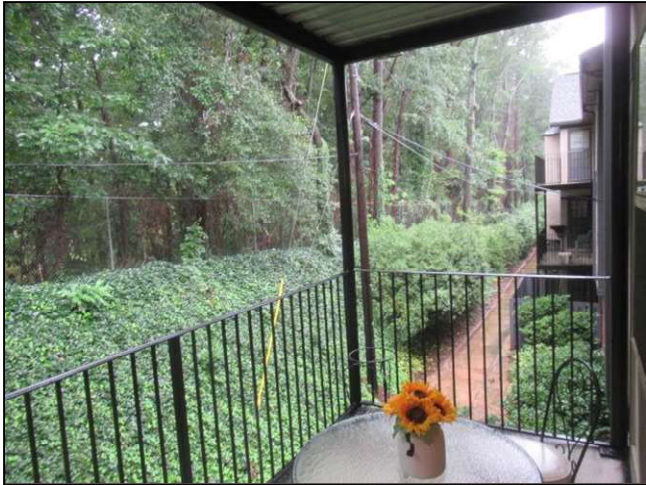
1.4 Item 1(Picture)

**1.4** The porch is in good condition.

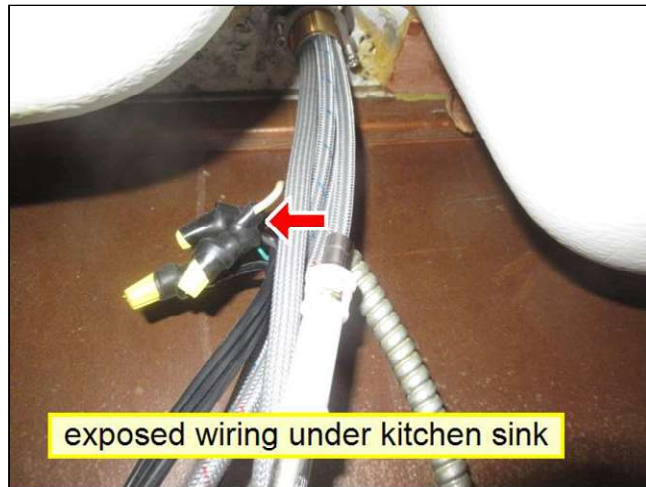
3.6 Item 1(Picture)

**3.6** There are exposed wiring connections below the kitchen sink that should be corrected to be in covered and secure electrical junction box.

The kitchen ceiling fan shakes when it is on and should be serviced.,

There are exposed wiring connections below the kitchen sink that should be corrected to be in covered and secure electrical junction box.

The kitchen ceiling fan shakes when it is on and should be serviced.,

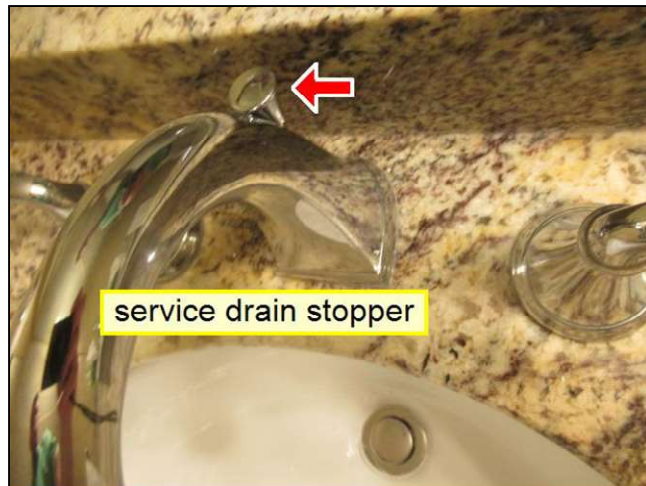
4.2 Item 1(Picture)

**4.2** The sink drain stopper control should be repaired to be operational at the master bathroom.

The sink drain stopper control should be repaired to be operational at the master bathroom.

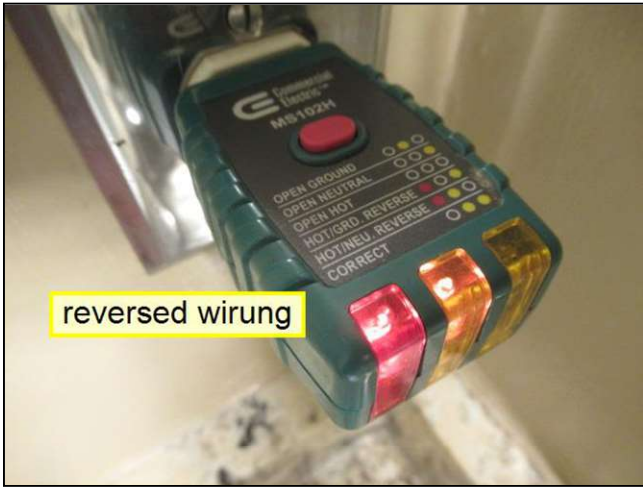
4.3 Item 1(Picture)

**4.3** The master bathroom power receptacles have reversed wiring that should be corrected for proper operation.

The master bathroom power receptacles have reversed wiring that should be corrected for proper operation.

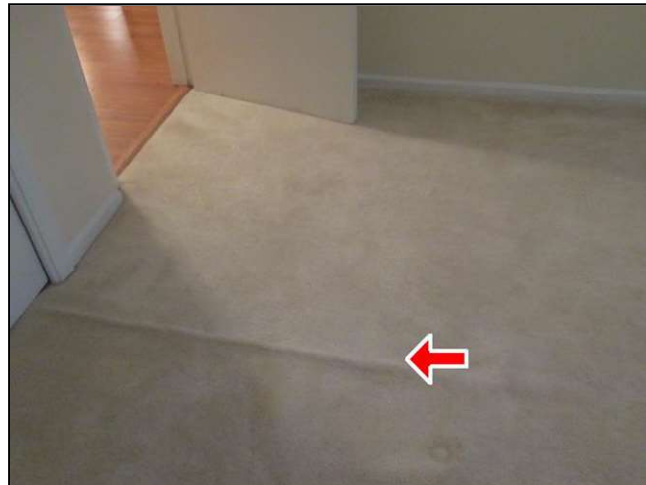
5.2 Item 1(Picture)

**5.2** The carpet in the front bedroom is raised and should be re stretched to prevent tripping.

There are areas where the floors are not level because of settlement. This is not unusual and does not appear to be from recent movement.

The carpet in the front bedroom is raised and should be re stretched to prevent tripping.

There are areas where the floors are not level because of settlement. This is not unusual and does not appear to be from recent movement.

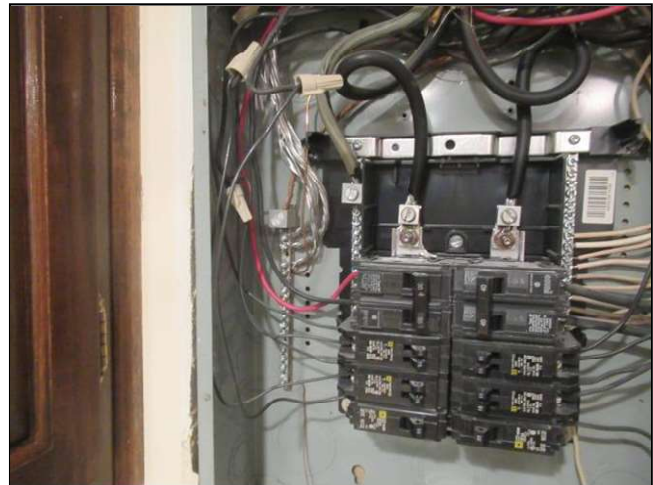
7.2 Item 1(Picture)

**7.2** One electrical circuit (#9 BREAKER) in the power panel has undersized number fourteen wire on a twenty amp breaker. The undersized wire was added to a properly sized number twelve wire in the panel. Have the undersized wire in the panel replaced for safety.

Four of the circuit breakers should be labeled to know what they control.

One electrical circuit (#9 BREAKER) in the power panel has undersized number fourteen wire on a twenty amp breaker. The undersized wire was added to a properly sized number twelve wire in the panel. Have the undersized wire in the panel replaced for safety.

Four of the circuit breakers should be labeled to know what they control.

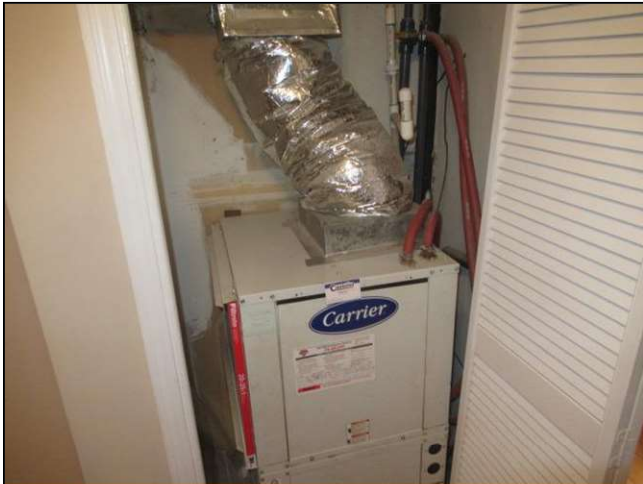
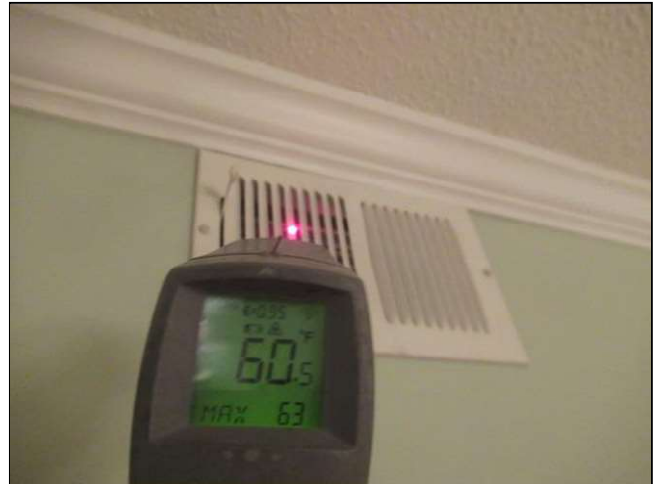
8.0 Item 1(Picture)

**8.0** The seventeen year old Carrier hvac system is functioning properly.
