Inspection Report

360 Mystic Ridge Lane #4542
Sandy Springs GA 30342

AllPro Inspections, LLC

Date: 4/3/2020	Time: 09:00 AM	Report ID: 360mystic
Property: 360 Mystic Ridge Lane #4542 Sandy Springs GA 30342	Customer: Michael Childs	Real Estate Professional: Shawn Davis Atlanta Fine Homes Sotheby's

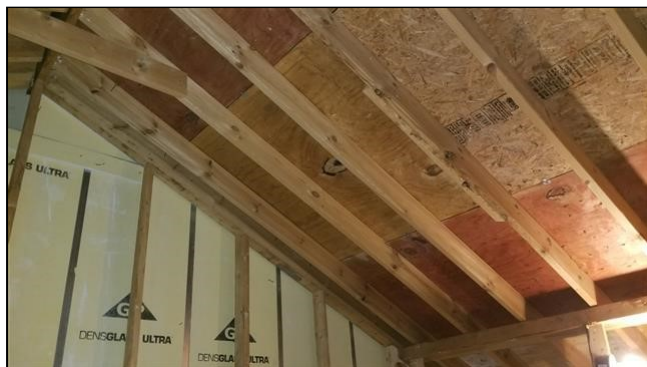
1.5 Item 1(Picture) right side wall

The right side exterior wall is fire rated as is required between units. The roof line is at the same elevation as the neighboring unit on this side so the first four feet of roof decking (closest to the wall) must maintain the same fire rating as the wall. Some of the plywood along this area is fire rated and some is not. Recommend a qualified professional further evaluate and correct as necessary in order to maintain proper fire separation between units.

The right side exterior wall is fire rated as is required between units. The roof line is at the same elevation as the neighboring unit on this side so the first four feet of roof decking (closest to the wall) must maintain the same fire rating as the wall. Some of the plywood along this area is fire rated and some is not. Recommend a qualified professional further evaluate and correct as necessary in order to maintain proper fire separation between units.

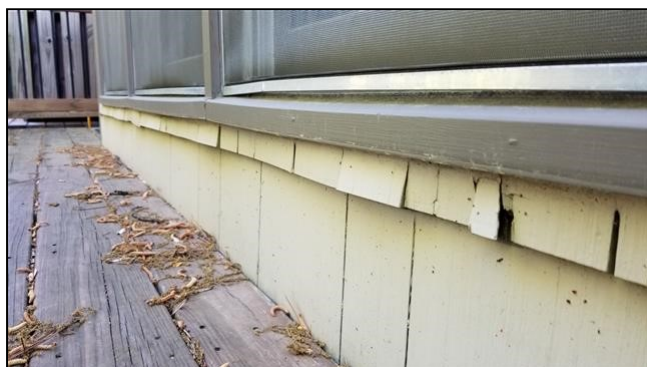
2.0 Item 1(Picture) triple window main floor

Some of the siding shingles under the triple window at the back deck are water damaged and loose. Recommend repairing/maintaining the shingles as necessary.

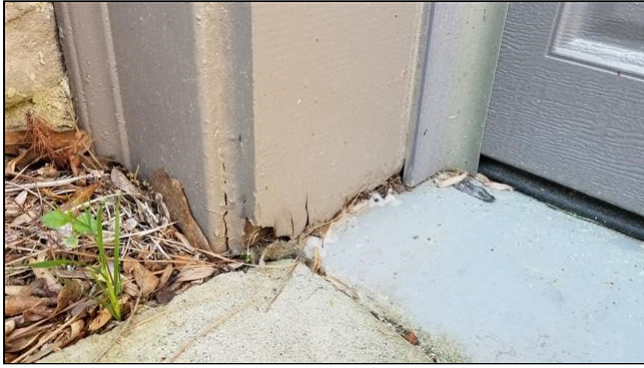
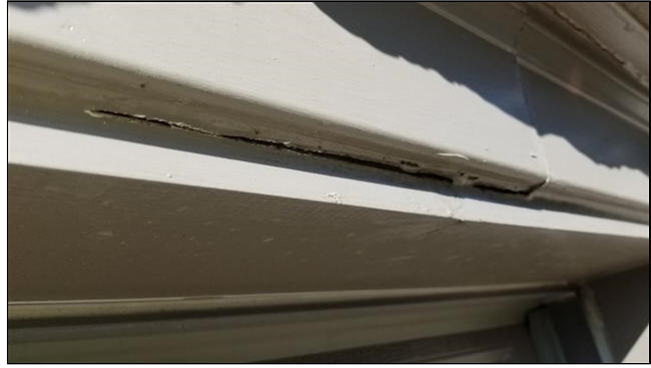
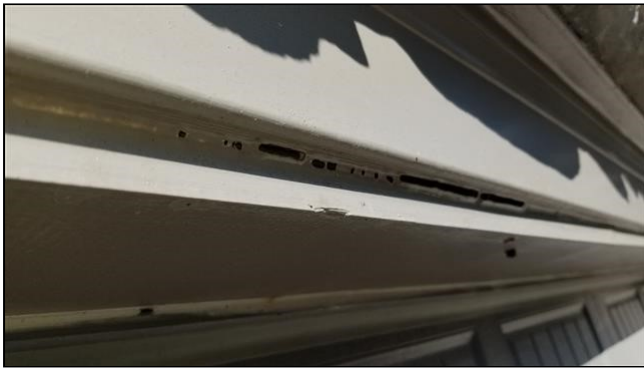
The bottom of the left side garage door jamb is water damaged. Also, the caulk along the top of the garage door frame has worn/cracked. Recommend maintaining these areas on the garage door frame.

2.1 Item 1(Picture) garage door jamb

2.1 Item 2(Picture) worn caulk at top of garage door frame

2.1 Item 3(Picture) worn caulk at top of garage door frame

The bottom of the left side garage door jamb is water damaged. Also, the caulk along the top of the garage door frame has worn/cracked. Recommend maintaining these areas on the garage door frame.

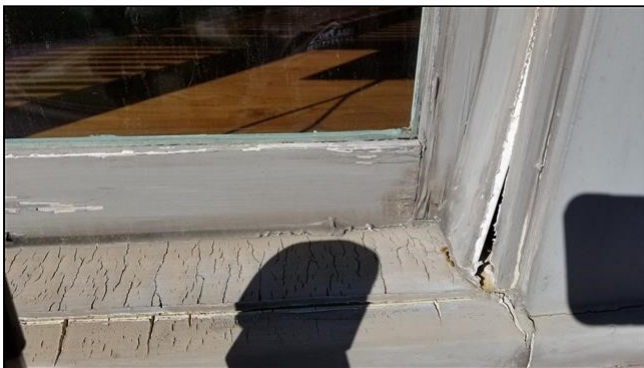
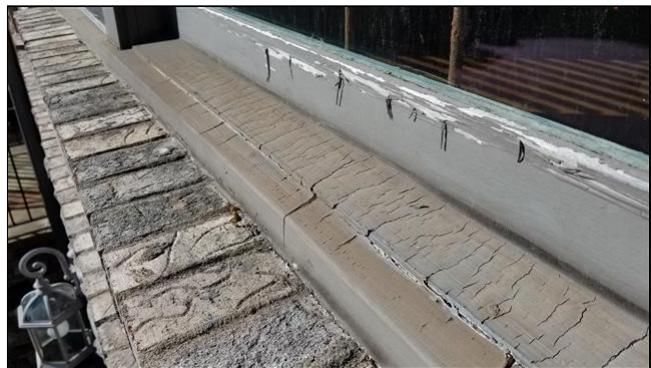
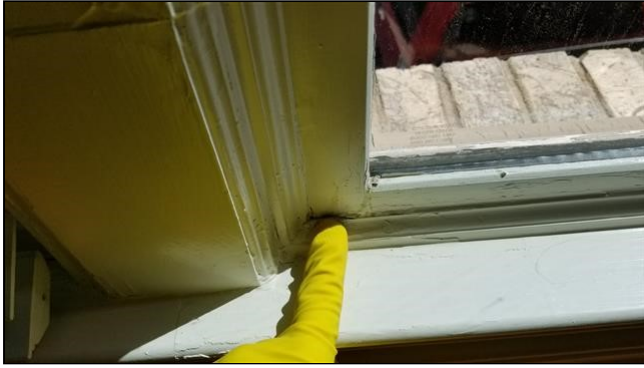
The bottom of the jamb, sash, and sill on the picture window over the garage are water damaged. The wood at the bottom corner of this window sash is no longer solid on the interior side. Recommend repair/replacing this window assembly as necessary.

2.2 Item 1(Picture) picture window over garage

2.2 Item 2(Picture) picture window over garage

2.2 Item 3(Picture) inside of picture window over garage

The bottom of the jamb, sash, and sill on the picture window over the garage are water damaged. The wood at the bottom corner of this window sash is no longer solid on the interior side. Recommend repair/replacing this window assembly as necessary.

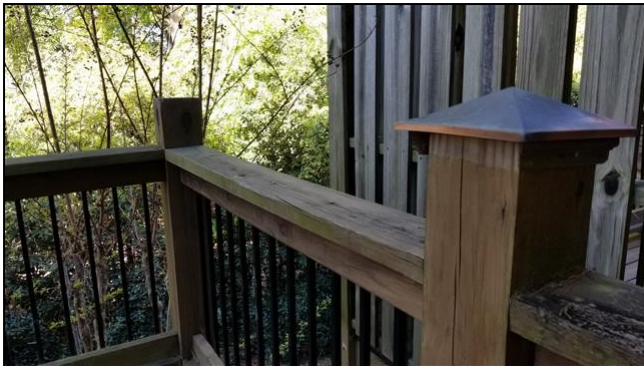
2.4 Item 1(Picture) post caps

(1) A railing post cap is missing and some trim pieces are missing from other railing posts. While these issues will not affect the safety or function of the deck, you may wish to repair/replace these items for esthetic purposes.

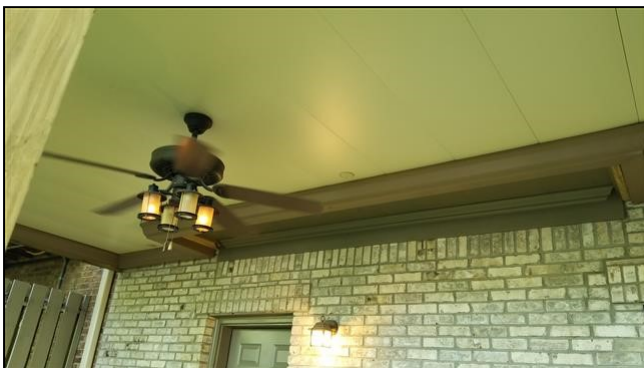
(2) The deck ledger attachment to the house is not visible due to a ceiling cover for the patio. Therefore the condition of the ledger, fasteners, and existence of ledger flashing can not be verified. The posts and railings are in good condition.

2.4 Item 2(Picture) deck ledger attachment not visible

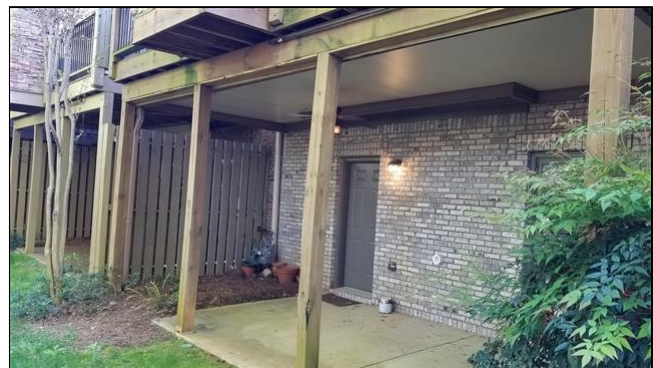
2.4 Item 3(Picture) posts are in good shape

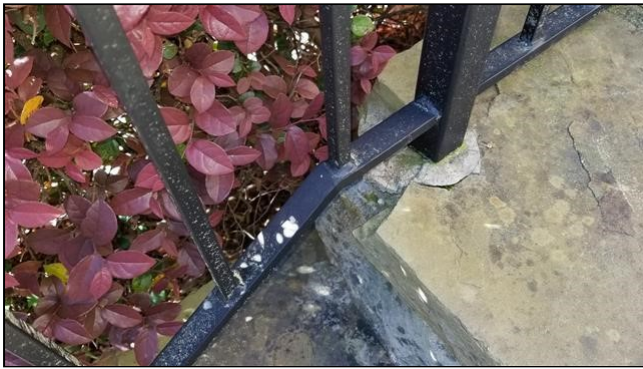
2.5 Item 1(Picture) front porch

The front porch is damaged where a railing post is mounted. Recommend a qualified professional repair as necessary.

The front porch is damaged where a railing post is mounted. Recommend a qualified professional repair as necessary.

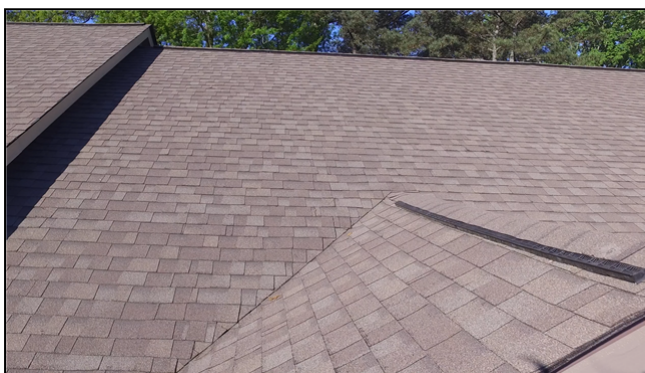
3.0 Item 1(Picture)

The roof shingles appear to be in overall good condition with no excessive wear or grit loss.

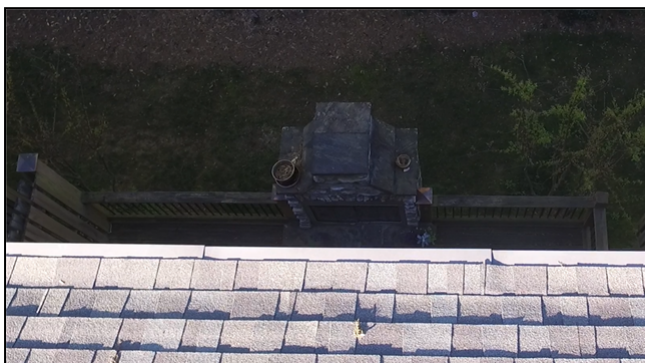
3.1 Item 1(Picture) back gutter

FYI - The rear gutter has hooded leaf protection installed.

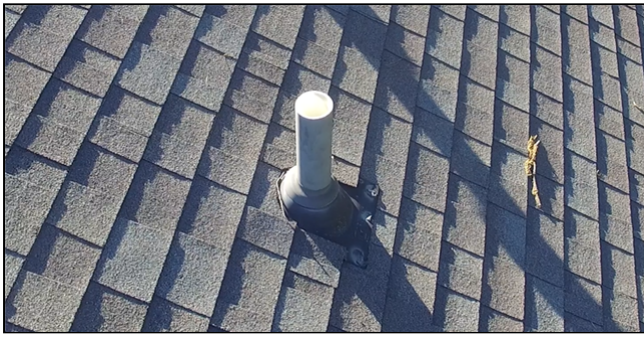
3.3 Item 1(Picture)

The rubber plumbing vent boot appears to be in good condition and water tight.

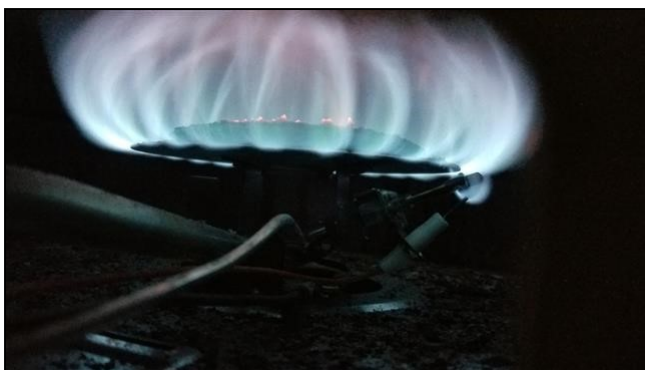
4.2 Item 1(Picture) water heater burner

The gas water heater burner fired quickly and burned clean.

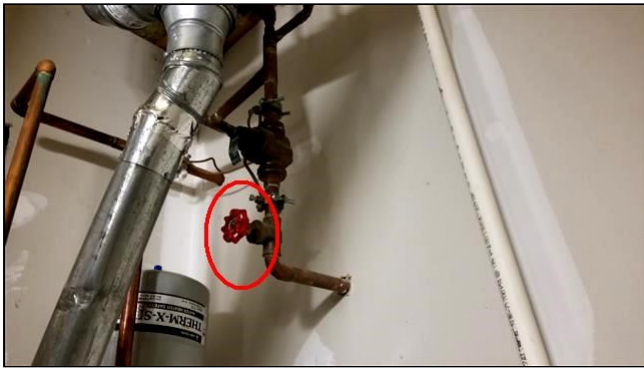
4.3 Item 1(Picture) main shut off

FYI - The main water shut off valve is located next to the water heater in the garage utility closet.

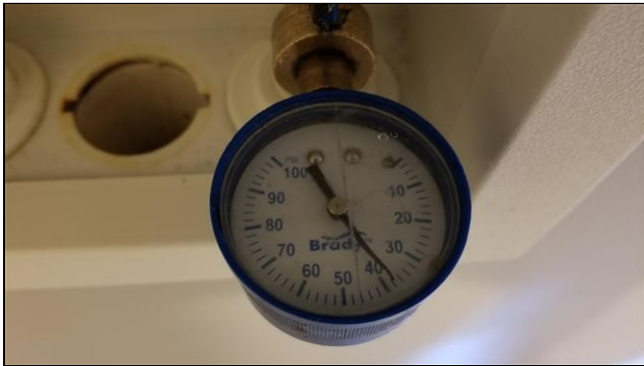
4.6 Item 1(Picture) water pressure 40psi

The house water supply pressure is 40 psi on the top floor which is within the normal/safe range. The flow rate was not measured but remained strong with multiple taps open.

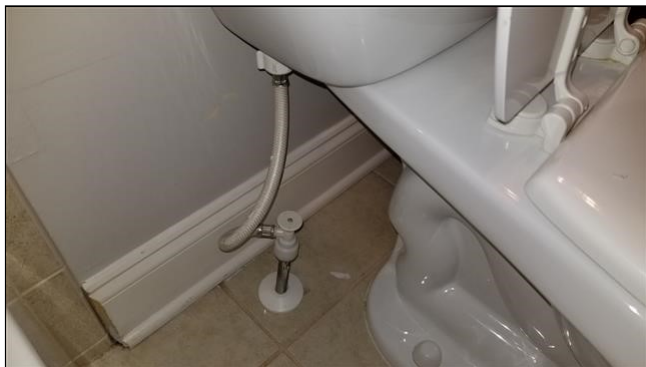
4.11 Item 1(Picture) upstairs guest shut off

The water supply for the toilet in the upstairs guest bathroom has been shut off. Therefore this fixture was not tested. Often, when the supply to a fixture has been shut off, it is due to a problem with that fixture or associated piping. Recommend further investigation.

The water supply for the toilet in the upstairs guest bathroom has been shut off. Therefore this fixture was not tested. Often, when the supply to a fixture has been shut off, it is due to a problem with that fixture or associated piping. Recommend further investigation.

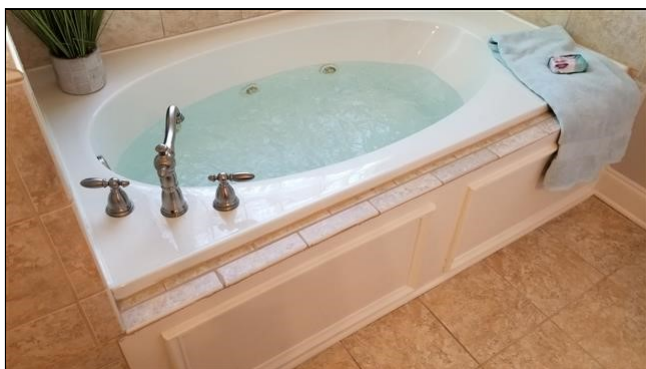
(1) The whirlpool tub worked well when tested. The reset for the motor's GFI protected circuit is located on the wall in the toilet closet.

4.13 Item 1(Picture) whirlpool tub

4.13 Item 2(Picture) GFI reset

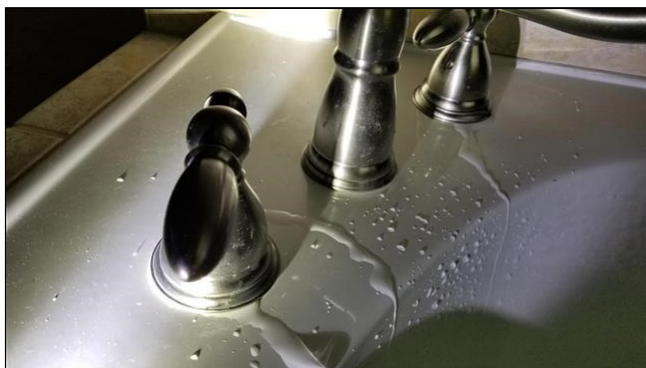
4.13 Item 3(Picture) whirlpool tub handles

(2) Water leaks from both of the whirlpool tub fixture handles. Recommend a qualified professional repair/replace this fixture as necessary.

(2) Water leaks from both of the whirlpool tub fixture handles. Recommend a qualified professional repair/replace this fixture as necessary.

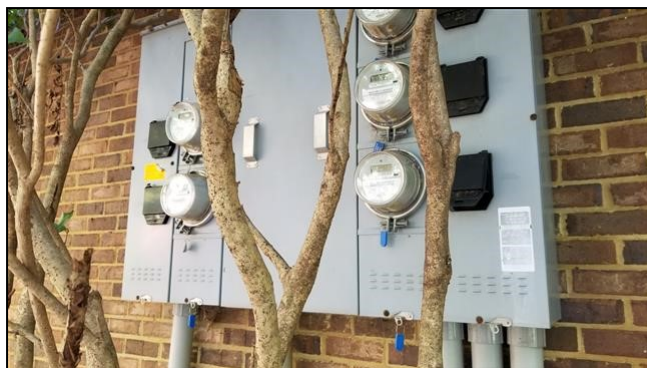
5.1 Item 1(Picture) right side of building

The meter and main shut off switch are located on the right exterior of the building among 4 others. The meters and switches are not labeled for unit identification. Recommend labeling the meter that belongs to this unit so that the power can be easily shut down.

The meter and main shut off switch are located on the right exterior of the building among 4 others. The meters and switches are not labeled for unit identification. Recommend labeling the meter that belongs to this unit so that the power can be easily shut down.

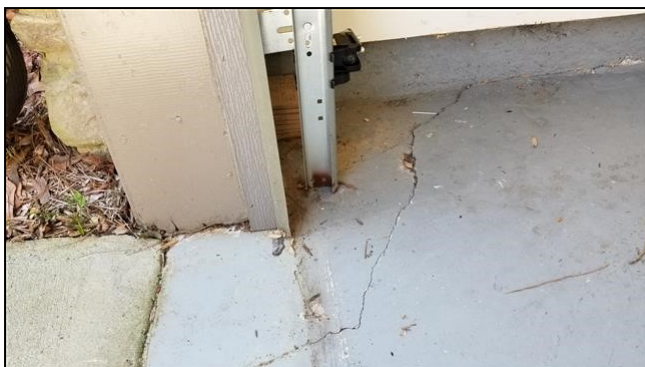
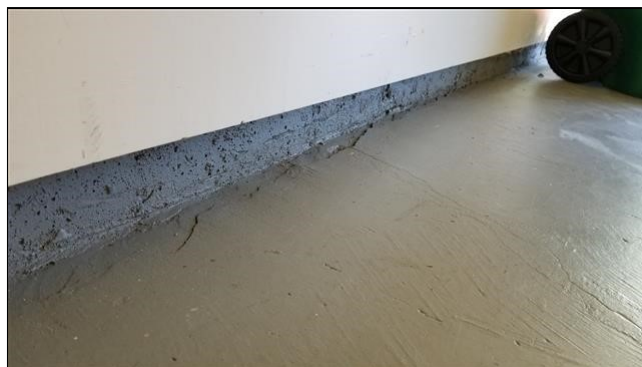
There is a crack at the front left corner of the garage slab that is offset about 1/8 inch. There is another crack along the right side of the garage slab that is also offset about 1/8 inch. The grade beams (footings) that run adjacent to these cracks have not cracked or settled. Recommend sealing the cracks in the slab and monitoring for additional movement.

6.1 Item 1(Picture) front left offset 1/8

6.1 Item 2(Picture) right side

There is a crack at the front left corner of the garage slab that is offset about 1/8 inch. There is another crack along the right side of the garage slab that is also offset about 1/8 inch. The grade beams (footings) that run adjacent to these cracks have not cracked or settled. Recommend sealing the cracks in the slab and monitoring for additional movement.

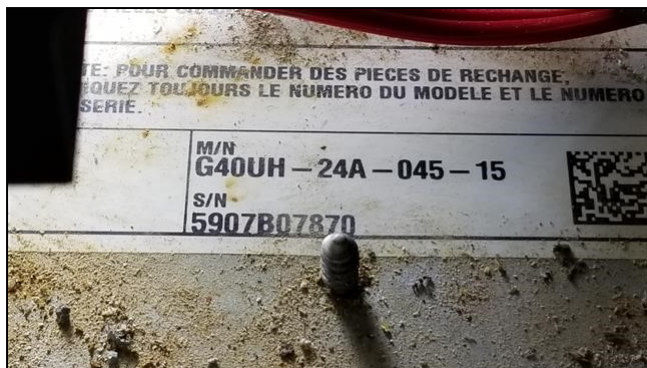
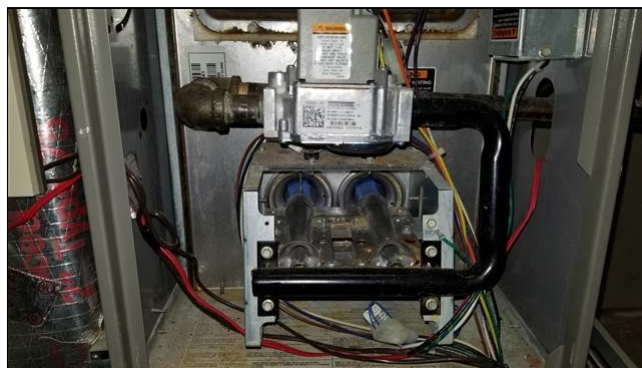
The gas furnace fired quickly and burned clean. No rust or corrosion was noted in or around the burner area. The heat pump produced a temperature rise in both "heat mode" and "emergency mode" that was within the normal range.

7.1 Item 1(Picture) furnace data plate

7.1 Item 2(Picture) furnace burner cabinet

7.1 Item 3(Picture) gas burners

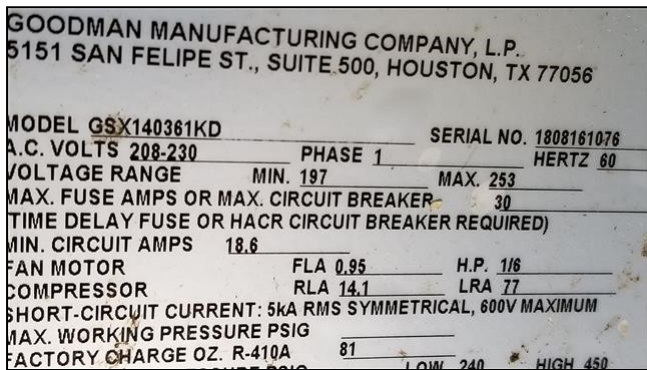
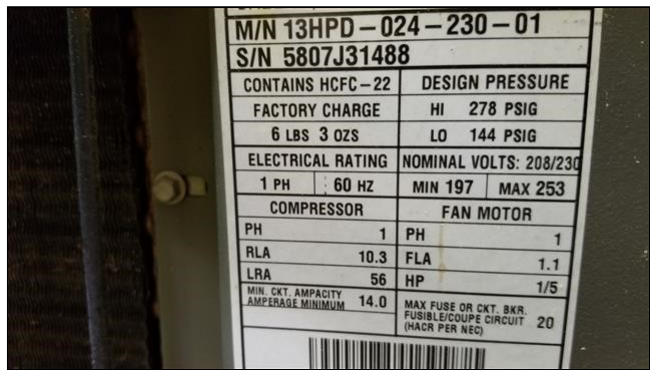
Both the air conditioner and the heat pump produced a temperature drop that was within the normal range.

7.2 Item 1(Picture) AC data plate

7.2 Item 2(Picture) heat pump data plate

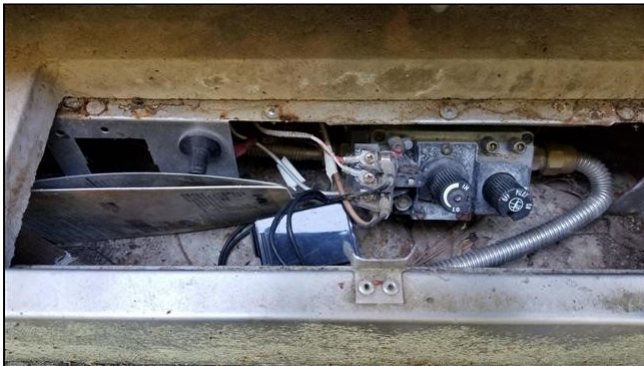
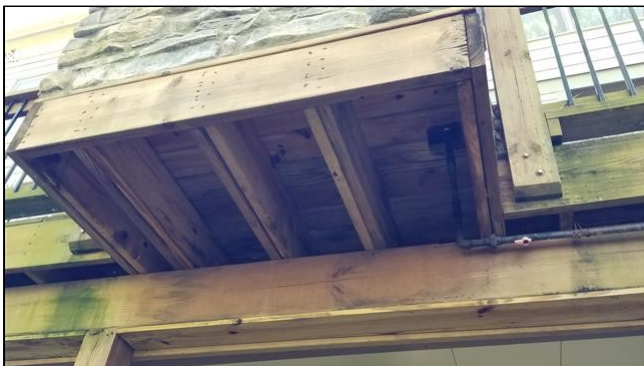
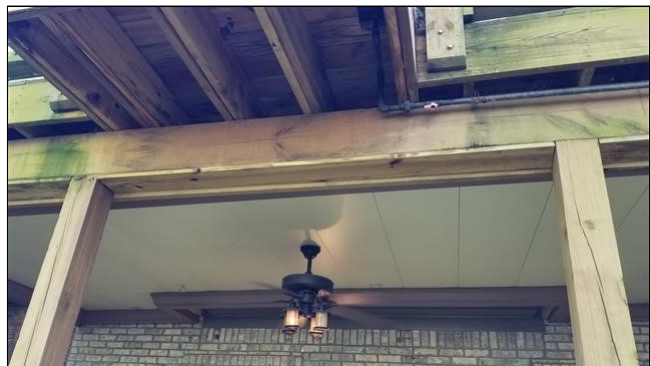
(1) There are vertical cracks along the two front corners of the outdoor stone fireplace. These type cracks are typically due to ground settlement, or in this case, flex in the cantilevered joists supporting the fireplace. The joists are doubled and appear to be adequate to support the load of the fireplace. The joist connections to the house band are not visible. Therefore verification of support to resist additional upload force from the fireplace could not be verified. The fireplace appears to be overall adequately supported. I lit the gas logs using the controls and igniter located in the compartment below the firebox. I was not able to make the gas logs turn on completely (may require a remote control) Recommend asking the seller to demonstrate this unit.

7.3 Item 1(Picture) right side crack

7.3 Item 2(Picture) left side crack

7.3 Item 3(Picture) controls under fireplace

7.3 Item 4(Picture) doubled cantilevered joists

7.3 Item 5(Picture) joist connection to house band not visible

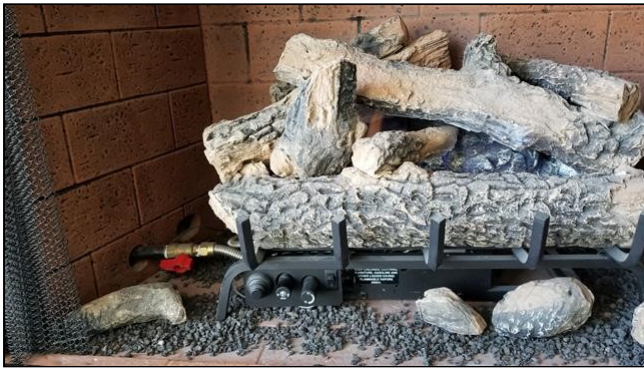
7.3 Item 6(Picture) indoor fireplace

(2) The indoor gas logs lit easily using the controls located inside the firebox.

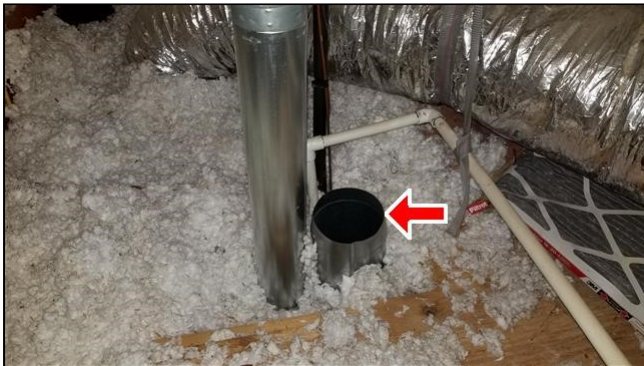
7.8 Item 1(Picture) pipe open to attic

FYI - The metal pipe that protrudes through the attic floor and terminates in the attic is supplying combustion air to the gas furnace and water heater in the basement utility closet.

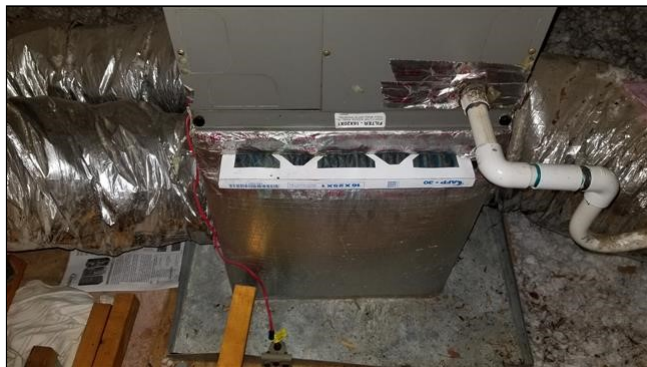
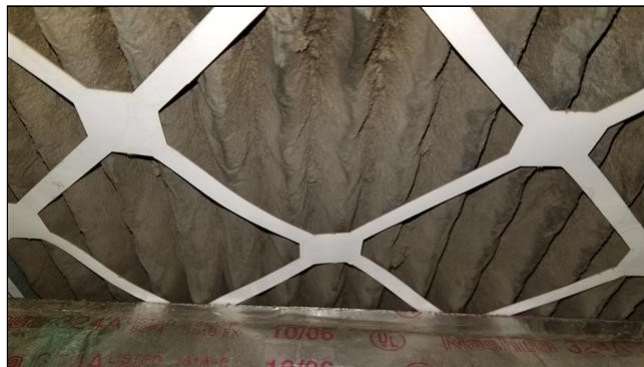
The filter in the attic HVAC unit is oversized and prevents installing a cover. This filter is also overdue to be replaced. Recommend installing a correctly sized filter along with a cover to prevent air from the attic from entering the system.

7.10 Item 1(Picture) attic unit

7.10 Item 2(Picture) clogged filter

The filter in the attic HVAC unit is oversized and prevents installing a cover. This filter is also overdue to be replaced. Recommend installing a correctly sized filter along with a cover to prevent air from the attic from entering the system.

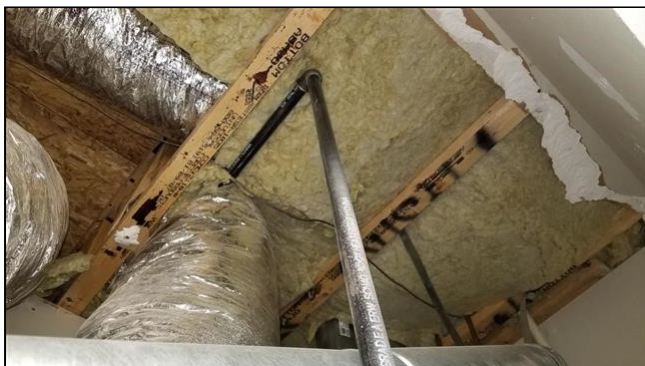
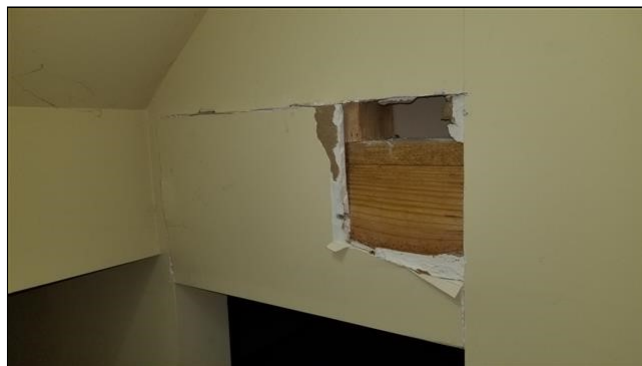
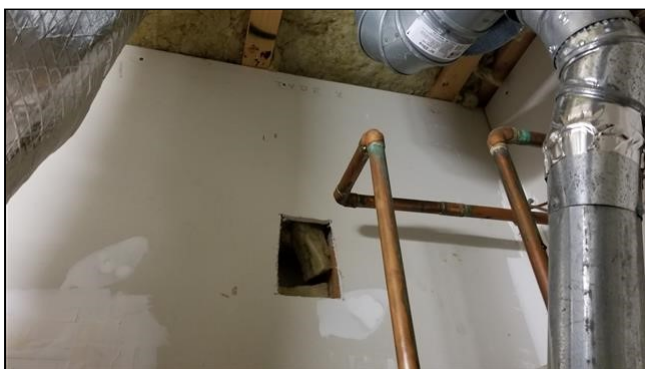
The ceiling drywall has been removed from the utility closet in the garage. Drywall has also been removed from a wall in this closet as well as a wall in the garage storage area. Recommend replacing all of the missing drywall in order to complete the fire block between levels as well as the fire/fume barrier between the garage and living space. Also recommend asking the seller why the drywall was removed in these three places in order to disclose any past issues that may have been remedied.

8.0 Item 1(Picture) utility closet in garage

8.0 Item 2(Picture) inside of garage storage area

8.0 Item 3(Picture) utility closet in garage

The ceiling drywall has been removed from the utility closet in the garage. Drywall has also been removed from a wall in this closet as well as a wall in the garage storage area. Recommend replacing all of the missing drywall in order to complete the fire block between levels as well as the fire/fume barrier between the garage and living space. Also recommend asking the seller why the drywall was removed in these three places in order to disclose any past issues that may have been remedied.

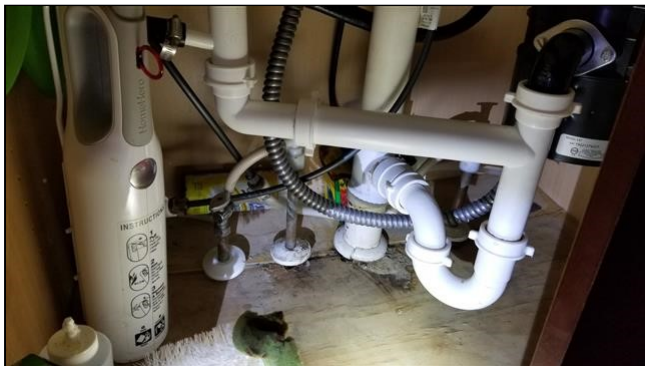
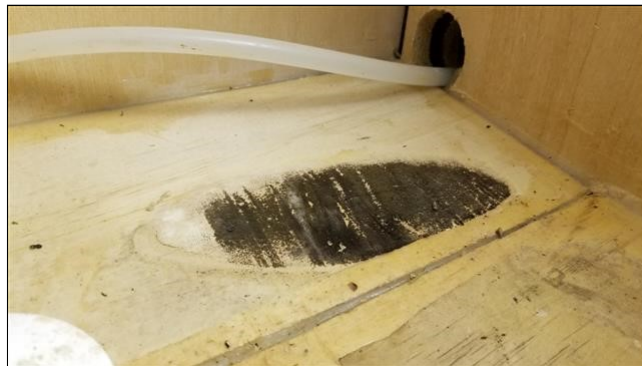
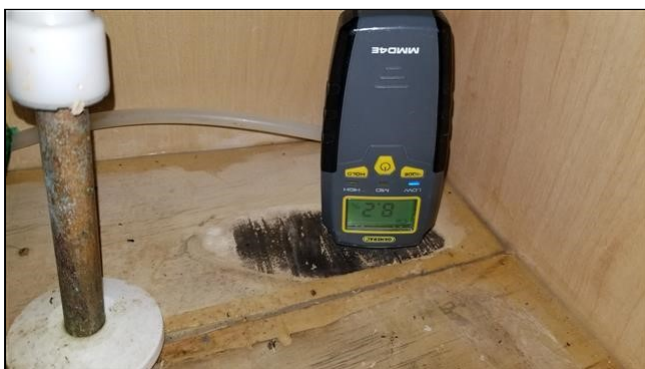
The cabinet base under the kitchen sink is water damaged. There is a stain on the base that resembles biological growth. There does not appear to be an active leak as the stained area tested dry with a moisture meter. Recommend replacing the cabinet base and monitoring for moisture in the future.

8.4 Item 1(Picture) kitchen sink cabinet base

8.4 Item 2(Picture) growth on cabinet base

8.4 Item 3(Picture) dry

The cabinet base under the kitchen sink is water damaged. There is a stain on the base that resembles biological growth. There does not appear to be an active leak as the stained area tested dry with a moisture meter. Recommend replacing the cabinet base and monitoring for moisture in the future.
