Request List for 5810 Vinings Retreat Ct SW Mableton GA 30126

Last Modified: 2020-04-08 18:35:07

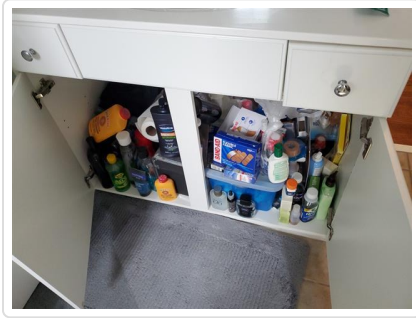
1. Lavatory Fixtures

2.4 Personal belongings of the seller in the master bath (left sink) sink cabinet obstructed the view to all of the sink plumbing. The inspector does not move belongings of the seller to inspect items. Potential plumbing leaks could have been missed. The seller needs to confirm that there are no plumbing leaks in the sink cabinet when the cabinet is emptied. Repairs, if needed, should be made by a licensed plumbing contractor.

Sellers to advise/disclose if there are any current or past plumbing leaks. Provide photos to Buyers of cleared out area underneath sink along with photos of the plumbing.

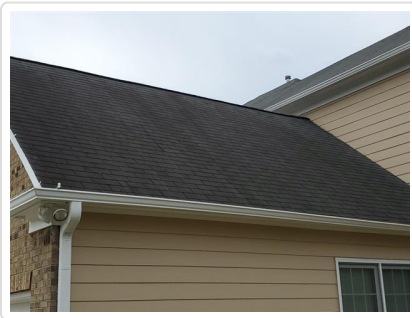
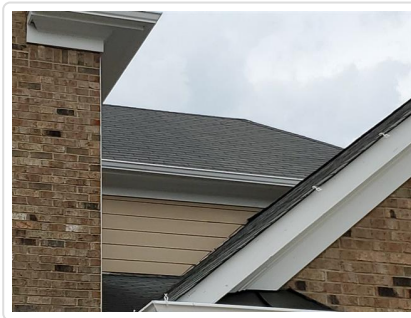
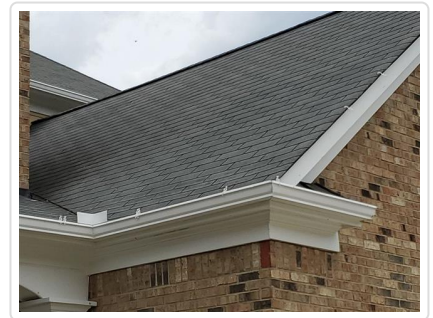
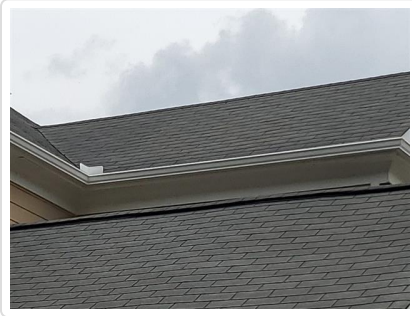
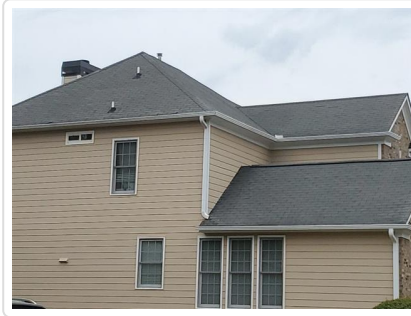
20. Roof Coverings

- **Replace Requested**
Seller to replace entire roof and remove the satellite dish and repair and damage caused by such removal.
- **Inspector's Comment**
13.0 (1) The roof is being replaced due to storm damage.

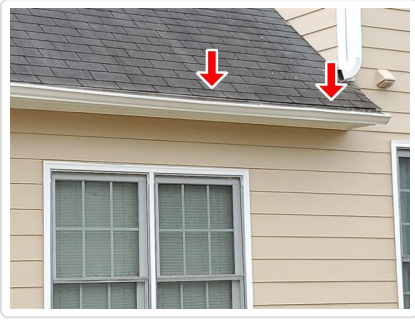
22. Gutter Drainage Systems

- **Repair Requested**
Seller to have roofer repair and re-nail gutter to the fascia after roof is replaced.
- **Inspector's Comment**
13.3 (1) Gutter is pulling away from the fascia on the right side of the house. A qualified contractor needs to re-nail gutter to the fascia after roof is replaced.

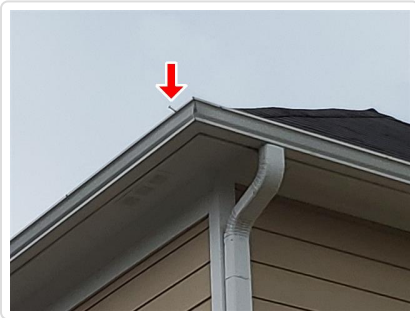
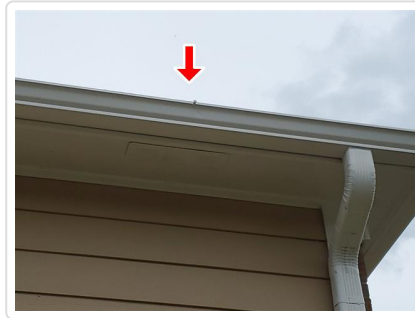
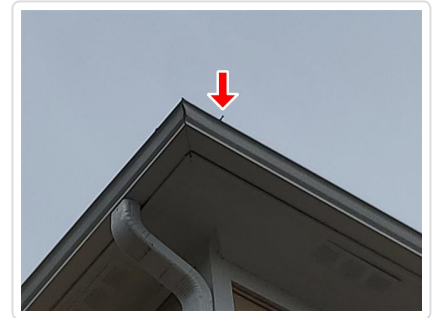
23. Gutter Drainage Systems

- **Repair Requested**
Seller to have roofer re-nail the gutters to the fascia.
- **Inspector's Comment**
13.3 (2) Gutter nails are backing out of the gutters. A qualified contractor needs to re-nail gutter to the fascia after roof is replaced.
