EXHIBIT 2-A

Property Address:
195 Ardsley Ln
Alpharetta GA 30005

Inspector: Tim Skillingstad

Residential Inspector of America, Inc.

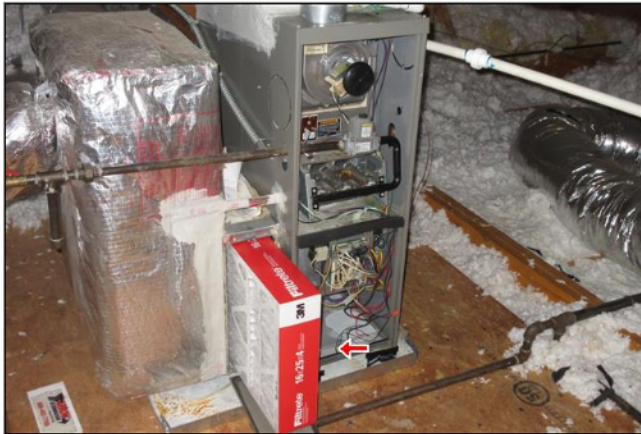
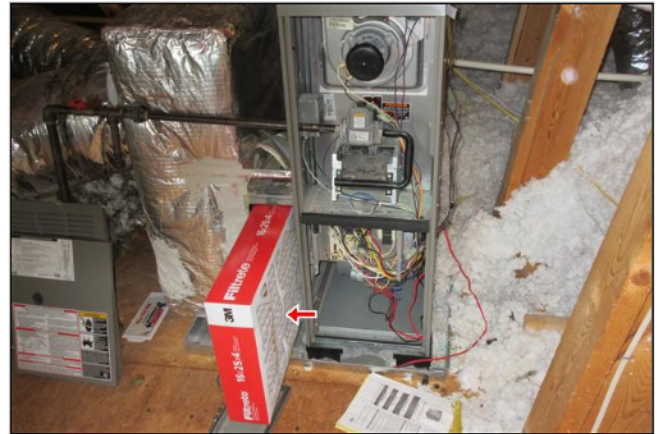
🔧 (1) Filter location. See photo. As a part of maintenance, it is recommended that the 1" filter(s) be changed every 3 months. 3" to 5" (thicker) filters are typically replaced every 6 months to 1 year. This will help maintain the life of the unit(s).

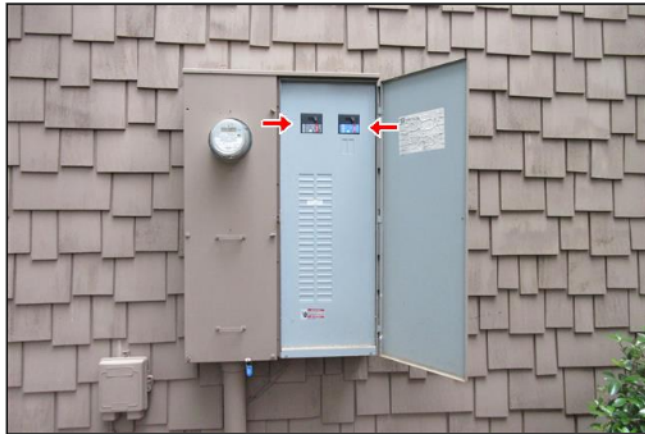
The main panel box is located at the basement. However, the main disconnect (shut-off) is outside at meter base panel (for your information). Panel was inspected for function (not code compliance) and building codes and standards have changed over the years.
