## Property Inspection Report

Property address: **1795 Horsham Trail  
Alpharetta GA 30004**

Inspection date: **Wednesday, August 5, 2020**

**Report number:** 080520JM1

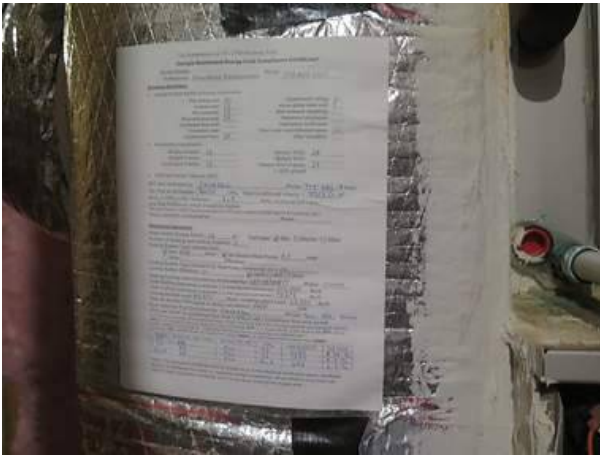
Photo 3-1

3) **i** General photo of the Georgia Residential Energy Code Compliance Certificate located in the basement area.

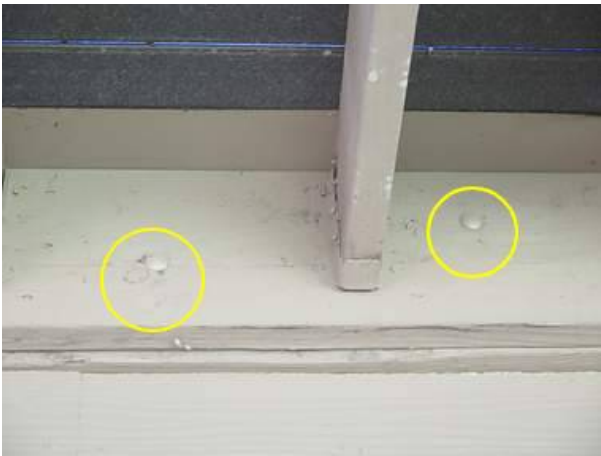
Photo 6-1

One or more deck or porch ledger boards were nailed to the building or attached with carriage bolts rather than being attached by lag screws or bolts. As a result, decks or porches may separate from the building and collapse. This is a potential safety hazard. Lag screws or bolts, minimum 1/2 inch in diameter, should be installed to securely attach ledger boards to the main structure. Recommend that a qualified person install fasteners per standard building practices. For more information, visit:

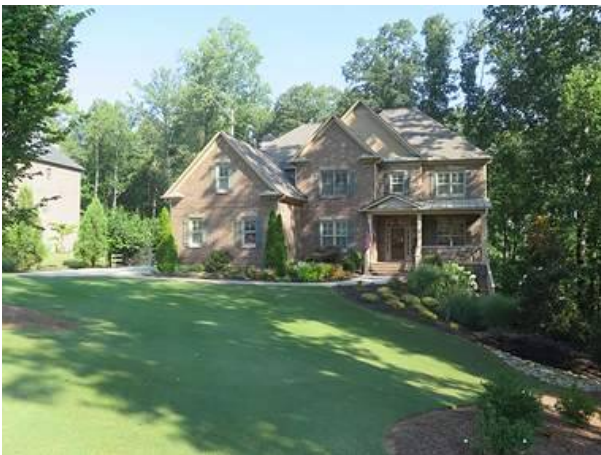
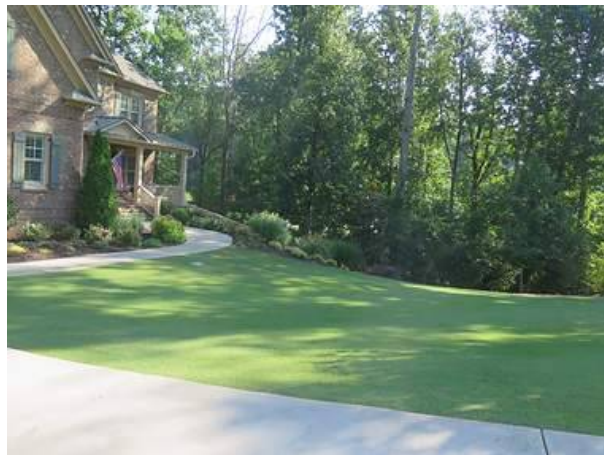
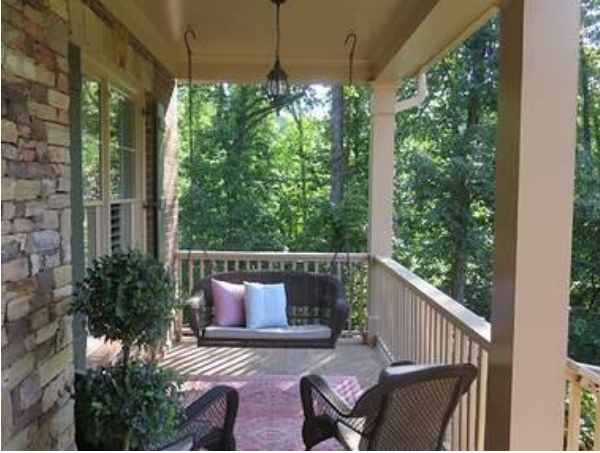
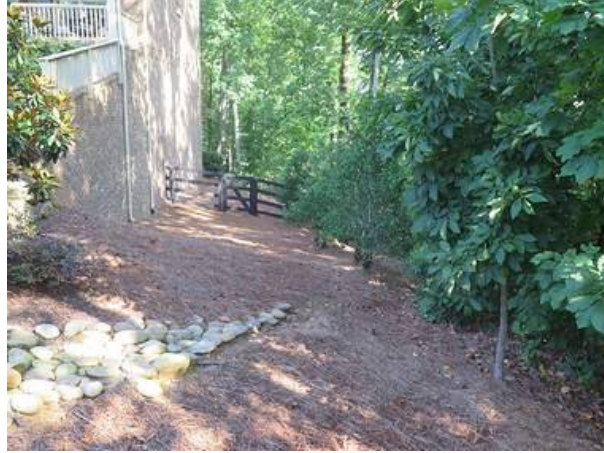
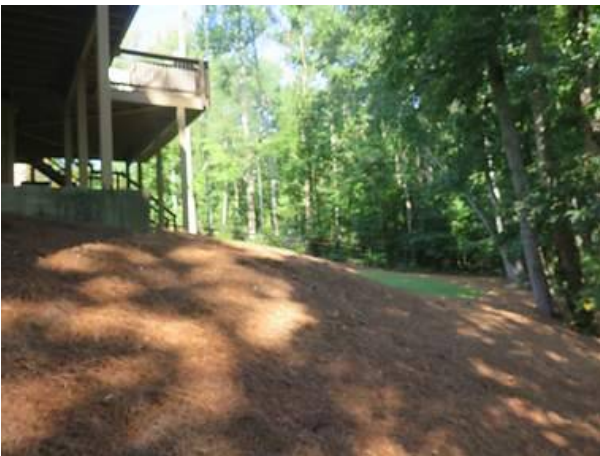
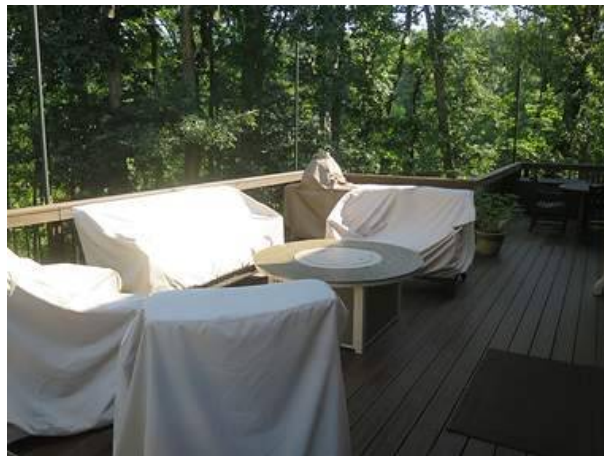
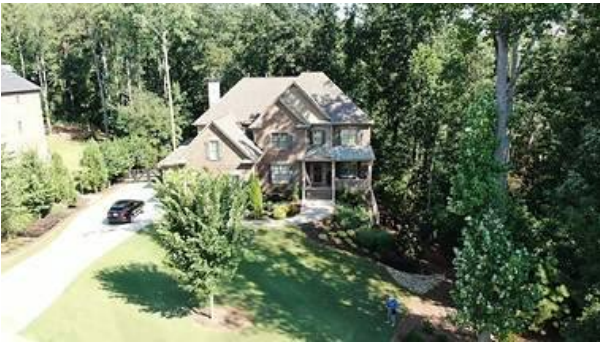
General photos of the grounds of the property.

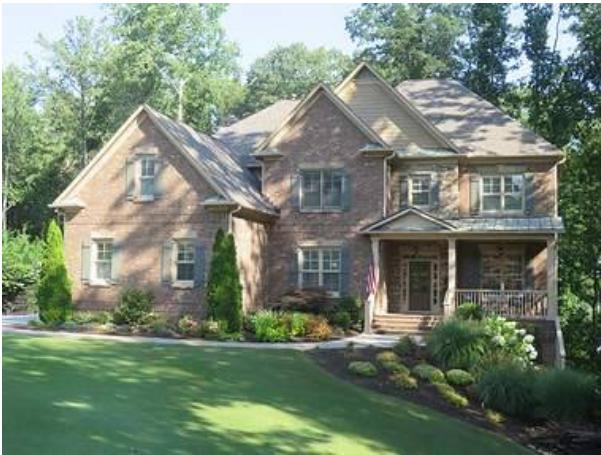
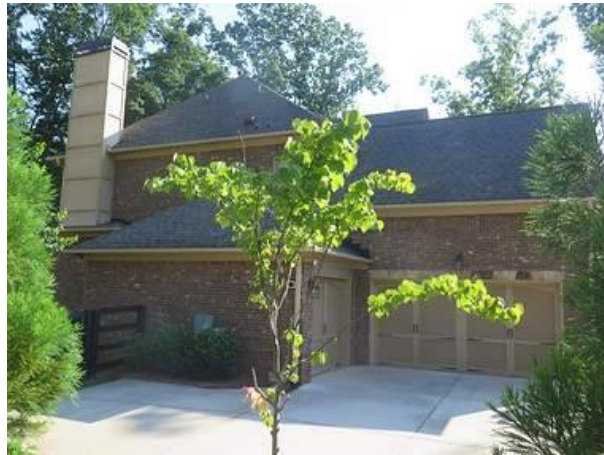
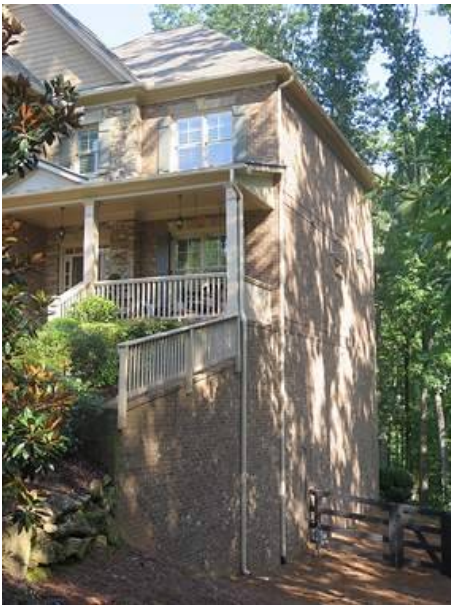
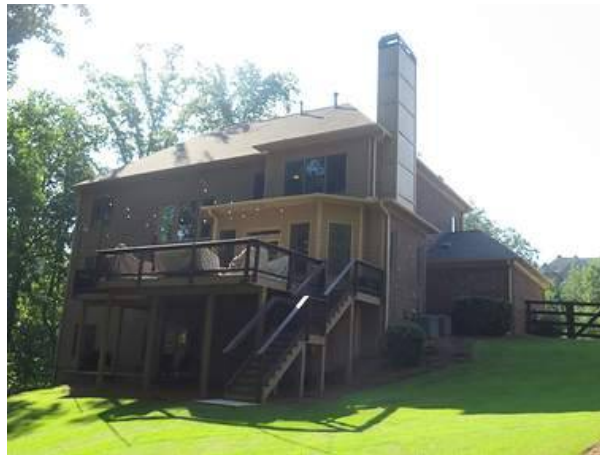
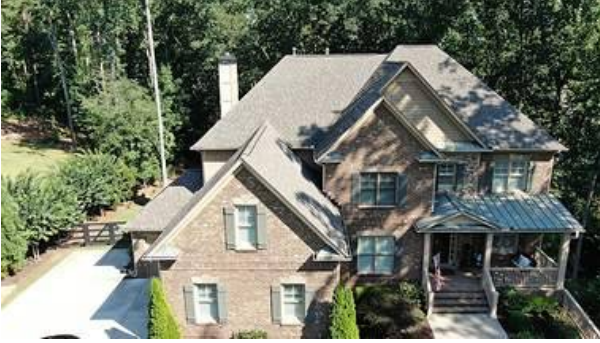
General photos of the exterior of the property.

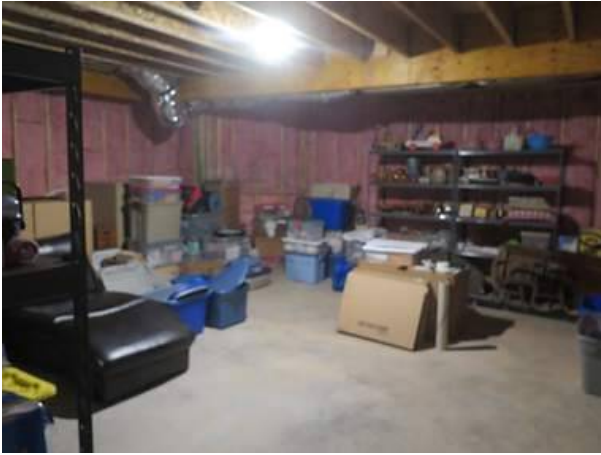
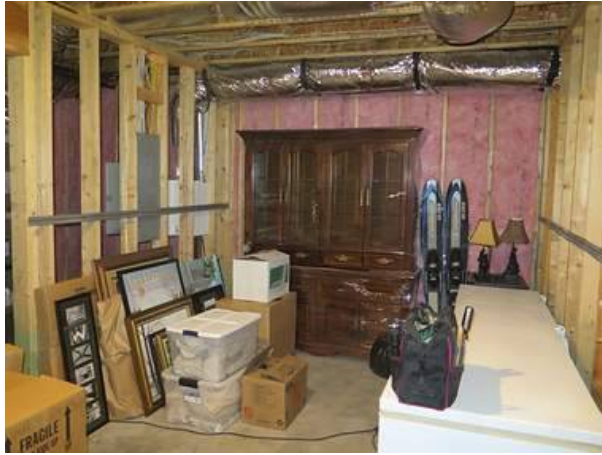
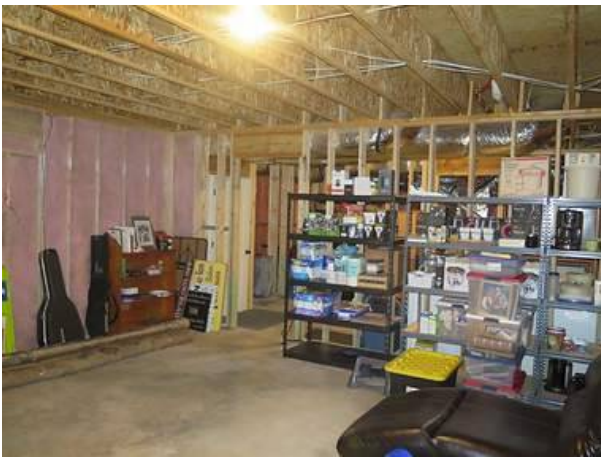
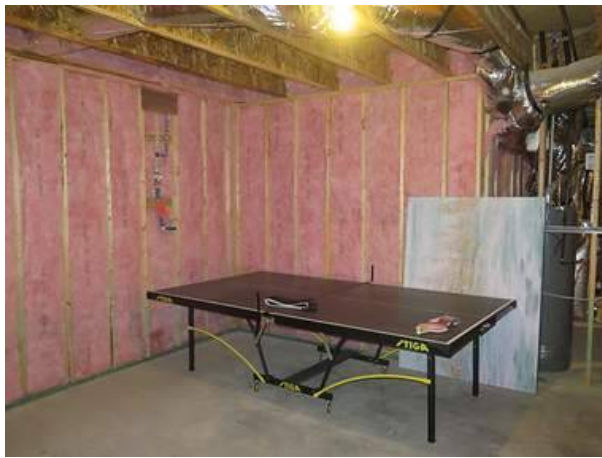
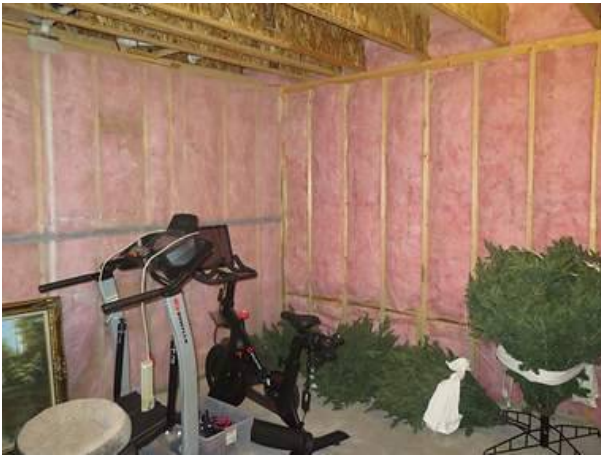
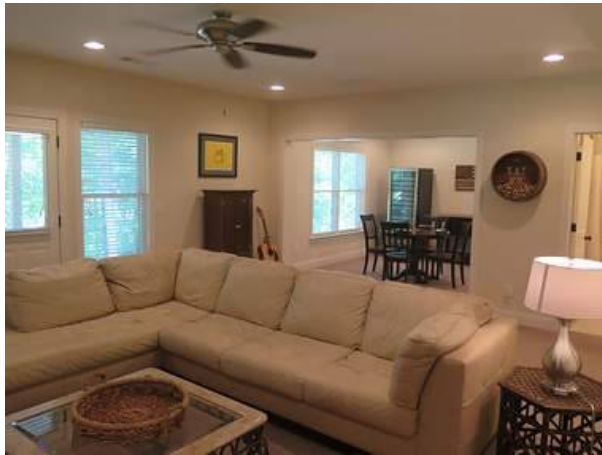
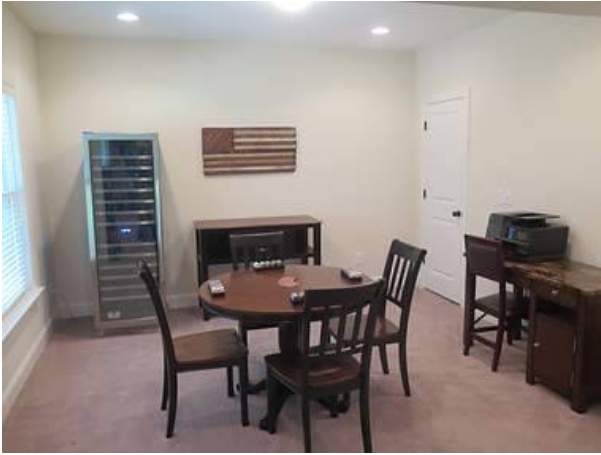
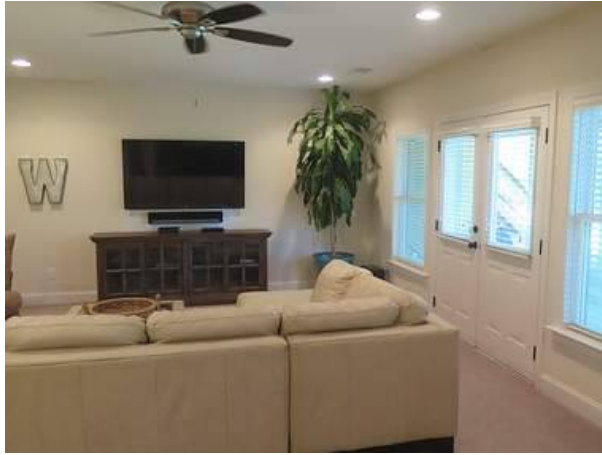
General photos of the basement area.

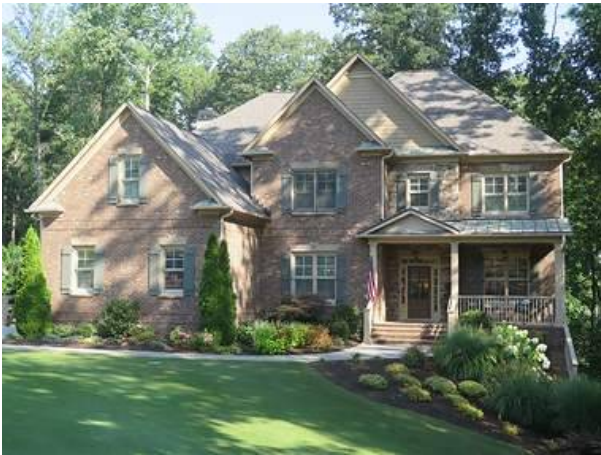
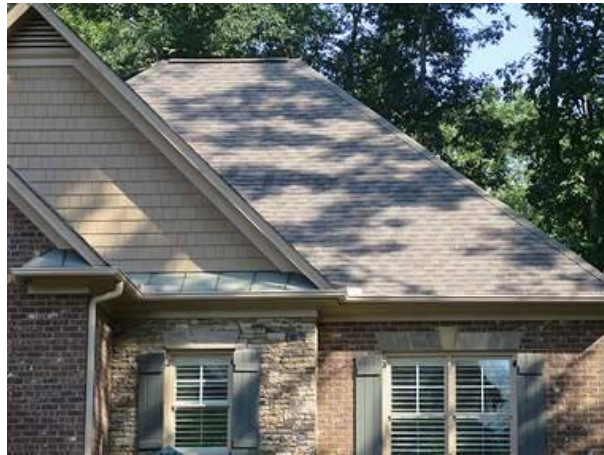
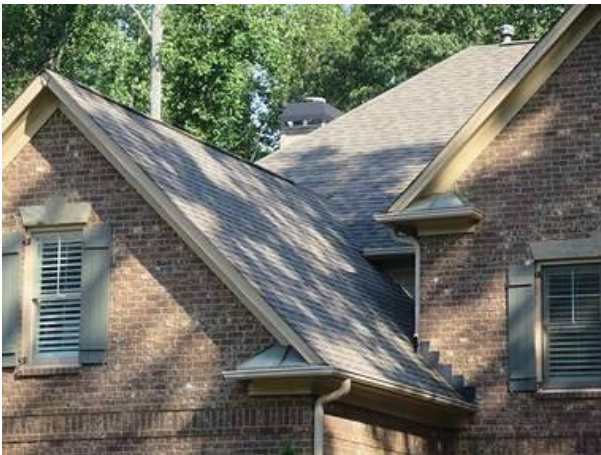
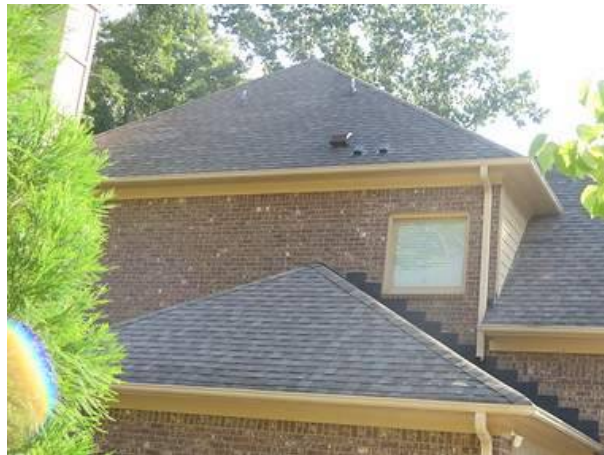
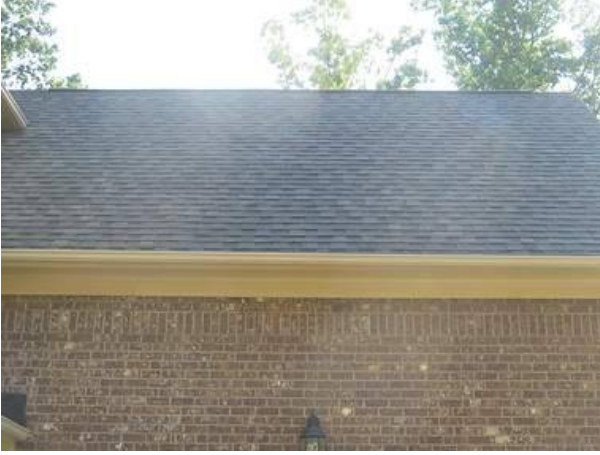
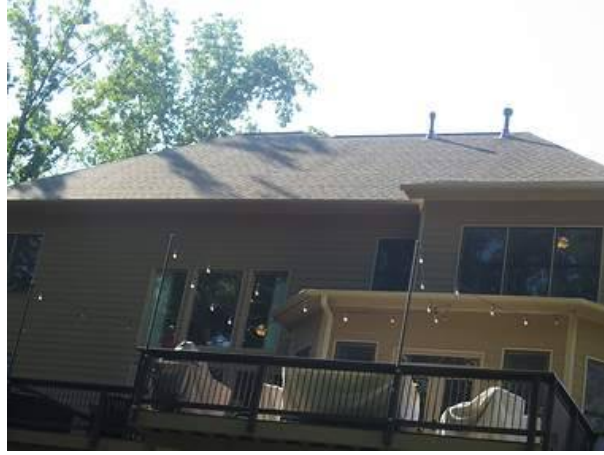
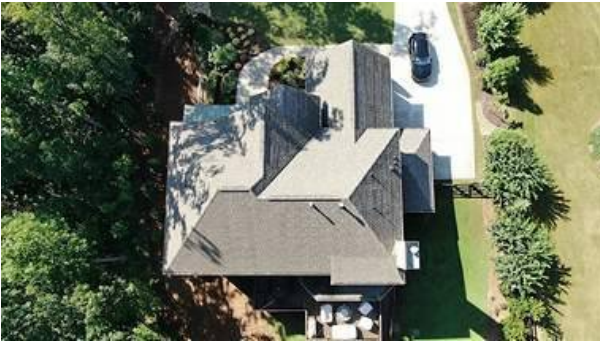
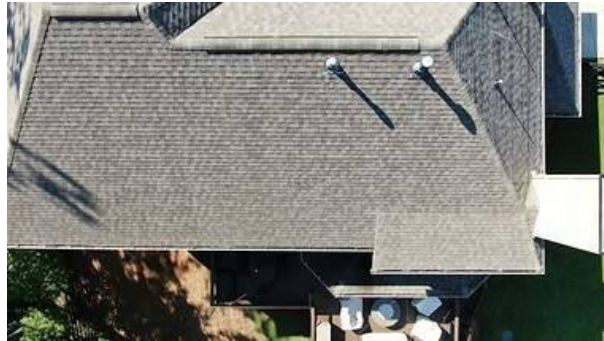
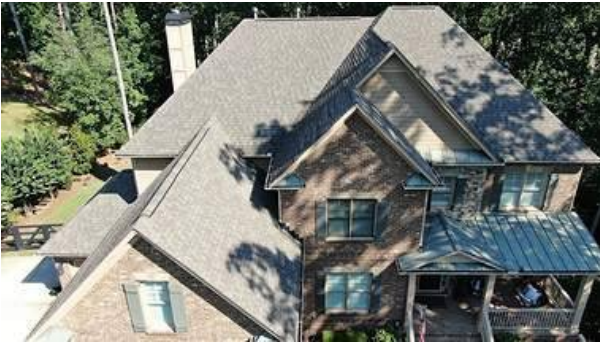
General photos of the roof surface.

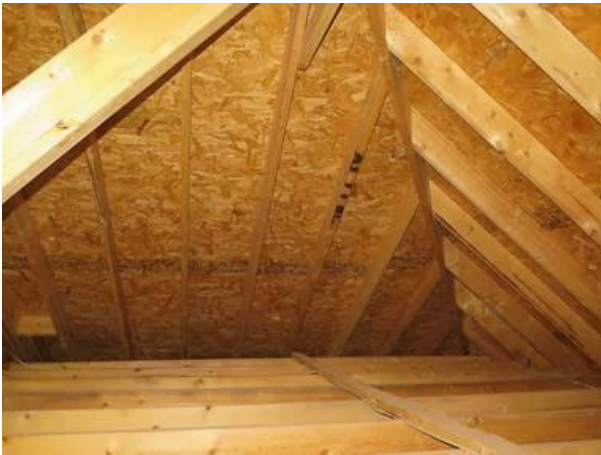
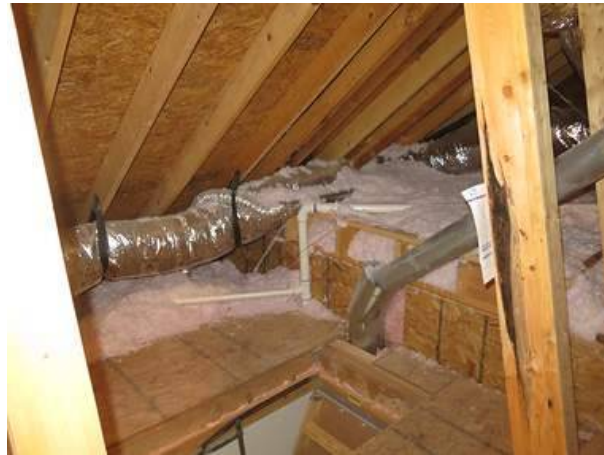
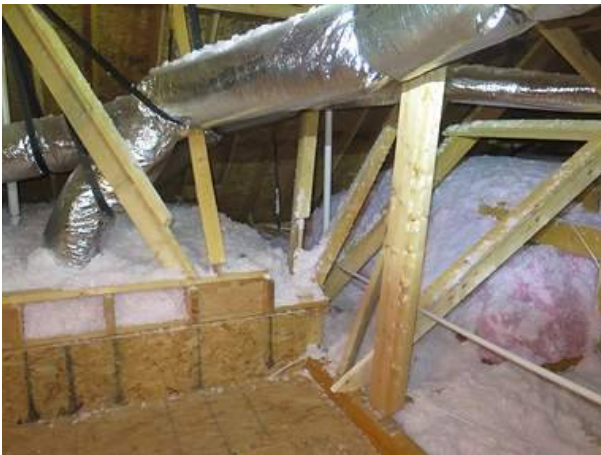
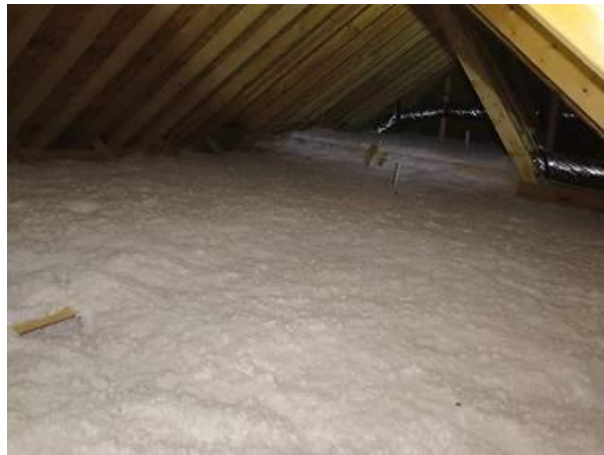
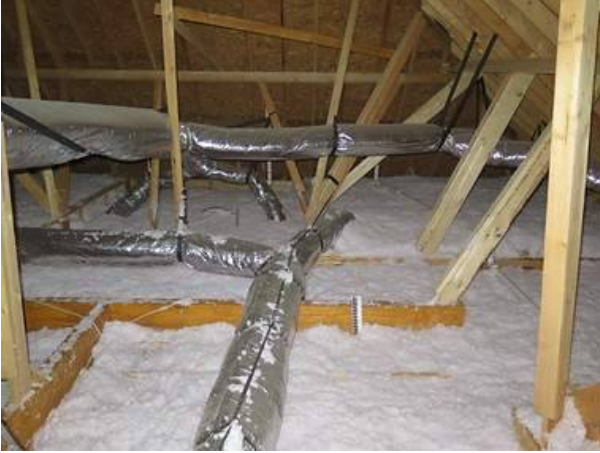
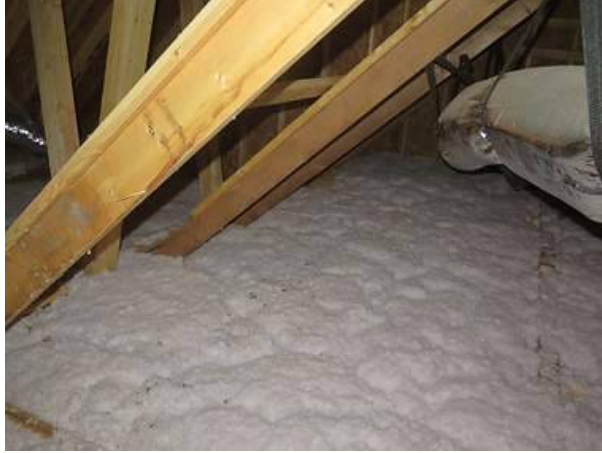
General photos of the attic area and roof structure.

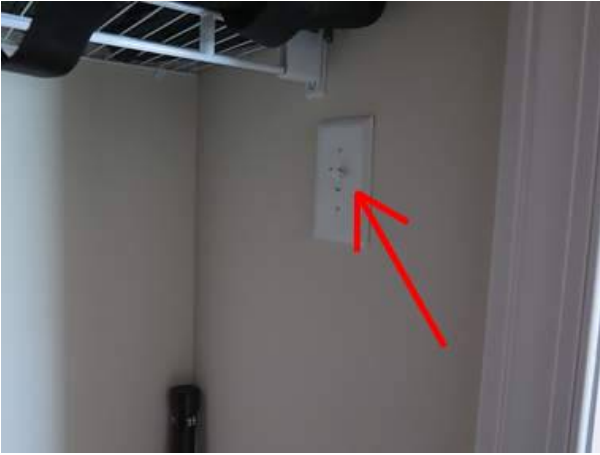
Photo 27-1

General photo of the attic light switch and location.

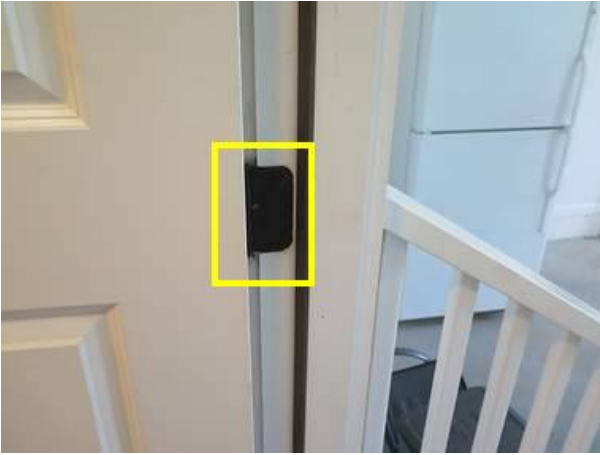
Photo 28-1

The garage-house door isn't equipped with an automatic closing device such as spring hinges. This door should close and latch automatically to prevent vehicle fumes from entering living spaces and/or to slow the spread of fire from the garage to living spaces. A qualified contractor should install automatic closing device(s) as necessary, and as per standard building practices, so this door closes and latches automatically.

IRC 09 & 12 - (302.5.1)

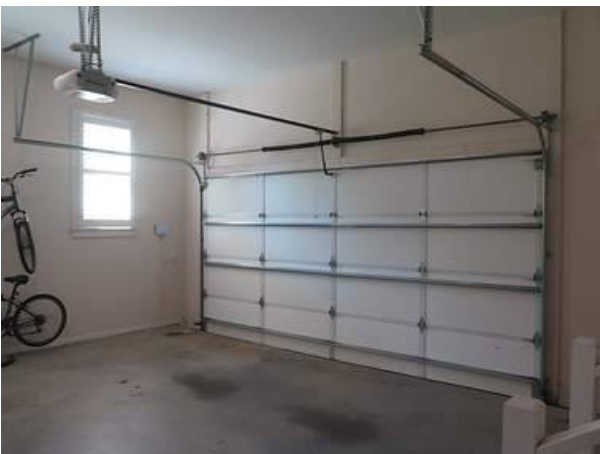
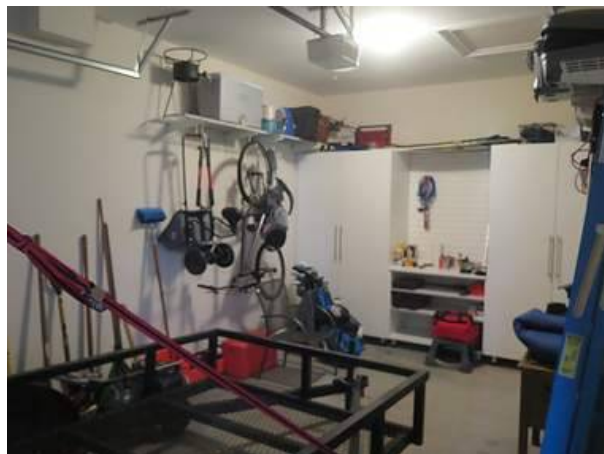
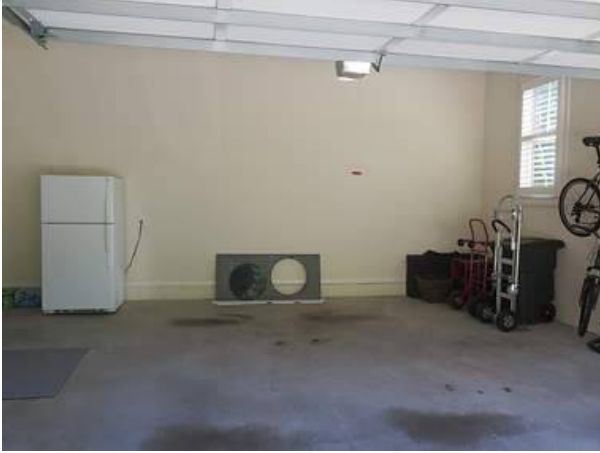
30) ⓘ General photos of the Garage or Carport area. Some floor areas were obscured by stored items and couldn't be fully evaluated.

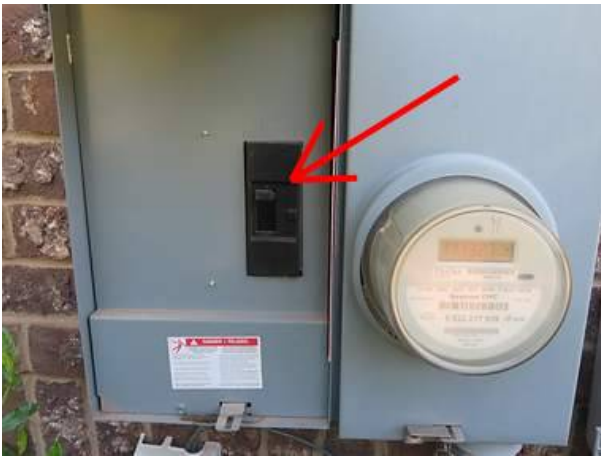
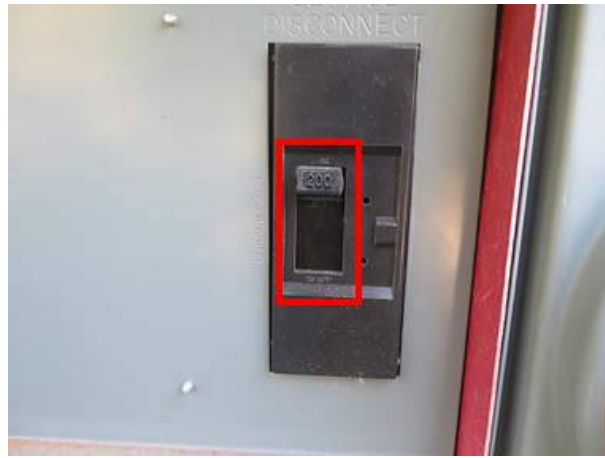
Photo of the main service switch located adjacent to the meter on the left side of the home.

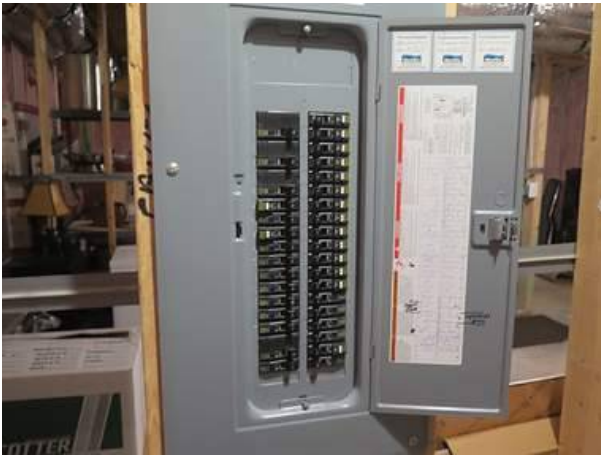
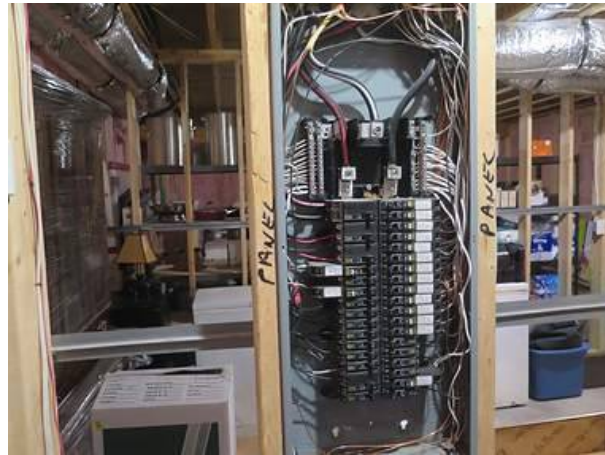
Photos of the service panel located in the basement.

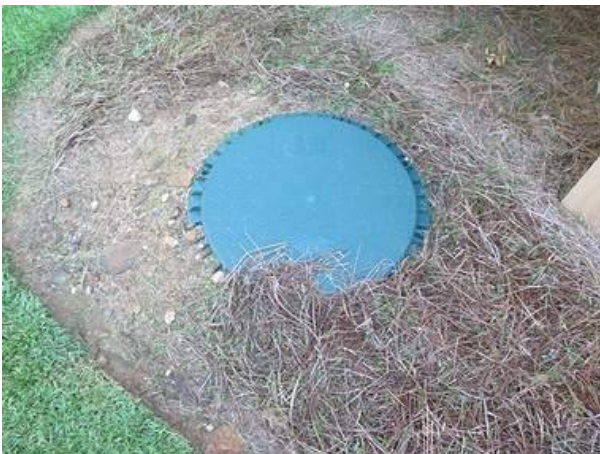
Photo 36-1

Based on visible components or information provided to the inspector, this property appeared to have a private sewage disposal (septic) system. These are specialty systems and are excluded from this inspection. Comments in this report related to this system are made as a courtesy only and are not meant to be a substitute for a full evaluation by a qualified specialist. Generally, septic tanks should be pumped and inspected every 3 years. Depending on the type of system and municipal regulations, inspection and maintenance may be required more frequently, often annually. Recommend the following:

- Consult with the property owner about this system's maintenance and repair history
- Review any documentation available for this system
- Review inspection and maintenance requirements for this system
- That a qualified specialist evaluate, perform maintenance and make repairs if necessary

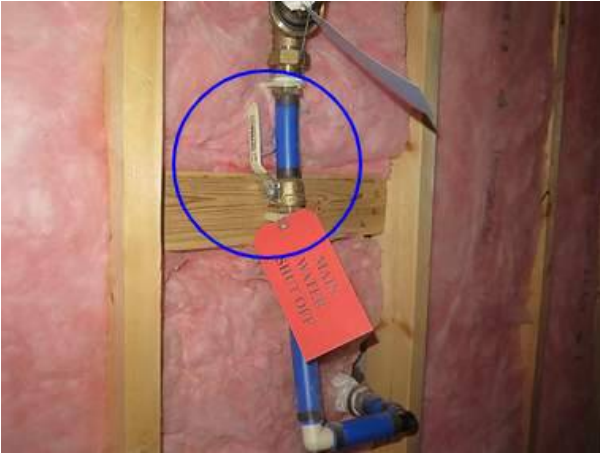
Photo 37-1

Photo of the main water shut-off valve located in the basement.

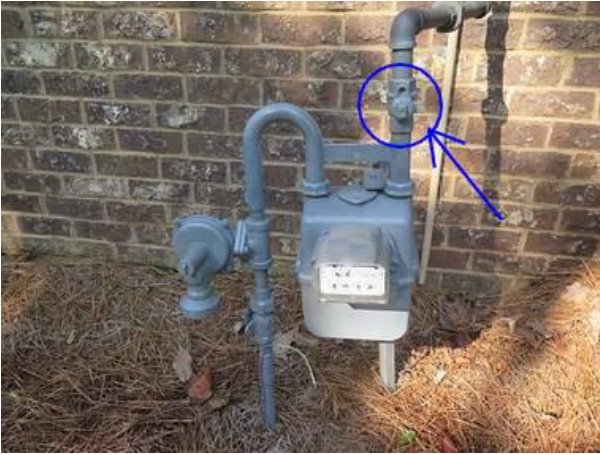
Photo 38-1

Photo of the main natural gas shut-off valve adjacent to the meter along the right side of the home.

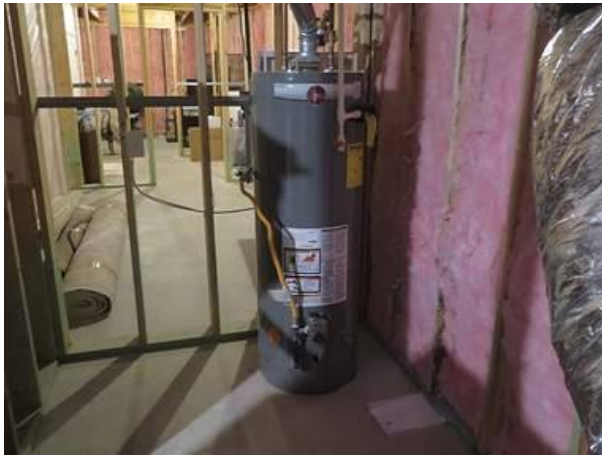
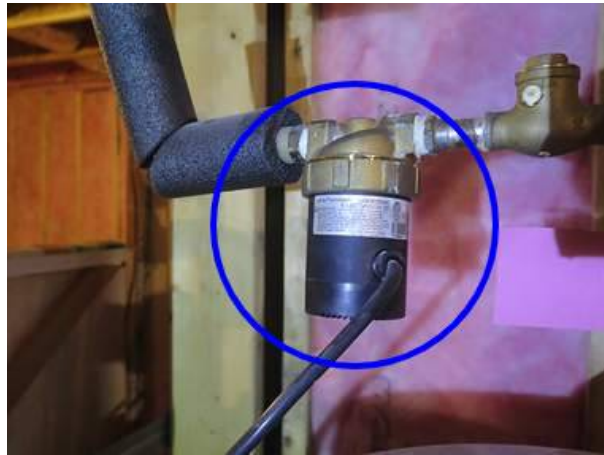
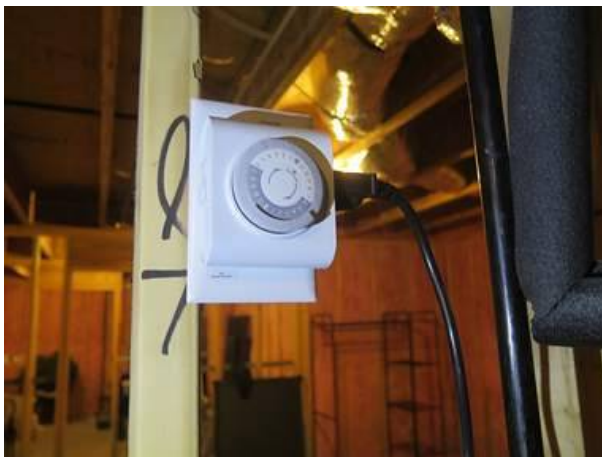
40) ⓘ A circulating pump was installed for the hot water supply. It is intended to make hot water immediately available when faucets are turned on. Timers are typically integrated with these pumps, and should be configured so water circulates only at desired times for better energy efficiency. The client should familiarize themselves with the timer's operation and configure it as needed. Note that this is a specialty item and excluded from this inspection. The inspector did not determine if it was serviceable or operable.

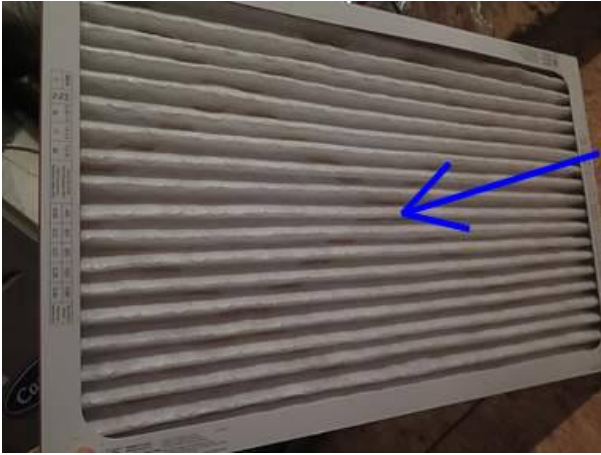
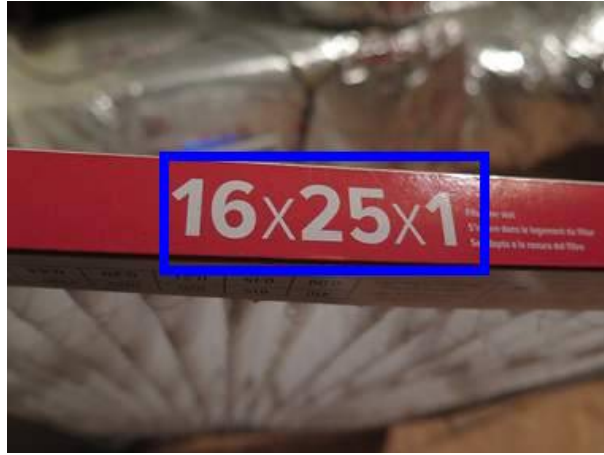
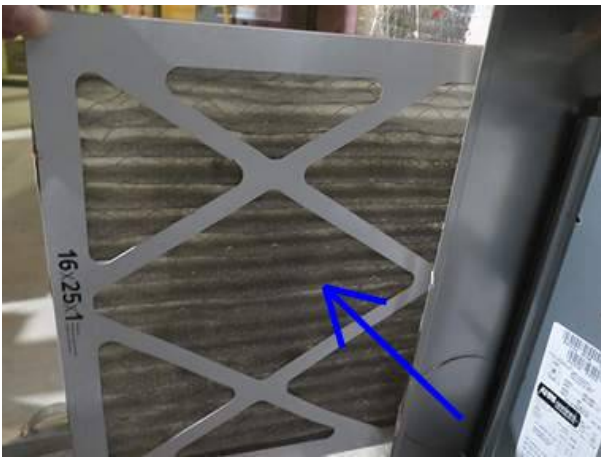
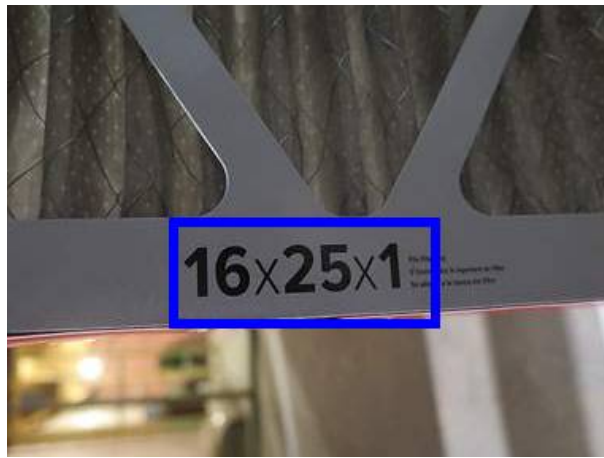
\*NOTE\* filter size - 16x25x1

Recommend replacing or washing HVAC filters upon taking occupancy depending on the type of filters installed. Regardless of the type, recommend checking filters monthly in the future and replacing or washing them as necessary. How frequently they need replacing or washing depends on the type and quality of the filter, how the system is configured (e.g. always on vs. "Auto"), and on environmental factors (e.g. pets, smoking, the frequency of house cleaning, number of occupants, the season).

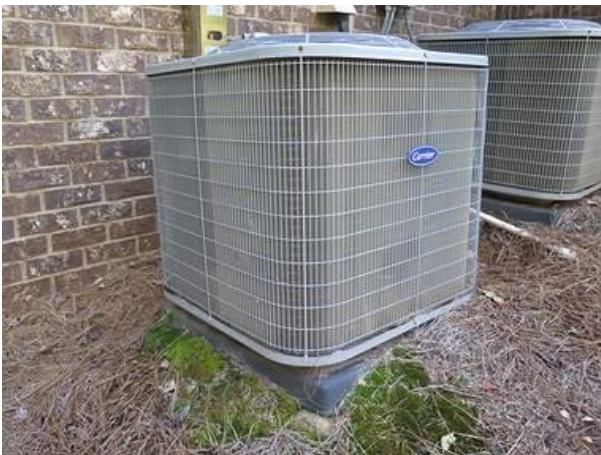
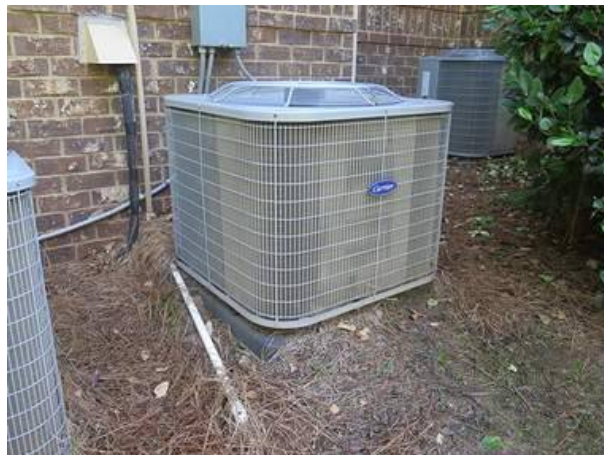
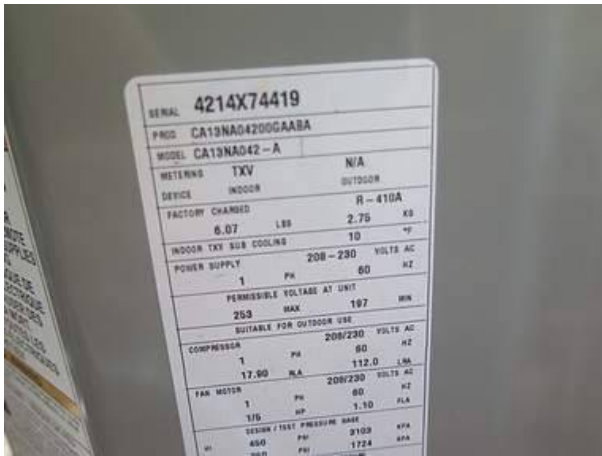
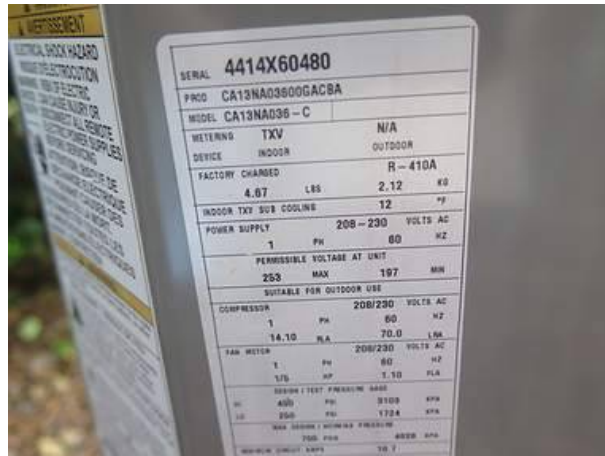
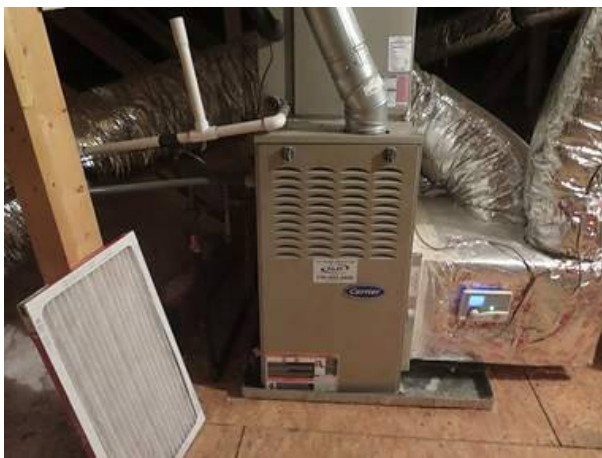
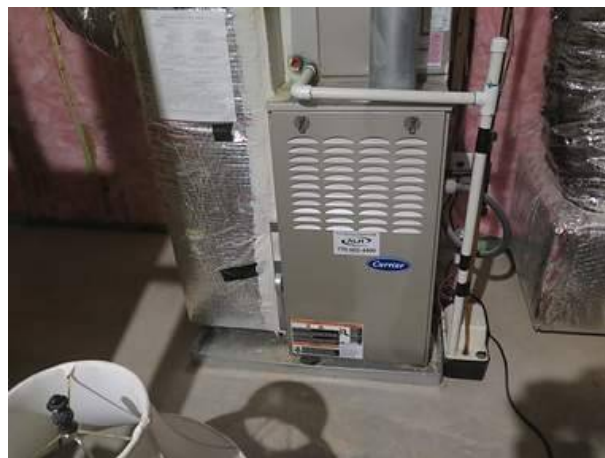
46) ⓘ General pictures of the heating and cooling equipment.

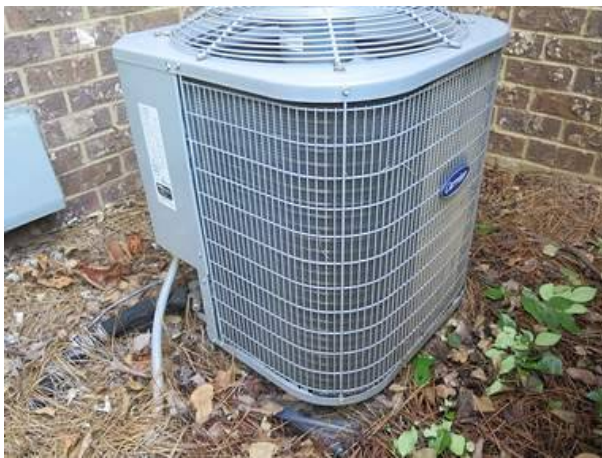
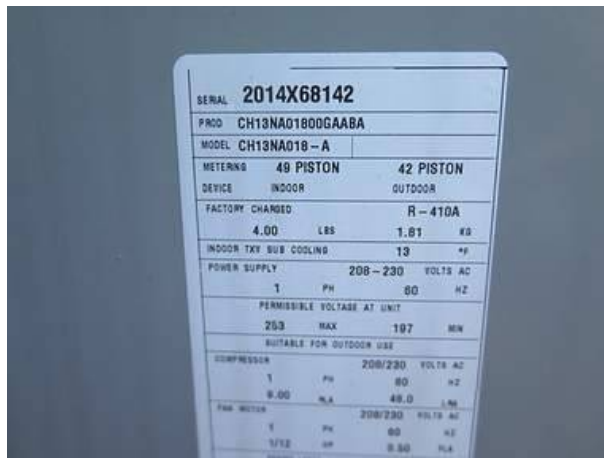
General pictures of the heating and cooling equipment.

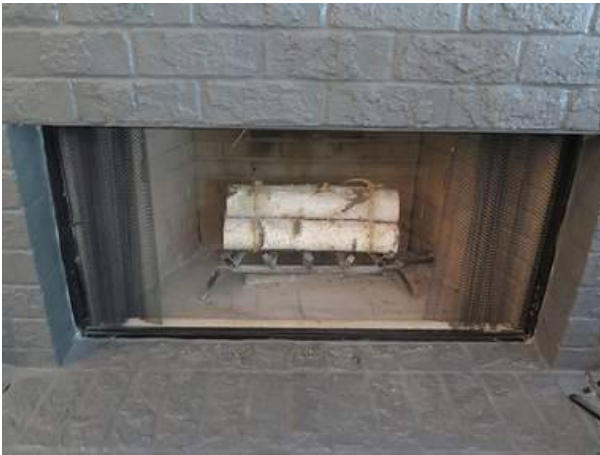
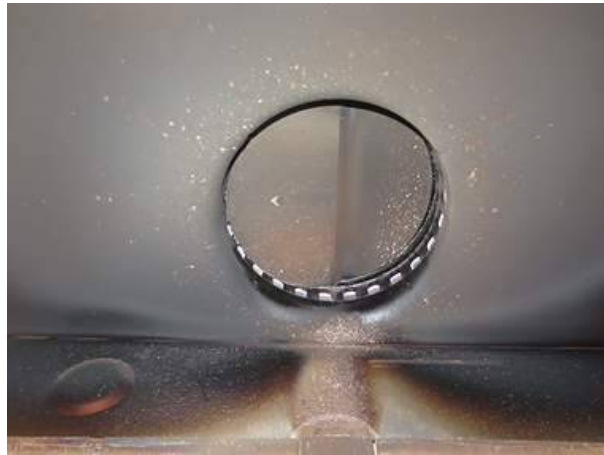
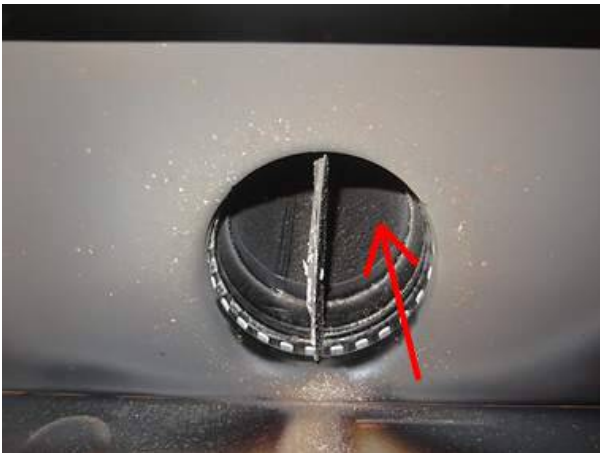
**Condition of wood-burning fireplaces, stoves:** Required repair, replacement and/or evaluation (see comments below)

One or more wood-burning fireplaces or stoves were found at the property. When such devices are used, they should be professionally inspected and cleaned annually to prevent creosote build-up and to determine if repairs are needed. The National Fire Protection Association states that a "Level 2" chimney inspection should be performed with every sale or transfer of property with a wood-burning device. Recommend consulting with the property owner about recent and past servicing and repairs to all wood-burning devices and chimneys or flues at this property. Recommend that a qualified specialist evaluate all wood-burning devices and chimneys, and clean and repair as necessary. Note that if a wood stove insert is installed, it may need to be removed for such an evaluation. For more information, search for "chimney inspection" at:

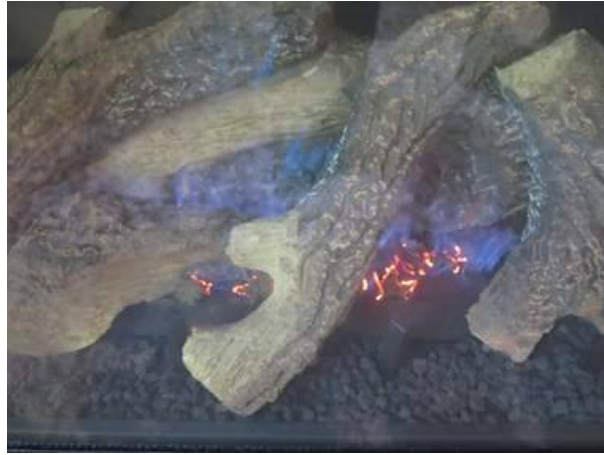
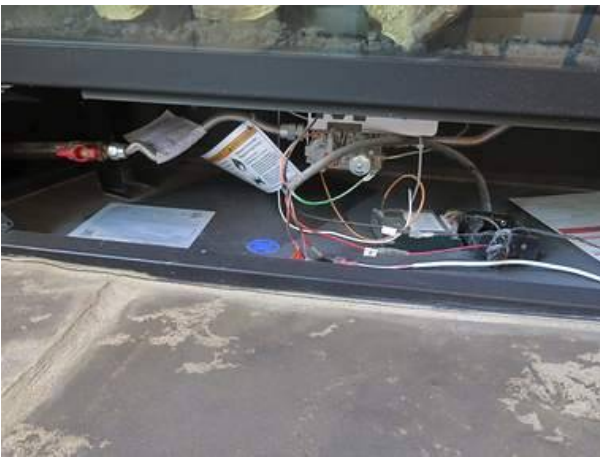
Recommend that the client review all available documentation for gas-fired fireplaces and stoves. Depending on how they are operated (for routine heating versus ambiance), such appliances normally need servicing annually or every few years. Consult with the property owner and/or a qualified specialist to determine if service is needed now.

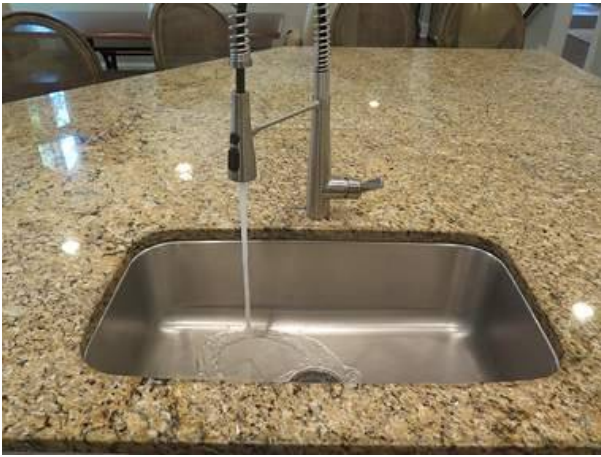
Photo 52-1

The sink faucet and sprayer were checked and appeared to be functional.

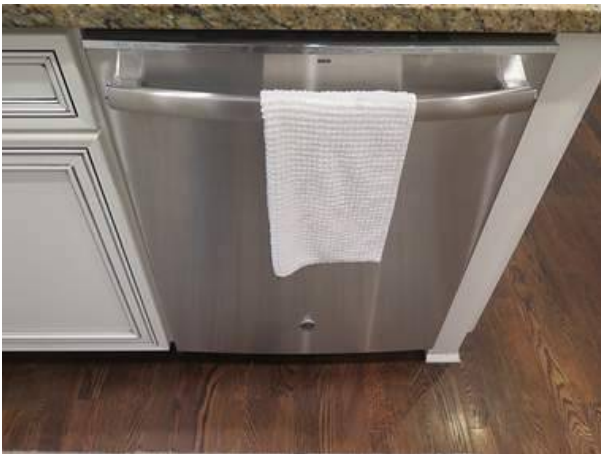
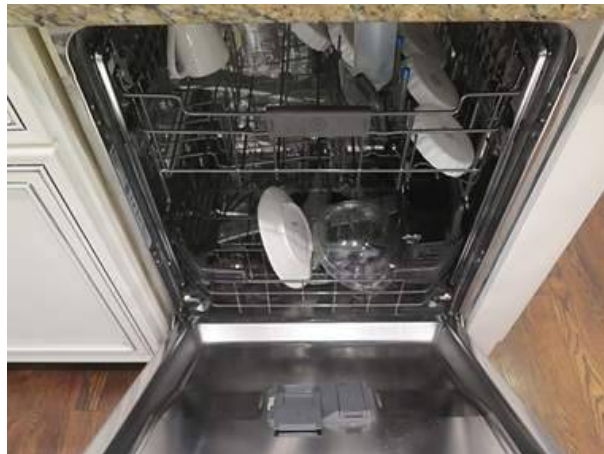
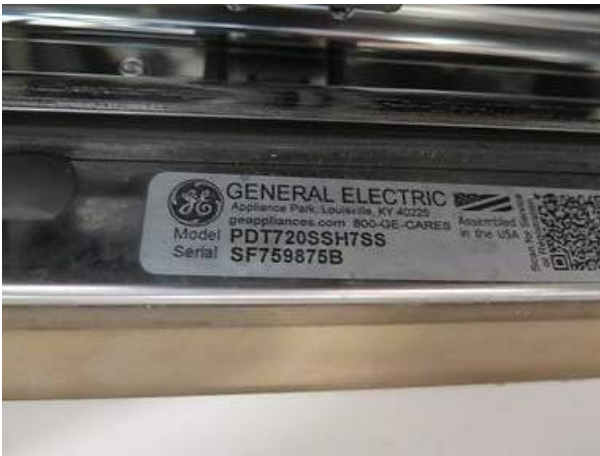
The dishwasher was checked and appeared to be functional.

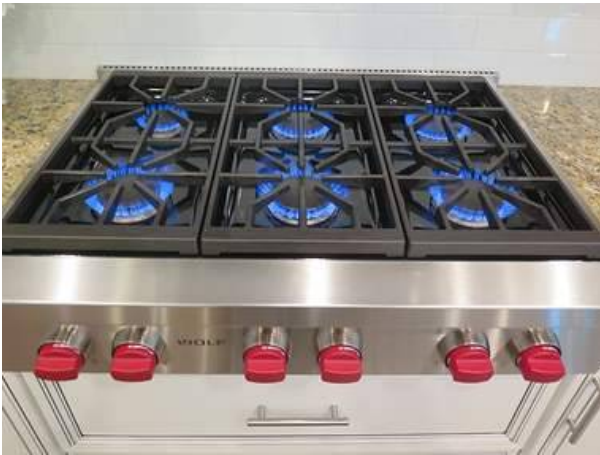
Photo 54-1

The Cooktop was checked and appeared to be functional.

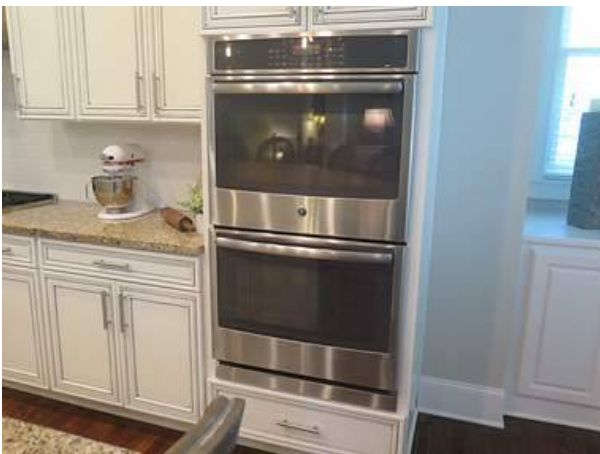
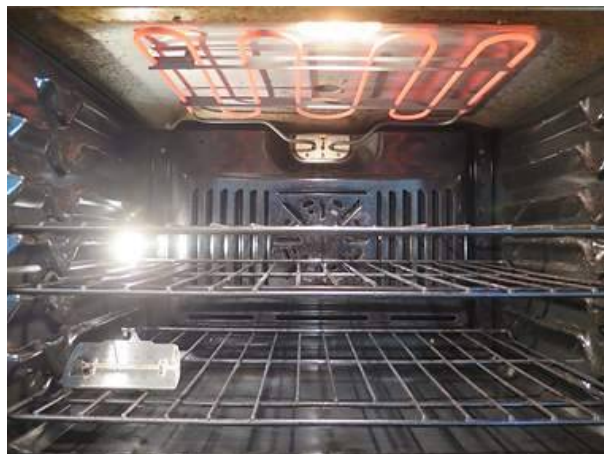
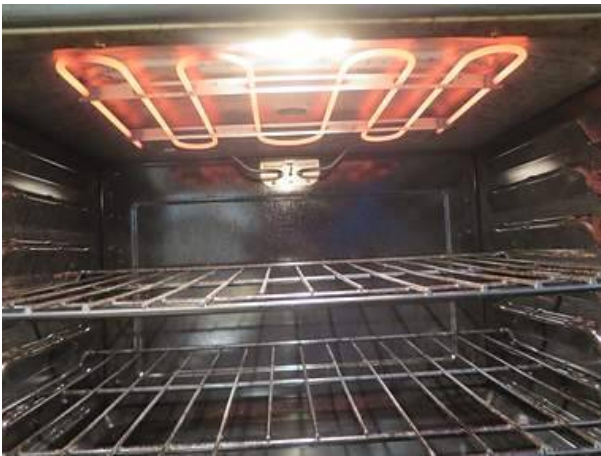
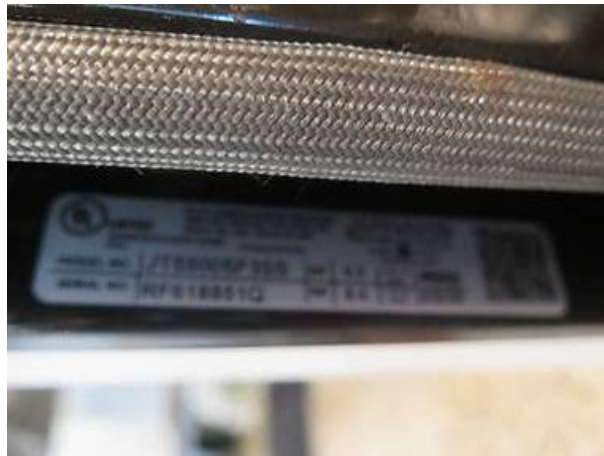
The Double/oven was checked and appeared to be functional.

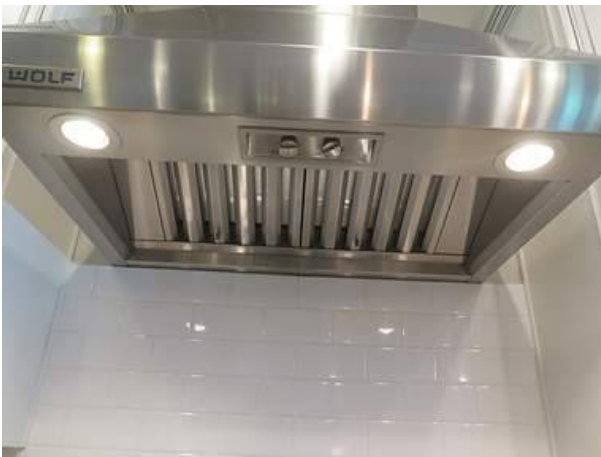
Photo 56-1

The exhaust hood/fan was checked and appeared to be functional.
