## Property Inspection Report

Property address: **1795 Horsham Trail  
Alpharetta GA 30004**

Inspection date: **Wednesday, August 5, 2020**

**Report number:** 080520JM1

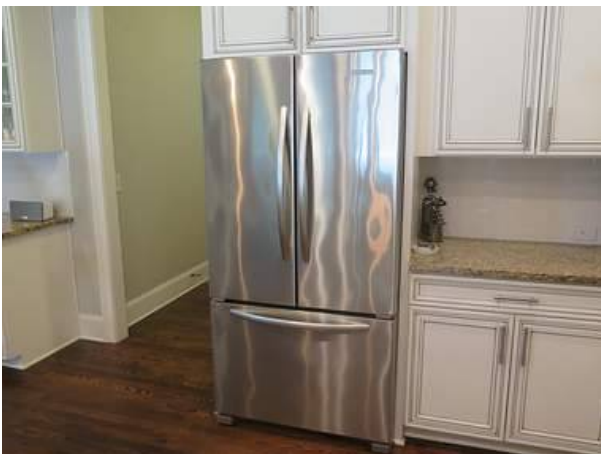
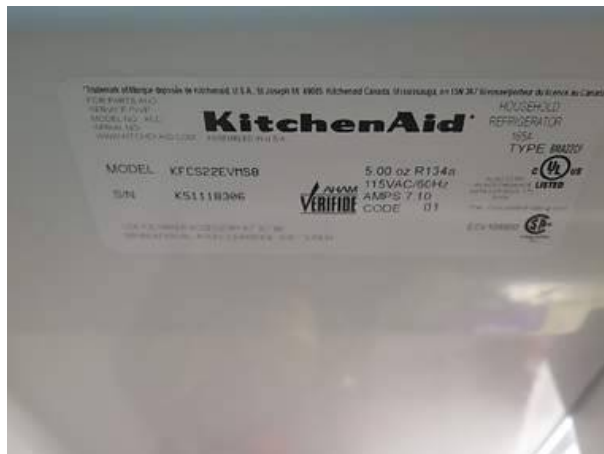
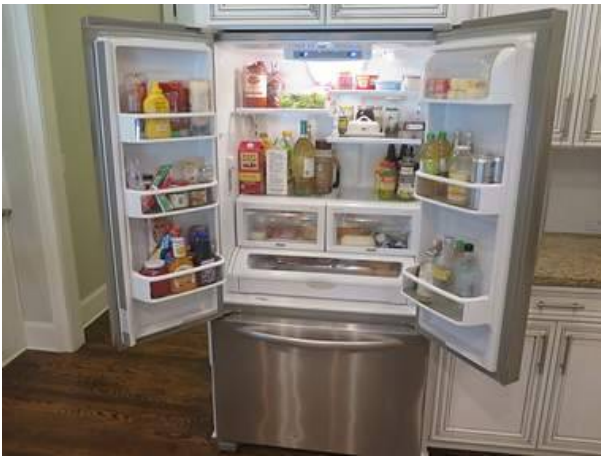
The refrigerator was checked and appeared to be functional.

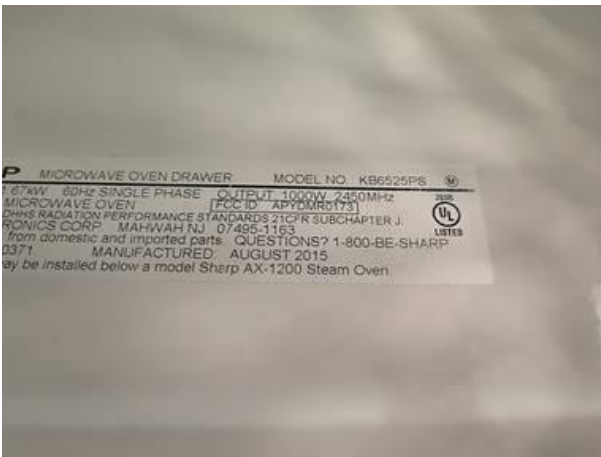
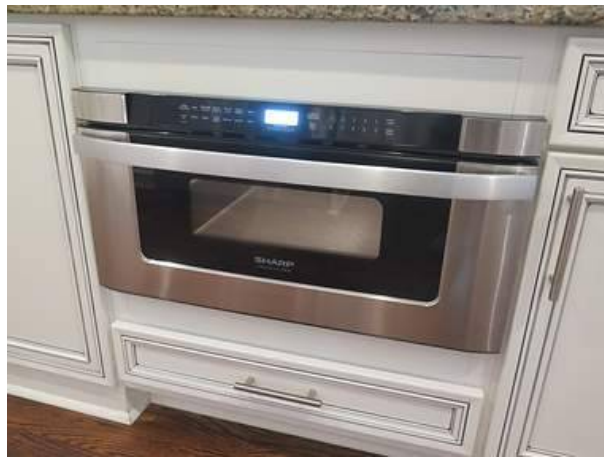
The microwave was checked and appeared to be functional.

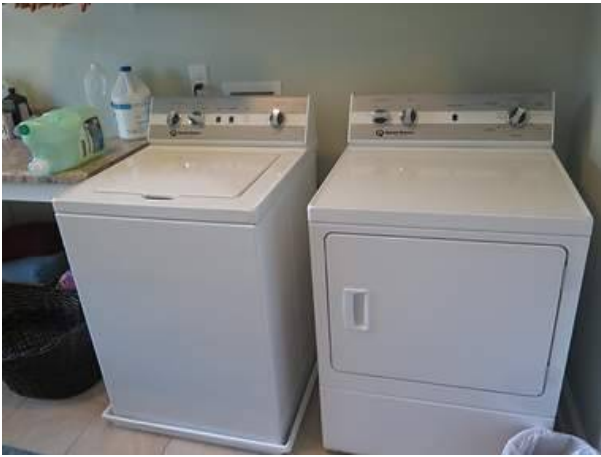
Photo 61-1

Neither the clothes washer or dryer were operated or evaluated. These appliances are excluded from this inspection.

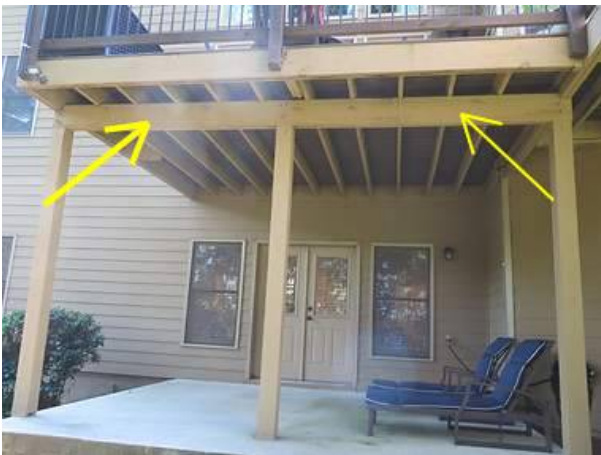
**Photo 4-1**

4) 🛠️ One or more decks or porches were unstable due to missing or substandard bracing, or lack of attachment to the main structure.

\*NOTE\* (Diagonal bracing is required at all corner posts and secured to the beam that is greater than 2 feet in height to minimize lateral movement).

This is a safety hazard since severe movement may cause the decks or porches to collapse. Recommend that a qualified contractor evaluate and provide options and costs to repair per standard building practices prior to the end of the contingency period.

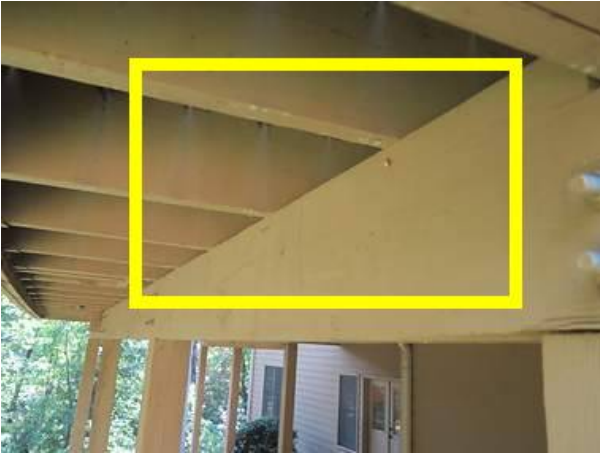
**Photo 5-1**

The beams appear to be improperly attached to the post. This could result in a structure collapse causing injury. Decks and porches are subject to movement under live loads and require a positive connection between their support posts and beams. Currently accepted standards recommend that beams should be supported by posts and footings that are properly spaced.

Deck or porch beams are commonly connected to support posts by "toenailing," which is inadequate. Recommend that a qualified contractor repair per standard building practices. For example, by installing metal plates, plywood gussets or dimensional lumber to connect posts and beams.

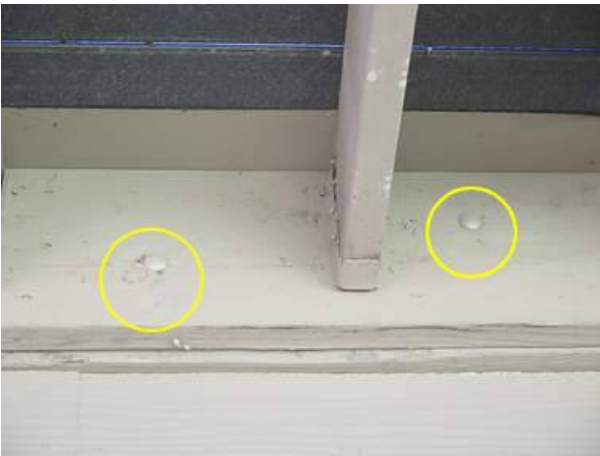
**Photo 6-1**

One or more deck or porch ledger boards were nailed to the building or attached with carriage bolts rather than being attached by lag screws or bolts. As a result, decks or porches may separate from the building and collapse. This is a potential safety hazard. Lag screws or bolts, minimum 1/2 inch in diameter, should be installed to securely attach ledger boards to the main structure. Recommend that a qualified person install fasteners per standard building practices. For more information, visit:

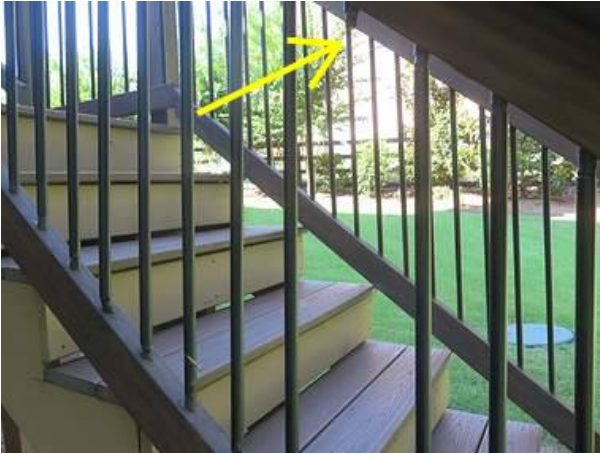
Photo 7-1

Guardrails at one or more locations with drop-offs higher than 30 inches had gaps that were too large. This poses a safety hazard for children (e.g. falling, getting stuck in railing). Guardrails should not have gaps or voids that allow passage of a sphere equal to or greater than 4 inches in diameter, or 6 inches in diameter at triangular spaces between stair edges and guardrails. Stair guards should not have gaps or voids that allow passage of a sphere equal to or greater than 4 3/8 inches in diameter. Recommend that a qualified contractor repair or replace guardrails per standard building practices.

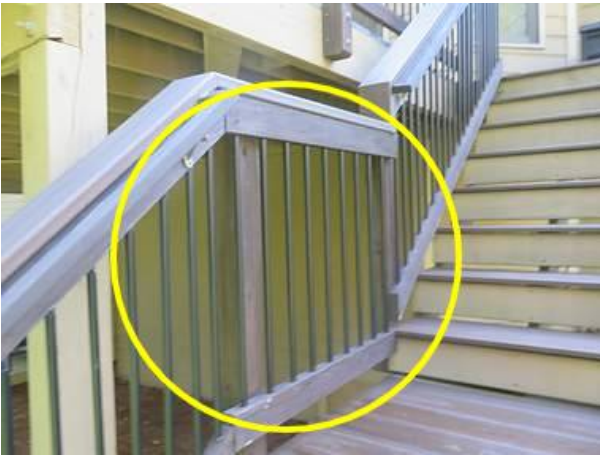
Photo 8-1

Handrails at one or more flights of stairs were loose and/or wobbly. This is a safety hazard. Recommend that a qualified person repair as necessary.

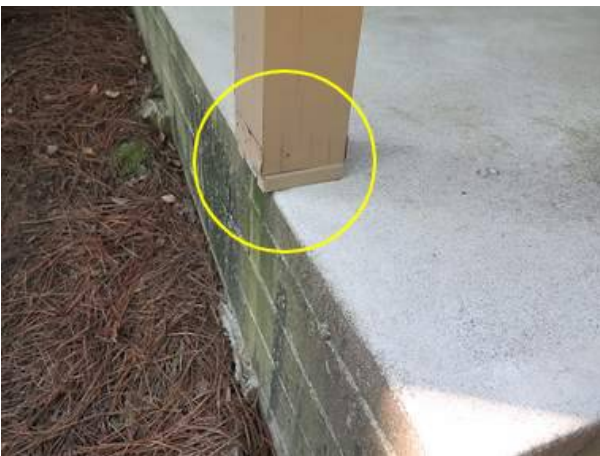
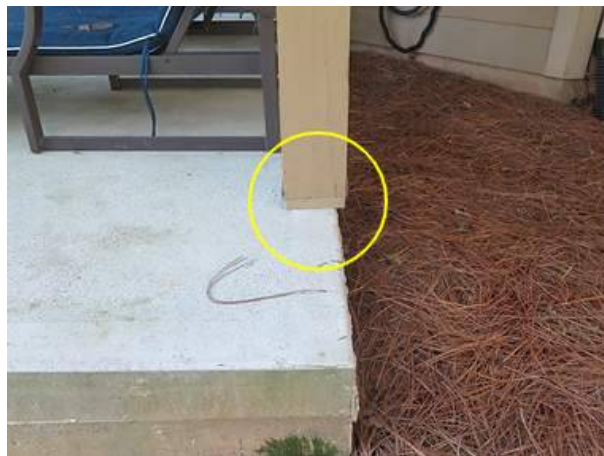
The concrete footings below one or more posts supporting the deck were substandard or missing. (Footings should be a minimum of 12" x 12", 7" thick, and 12" below grade or equivalent). **The posts should be centered on one-third of the footing.** Recommend that a qualified -contractor evaluate and provide options and costs to repair per standard building practices prior to the end of the contingency period.

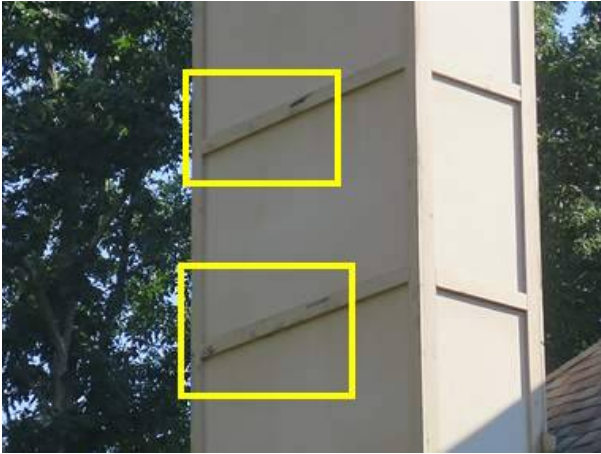
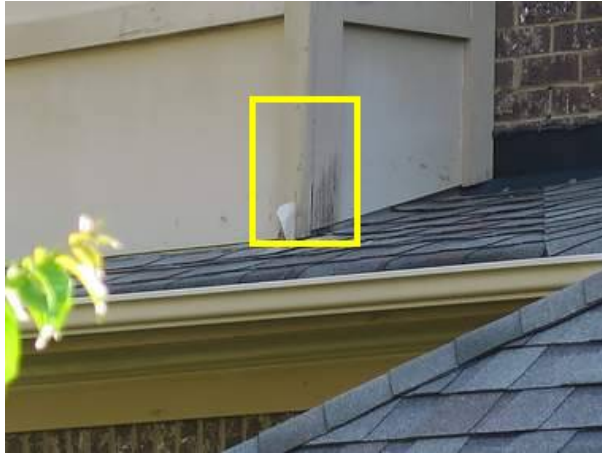
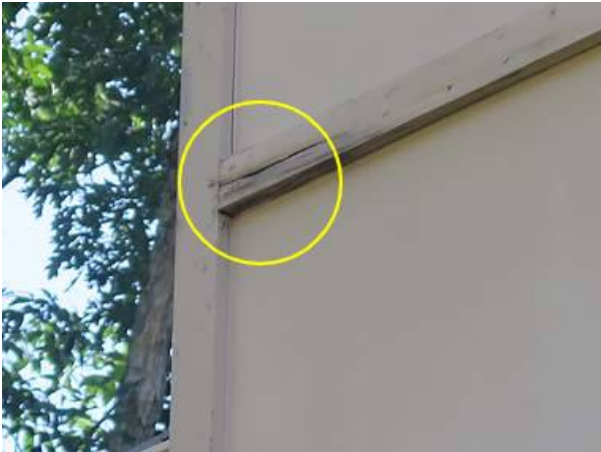
Some sections of siding and/or trim were deteriorated and/or damaged. Recommend that a qualified person repair, replace or install siding or trim as necessary.

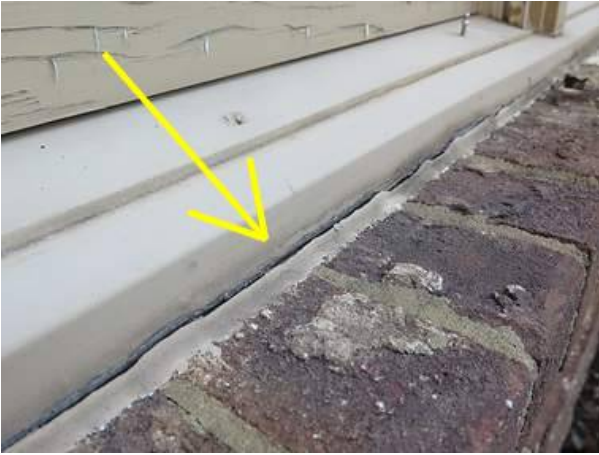
Photo 15-1

15) 🛠️💧 Sealant was deteriorated in some areas. For example, around windows. Recommend that a qualified person renew or install sealant (caulking) as necessary. Where gaps are wider than 1/4 inch, an appropriate material other than sealant should be used. For more information, visit: <https://www.reporthost.com/?CAULK>

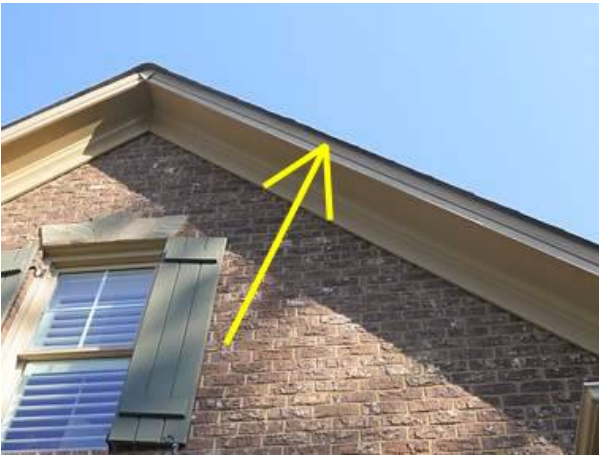
Photo 20-1

No "drip edge" flashing was visible at roof eaves (lower edges) or rakes (gable end edges). Drip edge helps prevent water from soaking into the edges of the roof sheathing material (typically plywood or oriented strand board). This reduces the chance of fungal rot or deterioration from water damage in the roof sheathing. Recommend that a qualified contractor install drip edge flashings where missing and per standard building practices.

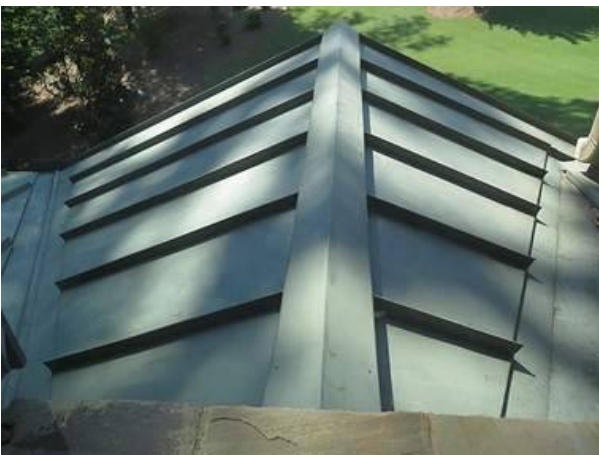
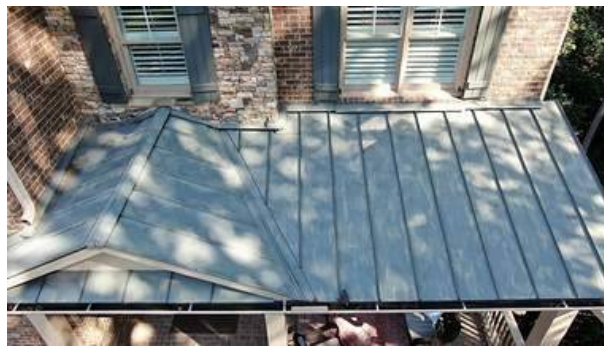
One or more sections of metal roofing had a failing paint finish. For example, peeling and/or missing paint. The service life of the metal roofing may be reduced as a result. Recommend having a qualified contractor prep and repaint metal panels where necessary.

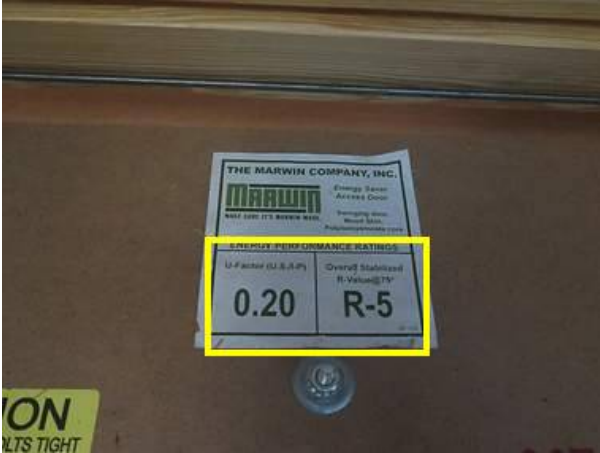
Photo 23-1

23) 🔍 The pull-down attic stairs were poorly insulated. Typically, such stairs that are not insulated also do not have any weatherstripping installed. Recommend that a qualified person install insulation and weatherstripping per standard building practices for better energy efficiency. For more information, visit:

\*Note that code requirements for hatches have recently been tightened. According to the 2009 IECC and IRC, "Access doors from conditioned spaces to unconditioned spaces ... shall be weatherstripped and insulated to a level equivalent to ... surrounding surfaces." In this home that would be an R30 or equivalent.

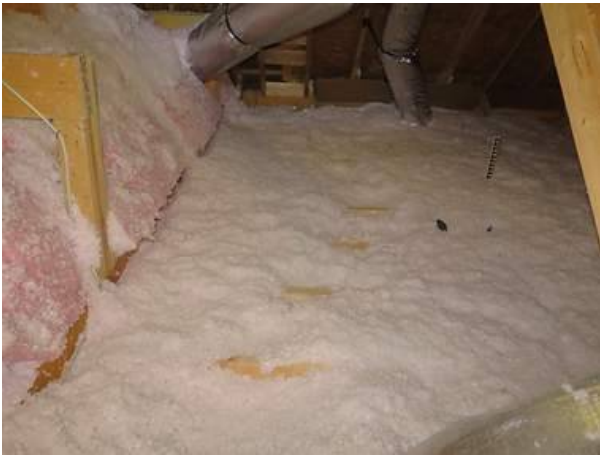
Photo 24-1

24) 🪛 The ceiling insulation in one or more areas of the attic was compacted or uneven. Heating and cooling costs may be higher due to reduced energy efficiency. Recommend that a qualified person repair, replace or install insulation as necessary and per standard building practices (typically R-38).

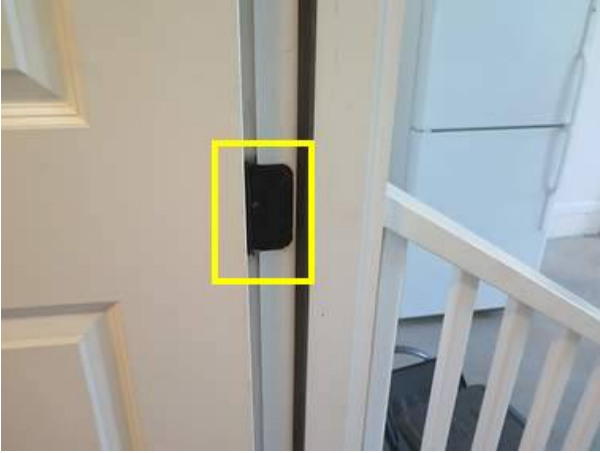
Photo 28-1

28) 🛠️ The garage-house door isn't equipped with an automatic closing device such as spring hinges. This door should close and latch automatically to prevent vehicle fumes from entering living spaces and/or to slow the spread of fire from the garage to living spaces. A qualified contractor should install automatic closing device(s) as necessary, and as per standard building practices, so this door closes and latches automatically.

IRC 09 & 12 - (302.5.1)

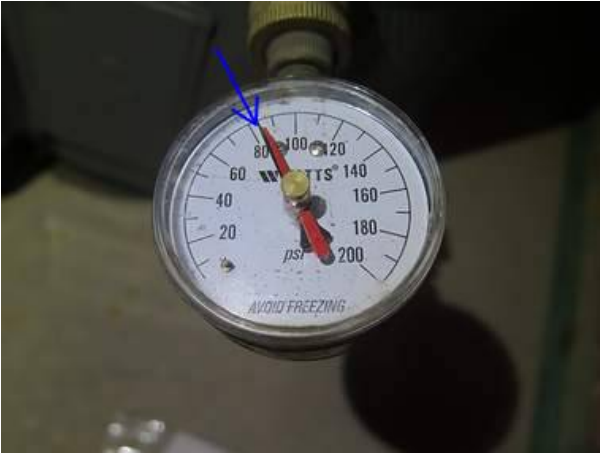
Photo 34-1

The water supply pressure was greater than 80 pounds per square inch (PSI). Pressures above 80 PSI may void warranties for some appliances such as water heaters or washing machines. Flexible supply lines to washing machines are likely to burst with higher pressures. 40-80 PSI is considered the normal range for water pressure in a home, and most plumbers recommend 50-60 PSI. Typically, the pressure cannot be regulated at the water meter. Recommend that a qualified plumber evaluate and make modifications to reduce the pressure to below 80 PSI. Installing a pressure reducing valve on the main service pipe is a common solution to this problem. If one exists, then it should be adjusted, repaired or replaced as necessary to maintain lower pressures. Note that installing a pressure reducing valve creates a "closed system," which may require installing an expansion tank at the water heater if one is not already installed.

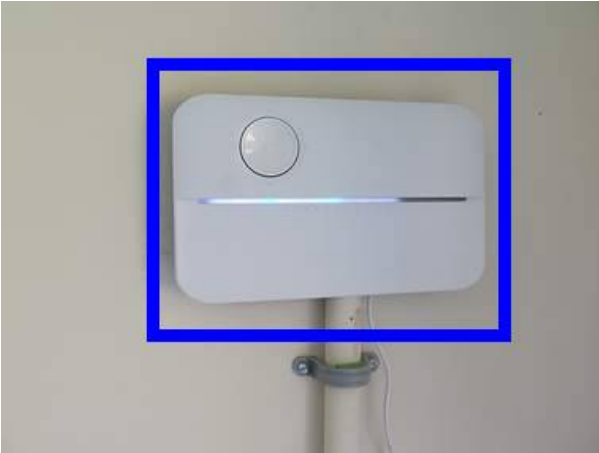
**Photo 35-1**

Based on visible equipment or information provided to the inspector, this property appeared to have a yard irrigation (sprinkler) system. These are specialty systems and are excluded from this inspection. Comments in this report related to this system are made as a courtesy only and are not meant to be a substitute for a full evaluation by a qualified specialist. When this system is operated, recommend verifying that water is not directed at building exteriors, or directed so water accumulates around building foundations. Sprinkler heads may need to be adjusted, replaced or disabled. Recommend that a qualified plumber verify that a backflow prevention device is installed per standard building practices to prevent cross-contamination of gray water and potable water, and install an expansion tank at the water heater if missing and necessary. Recommend that a qualified specialist evaluate the irrigation system for other defects (e.g. leaks, damaged or malfunctioning sprinkler heads) and repair if necessary.

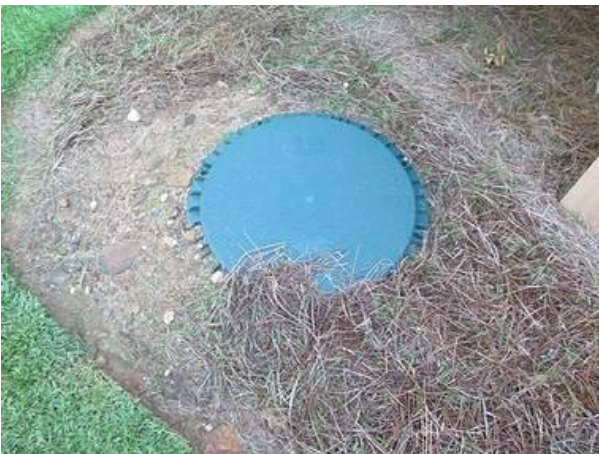
**Photo 36-1**

Based on visible components or information provided to the inspector, this property appeared to have a private sewage disposal (septic) system. These are specialty systems and are excluded from this inspection. Comments in this report related to this system are made as a courtesy only and are not meant to be a substitute for a full evaluation by a qualified specialist. Generally, septic tanks should be pumped and inspected every 3 years. Depending on the type of system and municipal regulations, inspection and maintenance may be required more frequently, often annually. Recommend the following:

- Consult with the property owner about this system's maintenance and repair history
- Review any documentation available for this system
- Review inspection and maintenance requirements for this system
- That a qualified specialist evaluate, perform maintenance and make repairs if necessary

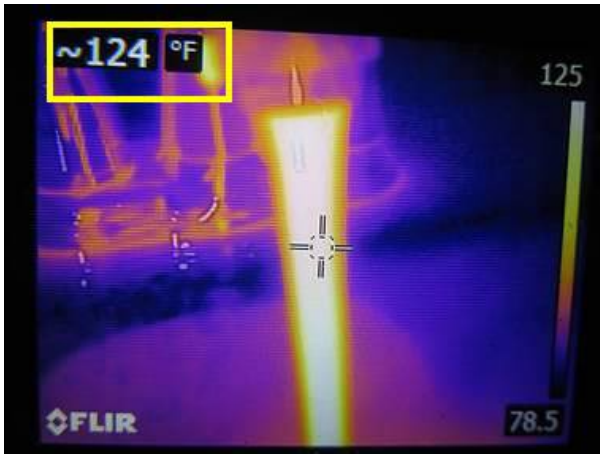
Photo 39-1

The hot water temperature was greater than 120 degrees Fahrenheit. This is a safety hazard due to the risk of scalding. The thermostat should be adjusted so the water temperature doesn't exceed 120 degrees. If the water heater is powered by electricity, a qualified person should perform the adjustment, since covers that expose energized equipment normally need to be removed. For more information on scalding dangers, visit:

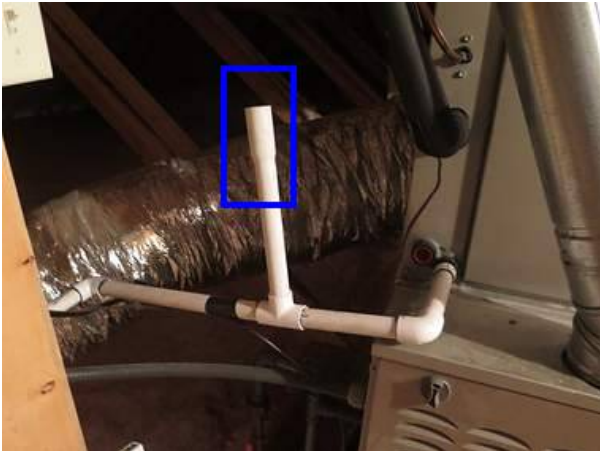
Photo 42-1

The air handler's primary condensate drain line trap was missing and/or missing cap. A U-shaped trap with a 2-inch drop should normally be installed to prevent air from moving in or out of the air handler during operation. Without a correctly configured trap, efficiency can be reduced, or condensate water can be pulled into the equipment resulting in wet insulation or components, or microbial growth. Recommend that a qualified HVAC contractor repair per standard building practices.

Without a trap, this doesn't happen. Air that is lost through the condensate drain in blow-through systems primarily is an efficiency issue. Failure to install a trap on a blow-through system can be likened to drilling a hole in the ducts for each drain connection. As for draining away condensate, the pressure around the pan on a blow-through system almost guarantees the pan will drain, trapped or not.

Trapping is a major issue on draw-through systems. Untreated air can be drawn into the airstream while the system is running. If the coil is located in an attic or other warm space, there is even greater reason for concern. As on a blow-through system, an untrapped drain on a draw-through system is an efficiency issue. But more importantly, the air being sucked through the drainpipe can prevent the pan from draining, causing it to run over.

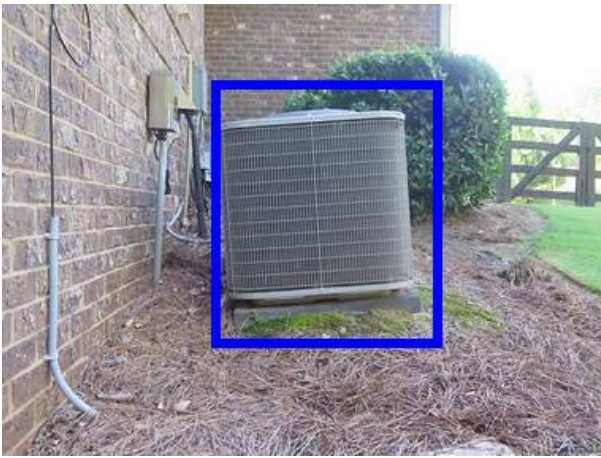
Photo 43-1

The pad for the heat pump or air conditioning condensing unit was not level. This unit requires adequate support. The compressor may be damaged if this unit is tilted 10 degrees or more. Also, the pad should elevate the unit above the soil to prevent corrosion. Recommend that a qualified person repair as necessary.

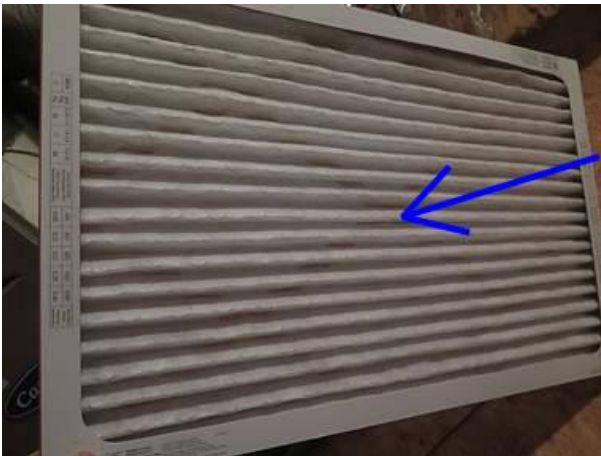
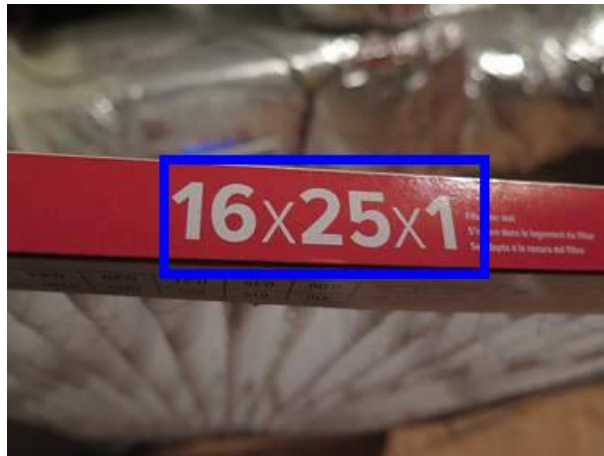
Recommend replacing or washing HVAC filters upon taking occupancy depending on the type of filters installed. Regardless of the type, recommend checking filters monthly in the future and replacing or washing them as necessary. How frequently they need replacing or washing depends on the type and quality of the filter, how the system is configured (e.g. always on vs. "Auto"), and on environmental factors (e.g. pets, smoking, the frequency of house cleaning, number of occupants, the season).

\*NOTE\* filter size - 16x25x1

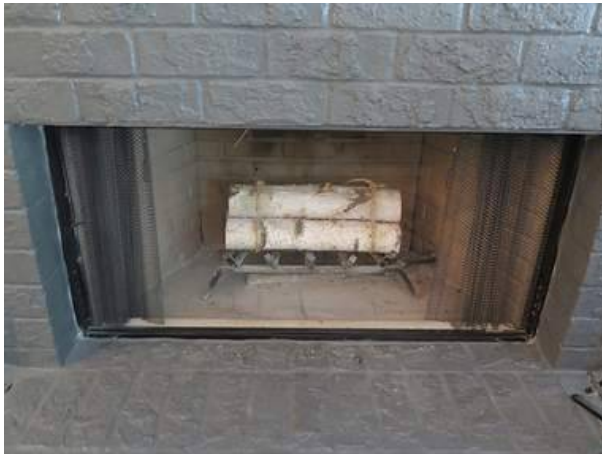
Photo 49-1

49) 🛠️ 🔍 One or more wood-burning fireplaces or stoves were found at the property. When such devices are used, they should be professionally inspected and cleaned annually to prevent creosote build-up and to determine if repairs are needed. The National Fire Protection Association states that a "Level 2" chimney inspection should be performed with every sale or transfer of property with a wood-burning device. Recommend consulting with the property owner about recent and past servicing and repairs to all wood-burning devices and chimneys or flues at this property. Recommend that a qualified specialist evaluate all wood-burning devices and chimneys, and clean and repair as necessary. Note that if a wood stove insert is installed, it may need to be removed for such an evaluation. For more information, search for "chimney inspection" at:

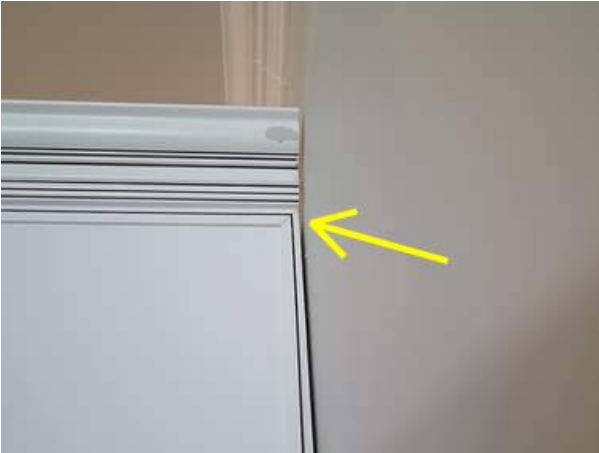
Photo 51-1

One or more cabinets appear to be loose. An adequate number of appropriate fasteners should be used. Recommend that a qualified person repair as necessary.

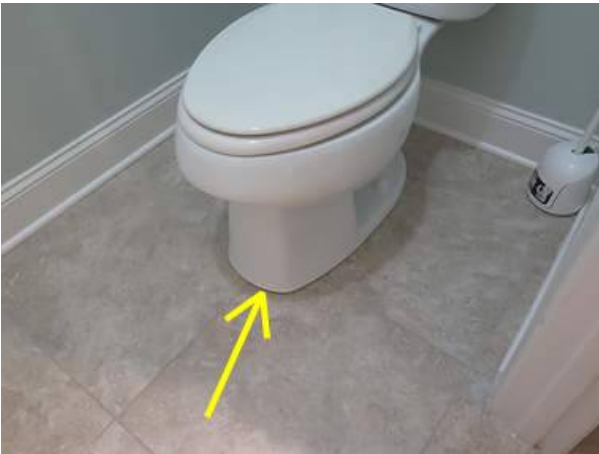
Photo 60-1

Caulk around the base of the toilet at location(s) #E was missing, substandard and/or deteriorated. Modern standards require caulk to be installed around the entire toilet base where it meets the floor for sanitary reasons. Without it, soiled water can soak into flooring and sub-floor materials if the toilet overflows. Condensation from the toilet can also soak into the flooring. Recommend that a qualified person caulk around toilet bases per standard building practices.

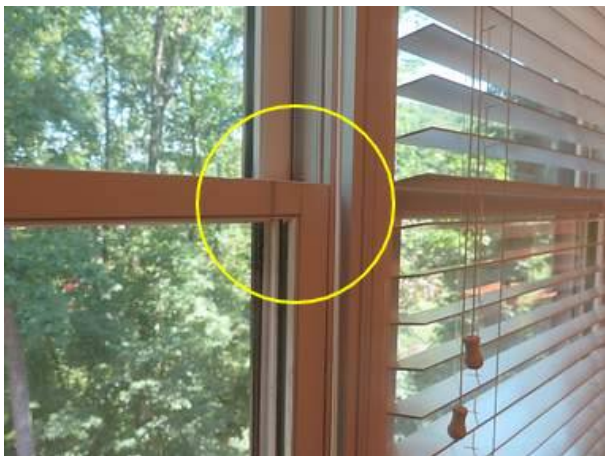
Photo 63-1

One or more windows that were designed to open and close were stuck shut and/or difficult to open and close. Recommend that a qualified person repair windows as necessary so they open and close easily.
