Your Inspection Report

2238 Edison Avenue
Atlanta, GA 30305

INSPECTION DATE:
Wednesday, December 18, 2019

Home-Probe
315 West Ponce de Leon Ave, Suite 559
Decatur, GA 30030

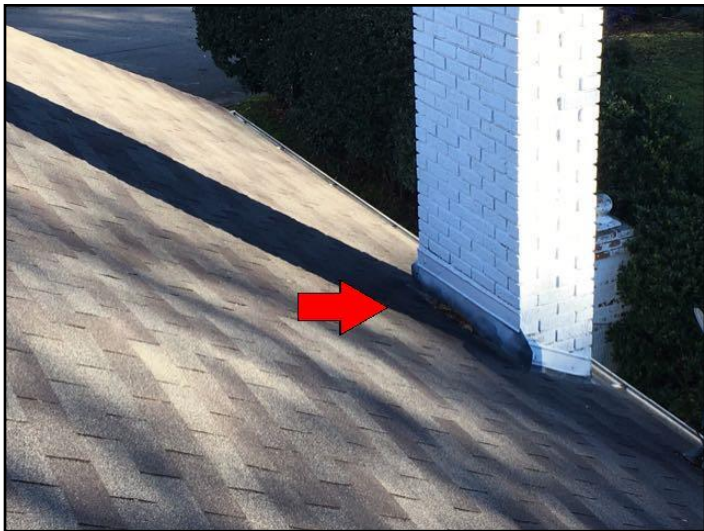
Condition: • Cricket needed

4. Cricket needed Location: Exterior roof at...

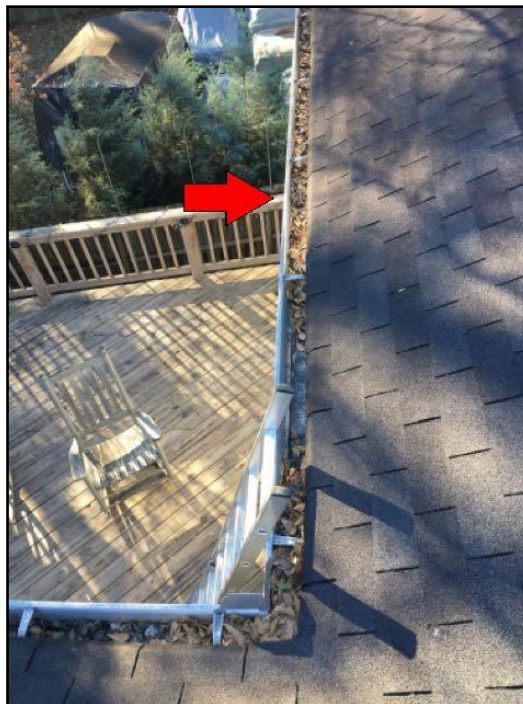
10. Clogged Location: Throughout...

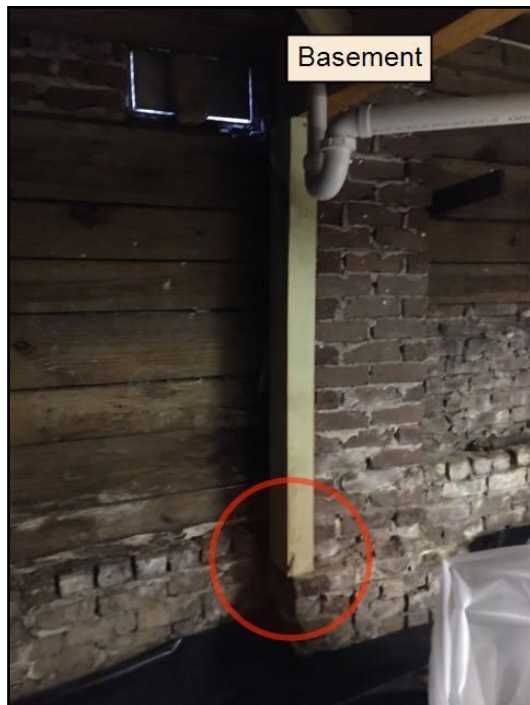
24. Poorly secured at top or bottom Task:...

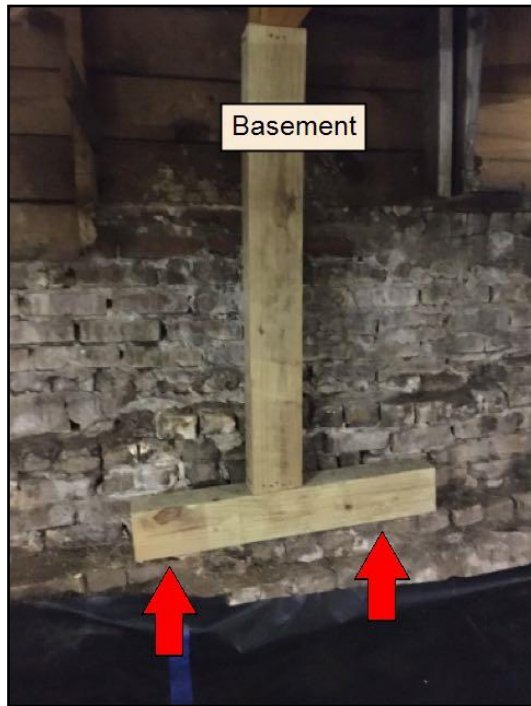
26. Poorly secured at top or bottom Task:...

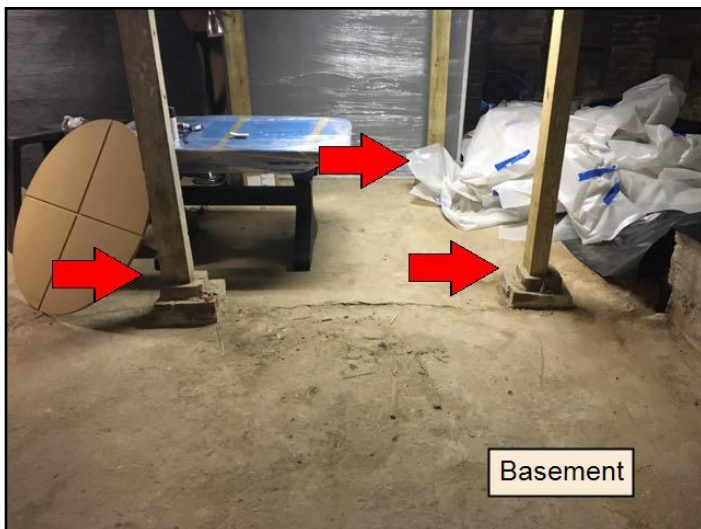
28. Poorly secured at top or bottom Task:...

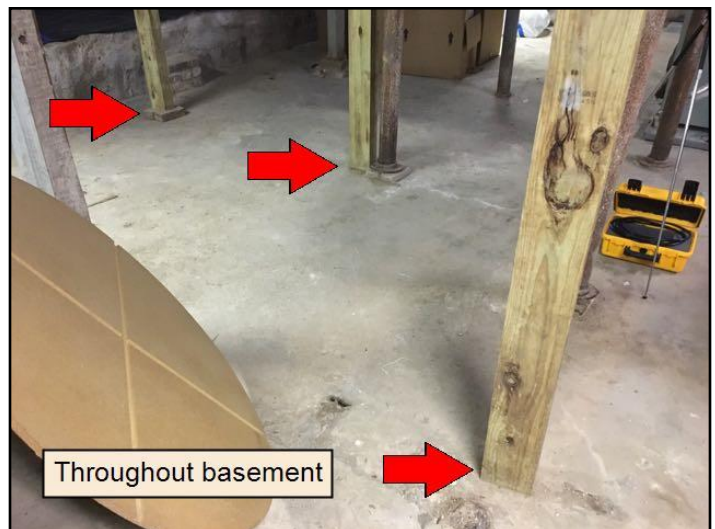
29. Poorly secured at top or bottom Task:...

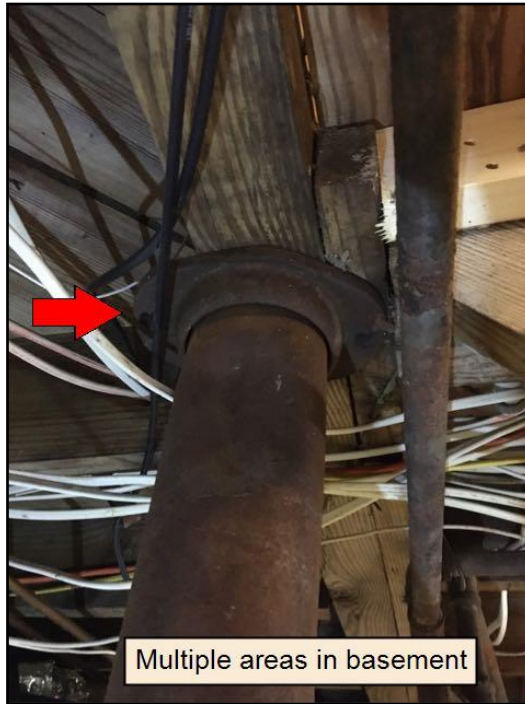
30. Poorly secured at top or bottom Task:...
