# AMENDMENT TO ADDRESS CONCERNS WITH PROPERTY AMENDMENT #1

Exhibit 1

Property Address 6007 Casleton Manor

Others Present Buyer Property Occupied Occupied  
Estimated Age 20 Years Entrance Faces North  
Inspection Date 01/11/2020  
Start Time 12:20 PM End Time 3:40 PM  
Electric On  Yes  No  Not Applicable  
Gas/Oil On  Yes  No  Not Applicable  
Water On  Yes  No  Not Applicable  
Temperature 67 Degrees  
Weather Rain Soil Conditions Wet  
Space Below Grade Basement  
Building Type Single family Garage Attached  
Sewage Disposal County How Verified Visual Inspection  
Water Source County How Verified Visual Inspection  
Additions/Modifications None

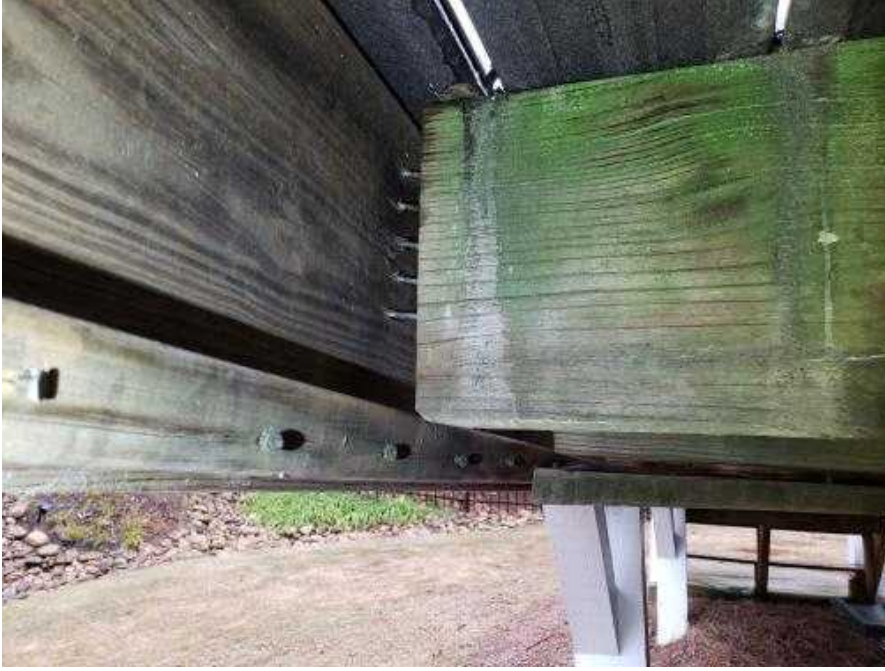
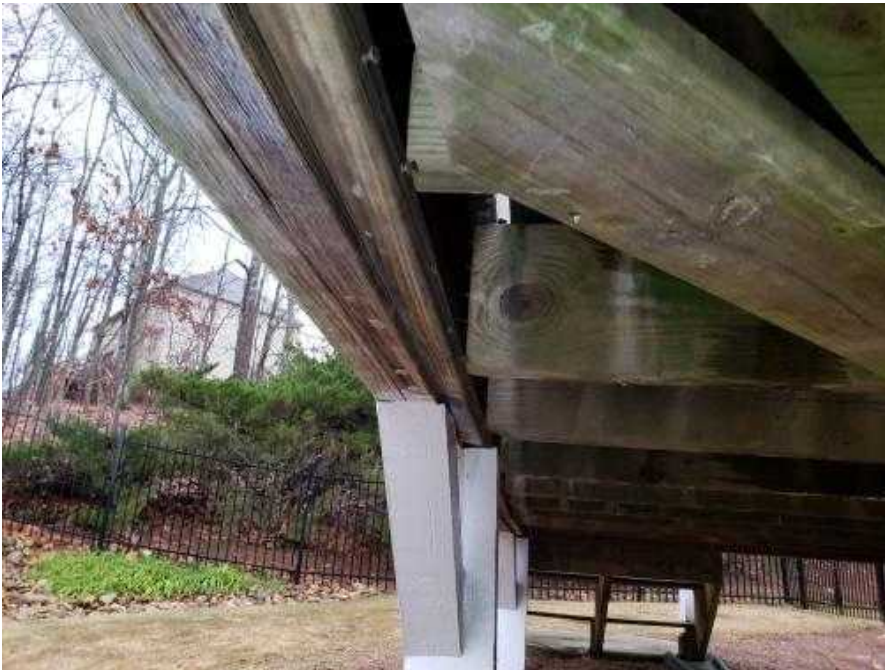
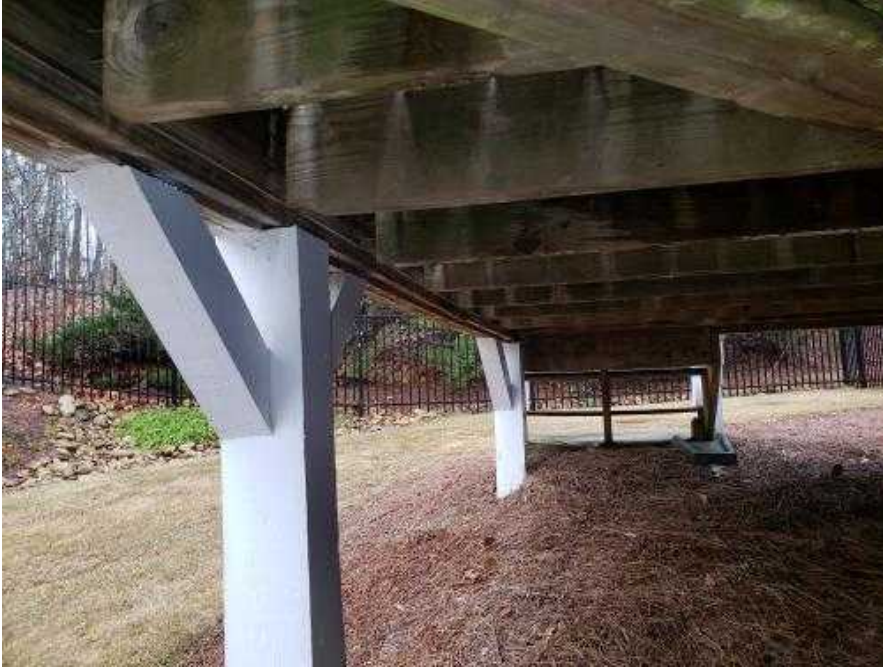
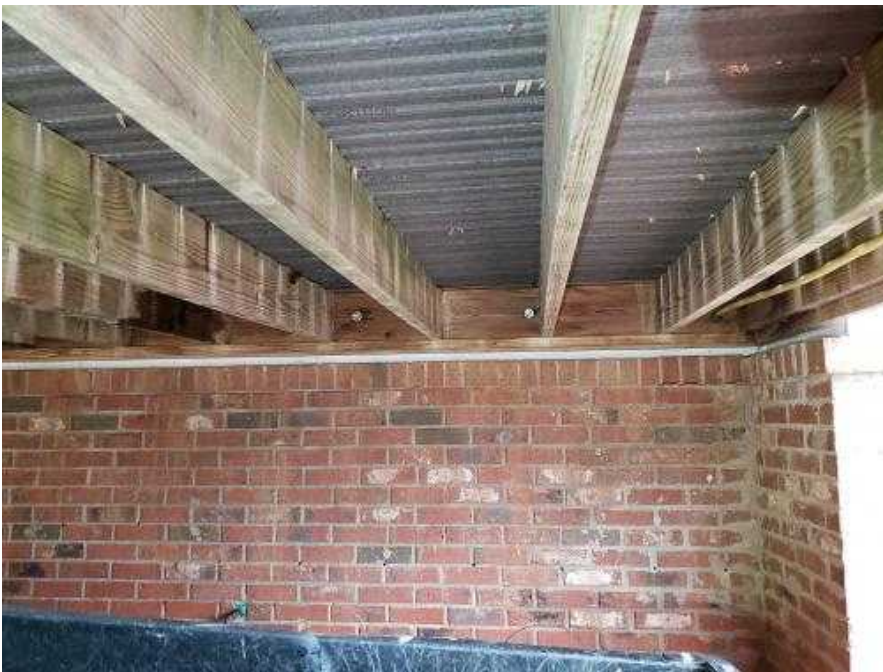
Deck: (continued)

Center post at deck was not properly supported and has shifted forcing the floor joist to separate from outer ban. Many of the floor joist are not in contact with outer ban. Further evaluation by qualified contractor is needed to estimate repairs. A new 6x6 post should be installed with permanent footer installed. Outer ban is heavily warped and many need to be replaced. All floor joist should be brought up to code : Floor joist for deck are not properly supported by joist hangers. Joist hangers need to be installed at outer and inner bands to ensure floor system is properly supported.

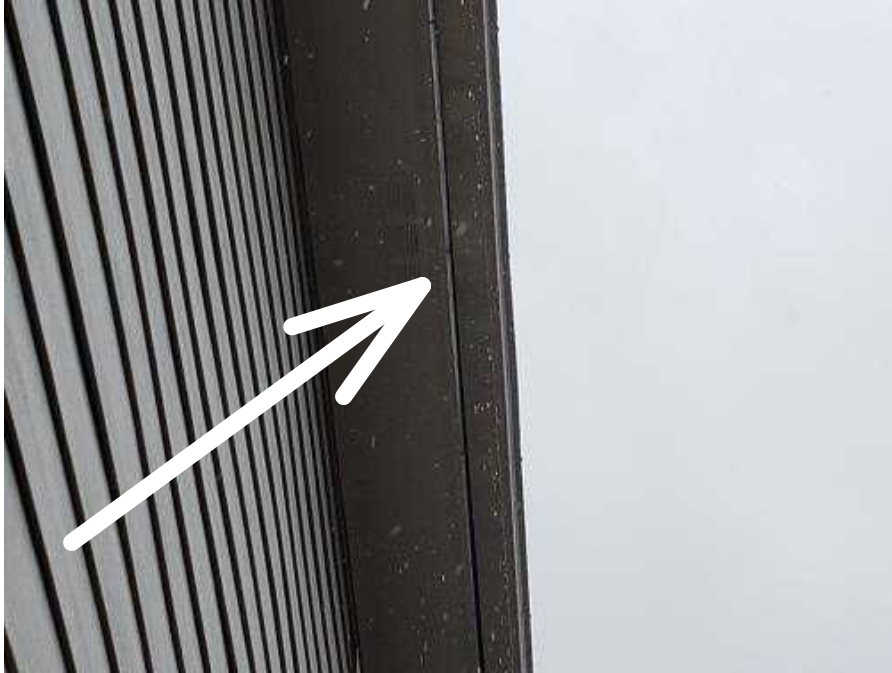
Gutters: (continued)

11. The sellers agree to clean the dirty gutters and roof to ensure proper rainwater run off and repair/replace the gutter at rear of home which is pulling away from home.

Gutter at rear of home is pulling away from home and needs to be repaired.

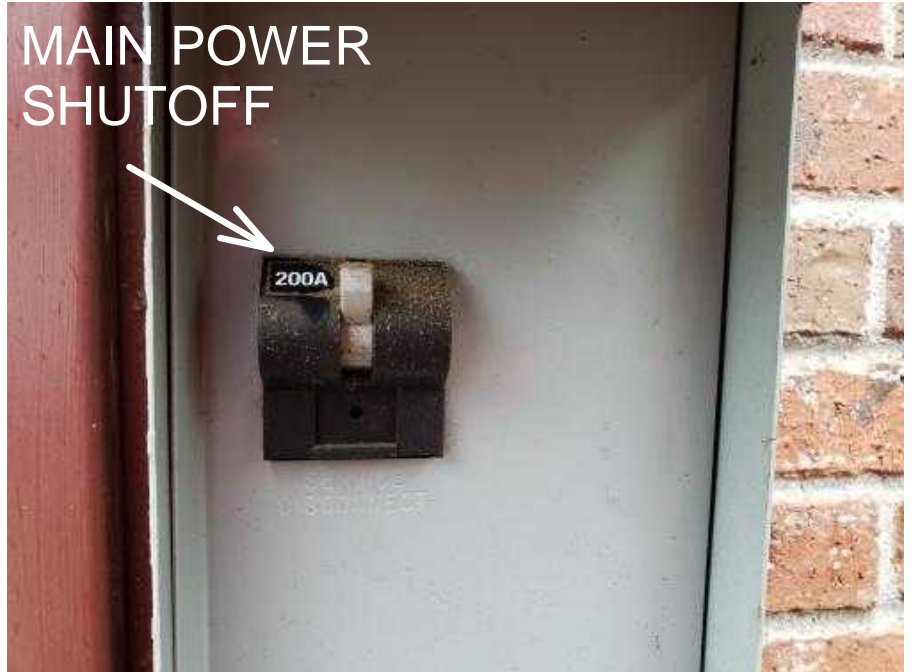
10.      Main Breaker Size: 200  
Amps

Current code calls for all living spaces to have AFCI breaker and outlet protection installed. Recommend updating homes electrical system to ensure safe and proper operation per code.

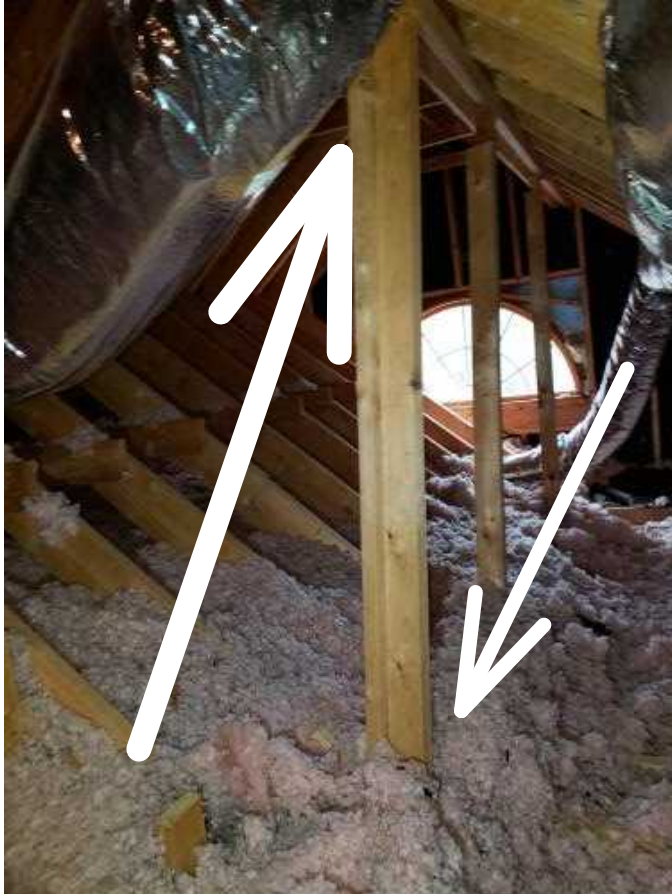
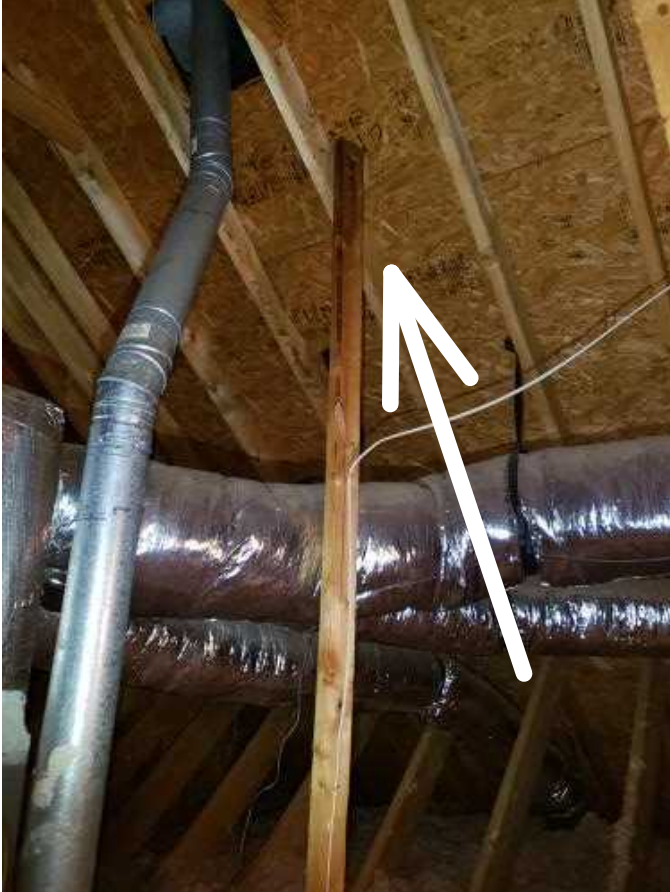
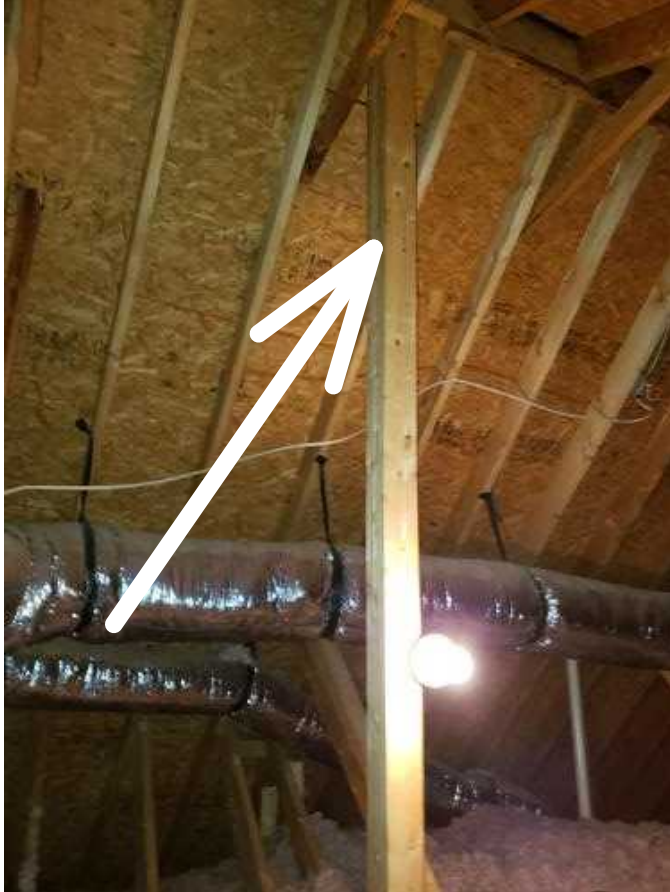
Roof Framing: (continued)

There is a cracked/damaged 2x6 framing member at rear of home the needs an additional 2x6 sistered up to it to ensure integrity.

There a few loose 2x4 framing members that are loose and need additional fasteners added.

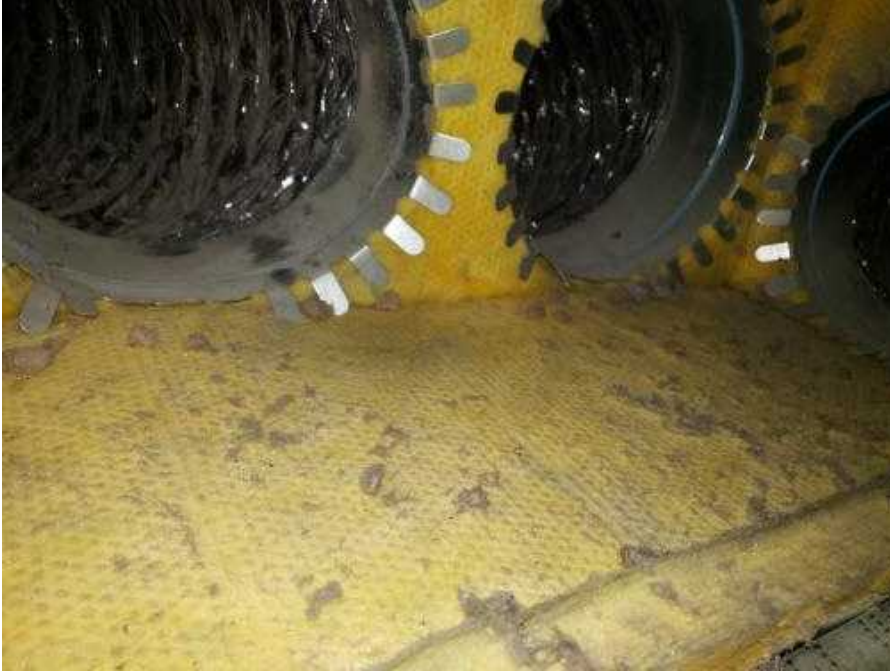
Distribution: (continued)

Recommend duct cleaning service for all ductwork.

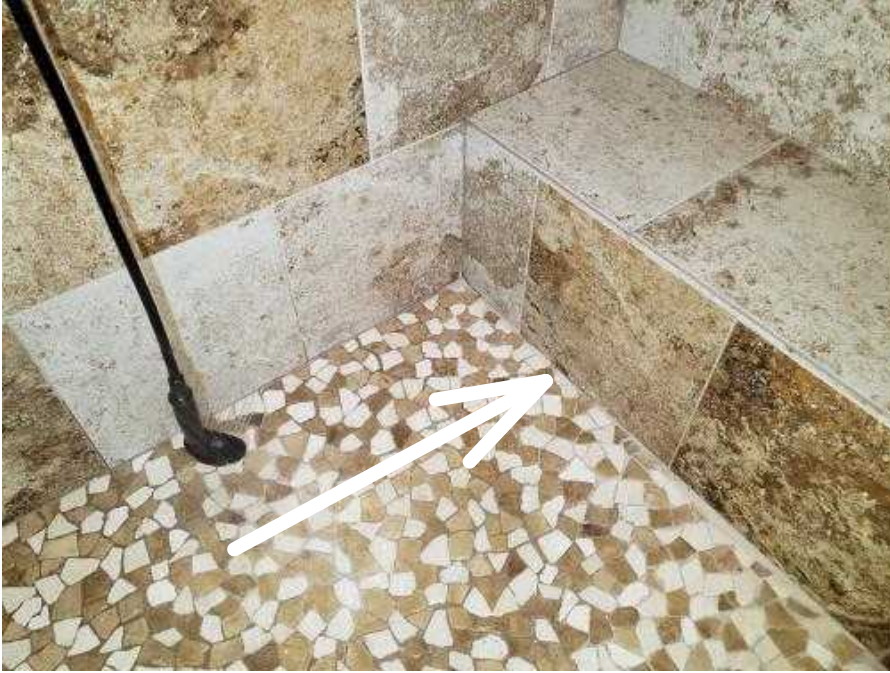
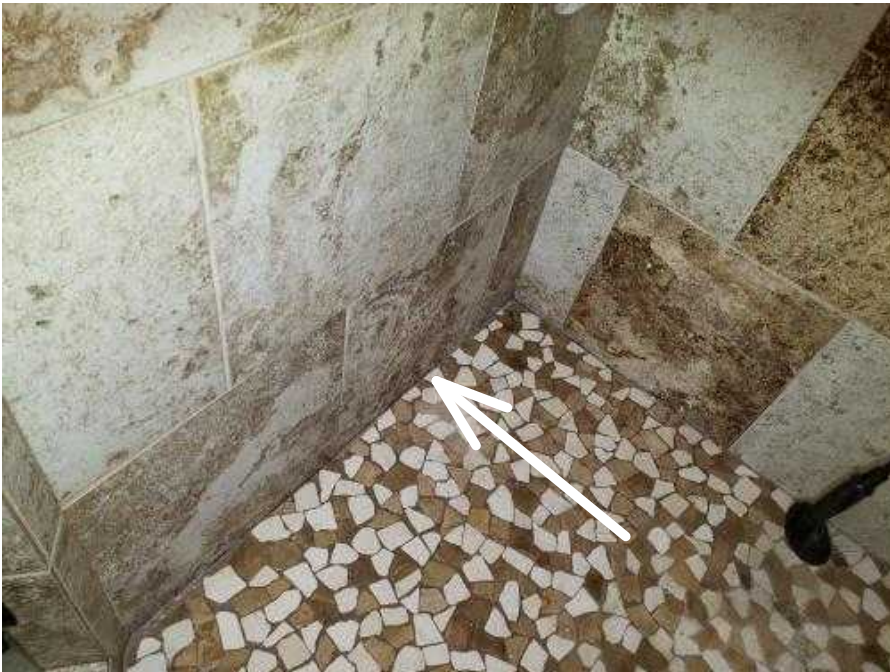
Shower/Surround: (continued)

Glass shower partition is loose and needs additional bracket installed to secured it to surround.

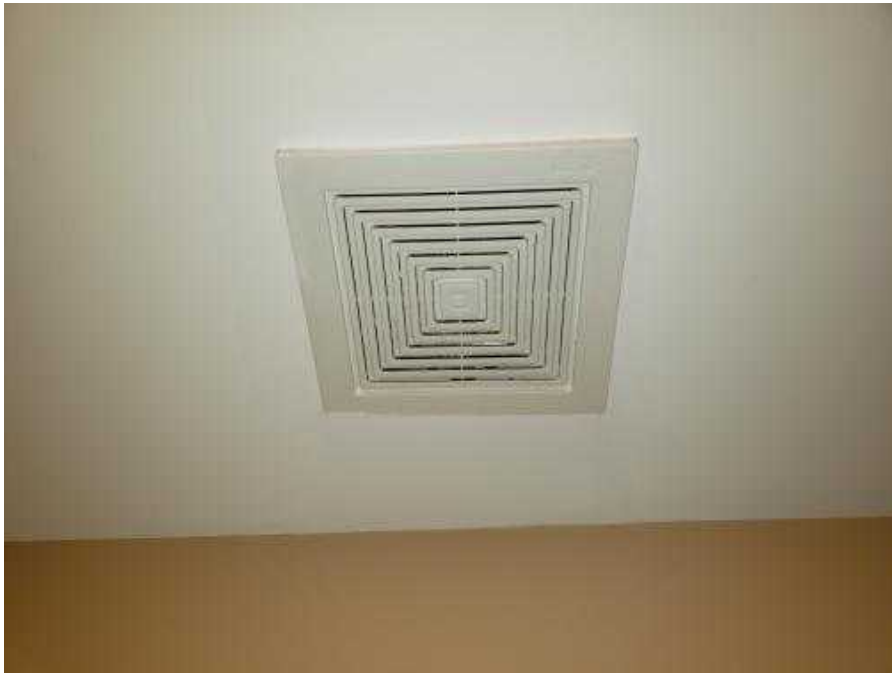
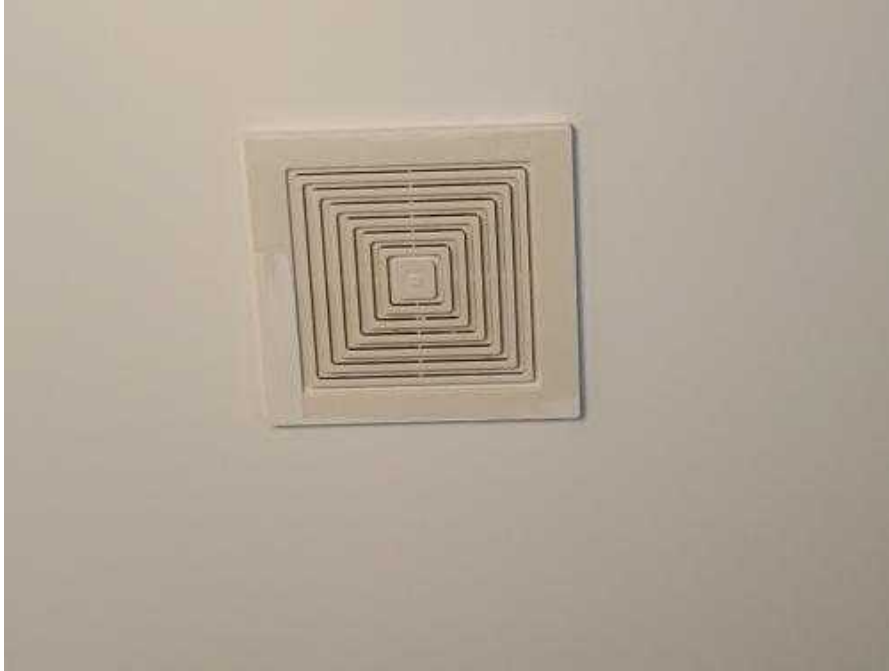
Ventilation: (continued)

Vent and vent cover need to be cleaned to ensure proper ventilation.

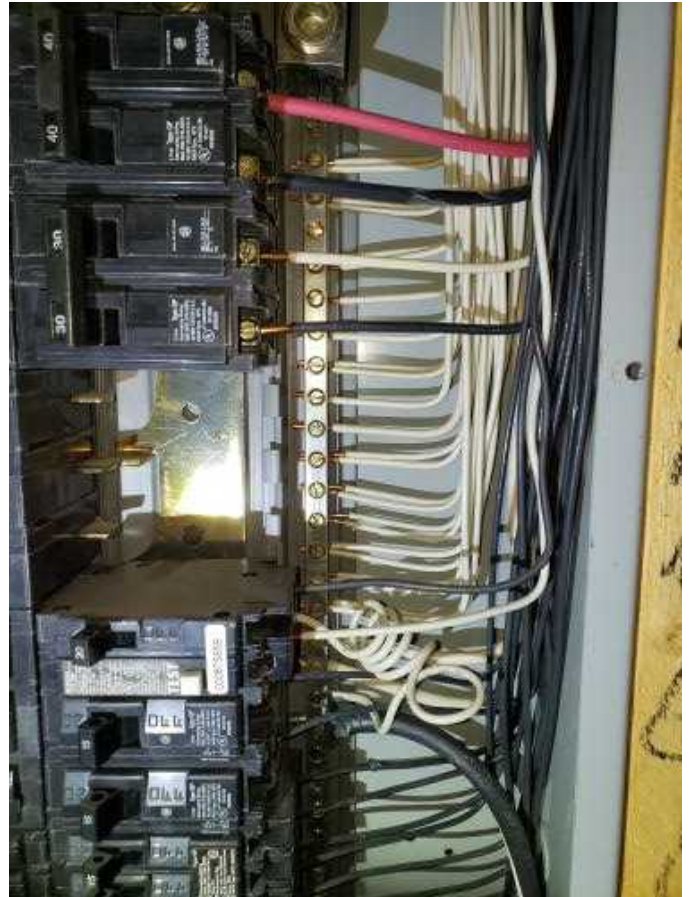
#### 1. 120 VAC Branch Circuits: Copper -

Doubled up neutrals need to be separated out onto individual on locations on the bus bar.

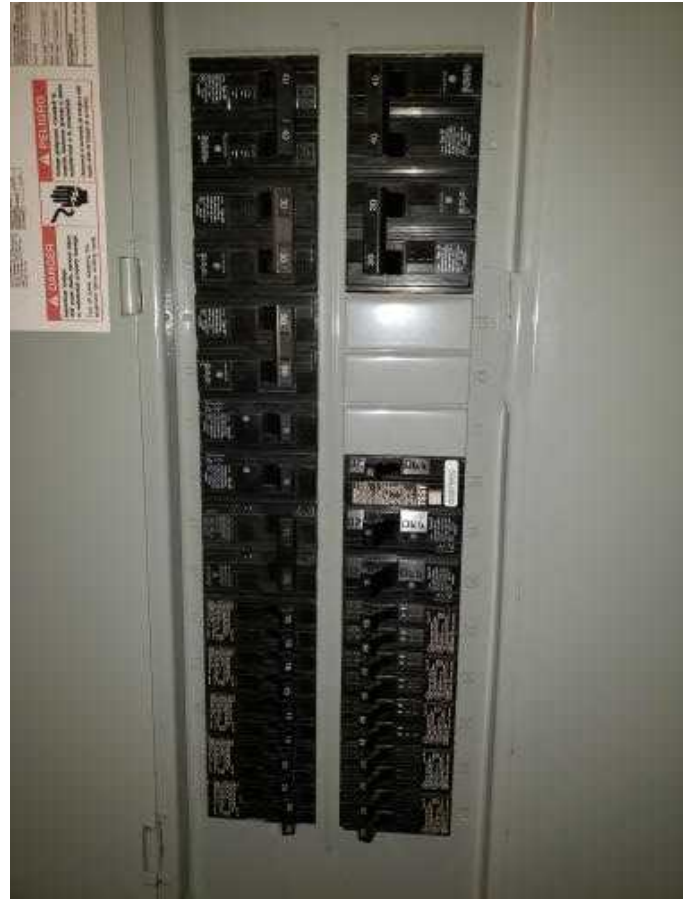
### 2. Basement Electric Panel AFCI: 110 volt -

Current code calls for all living spaces to have AFCI breaker and outlet protection installed. Recommend updating homes electrical system to ensure safe and proper operation per code.

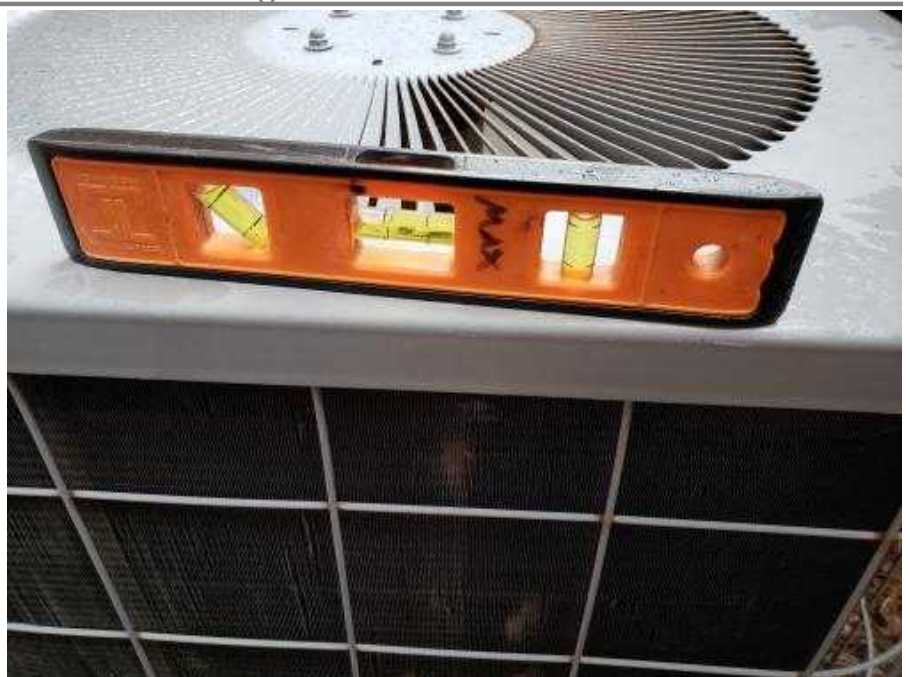
### 3. Main AC System A/C System Operation: Functional -

A/C unit is not level. Recommend leveling to ensure proper operation.

The unit is nearing the end of the manufactures stated design life.

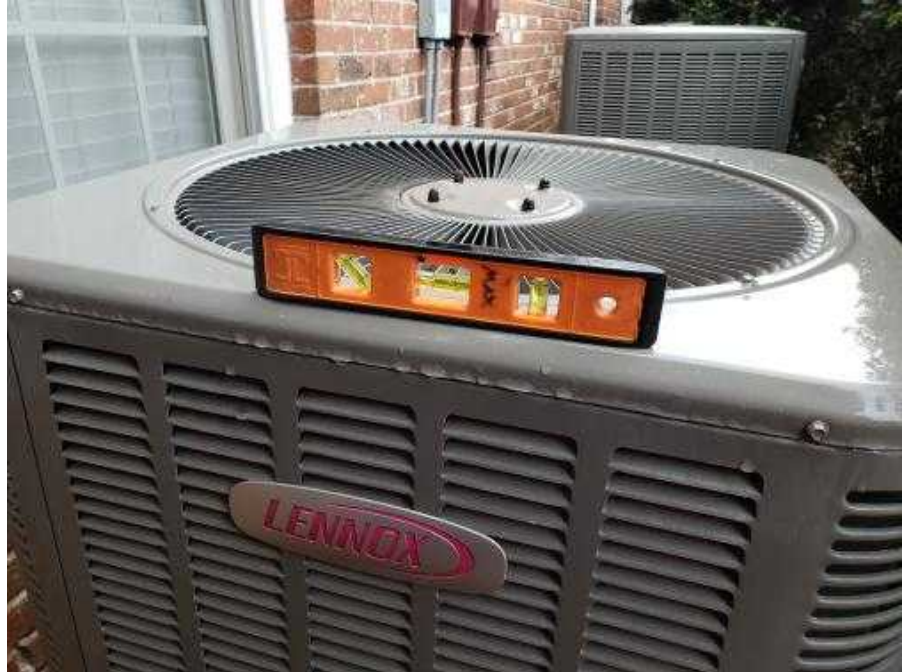
4. Main AC System A/C System Operation:  
Functional -

A/C unit is not level. Recommend leveling  
to ensure proper operation.

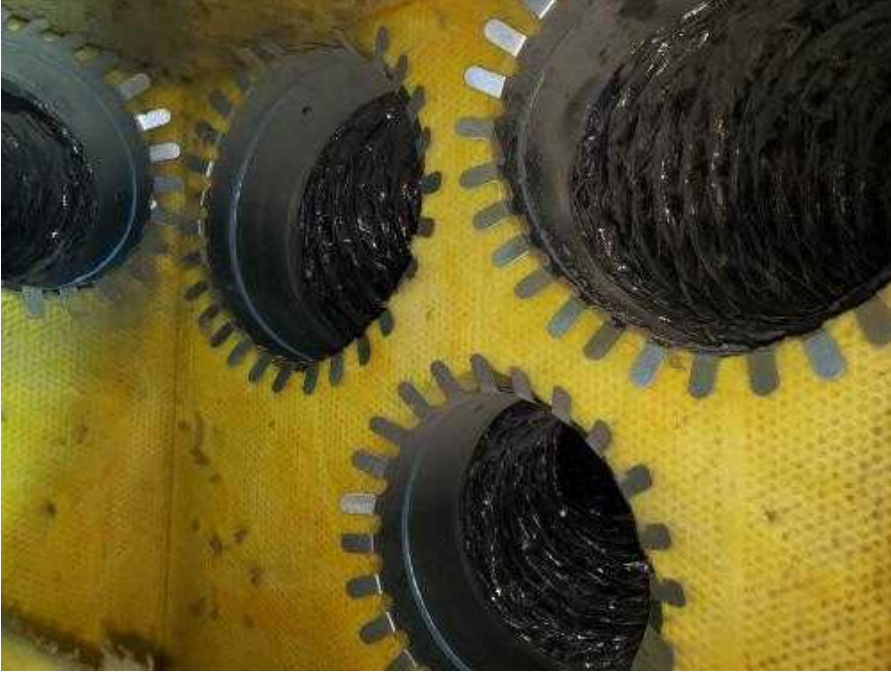
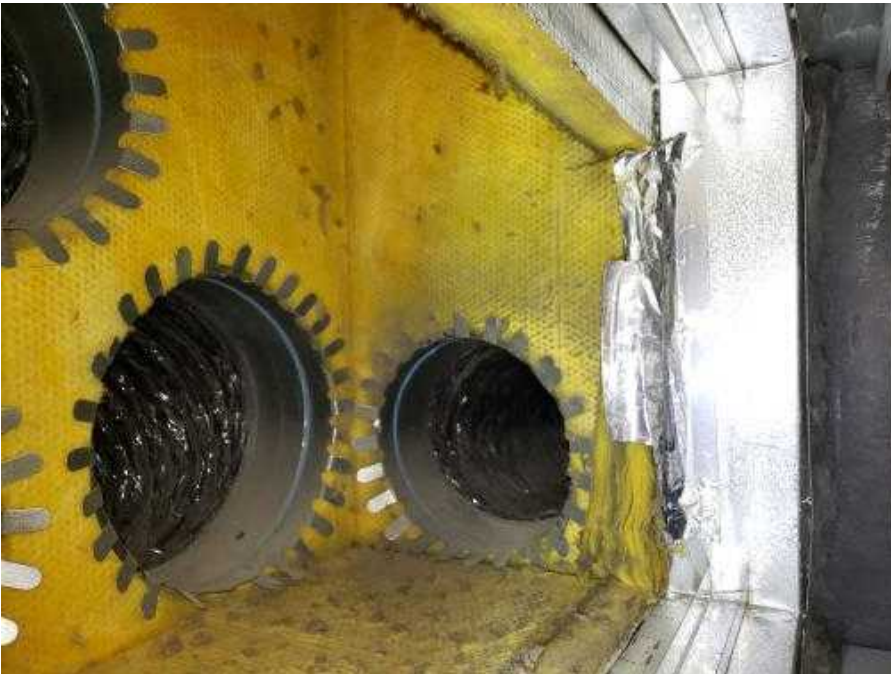
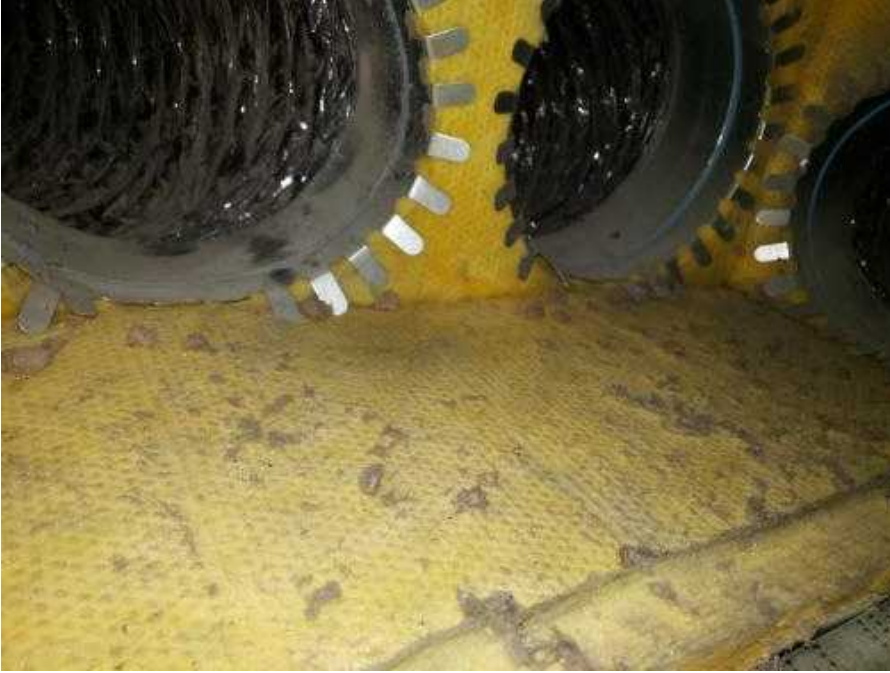
5. Attic Heating System Distribution: Insulflex duct -

Recommend duct cleaning service for all ductwork.

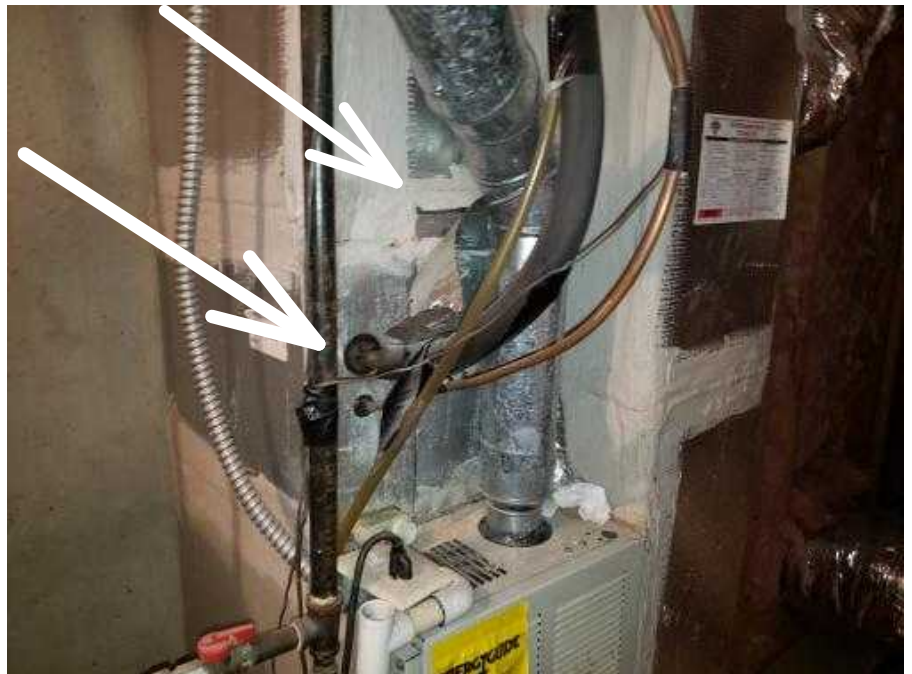
6. Basement Heating System Heating System Operation: Adequate -

Furnace is not properly sealed and is allowing conditioned air to escape which is effecting overall efficiency. Seal unit to ensure proper efficiency.

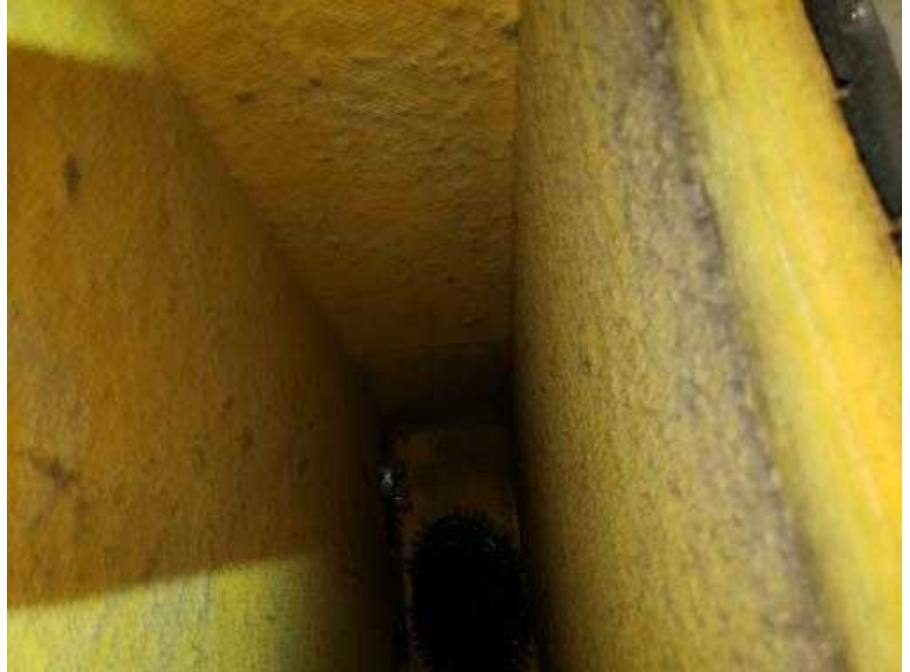
7. Basement Heating System Distribution:  
Insulflex duct -

Recommend duct cleaning service for all ductwork.

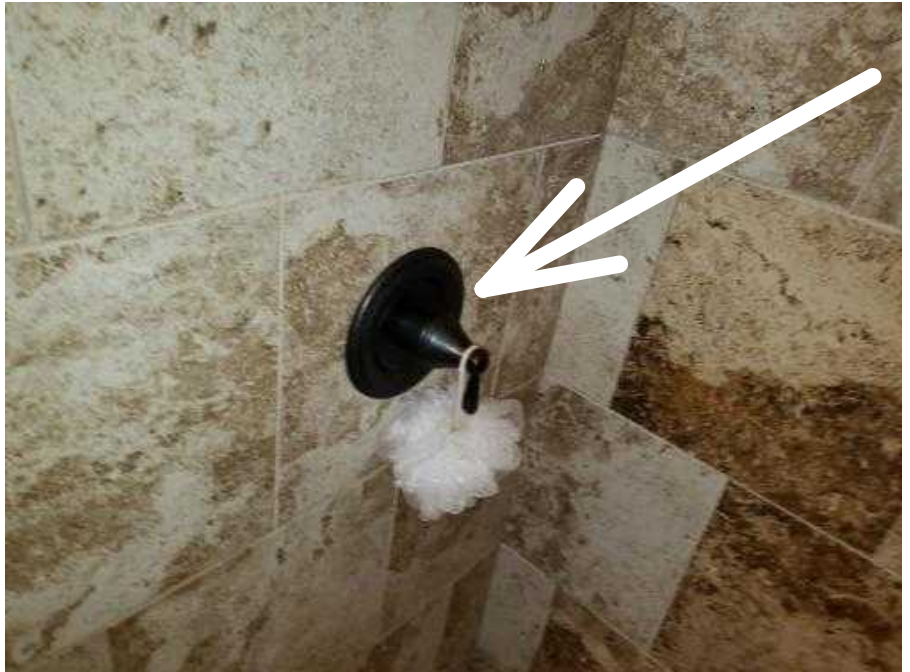
8. Master Bathroom Faucets/Traps: Delta fixtures with a PVC trap -

Mixture valve is loose behind wall and should be secured to framing.

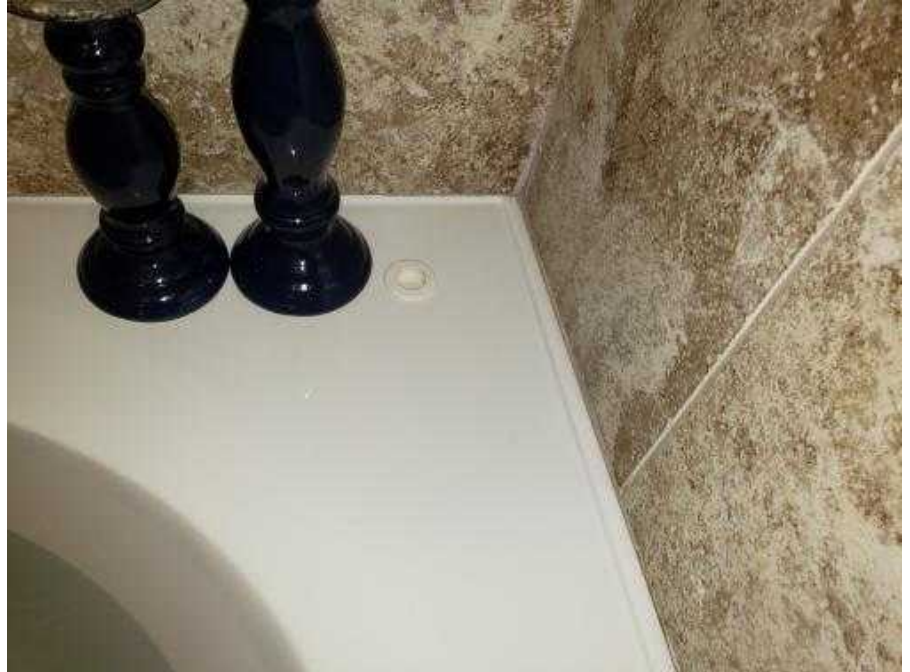
9. Master Bathroom Tub/Surround:  
Fiberglass tub and ceramic tile surround -

Jacuzzi action button is inoperative and needs to be replaced.

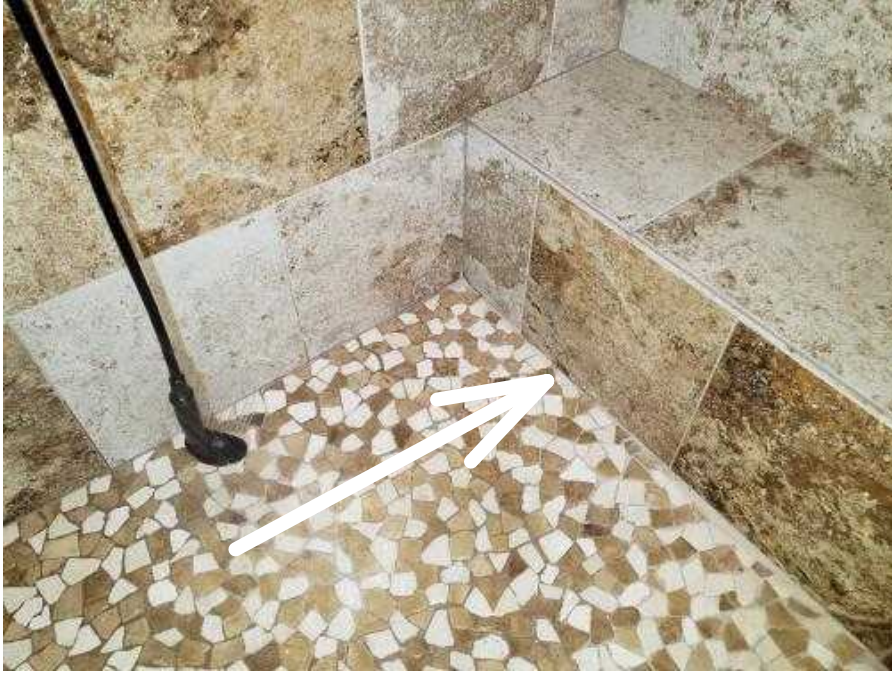
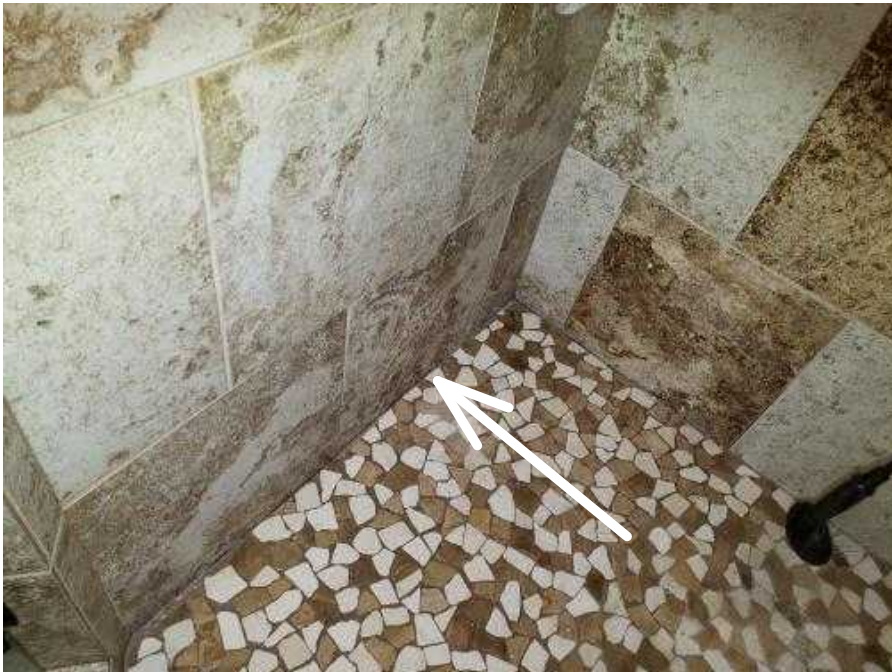
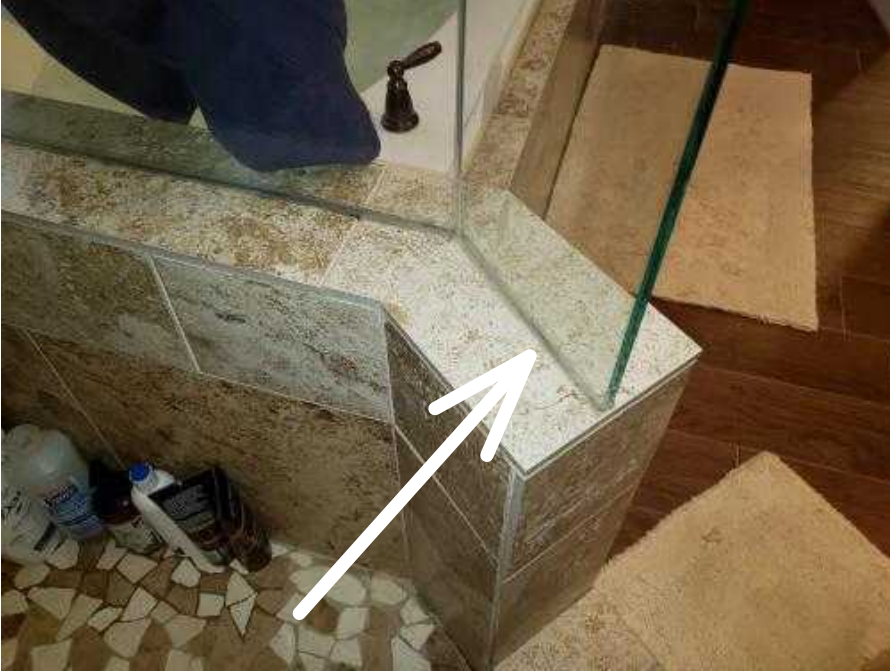
10. Master Bathroom Shower/Surround: Ceramic tile pan and ceramic tile surround -

All seams in shower surround need to be sealed.

Glass shower partition is loose and needs additional bracket installed to secured it to surround.

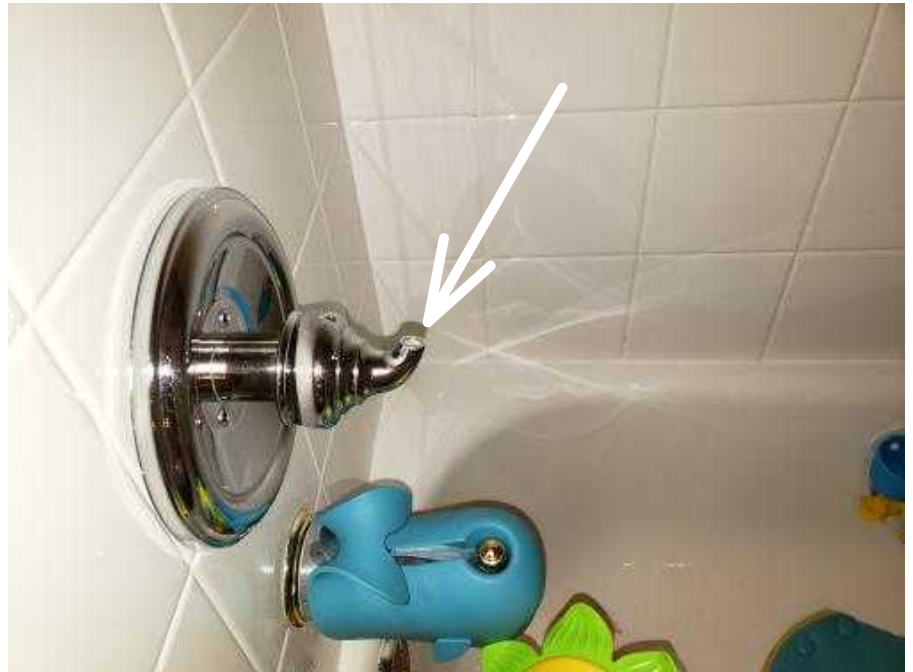
11. 2nd Floor Bathroom Bathroom  
Faucets/Traps: Delta fixtures with a PVC  
trap -

Mixture valve handle is missing parts and  
needs to be repaired.

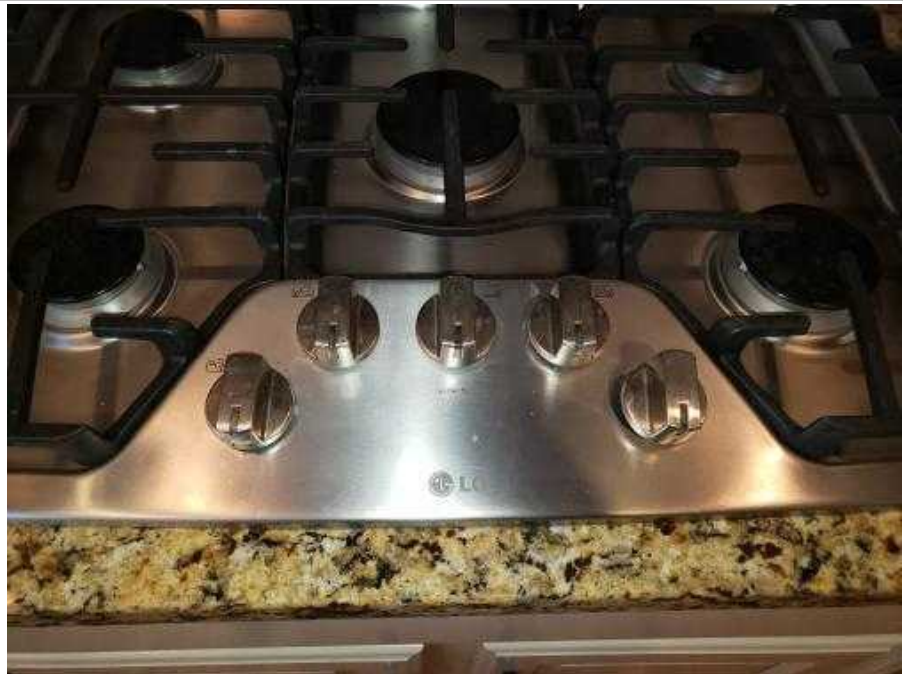
13. Main Kitchen Cooking Appliances: LG -

Cook top burner displays are not legible.

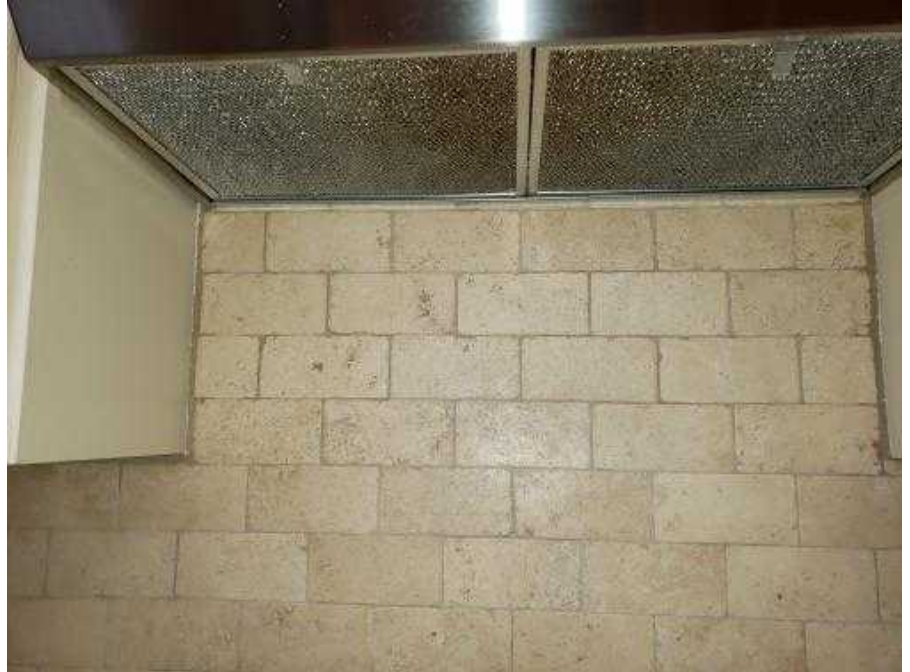
14. Main Kitchen Ventilator: Allure -

Grease filters need to be cleaned.

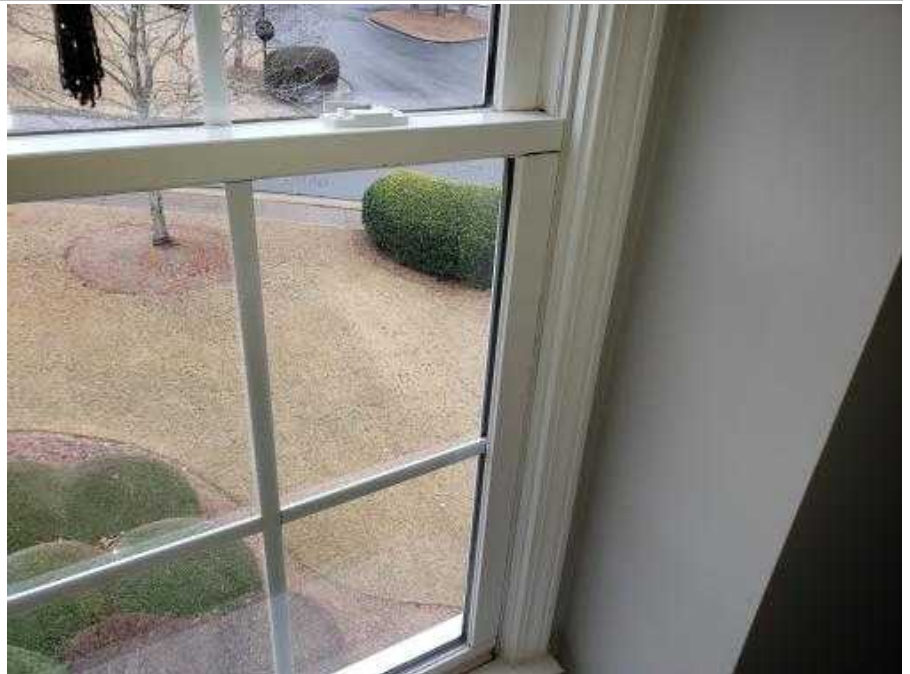
15. Front Left Bedroom Windows: Wood double hung -

Window is painted shut and needs to be repaired.

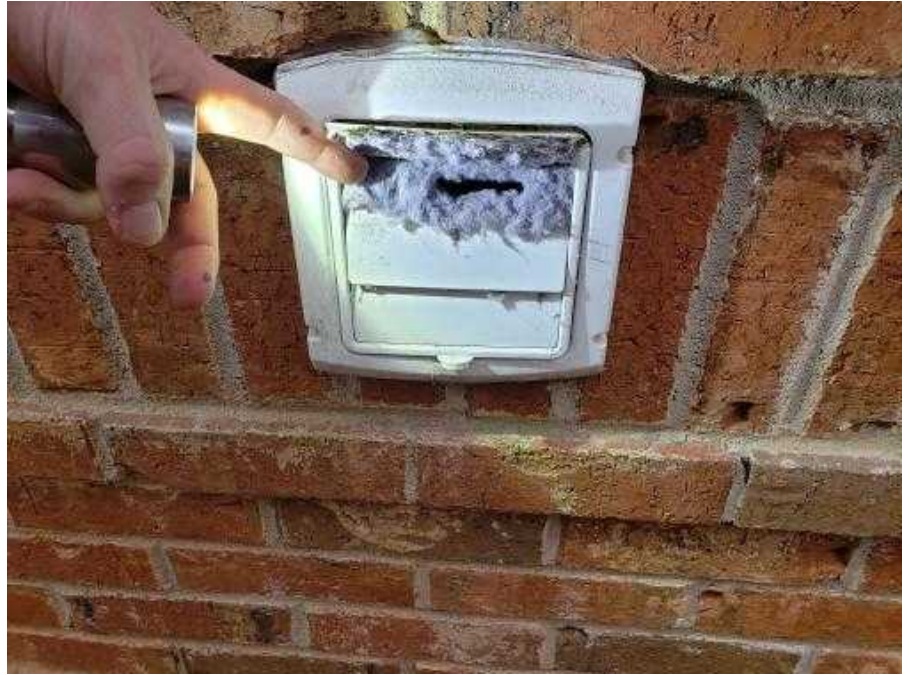
16. 1st Floor Laundry Room/Area Dryer Vent:  
Rigid metal -

Dryer vent needs to be cleaned to ensure proper operation.

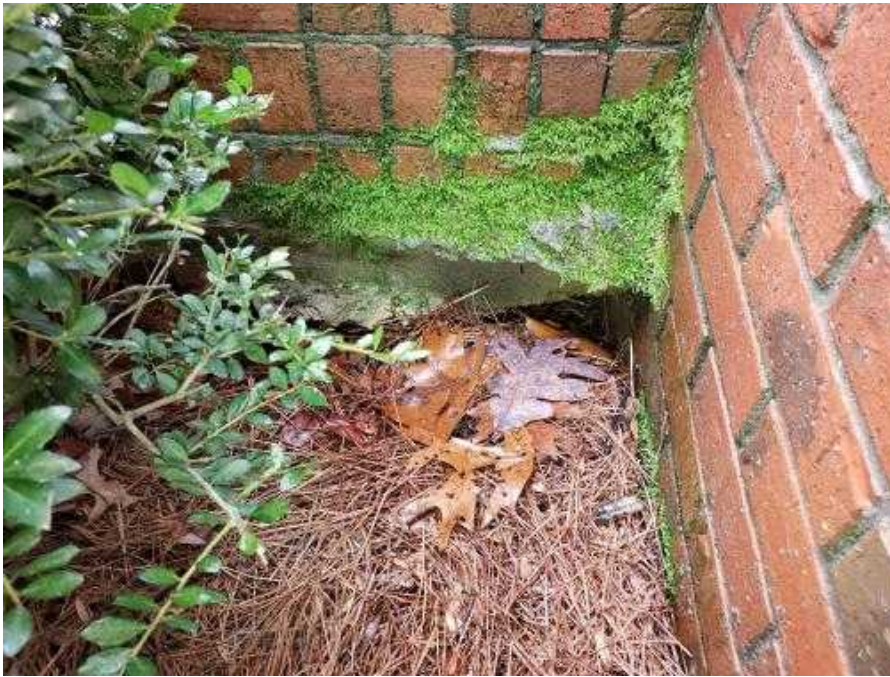
#### 1. Steps/Stoops: Brick -

Brick steps at front of home were not properly back filled with dirt and there is a void under stairs the needs to be back filled with gravel to ensure proper support.
