# AMENDMENT TO ADDRESS CONCERNS WITH PROPERTY AMENDMENT #1

Exhibit 1

Property Address 6007 Casleton Manor

Others Present Buyer Property Occupied Occupied  
Estimated Age 20 Years Entrance Faces North  
Inspection Date 01/11/2020  
Start Time 12:20 PM End Time 3:40 PM  
Electric On  Yes  No  Not Applicable  
Gas/Oil On  Yes  No  Not Applicable  
Water On  Yes  No  Not Applicable  
Temperature 67 Degrees  
Weather Rain Soil Conditions Wet  
Space Below Grade Basement  
Building Type Single family Garage Attached  
Sewage Disposal County How Verified Visual Inspection  
Water Source County How Verified Visual Inspection  
Additions/Modifications None

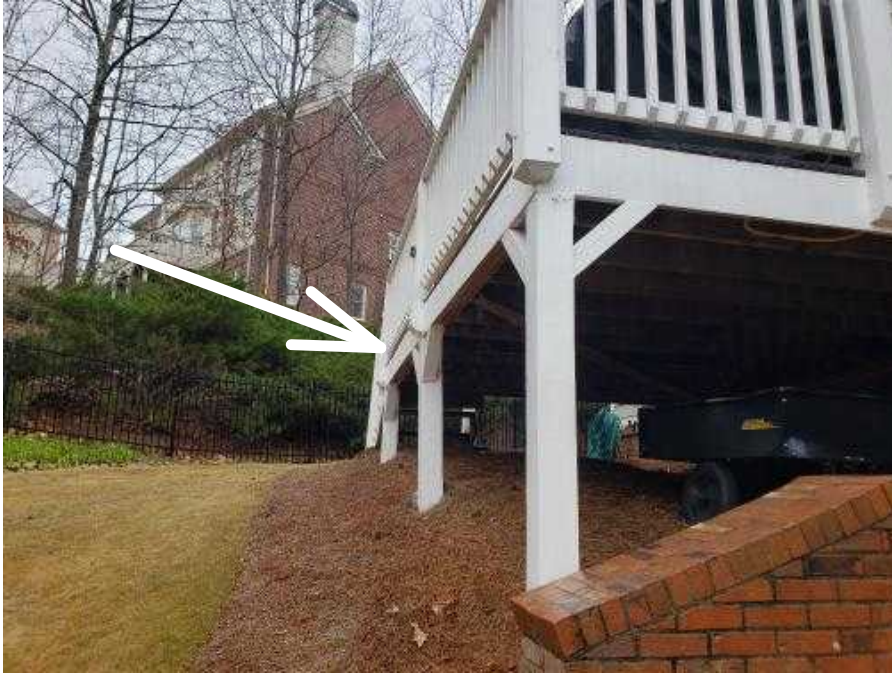
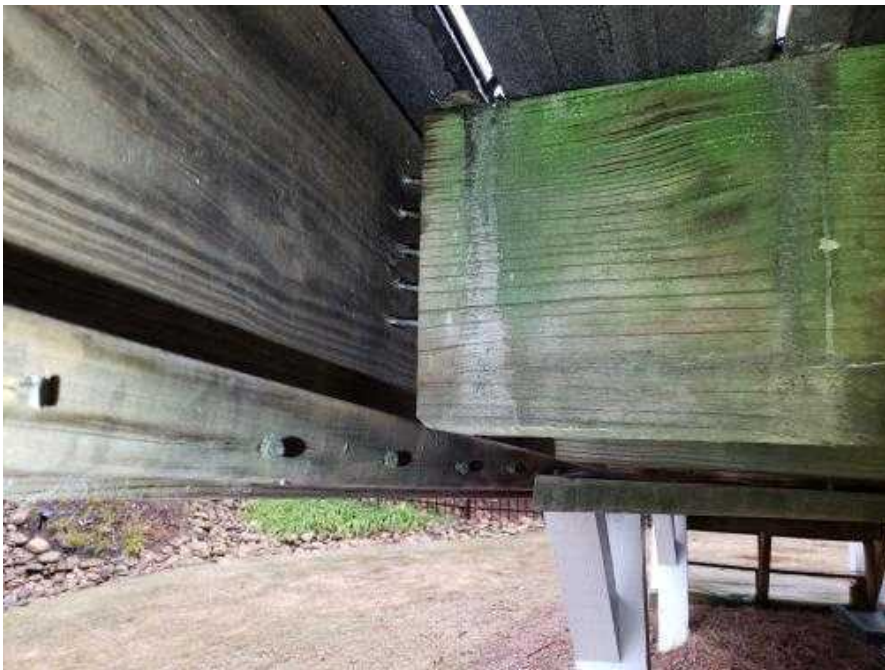
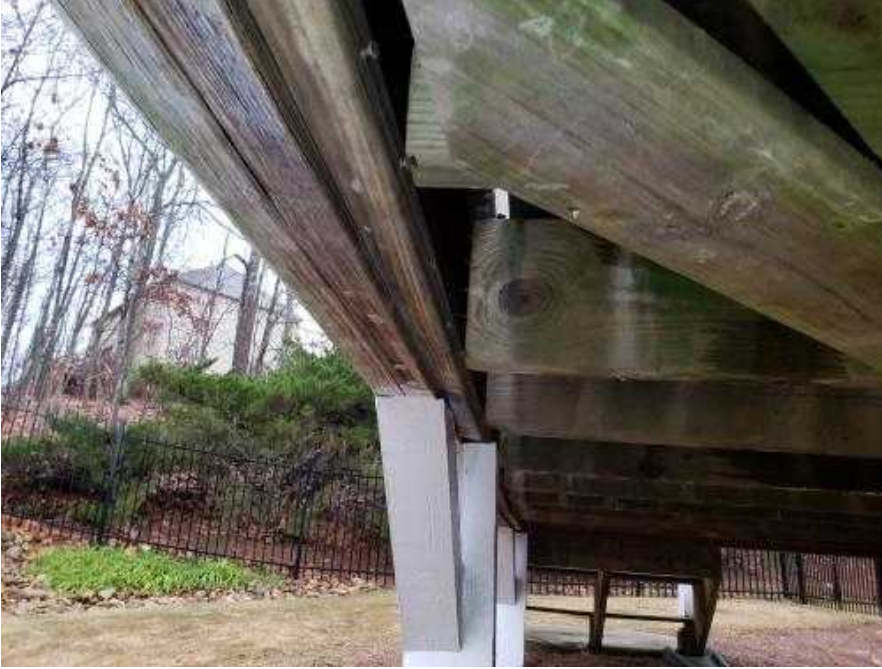
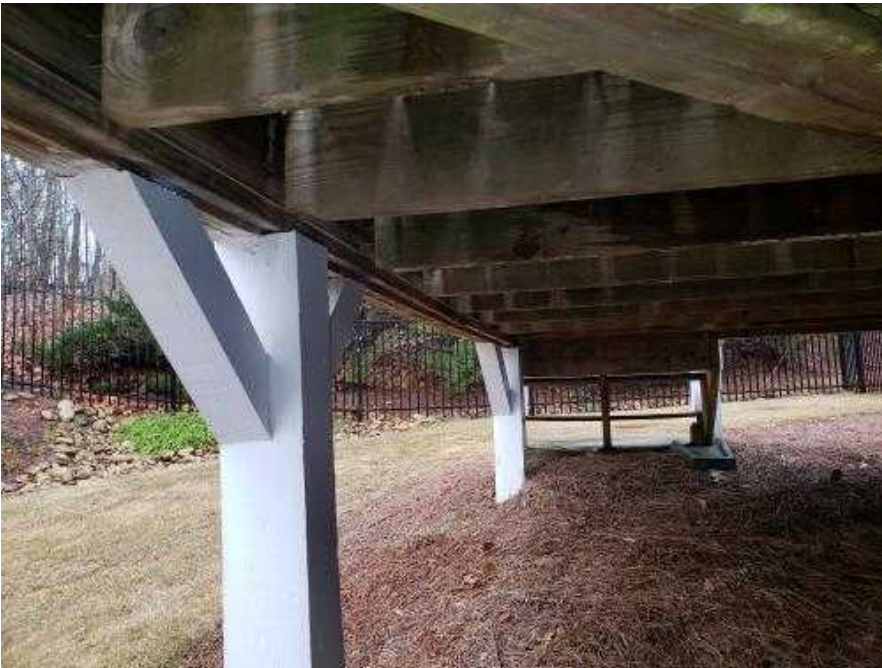
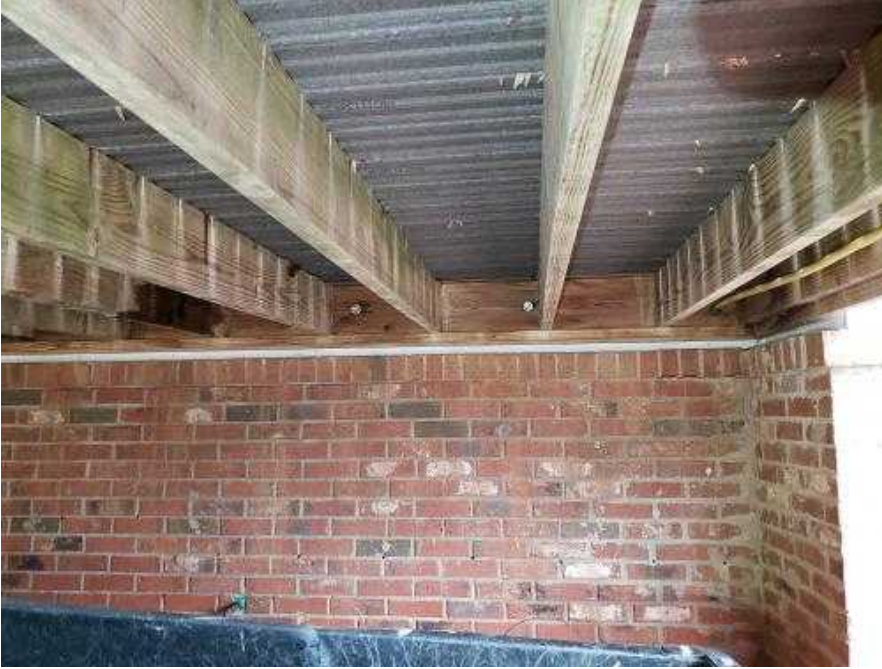
2. Deck: Treated wood -

Center post at deck was not properly supported and has shifted forcing the floor joist to separate from outer ban. Many of the floor joist are not in contact with outer ban. Further evaluation by qualified contractor is needed to estimate repairs. A new 6x6 post should be installed with permanent footer installed. Outer ban is heavily warped and many need to be replaced. All floor joist should be brought up to code : Floor joist for deck are not properly supported by joist hangers. Joist hangers need to be installed at outer and inner bands to ensure floor system is properly supported.

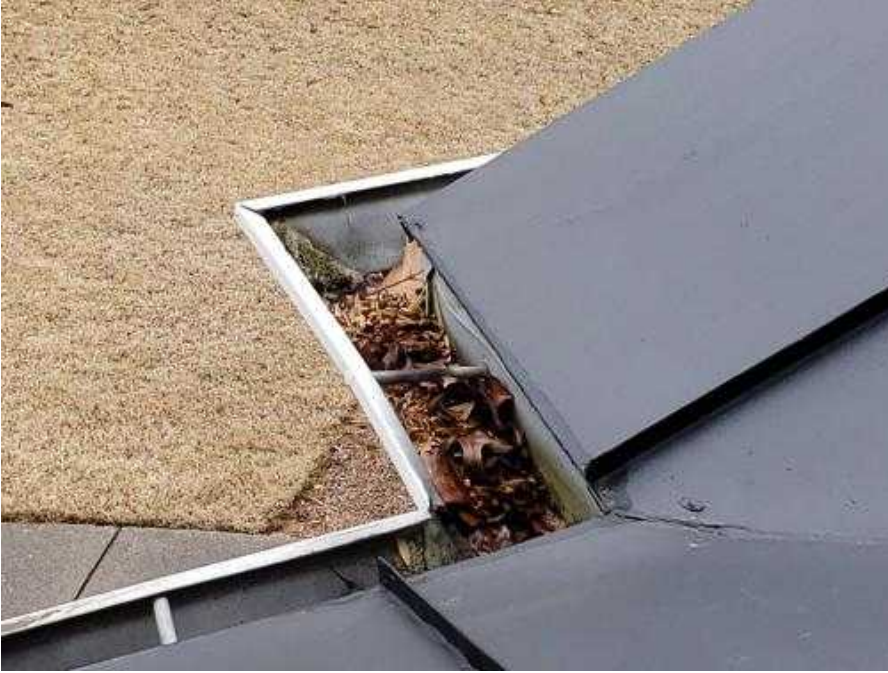
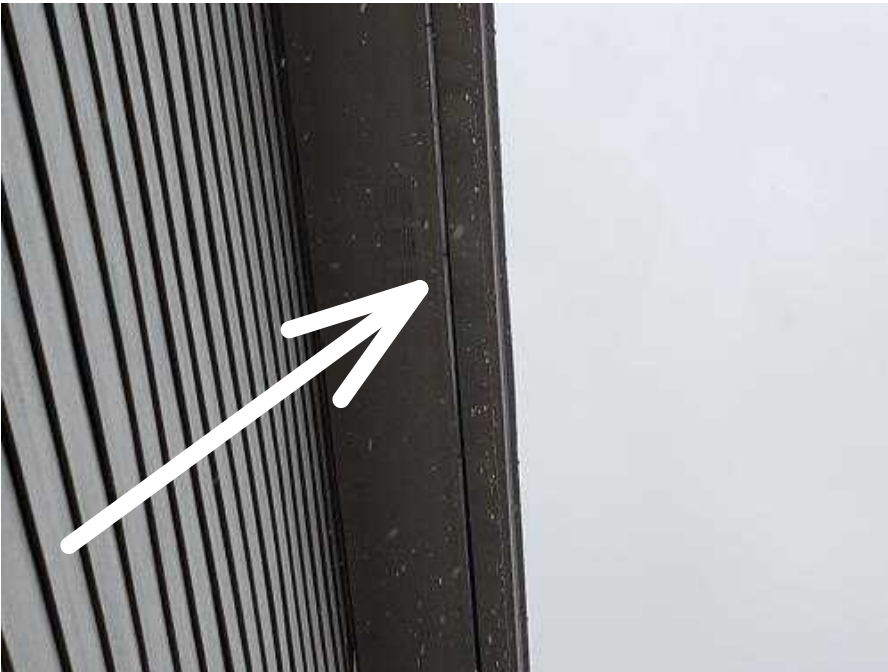
### 3. Gutters: Aluminum -

Gutter at rear of home is pulling away from home and needs to be repaired.

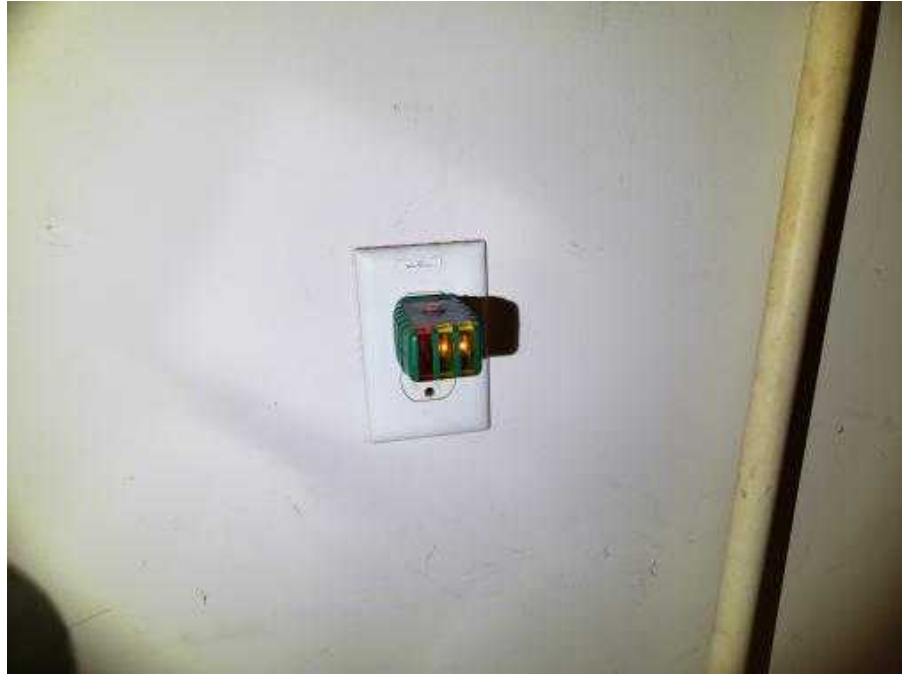
4. Attached Garage Electrical: 110 VAC outlets and lighting circuits -

Non-GFCI circuit -recommend GFCI circuit be installed.

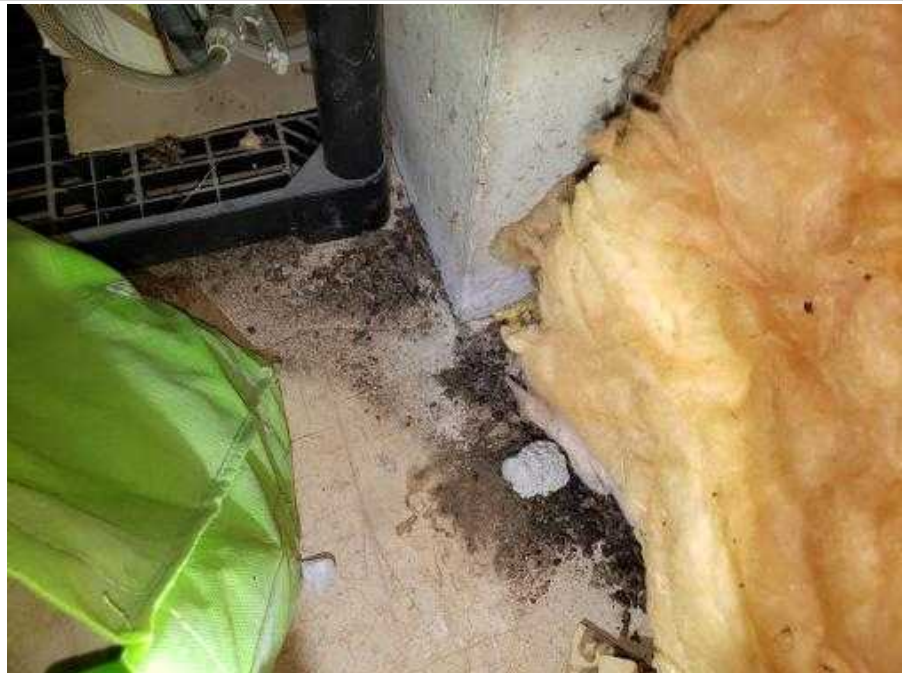
5. Sub Basement Floor: Poured Slab -

Rodent activity observed at unfinished room in basement. Recommend further evaluation by pest control company.

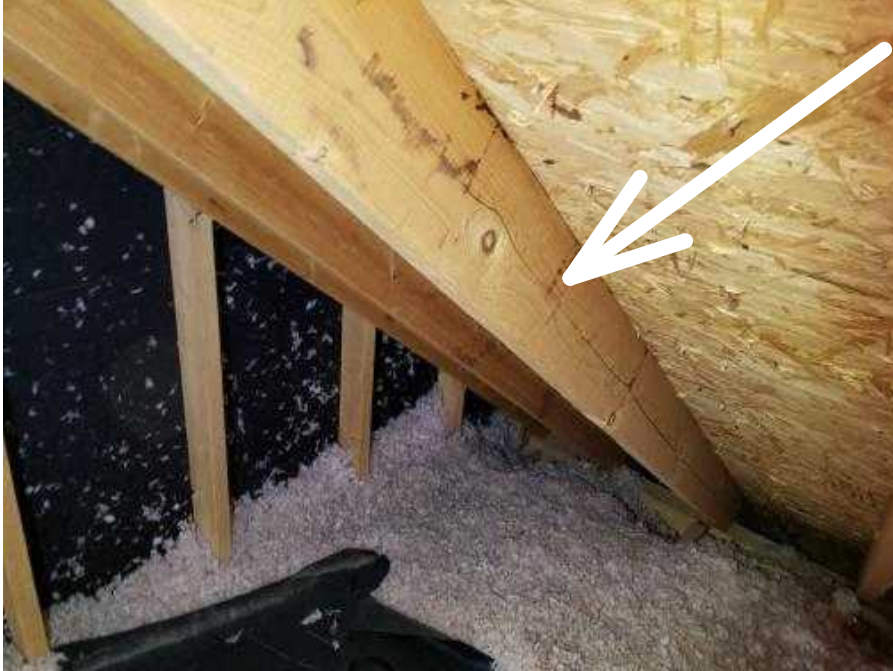
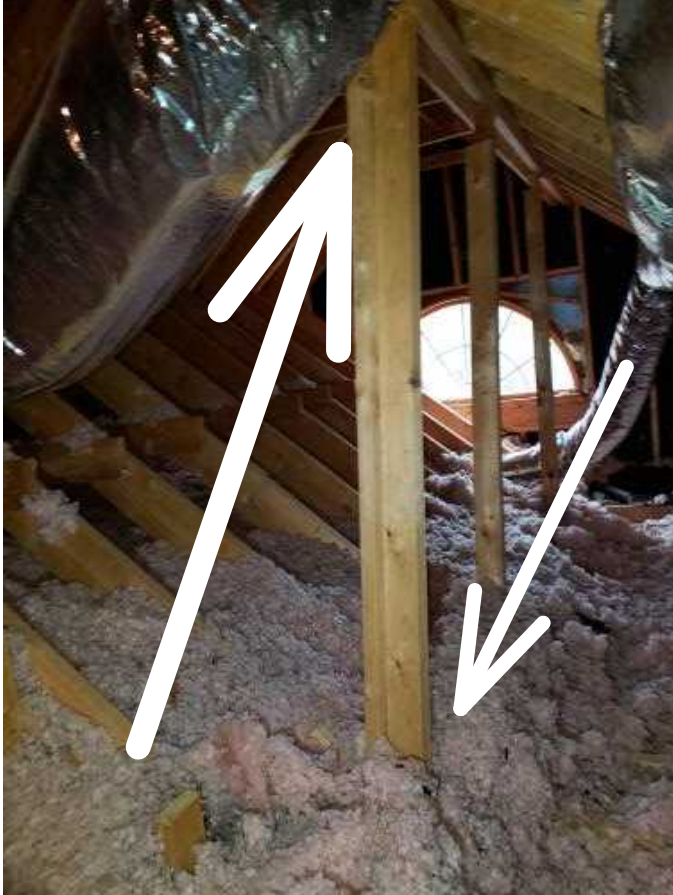
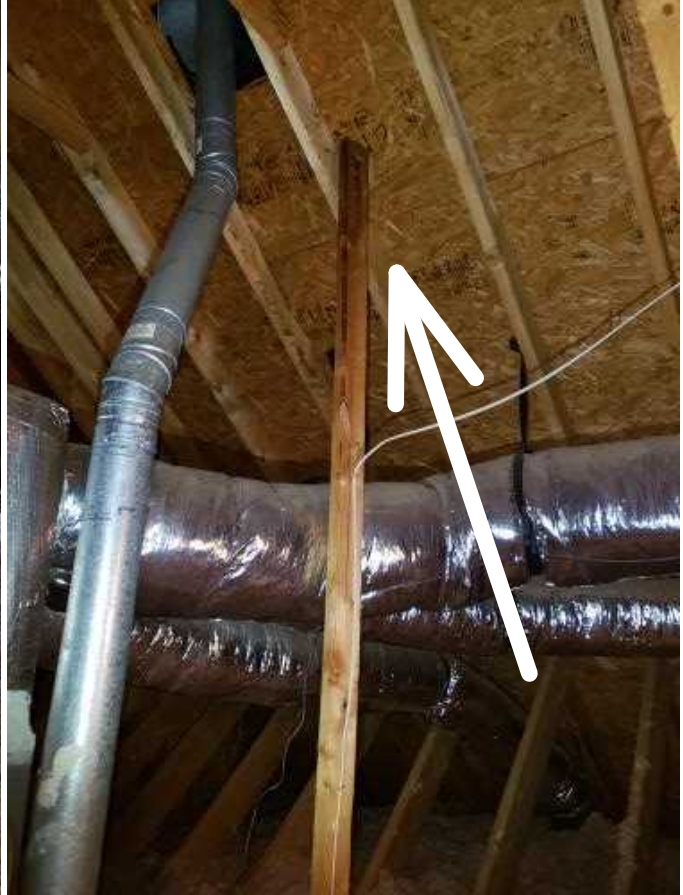
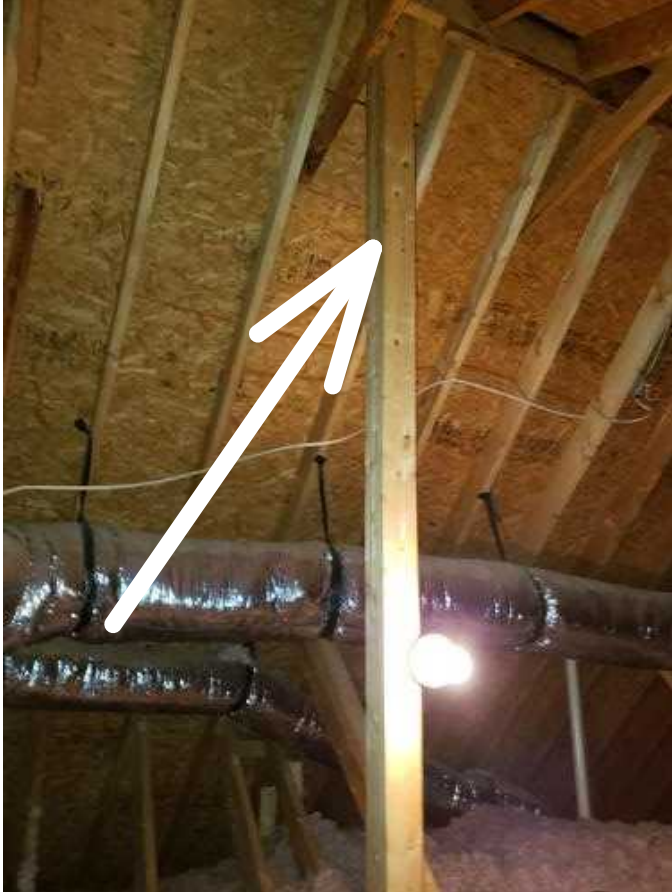
There is a cracked/damaged 2x6 framing member at rear of home the needs an additional 2x6 sistered up to it to ensure integrity.

There a few loose 2x4 framing members that are loose and need additional fasteners added.

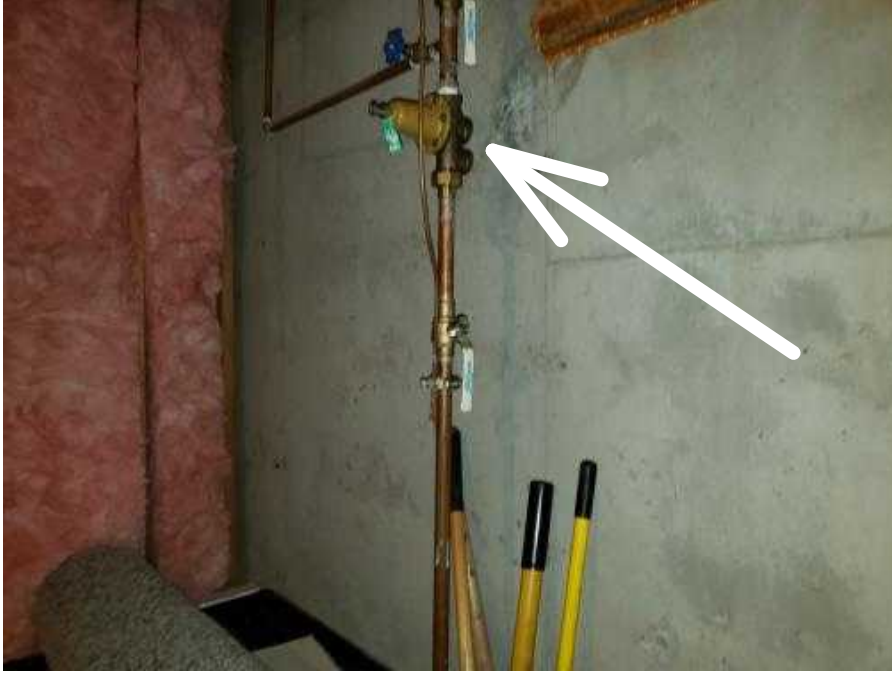
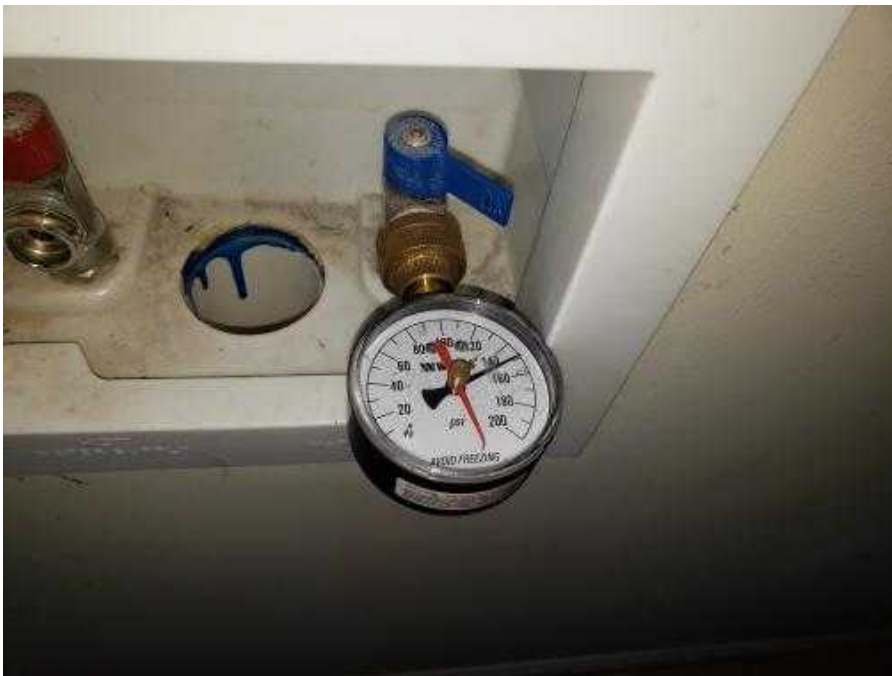
8. Service Line: Copper -

Faulty pressure regulator needs to be replaced.

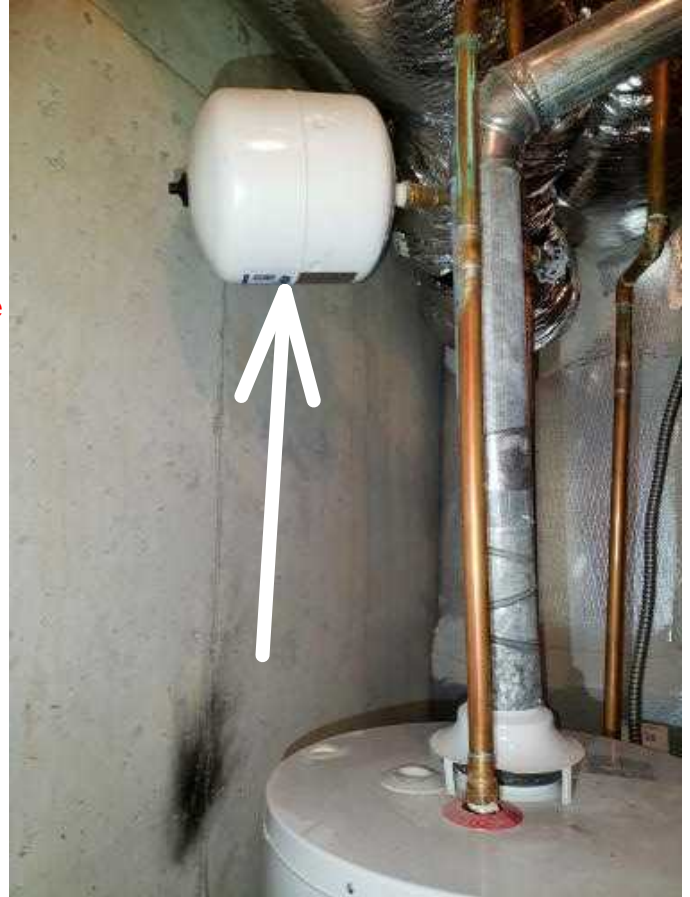
### 9. Basement Water Heater Water Heater Operation: Adequate

Water heater is undersized/inadequate for homes current needs with the addition of kitchen and full bath in basement. Recommend tank less water heater be installed.

Expansion tank was not installed properly. It is design to be installed vertically to ensure water can not enter the tank and add unwanted pressure to plumbing. Support strap should be added from tank to framing above.
