# Atlanta Property Inspections, Inc.

## HOME INSPECTION REPORT

**3799 Crossvine Bend, Marietta, GA 30066**  
**Inspection prepared for: Kelley Debeb**  
**Date of Inspection: 12/19/2019 Time: 1:30**  
**Age of Home: 5 Years Old (2014) Size: 4134 SF**  
**Weather: Sunny, Dry Soil, 49 Degrees**

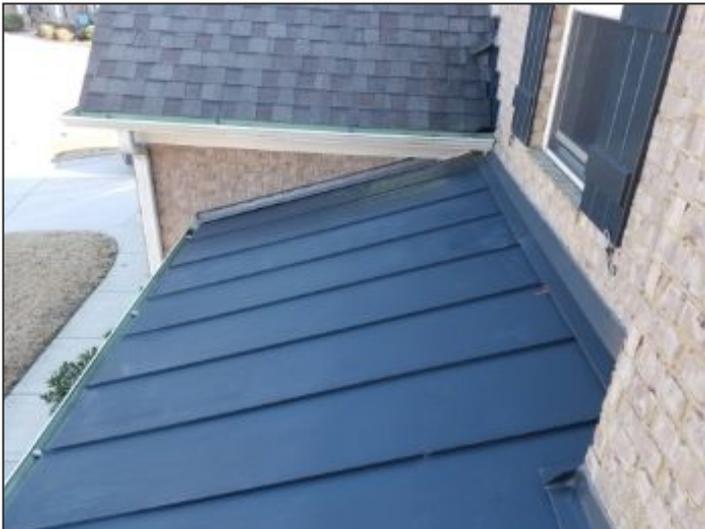
**• ROOF INSPECTION ACCESS: The inspector walked on the lower roof and viewed the upper roof from the ground with binoculars.**

Walked lower roof during inspection

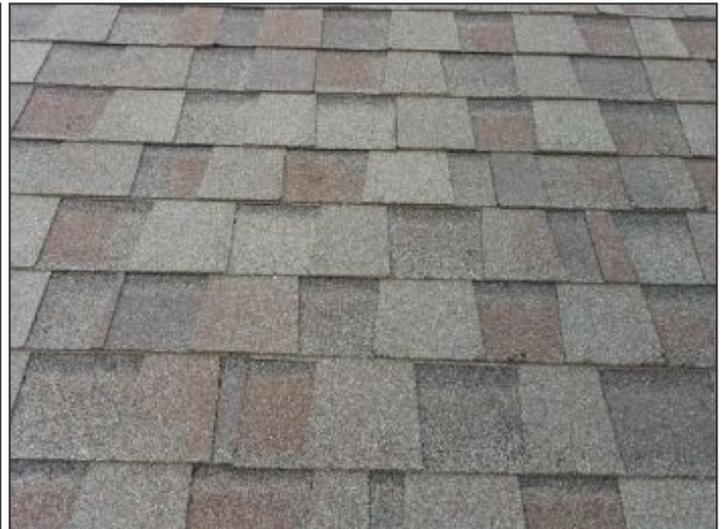
Architectural shingles present

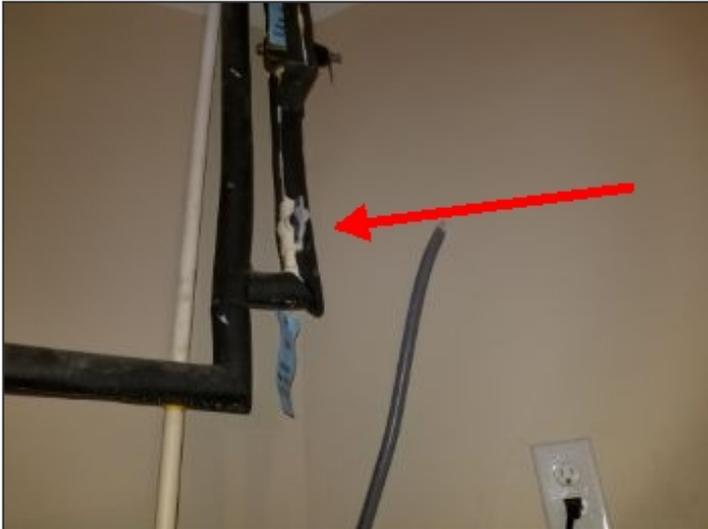
Main water cut-off handle located above water heater

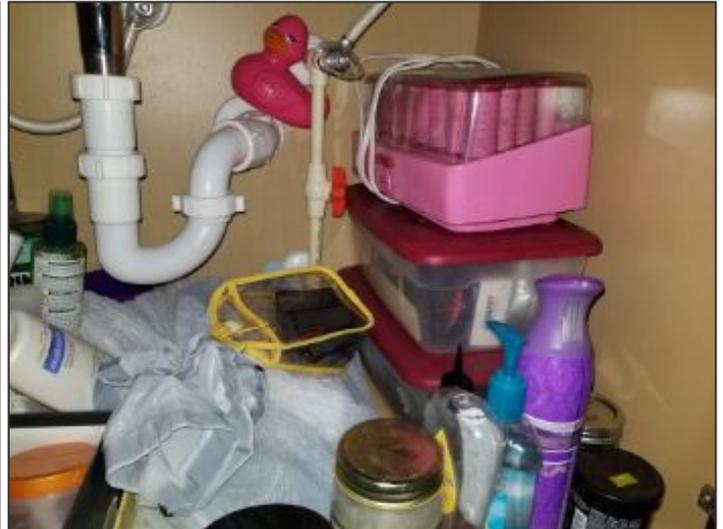
Rear wall hose bib cut-off handle located below shared bathroom sink

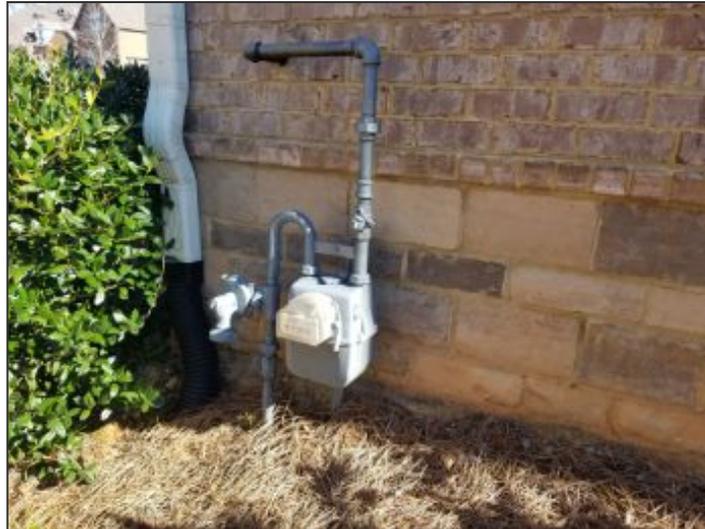
• The gas meter is located at the right side wall exterior wall and appears serviceable; no concerns were found.  
**(NOTE: The gas lines inside the walls, ceilings and floors are not fully visible for inspection and could not be evaluated).**

Gas meter at right side

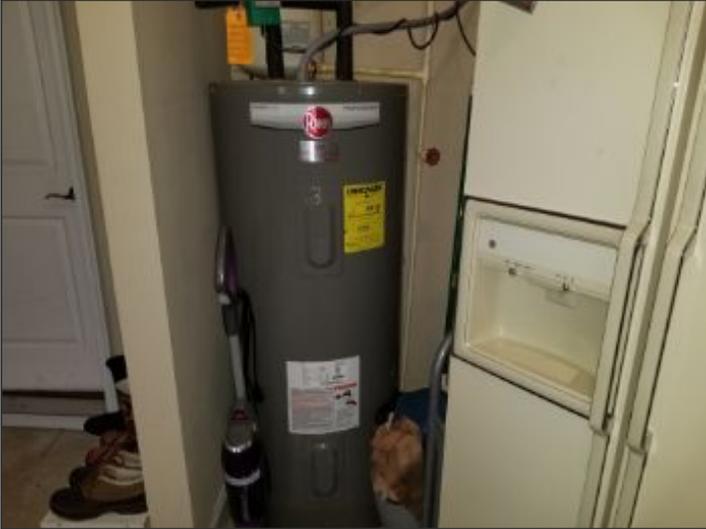
**Water heater located in garage**

**Because the hot water recirculating pump can become a constant energy user, installation of a timer is recommended to control when the recirculating pump should come on and turn off.**

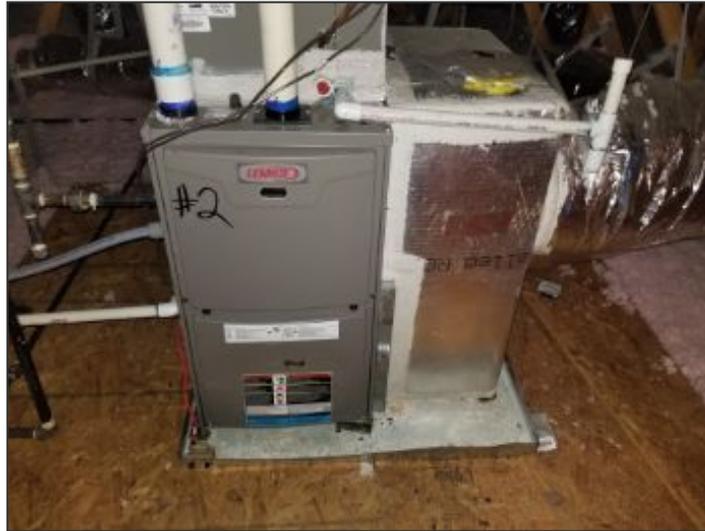
• **POSITIVE FEATURE: This furnace has a 95% efficiency rating which is better than most furnaces that have only an 80% rating.**

• **The heating system appears serviceable; the heating system was operated and was found to be functioning normally during a limited visual inspection, no significant concerns were noted. Continue to maintain the system and have it serviced regularly.**

Main floor furnace located in attic

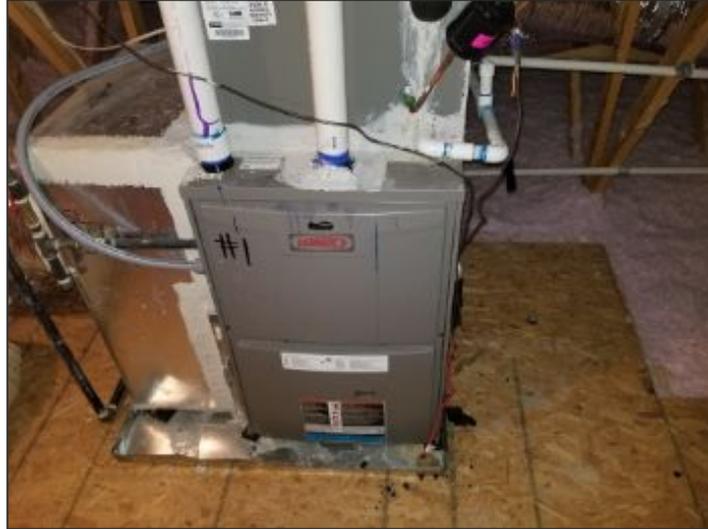
• **POSITIVE FEATURE: This furnace has a 95% efficiency rating which is better than most furnaces that have only an 80% rating.**

• **The heating system appears serviceable; the heating system was operated and was found to be functioning normally during a limited visual inspection, no significant concerns were noted. Continue to maintain the system and have it serviced regularly.**

**Second floor furnace located in attic**

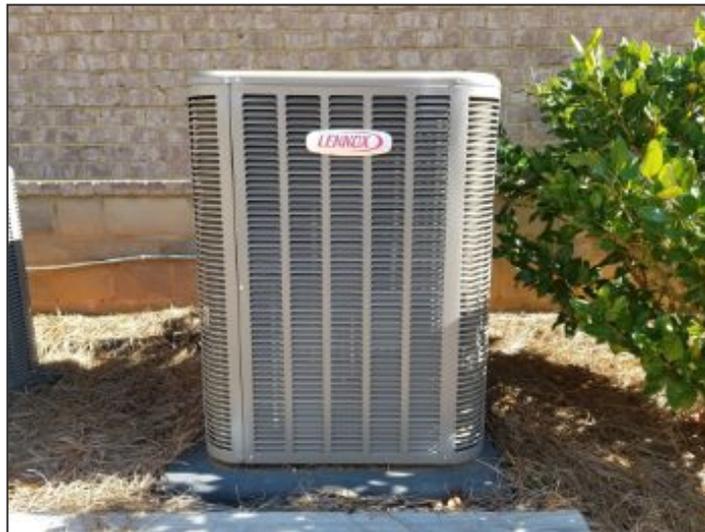
**We are unable to inspect the cooling system due to cold weather. The outside temperatures have dropped below 60 degrees during the day or during the previous overnight hours. Due to concerns regarding possible damage to the unit, the air conditioner was not operated and could not be fully inspected during this cold weather inspection. This inspection is limited to a visual inspection and a quick start up to insure the unit is functional.**

Main floor AC unit

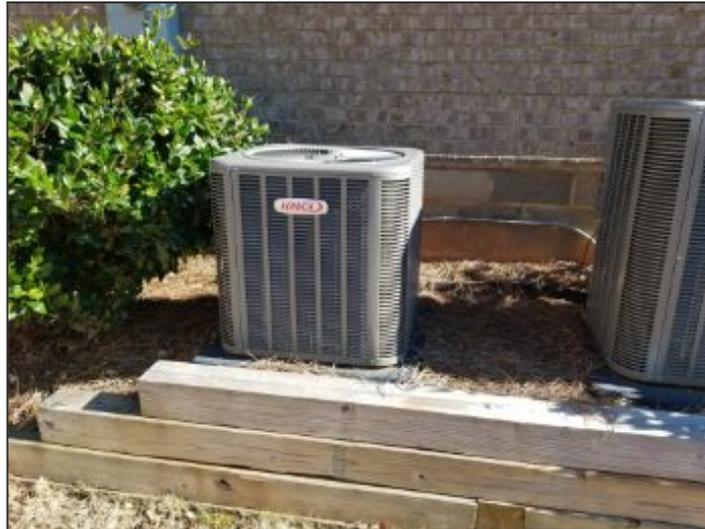
**We are unable to inspect the cooling system due to cold weather. The outside temperatures have dropped below 60 degrees during the day or during the previous overnight hours. Due to concerns regarding possible damage to the unit, the air conditioner was not operated and could not be fully inspected during this cold weather inspection. This inspection is limited to a visual inspection and a quick start up to insure the unit is functional.**

Second floor AC unit
