Home Inspection Report

547 Gables Run
Alpharetta, GA 30004

Prepared for: Jon Kuck

February 11, 2020

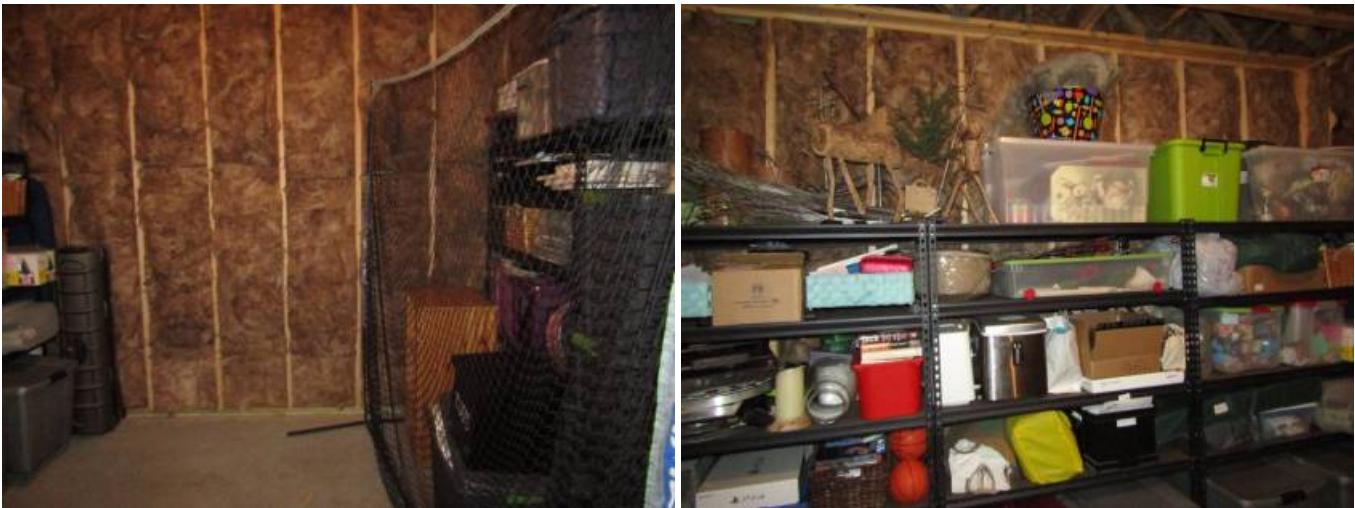
Foundation Condition: The exposed portions of the foundation walls appear to be satisfactory. The interior view of the foundation is limited because the walls are insulated and because of stored items. Foundation walls blocked from view are not covered by this inspection.

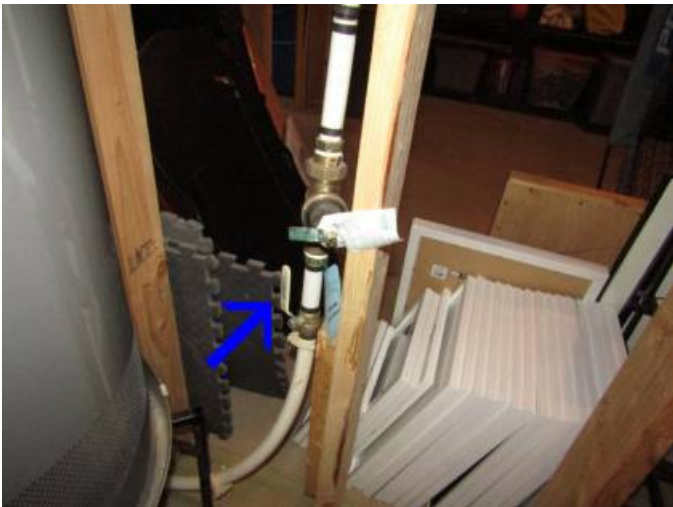
Main Water Shut off: The main water shut off valve is located to the right of the water heater and at the meter by the street.

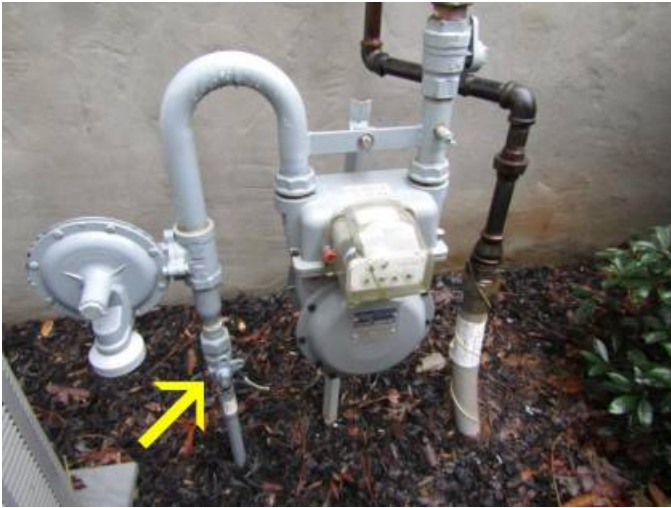
Gas Supply: Natural gas. The main gas shut-off valve is located at the gas meter on the left side of the home. The interior piping is predominately black iron pipe.
