# Atlanta Property Inspections, Inc. HOME INSPECTION REPORT

**2560 Highland Pointe Drive, Cumming, GA 30041**

**Date of Inspection: 1/30/2020 Time: 1:00 PM**

**Age of Home: 26 Years old (1994) Size: 3500 SF**

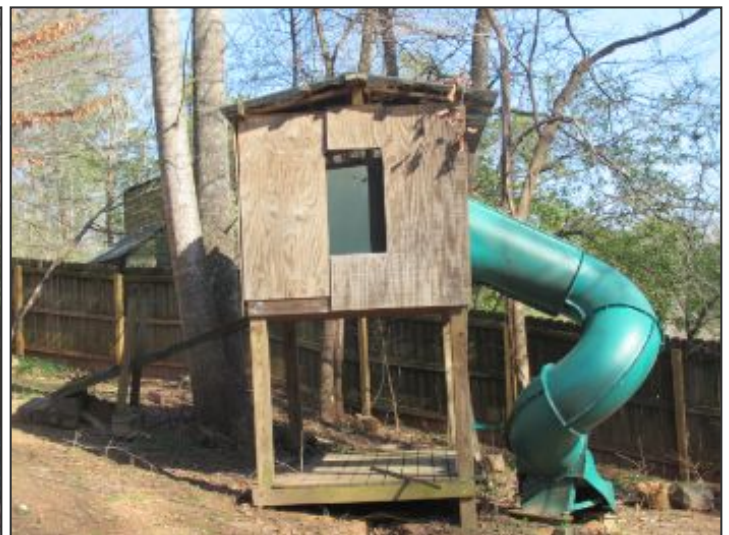
Playhouse not inspected

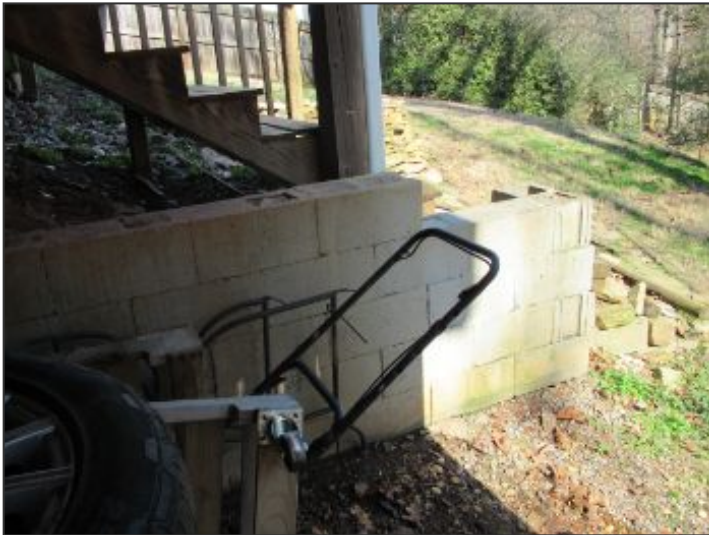
• The concrete block retaining wall is incorrectly built - the wall has no structural footing below the blocks, and the wall was constructed with dry blocks with no mortar between the blocks. In addition, there are voids below the wall confirming the lack of a proper footing (see photos). Due to this concern, further evaluation is recommended by a professional retaining wall contractor to determine the full scope of repair or replacement needs and costs.

Retaining wall below rear porch

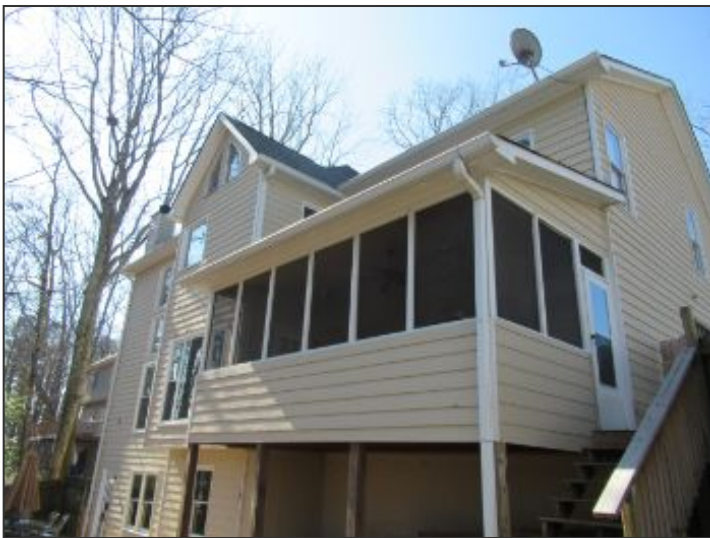
• **The rear screened porch appears serviceable, except as listed below:**  
 1. The porch joists are supported by a small 2x2 ledger strip; the ledger strip is not adequately nailed. Recent nailing standards call for at least 3 nails on the ledger strip below each joist to support the weight at this location. Correction is recommended to fully nail the 2x2 strip below each joist. For even better support, installation of joist hangers is suggested instead of the 2x2 ledger strip.

2. The screened porch does not include any screening below the porch floor; this condition can still allow insects into the porch. Correction is recommended so that the porch is fully screened.

View of screened porch

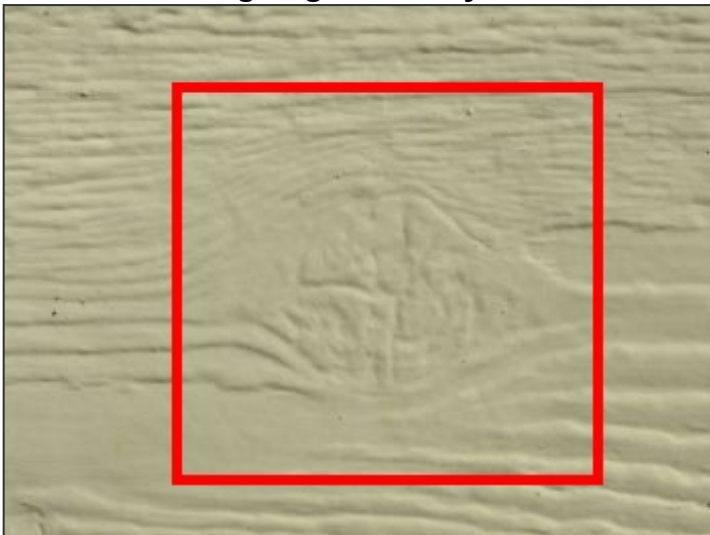
LP signature knot imprint on siding boards

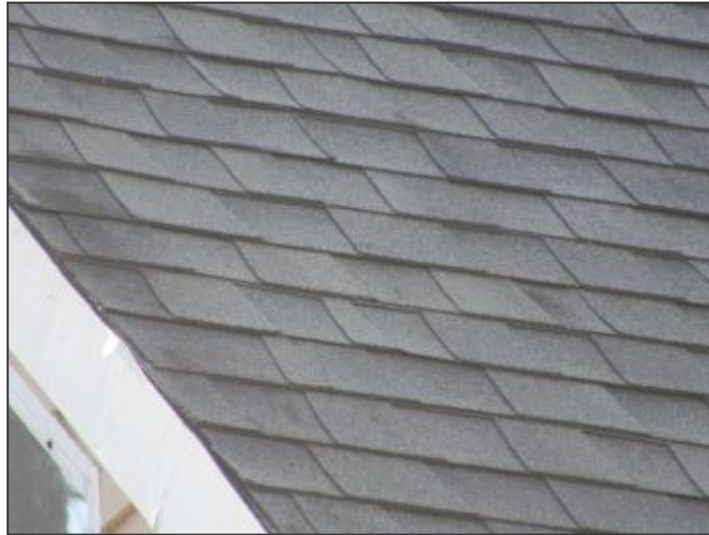
This roof has architectural or profile shingles; this attractive and slightly more expensive shingle is a significant upgrade from traditional roof shingles. It also has a longer warranty period of 25-35 years and should provide an extended lifespan when compared to traditional roof shingles. This type of shingle also performs better in storms and when exposed to hail.

Architectural shingles are present

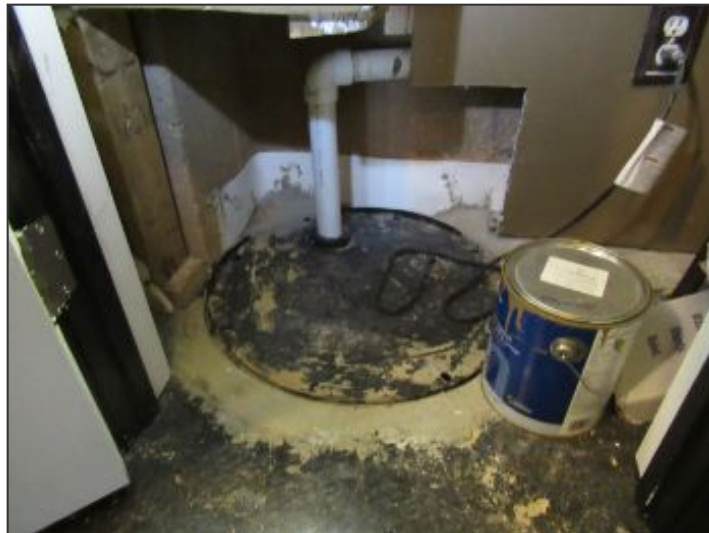
• A water proofing drainage system is present at the front foundation wall below the dining room (see photo). Due to the underground nature of the system, the adequacy of this basement drainage system can not be determined during this limited visual inspection. It is recommended that client ask the home seller for more information regarding this system including warranty status.

Professional water proofing system at front basement

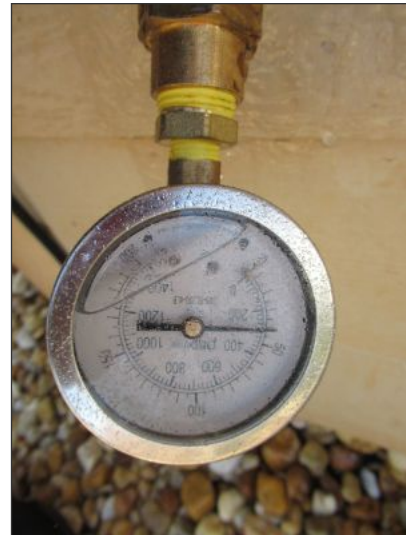
• The supply piping appears to be serviceable, no concerns were noted. A water pressure reading was taken at the rear hose bib and was found to be normal at 45 PSI.

Normal water pressure at 45 PSI

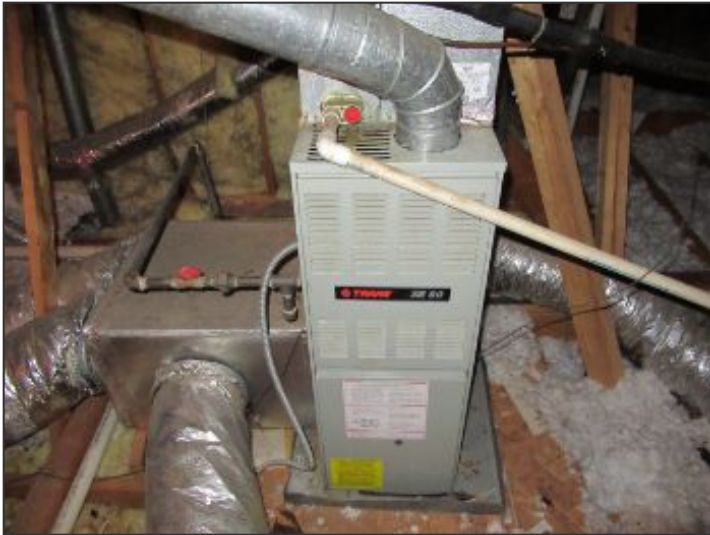
Due to the advanced age of this heating system, client should budget for replacement soon which is expected to be a major expense. Based on the available manufacturing date on the equipment, the heating system is at or past the normal expected lifespan of 15-20 years.

**Second floor furnace in attic - 1994**

Due to the advanced age of the system, a full heat exchanger inspection is advised by a professional HVAC contractor and to provide written certification that the heat exchanger is in good working condition and is safe to operate. Additional heat exchanger inspections are advised each year for as long as this older furnace is in service.

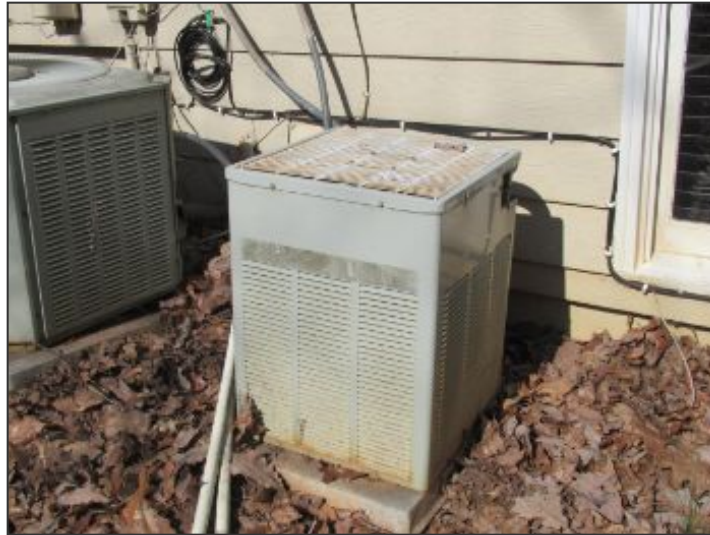
First floor AC unit - 1994

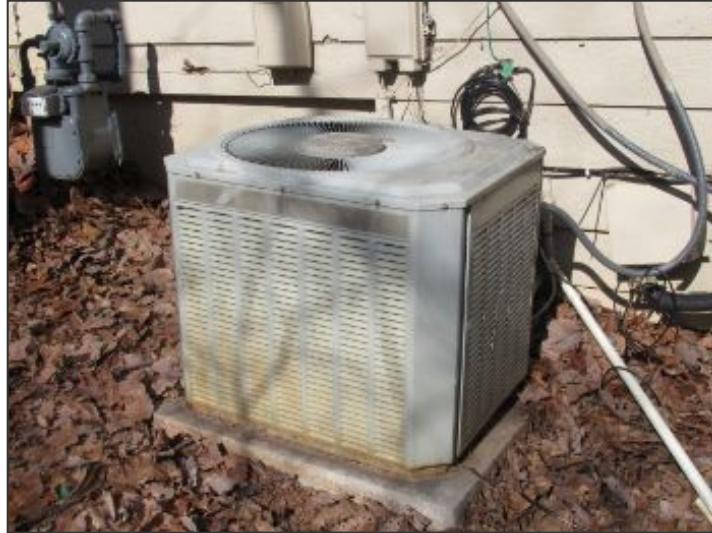
**Second floor AC unit - 1994**
