Inspection Report

**Property Address:
5452 Chanel Ct
Dunwoody Ga 30338**

Inspector: Brandon Williams

**Residential Inspector of America
3276 Buford Drive, Ste. 104-306
Buford, GA 30519
770.476.4963**

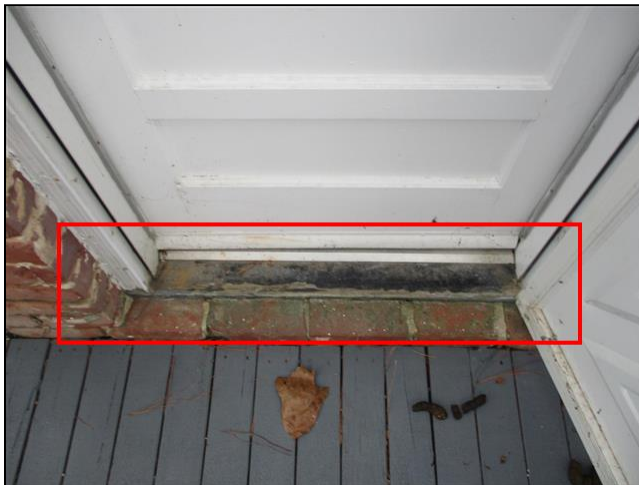
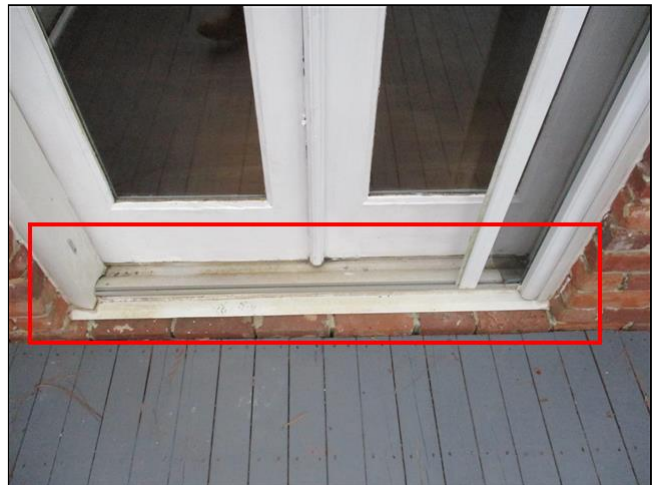
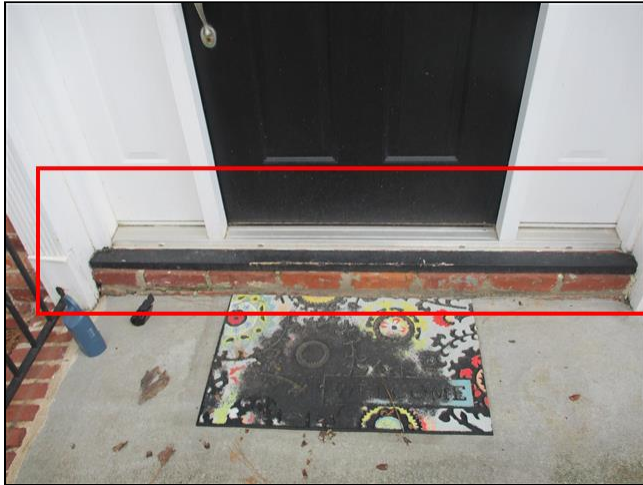
(1) Seal the gaps between the metal threshold, lower parts of side jams, and the lap siding at the bottom of the exterior doors. This is part of general maintenance and should be performed every few years as needed.

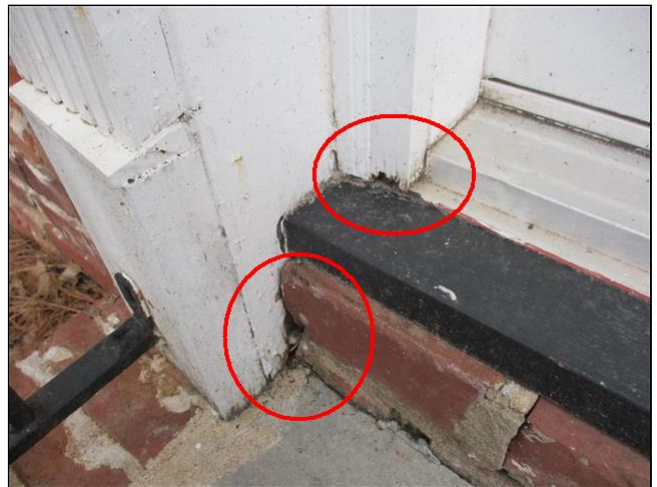
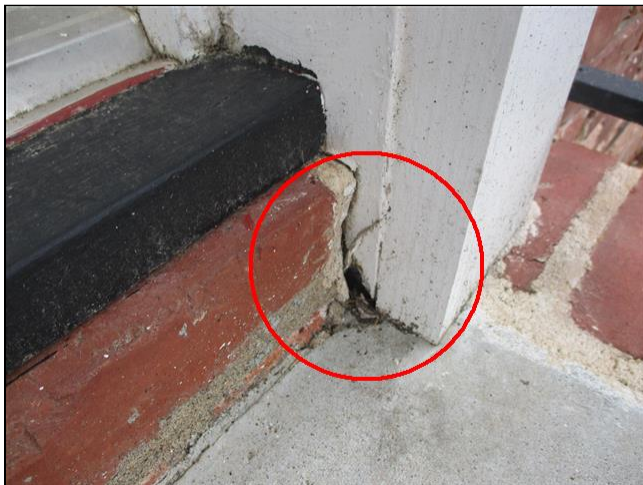
(2) Minor rot damage on the lower part(s) of the front and rear deck door. Repair or replace damaged wood. See photo(s). This is a common area for damage and will need to be maintained. Fill repairs will not be long lasting.

🔧 (2) Minor rot damage on the lower part(s) of the front and rear deck door. Repair or replace damaged wood. See photo(s). This is a common area for damage and will need to be maintained. Fill repairs will not be long lasting.

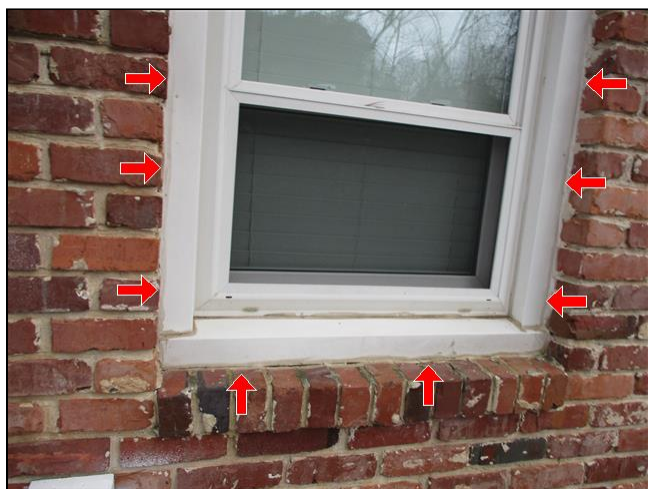
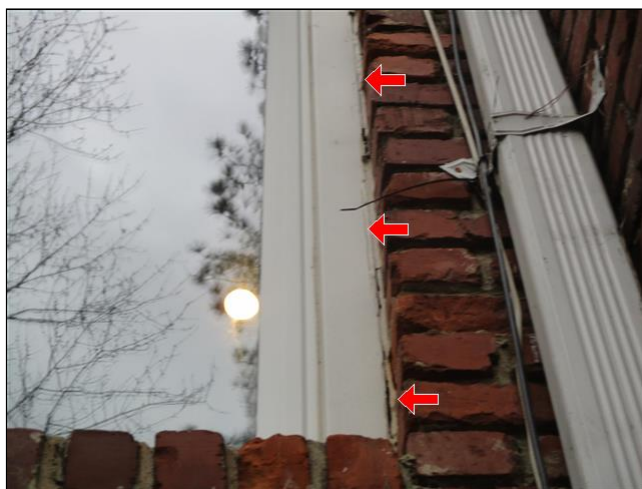
As part of general maintenance it is recommended to seal the exterior trim around windows to the brick veneer to prevent any possible water or air leaks.

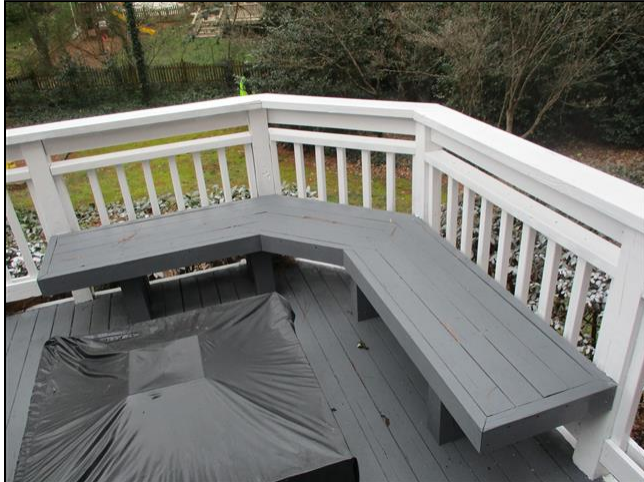
1.4 Item 3(Picture)

(3) Benches on rear deck guardrails could be a hazard for small children. Use supervision when small kids are present.

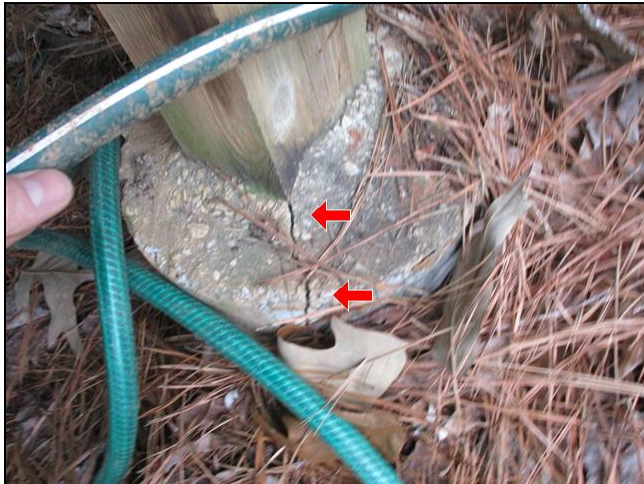
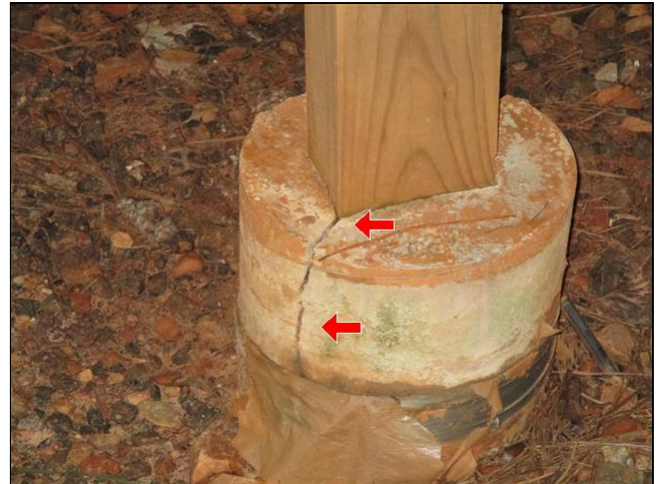
(4) Cement footers for deck posts are cracking in areas, likely due to settlement. Have patched to prevent water entry and damage to the deck post.

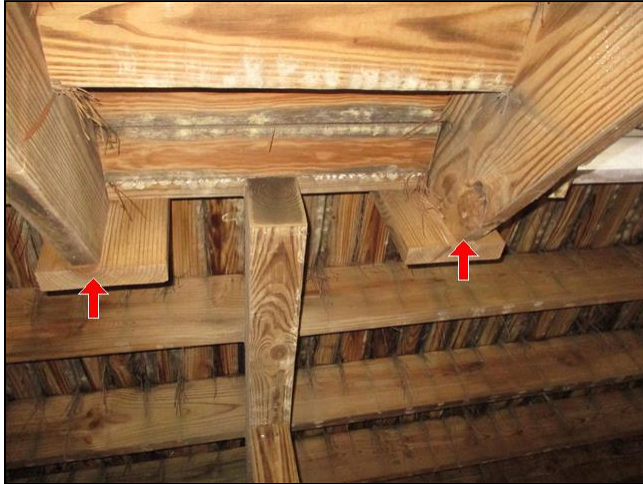
1.4 Item 6(Picture)

(5) Better support (hanger brackets or ledger strip) needed under top of rear deck stringers where they connect to the deck rim joist. See photo. This will help ensure a stronger connection.

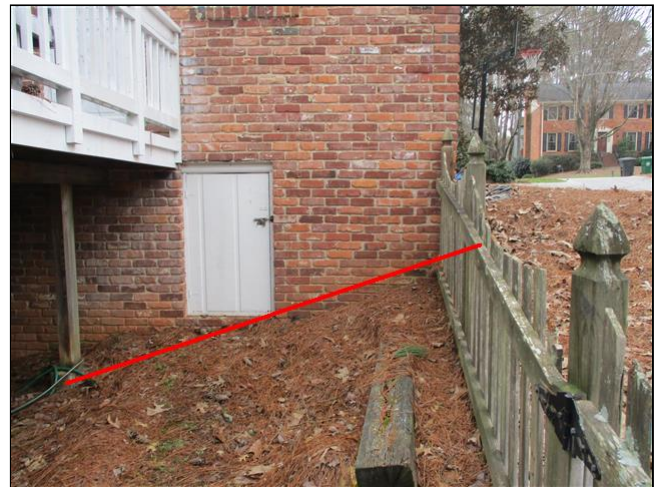
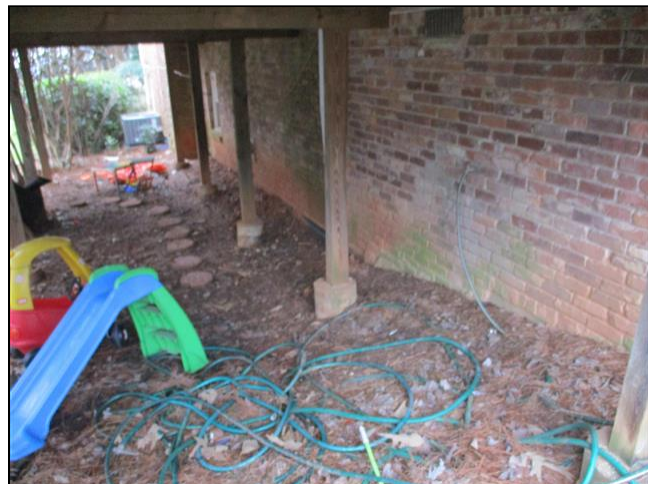
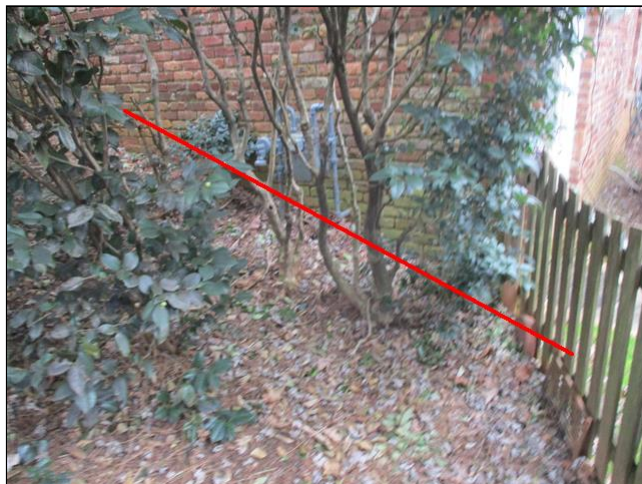
(1) Negative slope towards/along the foundation at front right corner, both rear corners, and under the rear deck. These areas do not appear to drain water away from the home and needs to be re-sloped or drained in some way to prevent surface and sub surface water from flowing to the foundation. It is possible that exterior water runoff may enter the foundation area during conditions not present during the inspection. Poorly graded soil can lead to water intrusion into the foundation areas. See photo(s). Buyer should resolve all concerns prior to closing.
-

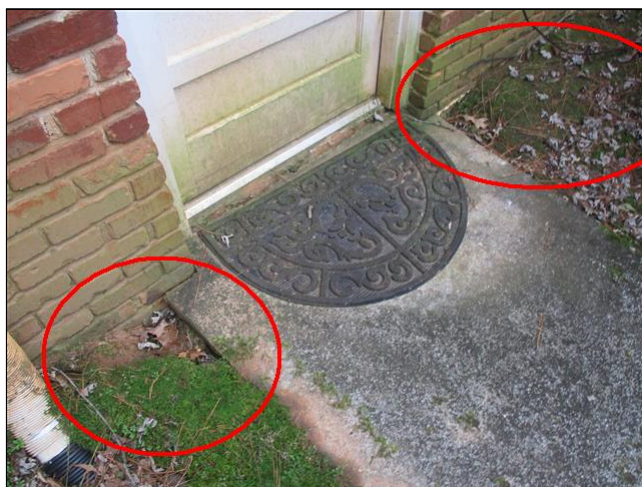
1.5 Item 6(Picture)

(2) Recommend corrective landscaping around the rear basement door pad to help prevent further settlement of the slab

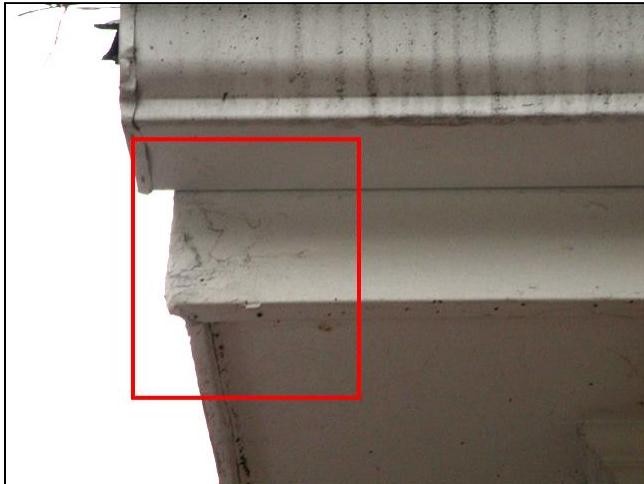
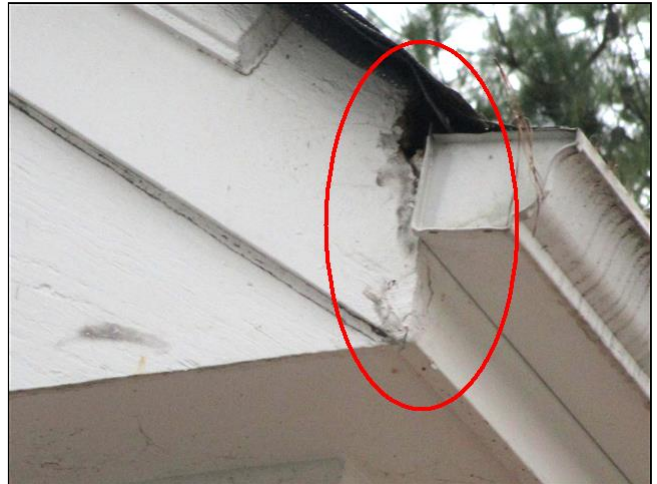
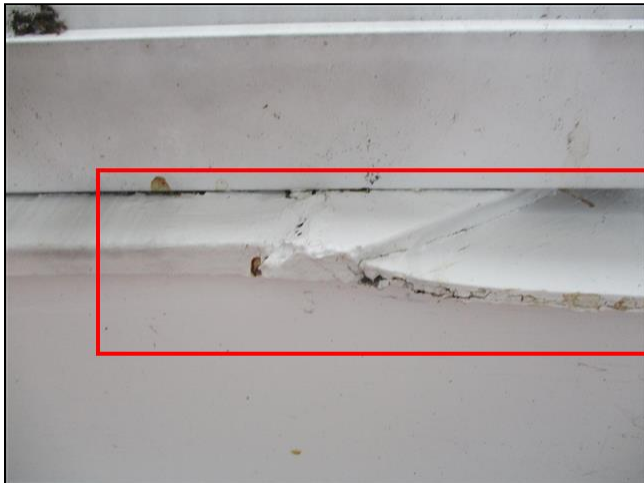
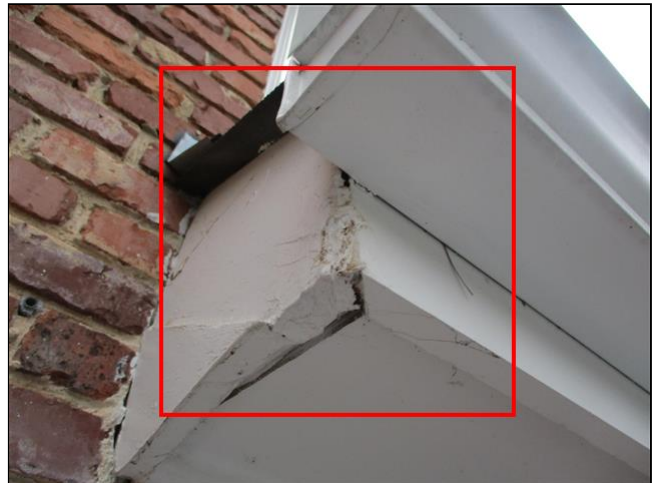
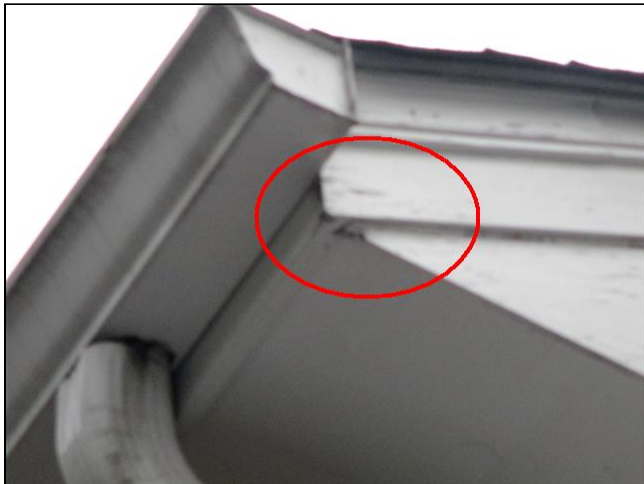
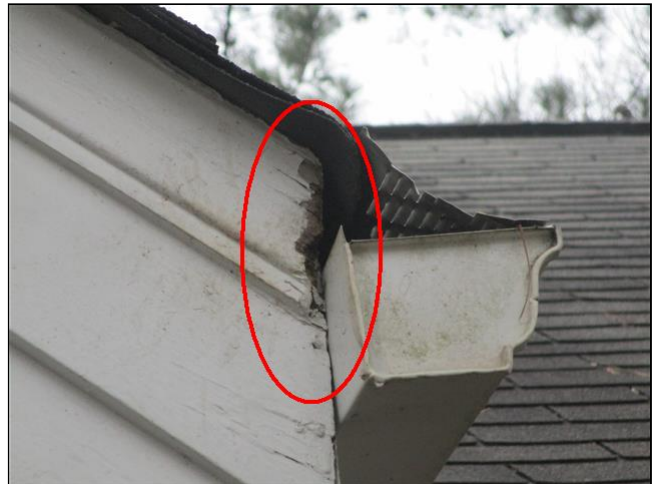
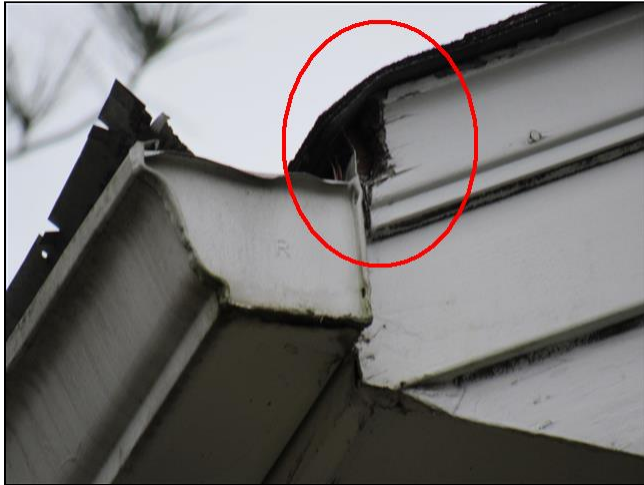
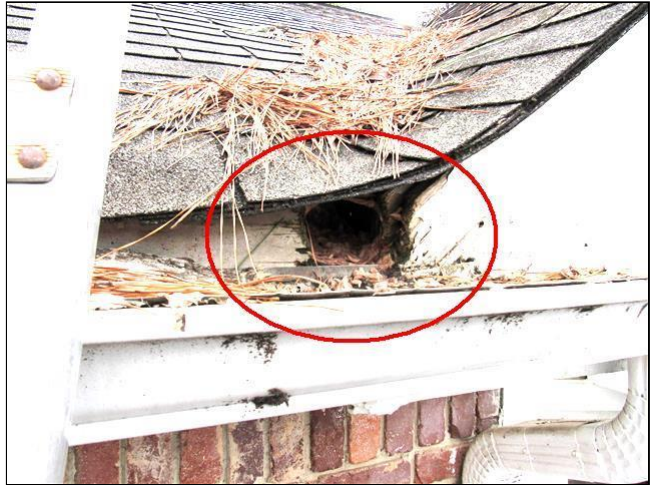
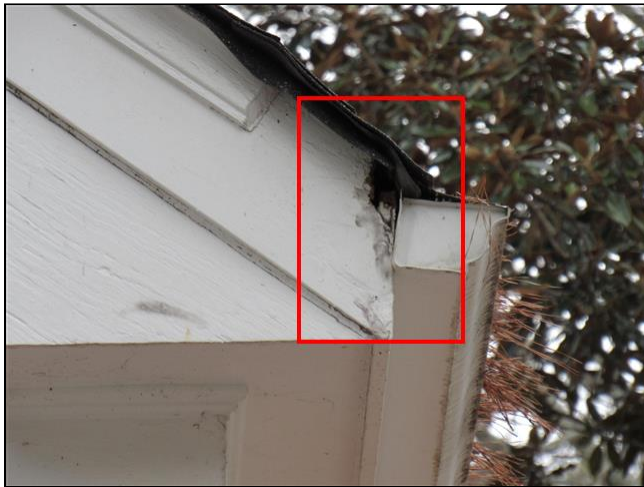
Water damage, fill repairs, and chewed rodent entry found on soffit and fascia trim in several areas. See photos for examples. Have contractor evaluate all soffit/fascia and have all damaged wood replaced.

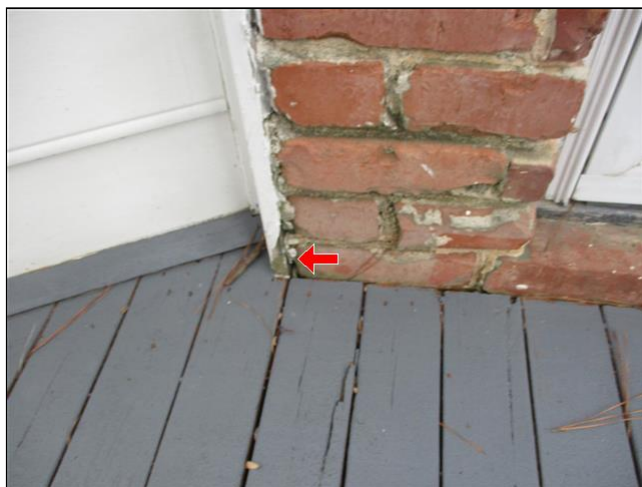
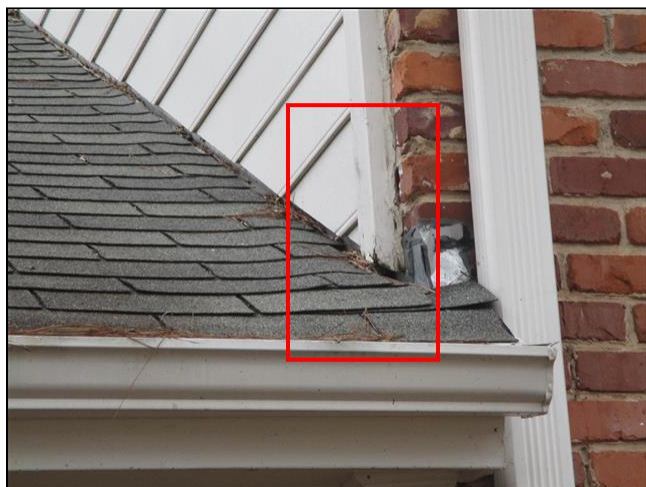
Rot damage found on exterior wood trim in a few areas around the home. See photos below for examples of these locations. It should be understood that more minor water damage may be present on other trim around the house.

This is very common and more should be expected in the future. If water damage occurred in the past, it will occur again in the future. Have contractor evaluate all trim and have all water damaged trim replaced or repaired.

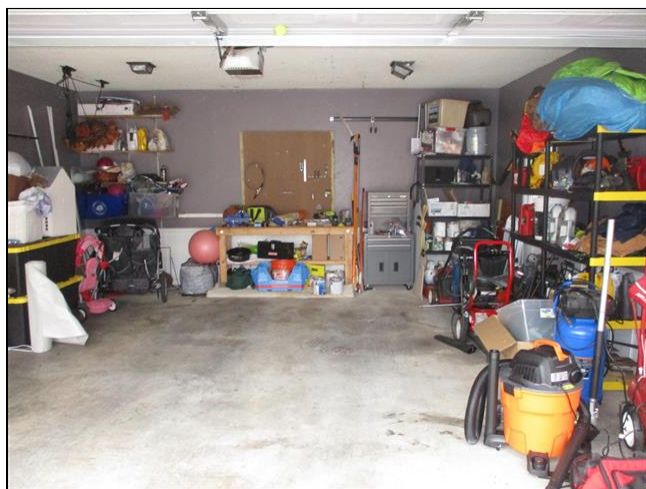
2.1 Item 1(Picture)

(1) The garage inspection was limited due to stored items being in the garage at the time of the inspection.

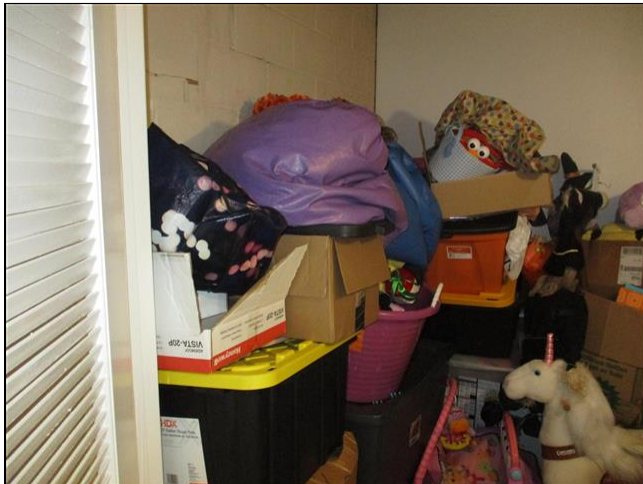
3.0 Item 1(Picture)

(1) Basement is mostly finished limiting visual inspection of the floor, walls and ceiling areas. Not all insulation was removed from between floor joist and along rim joist. A select few ceiling tiles were removed for inspection of space between drop ceiling and floor frame. Many stored items were present in the unfinished areas limiting visual

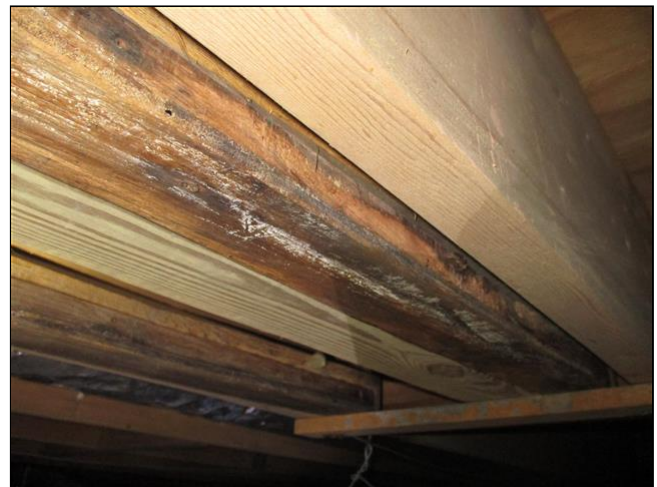
3.0 Item 6(Picture)

🔍 (2) Signs of minor mold or suspected mold growth is present on the floor system overhead in basement and crawlspace in several areas. The underlying cause of mold problems is normally moisture or high humidity. A visual inspection cannot determine the extent of the mold problem or if any health hazards exist. Mold testing can be completed if desired. Resolve all mold concerns prior to closing. Please click [HERE](#) for more information on mold testing.

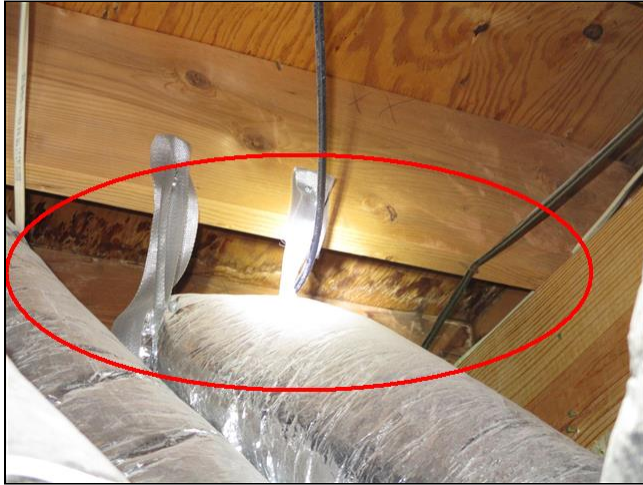
3.3 Item 1(Picture)

Water staining on the subflooring in the basement mechanical room. Stains were dry at the time of the inspection, but conditions could change and the leaks could become active again in the future. Have any concerns resolved prior to closing. See photo

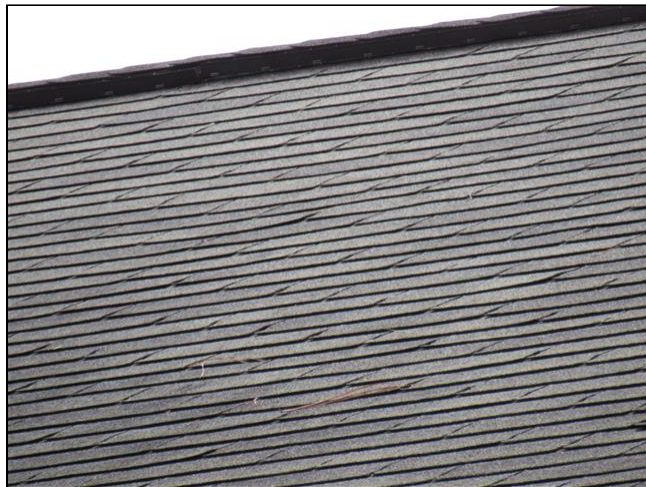
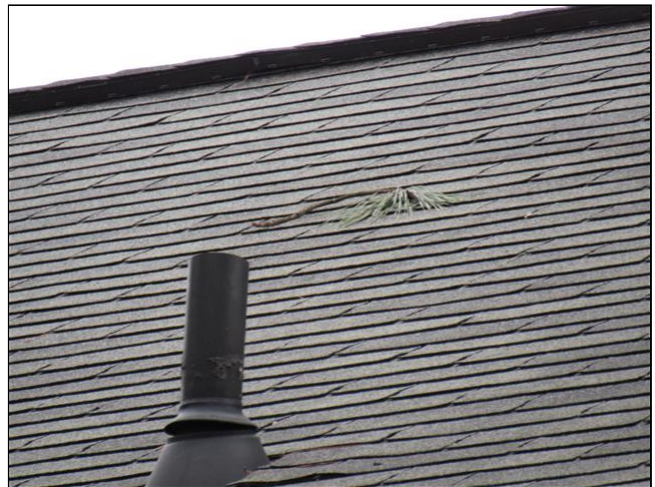
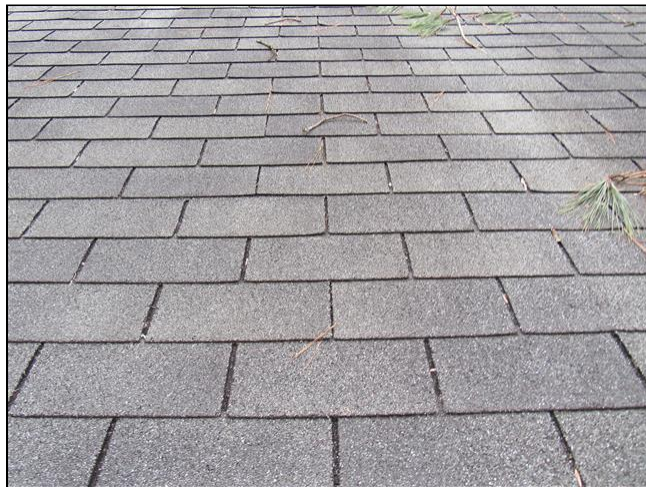
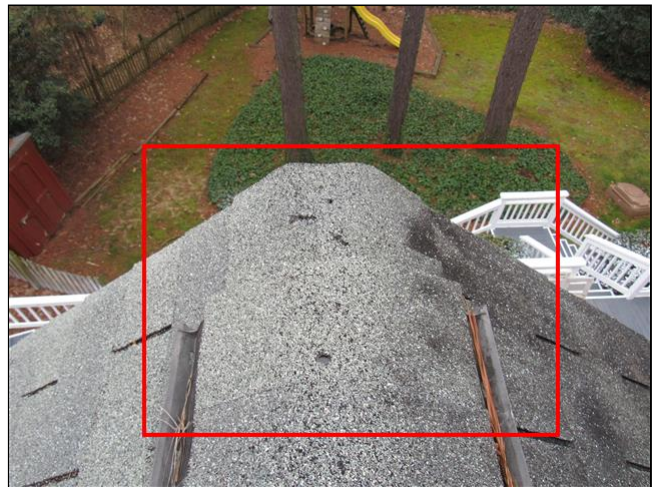
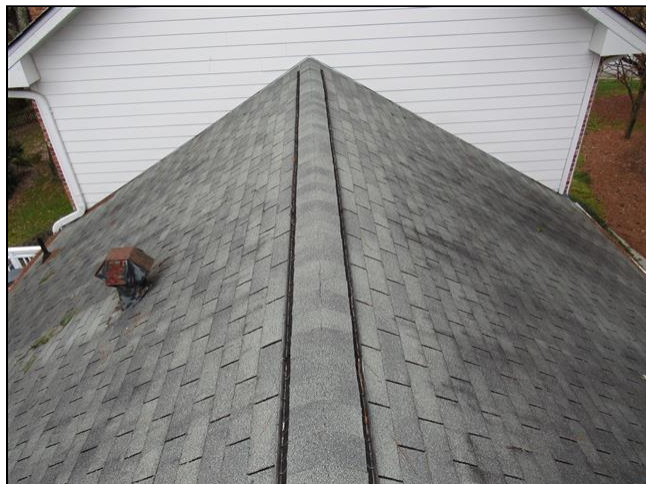
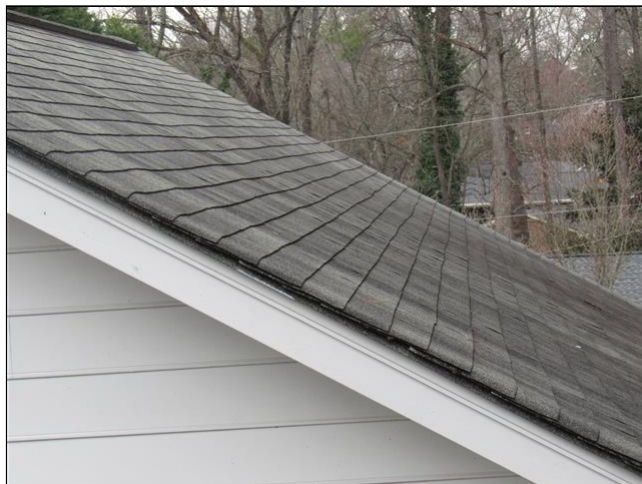
👉 (1) Shingles on the roof are the 3 tab type with a life expectancy of about 15-20 years (depending on conditions) and the shingles are showing signs of age and wear. Some shingles have lost granules and some shingle mats are getting brittle. As the roof continues to age, it may begin to leak.

Missing shingle found on the front of the garage level roof near the gutter line, and there were some damaged shingles and hole found in the rear garage roof over the rear gable vent. See photos. Have roofer evaluate all of roof and repair/replace as needed

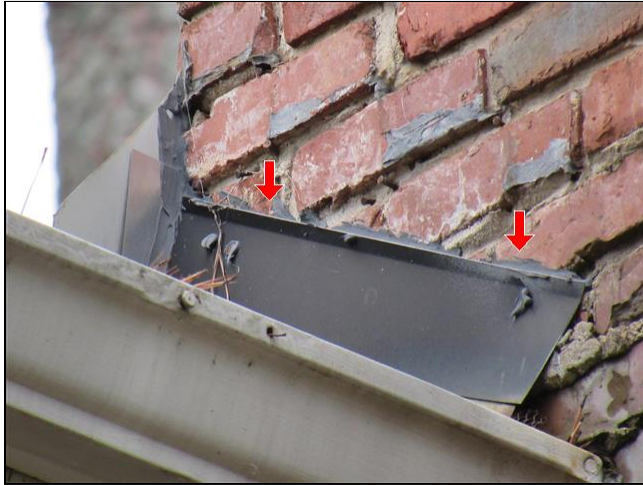
4.1 Item 1(Picture)

Metal flashing to brick wall seal needs to be maintained to prevent leaks into the wall cavity. Metal flashing tend to pull away from the brick and water can leak into gaps. See photos for examples.

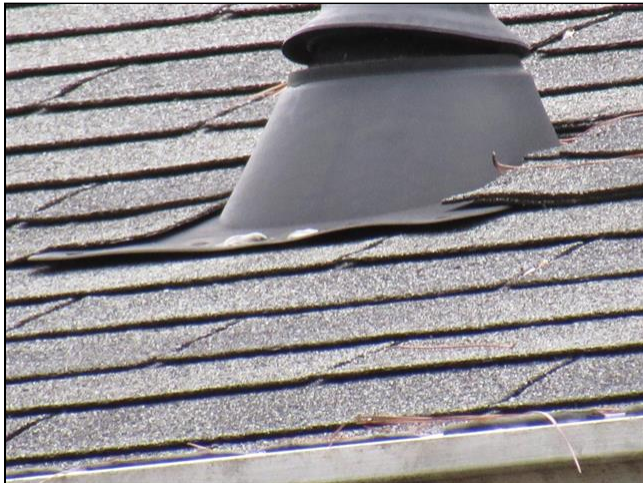
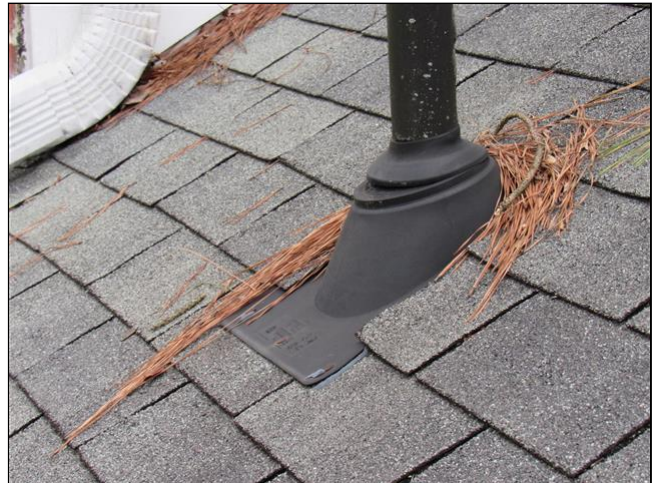
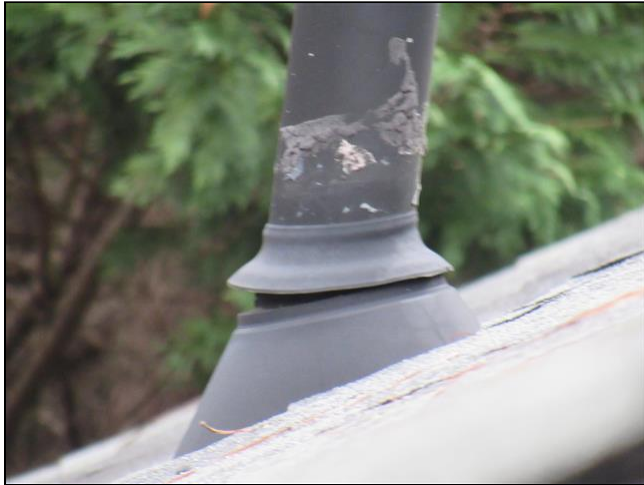
(1) Boot flashing around plumbing vents on the roof are ok now, but these last about 5-7 years before needing replacement. They crack and split and allow rain water to leak into attic.

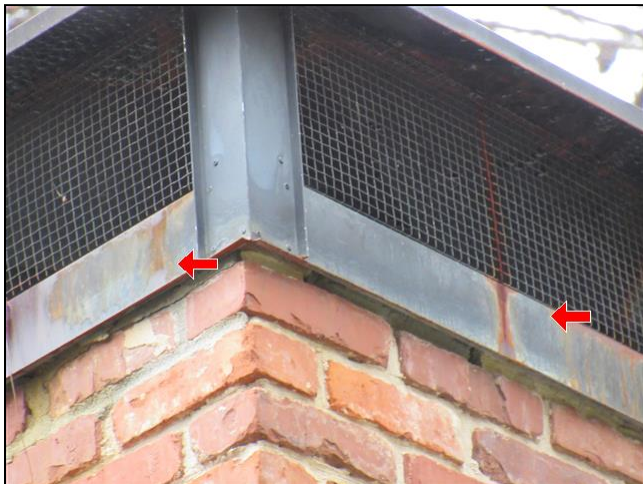
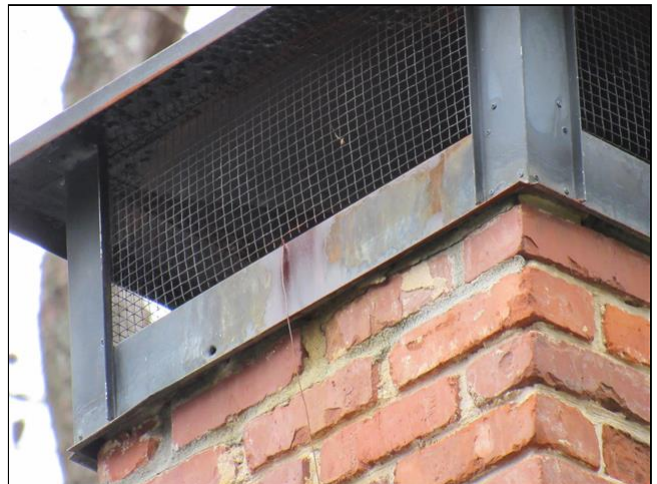
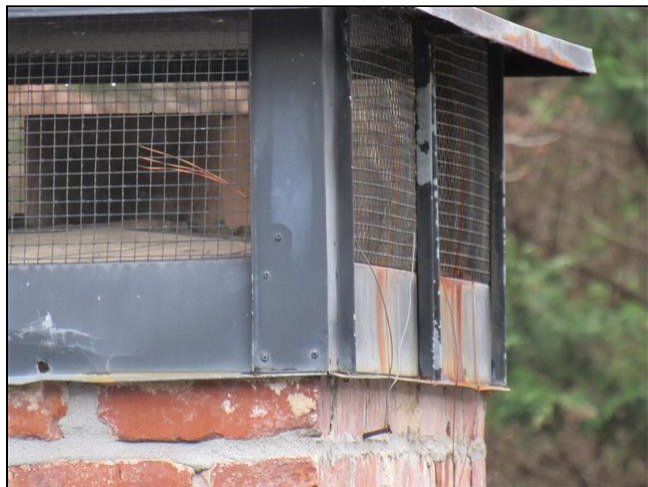
🔧 (4) Rust is developing on the cap on the top of the chimney. It will soon need to be replaced, but it does not appear to be leaking now.

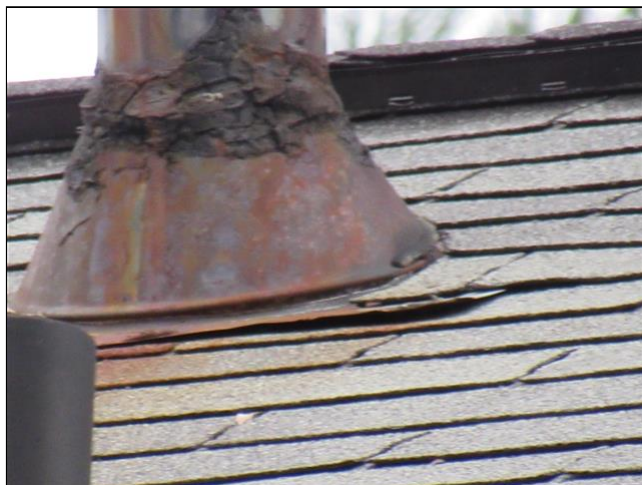
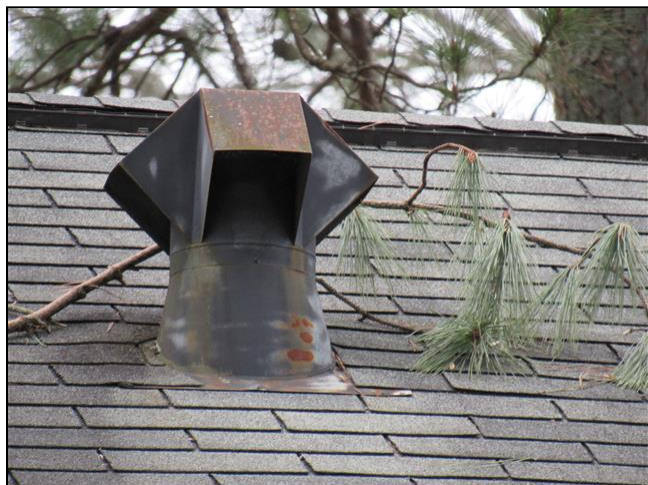
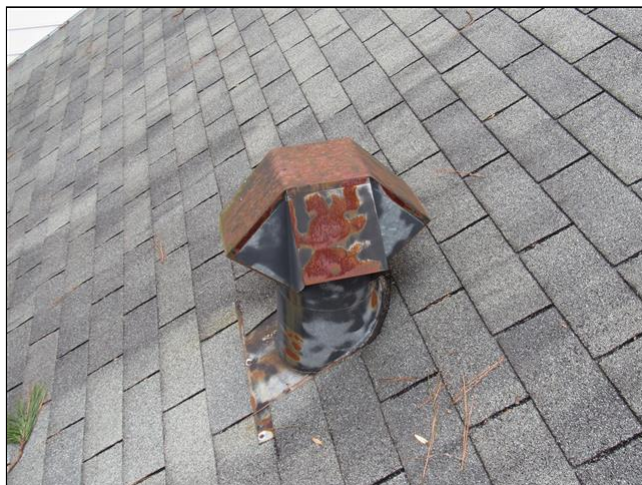
🔧 (5) Replace the rusted out caps on the roof for the furnaces. Condition of pipe in the concealed parts of the interior is not known. See photos.

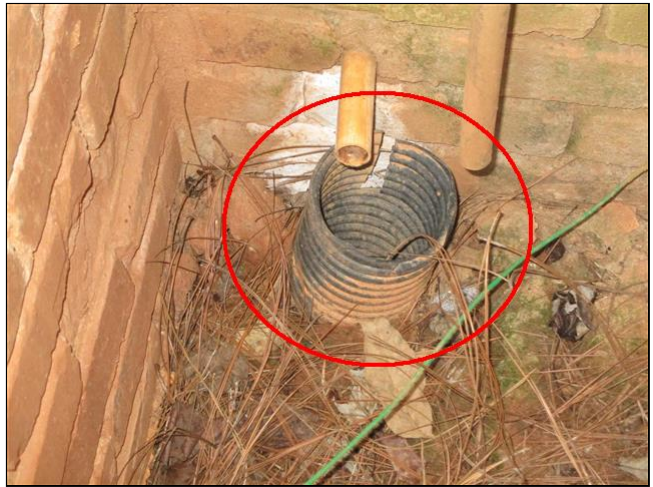
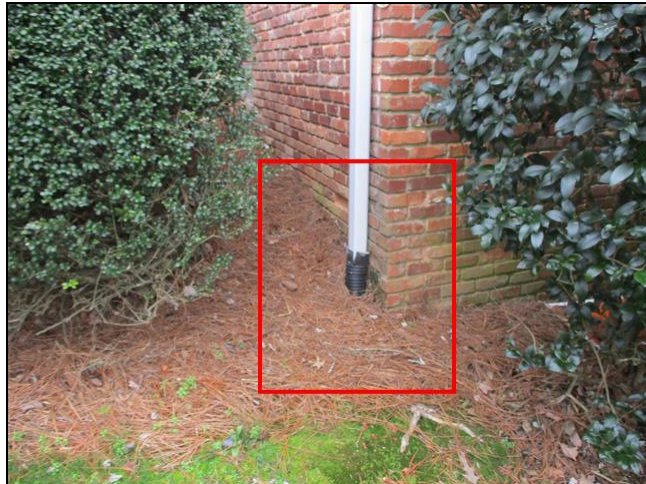
👉 (1) Have owner point out location of the outlets of the buried down spout extensions and yard drains. They should come to daylight and the ends were not found.

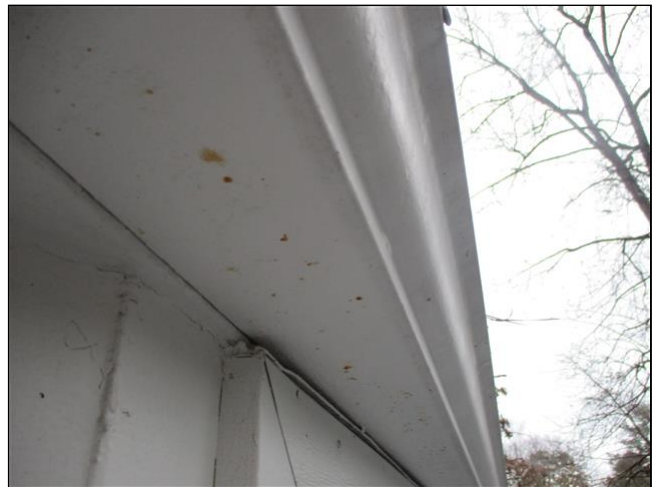
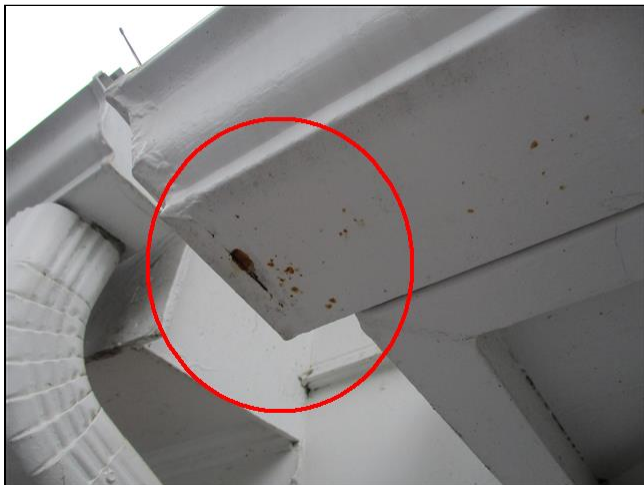
🔧 (3) Rear bay window gutter rusting out and need to be replaced in the near future. Gutters usually last about as long as a roof if they are kept clean.

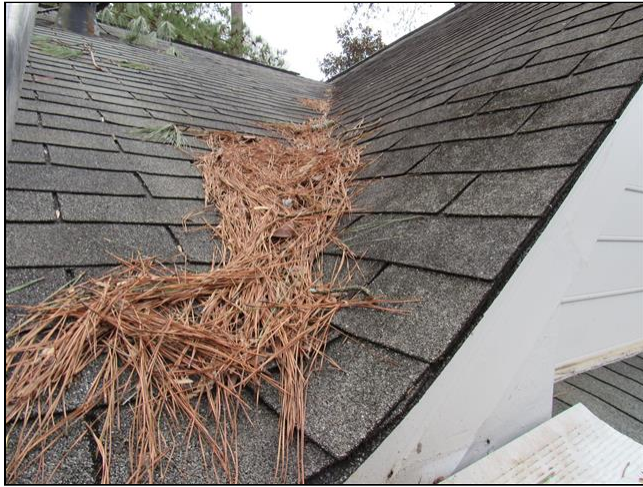
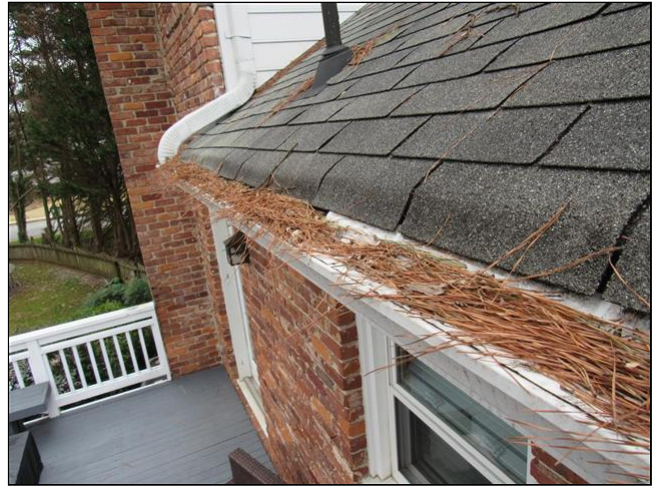
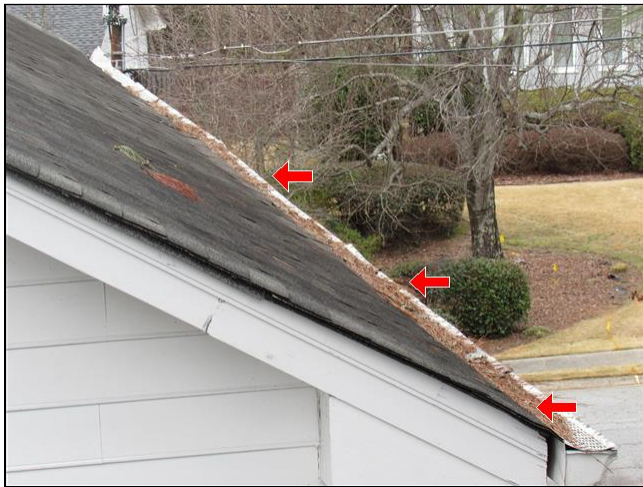
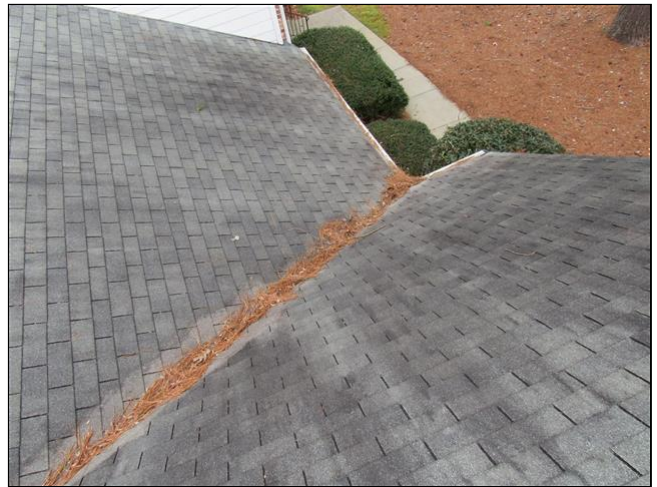
(4) The tops of the gutter guards and roof valleys are full of debris in areas and needs to be cleaned.

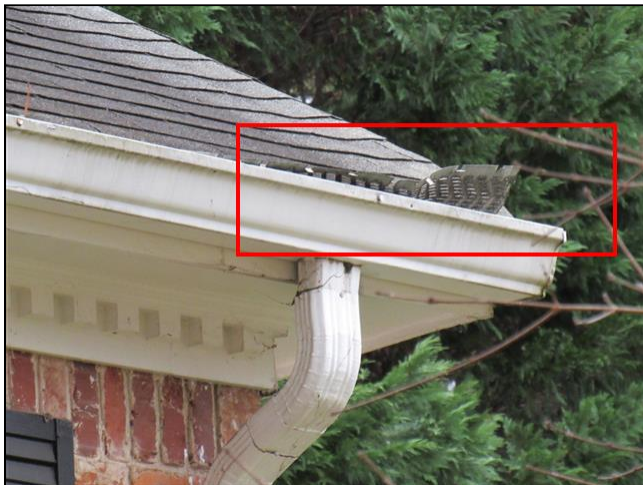
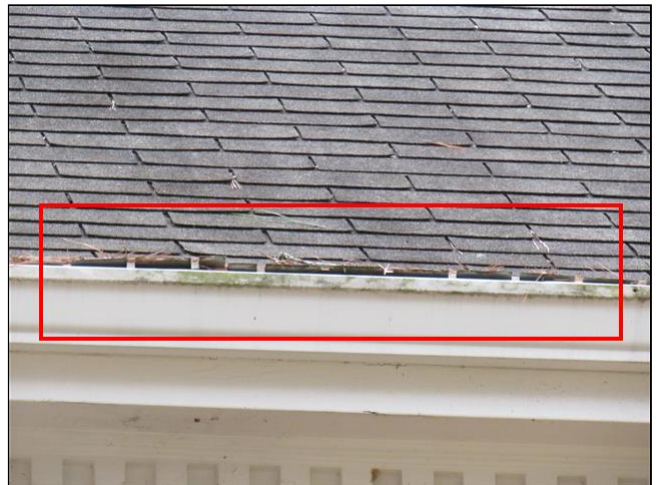
(5) Secure all loose/lifted gutter guards around the home. See photos for examples

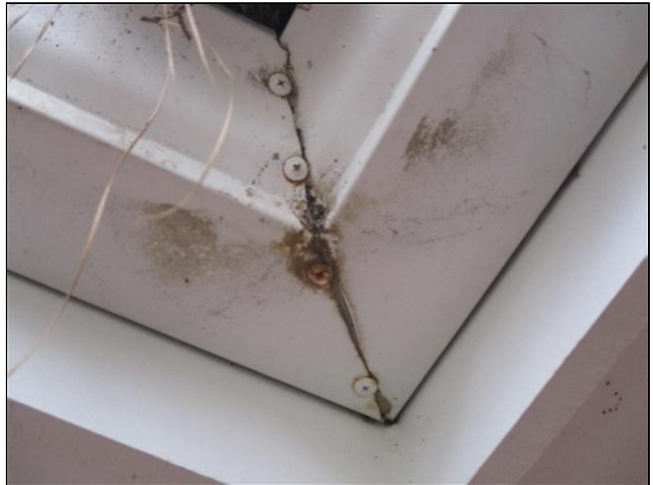
4.3 Item 16(Picture)

🔧 (6) Several leaks found in gutters at the seams. Seams need to be sealed to prevent further leaks. See photos for examples.

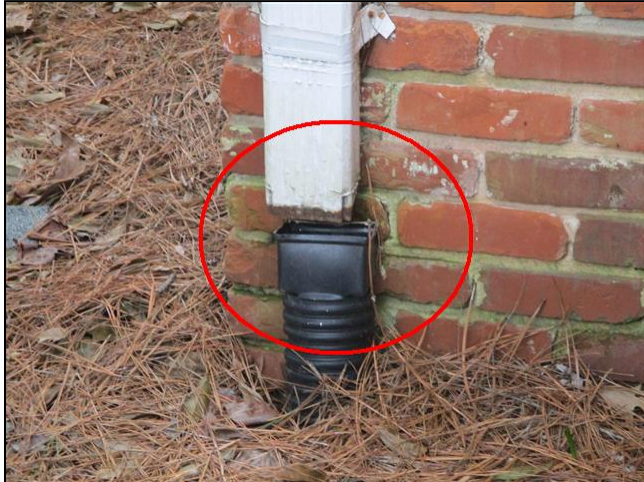
4.3 Item 17(Picture)

(7) Re-attach loose down spout extension at front of home to down spout to ensure that roof run off flows away from house.

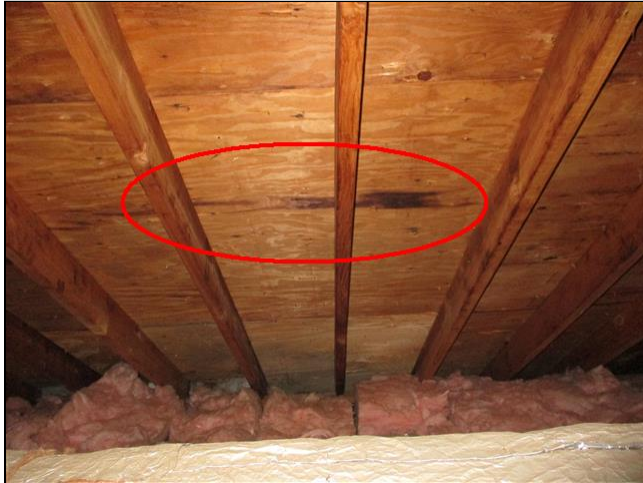
4.4 Item 1(Picture)

Several areas of stains and minor damage were found in the roof decking in the upper level attic. Some of the stains were reading elevated to high levels of moisture when tested with a moisture meter, indicating active roof leaks. Due to low clearance in the eaves not all stains were accessible to determine if active or previous roof leaks. See photos for examples.

Roofer will need to repair as soon as possible. Roofer should (and likely will) evaluate the rest of the roof because it is not uncommon that other leaks are present that were not revealed during the conditions present during this inspection. It has to be assumed that the roof will likely leak again as it continues to age

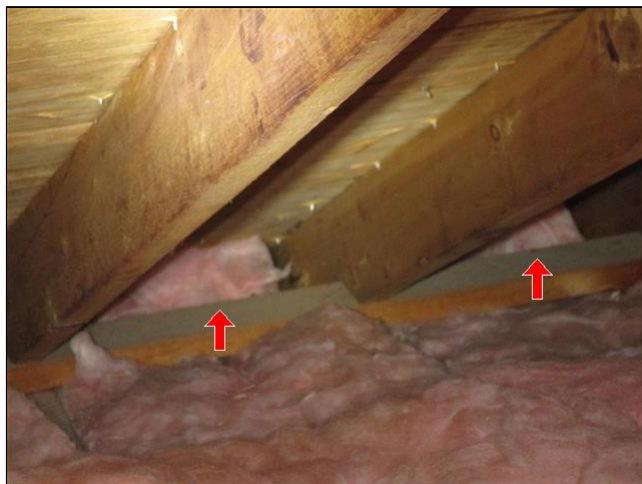
5.0 Item 2(Picture)

🔧 (2) Install missing baffles at all soffit vents in the attic to prevent insulation from covering the vents in the eaves.

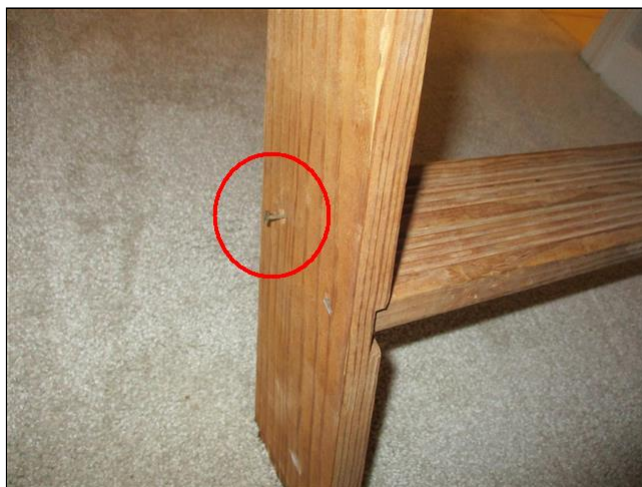
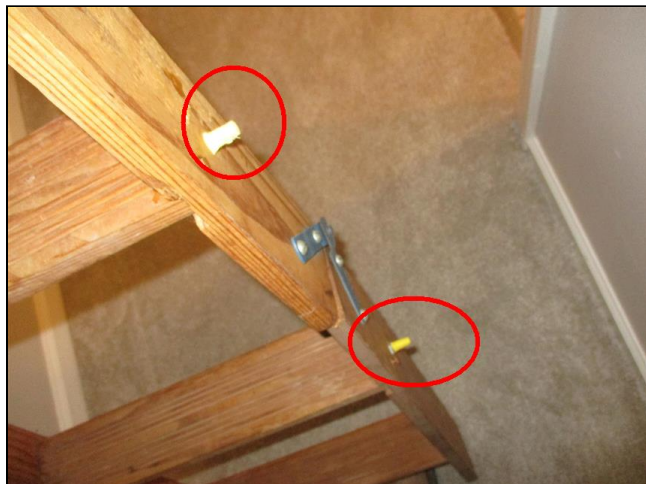
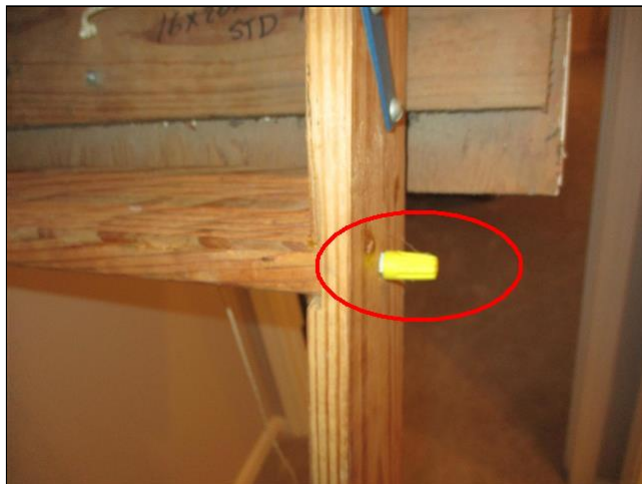
🔧 (3) Attic steps have had screws and nails come loose over time and poor repairs have been made in response. It is recommended to have a qualified contractor evaluate and make all repairs as needed to put attic steps in a safe condition

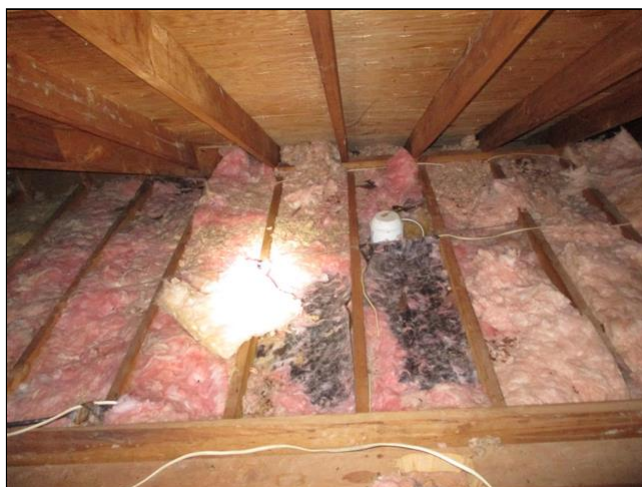
5.0 Item 8(Picture)

🐭 (4) Some areas of insulation in lower level attic has been soiled by rodents. It is recommended that it be removed and replaced with an amount equal to R-30 after the rodent entry issue has been resolved

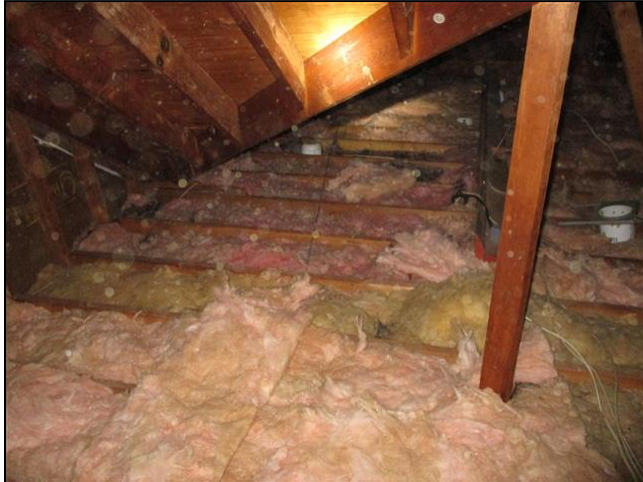
5.0 Item 10(Picture)

(5) Insulation in the attic is missing or is less than normal in several areas. See photo. Have more added to bring levels equal to R-30
