Inspection Report

**Property Address:
5452 Chanel Ct
Dunwoody Ga 30338**

Inspector: Brandon Williams

**Residential Inspector of America
3276 Buford Drive, Ste. 104-306
Buford, GA 30519
770.476.4963**

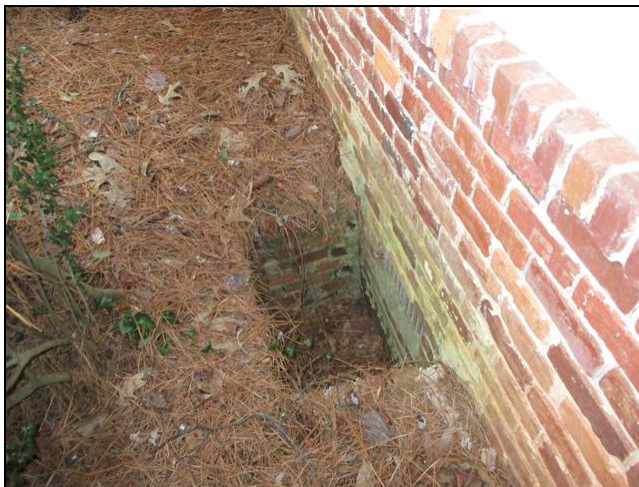
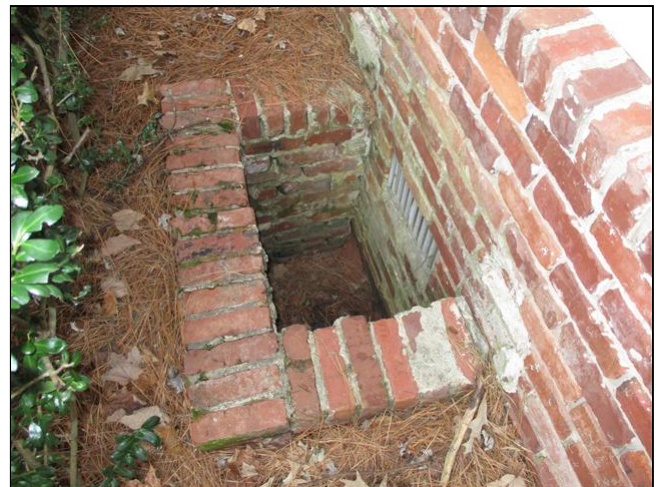
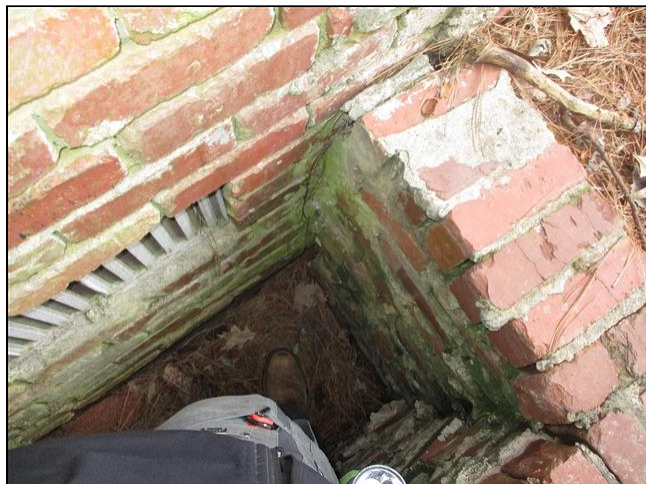
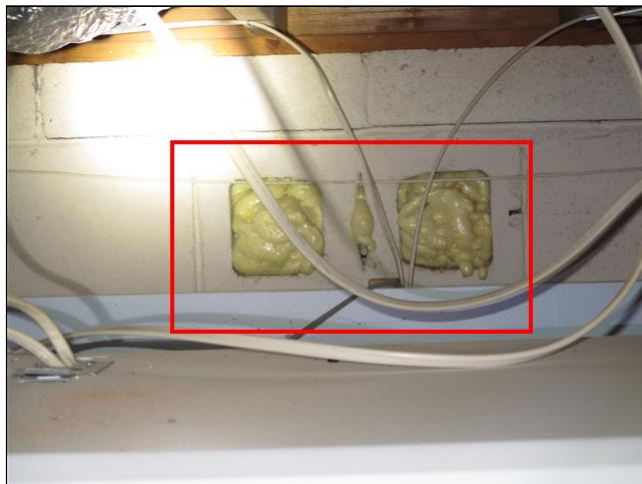
The two vent wells at the front of the home are very deep, below brick layer, and the foundation vents have been sealed off and are not longer in use. It is recommended to have a brick mason evaluate, remove foundation vents and brick over opening, then backfill the foundation vent wells

5.2 Item 4(Picture) foundation vent sealed

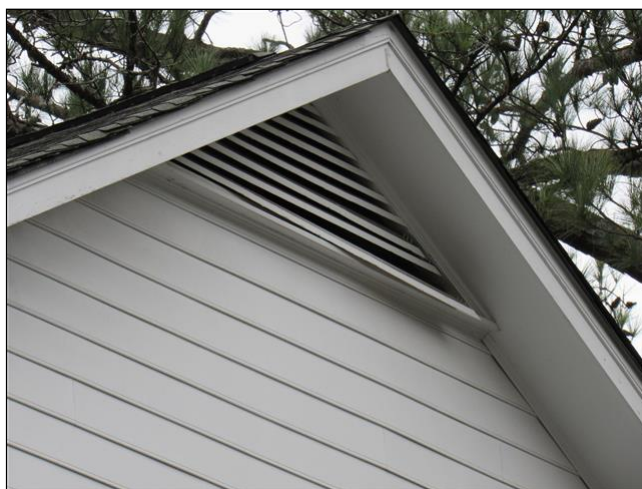
5.3 Item 2(Picture)

Secure loose gable vent slats at the left side upper level gable vent seen in photo

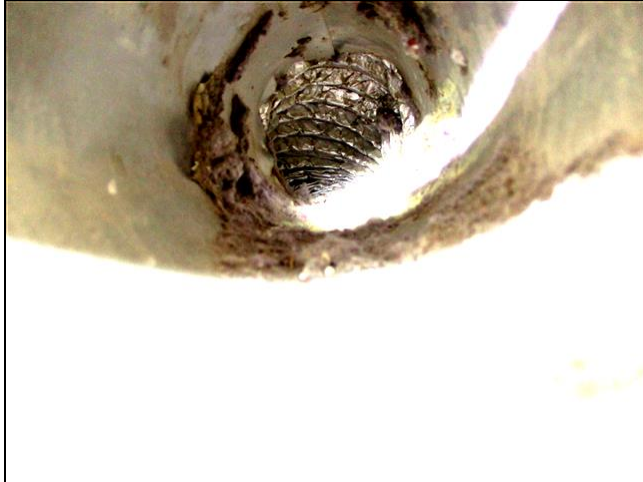
5.4 Item 1(Picture)

(1) Lint build up was noted at the dryer exhaust outlet, and it is recommended that the lint be removed around the outlet so that the damper can fully open. It is also recommended that the dryer duct (which is not visible) be cleaned out as much as possible to ensure adequate exhaust flow.

Dryer vent is the louvered door type, this is not a recommended type of vent for dryers. They are conducive to lint build up. Recommend replacing with a vent hood, and do not install screening underneath.

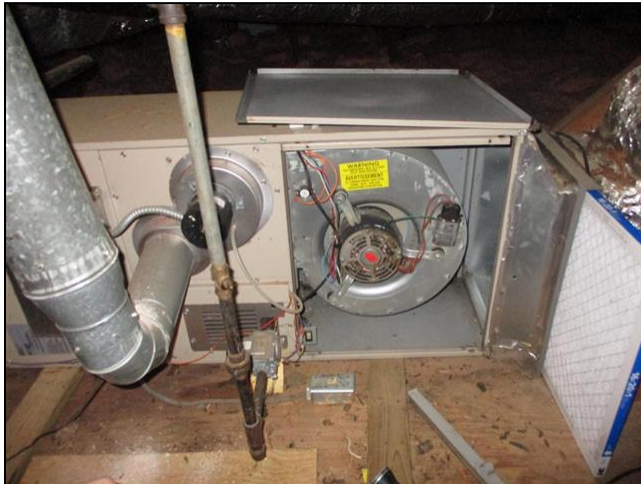
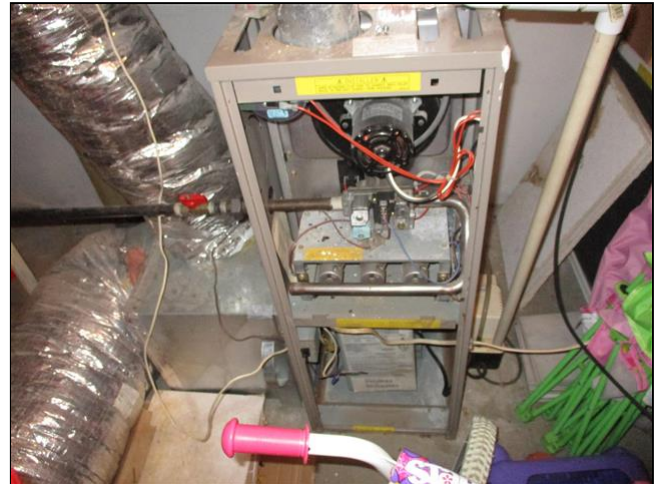
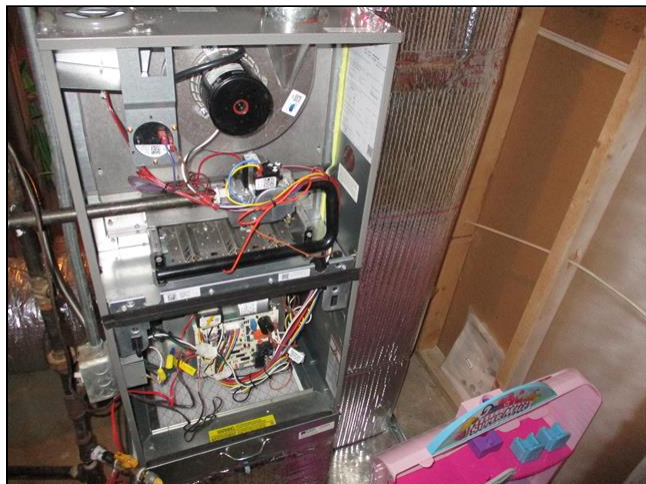
🔧 (1) Have an hvac tech service the heating and cooling equipment to clean the blower motor, the evaporator coils, the condensing coils, the electrical contacts, check refrigerant levels, check size of units compared to size of home and ascertain that the heat exchangers are not cracked and the equipment is safe to operate and functioning properly. Much of internal parts of the hvac system is concealed from view, and our inspection is visual and is intended to check the function of the systems. The inspection does not make any assessment of the internal parts of the duct system, since it is not visible. Therefore, an hvac tech should evaluate for any concealed defects or hazards in the system. Furthermore, manufacturers recommend annual maintenance and servicing to keep the system working at peak efficiency.

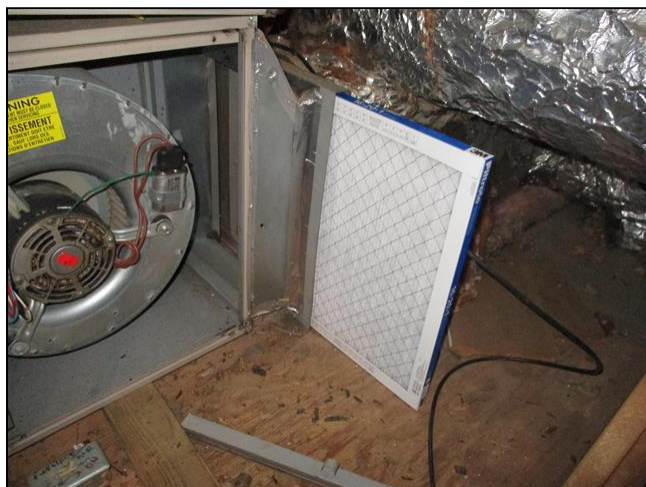
6.2 Item 1(Picture)

(1) Filter location similar on all furnaces.

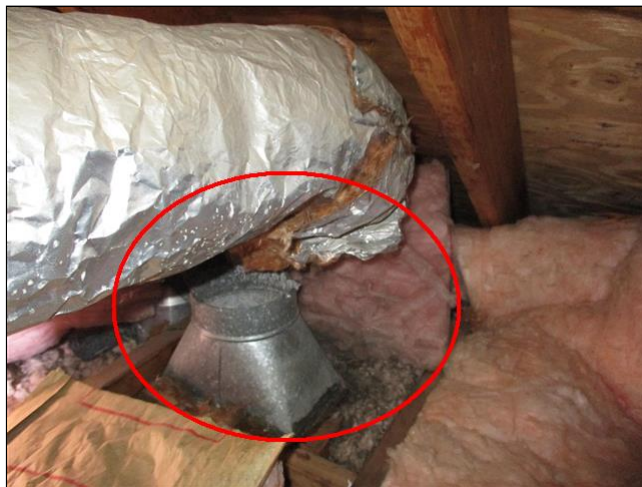
6.2 Item 3(Picture)

🔧 (2) One of the ducts in the rear of the attic is disconnected from its supply vent, and is venting conditioned air into the attic space. Have hvac tech evaluate and repair.

There are also gaps felt in the plenum allowing conditioned air to escape into the attic space as well. HAVe hvac tech evaluate and repairs

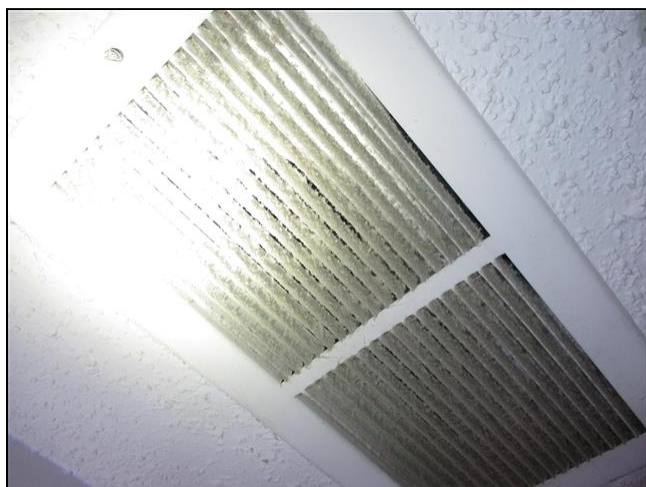
6.2 Item 4(Picture)

🔧 (3) The debris seen in the vents and ductwork indicates the need for cleaning the ductwork in the home

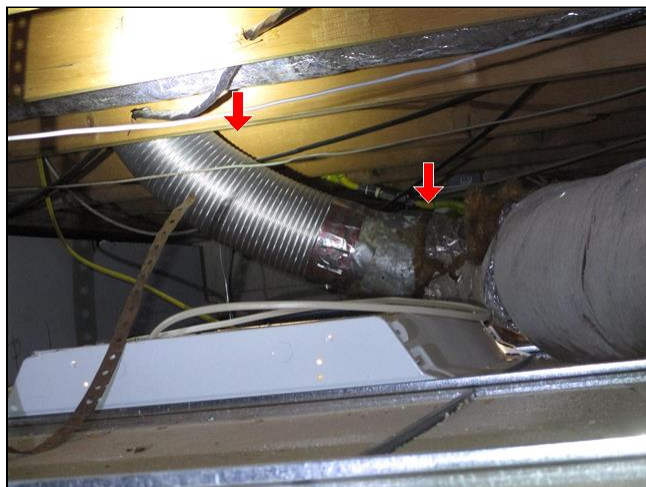
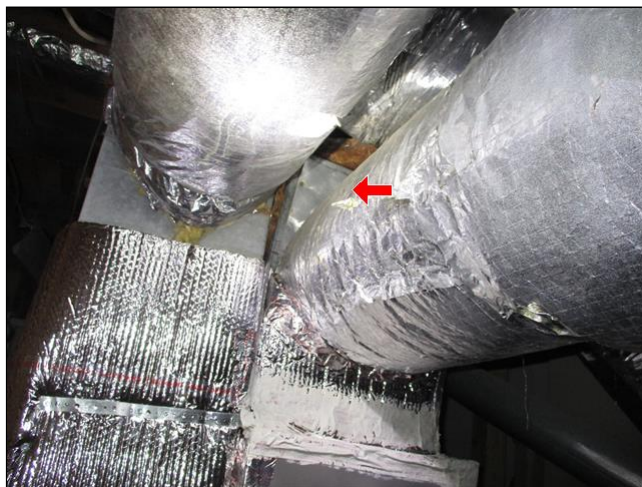
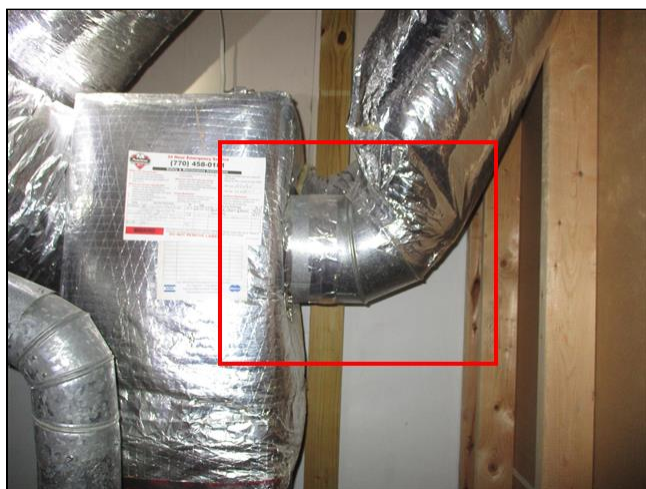
(4) Some of the ductwork above the basement drop ceiling and around the furnace plenums is not insulated and may condensate if not corrected. Have hvac tech evaluate and insulate as needed. See photos for examples

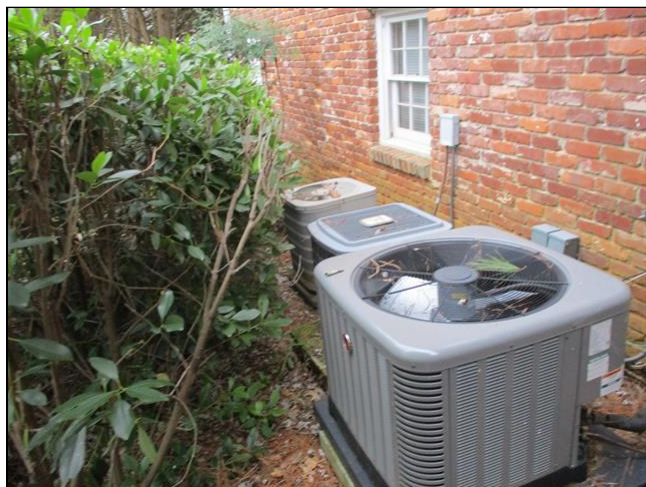
6.7 Item 3(Picture)

🔧 (3) Along with servicing the heating unit(s), hvac tech should check refrigerant levels in the a/c system to ensure that the systems are working at peak efficiency. This inspection is visual and checks the operation of the system(s). Unit was not disassembled.

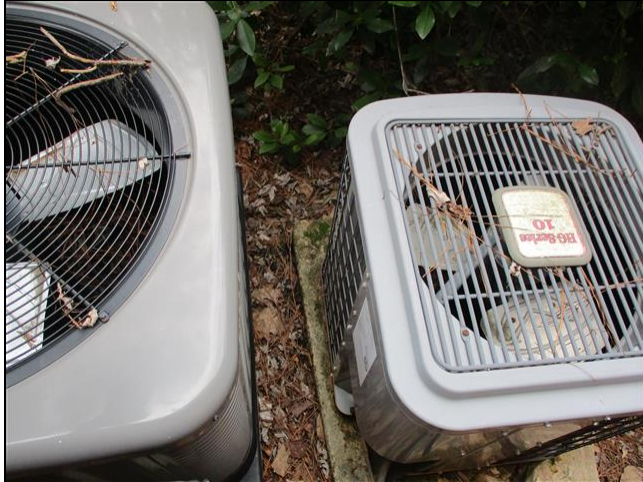
6.7 Item 4(Picture)

(5) It is recommended to trim bushes away from the a/c units outside. A/c units are supposed to have at least 2' of clearance on all sides to allow for adequate air flow. When constricted the units can run hot and will not be as efficient.

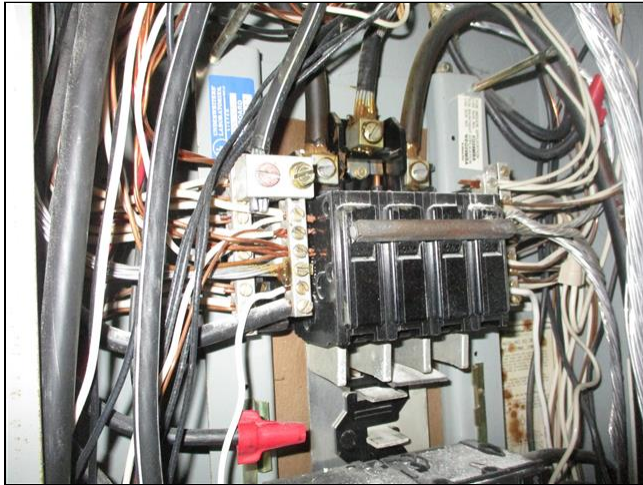
7.0 Item 1(Picture)

Main electrical disconnect location is in main panel in the basement

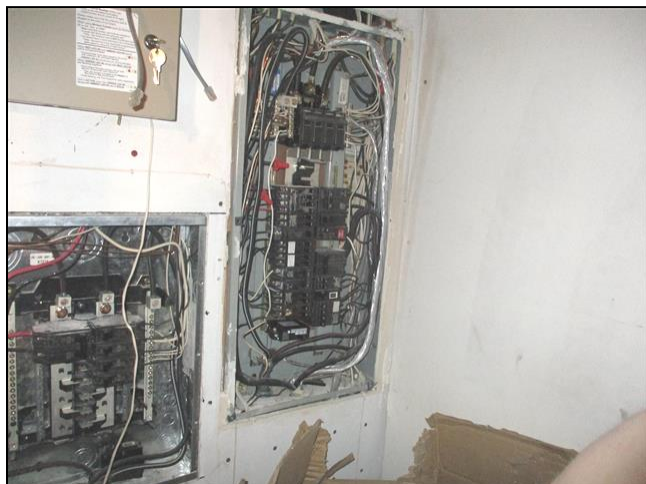
7.2 Item 1(Picture)

(1) View of panels. Panel was inspected for function (not code compliance) and building codes and standards have changed over the years.

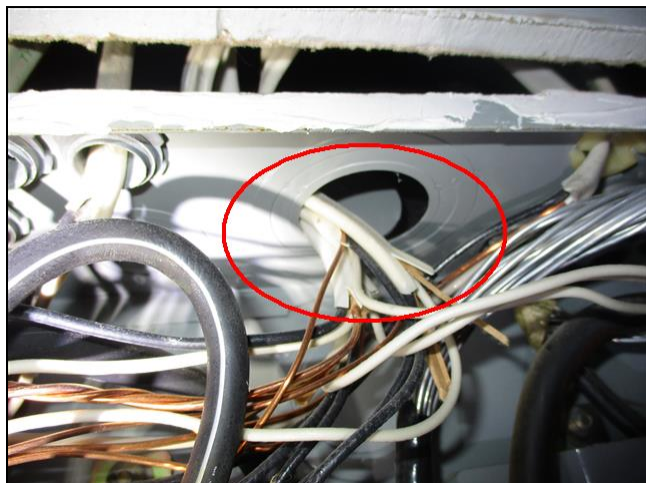
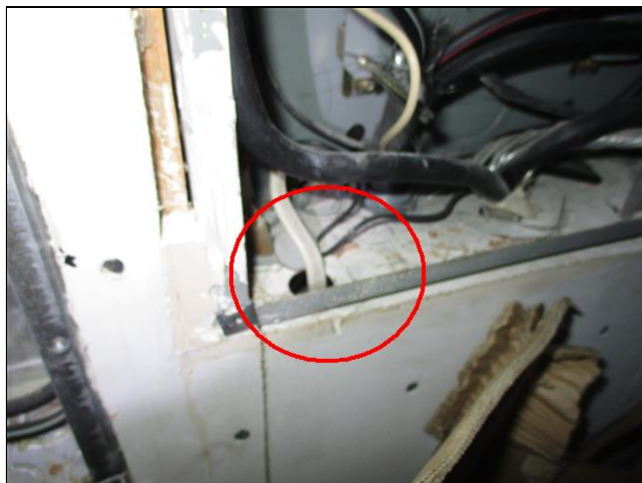
(2) See photo of wiring entering main panel box without the use of a bushing or retainer. Standard wiring practice calls for a bushing or retainer to be installed where the cable enters the box.

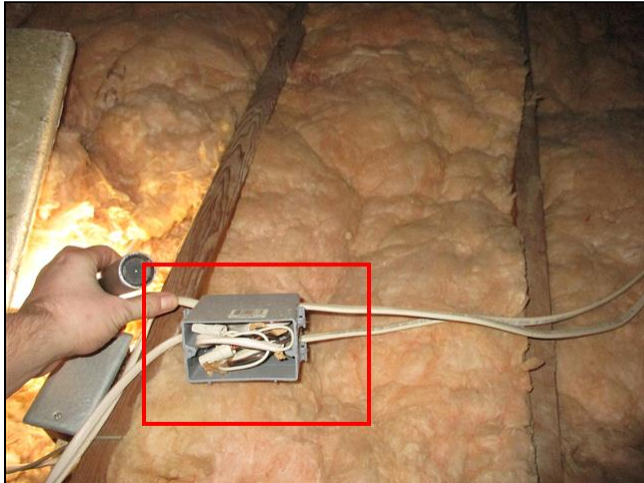
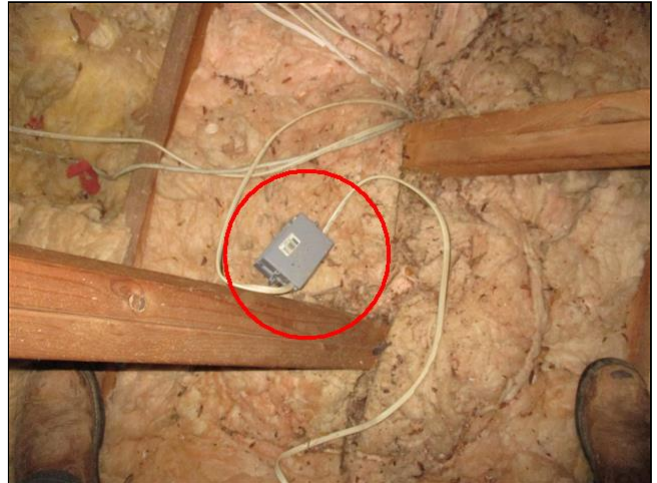
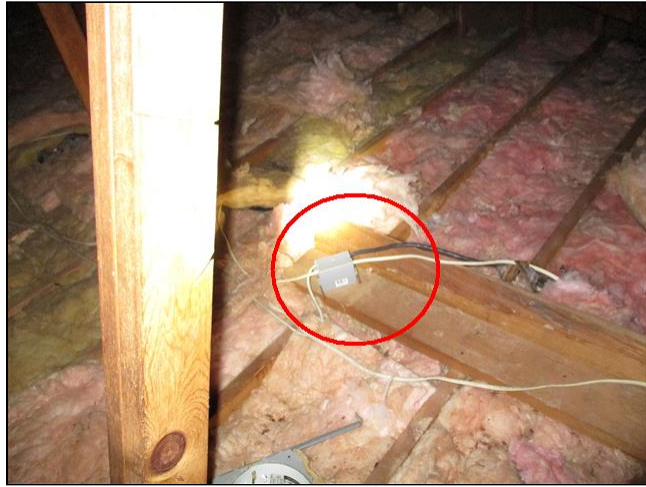
🔧 Cover needed on the open junction boxes in the garage attic area. Covers are used to control sparking. See photo(s) for location(s) and have electrician correct,

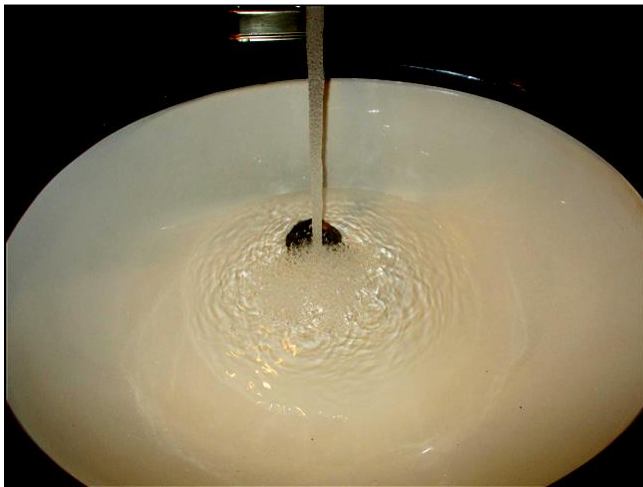
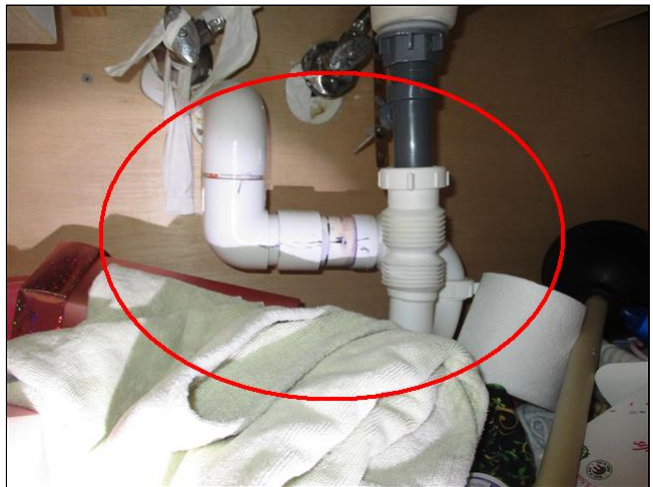
Slow drain in upstairs hall bath sink, may be due to the drain configuration below. See photo. Have plumber evaluate

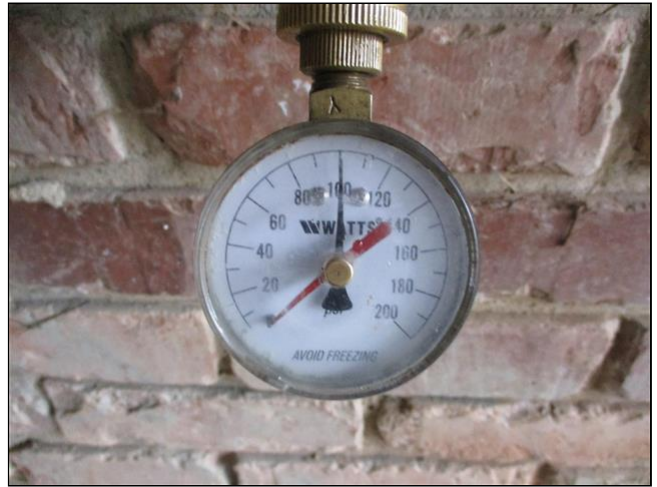
8.1 Item 2(Picture)

🔧 Have plumber check pressure reducing valve and adjust/replace as needed. Pressure was over 95-100 psi when tested at the rear and left side hose bibbs. High water pressure can have an adverse affect on plumbing fixtures, dishwashers, water heaters, washing machines, ect... Maximum pressure is typically 80 psi.

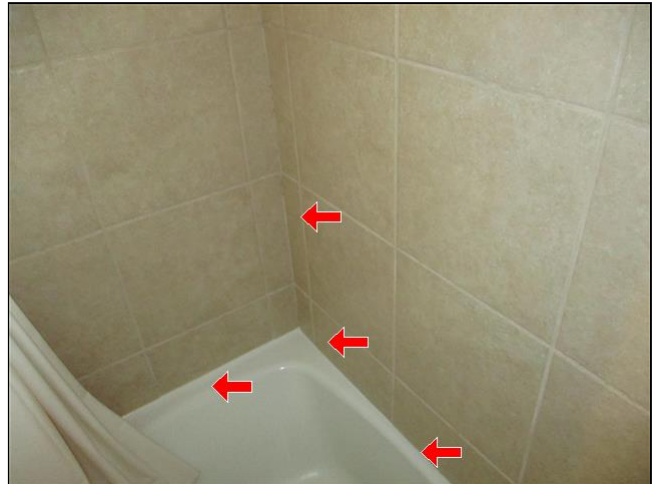
8.2 Item 3(Picture)

(2) Touch up grouting needed between tiles in bathroom shower stalls. Water can enter into the tile and get into wall. Condition of framing behind tiles in baths is unknown.

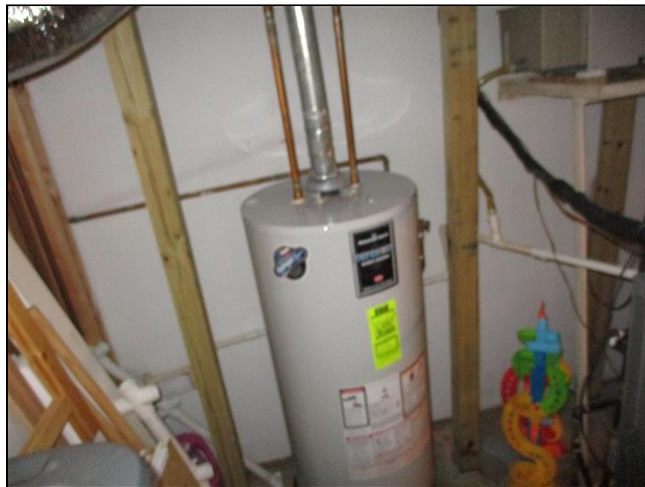
8.3 Item 1(Picture)

(1) View of water heater.

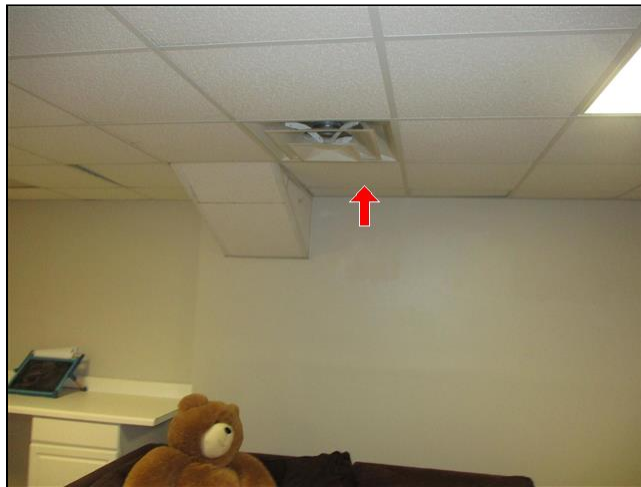
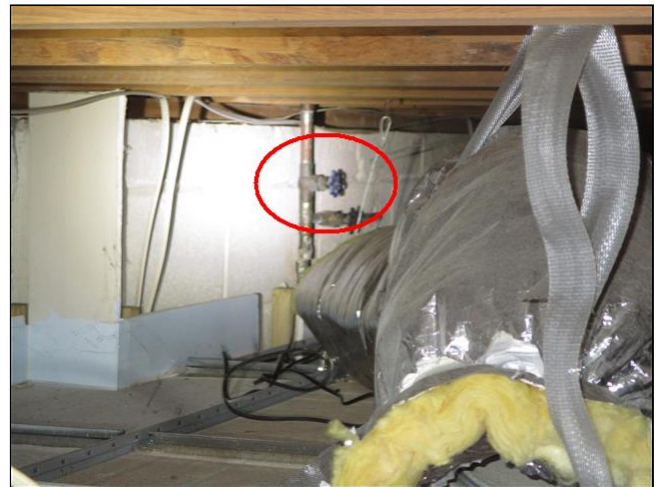
The main water shut off is located in the basement above ceiling tiles. See photo for location.

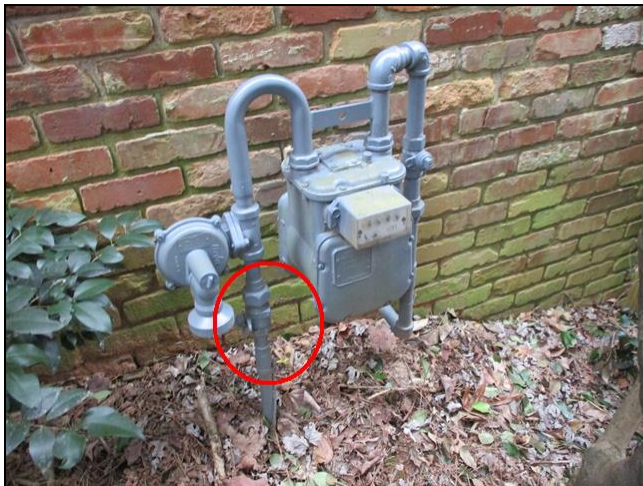
8.6 Item 1(Picture)

The main gas shut off is located at the meter.

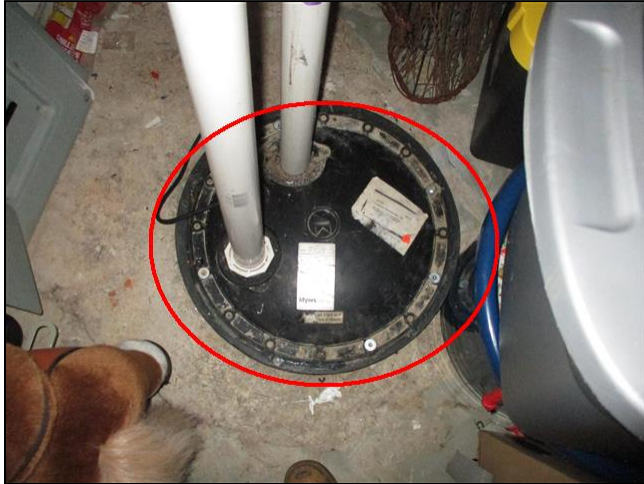
8.7 Item 1(Picture)

Occasional sealant maintenance will be needed around pump lid and where pipes pass through lid to prevent sewer gas odors in living space.

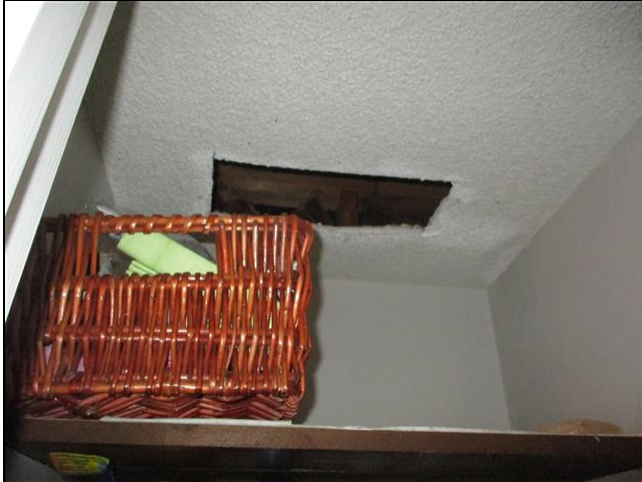
9.0 Item 1(Picture)

(1) Several small blemishes, holes, and cracks found in walls and ceilings due to normal settlement. None of the cracks, peeling tape or nail pops appear to indicate any type of major structural issue.

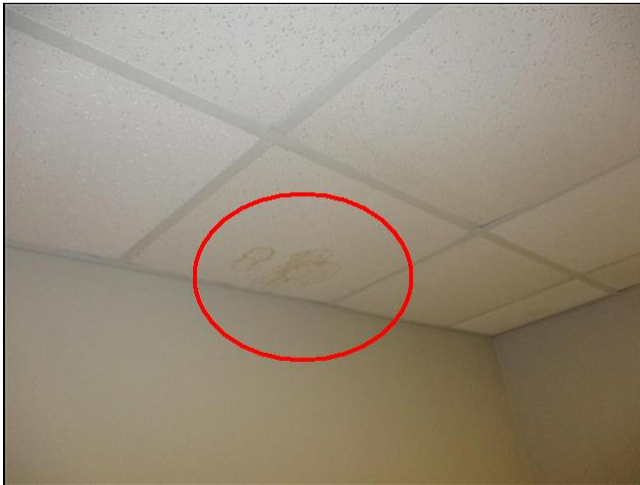
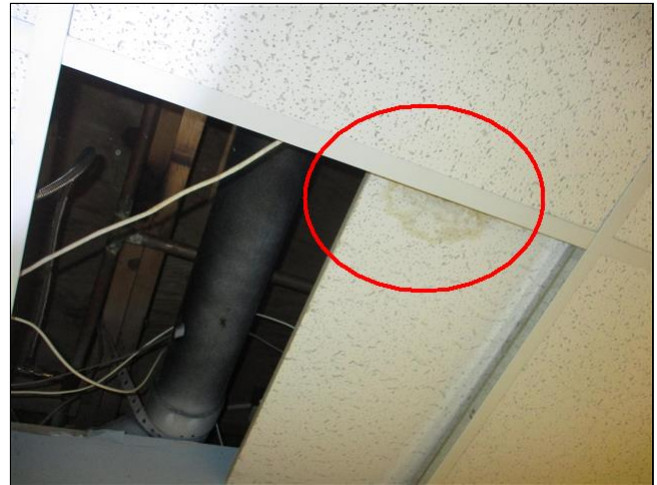
(2) Old water stains found on ceilings from past leaks. Stains were not wet at time of inspection, but conditions could change and leaks could become active again. Before stains are sealed and painted over, buyer should resolve all concerns prior to closing. See photo(s).

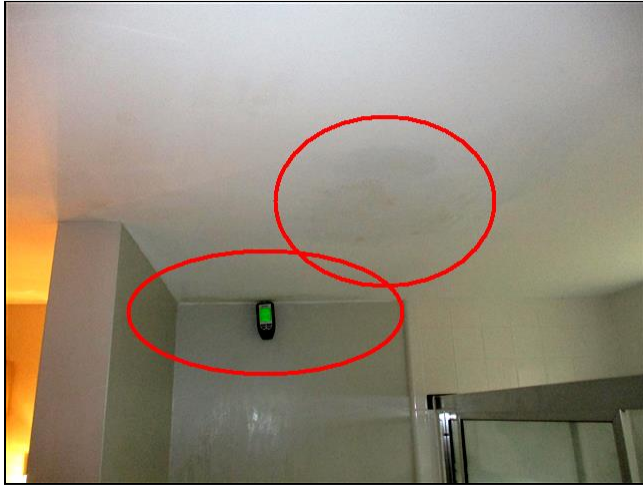
9.0 Item 4(Picture)

(3) Patched/painted over areas found in the main level bathroom ceiling were reading elevated levels of moisture when tested with a moisture meter, which could indicate a slow leak in the plumbing above. No leaks were detected in the bathroom above, but the plumbing above the drywall in the main level bath was not visible. Have a plumber evaluate and make any repairs as needed

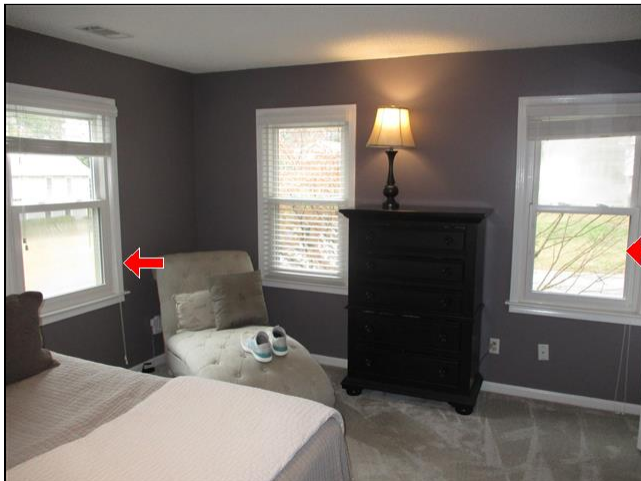
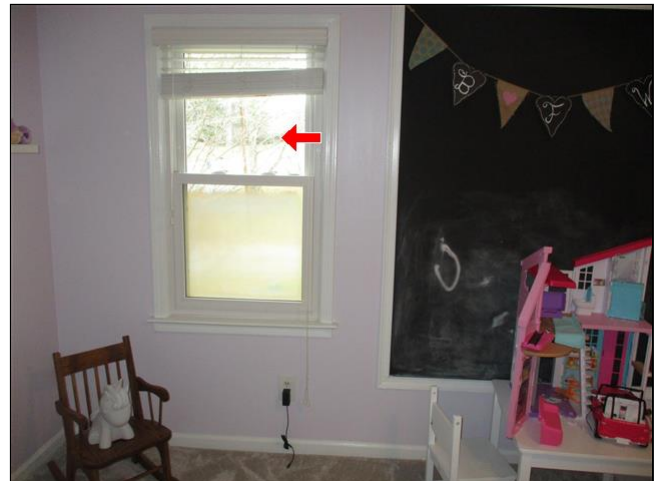
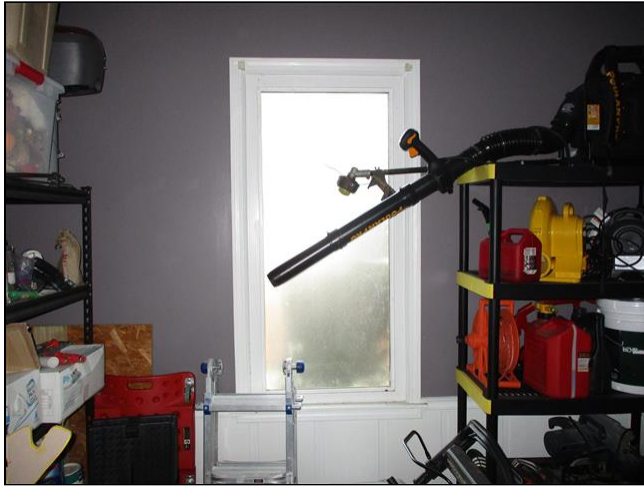
👉 (1) The Low-E thermal coating has failed on several windows in the home, see photos for examples. This does not mean that the window has failed, but will not insulate or reflect sun as well. Replace as needed.

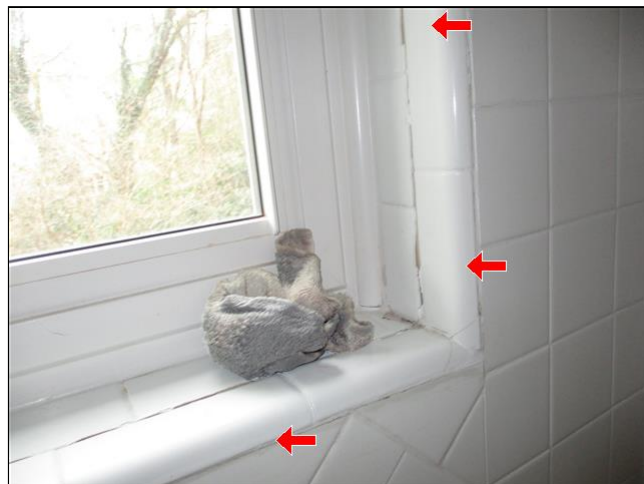
9.6 Item 2(Picture)

Windows are present in the walls of the showers. The seal and paint around the windows needs to be maintained to prevent water damage. This is part of general maintenance.

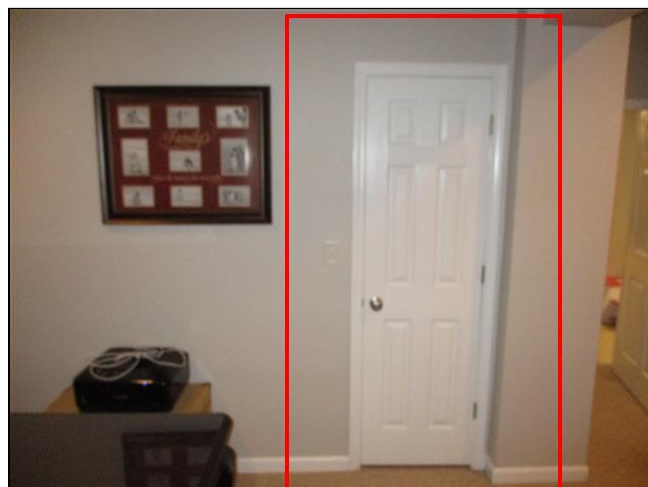
9.7 Item 1(Picture)

Basement bedroom closet door is locked and area inside was not able to inspected. Have any concerns resolved prior to closing

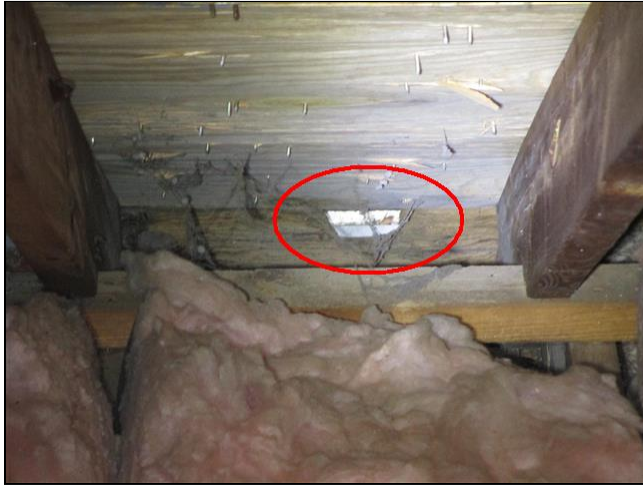
There is evidence of rodent activity in the attic as noted by tunnels in the insulation, nesting, chewed entry, rodent droppings, and what appear to be raccoon droppings in the lower level attic. A wildlife company should be consulted to determine if the activity is past or present and to repair all possible entry points to the attic and the entire home. See photos for examples

9.8 Item 1(Picture) chewed entry

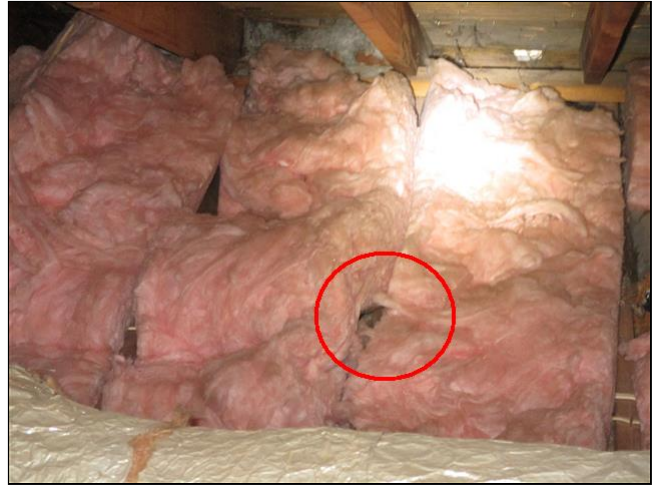
9.8 Item 2(Picture) rodent tunnel

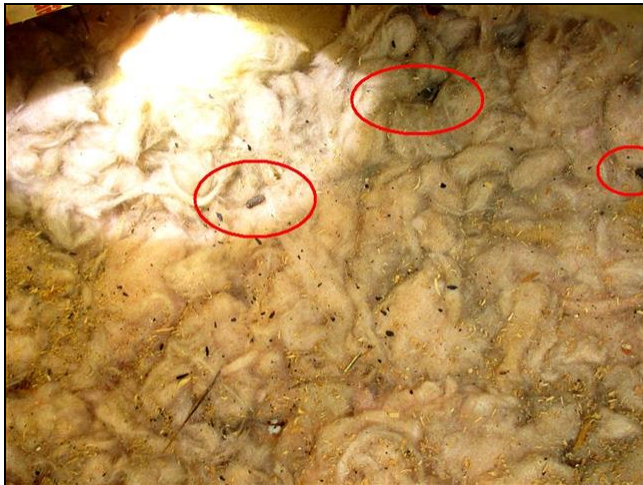
9.8 Item 3(Picture) droppings

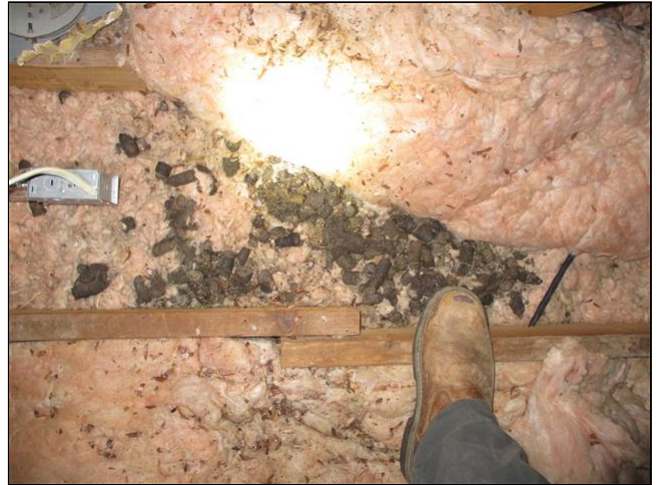
9.8 Item 8(Picture) suspected raccoon feces

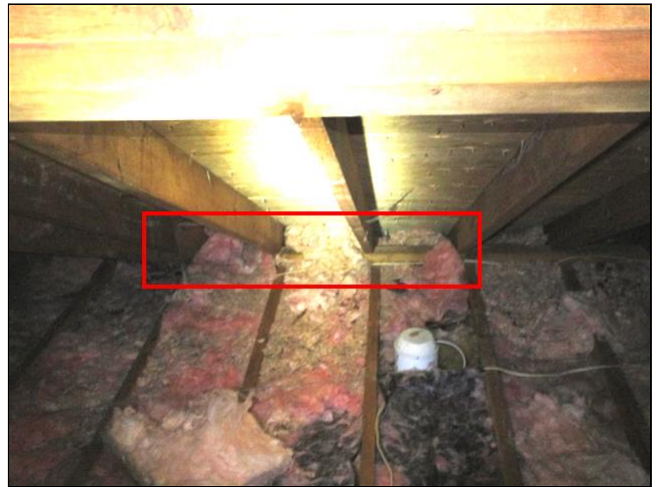
9.8 Item 10(Picture) nesting

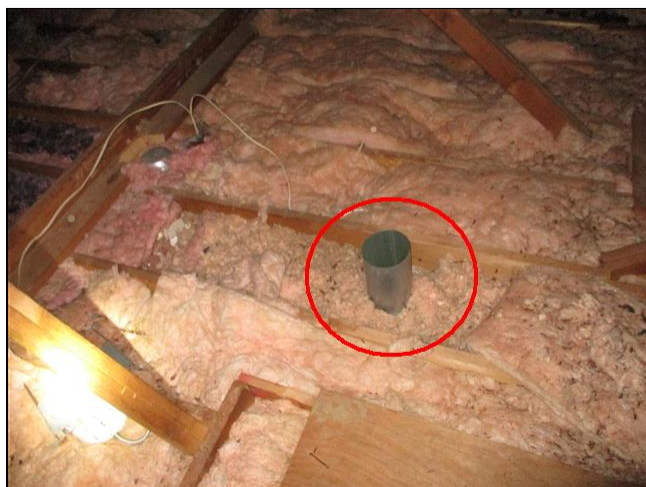
10.2 Item 1(Picture)

The vent hood over the stove top is venting into the attic instead of the exterior of the home. Have corrected
