Atlanta Property Inspections, Inc.

HOME INSPECTION REPORT

2150 Weldonberry Drive, Brookhaven, GA 30319
Inspection prepared for: Salena Barnes
Date of Inspection: 12/21/2019 Time: 9:30
Age of Home: 12 Years Old (2007) Size: 1845 SF
Weather: Rainy, Wet Soil, 45 Degrees

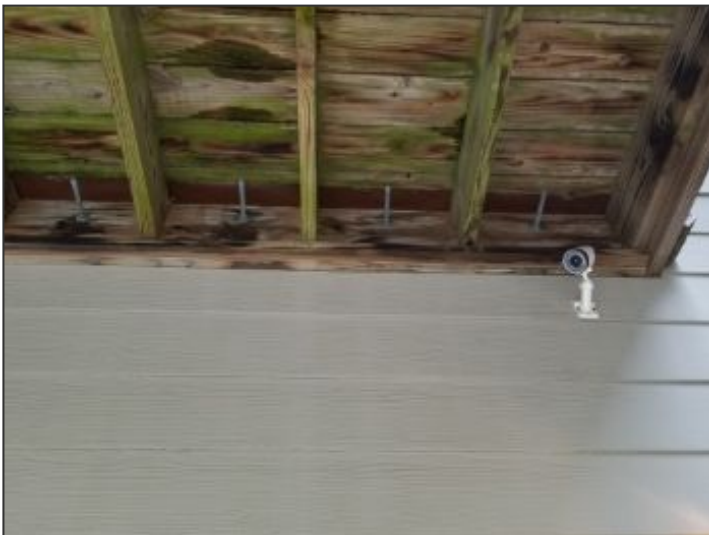
Good flashing, deck attachment and joist support at rear deck

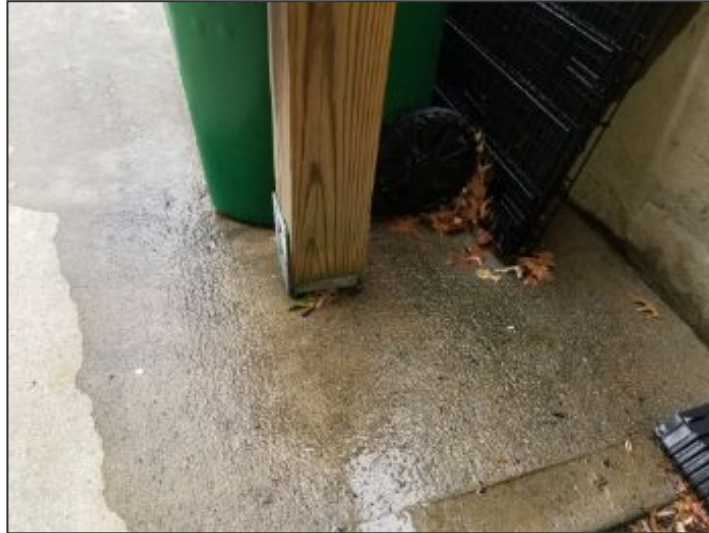
Good footing brackets at deck posts

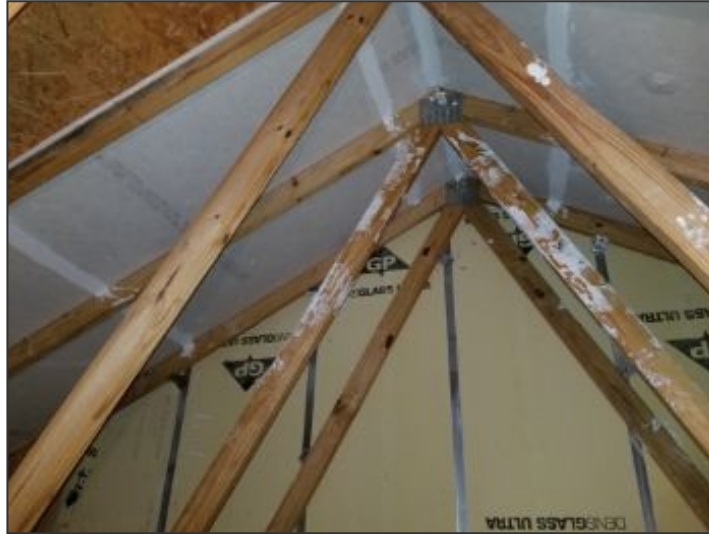
• **An approved firewall is present at the shared attic walls as required by local building codes. The firewall extends four feet across the roof as needed to meet this fire safety standard.**

Good fire walls in attic

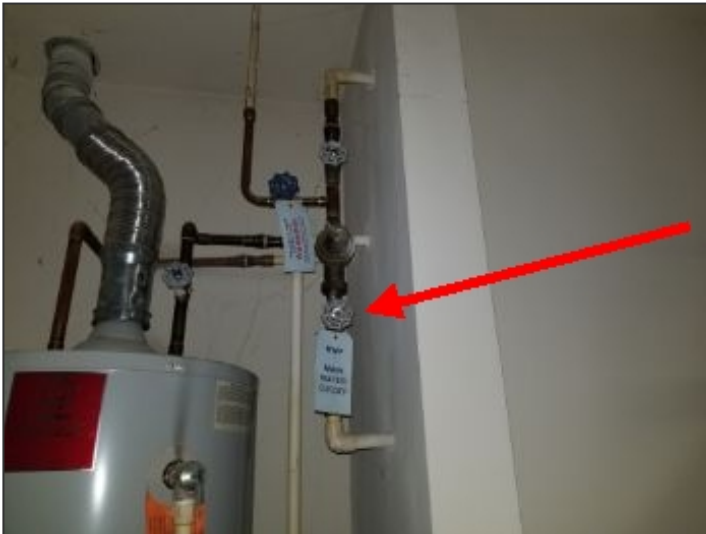
Main water cut-off handle located in garage

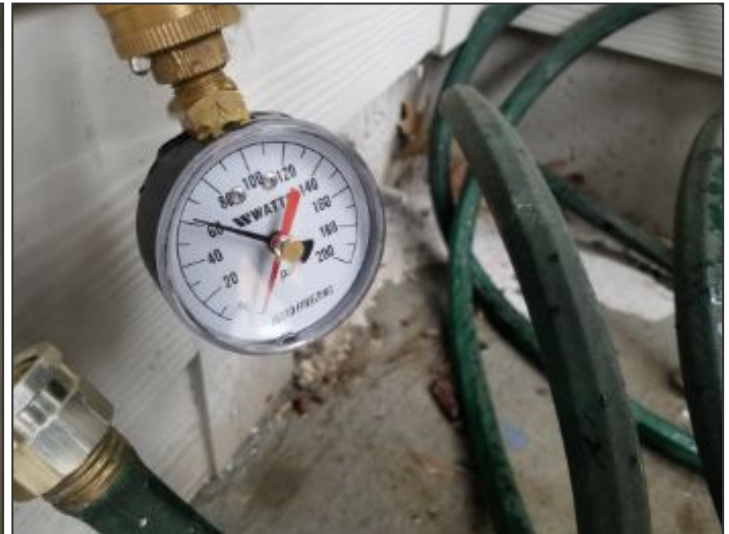
• The supply piping appears to be serviceable, no concerns were noted. A water pressure reading was taken at the rear hose bib and was found to be normal at 62 PSI.

Water pressure normal at 62 PSI

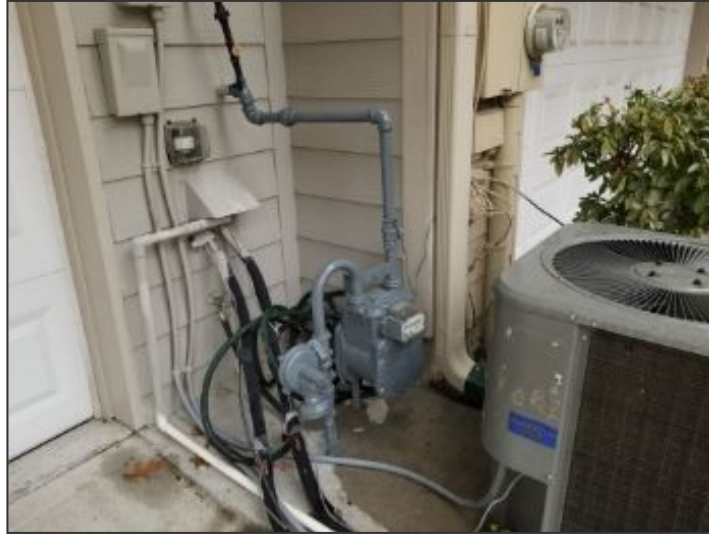
- The gas meter is located at the rear exterior wall and appears serviceable; no concerns were found. (NOTE: The gas lines inside the walls, ceilings and floors are not fully visible for inspection and could not be evaluated).

Gas meter at rear wall

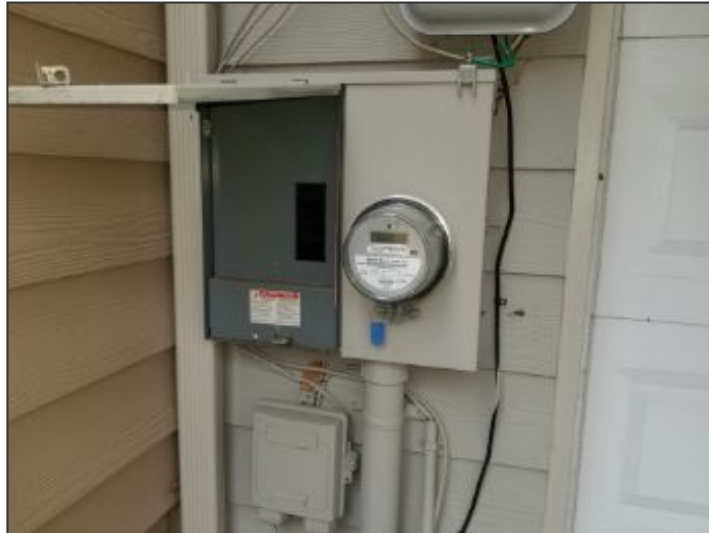
- The electrical service is underground - 110/220 volt;
- The electrical grounding consists of a single ground rod near the electrical meter. The electrical service and grounding appears serviceable; no concerns were noted.
- A 150 amp main breaker is present at the exterior meter location. Appears serviceable, no concerns were noted.

Main electrical disconnect at exterior meter

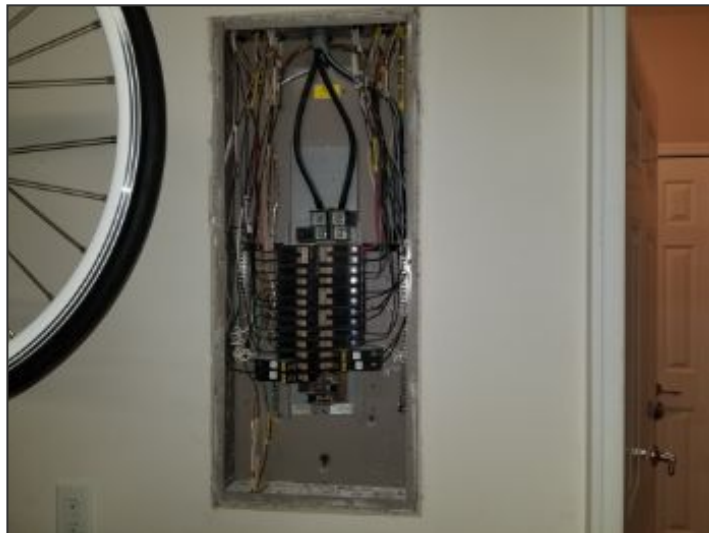
- The main panel is located in the garage. Circuit breakers are present. The main panel box appears serviceable and was found to be neat and well organized during a limited visual inspection inside the panel; no concerns were found.

View inside main panel box - neat and well organized

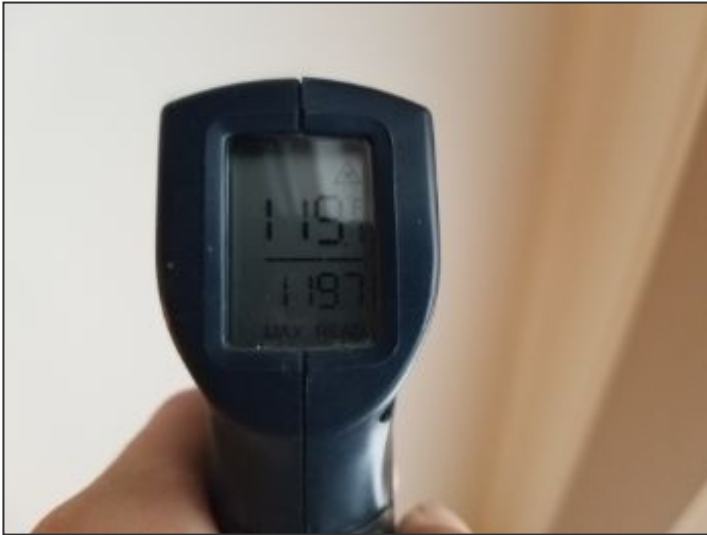
• **The heating system appears serviceable; the heating system was operated and was found to be functioning normally during a limited visual inspection, no significant concerns were noted. Continue to maintain the system and have it serviced regularly.**

Good temps during testing of main floor furnace

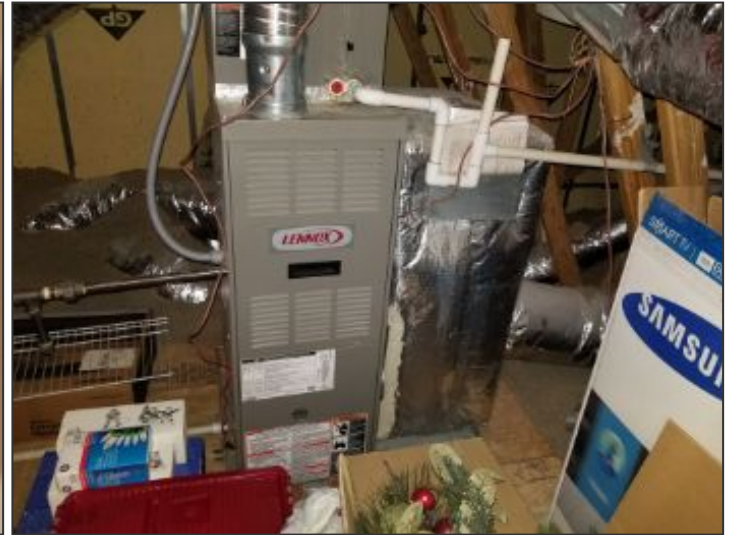
Main floor furnace located in attic Second

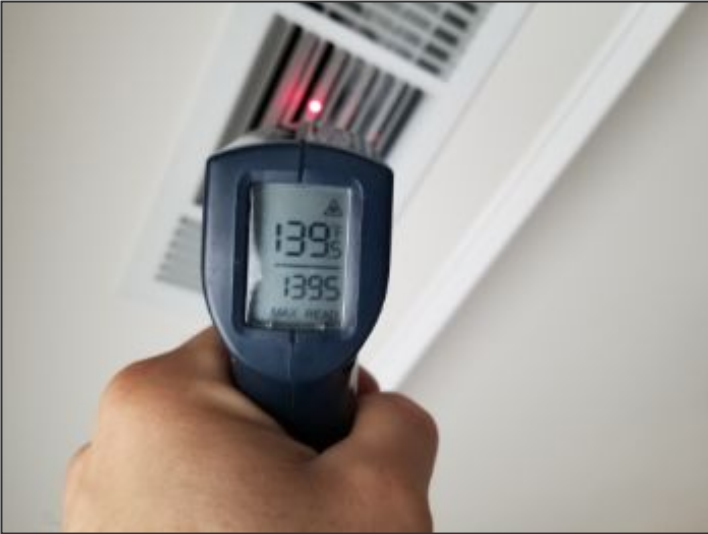
• **The heating system appears serviceable; the heating system was operated and was found to be functioning normally during a limited visual inspection, no significant concerns were noted. Continue to maintain the system and have it serviced regularly.**

Good temps during testing of second floor furnace

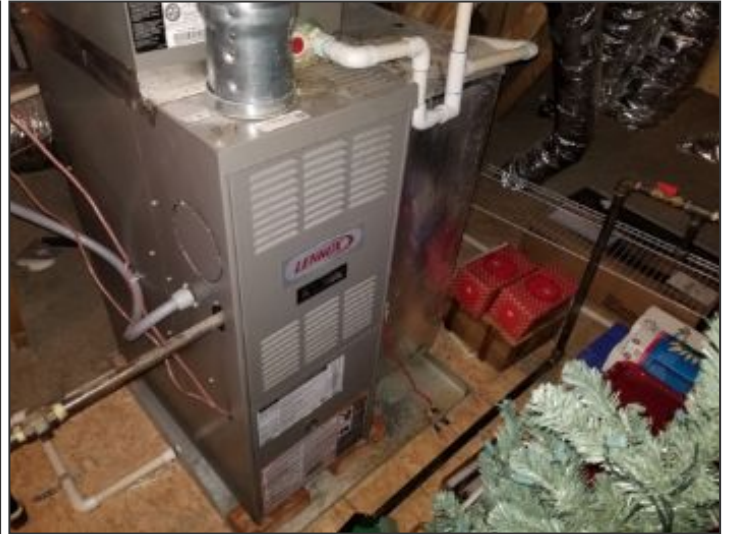
Second floor furnace located in attic

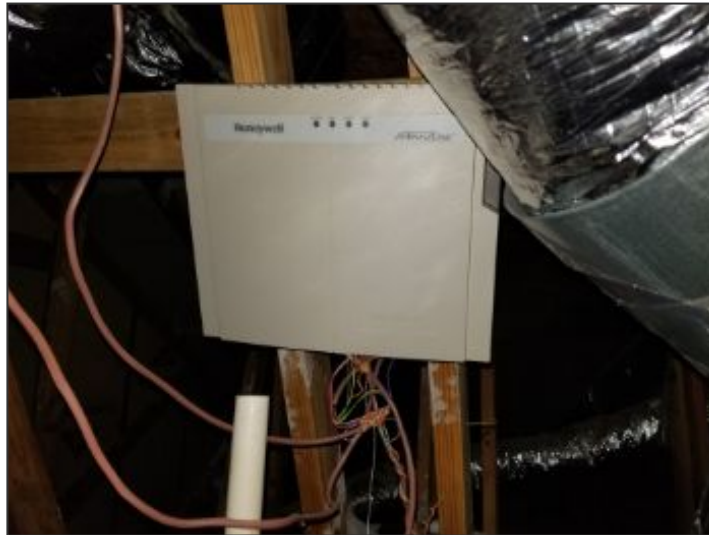
• The thermostats appear to be functional and working normally during testing of the HVAC systems.

Dual zone thermostat control for HVAC system
