Inspection Report

**Property Address:
1145 Haven Brooks Ln NE
Atlanta Ga 30319**

Inspector: Brandon Williams

Date: 2/26/2020	Time:	Report ID: 80220
Property: 1145 Haven Brooks Ln NE Atlanta Ga 30319	Customer: Emily Mason	Real Estate Professional: Michael Hermance Keller Williams

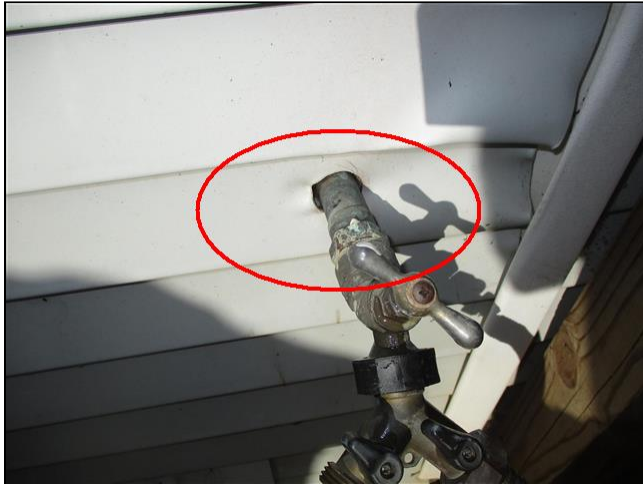
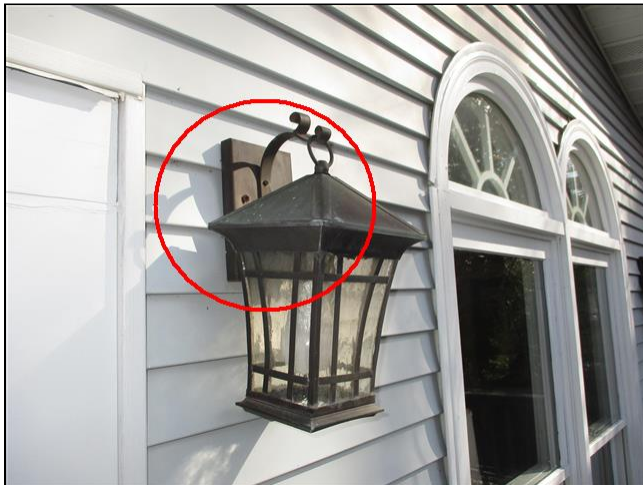
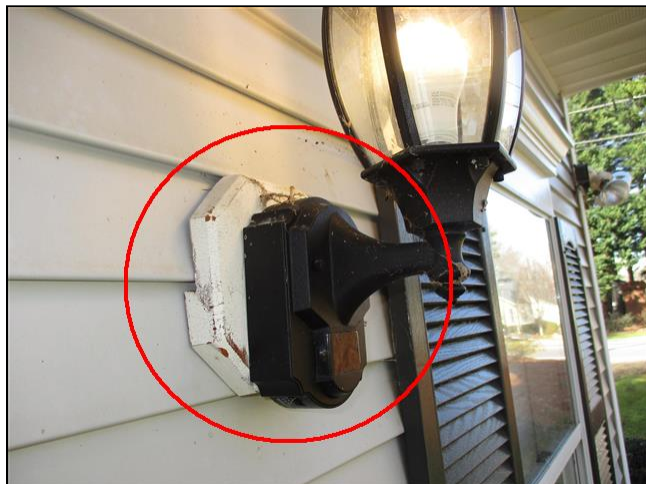
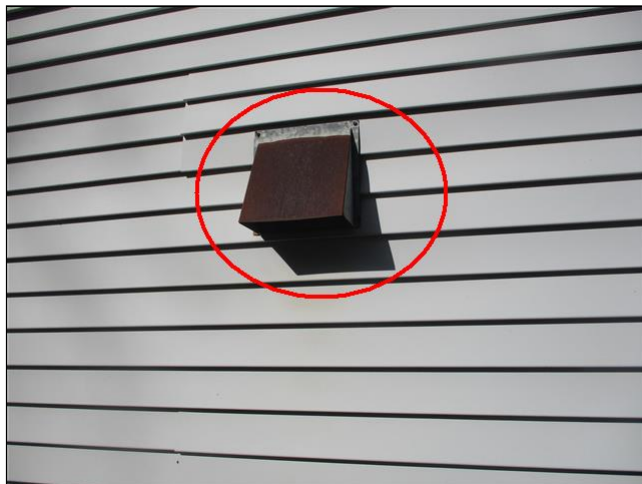
Seal around all plumbing entries into siding to prevent water entry into wall cavities.

Seal the light fixtures to the lap siding around the house to prevent water entry into the wall cavity and fixture box.

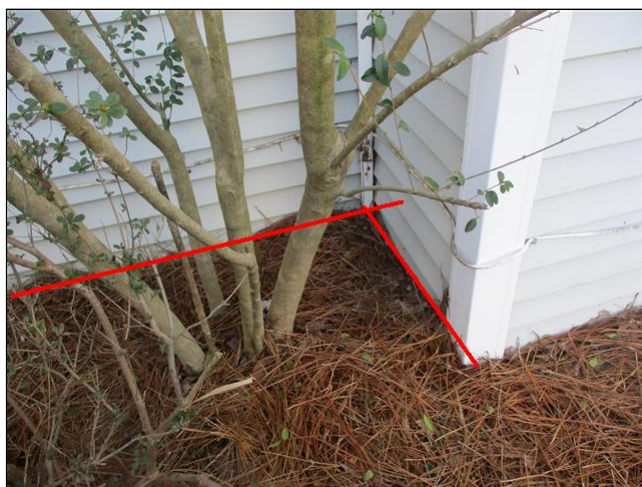
1.1 Item 8(Picture)

🔧 (2) The soil is too close to the last pieces of lap siding front and right side of the home. This could be an avenue for possible termite infestation. Have all soil pulled away from the last pieces of lap siding at least 4-6 inches.

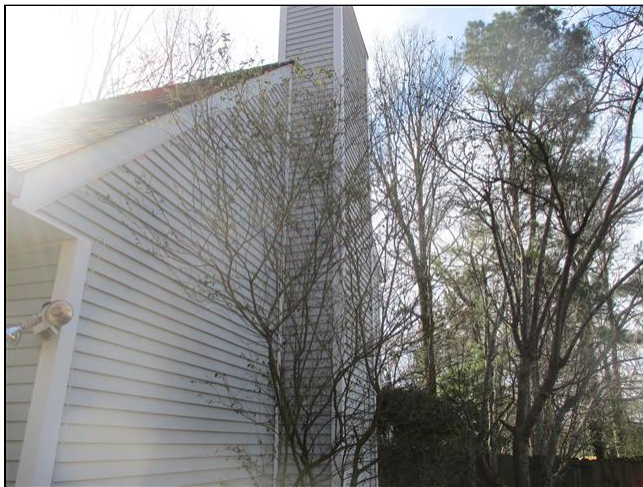
1.5 Item 1(Picture)

(1) Trim vegetation away from house siding. It is best to have a clear path around the house.

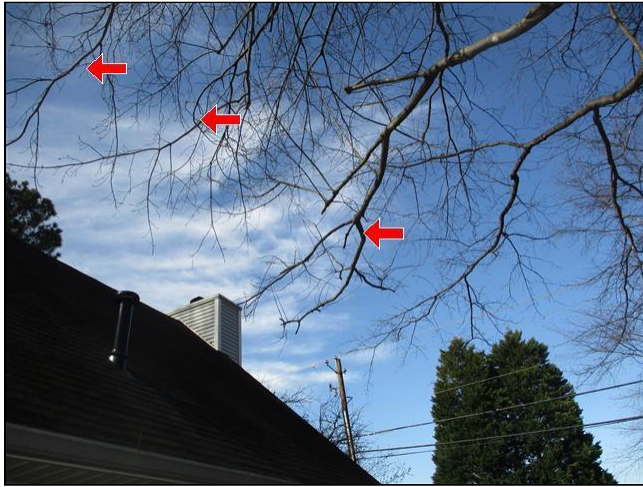
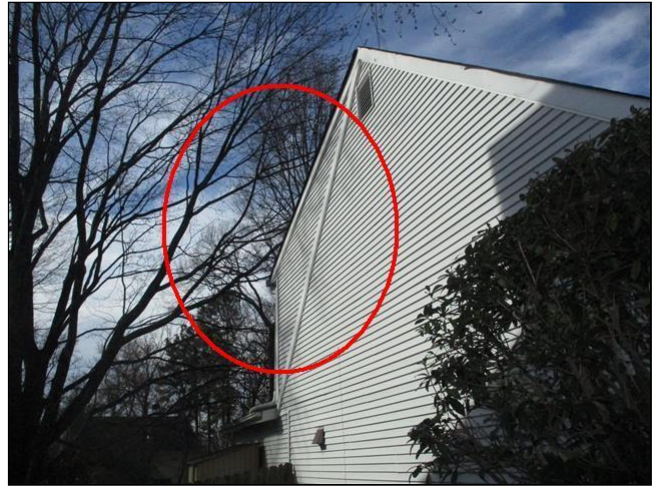
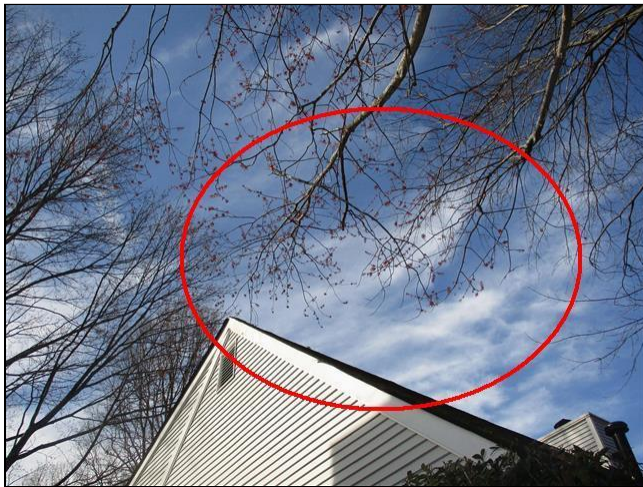
(2) The tree limbs that are in contact with roof or hanging near roof should be trimmed.

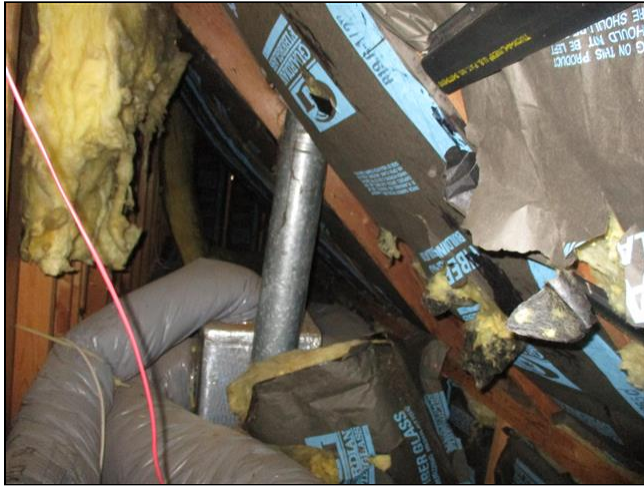
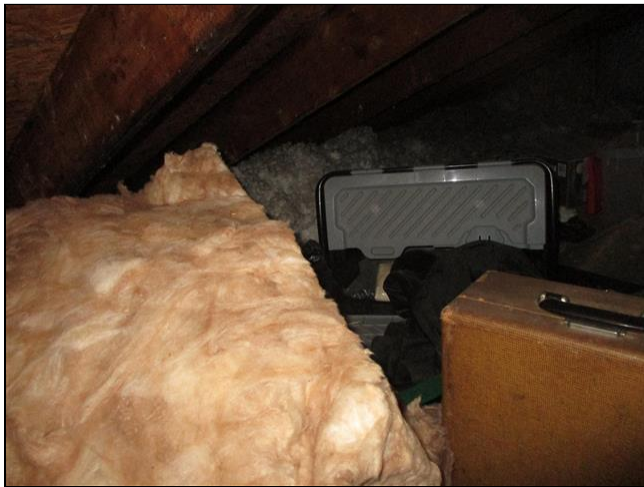
(3) Have all storage and excess batts insulation removed from the upper attic

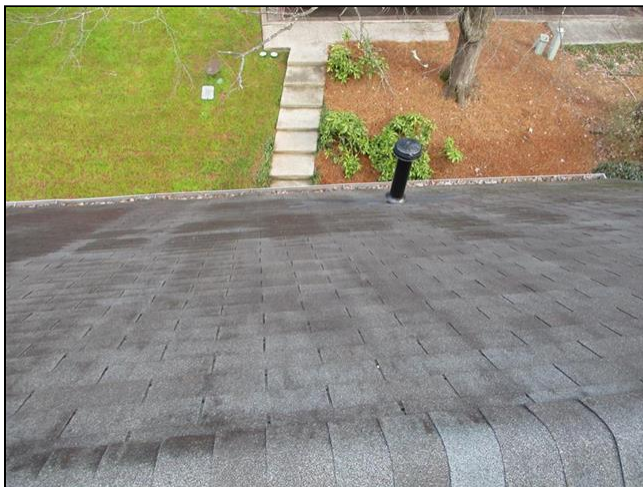
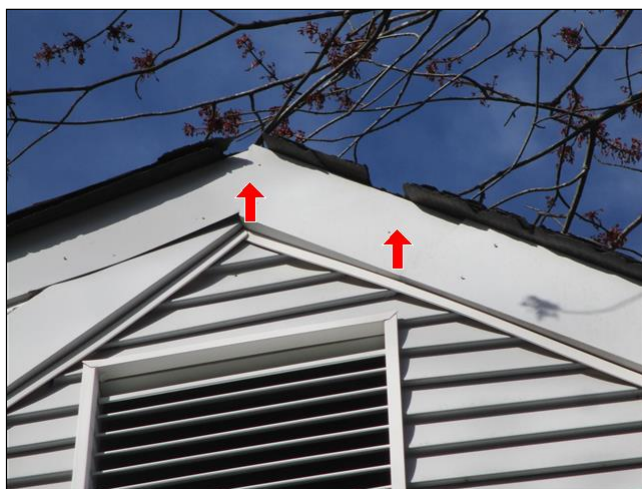
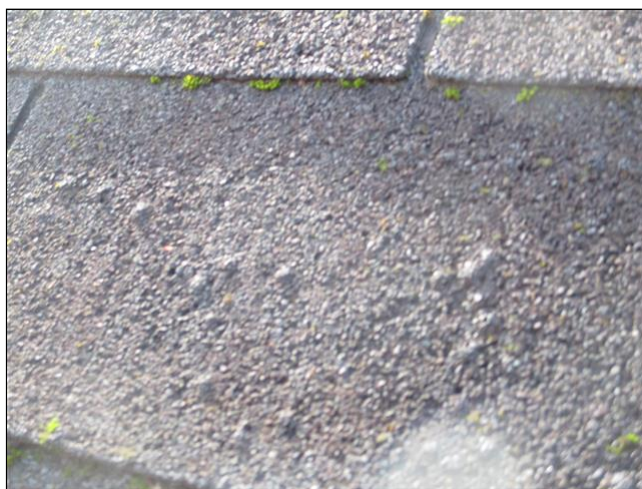
- 🔧 (2) Have roofer replaced the damaged shingles at the left side roof at the ridge line.
- 🔧 (3) The lower part of the roof on the front of the home is blistering. Likely due to lack of ventilation in lower attic. Have roofer evaluate and make any repairs/replace as needed.

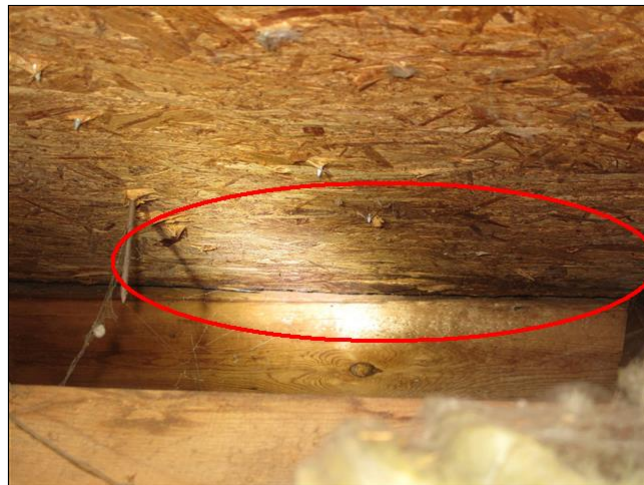
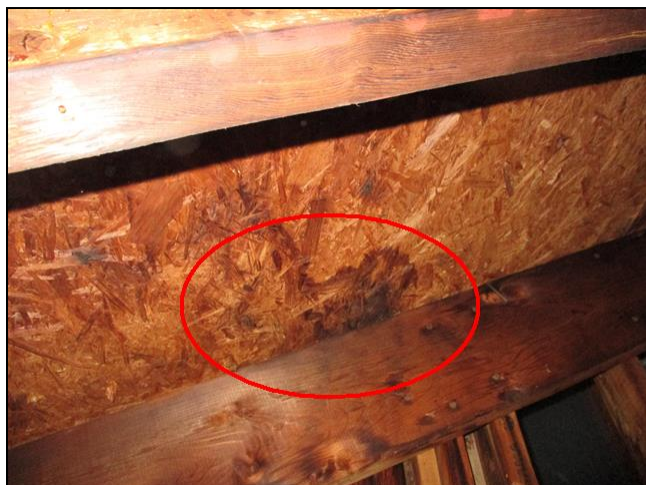
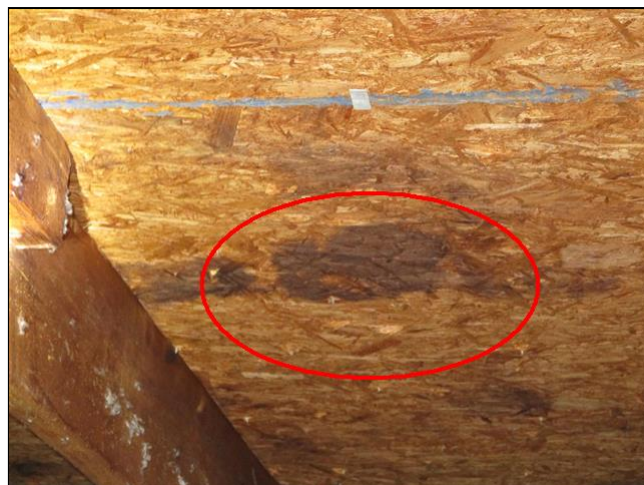
- 🔧 Water stains and possible slight damage noted in the roof decking in the attics in a couple areas. Roofer will need to evaluate roof and ensure that it is water tight. Even though these areas were not wet during the inspection, it is possible that outdoor and weather conditions could cause leaks to become active again. See photo(s) for examples of location(s).
-

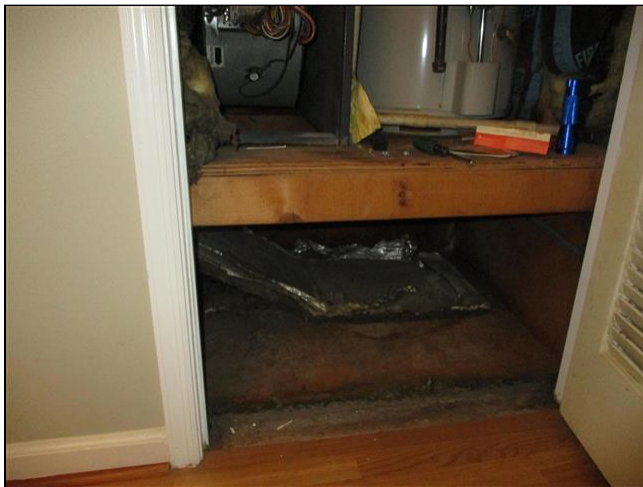
6.2 Item 3(Picture)

- (1) Have an hvac tech service the heating and cooling equipment to clean the blower motor, the evaporator coils, the condensing coils, the electrical contacts, check refrigerant levels, check size of units compared to size of home and ascertain that the heat exchangers are not cracked and the equipment is safe to operate and functioning properly. Much of internal parts of the hvac system is concealed from view, and our inspection is visual and is intended to check the function of the systems. The inspection does not make any assessment of the internal parts of the duct system, since it is not visible. Therefore, an hvac tech should evaluate for any concealed defects or hazards in the system. Furthermore, manufacturers recommend annual maintenance and servicing to keep the system working at peak efficiency.

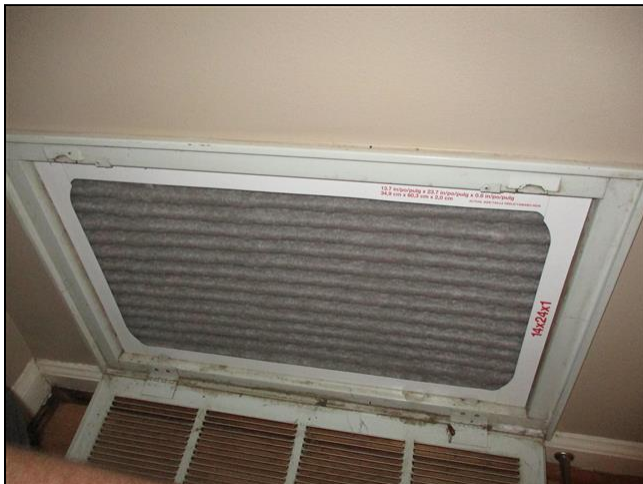
6.2 Item 4(Picture)

(2) Filter location in foyer return vent

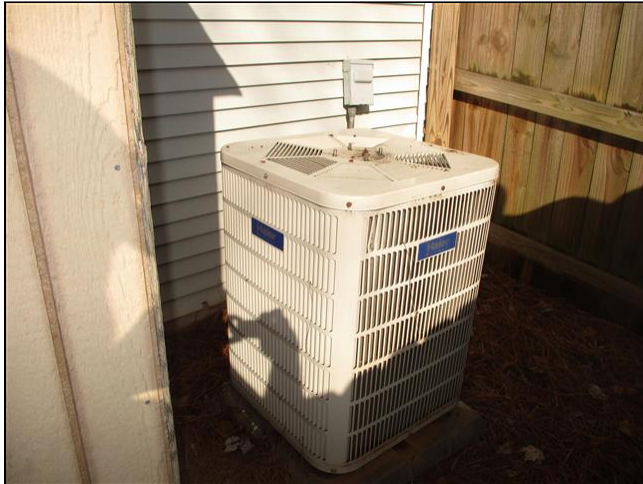
6.7 Item 1(Picture)

Along with servicing the heating unit(s), hvac tech should check refrigerant levels in the a/c system to ensure that the systems are working at peak efficiency. This inspection is visual and checks the operation of the system(s). Unit was not disassembled.

A/c units use the older R-22 type of refrigerant gas (freon) that is being phased out of production and will likely be expensive and difficult to find in the near future. The newer type of freon does not mix with the older type.

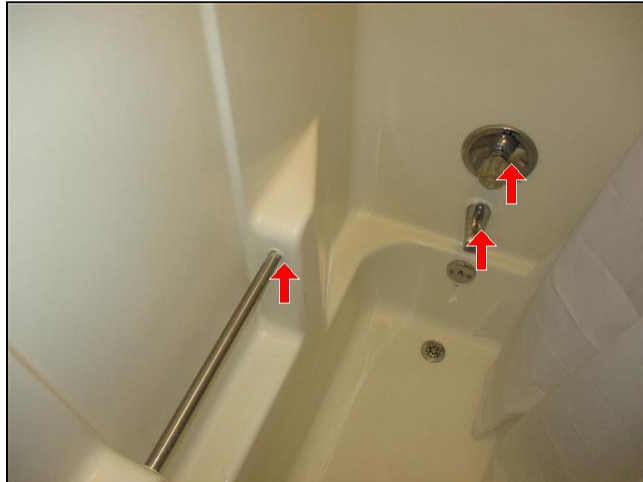
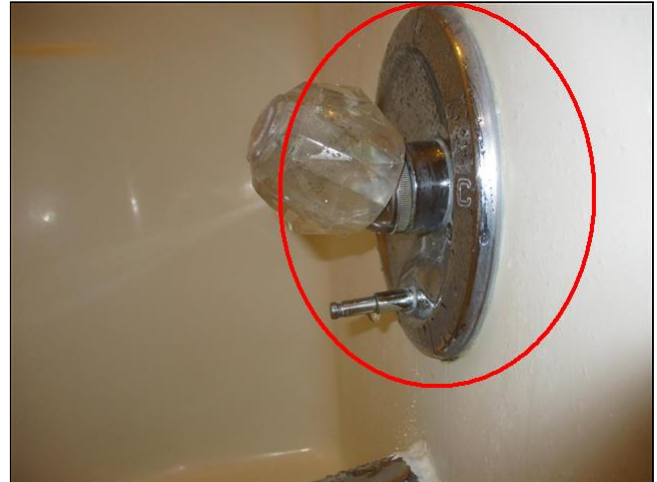
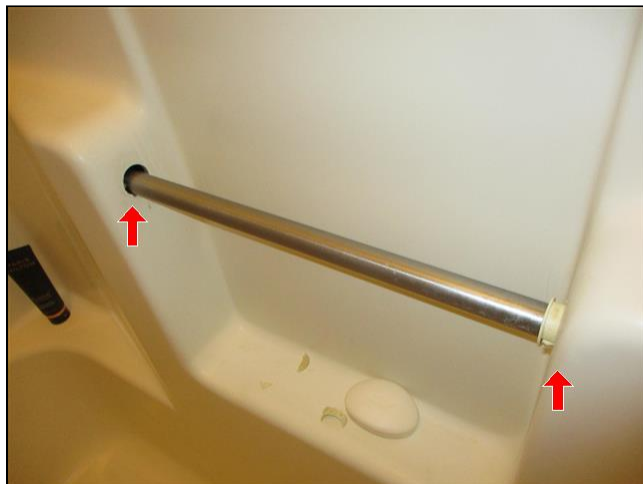
(2) Seal gaps around plumbing fixtures in shower stalls to help prevent water entry into the wall cavity behind.

Seal gaps around grab bars in shower stalls to prevent water entry into the wall cavity. See photo for example

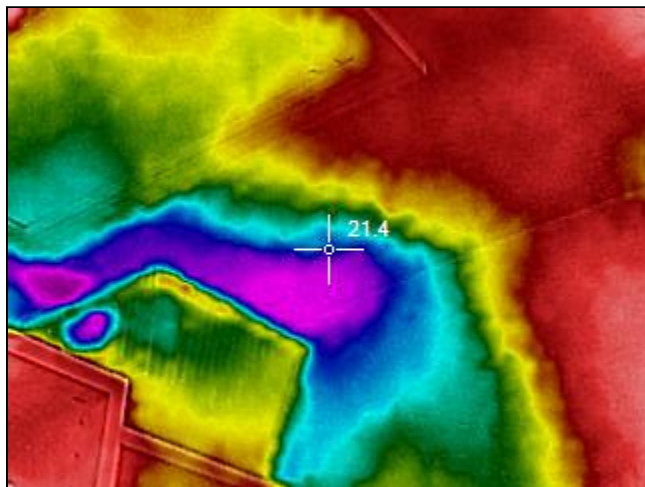
11.3 Item 3(Picture) right side bedroom closet ceiling

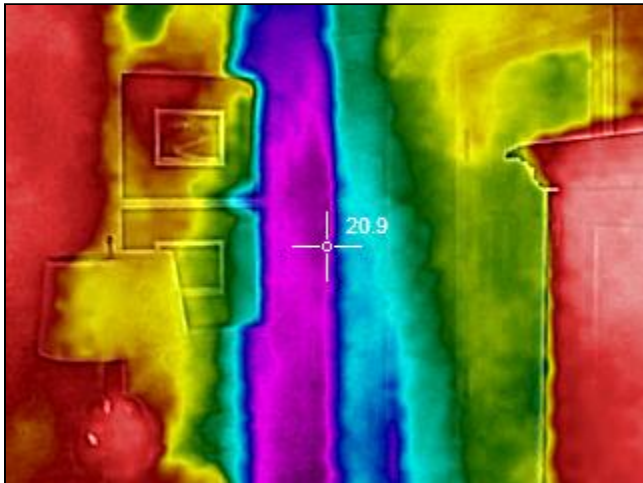
11.4 Item 3(Picture) right side bedroom
