BPG Inspection Services

**1229 McLendon Avenue Northeast
Atlanta GA 30307**

Client(s): English
Inspection Date: 3/9/2020
Inspector: Chuck Turner ,

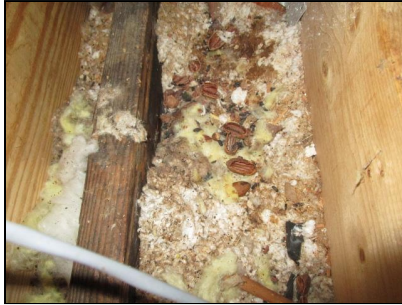
- ❌ 1. **SAFETY / HEALTH:** Although not considered as part of the scope of our inspection, there is ample evidence of pest infestation in the attic and / or crawlspace. A pest report needs to be obtained from a qualified contractor and all repairs made as outlined in the report.

Signs of rodent intrusion in the attic and crawlspace.

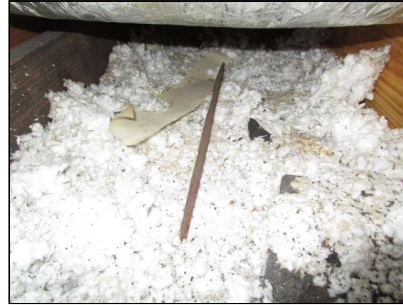
Signs of rodents in the insulation.

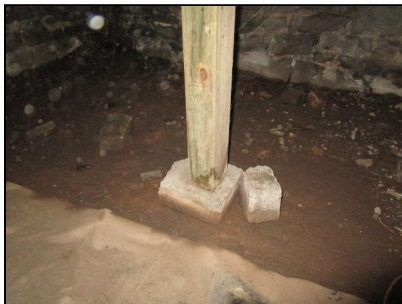
- ❌ 2. **MAJOR DEFECT:** There are numerous improperly installed supports for additional beams in the crawlspace. Many of the support posts were installed on bricks or small concrete blocks. Screw posts were used in several places. Some screw posts in contact with the soil. Have a general contractor evaluate all framing and posts in the crawlspace and repair as needed.

Evaluate all posts, install proper footers to prevent settling

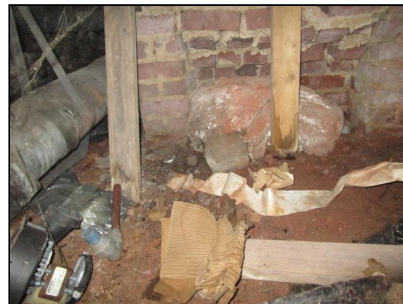
Support posts missing footers, in contact with the soil.

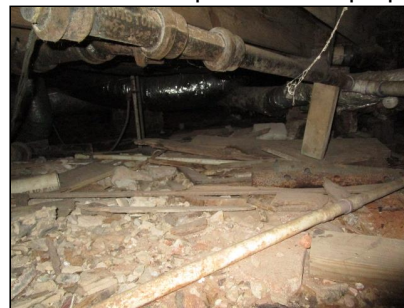
- ❌ 5. **SERVICE / REPAIR:** Wood and other cellulose debris found in crawlspace. Required by most termite companies to eliminate conducive conditions for termites. Have all removed for best protection of property.

Remove all debris from the crawlspace.

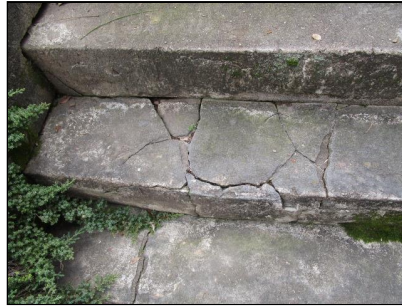
- ❌ 6. **SERVICE / REPAIR:** The concrete stairs are cracked and damaged. Repair the stairs.

Repair cracked front stairs.

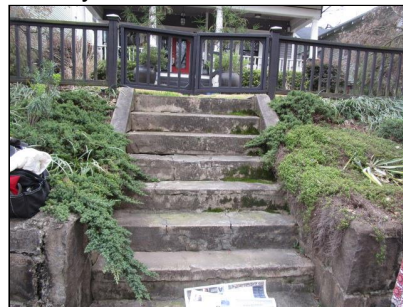
- 7. **SERVICE / REPAIR:** Missing hand railing on at least one side of stair. Required for any stairway of 30 inches or more in height (more than 4 steps). Recommend install for safety.

Add handrail to the stairs at the front of the house.

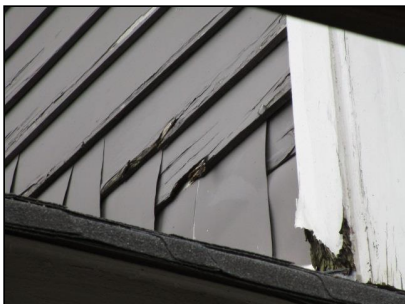
- 8. **MAJOR DEFECT:** Extensive deterioration of the siding/trim materials observed. Have a professional contractor evaluate and repair or replace as needed.

Replace all damaged siding.

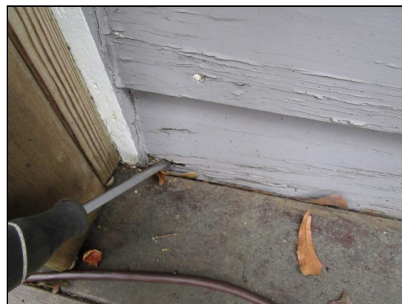
Replace damaged siding

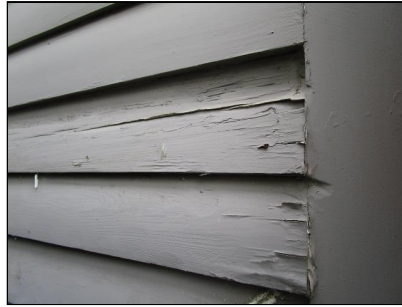
Replace damaged siding

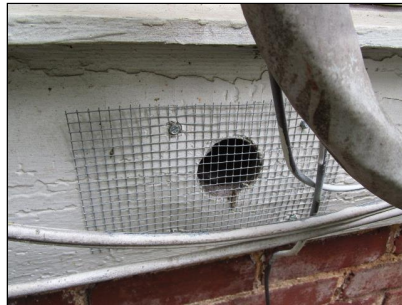
Have holes in the siding repaired.

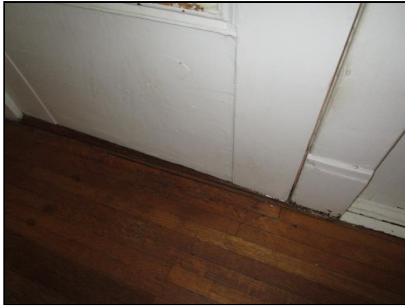
- ☒ 10. **SERVICE / REPAIR:** The exterior door sticks and is difficult to operate at the front and rear entry doors. The rear door does not latch properly and will not secure easily. Daylight is visible around the rear french doors. Modify or repair as necessary to operate normally.

Front door sticks at the sill.

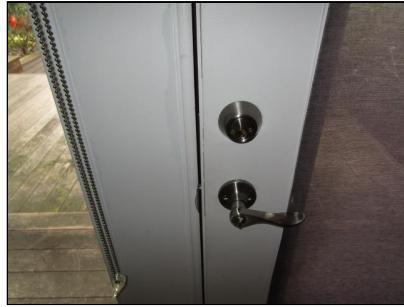
Rear doors stick at the bottom and do not latch properly.

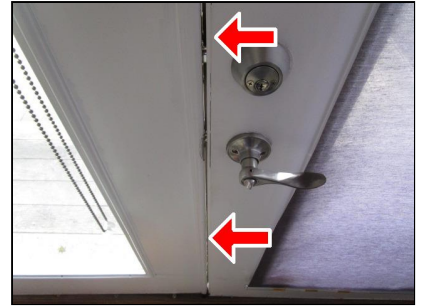
Daylight visible between doors.

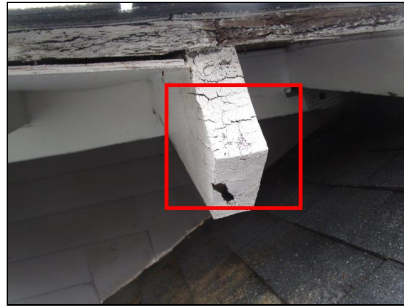
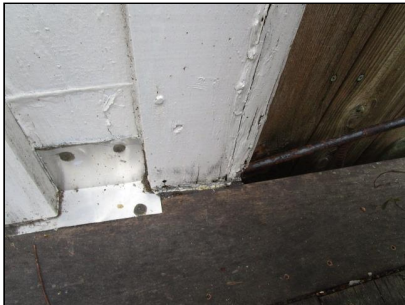
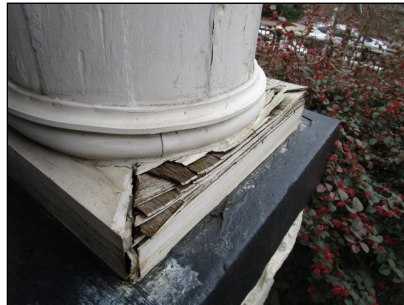
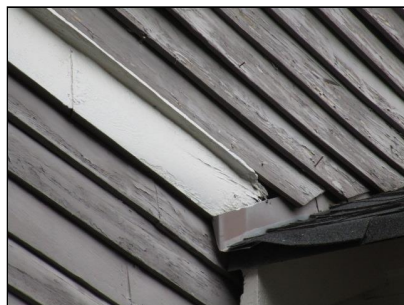
❌ 11. **MAJOR DEFECT:** Wood rot and deterioration are present. Evaluate all areas and replace/repair all wood rot to the extent found to prevent further damage to any area. All replacement wood should be primed on all sides, caulked and painted as required. Any damage on the exterior wall or trim that allows openings into the wall cavity or interior can cause significant water damage over time if not repaired.

Repair all damaged trim

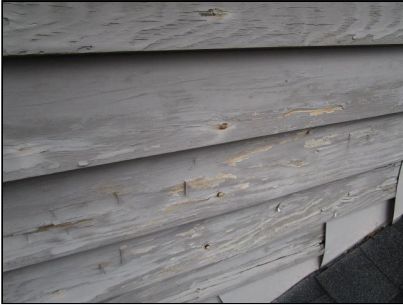
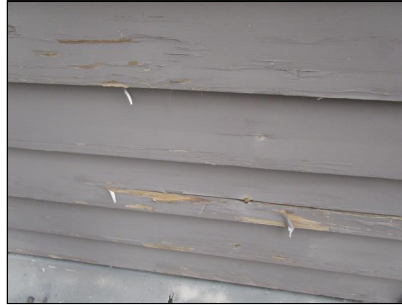
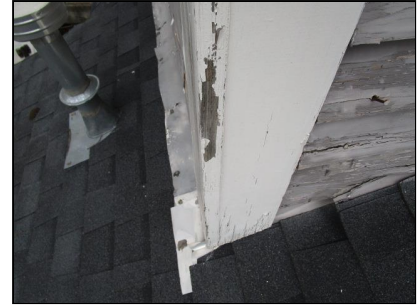
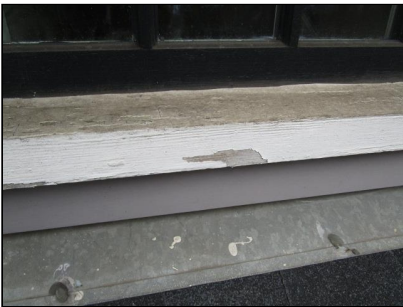
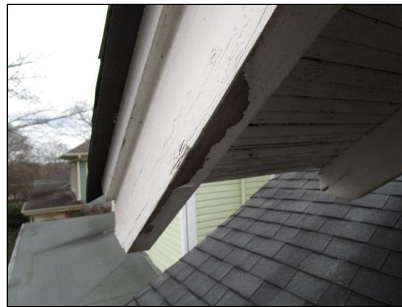
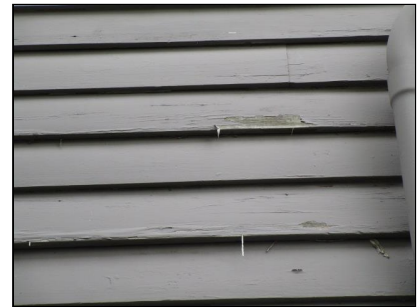
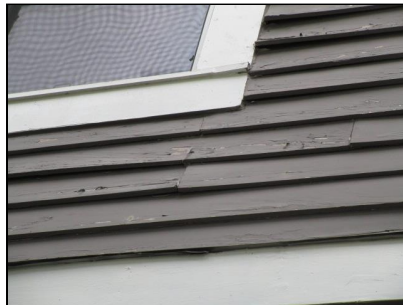
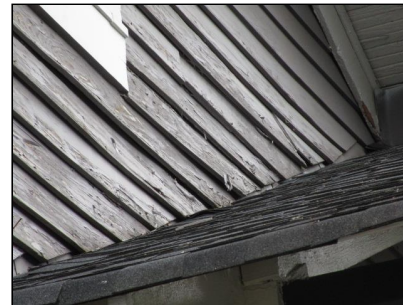
- ❌ 12. **MAJOR DEFECT:** Paint on the siding, window and door trim, soffit and fascia found in weathered condition. Sand, prime bare wood, caulk and paint to prevent moisture damage to the affected areas.

Paint weathered and peeling on the siding

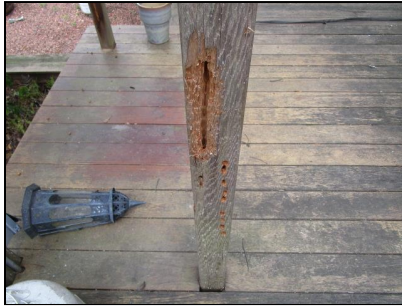
- ❌ 13. **SERVICE / REPAIR:** There is noticeable carpenter bee damage to the rear deck roof support posts with residue splattered on surfaces below entry hole. Damage is generally not significant but should consider having repaired by sealing holes to avoid further damage to the wood.

Repair carpenter bee damage to the deck roof support posts.

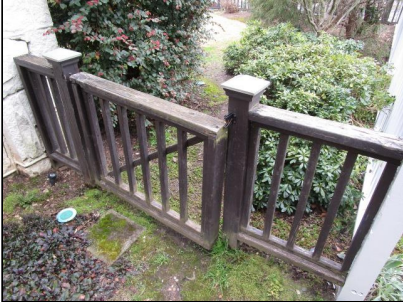
- ❌ 16. **SERVICE / REPAIR:** Damaged sections of fencing observed. Have the fence repaired or modified in a manner to contain children or pets as needed.

Gates do not close and latch properly

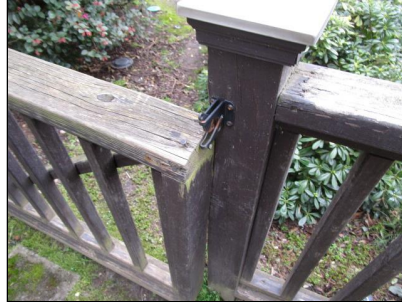
Repair all gates in the fencing.

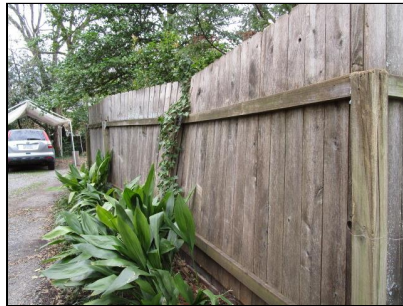
Secure the loose fence post at the rear of the house.

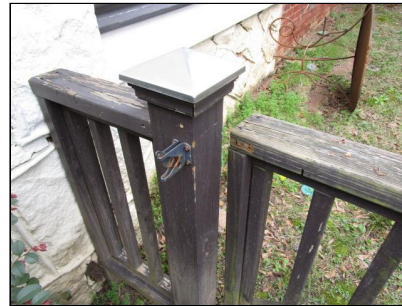
Repair all gates to latch properly.

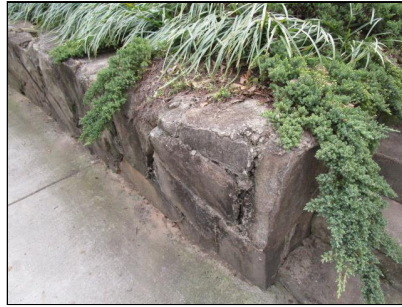
- ❌ 17. **MAJOR DEFECT:** Deterioration of the retaining wall observed. Have a professional contractor evaluate the wall and repair as necessary.

Retaining wall leaning and cracking.

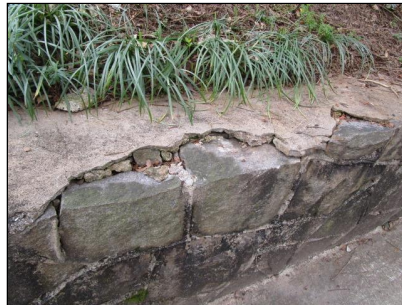
Extensive deterioration of the exterior front retaining wall.

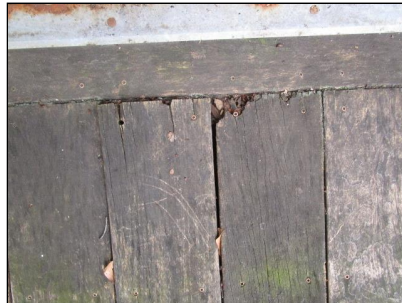
- ❌ 18. **SERVICE / REPAIR:** Deck boards are weathered and rotting. Recommend evaluate all and repair / replace to the extent found.

Replace damaged decking.

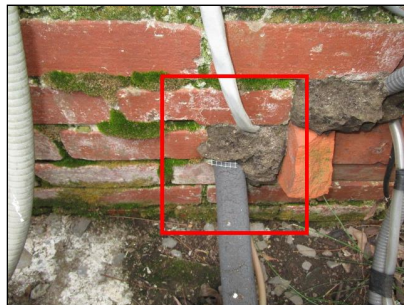
- ❌ 20. **SERVICE / REPAIR:** No metal hood for HVAC line penetration of siding installed. Recommend install and seal to prevent moisture and insect access.

Add vent hood where missing

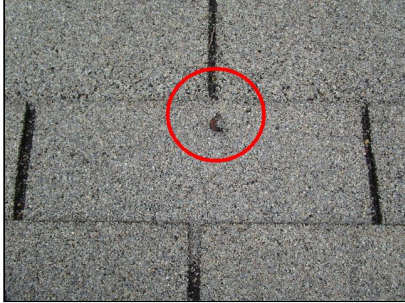
- ❌ 22. **SERVICE / REPAIR:** Nail pops lifting / penetrating shingles in several locations. Have loose shingles secured to prevent wind or moisture damage. Nails popping through roof surface can allow moisture intrusion. Entire roof should be evaluated and all exposed nails should be removed and the holes sealed to protect from moisture.

Nail pops penetrating shingles.

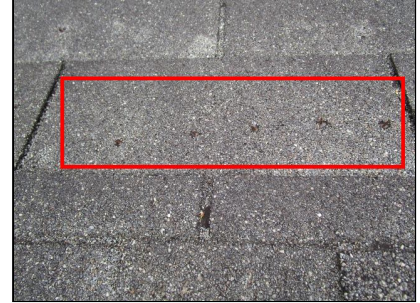
Nails penetrating shingles.

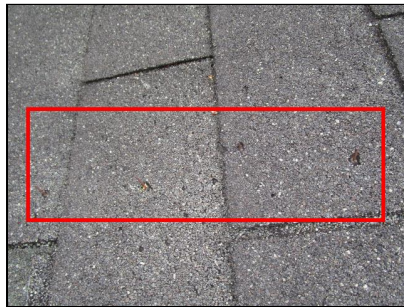
Numerous nails penetrating the shingles.

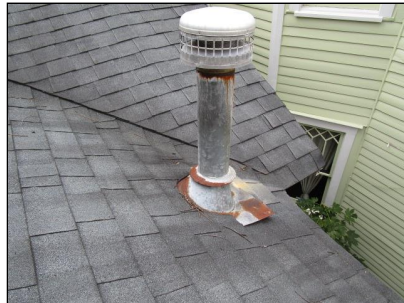
- ☒ 24. **SERVICE / REPAIR:** Metal flue assembly on roof is rusting. Recommend clean and paint with rust inhibitor paint designed for high temperatures to prevent further damage and moisture intrusion.

Prime and paint the flue assembly

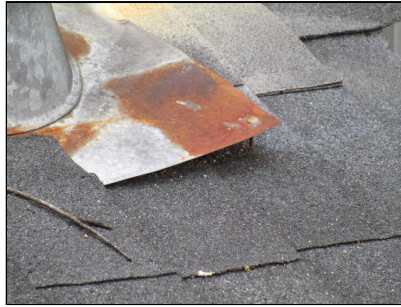
- ☒ 25. **SERVICE / REPAIR:** Flange of furnace flue found raised / loose and recommend having corrected by roofer to avoid pest intrusions to attic.

Secure the loose flange to the roof.

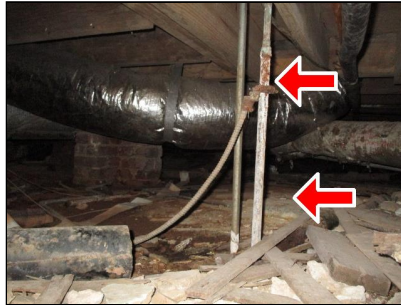
- ❌ 26. **SERVICE / REPAIR:** Water supply lines in this properly found to be galvanized pipe in some areas. Galvanized service line is responsible for reduced pressure with multiple fixture use. Brown tint is also a common upon initial use. Replacement is only remedy to provide normal pressure - decision to replace is somewhat subjective in many cases. Recommend a licensed plumber inspect further and repair as necessary.

Replace all galvanized pipes in the crawlspace.

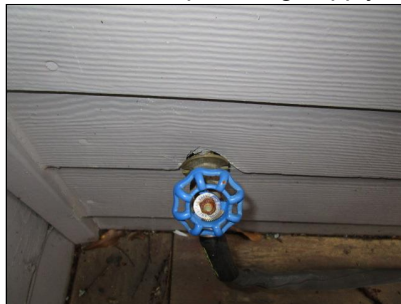
- ❌ 27. **SERVICE / REPAIR:** The exterior spigot was found loosely mounted to wall at the rear of the house and should be properly secured in place to avoid excess stress on plumbing supply line when pulling on garden hose.

Secure the rear hose bibb to the siding. .

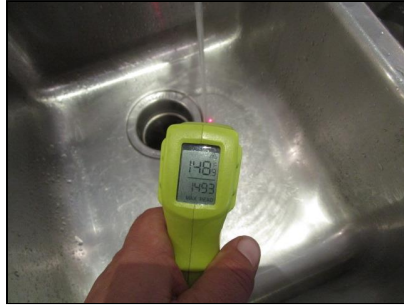
less than optimum temperature. Temperatures higher than 120-125 degrees is not safe for personal and child safety reasons and should be lowered.

Turn the water heater down, 148 degrees.

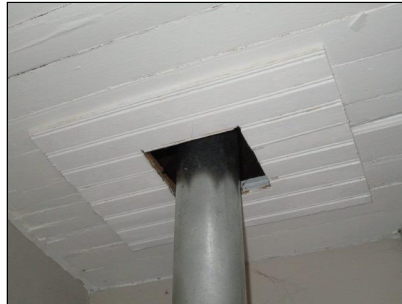
- ❌ 29. **SAFETY / HEALTH:** The water heater vent stack does not have a fire stop where it enters the ceiling. Where the vent enters the ceiling there should be an appropriate gap from combustable materials (six inches for single wall vents and one inch for double wall vents) and a fire barrier composed of an approved material to resist the free passage of fire or the products of combustion. Recommend a licensed plumber inspect further and repair as necessary.

Add required firestop at the flue penetration through the ceiling.

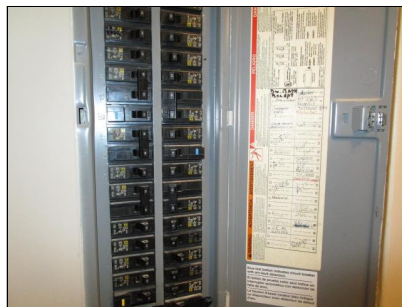
- ❌ 30. **SERVICE / REPAIR:** The panel box is not properly or completely labeled. All electrical disconnects should be clearly labeled so that they can be easily de-energized in case of emergency and for purposes of electrical work. Correct as necessary.

Properly label the interior of the panel box.

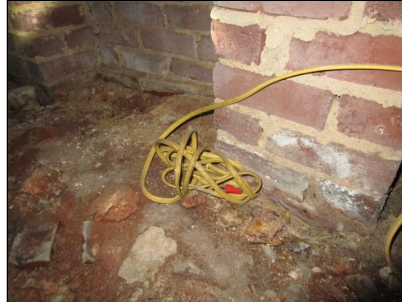
- ❌ 31. **SAFETY / HEALTH:** Improper wiring observed. All electrical splices and terminations should be inside of an approved junction box with cover plate for safety. Recommend a licensed electrician to evaluate the condition and correct for compliance. **LOCATION:** Crawlspace.

Secure loose wiring and terminate in a junction box.

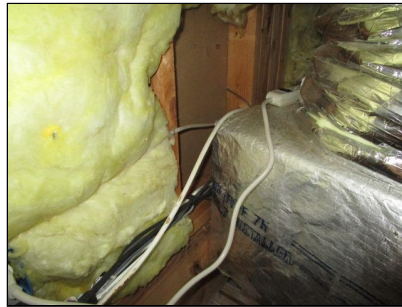
- ❌ 32. **SERVICE / REPAIR:** Extension cords are being used as permanent wiring in the attic at the heat pump. Have the cord removed or have an electrician evaluate and run dedicated circuits to replace the extension cord.

Add receptacles and eliminate the extension cord.

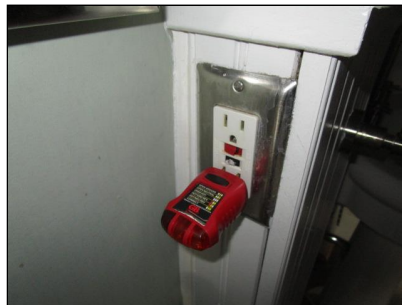
- ❌ 33. **SAFETY / HEALTH:** GFCI receptacle measured dead and would not reset. All other resets throughout property were checked to verify reset and would recommend having electrician review and correct as necessary. **LOCATION:** bathroom receptacle

Replace the damaged bathroom receptacle.

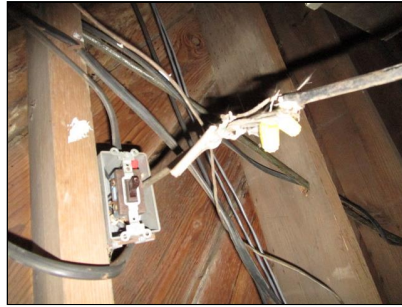
- ❌ 34. **SERVICE / REPAIR:** Missing receptacle/switch plates noted. Replacement is advised to prevent an electrical hazard. One switch in the attic is improperly wired and there is a missing junction box at the connection for the condensate pump in the attic. **LOCATION: Attic area, main level**

Add switch plate, properly install wiring for the condensate pump in the attic.

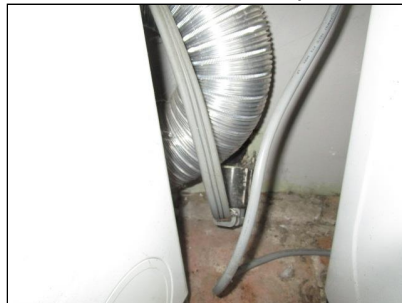
- ❌ 35. **SAFETY / HEALTH:** Loose wall receptacles should be securely mounted in the wall where found. Recommend a licensed electrician to evaluate the condition and correct for compliance. **LOCATION: Dryer receptacle**

The dryer receptacle is loose from the wall.

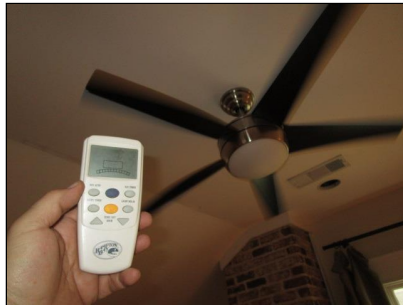
- ❌ 37. **SERVICE / REPAIR:** Replace the batteries in the remote control for the light / fan so the unit can be operated properly

Replace batteries and test the fan / light in the upper level

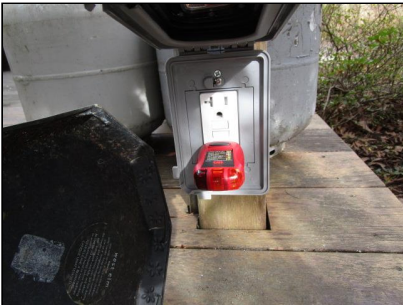
- ❌ 38. **SERVICE / REPAIR:** The lights in the laundry room were inoperable. The lights, receptacles and fans on the rear porch were not functional. Have an electrician evaluate and repair as needed.

No power to the exterior receptacle on the rear porch

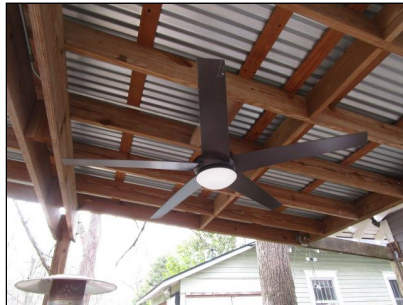
Fan and light not functional.

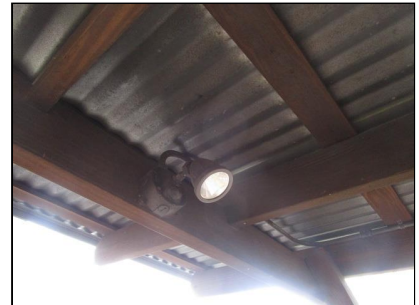
Rear lights not functional.

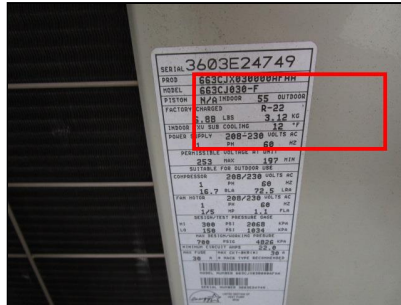
- ❌ 39. **GENERAL NOTE:** The upper level A/C unit in this home operates on R-22 refrigerant. R-22 refrigerant has been phased out of production or importation into the United States as of January 1, 2020. The buyer should expect the cost for R-22 refrigerant to increase significantly to the point where charging the system, if needed, will become prohibitively expensive. The buyer should discuss the scope of any repairs with the A/C technician prior to authorizing repairs to determine the cost if refrigerant is needed. If refrigerant needs to be added, there is a leak in

the system that should be identified and repaired. Replacement of the system may be a more cost effective option if repairs and refrigerant are necessary.

R-22 refrigerant in the upper level system

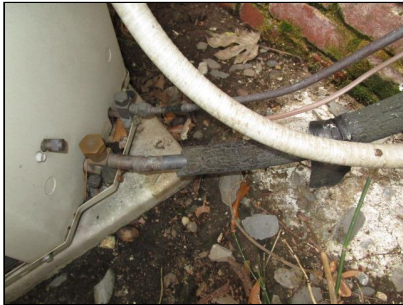
- ❌ 40. **SERVICE / REPAIR:** A/C compressors have an average life expectancy of 12 -15 years. The upper level compressor is 17 years old and the main level unit is 13 years old. Advise to budget for future replacement or recommend that warranty program be set up. Recommend that the units be serviced, cleaned and returned to a warrantable condition or replaced if necessary prior to closing.
- ❌ 41. **SERVICE / REPAIR:** Freon refrigerant line insulation is damaged / missing. Replace and repair to prevent condensation and energy loss during operation.

Add insulation where missing

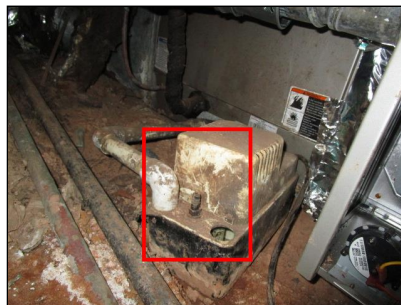
- ❌ 42. **SERVICE / REPAIR:** The condensate drain line is not properly secured to the pump. Have a new hose installed and properly secured to the pump.

Drain line not properly connected to the pump.

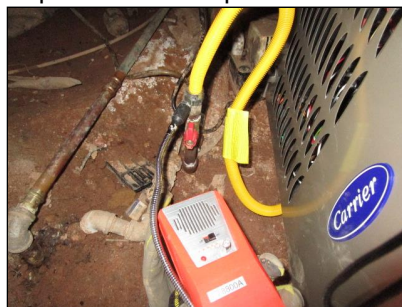
- ❌ 45. **SAFETY / HEALTH:** Gas leak measured with TIFF 8800 at unit. Have leak verified and repaired for safety. Recommend a licensed plumber or HVAC professional inspect further and repair as necessary.

Gas leak detected at the junction at the crawlspace furnace.

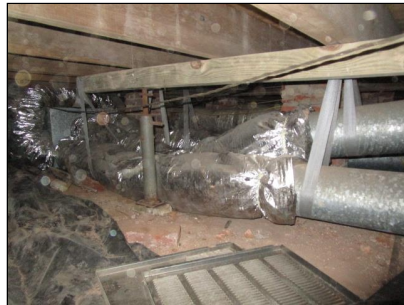
- ✘ 47. **SERVICE / REPAIR:** Areas of ductwork found without insulation. All supply and return air ductwork installed in uninsulated spaces are required to be insulated to prevent energy loss and prevent condensation in and on system. There are ducts on the ground in several places and one damaged return duct. Have all ducts repaired and removed from ground contact. Have damaged and missing insulation replaced. Recommend insulation be installed where missing.

Remove ducts from ground contact.

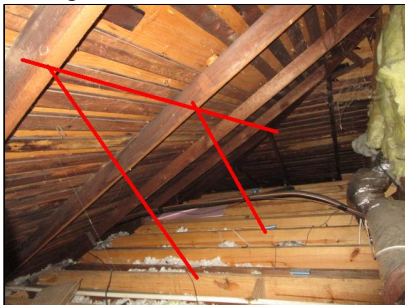
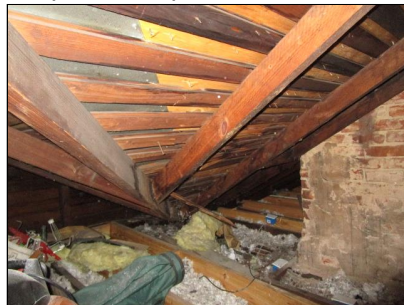
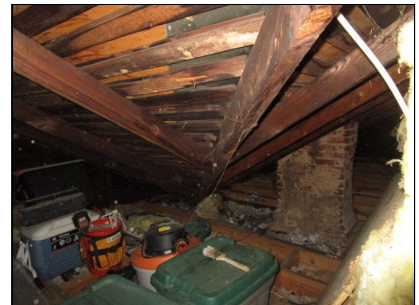
- 48. **SERVICE / REPAIR:** Purlins are permitted to be installed to reduce the span of rafters. Purlins shall be sized no less than the required size of the rafters that they support. They shall be continuous. They shall be supported at a minimum by struts (braces)installed to load bearing walls at a slope not less than 45 degrees from the horizontal. The braces shall be spaced not more than 4 feet apart and the unbraced length of braces shall not exceed 8 feet. (over 8 feet requires a second member nailed to the first at 90 degrees to prevent deflection of the strut (T braced) . Have a general contractor evaluate and repair as required.

Add a purlin and brace system to prevent sagging of the roof.

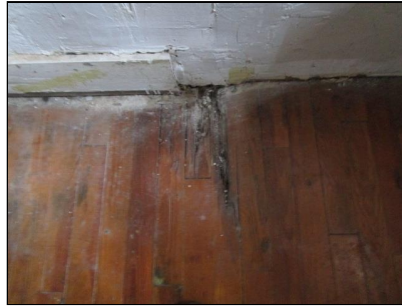
- 49. **MAJOR DEFECT:** Damaged areas of flooring observed. Have a professional flooring contractor evaluate and repair or replace the flooring as needed.

Damaged flooring in the rear closet.

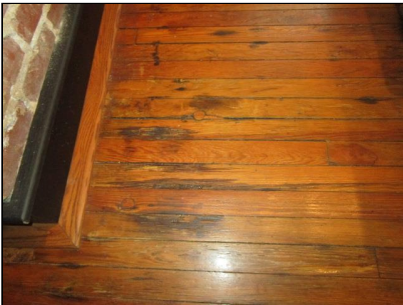
Damaged flooring in the kitchen

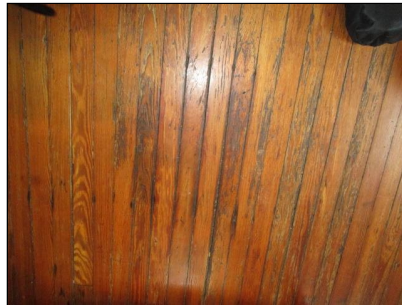
Damaged flooring in the kitchen.

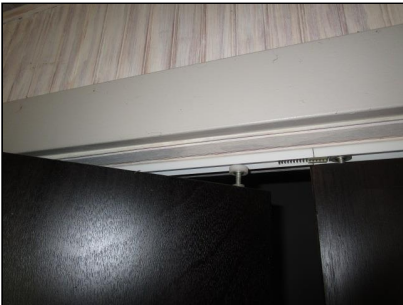
- ☒ 50. **SERVICE / REPAIR:** The doors stick when tested. Evaluate and correct all doors for proper operation. Verify latching when after corrected. Possibly a result in improper installation, settling or misaligned hardware.

Laundry doors do not track properly

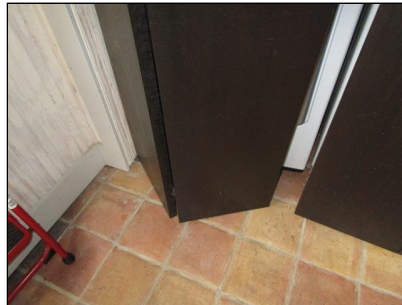
Laundry doors rub on the floor.

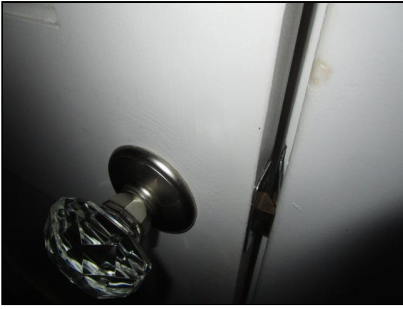
- ☒ 51. **SERVICE / REPAIR:** Modify or adjust door to latch when closed. Recommend correcting to latch as intended.
LOCATION: Office door doesn't latch, main room closet doors

Adjust all doors to latch properly

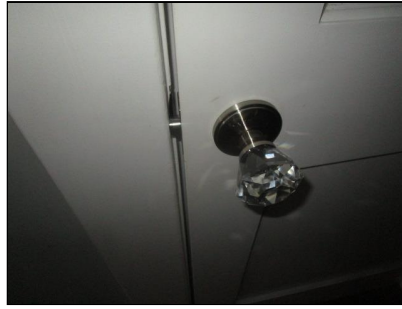
Adjust all doors to latch properly

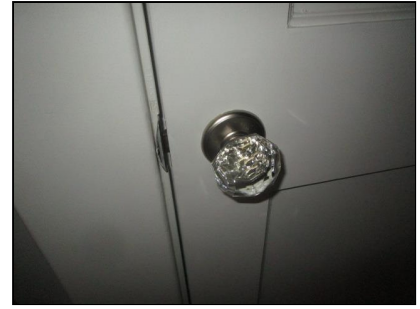
Adjust all doors to latch properly

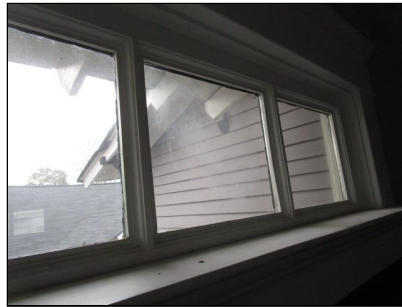
- ❌ 52. **SERVICE / REPAIR:** Condensation and / or hazing was noted between insulated window panes. - Location: upper level small windows - The thermopane insulated glass has lost its vacuum seal and may eventually completely cloud over. Broken seals also reduce the original insulation value of the window. (Dirty windows should be cleaned to assure that conditions do not exist in other units and were not obvious at time of inspection.) Recommend replacement of all damaged windows listed plus any others throughout house that may be identified by glass service.

Failed windows in the upper master sitting area

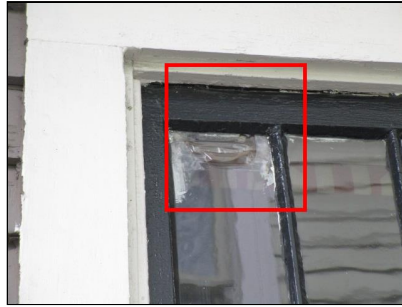
Replace cracked and damaged window panes.

- ❌ 54. **SERVICE / REPAIR:** Cracked window observed. Inspect all windows and replace the affected glass as needed.
LOCATION: Several window panes throughout the house.

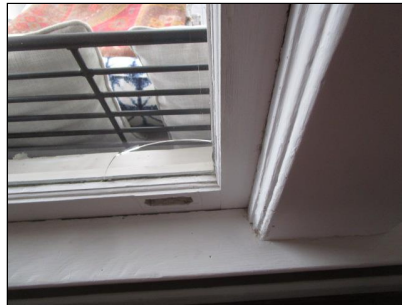
Replace all cracked window panes.

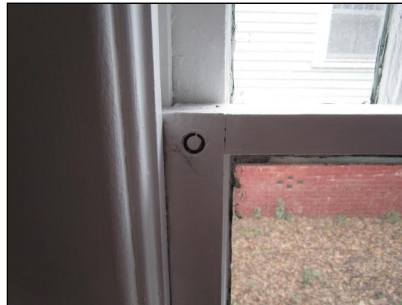
- ❌ 55. **SERVICE / REPAIR:** Windows found pinned for security with special tool available for removal. These locking devices are prohibited from use in bedrooms for secondary emergency egress. Recommend having eliminated and insure that latches are adequate.

All main level windows were pinned shut.

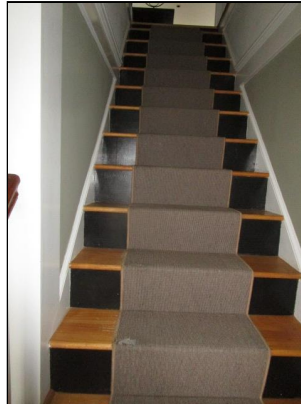
Add missing handrail at the stairs to the upper level

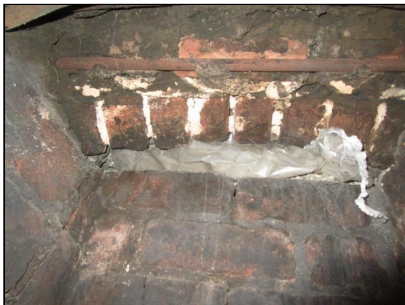
Some fireplaces blocked off.

57. **MAJOR DEFECT:** The NFPA (National Fire Protection Association) recommends a Level II examination of a chimney flue whenever a real estate property changes ownership. This examination includes a complete review of all accessible portions of the fireplace and chimney from the top to the bottom, including both the interior and exterior portions. Video scanning equipment or other means shall be used as necessary to observe these areas. There are no dampers on the fireplaces. Have dampers installed. Some fireplaces are currently only decorative and may need extensive repairs to make functional. Some fireplaces will probably only be able to have gas logs installed.

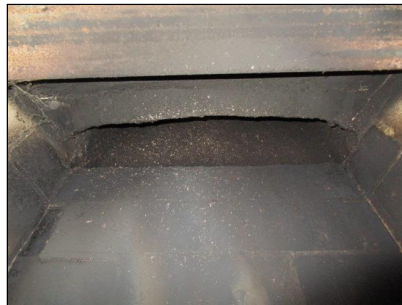
Have chimney swept and inspected, repaired as needed.

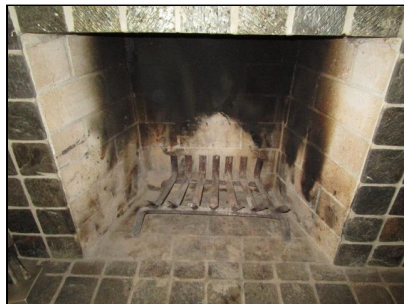
Have chimneys swept.

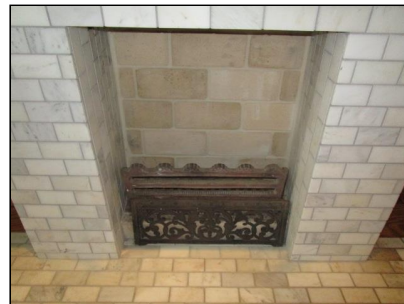
Fireplace too shallow for anything but gas logs

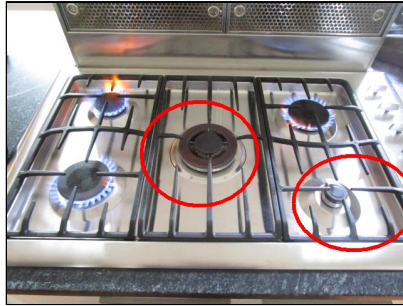
- ❌ 58. **SERVICE / REPAIR:** Cooktop gas burner on the middle and right front fails to light through ignition source provided (will light manually). Possibly just dirty. But if unable to clear to function properly, recommend that appliance repair technician review and repair to function as designed.

Burners did not light, were lit by hand.

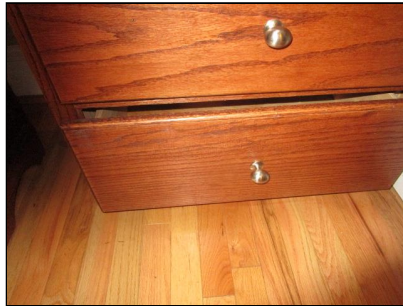
- ❌ 59. **SERVICE / REPAIR:** Master bathroom cabinet drawers found to be rough in operation with guides damaged or failing. Recommend reviewing conditions and have corrected or replaced to provide normal access to storage items.

Repair drawers in the master bathroom

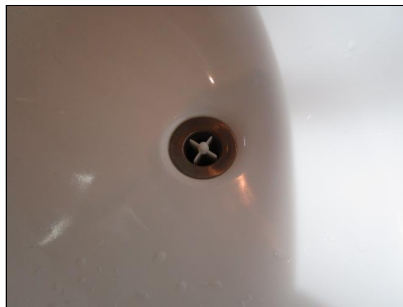
- ❌ 60. **SERVICE / REPAIR:** Pop up drain stopper device is missing at the master bathroom vanity sink and should be replaced to function as designed.

Replace the missing pop up drain.

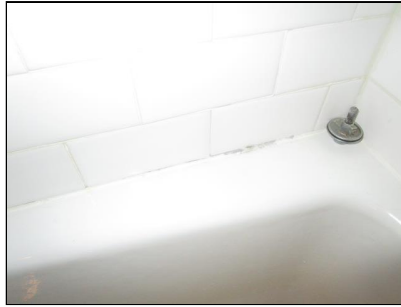
- ❌ 61. **SERVICE / REPAIR:** Mildew in caulking found at bathing area of the guest bathroom. Recommend having affected caulking removed and replaced.

Remove and replace mildewed caulk in the guest bathroom

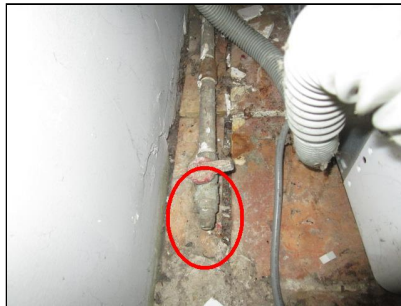
- ❌ 62. **SERVICE / REPAIR:** Unused gas line to clothes dryer should have open end capped for added safety even with in line valve off.

Cap the gas line at the dryer if not used.
