Atlanta Property Inspections, Inc.

HOME INSPECTION REPORT

5892 Gresham Place, Mableton, GA 30126
Inspection prepared for: Ashley Zomalt
Date of Inspection: 3/14/2020 Time: 9:30 AM
Age of Home: 63 Years Old (1957) Size: 1918 SF
Weather: Overcast, Damp Soil, 58 Degrees

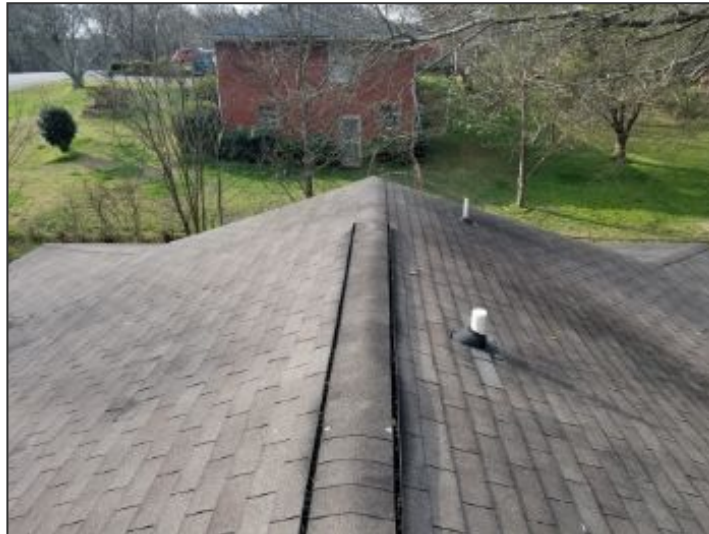
Walked roof during inspection

• **ROOF INSPECTION ACCESS:** The inspector walked on the roof during this inspection. Not all inspectors will walk the roof during the home inspection. We make every effort to walk the roof, when possible and safe, to provide our clients with a more detailed roof inspection.

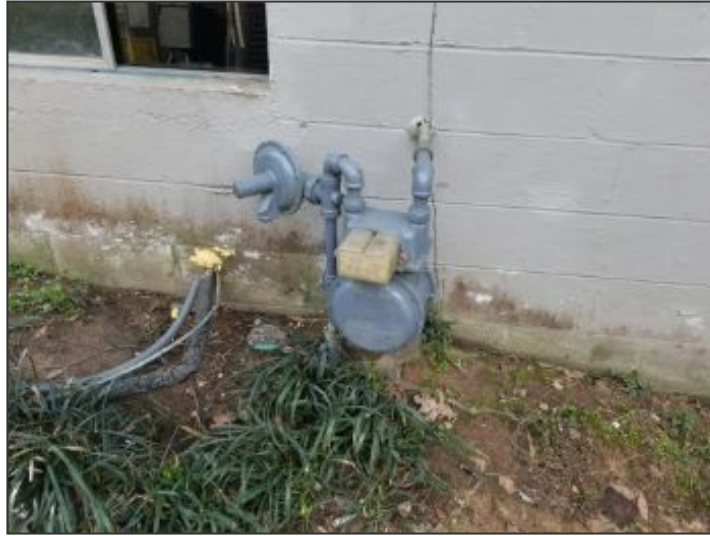
Gas meter at right side wall

• The gas meter is located at the right side wall exterior wall and appears serviceable; no concerns were found.
 (NOTE: The gas lines inside the walls, ceilings and floors are not fully visible for inspection and could not be evaluated).

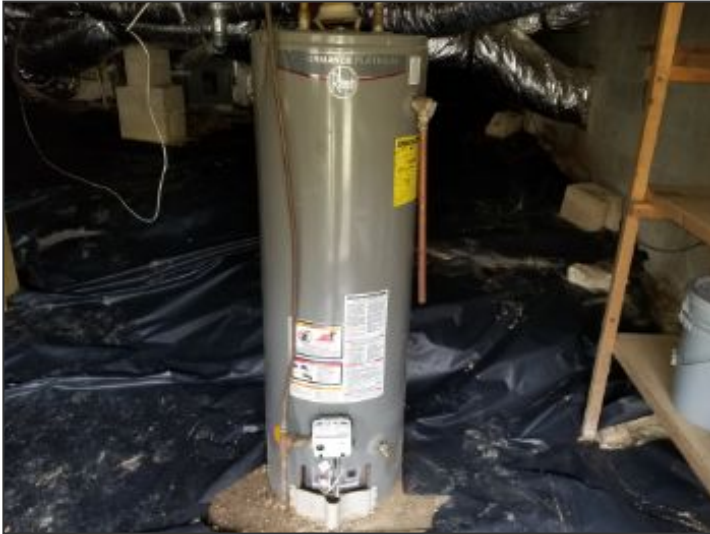
Water heater located in crawl space

- **The gas water heater appears serviceable, no concerns were noted. The gas piping, exhaust venting and **combustion air** requirements all look good except as mentioned below.**

- **The temperature and pressure (T&P) relief drain pipe incorrectly drains onto the crawl space floor which is not advised. Correction is recommended by a qualified plumbing contractor so that the drain terminates outside or into an approved drain.**

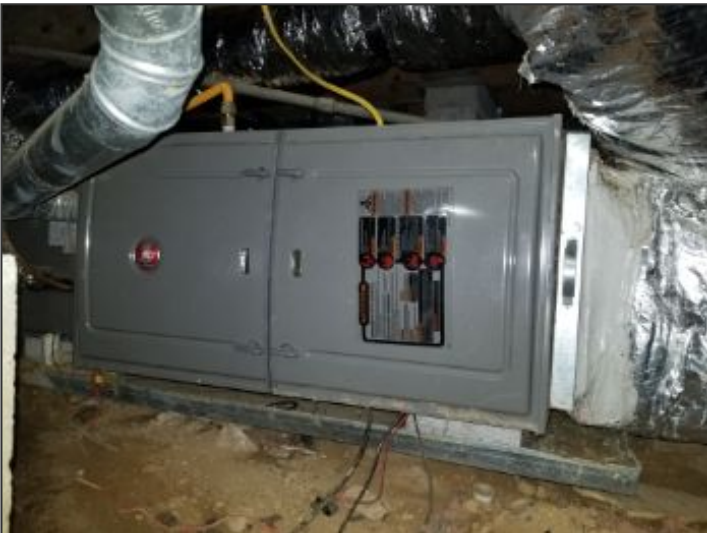
Furnace located in crawl space

• **The heating system appears serviceable; the heating system was operated and was found to be functioning normally during a limited visual inspection, no significant concerns were noted. Continue to maintain the system and have it serviced regularly.**

• **The electrical wiring to the furnace does not include the protective conduit or cable as required by the National Electric Code (NEC). Correction is recommended by a licensed electrician.**

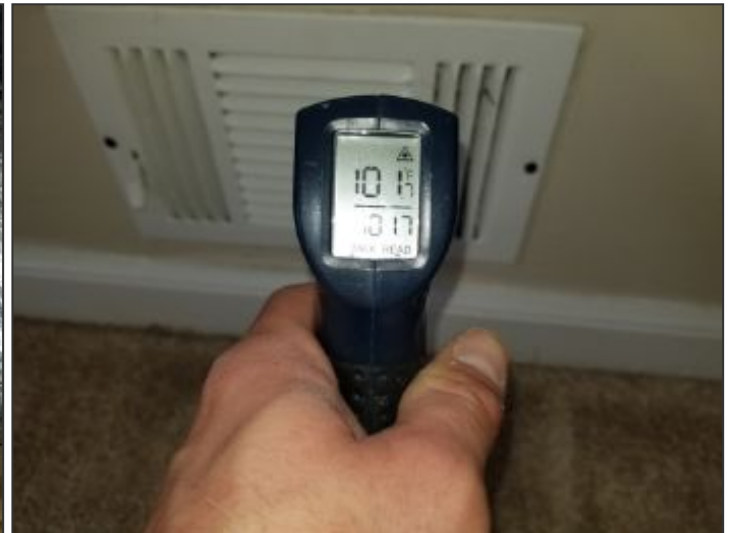
Good temps during testing of furnace

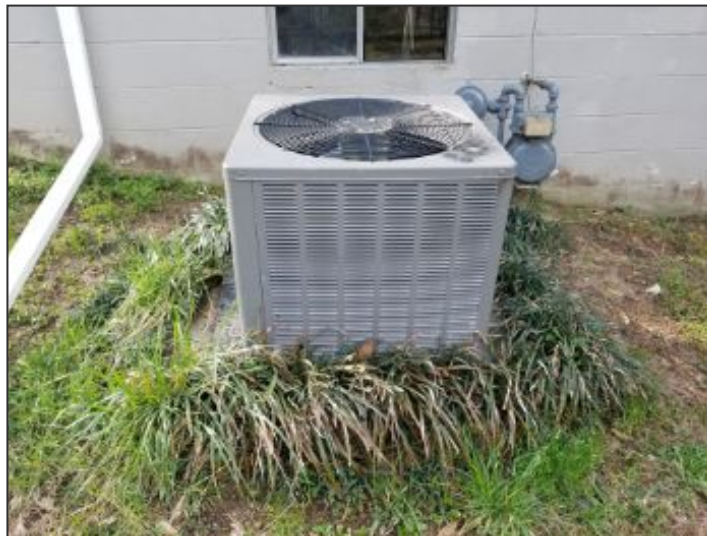
AC unit at right side wall

• **LIMITED INSPECTION:**

We are unable to inspect the cooling system due to cold weather. The outside temperatures have dropped below 60 degrees during the day or during the previous overnight hours. Due to concerns regarding possible damage to the unit, the air conditioner was not operated and could not be fully inspected during this cold weather inspection. This inspection is limited to a visual inspection and a quick start up to insure the unit is functional.
