National Property Inspections

Dianna Newton, 1685 Stanwyck Terrace, Tucker, GA, 30084

Inspection Date:
02/18/2020

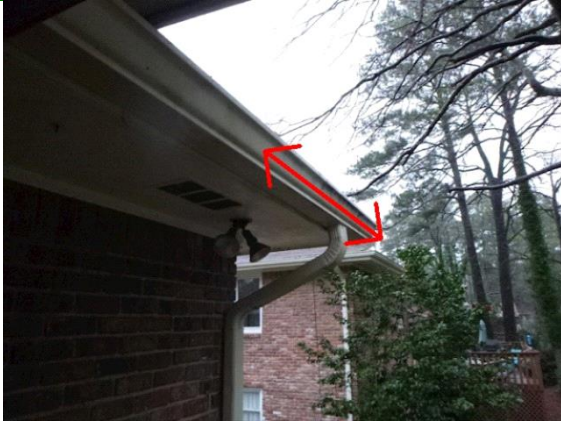
Gutters have signs of overflowing during heavy rainfall, however they are in good condition and are lean. This is likely due to excessive rainfall. Unable to determine a solution. You may want to consult with a gutter contractor for further evaluation and recommendations.

Gutters/Down Spouts: signs of overflowing

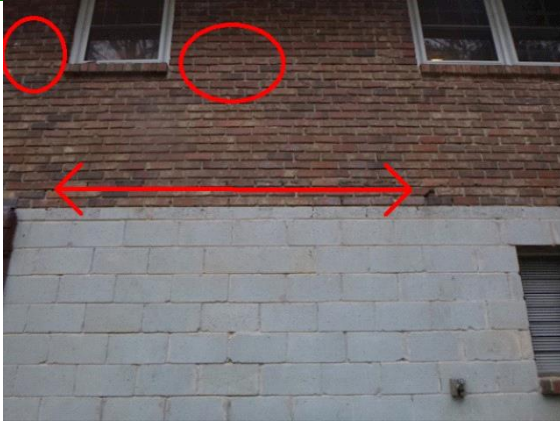
There are numerous holes in the brick at the rear of the home due to an old deck having been removed. There are also some voids in the mortar above this area at the rear of the home. Recommend a qualified contractor seal the holes to prevent water/pest intrusion.

Exterior Surface: seal holes

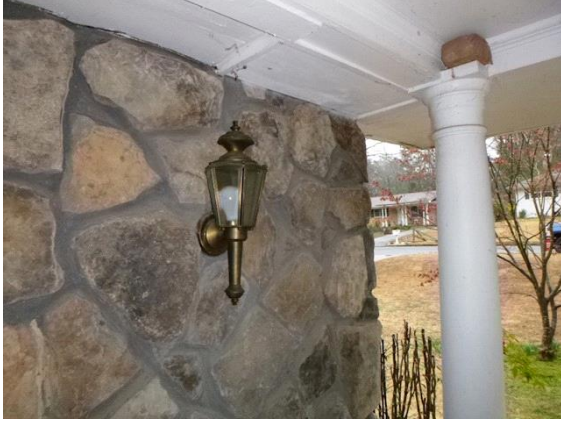
Exterior lights are not all working. Recommend changing bulbs and retesting.

Exterior Surface: light not working

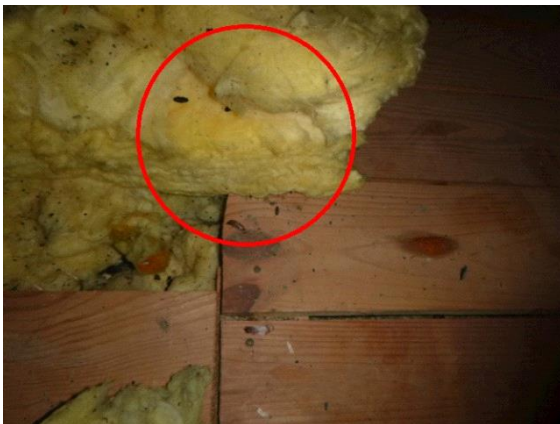
Suspected nuisance pest activity is evident in the attic with tunnels in the insulation and droppings on top of the insulation. Unable to determine if activity is current or not. Recommend wildlife pest control inspection by a qualified contractor. Follow pest control contractor recommendations for repair/exclusion.

Attic Insulation: droppings

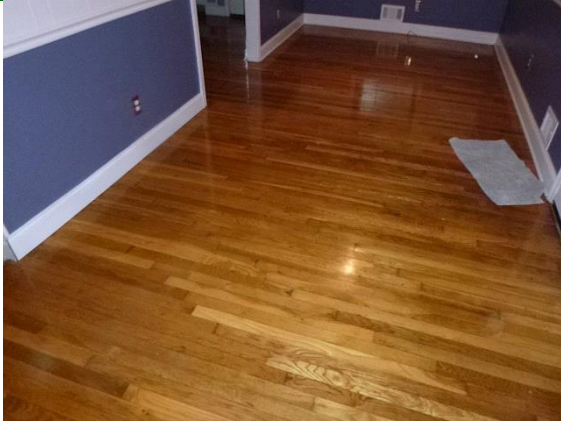
Floor/Slab: creaking flooring

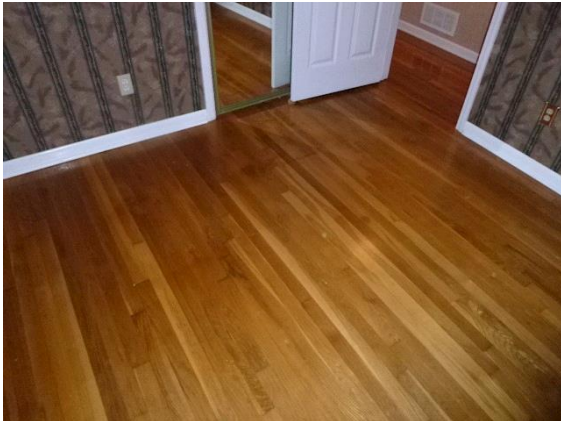
Floor/Slab: creaking flooring

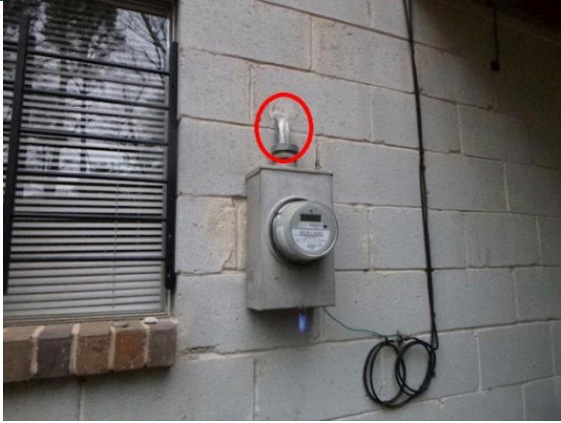
Electrical: frayed cable sheathing

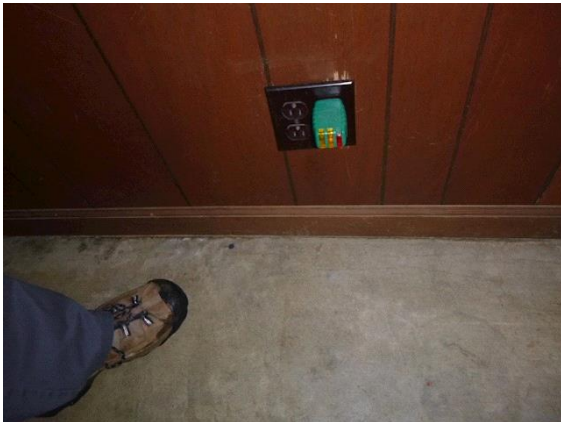
Electrical: outlet not grounded - example

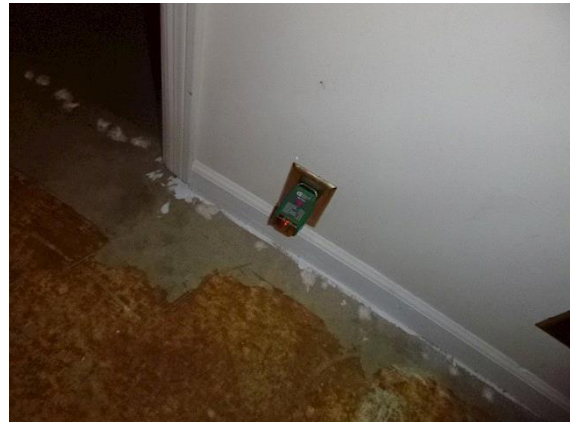
Electrical: outlet not grounded - example

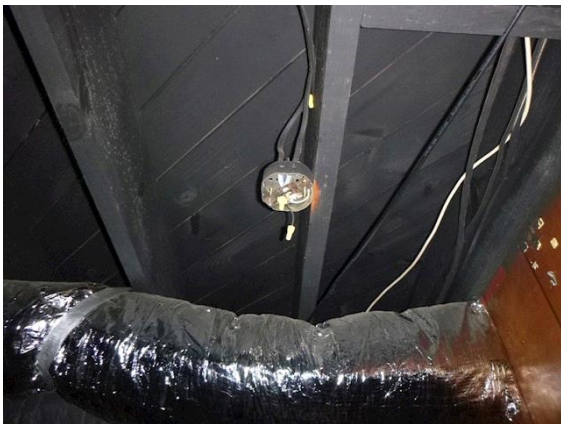
Electrical: open junction box

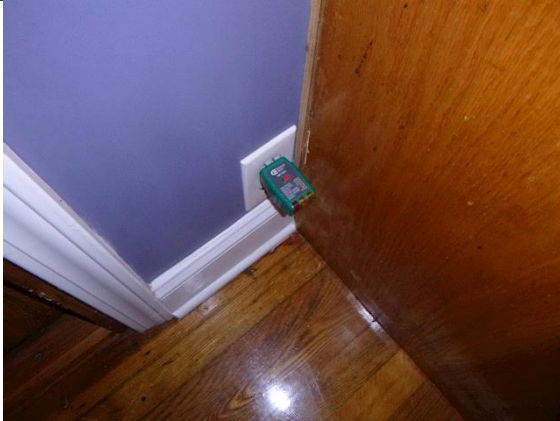
Electrical: outlet not grounded - example

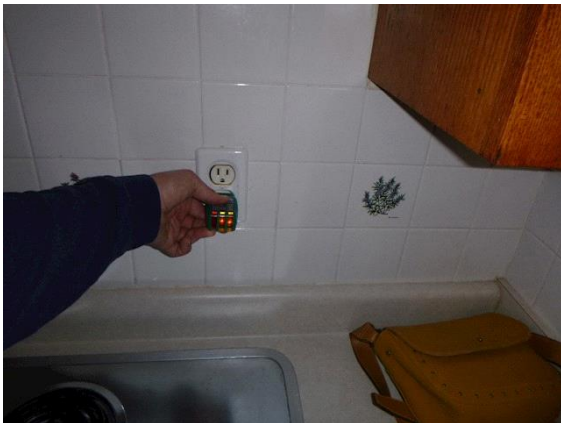
Kitchen: Outlet not GFCI protected

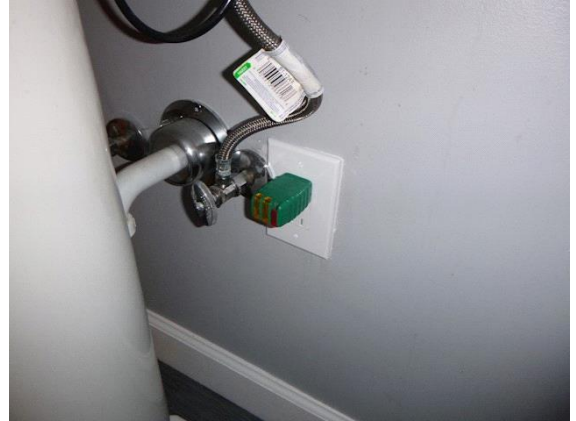
Hall Bathroom : no power

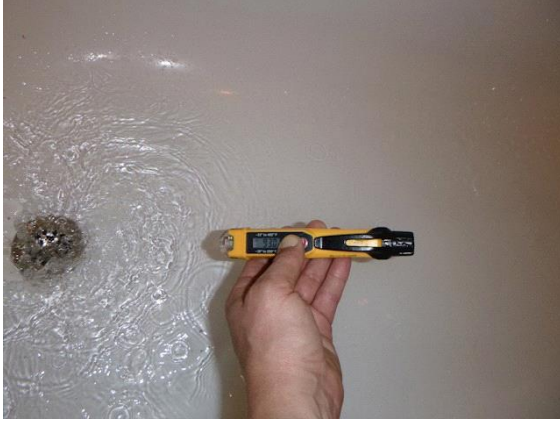
Hot water at shower does not get as hot as other fixtures in the home indicating a problem with the installation or mixing valve. The max temp at the shower was 93F, other fixtures on the home were 99F and above. Recommend repair by a qualified plumber.

Hall Bathroom : shower water temp at 93F

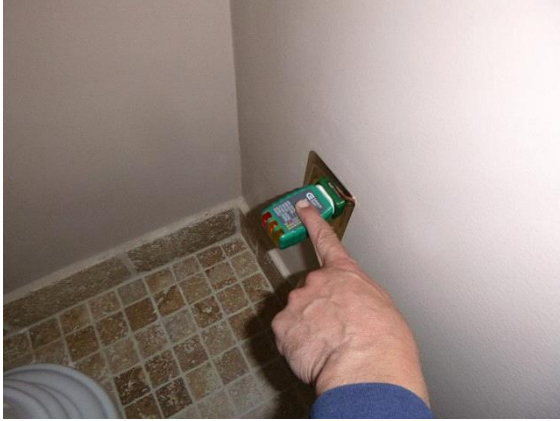
The outlet on the wall is not GFCI protected as required. Recommend repair by a qualified electrician.

1/2 Bathroom: Outlet not GFCI protected

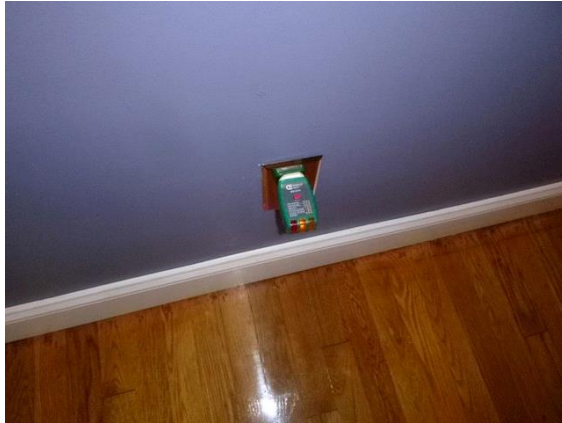
1

outlet not grounded - example

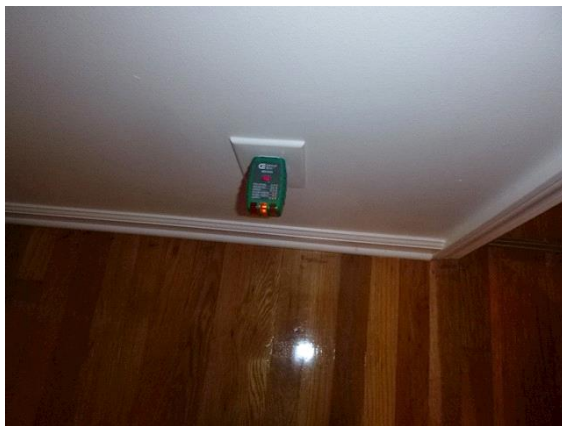
3

outlet not grounded - example
