## HOME INSPECTION

03/17/20

4925 Wimborne Ct  
Suwanee, GA 30024

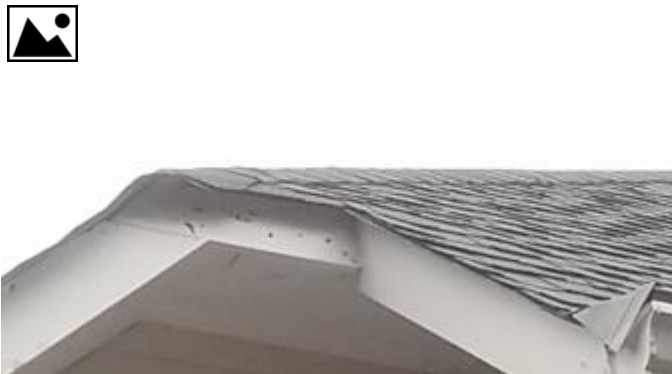
Issue There is evidence of insect damage to the trim. There may be hidden damage behind the trim.
- Location Left rear corner
- Action *Replace the trim and repair any damage which may be revealed.*

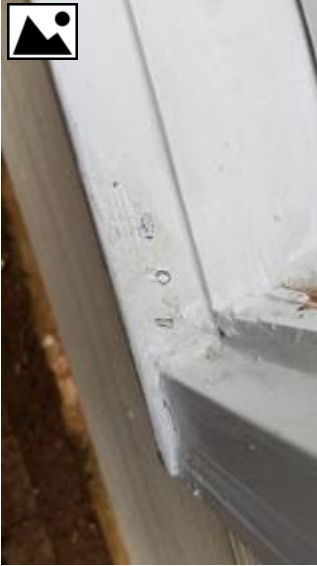
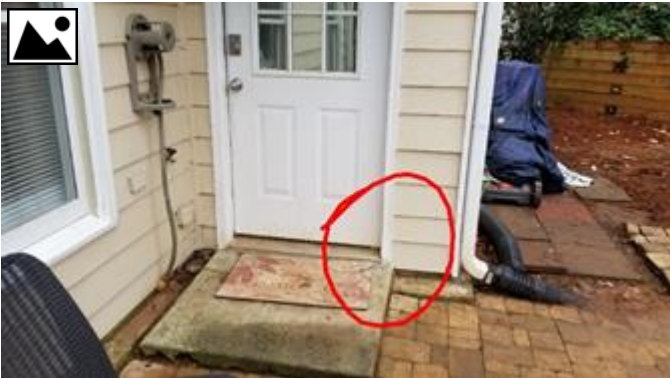
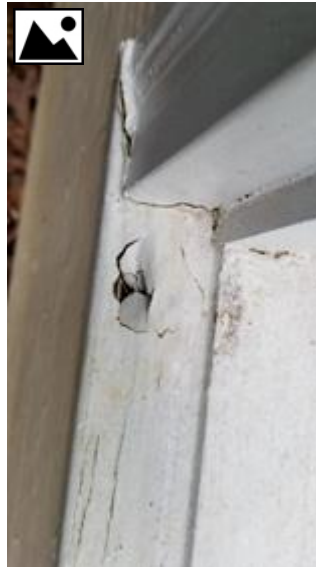
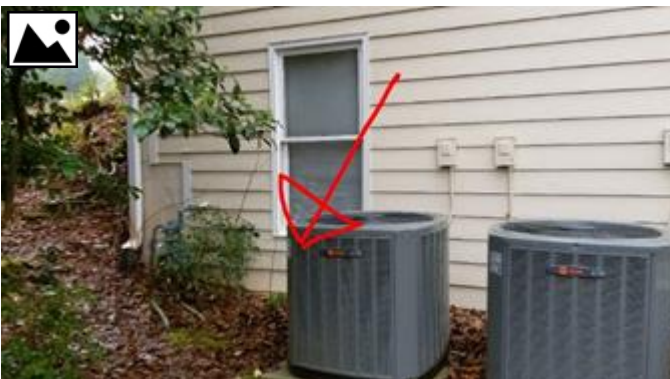
- Issue** The trim is deteriorated. This permits moisture to enter and may cause further deterioration. There may be hidden damage behind the trim.
- Location** Rear windowsills & door, bay window
- Action** *Replace the trim and repair any damage which may be revealed. Caulk, one-part putty fillers, and paint are not acceptable substitutes for solid material.*

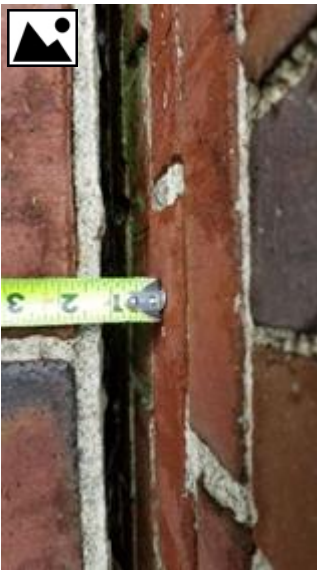
- X** Issue There is excessive settlement at the steps. This may cause someone to trip and fall, and is a water penetration concern.
- Location Front
- Action *Repair and stabilize the steps to prevent further settlement. Repair and seal any gaps to prevent moisture intrusion.*

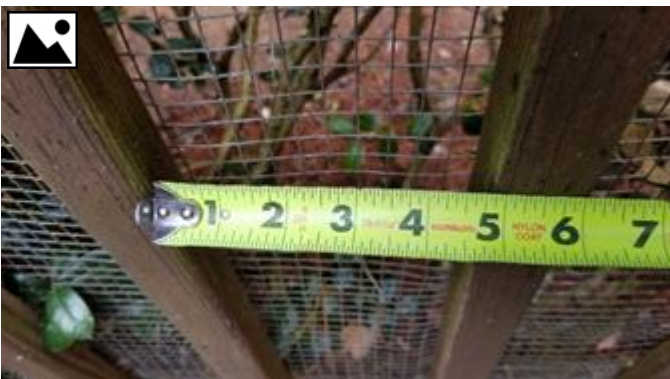
- 03 The balusters are improperly spaced at the guardrail. The opening between balusters should not exceed 4". This is a safety concern. **Location:** Rear. *Repair or replace the balusters.* [22](#)

- Issue** The balusters are improperly spaced at the guardrail. The opening between balusters should not exceed 4". This is a safety concern.
- Location** Rear
- Action** *Repair or replace the balusters.*

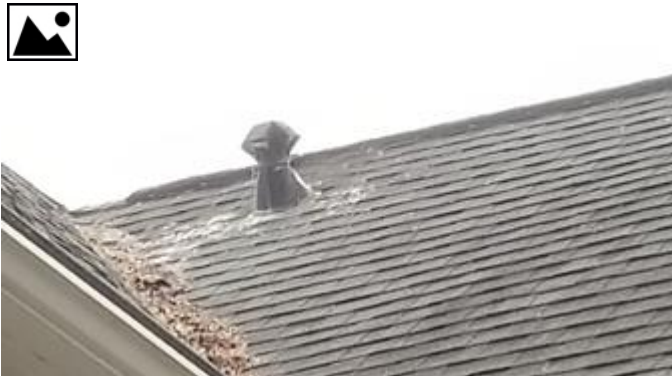
Issue There is a light colored stringy substance on the roof surface around a vent. Unable to determine what the material is or why it's there.
- Location Left Side
- Action *Recommend further evaluation and repair as needed.*

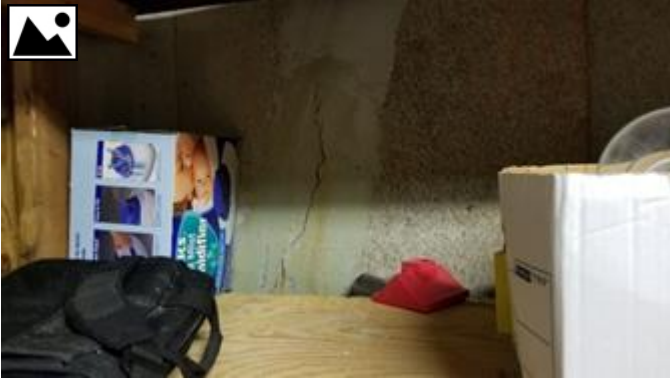
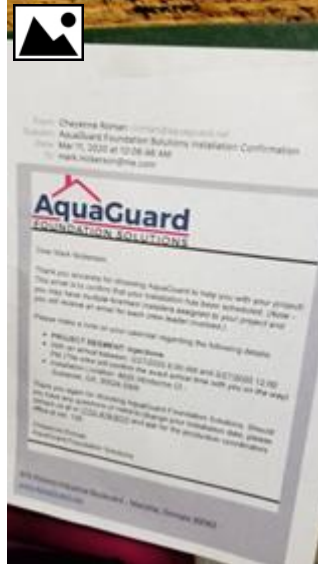
- X** Issue There is minor cracking in the foundation wall. No settlement or displacement is visible.
- Location Utility room
- Action *Repair and seal the cracks.*

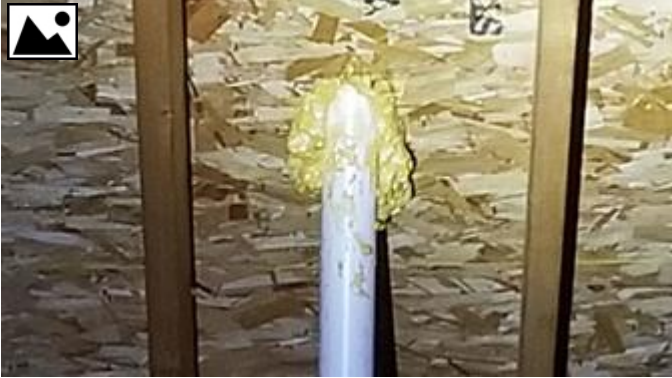
Issue There is expandable foam around a waste vent pipe at the roof sheathing. This is commonly done to prevent leaks.
- Location Right side
- Action *Recommend further evaluation and repair as needed.*

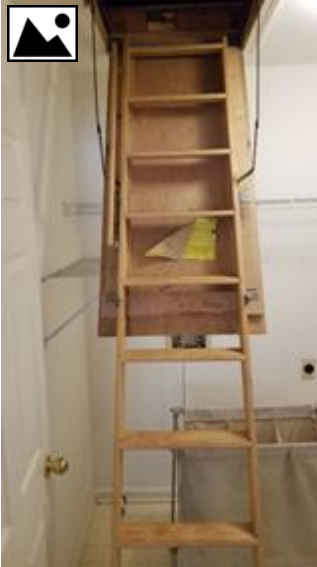
**Issue** The seal or insulation at the attic access is inadequate. This permits energy loss and permits moisture to enter the attic.
- Location** Main Home
- Action** *Repair or replace the seal and add insulation as needed.*

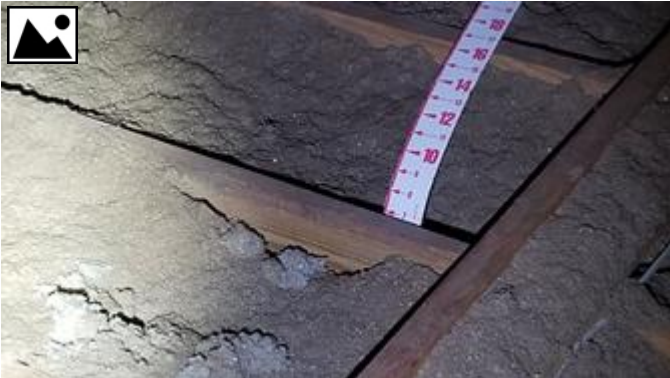
**Issue** The level of insulation is considered inadequate by today's standards. Current standards require R-30 or approximately 8" of cellulose.
- Location** Multiple Locations
- Action** *Install additional insulation in accordance with local guidelines.*

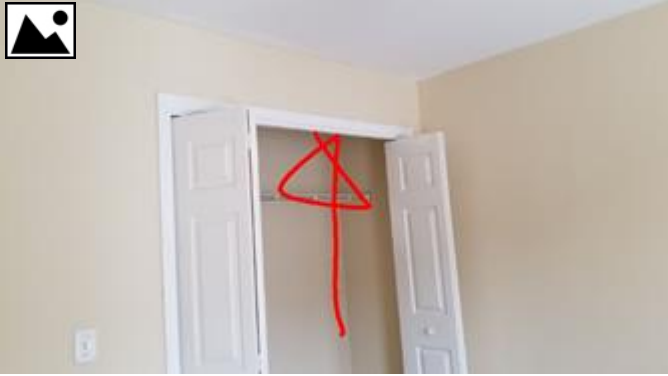
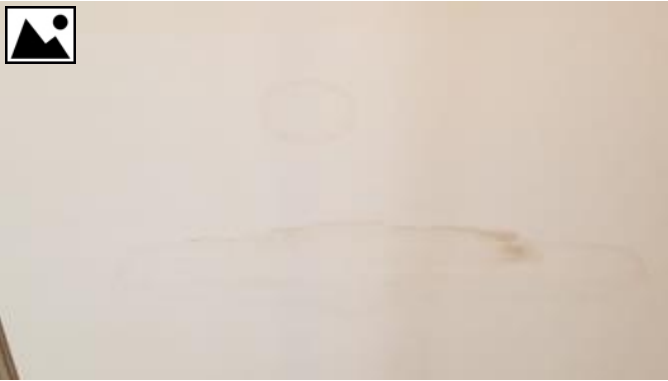
Issue The ceiling is water damaged. Testing with a moisture meter indicates low moisture content (dry).
- Location Bedroom closet, garage ceiling
- Action *Hire a contractor for an evaluation and to make repairs as needed.*

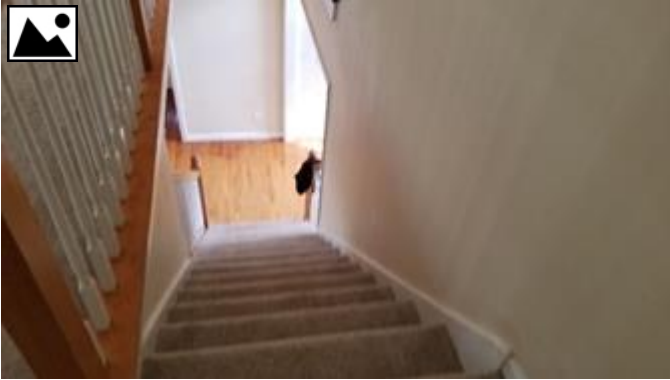
- 10 The handrail is missing. This is a safety concern. Current standards require handrail the entire flight of the stairs. **Location:** Central. *Install a handrail.* [36](#)

Issue The handrail is missing. This is a safety concern. Current standards require handrail the entire flight of the stairs.  
Location Central  
Action *Install a handrail.*

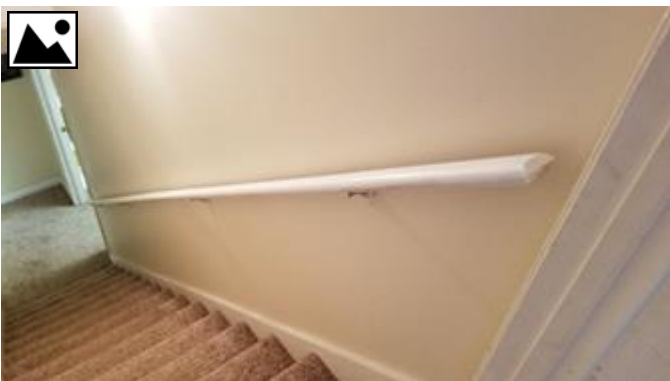
Issue The handrail does not have a return back to the wall. This is a safety concern.  
Location Basement  
Action *Add a handrail return back to the wall.*

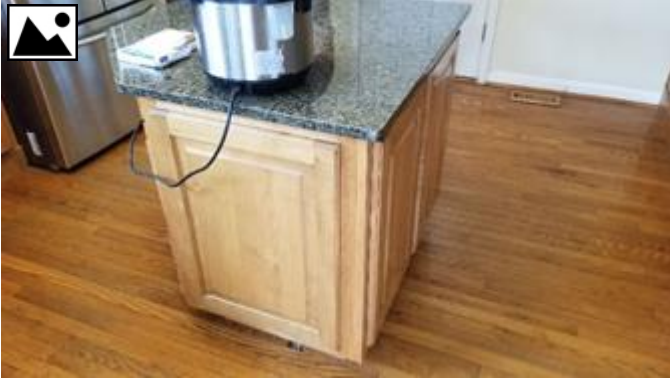
- 13 The cabinet is not properly secured. This is a safety hazard. **Location:** Kitchen island. *Secure the cabinet using approved fasteners.* [37](#)

- Issue The cabinet is not properly secured. This is a safety hazard.
- Location Kitchen island
- Action *Secure the cabinet using approved fasteners.*

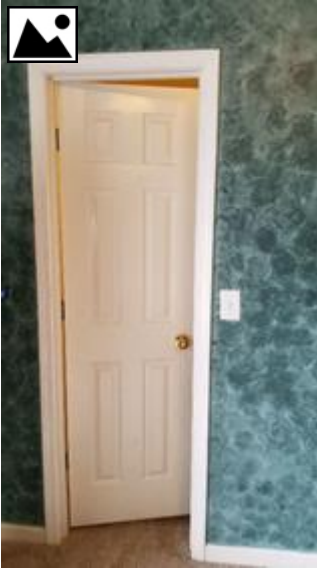
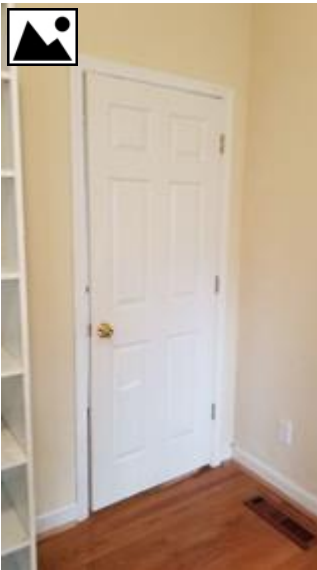
- Ⓜ Issue The door does not latch properly. This affects proper function.
- Location Bedroom, office
- Action *Adjust the door, the latch mechanism, or the striker plate as needed.*

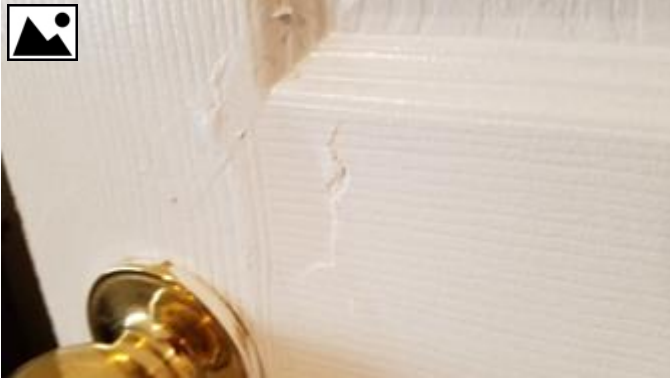
- X** Issue The door is damaged. This affects proper function.  
Location Master bedroom, bathroom  
Action *Repair or replace the door.*

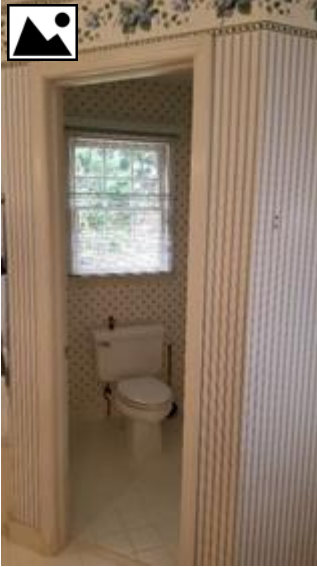
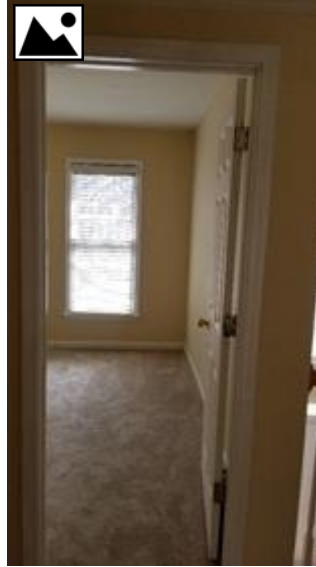
- X** Issue The door does not fit properly within frame. It is binding and/or has large gaps. This affects its function.  
Location Masterbath, front bedroom  
Action *Adjust or replace the door.*

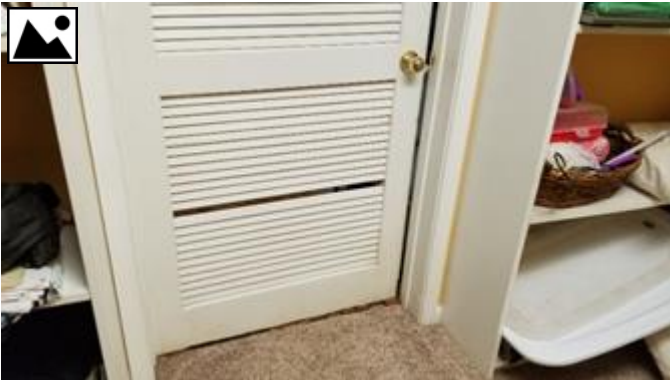
- X** Issue The louver door is missing or has a broken louver.  
Location Basement  
Action *Repair or replace damaged door.*

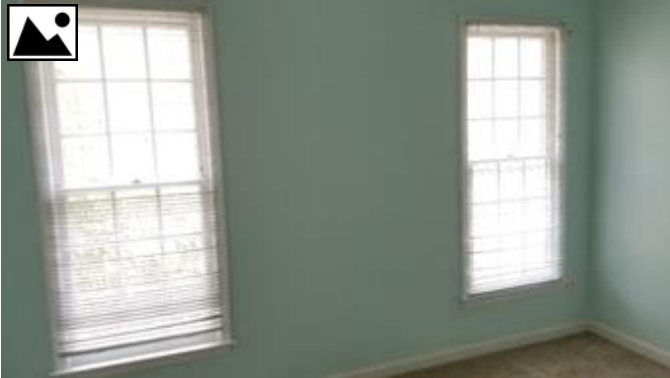
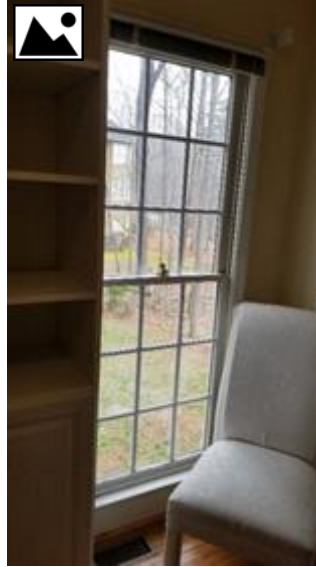
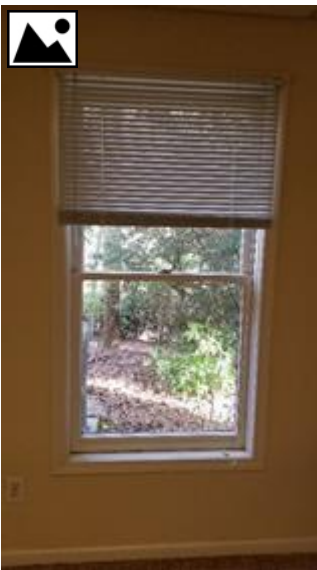
- 🔗 Issue The window is painted/stuck shut. This affects proper function.
- Location Bedrooms, office, basement
- Action *Remove the paint or repair the window as needed for proper operation.*

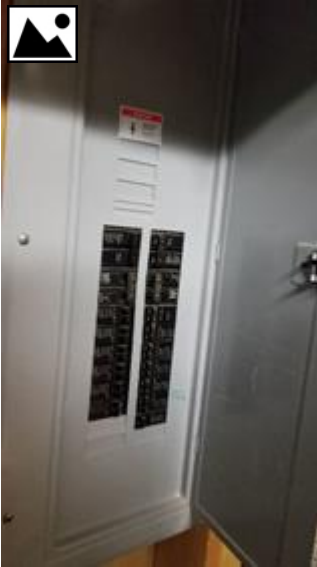
Issue The electrical sub-panel is not labeled or is only partially labeled. All panels must be completely labeled correctly to indicate which circuits the breakers or fuses serve.
- Location Utility Room
- Action *Label the panel.*

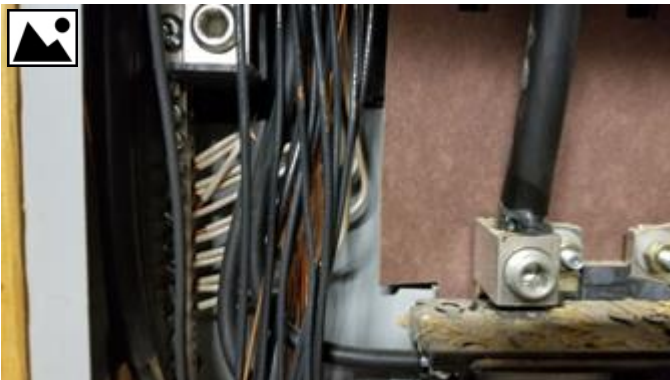
Issue There is more than one neutral wire connected to a single contact on the neutral bar. Multiple neutral wires are not permitted under a single lug. This is a safety concern.
- Location Utility Room
- Action *Hire an electrician to make the required repairs.*

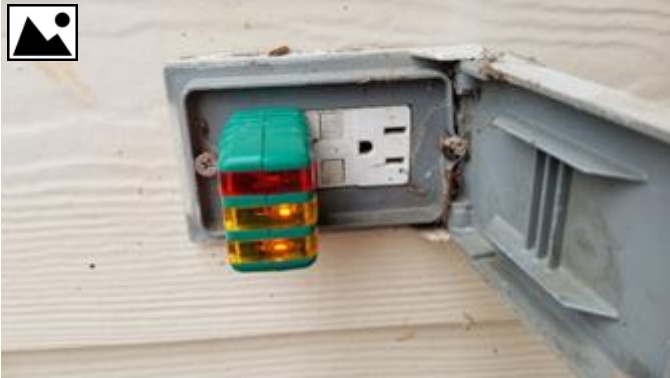
- Issue The GFCI receptacle has power, but it doesn't trip when the test button is pushed. This is a safety hazard.
- Location Over patio, screen porch
- Action Hire an electrician to replace the receptacle.

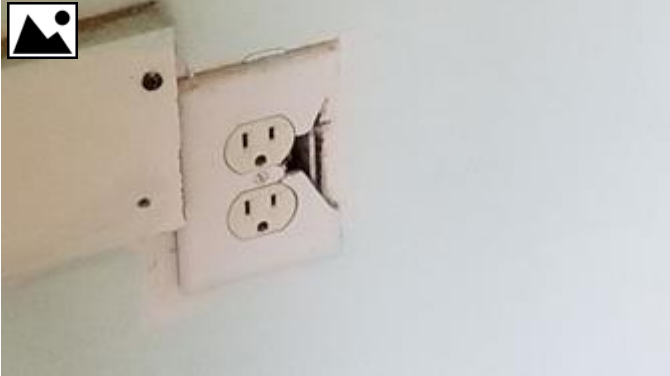
- 🔧 Issue The receptacle's cover plate is damaged. This is a shock and safety concern.
- Location Rear bedroom, basement office
- Action *Replace the cover plate.*

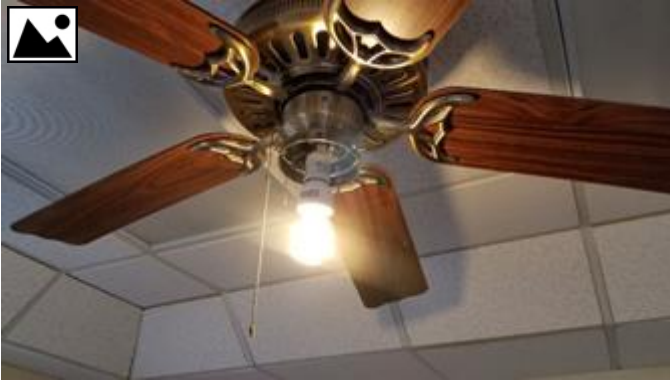
- 🔧 Issue The light fixture's glass globe or panel is damaged or missing. This is a safety concern.
- Location Basement office
- Action *Replace the globe or panel.*

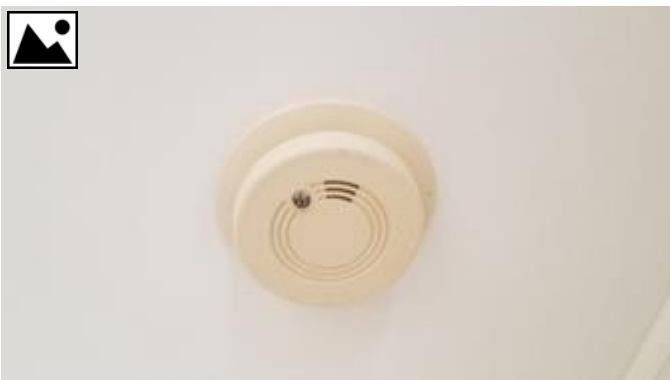
- 🔧 Issue The smoke detectors are 10+ years old and beyond their life expectancy. This is a safety hazard.
- Location Entire Home
- Action *Replace the smoke detectors.*

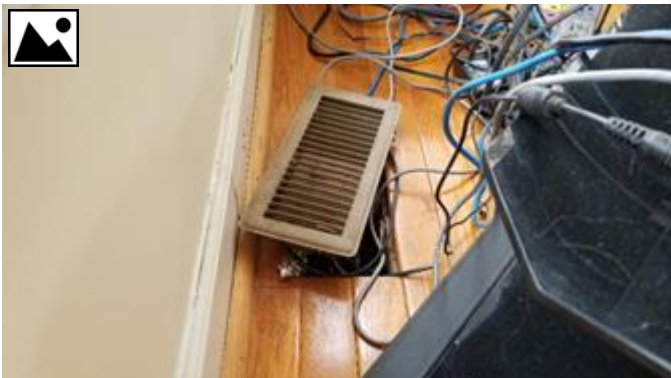
- X** Issue There are damaged or missing supply registers. The airflow cannot be properly controlled.
- Location Family room
- Action *Replace or install registers as needed.*

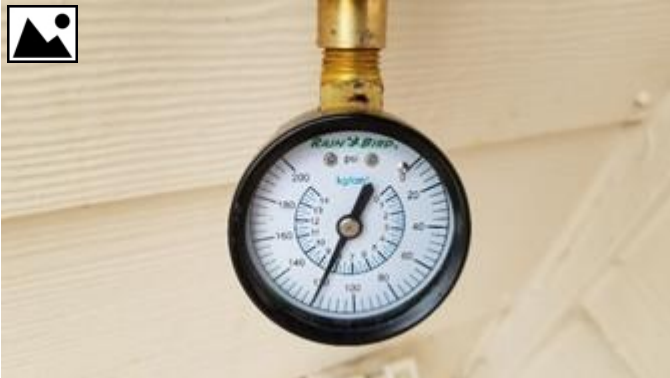
Issue The water pressure is too high. Pressure higher than 80 psi may cause pipes, valves, and faucets to fail prematurely.
- Location Rear
- Action *Hire a plumber to evaluate the water system and to make required repairs.*

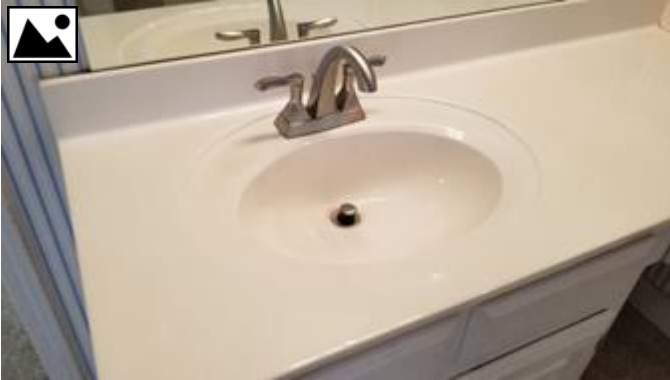
- X** Issue The sink stopper is not adjusted properly. The basin does not hold water without draining.
- Location Master Bathroom
- Action *Adjust or repair the stopper as needed.*

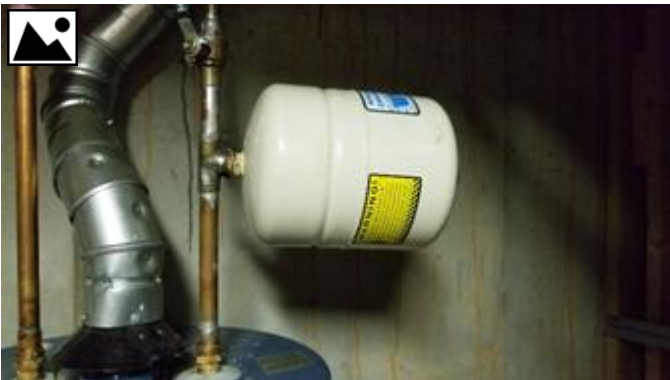
- X** Issue The expansion tank is not independently supported. This stresses pipes and fittings and may cause leaks.
- Location Utility Room
- Action *Hire a plumber to secure the expansion tank.*

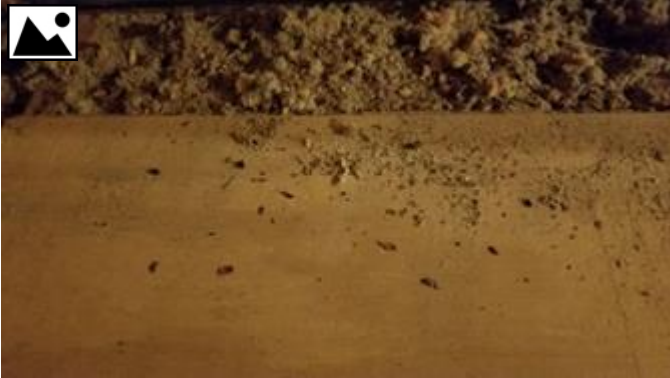
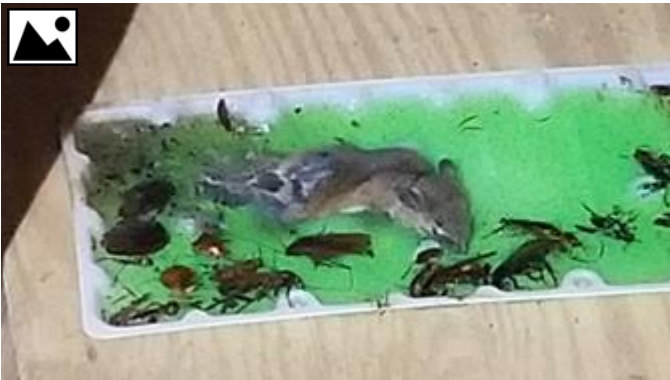
Environmental - Rodents

- Issue There is evidence of rodent activity within the home. This is a health and safety concern.
- Location Attic
- Action *Hire a specialist for an evaluation and to make required repairs.*
