Safety K3E March Highlight

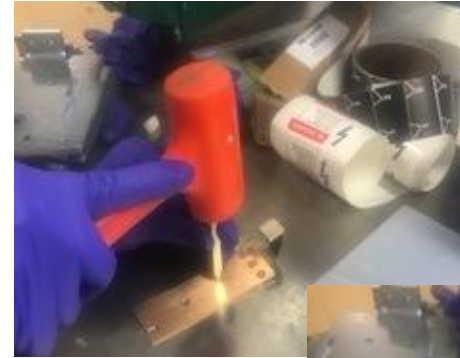
Before

The Assembler was required to use her hand as a fixture in order to hold the “T” and stamp the part. A chisel holder was purchased to hold the “T” stamp, removing the hand from being potentially struck.

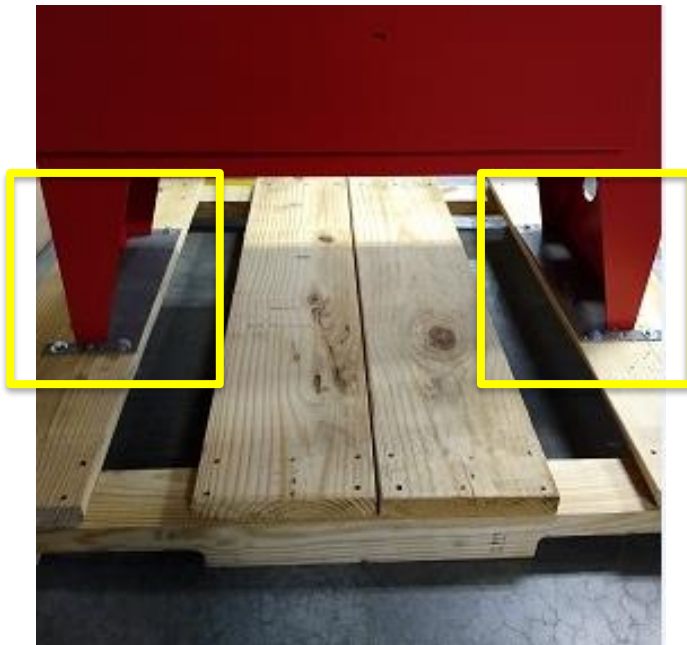
Pictured to the left:

The employee was required to bend down to secure the controller to the skid. Also, the mounting holes were located underneath the enclosure, which made them hard to reach and see.

Shipping brackets were fabricated to slide into the enclosure’s mounting legs. This holds the unit in place and mounting holes were moved to make it easier to install.
