EXHIBIT 2-A

Property Address:
195 Ardsley Ln
Alpharetta GA 30005

Inspector: Tim Skillingstad

Residential Inspector of America, Inc.

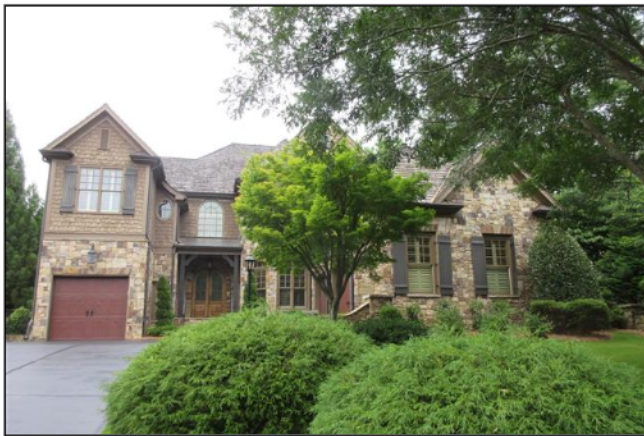
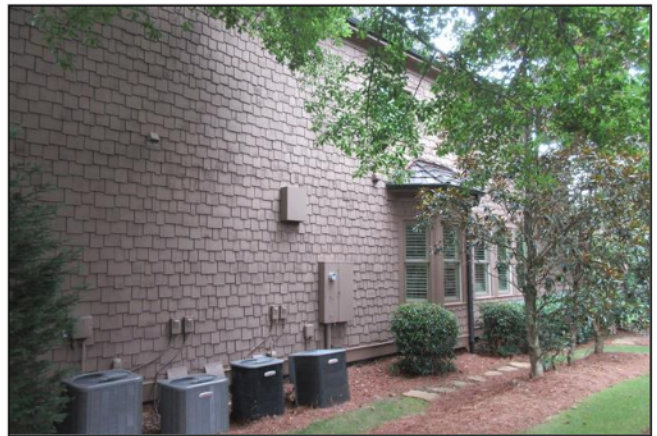
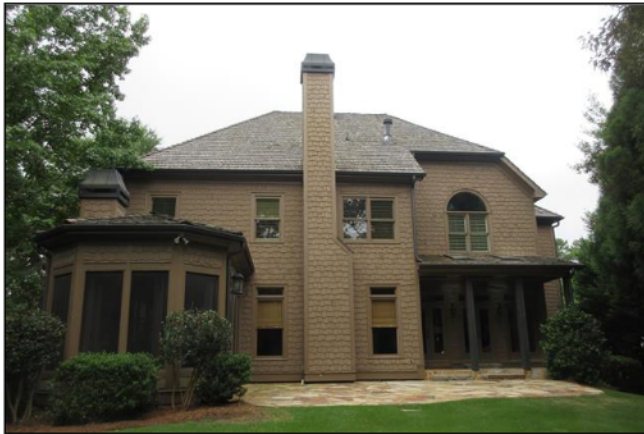
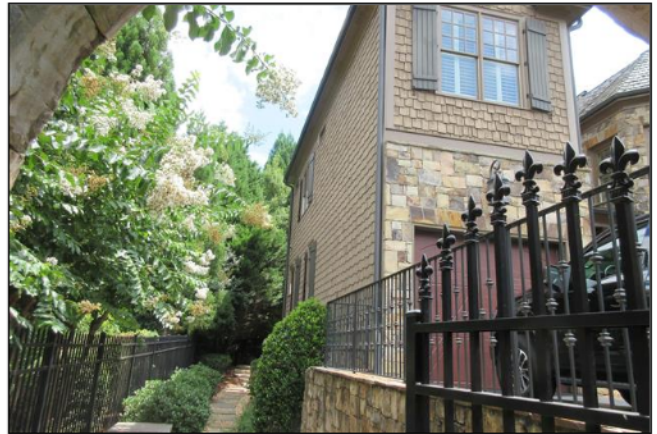
Elevation photos.

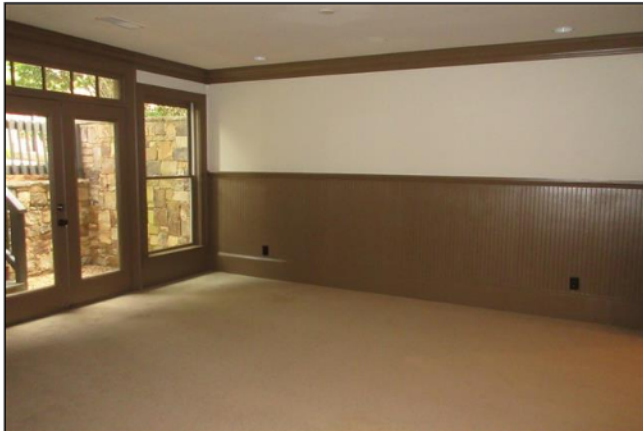
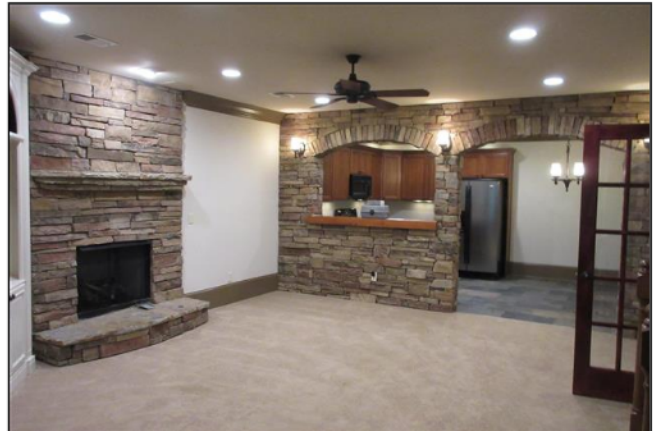
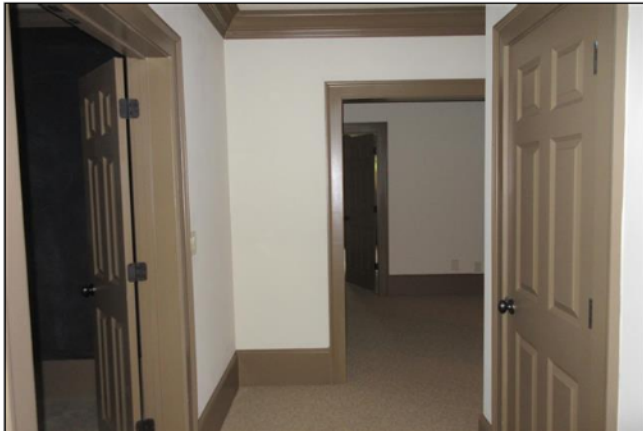
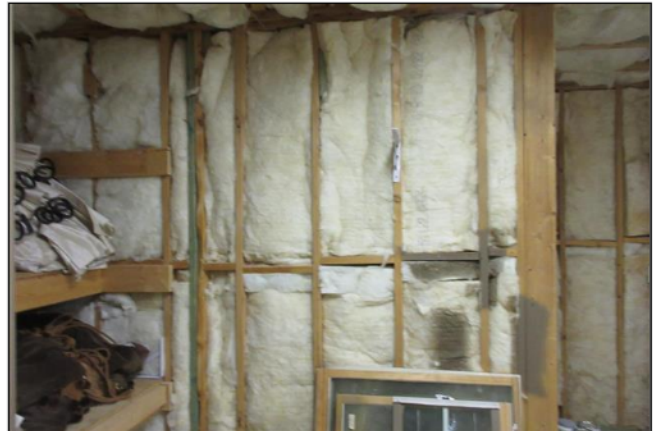
The basement and the foundation wall inspections were very limited due to the basement being finished off.

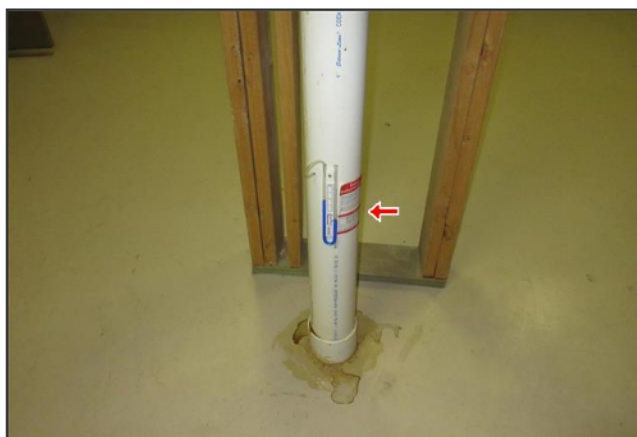
5.2 Item 1(Picture)

A radon mitigation system has been installed in the home. This is a permanent system that is intended to remove high readings of radon to an acceptable level. System fan appeared to be running and liquid display looked to be performing as intended. It is recommended to have sellers provide all possible information regarding this system and/or contact the installer for additional information as needed. See photo(s).

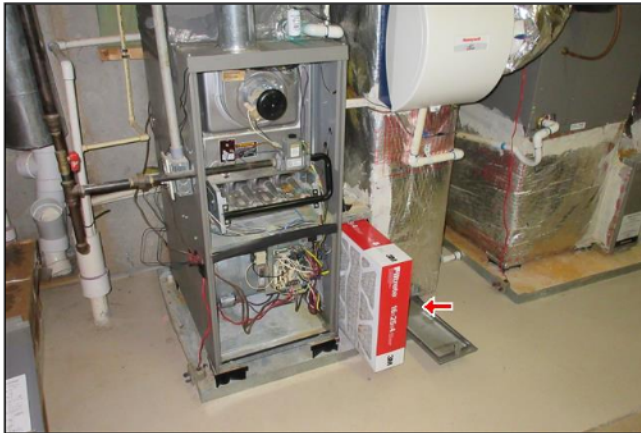
🔧 (1) Filter location. See photo. As a part of maintenance, it is recommended that the 1" filter(s) be changed every 3 months. 3" to 5" (thicker) filters are typically replaced every 6 months to 1 year. This will help maintain the life of the unit(s).

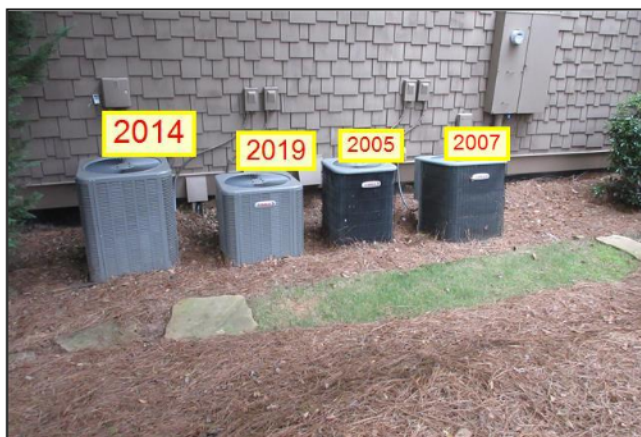
6.7 Item 3(Picture)

(3) Photo(s) of A/C unit(s).

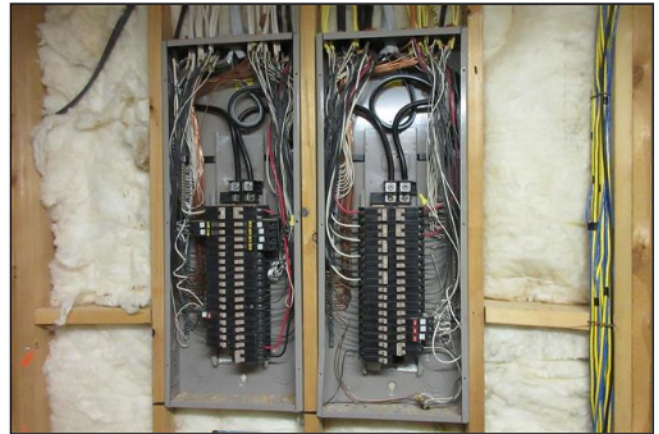
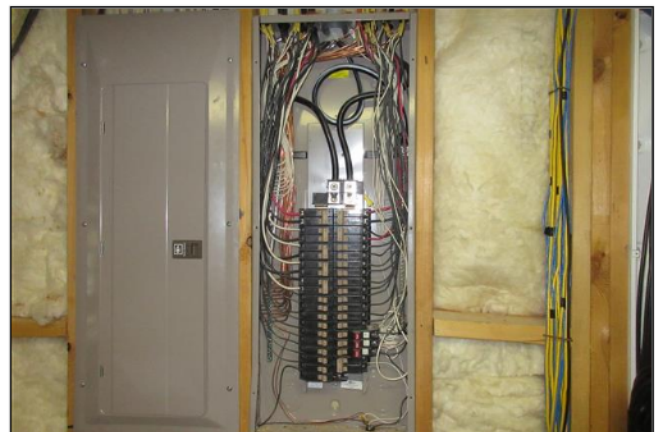
The main panel box is located at the basement. However, the main disconnect (shut-off) is outside at meter base panel (for your information). Panel was inspected for function (not code compliance) and building codes and standards have changed over the years.

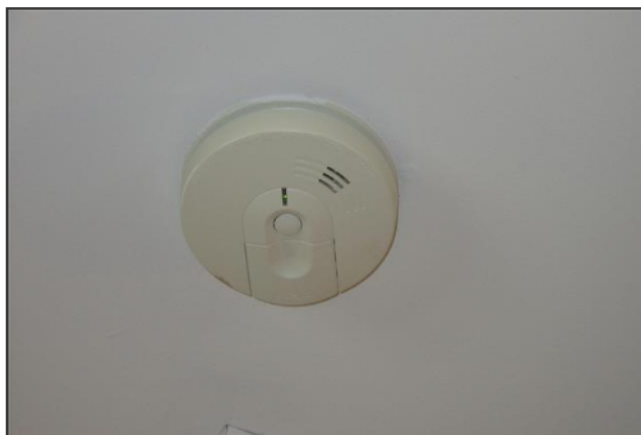
7.8 Item 1(Picture)

All smoke detectors should be tested upon moving in to the home. Typically, there should be at least one smoke detector per level, one in each bedroom and one in the immediate bedroom hallway. All of these detectors should be interconnected and work together without the use of a battery. There are different types of smoke detectors: *Ionization* and *Photoelectric*. Smoke detectors have an expiration date and typically last 10 years before needing replacement.

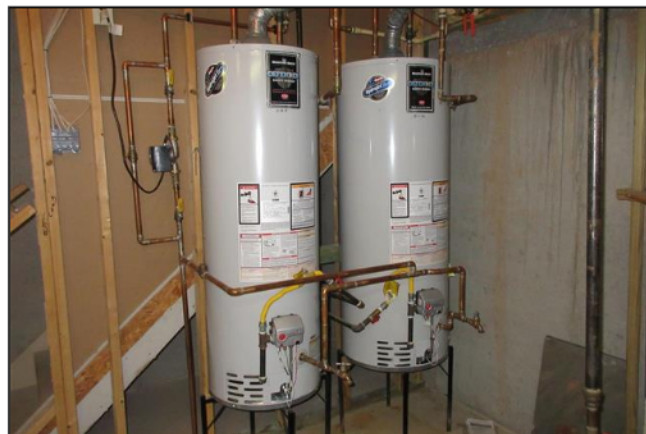
8.3 Item 1(Picture)

The water heaters are located in the basement utility room. This is for your information.

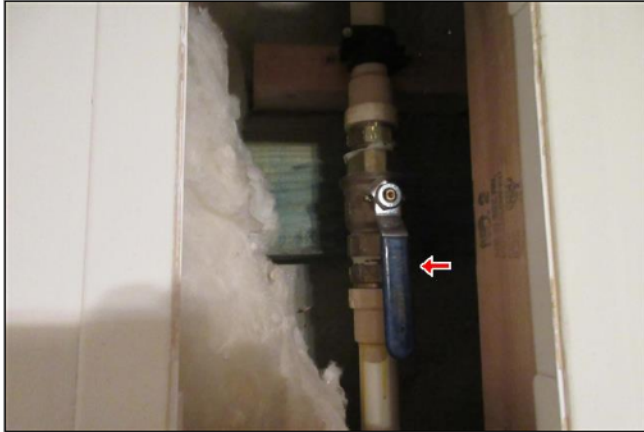
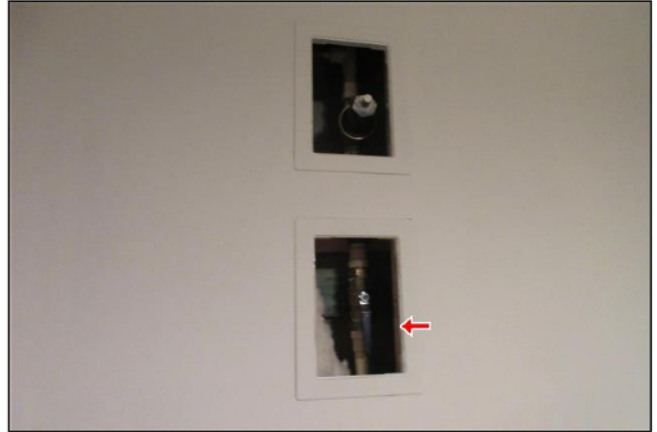
The main water shut-off is the blue lever located in the basement "chalkboard" room. This is for your information. See photo.

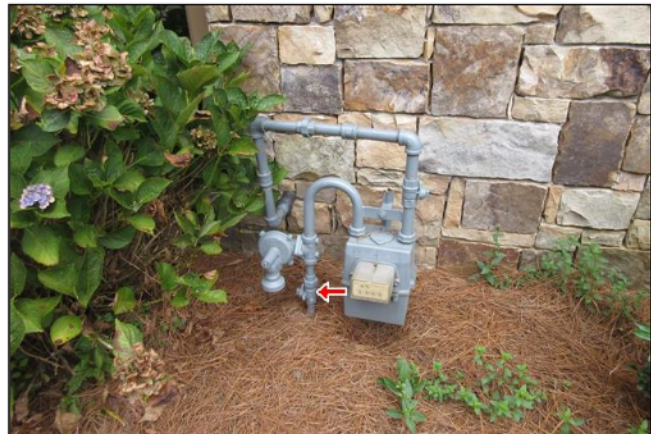
8.6 Item 1(Picture)

Main gas shut off.

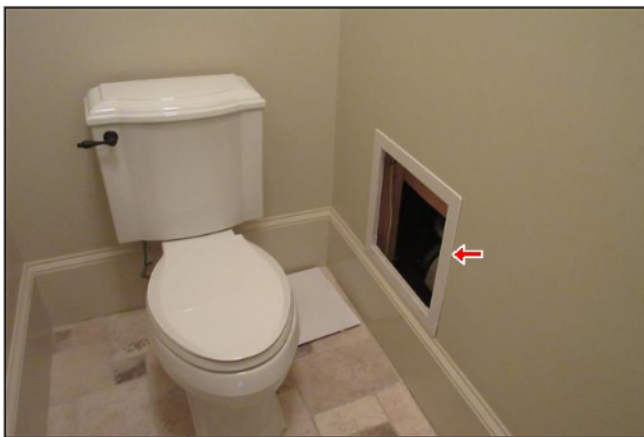
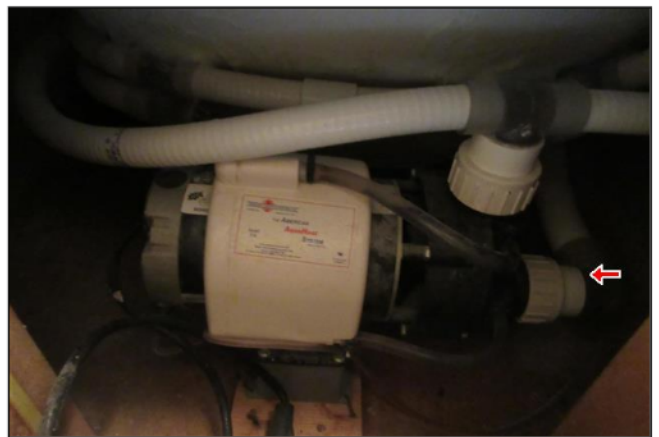
(1) Location of access panel for jetted tub in the master bathroom. This is for your information. See photo(s).
