Your Inspection Report

2238 Edison Avenue
Atlanta, GA 30305

INSPECTION DATE:
Wednesday, December 18, 2019

Home-Probe
315 West Ponce de Leon Ave, Suite 559
Decatur, GA 30030

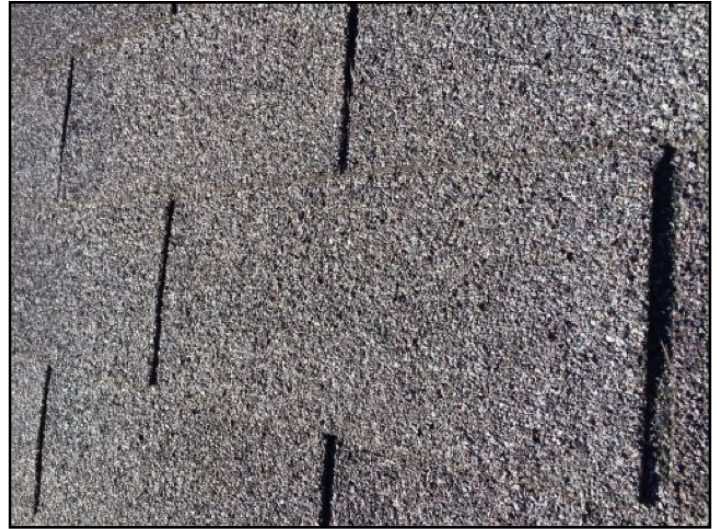
Condition: • Excessive blistering on shingles. Recommend further evaluation by qualified roofing contractor to determine cause and scope of work to repair / replace shingles if necessary.

2. Blistering shingles

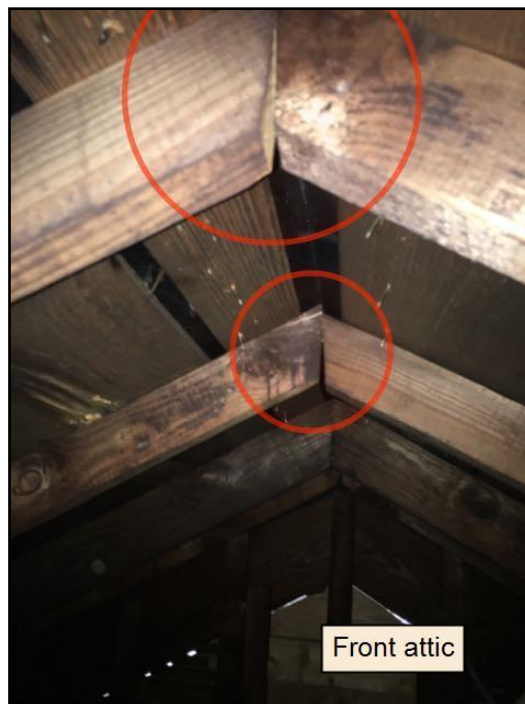
39. Weak connections

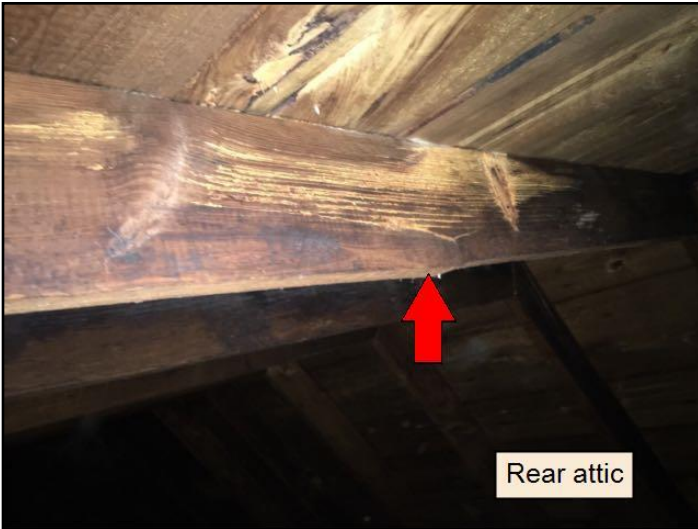
40. Split

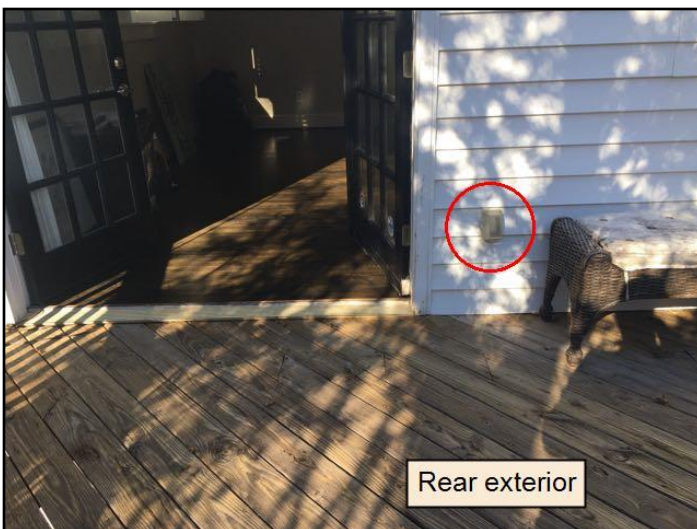
48. Inoperative

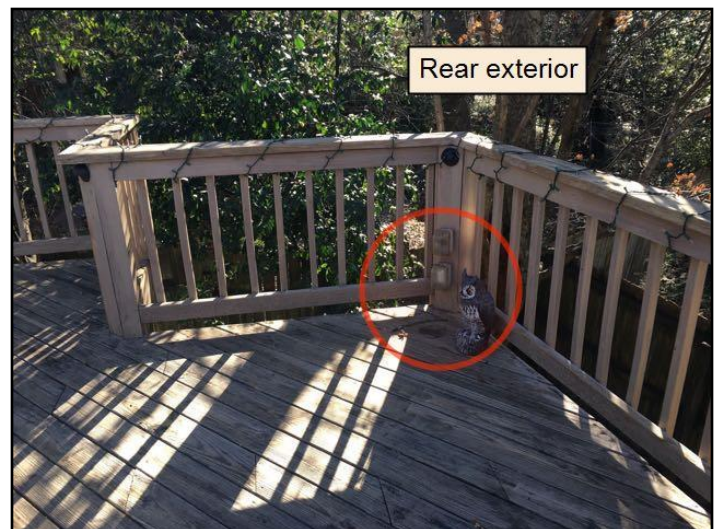
49. Inoperative

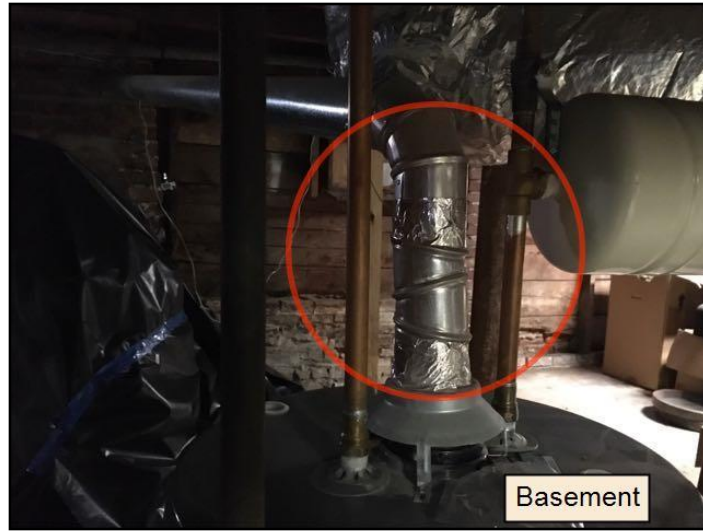
59. Tape not heat rated Task: Remove or replac...

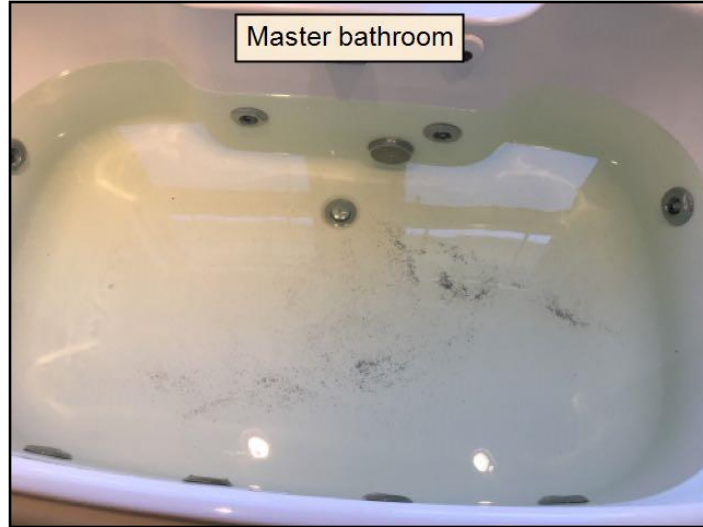
41. Condition: • [Dirty water from the jets](#)

66. Dirty water from the jets

Task: Clean
Time: Prior To Use
Cost: Regular maintenance item

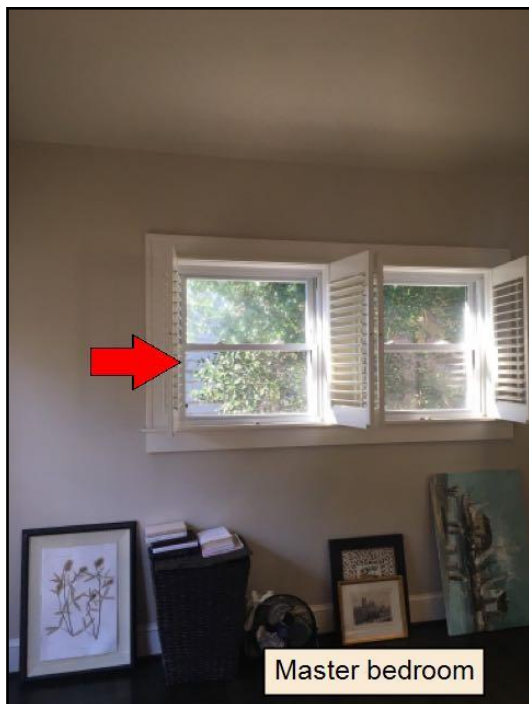
47. Condition: • Lost Seal in Double or Triple Glazing

73. Lost Seal in Double or Triple Glazing Task...

Task: Replace

Time: If Desired

Cost: \$300 to \$600 (Each)

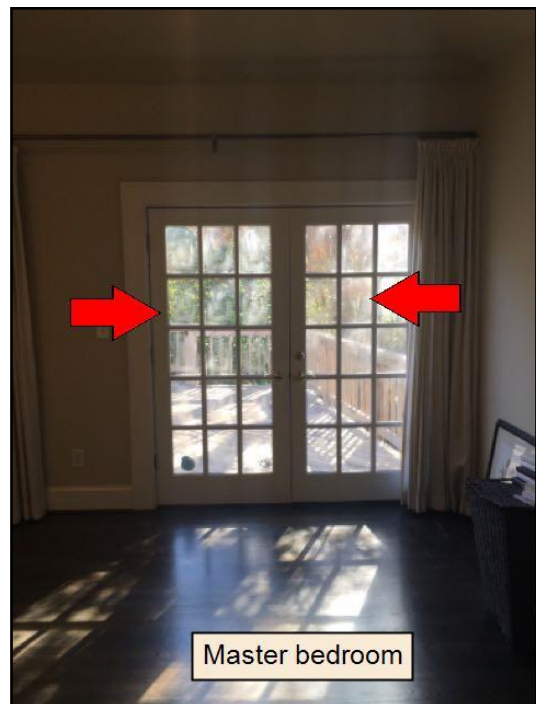
74. Lost Seal in Double or Triple Glazing Task...

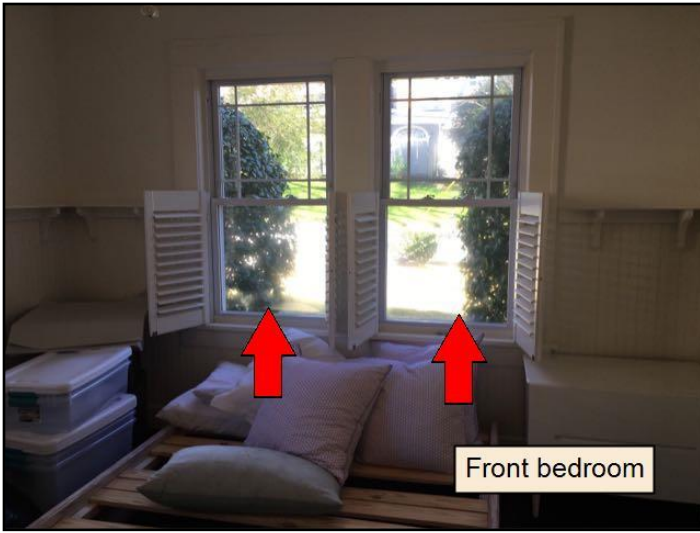
75. Lost Seal in Double or Triple Glazing Task...

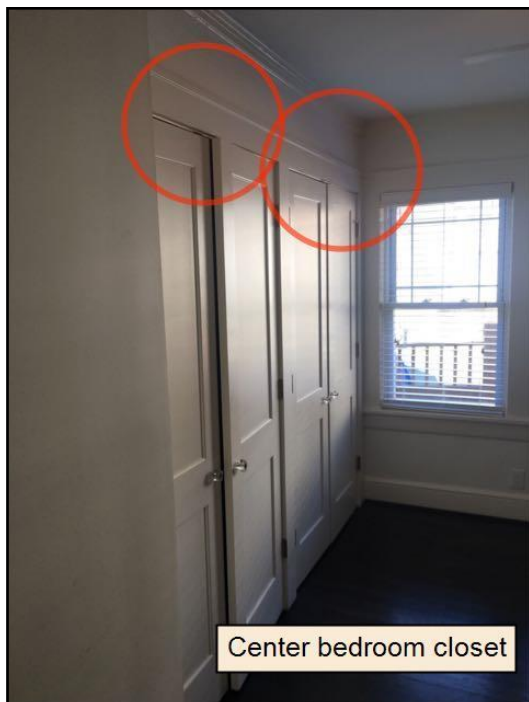
50. Condition: • Does Not Latch Properly

79. Does Not Latch Properly Task: Adjust Time...

Time: Discretionary

Cost: Minor

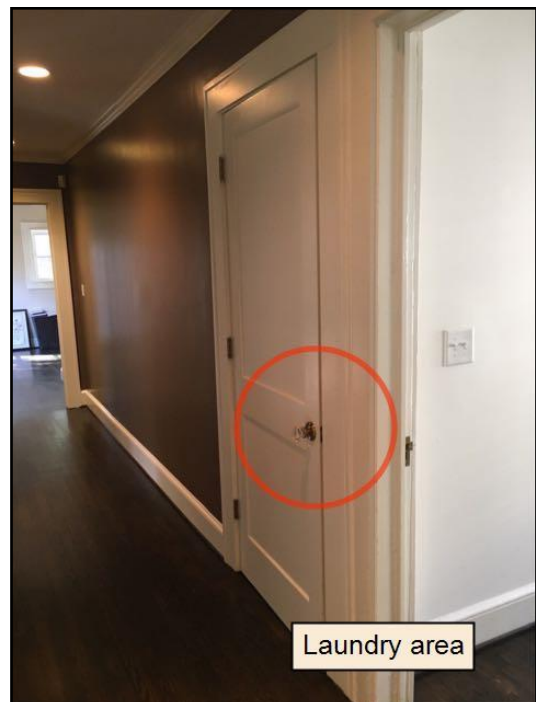
80. Does Not Latch Properly Task: Adjust Time...

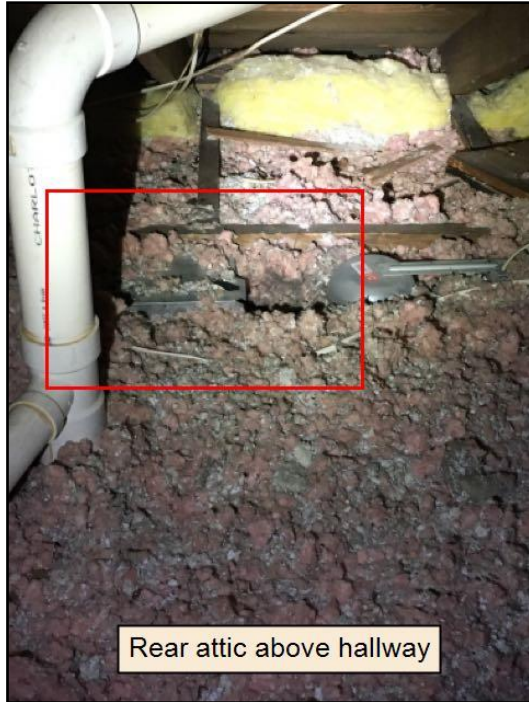
85.

56. Condition: • There is an exhaust fan in the ceiling at the end of the hall (visible from the attic) that is "on" mode and does not appear to be serving a ventilation purpose.

Task: Be Advised / remove

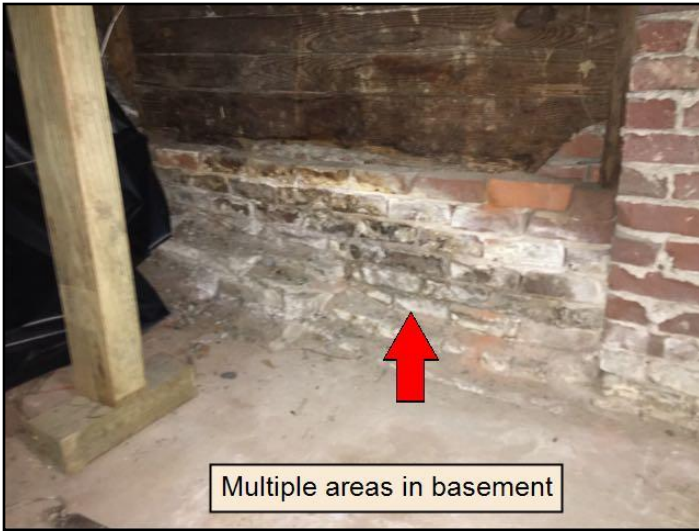
57. Condition: • [Efflorescence](#)

87. Efflorescence

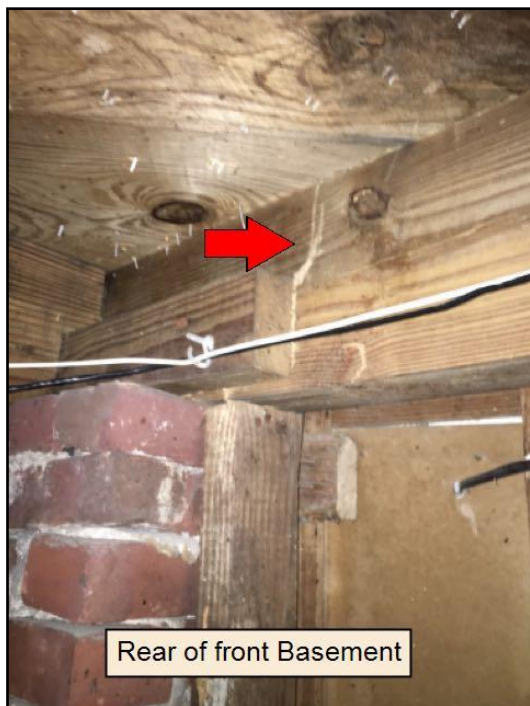
Rear of front Basement

61. • There are existing termite "tubes" or "tunnels". When a termite treatment has been done, it is customary to remove these. Although this is outside the scope of a home inspection, their presence suggests there may be current and ongoing termite activity. Consult with a pest control company as soon as possible.

91. There are existing termite "tubes" or...

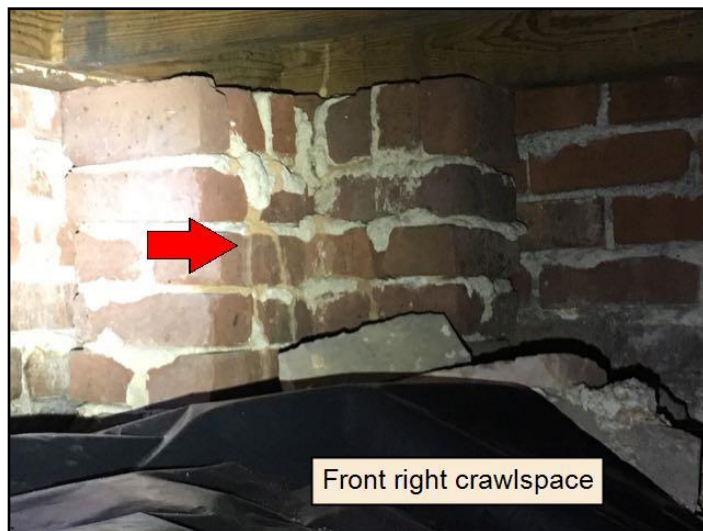
Front right crawlspace

92. There are existing termite "tubes" or...
