Inspection Report

715 Doe Ct

Alpharetta, GA 30005

Thursday, March 12, 2020

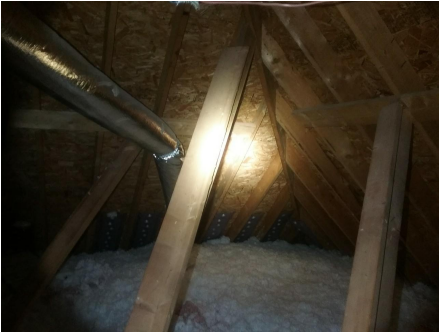
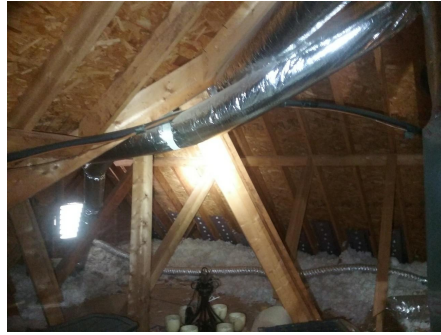
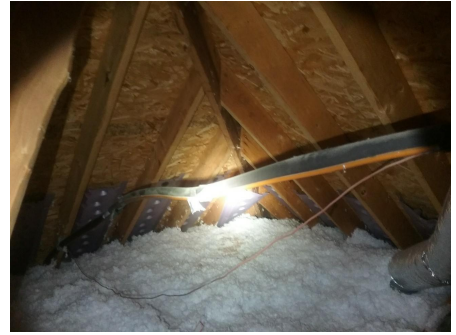
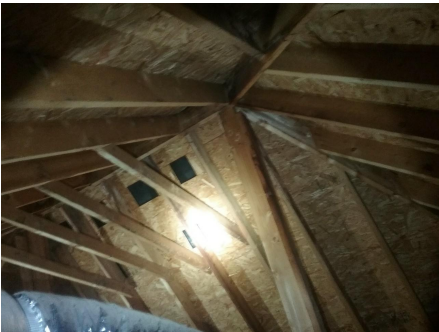
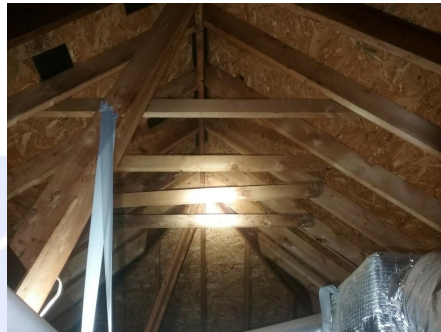
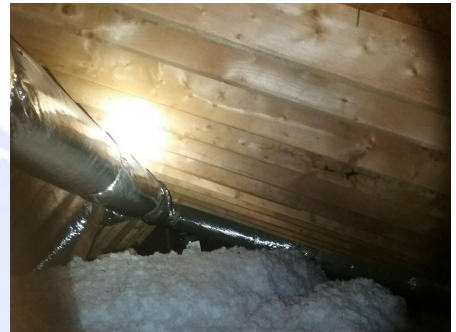
11: The roof is constructed using 2x dimensional lumber covered by OSB sheathing

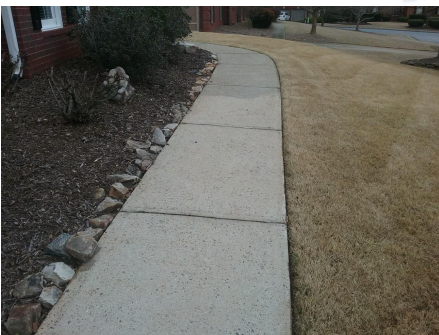
17: Serviceable, normal condition for the age of the material.

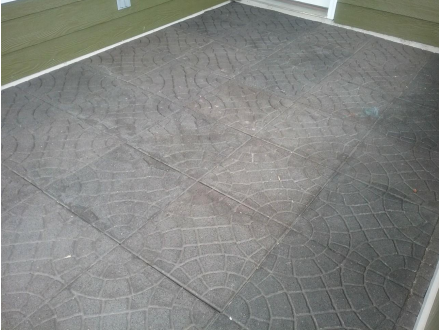
19: Stone tile with cork covering. Could not inspect due to covering.

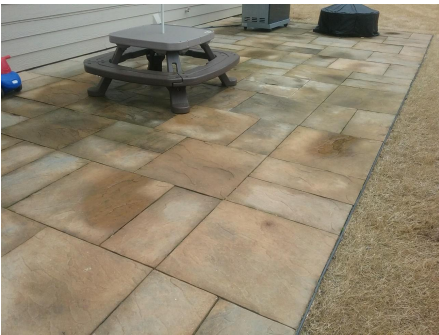
20: Serviceable, normal condition for the age of the material.

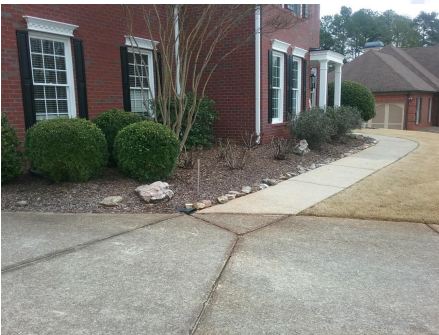
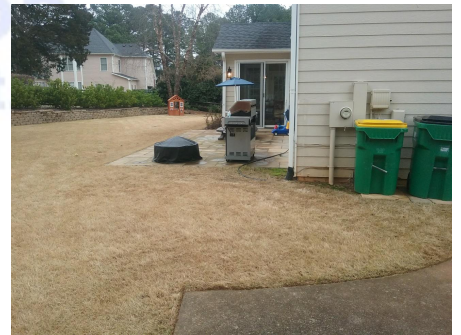
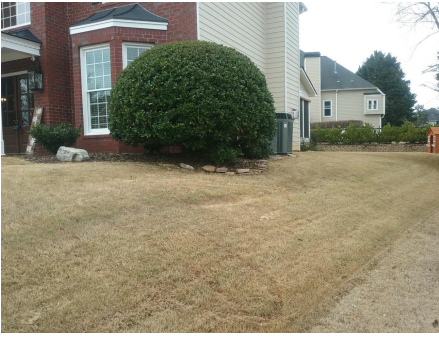
21: Grade at foundation appears serviceable aside from any listed defects allowing surface water to flow away from the foundation.

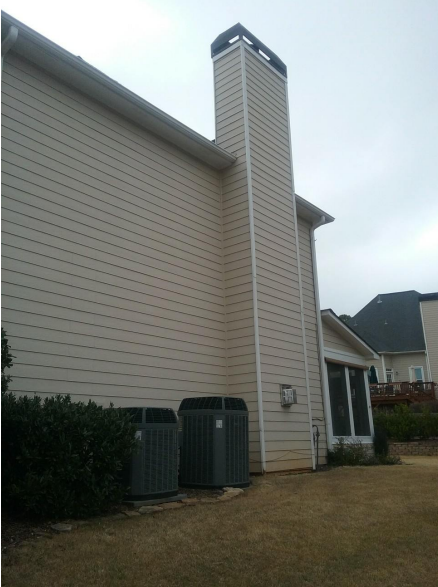
23: Appears in serviceable condition.

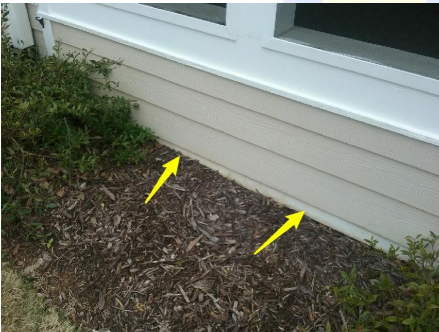
28: Earth to wood contact was observed at the right side of the rear right screened patio. Recommend correction by a licensed general contractor.

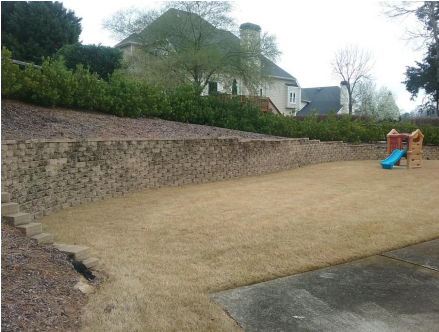
36: Appears serviceable

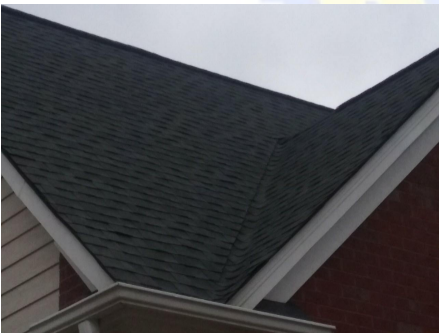
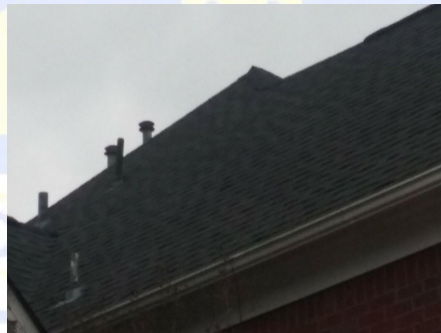
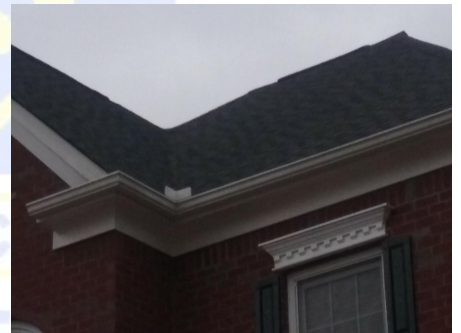
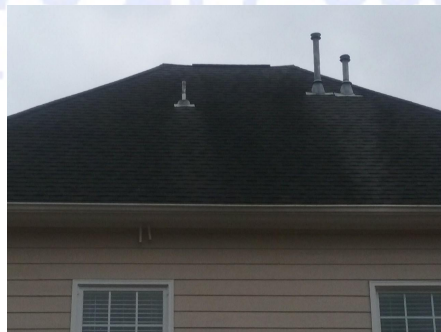
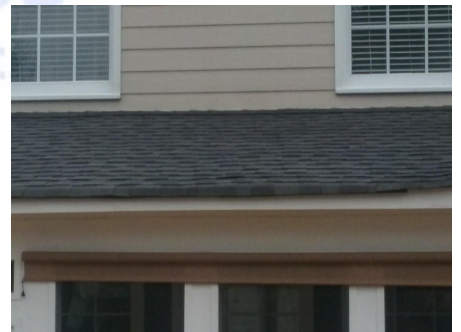
40: Good News! Excluding any listed defects, the overall condition of the roof surface, flashing, and roof/ attic ventilation were observed to be in serviceable condition when inspected.

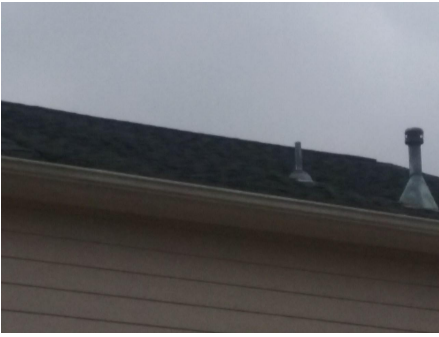
41: Normal deterioration for the age of the roof. At some point repairs will be required or leakage may occur. We cannot tell when leaks may develop in the future. Recommend inquiring with the seller if possible for additional information with regards to previous repairs or leakage history.

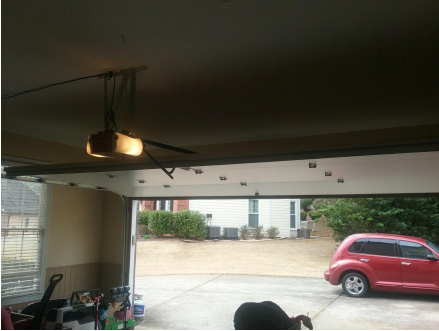
49: Aside from any listed defects the automatic garage door openers were observed to operate in serviceable condition.

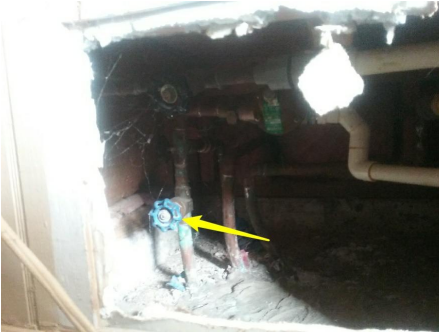
51: Garage, appears serviceable. Underneath water heater.

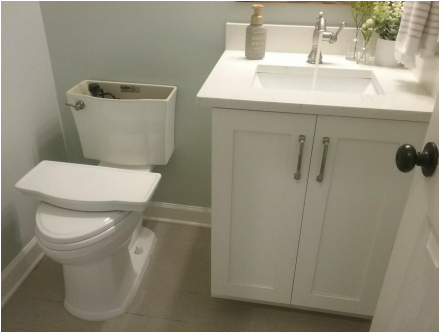
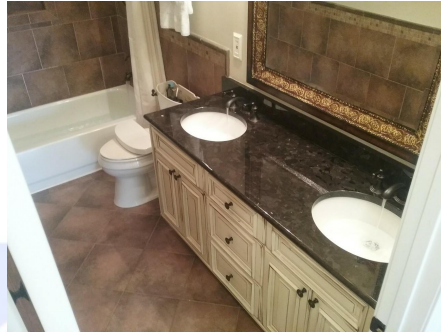
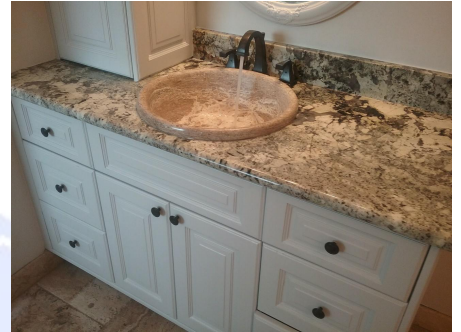
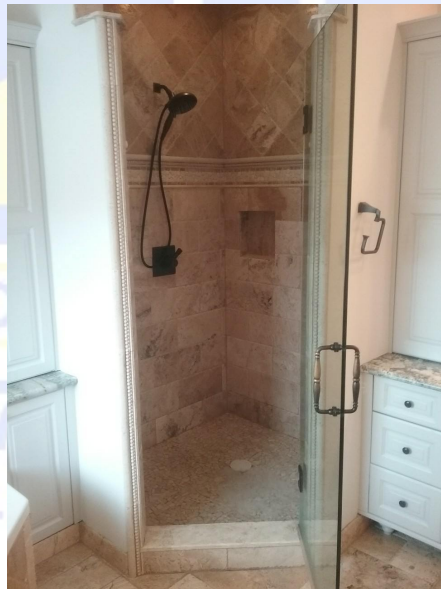
67: The condition of the bathrooms as a whole is typical for the age and area. As with all homes, there are some repairs needed.

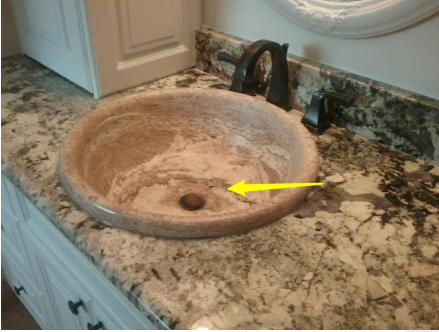
69: Slow drain noted in the front master bathrooms sink. Recommend repair by a licensed plumbing contractor.

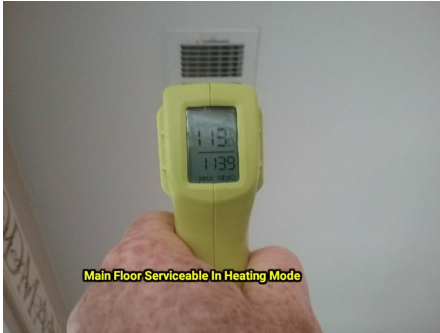
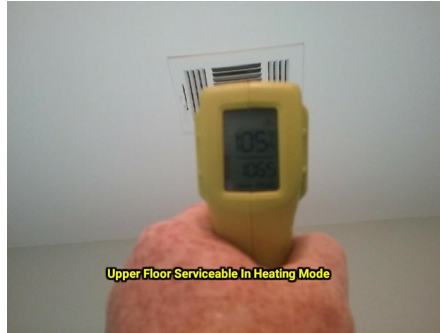
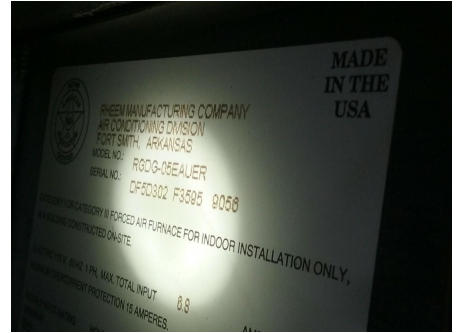
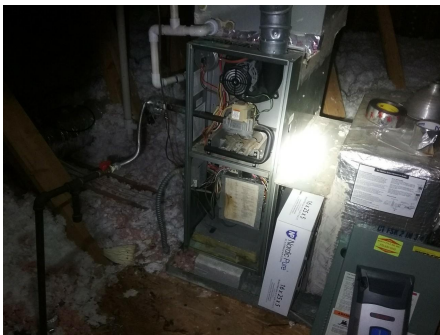
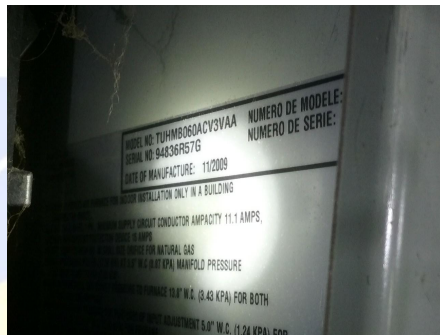
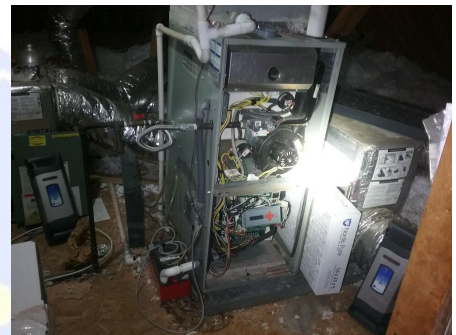
HEATING SYSTEM CONDITION

75: The system appears to be operating as designed.

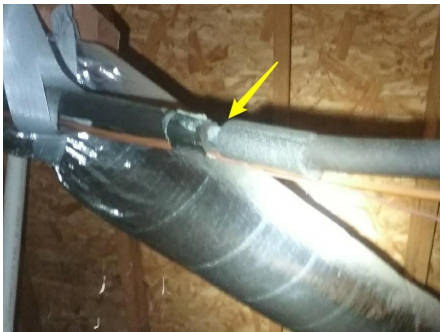
76: Damaged foam insulation was observed at the hvac high pressure pipe located at the attic hvac units. Recommend repair by a licensed general or hvac contractor.

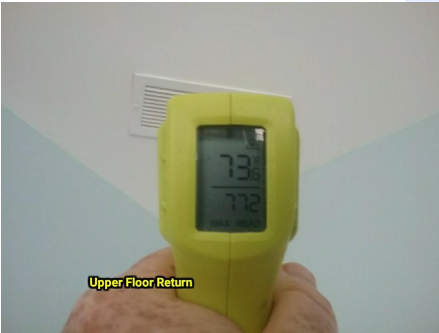
Upper Floor Serviceable In Cooling Mode

82: The system was operational as tested at the time of the inspection.

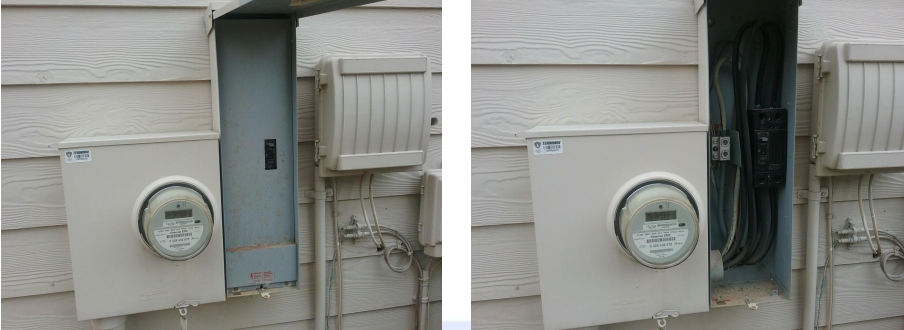
MAIN DISCONNECT

90: Inside the main electric panel.

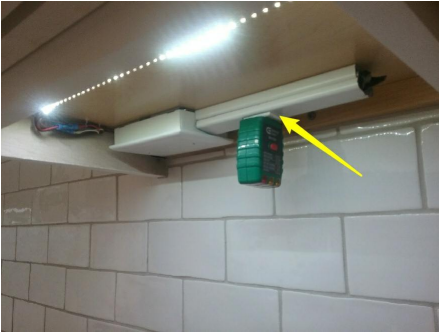
99: Outlet/s not working right of the kitchens electric range. Recommend repair by a licensed electrical contractor.

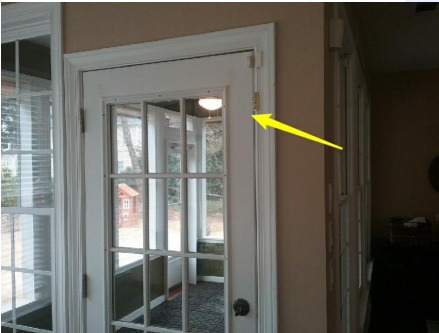
114: Rubbing doors were observed at the rear center and garages exterior doors and at the master bedrooms entrance door. Minor adjustment is recommended for proper operation by a licensed general contractor.

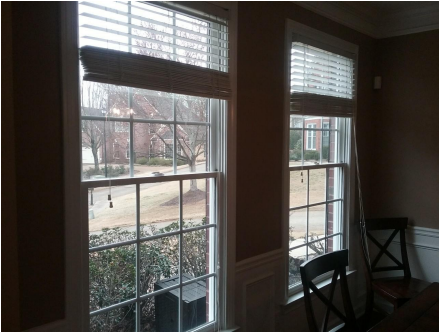
119: Some windows are sticking and hard to open or painted shut at various places of the home. This is a common problem especially when windows are not operated frequently or the inspection is conducted in humid conditions. There may be other problems such as broken springs or balances in some. We recommend having all windows operable prior to the final walkthrough.

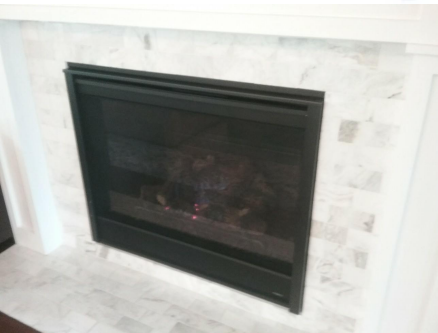
FIREPLACE DESCRIPTION

136: Direct vent gas fireplace. Keep small children away from the unit when operating as it gets very hot. Appears serviceable when tested.

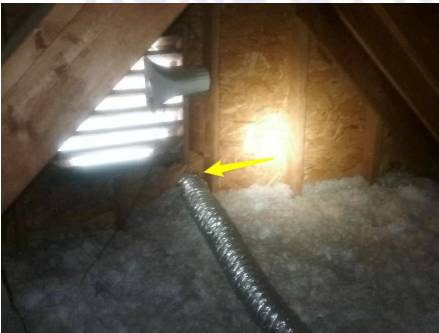
146: Bath fan(s) is improperly dumping the air into the attic rather than out of the building. Repairs are recommended by a qualified contractor.
