National Property Inspections

Dianna Newton, 1685 Stanwyck Terrace, Tucker, GA, 30084

Inspection Date:
02/18/2020

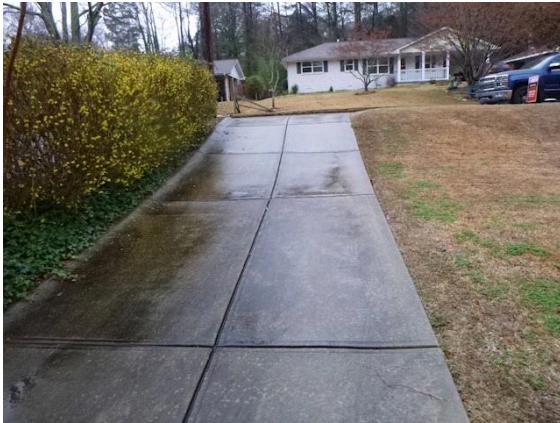
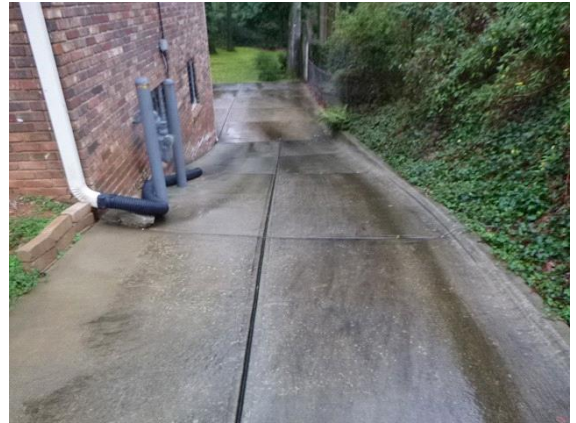
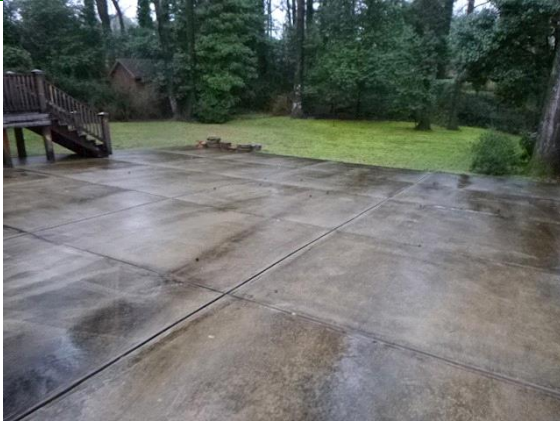
The left side concrete driveway is cracked and in general deteriorating due to age. Recommend repair of all cracked locations by a qualified contractor to avoid tripping hazards.

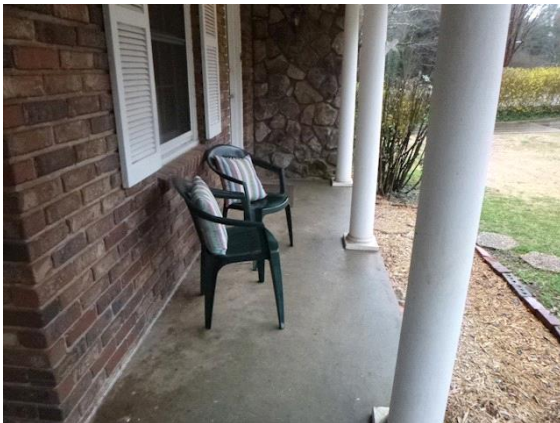
Porches / Stoops:

Wood rot observed on the bottom of the porch post trim on 2 of the posts. Recommend repair by a qualified contractor.

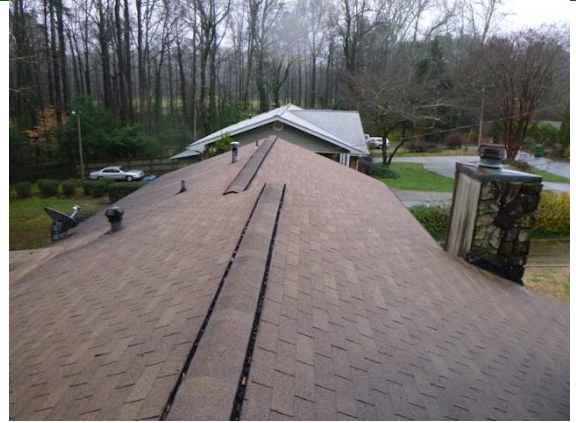
Roofing:

The roof above the deck is leaking in 2 locations where it connects to the main roof. This roof is sloped 1.5/12 and has standard 3-tab shingles. Roofs with a slope less than 3/12 should not use standard shingles according to the shingle manufacturers due to potential for leaks. Recommend a qualified roofing contractor evaluate and repair/replace the roof above the deck to prevent leaks.

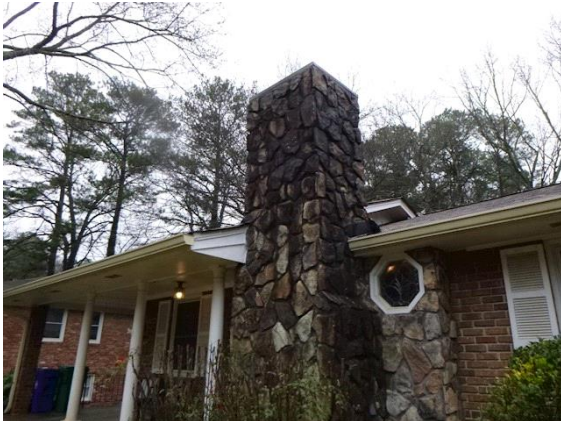
Chimney:

The back of the chimney is composed of wood siding. The siding is rotting. Recommend repair by a qualified contractor,

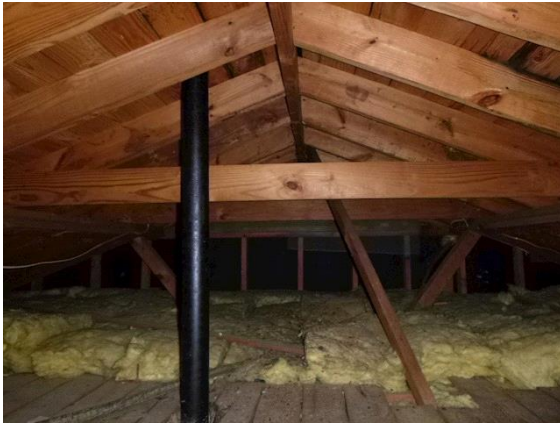
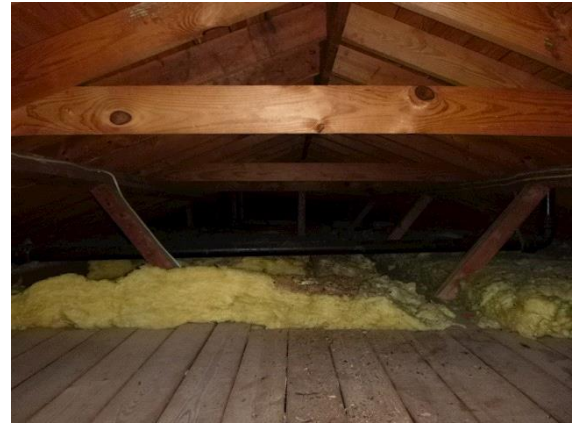
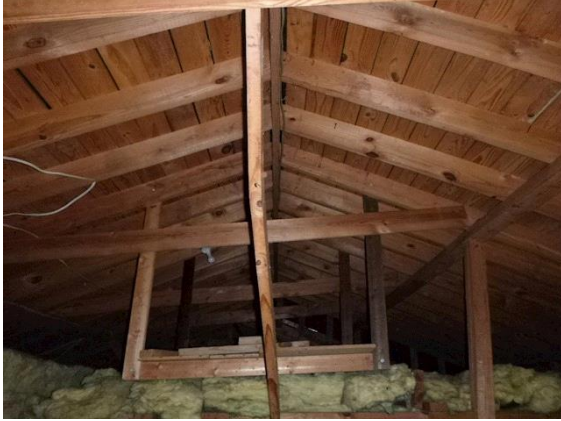
Roof leak and water stains on sheathing noted at the front right portion of the attic, water stains and suspected leak also noted above the hall bathroom. Recommend a qualified roofing contractor evaluate and repair to prevent leaks.

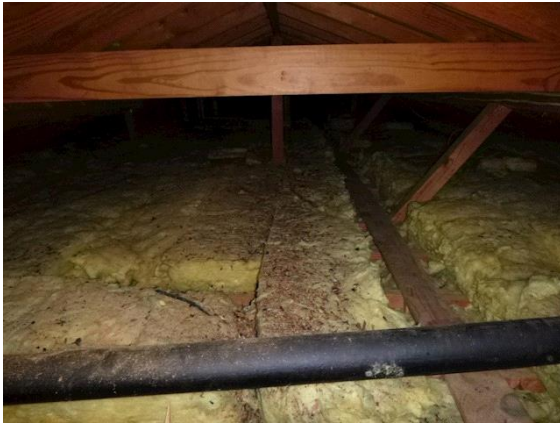
Attic Insulation:

Suspected nuisance pest activity is evident in the attic with tunnels in the insulation and droppings on top of the insulation. Unable to determine if activity is current or not. Recommend wildlife pest control inspection by a qualified contractor. Follow pest control contractor recommendations for repair/exclusion.

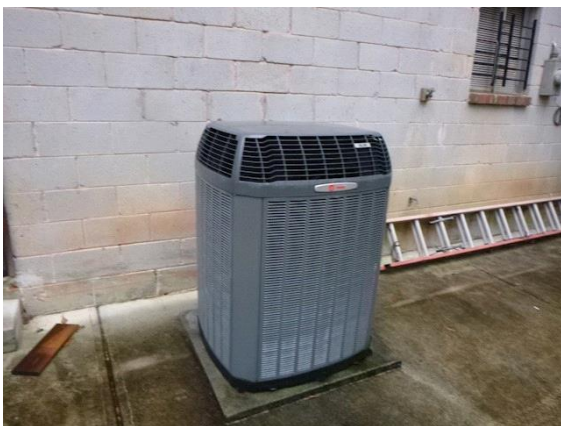
Cooling #1:

Unable to operate in cooling mode due to outdoor temperature below 60 degrees. Operation of unit at this temperature may damage compressor. Recommend re-testing when the temperature allows operation.
